## Utah Gas Corp. – Pumpjack Engine Emission Measurement Inspections – Uinta Basin, Utah Wellpads – On-Site Partial Compliance Evaluations (PCE)

**Inspection Dates:** 9/9/21

**Inspection Report Date:** 11/15/2021

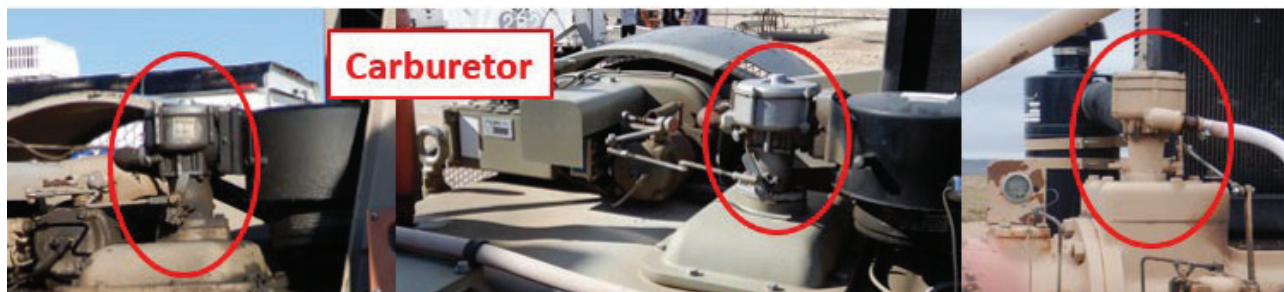
The fuel gas is routed to the carburetor where the air intake is also routed. The governor controls the engine speed and is linked to the carburetor.

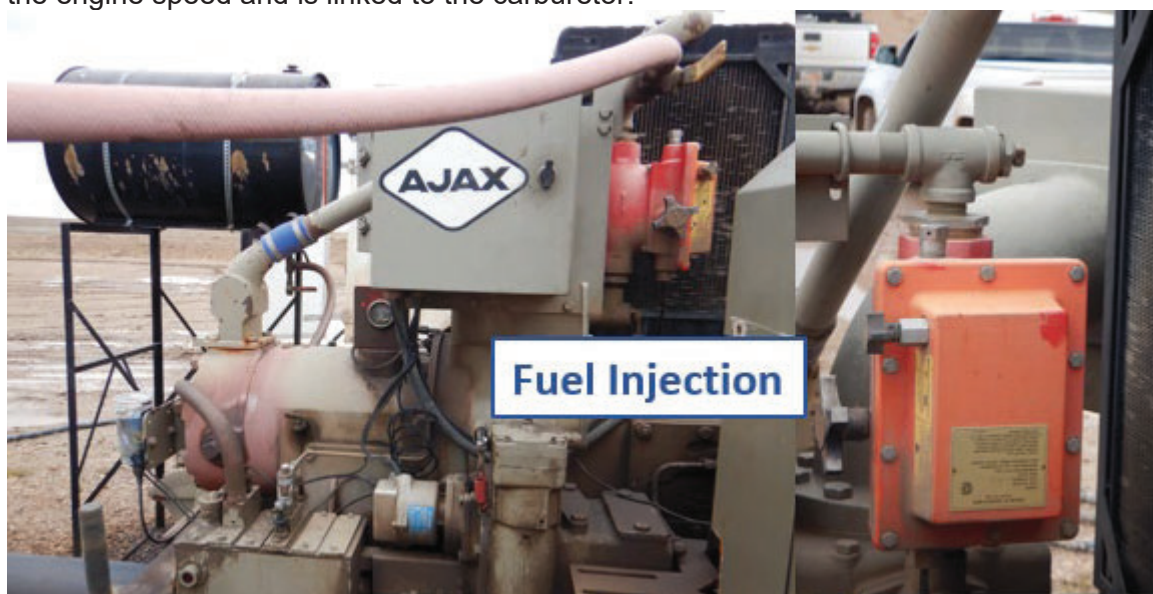
The "AJAX" control box + the red Murphy fuel control valve to the right of the AJAX box = fuel injection system.
