## Region 6 - Enforcement & Compliance Assurance Division

### INSPECTION REPORT

| Media Program: | RCRA Compliance Evaluation Inspection | |
| Company Name: | Monument Chemical | |

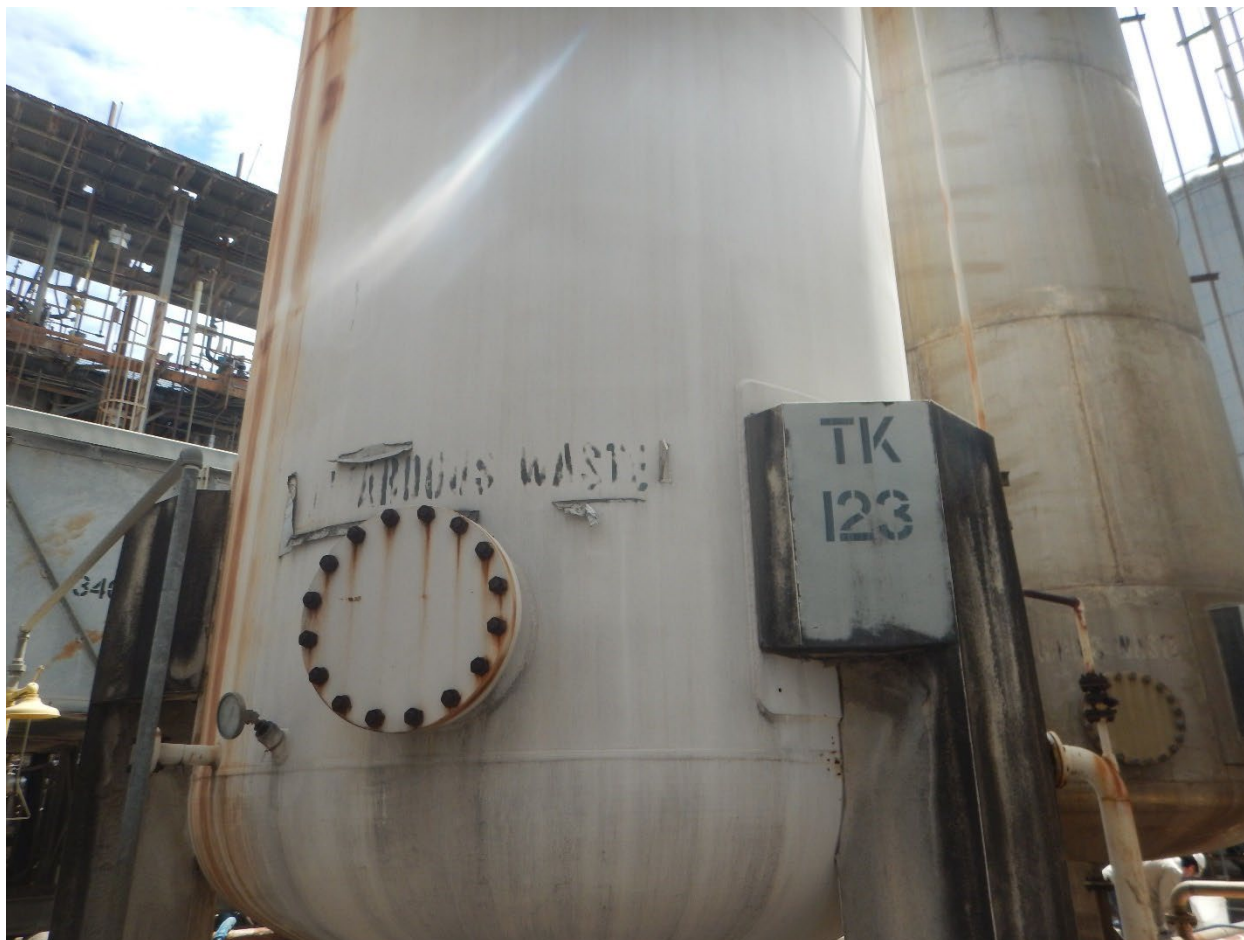
| Photo #: | DSCN1014 |

Six tanks are located at Tank Farm 1 which includes Tanks 119, 120, 121, 122, 123 and 124. Each has a capacity of 15,000 gallons. We observed that tank labeling was barely visible or nonexistent. (Appendix 1, Photos 1-3) We were told that Tank 119 is used to contain hazardous waste, however this tank was not labeled with a hazardous waste label. (Appendix 1, Photo 4)

| Description: Tank Farm 1: Trace of Hazardous waste label at tank 123. | |

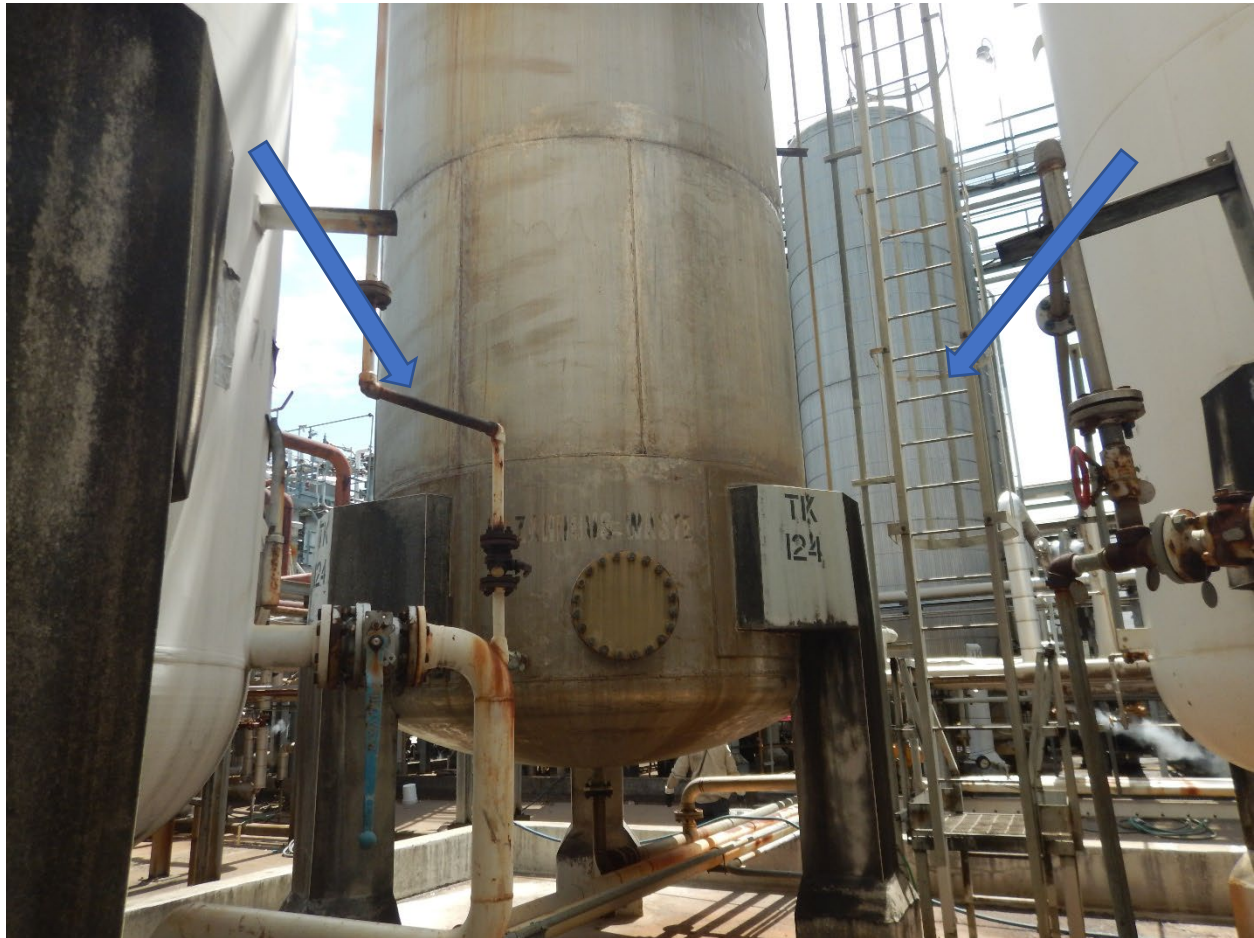
| Photo #: | DSCN1015 |

| Description: Tank Farm 1: Trace of Hazardous waste label at tank 124. | |

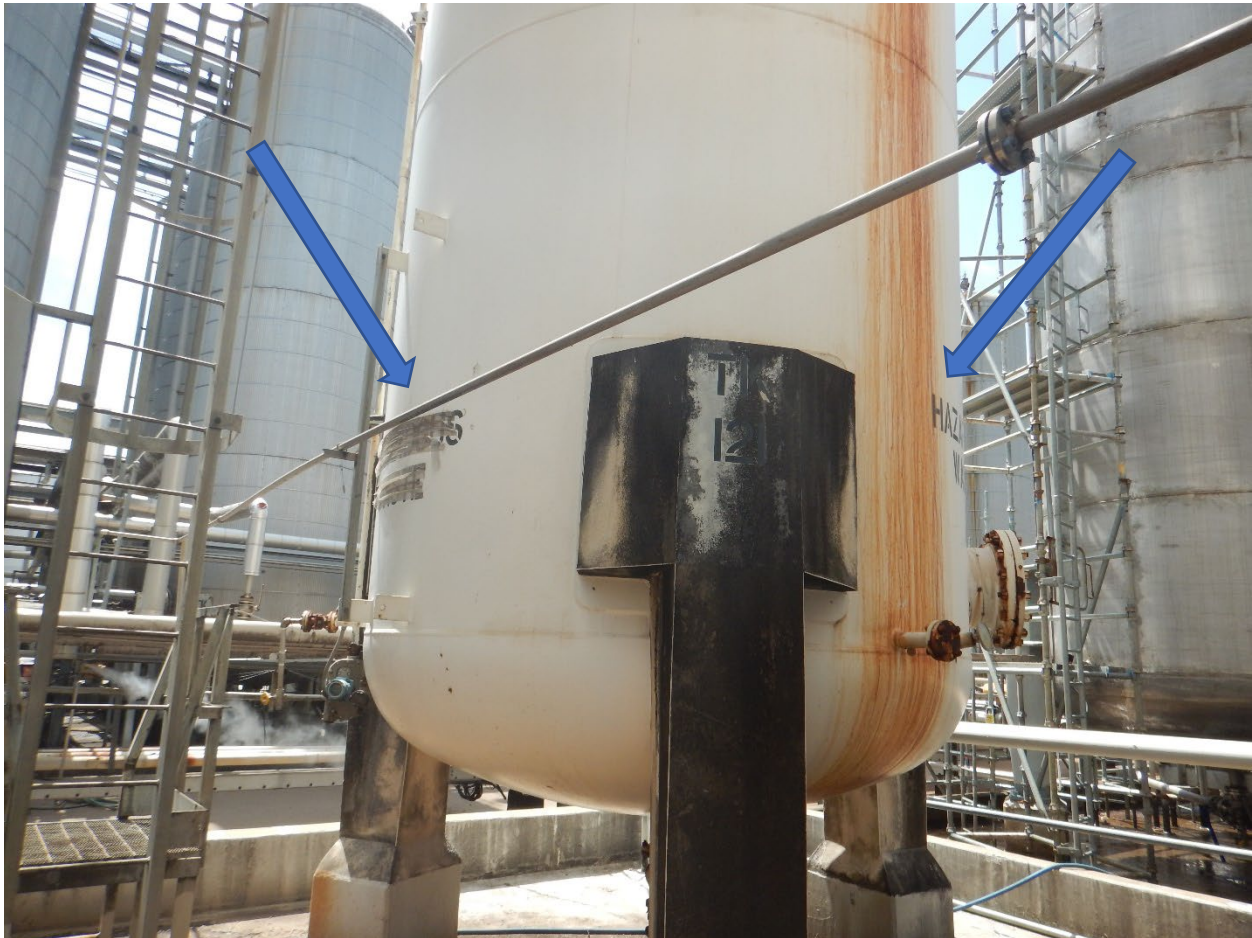
| Photo #: | DSCN1016 |

| Description: Tank Farm 1: Hazardous waste labels on Tank units- worn and not maintained | |

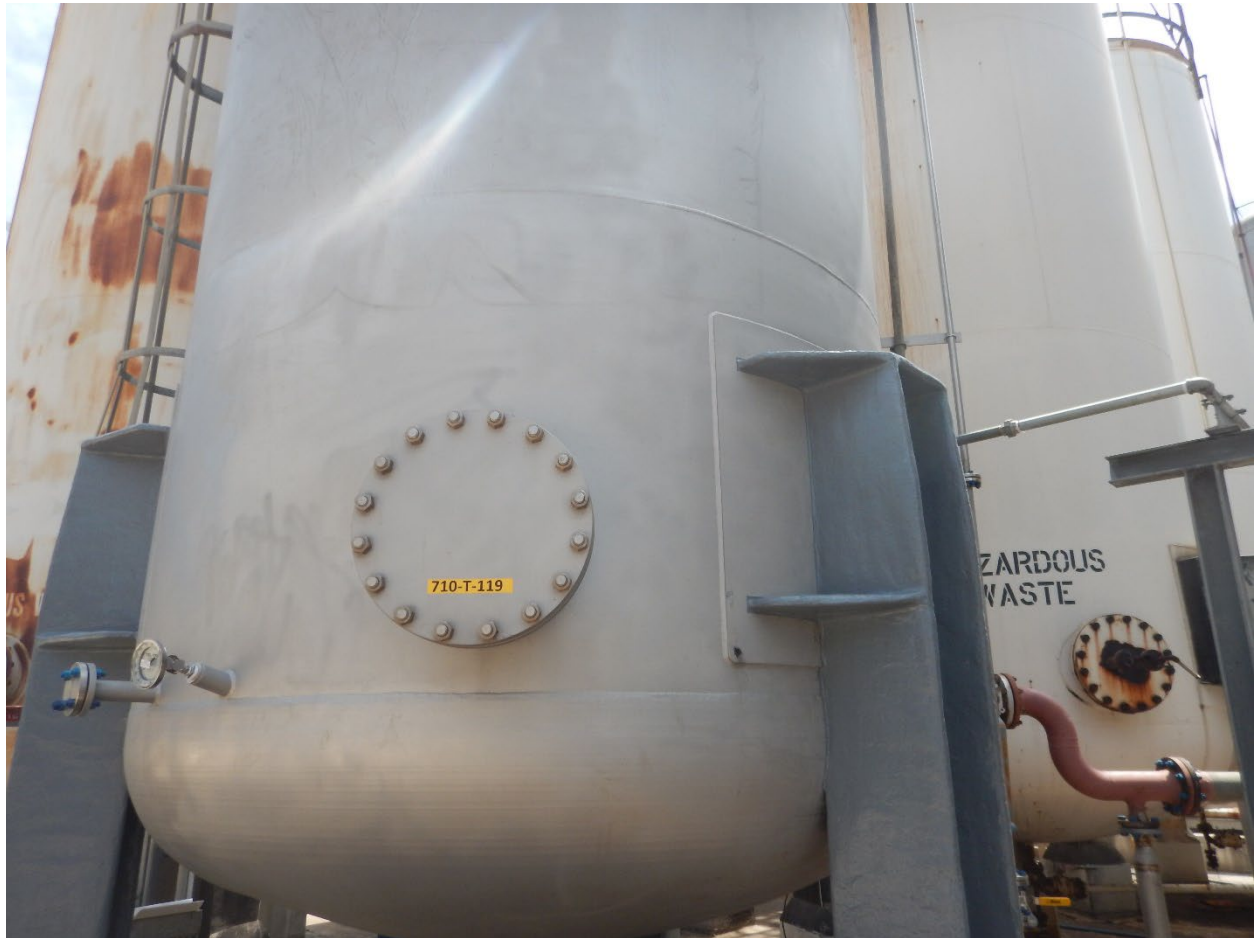
| Photo #: | DSCN1018 |

| Description: Tank Farm 1: Closeup view of Tank 119 which contains Hazardous Waste but is not labeled. | |

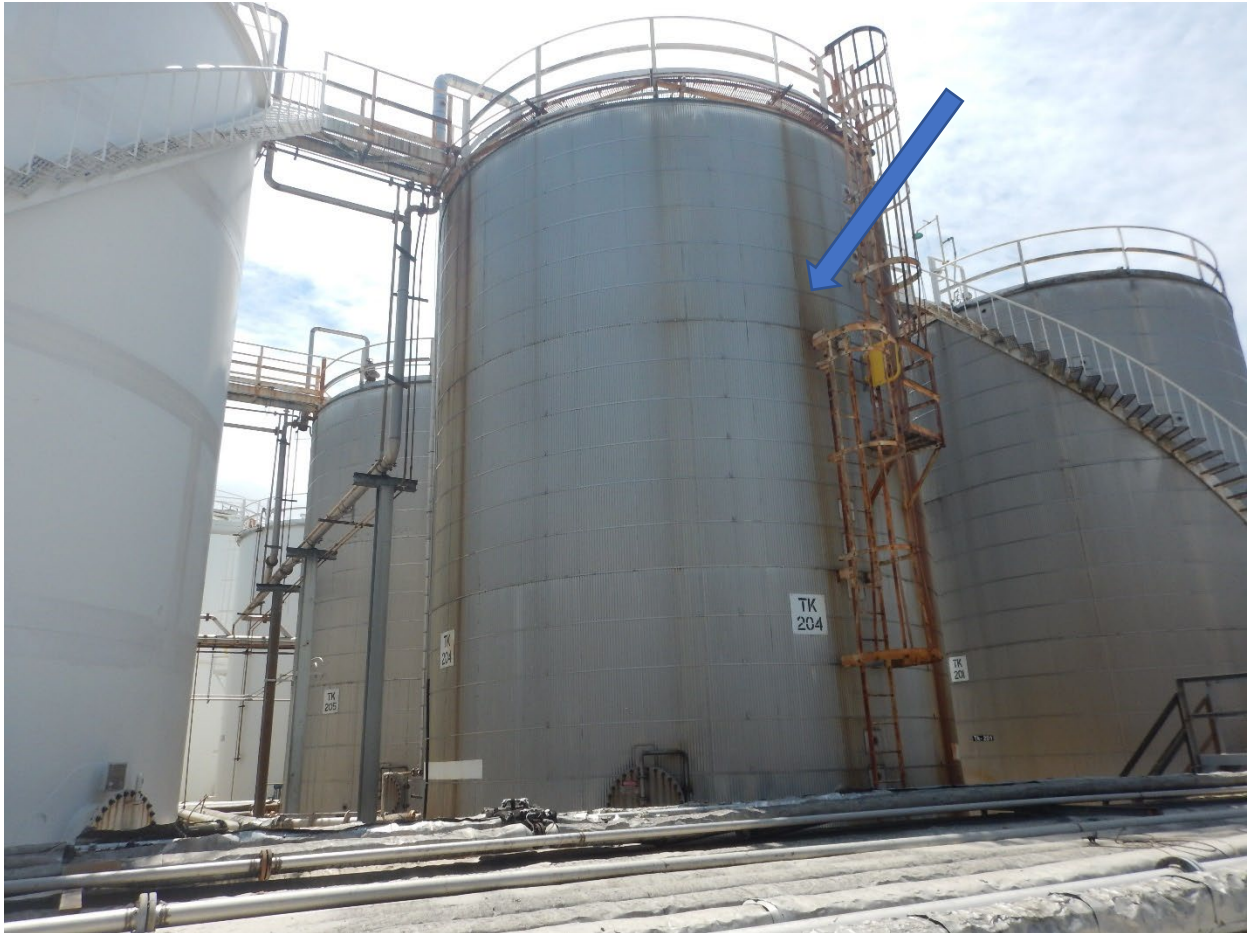
| Photo #: | DSCN1021 |

Five tanks are located at Tank Farm 2 which includes Tanks 204, 207, 208, 210 and 211. We observed that Tanks 204, 207, 208 and 211 contained hazardous waste without proper labels. (Appendix 1, Photo 5 & 6). In addition, Tank 204 has been operating without registration since March 28, 2012. We noticed Tank 211 Pressure Relief Valve (PRV) had a work order in place for a release. We inspected all PRV's of Tank Farm 1 and Tank Farm 2. We used the photoionization detector provided by the facility. No readings were of concern and closure devices appeared to be secured in the closed positions (Appendix 1, Photo 15)

- The facility was using Tank 204 to manage hazardous waste without active registration. State records show it was deactivated on March 28, 2012.
- We observed a hazardous waste drum with an open bung at the SAA which was corrected immediately by Monument (40 CFR 262.15(4)).
- We observed gaps and cracks in the secondary containment area at Tank Farm 2. The facility has reported on May 12, 2023 that the repairs of secondary containment area is close to completion (40 CFR 265.193(e)(iii)).
- We observed that the facility failed to properly label a container in the laboratory and hazardous waste tanks 119, 122, 123, 124, 204, 207, 208 and 211 with appropriate hazardous waste labeling. The facility added the labeling during the inspection (40 CFR 262.17(a)(5)(i) and (ii)).

| Description: Tank Farm 2: Hazardous waste Tank 204 without proper label. | |

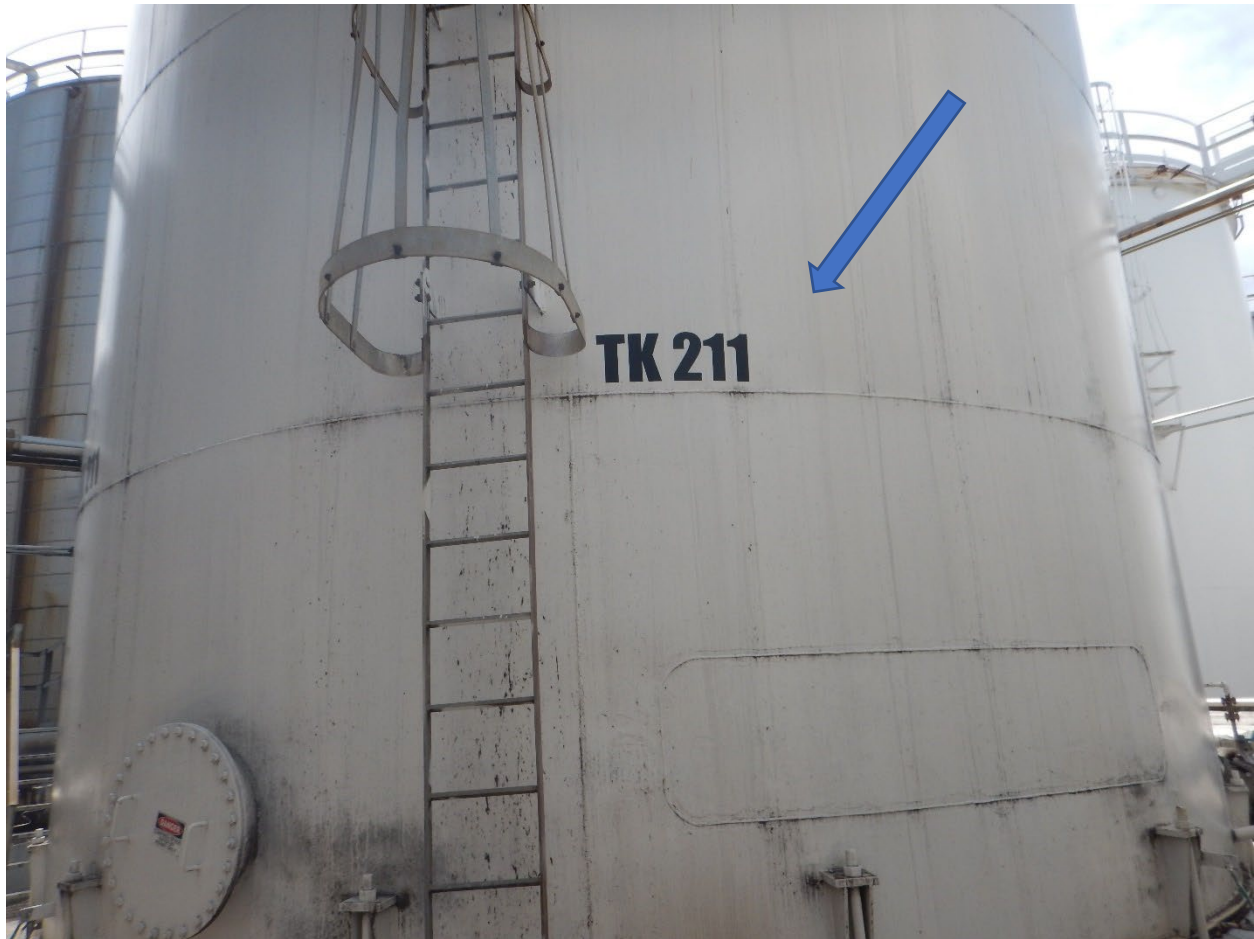
| Photo #: | DSCN1024 |

We observed an active spill being contained using synthetic sorbent pads at the base of tank 211. (Appendix 1, Photos 6-7).

| Description: Tank Farm 2: Close view of Hazardous waste Tank 211 | |

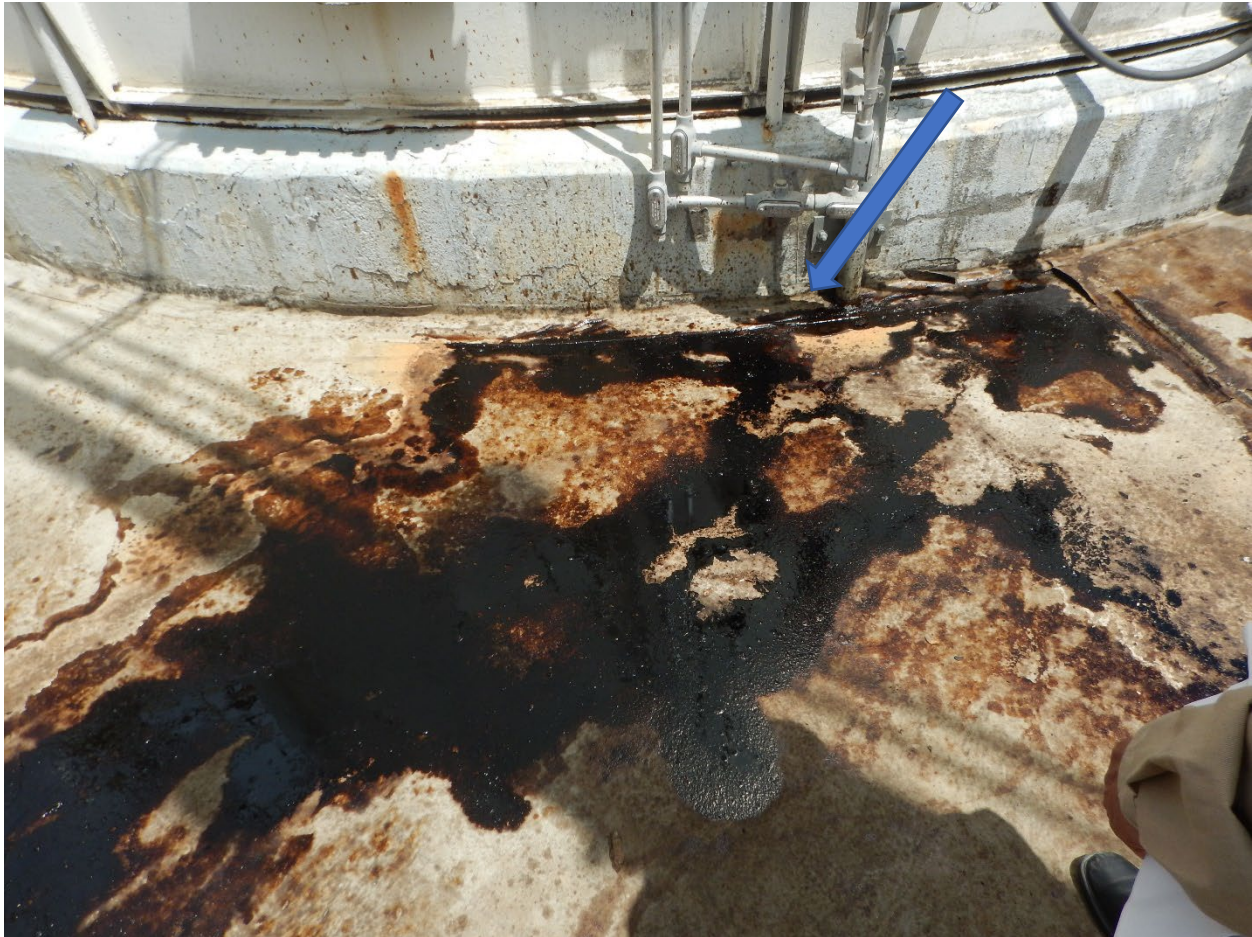
| Photo #: | DSCN1023 |

- Further investigation is required to rule out the possibility of hazardous waste spill at WTU1 and from Tank 211 and within the secondary containment of Tank Farm 2.
- Characterization and management of tank filters is a pending concern.
- We observed multiple buckets staged near CAA that were not characterized at the point of generation or labeled as either hazardous or non-hazardous waste (40 CFR 262.11).

| Description: Tank Farm 2: Rear view of Hazardous waste Tank 211 showing spill of waste. | |

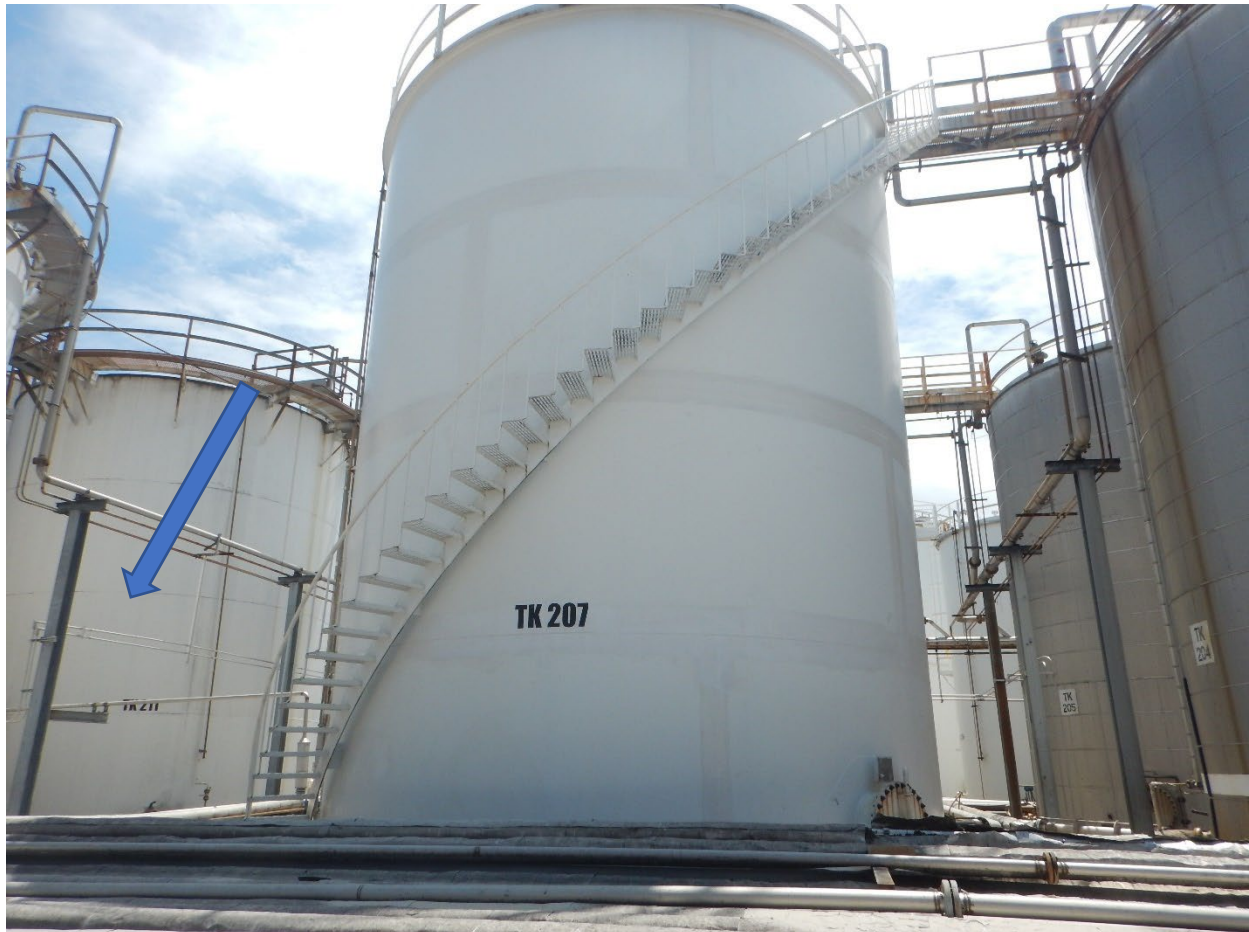
| Photo #: | DSCN1022 |

| Description: Tank Farm 2: Hazardous waste Tank 207 and Tank 211 without proper label. | |

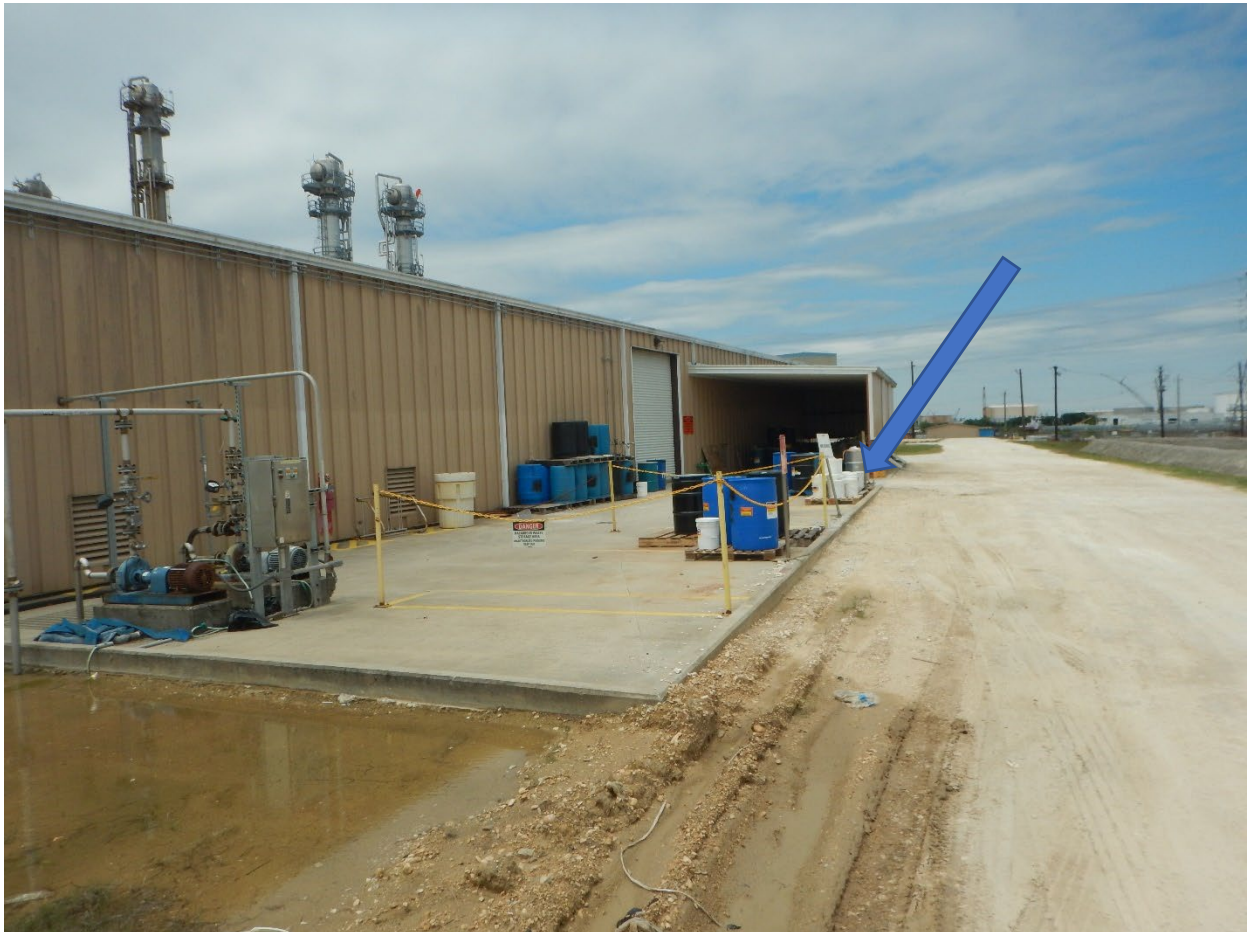
| Photo #: | DSCN1026 |

All drums located at the CAA were properly managed. However, we saw multiple five-gallon buckets of waste staged next to the CAA of not yet designated as hazardous waste and non-hazardous waste. They were collected from different points of generation within the facility. We informed the facility that a waste determination should be done at the source of generation. (Appendix 1, Photo 9).

| Description: Waste buckets staged near CAA without labeling to indicate waste as hazardous or non-hazardous | |

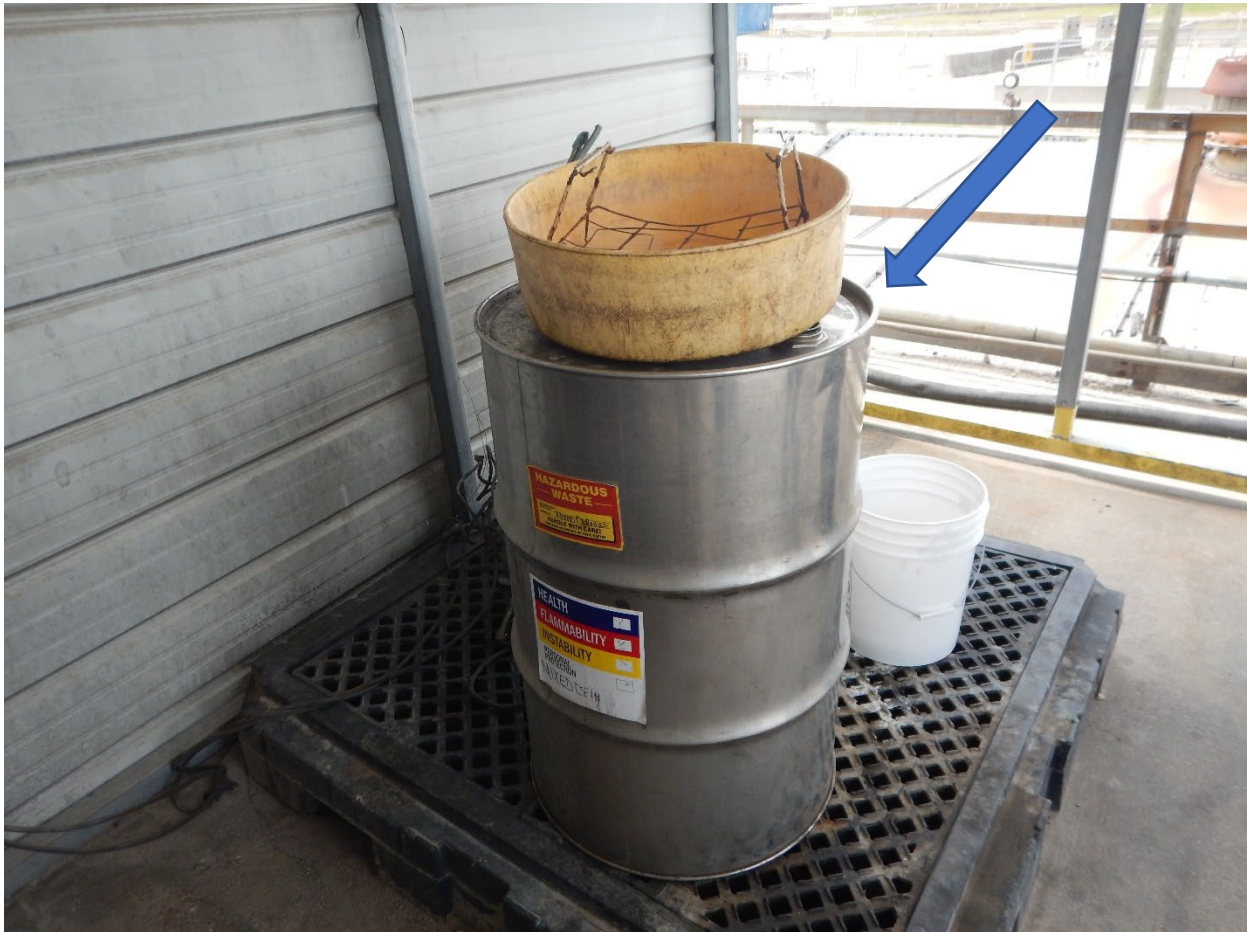
| Photo #: | DSCN1029 |

We observed a hazardous waste drum with an unsecured bung at the SAA. (Appendix 1, Photos 10-11).

| Description: Hazardous waste container at SSA without properly secured bung | |

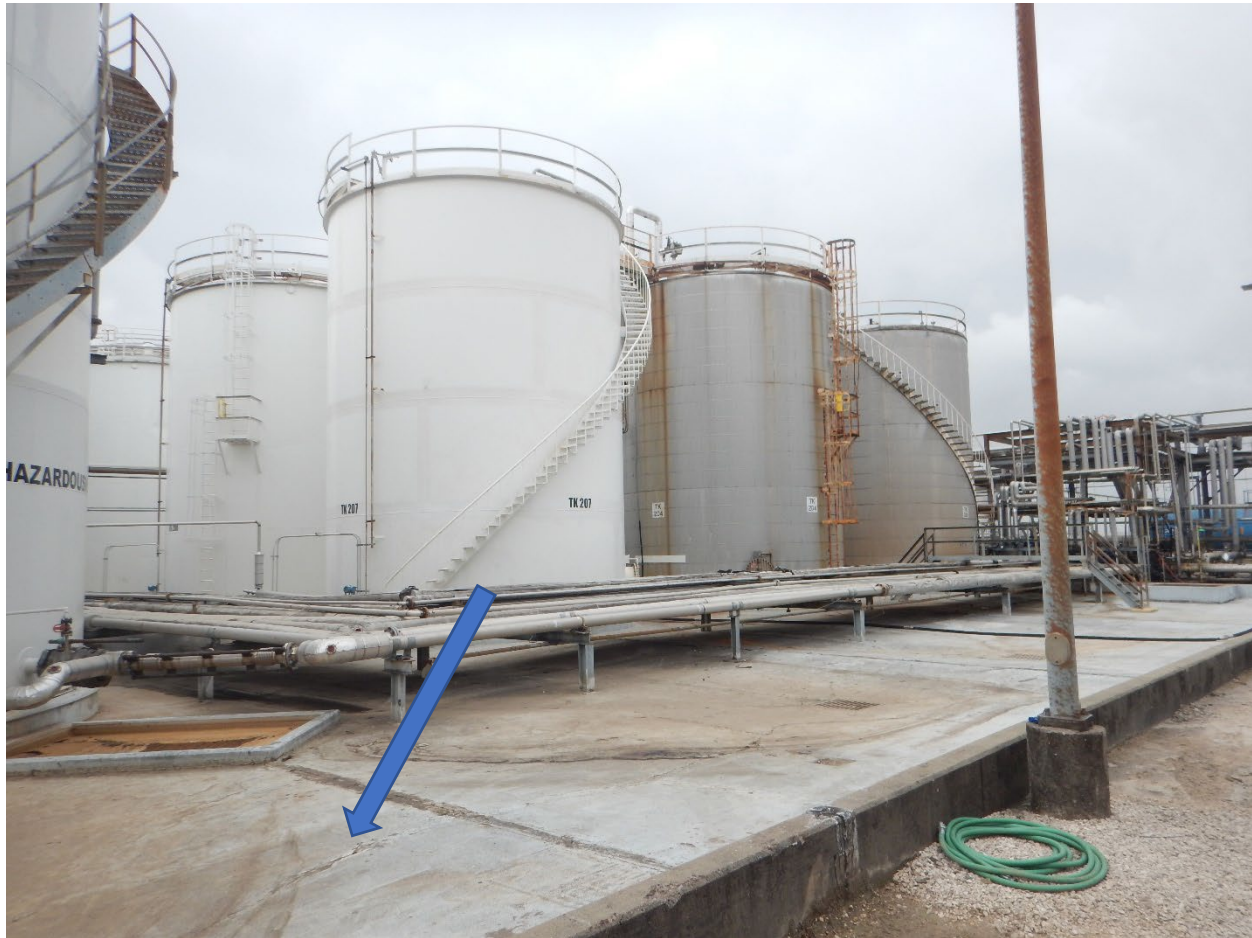
| Photo #: | DSCN1032 |

We conducted another walkthrough of Tank Farm 1 and 2 and we were told tank 210 in Tank Farm 2 and 119 in Tank Farm 1 contained hazardous waste. No issues were found with the tanks. These tanks have dedicated pumps that use filters. Evaluation of the filters as a managed waste, once removed, is required. We observed a gaps and cracks in the secondary containment area of Tank Farm2. (Appendix 1, Photo 13-14)

| Description: Overview of Secondary Containment Area associated with Tank Farm 2. Cracks and wearing observed. | |

- Few gaps seen in the secondary containment area CFR 40 264.193(e)  
Tanks 204 and 211 are missing labels for Hazardous Waste CFR 40 262.17
  - Need to inspect 90 days accumulation timeline.

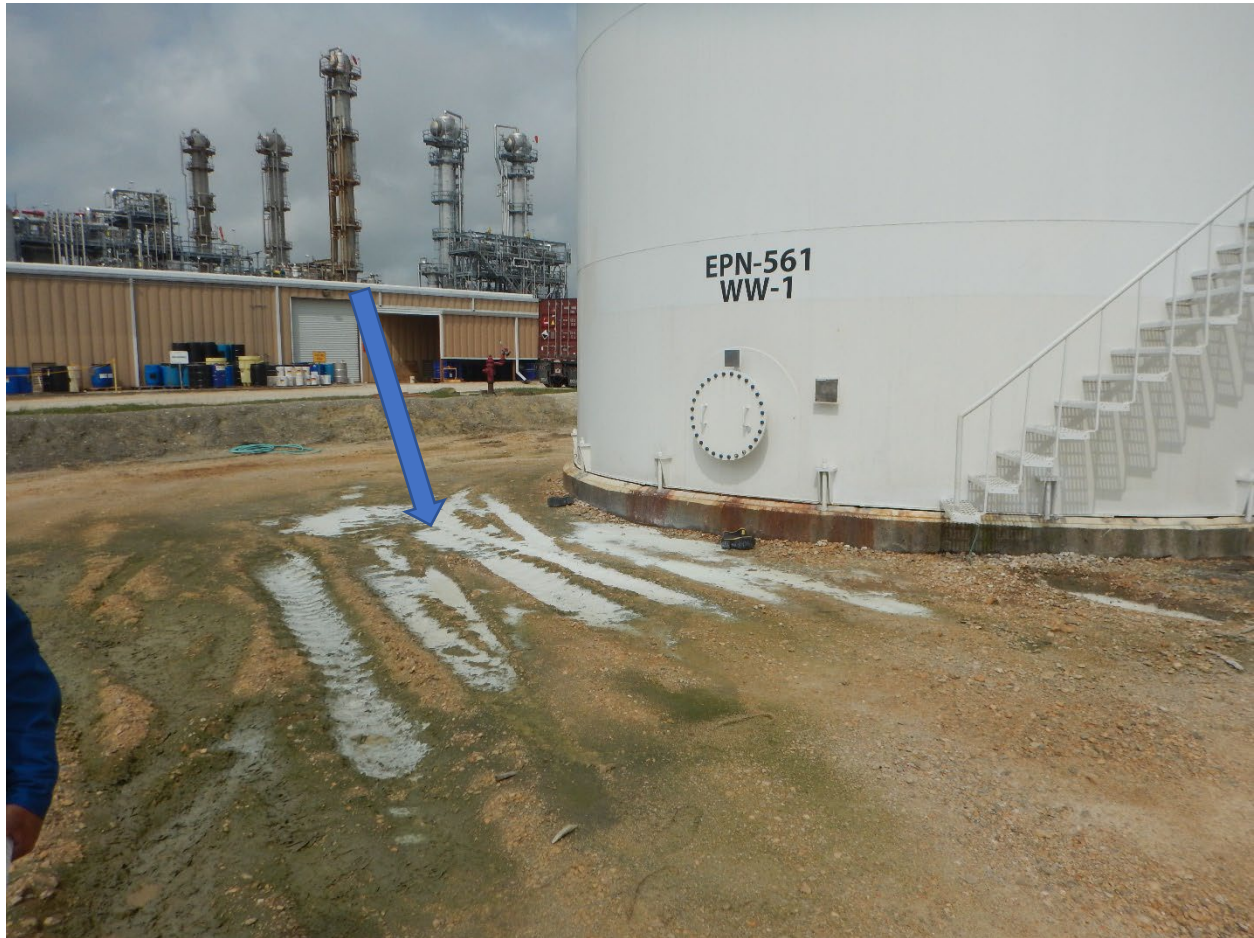
| Photo #: | DSCN1037 |

The WTU includes Tank 561 (WTU1), Tank 562 (WTU2) and Tank 563 (Equalization Tank). Processed wastewater is stored in tanks 140, 206, 303 and 164, however, the facility needs to verify the contents of these tanks. Wastewater from tanks C301A, 316, 216 and 317 are discharged to POTW. The WTU is inspected yearly by Gulf Coast Water Authority. We found a spill of unknown white substance at WTU1. Monument claimed it to be a caustic soda. (Appendix 1, Photo 16).
