Compliance Evaluation Inspection Report
Martin Luther King Jr. Federal Courthouse
50 Walnut Street, Newark, NJ 07102
09/04/2024

Compliance Evaluation Inspection

Facility Name: Martin Luther King Jr. Federal Courthouse
Facility Address: 50 Walnut Street, Newark, NJ 07102
Latitude & Longitude: 40.72974350433418, -74.17313012192682

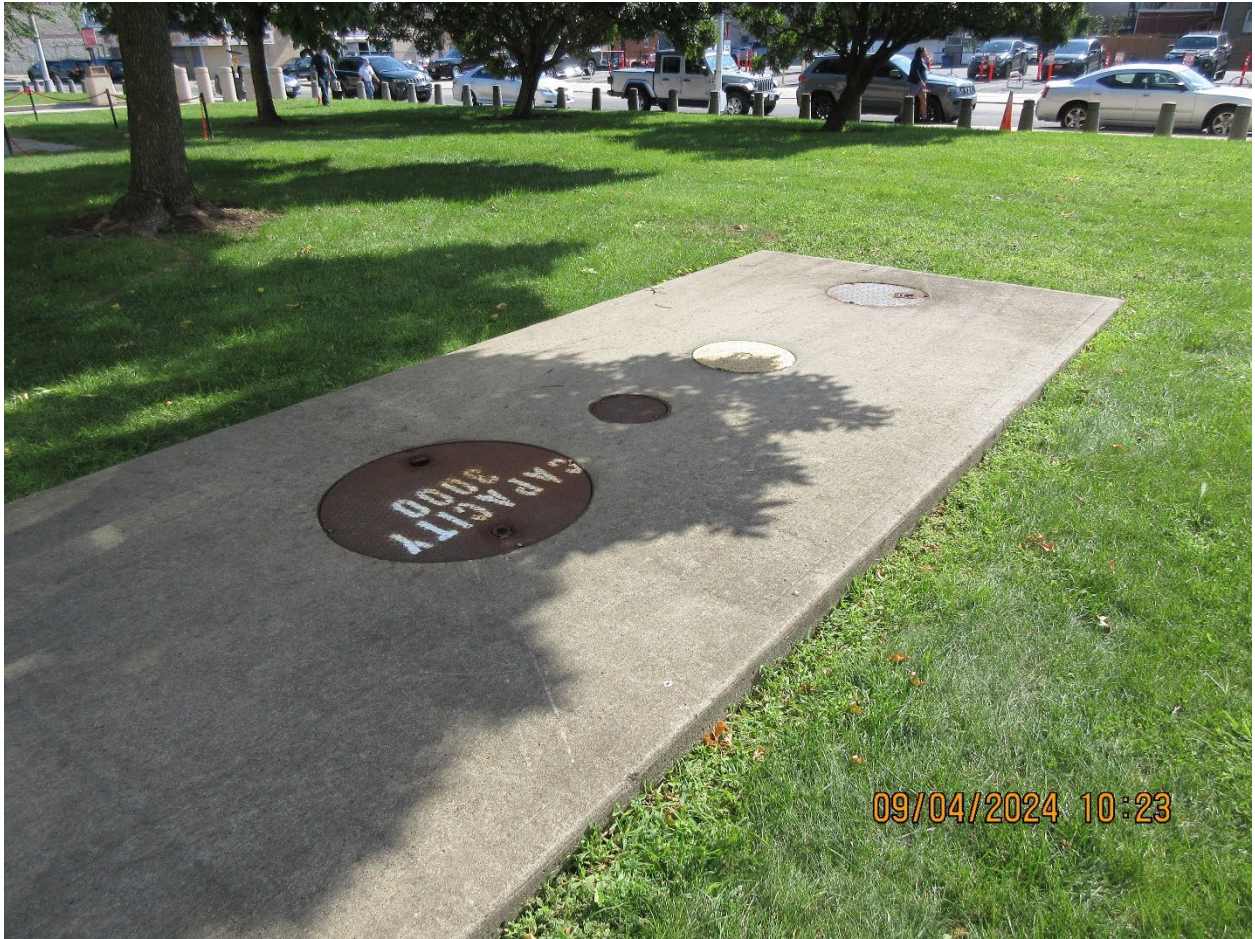
Photo 1 – Sumps for UST facing Mulberry Street

We were first escorted outside of the building to the grass lawn on the Eastern side of the courthouse facing Mulberry Street where we met with Tom Beere, the Chief Operating Engineer and Class C-operator. The UST is a 3,000-gallon No.3 diesel tank built in April 2009 (Photo #1). It is a double-walled, cathodically protected (STI-P3) steel tank with interstitial monitoring for release detection. The piping was safe-European suction and double-walled. The containment sump was opened (Photo #2) and contained product pipes as well as a sump sensor (Photo #3). Though not visually confirmed, leaks in double-walled piping should return to the containment sump where it would be detected by the sump's liquid sensor (Photo #4). No liquid or debris was observed within the containment sump.

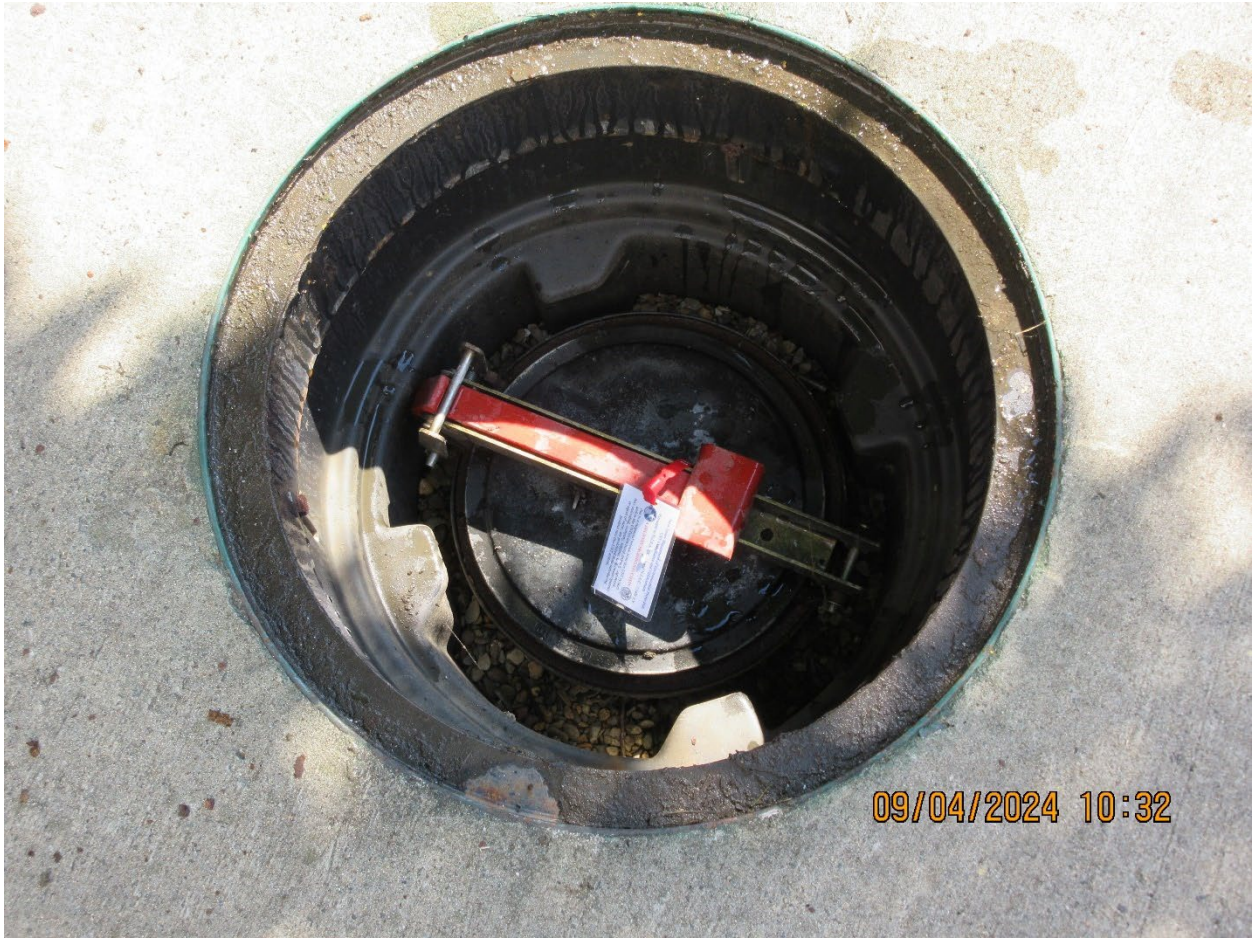
Photo 5 – Fill port and spill bucket

The fill port was then opened (Photo #5), revealing that the tank had a fuel delivery prohibition placed on it by the New Jersey Department of Environmental Protection (NJDEP). This fuel delivery tag (Photo #6) stated that "due to a suspected release from this UST system and/or the UST(s) not being properly registered. Any individual, company, supplier, tank owner/operator or agent of same, are prohibited from introducing product into this UST system." When asked about this, Mr. Beere stated that the tag was placed on the tank due to the "day tank not being connected to the ATG (automatic tank gauge)." Subsequent correspondence with representatives from the NJDEP on 9/9/2024 confirmed that the delivery prohibition was put in place because "They have one emergency generator day tank that doesn't have an interstitial sensor installed. They also do not have an UST registration with [the NJ DEP] so the tanks were

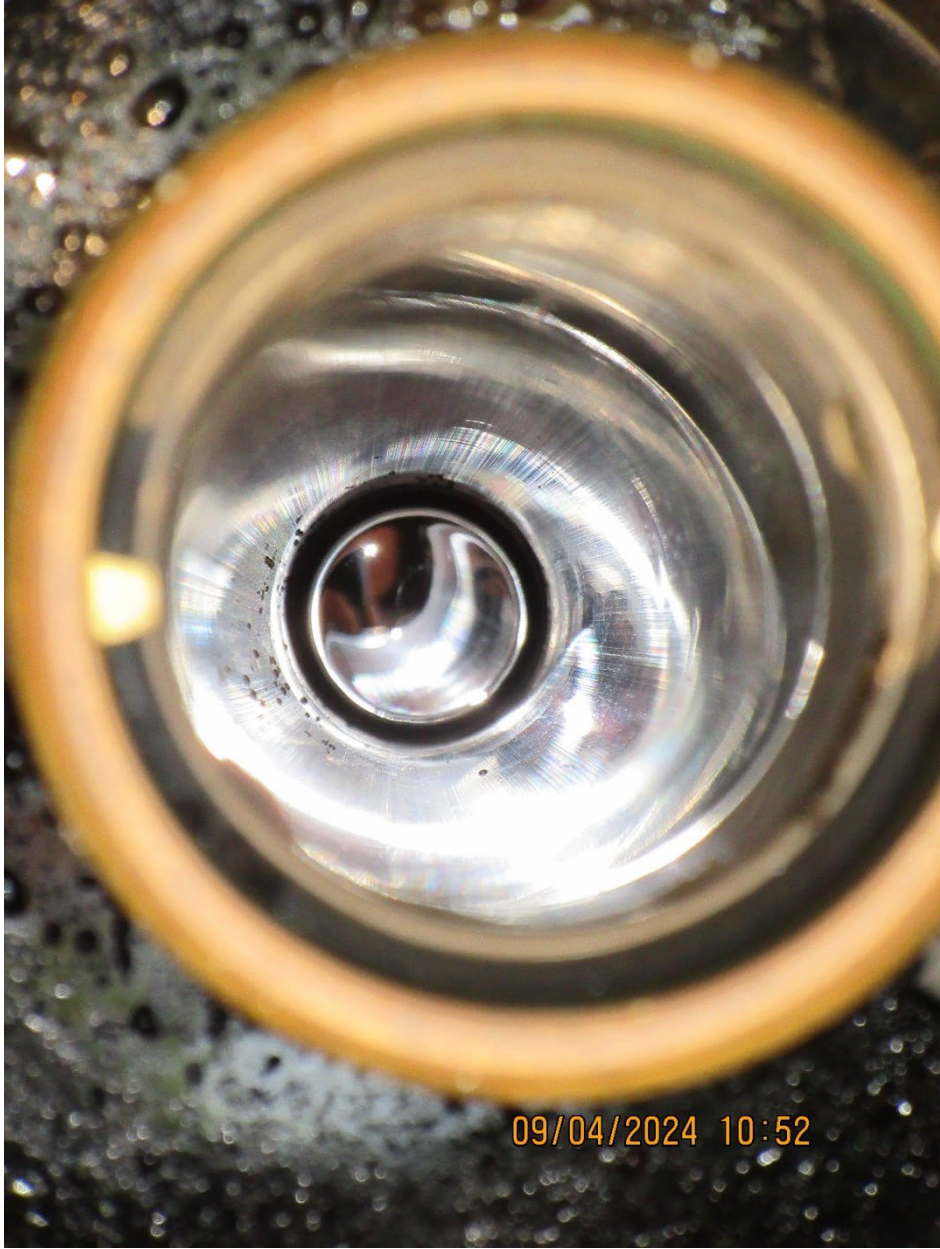
Photo 7 – Fuel delivery pipe interior

tagged.” We asked the facility to temporarily remove the tag so we could observe the inside of the fuel pipe. From this we observed that there was no flapper valve or ball float valve present in the system (Photo #7). There was no liquid or debris observed to be present within the spill bucket. The delivery tag was placed back on top of the fill port before we left.

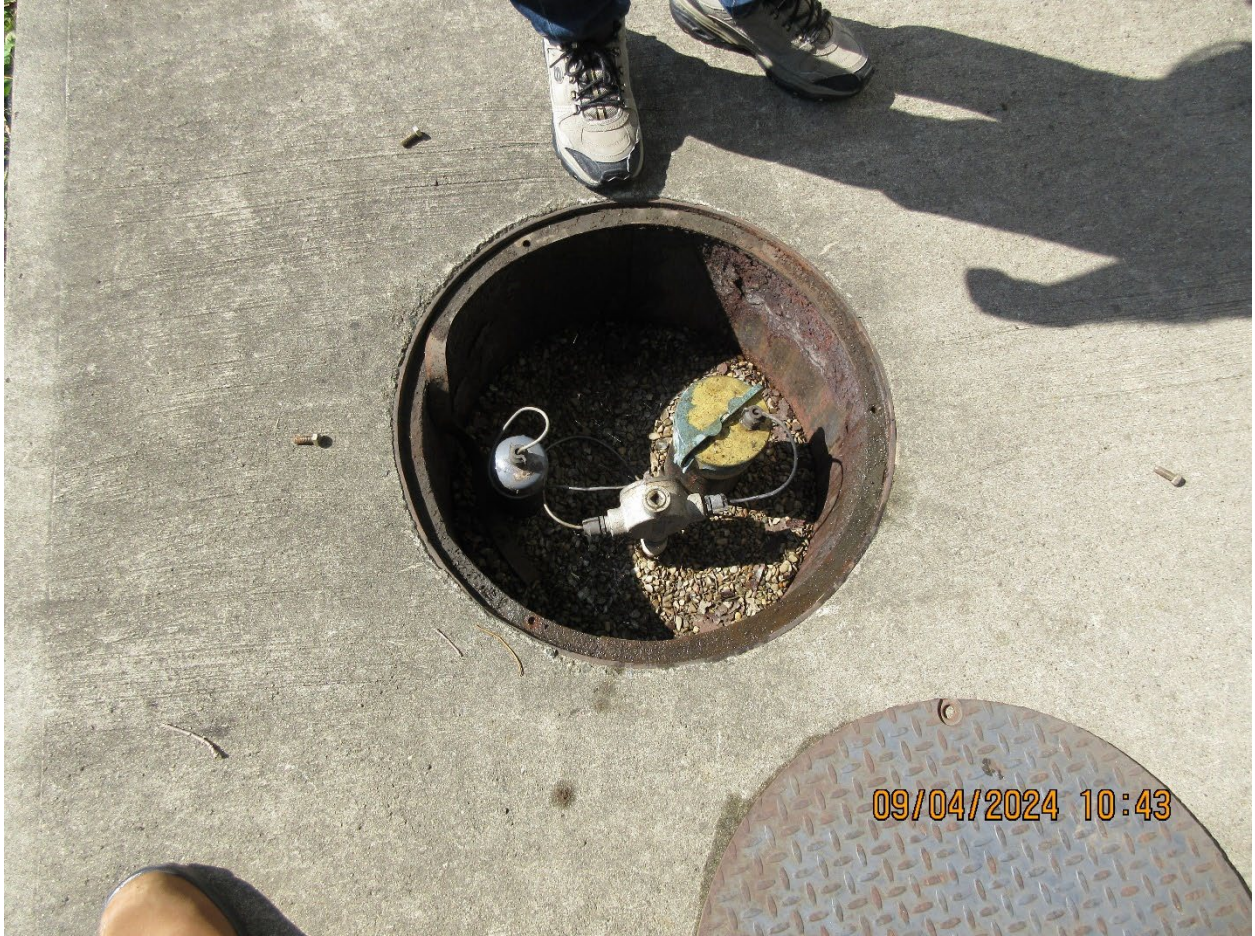
Photo 8 – Access port for ATG and HLA sensors

Located closest to the street was an access port for the ATG and high-level alarm (HLA) sensors. This access port contained no spill containment as no product or fill pipes existed within it (Photo #8). A secondary access port, located between the containment sump and the fill port, contained another pipe access for the tank but was not designed for filling (Photo #9). The pipe only went part way down into the tank and its purpose was unclear (Photo #10). The HLA was located on the wall of the facility directly adjacent to the UST (Photo #11). It was tested and was clearly audible from the filling location.

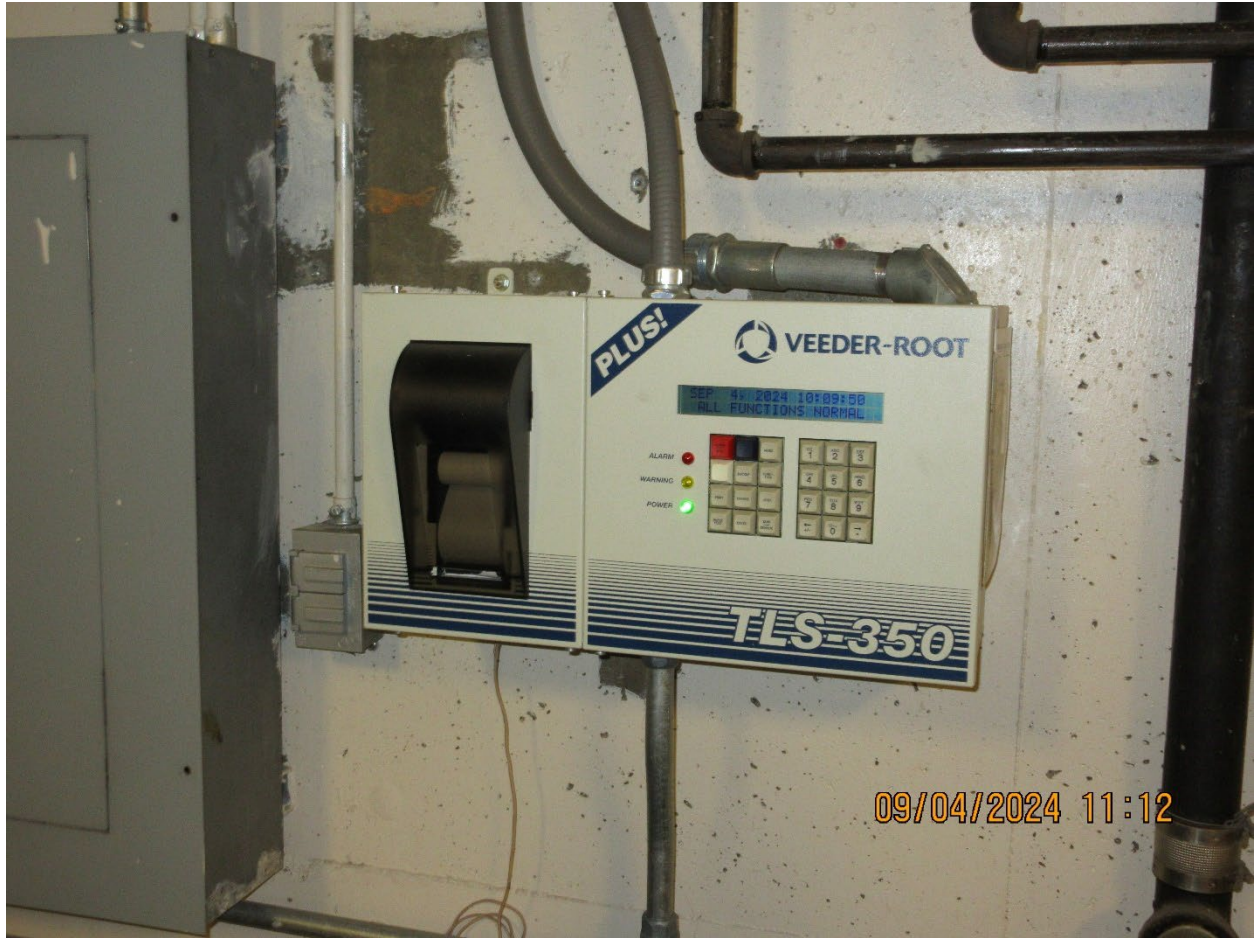
Photo 12 – Automatic tank gauge

We were then led to the pump and ATG room, located on the bottom floor of the facility on the side of the building facing Mulberry Street. The ATG was a Veeder-Root TLS-350 with an “All Functions Normal” message displaying on the screen (Photo #12). Print outs from the ATG showed that the interstitial and sump sensors were functioning normally and that the last leak test on September 4th, 2024, was invalid because “LEAK TEST TOO SHORT.” Located to the right of the ATG was the pump (Photo #13). Product pipes to the pump came from the exterior wall (Photo #14). From the pump on, the product pipes go upwards towards the roof of the facility (Photo #15) where the emergency generator is. These pipes seem to have some form of double-wall with an open valve on the bottom (Photo #16).

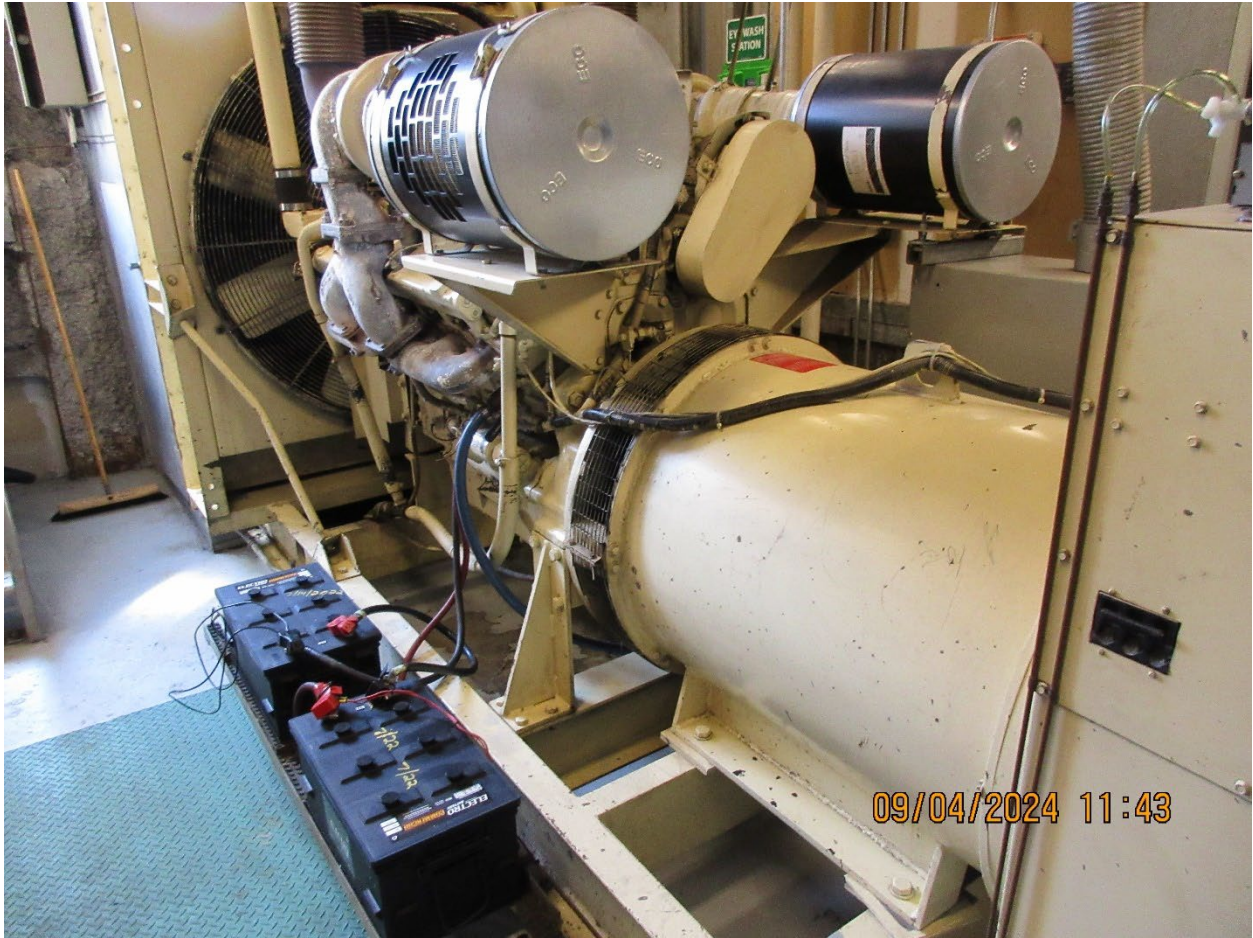
Photo 17 – Emergency generator

Finally, we were led to the roof of the facility, where the emergency generator was located within a concrete room (Photo #17). The day tank, located across from the generator, had secondary containment but no electronic liquid sensor to detect leaks (Photo #18). We then exited the facility around 12:00 pm.
