## **RCRA Inspection Report**

Mankiewicz Coatings LLC  
1200 Charleston Regional Parkway  
Charleston, South Carolina 29492

EPA ID# SCR000783035

December 15, 2022, at 9:15 a.m. EDT

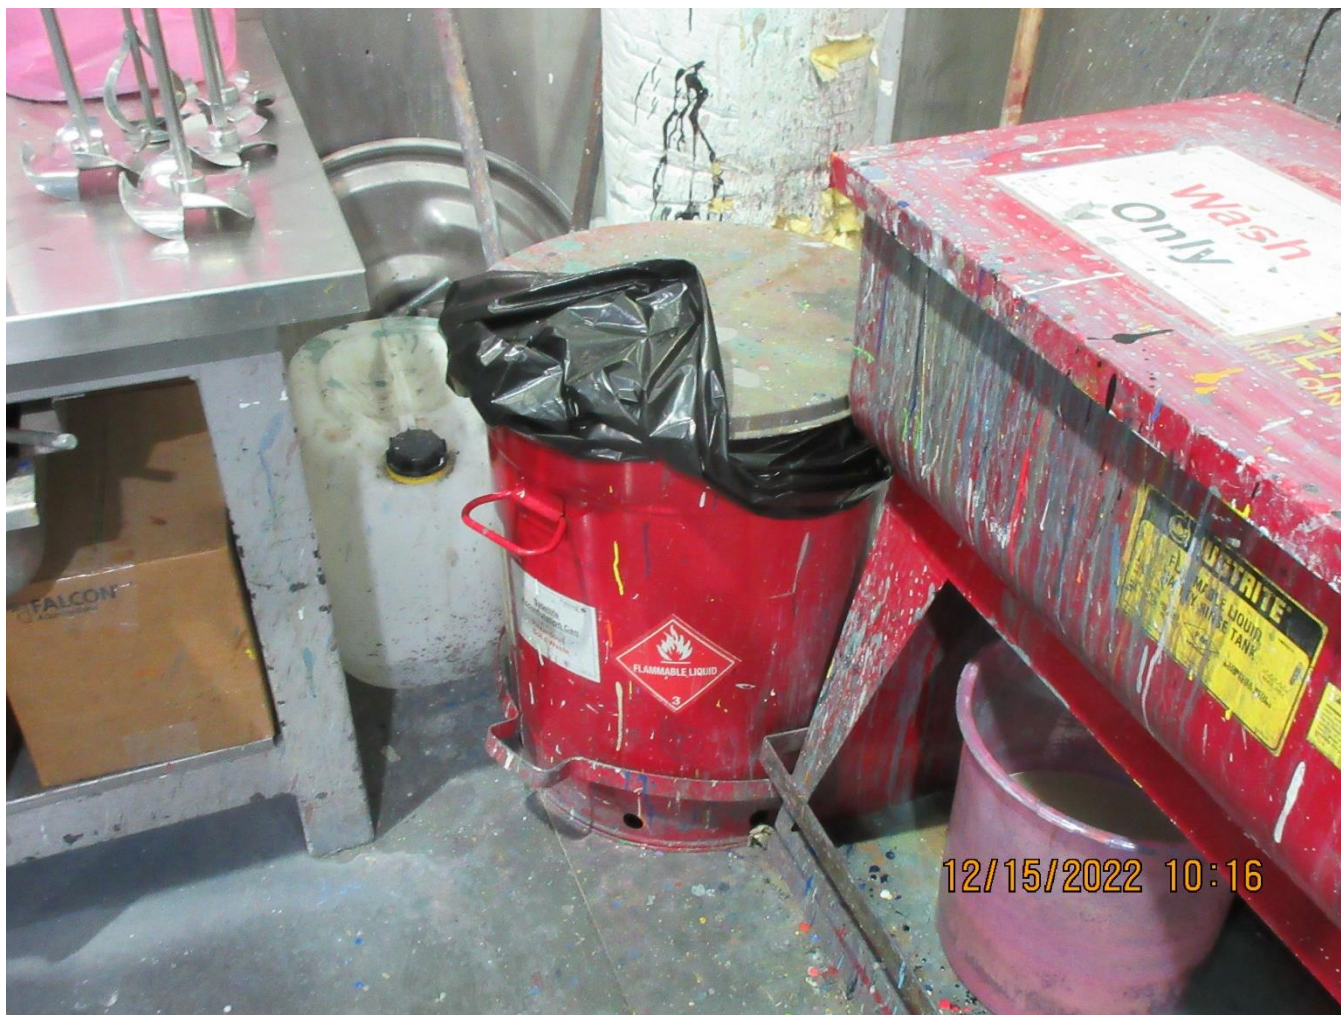
One 20-gallon container, used for the collection of hazardous waste solids (D001/F003), was observed in a SAA next to a solvent cleaning machine containing acetone. (Photo 1).

Photo 1 – 12-gallon container of hazardous waste solids in Tinting Area

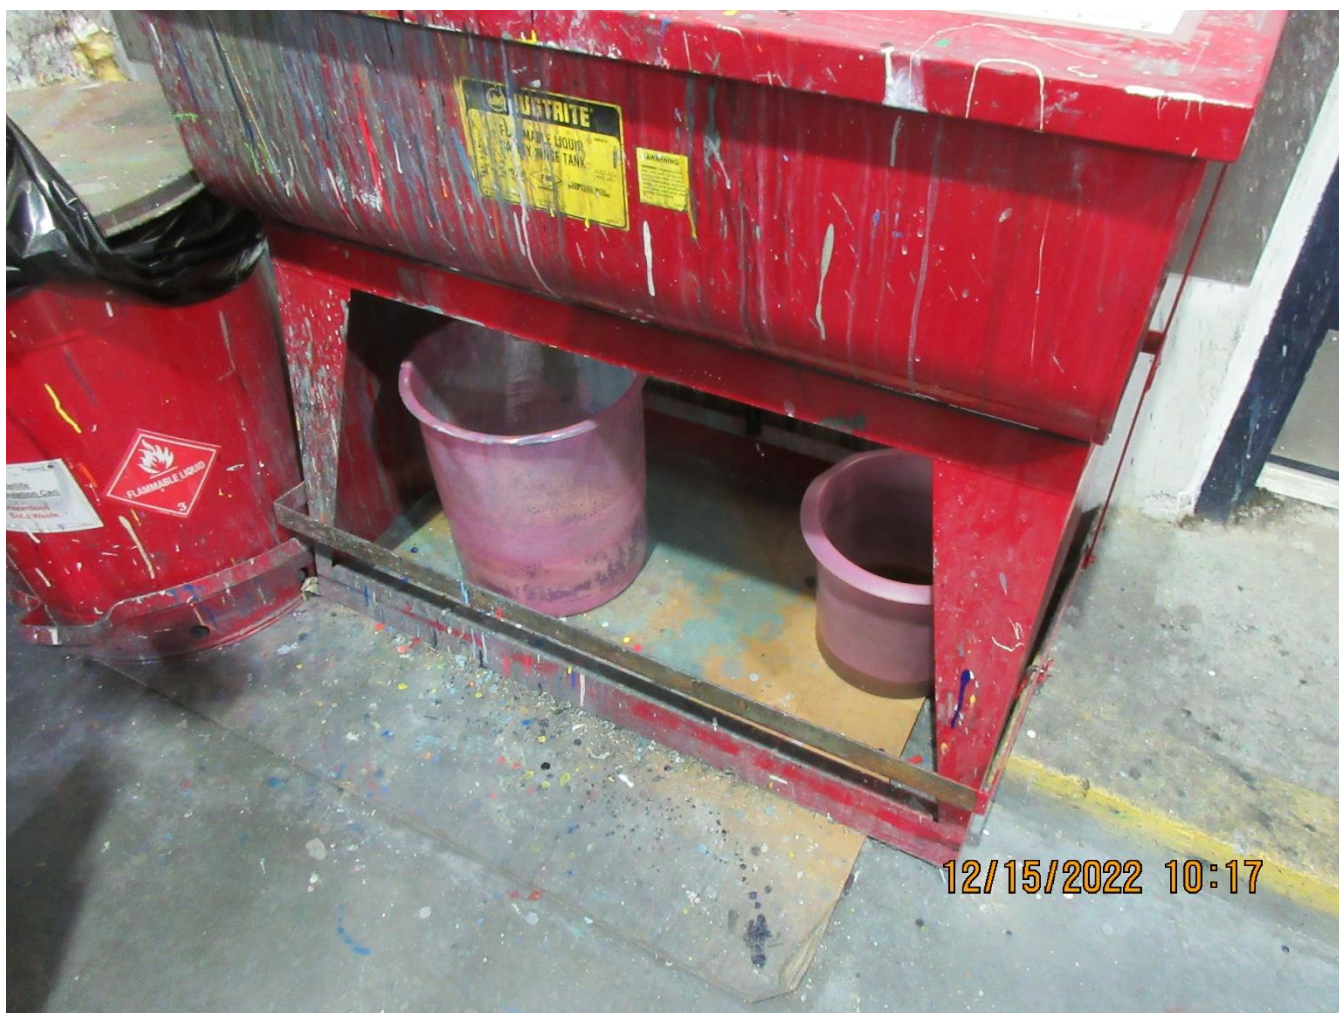
Beneath the acetone solvent cleaning machine, the inspectors observed two open and unlabeled containers of spent acetone solvent (Photo 2). One of the two containers had a volume of 6.4-gallons (12-inch diameter, 13-inch height) and was observed with 5-inches of spent solvent. The other container had a volume of 2.5-gallons (9-inch diameter, 9-inch height) and was observed with 2-inches of spent solvent within the container.

Photo 2 – Containers of in-use solvents beneath solvent cleaning machine in the Tinting Area

**Pursuant to S.C. Code Ann. Regs. 61-79.262.15(a)(5) [40 C.F.R. § 262.15(a)(5)], which is a condition of the SAA Permit Exemption, a generator is required to mark or label its containers (i) with the words “Hazardous Waste” and (ii) with an indication of the hazards of the contents.**

**Pursuant to S.C. Code Ann. Regs. 61-79.262.15(a)(4) [40 C.F.R. § 262.15(a)(4)], which is a condition of the SAA Permit Exemption, a generator is required to keep containers of hazardous waste closed at all times during accumulation, except when adding, removing, or consolidating waste; or when temporary venting of a container is necessary for the proper operation of equipment, or to prevent dangerous situations, such as build-up of extreme pressure.**

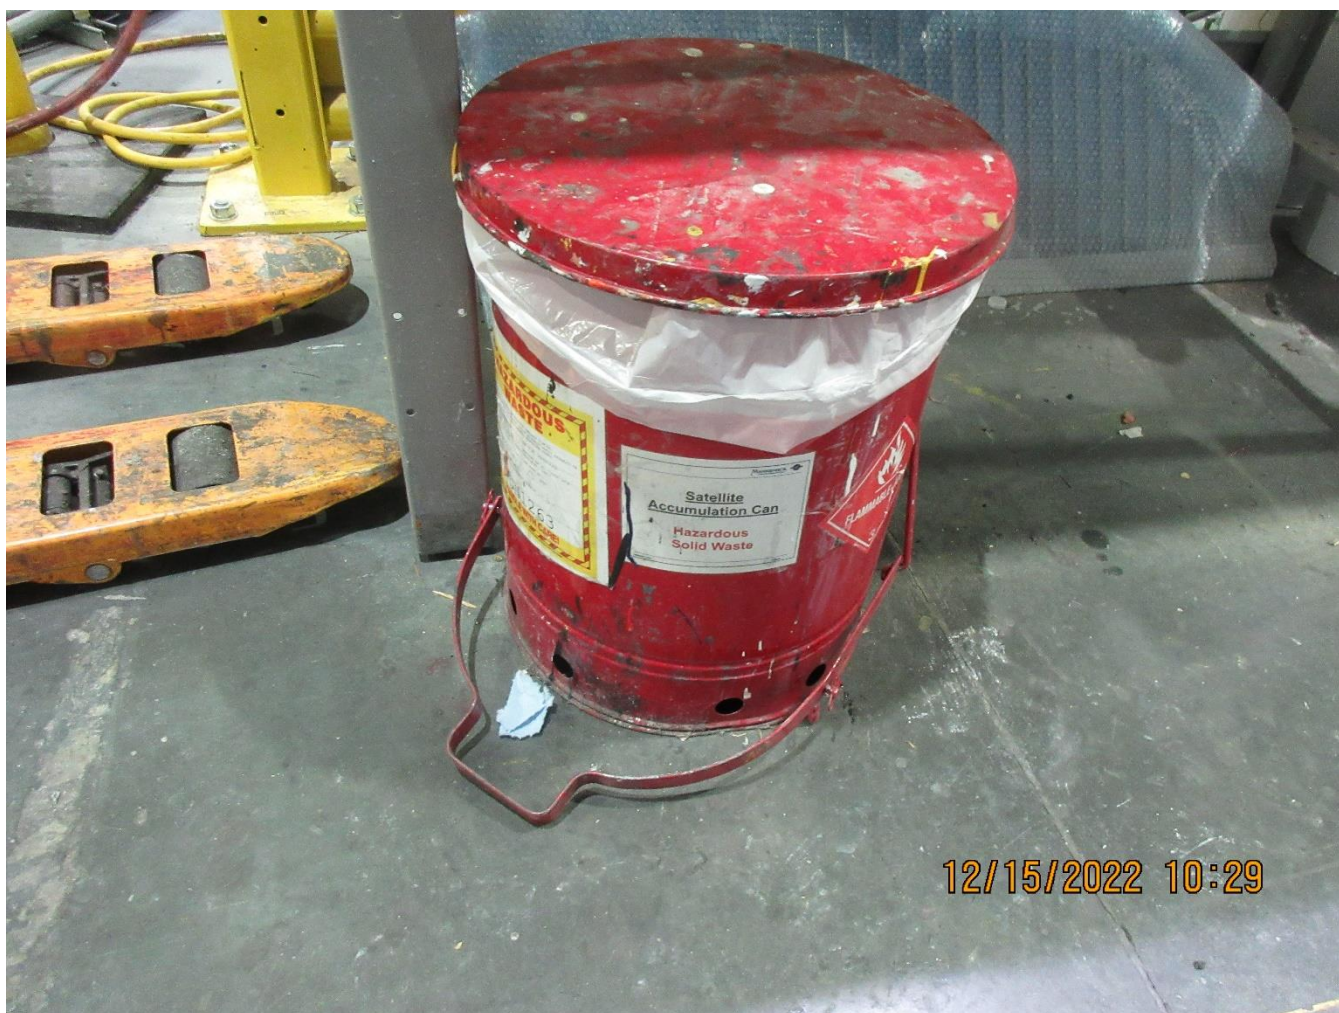
Two 12-gallon (14-inch diameter, 18-inch height) containers of hazardous waste solids were observed within SAAs near a workstation in this area (Photo 3 shows one of the containers).

Photo 3 – 12-gallon container of hazardous waste solids

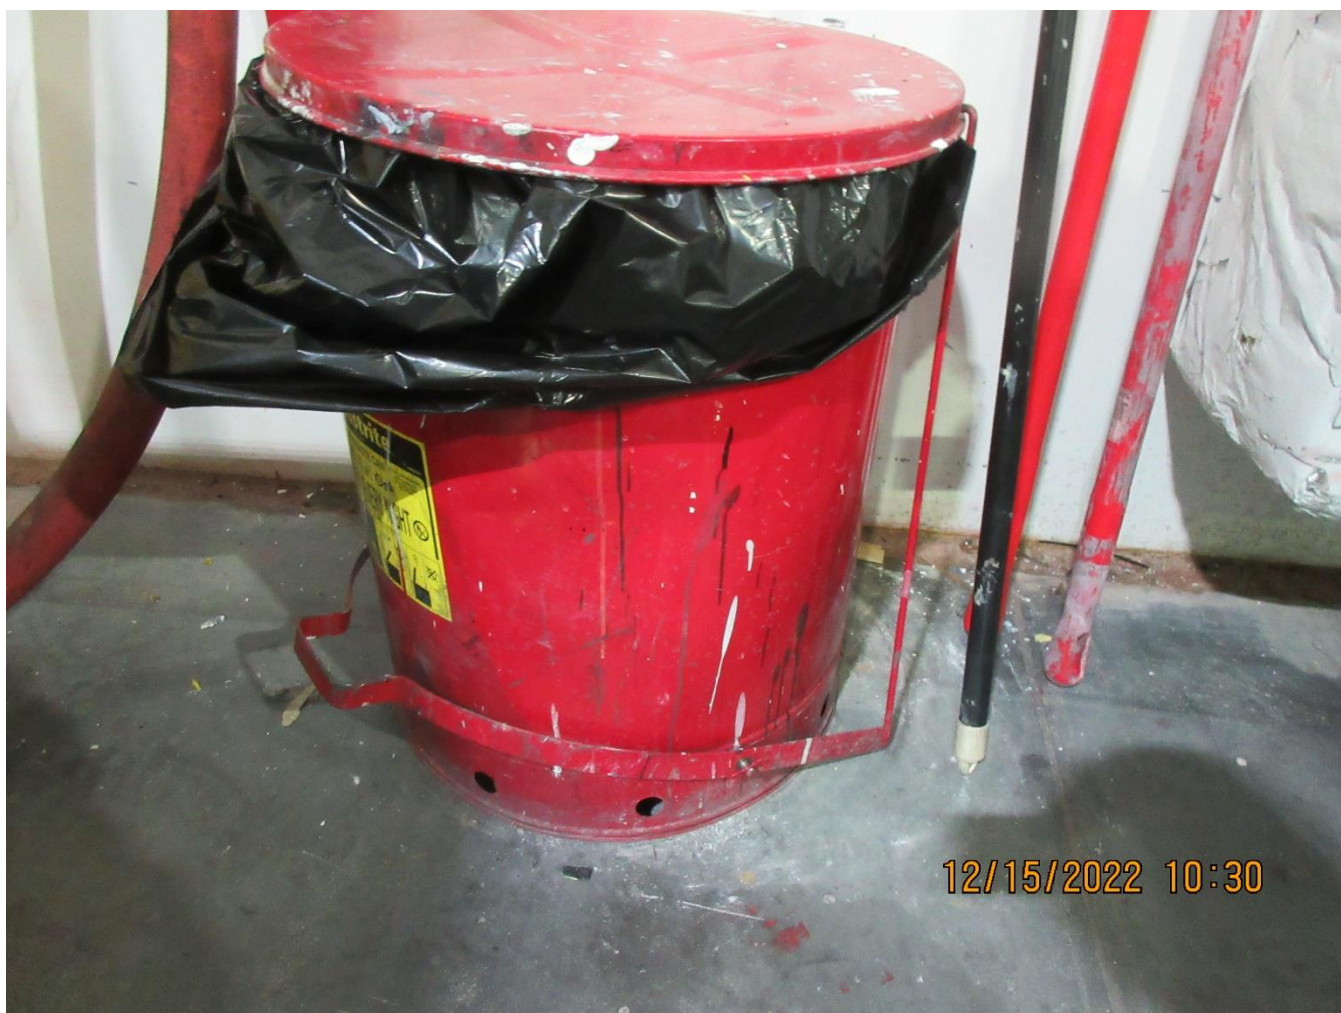
One 25-gallon (18-inch diameter, 23-inch height) container of hazardous waste solids (Photo 4) was also observed within a SAA in this area. (Photo 5 shows the contents of container).

Photo 4 – One of two 12-gallon containers of hazardous waste near a workstation in Scratch-On Production Area

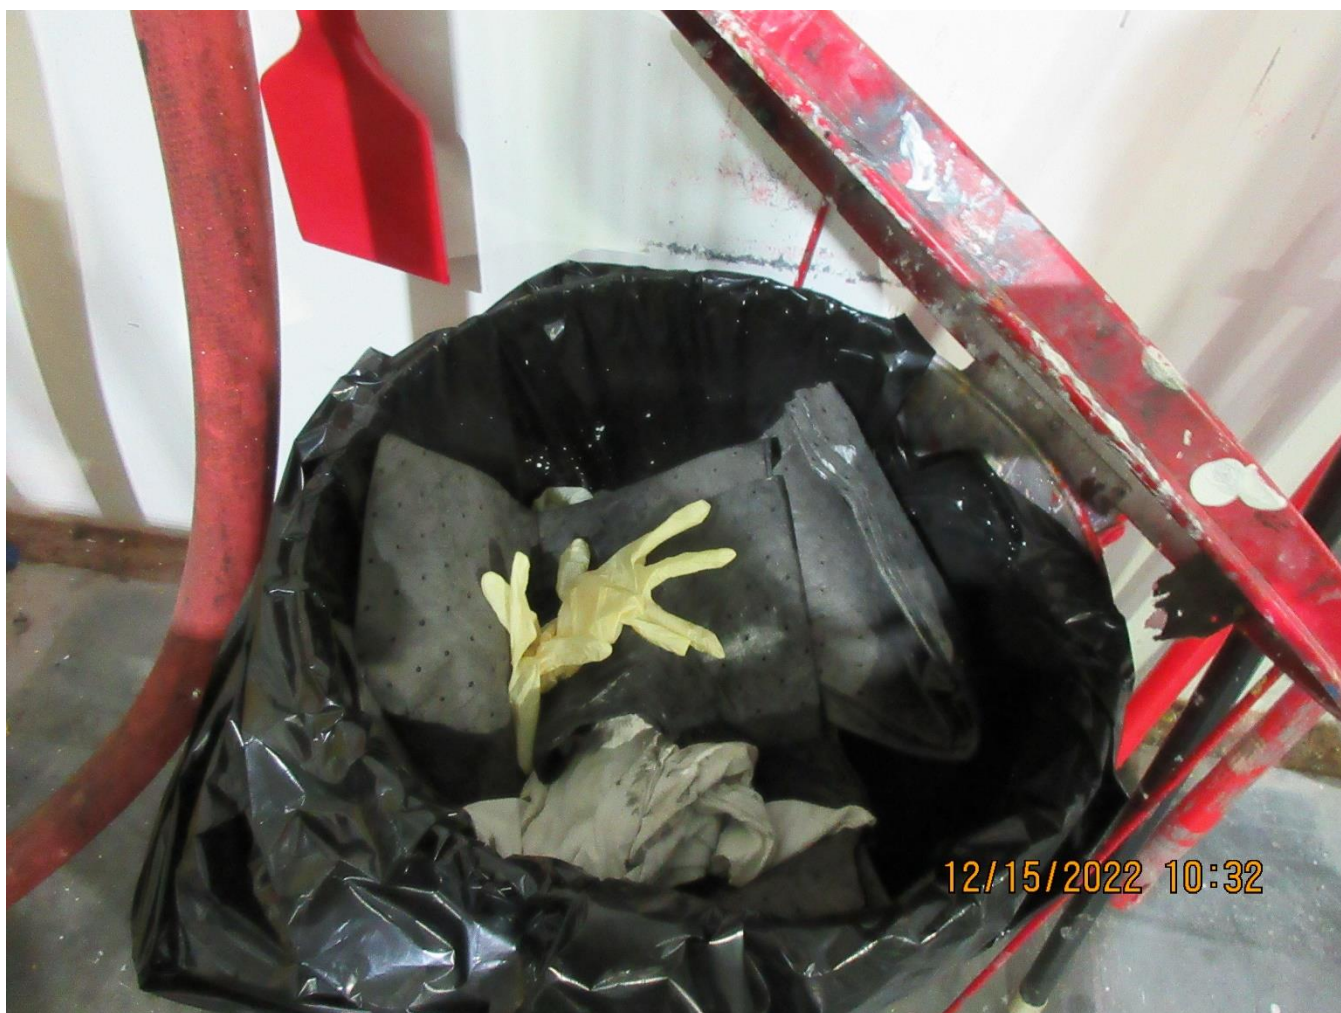
Photo 5 – Contents of 12-gallon container observed at workstation in Scratch-On Production Area

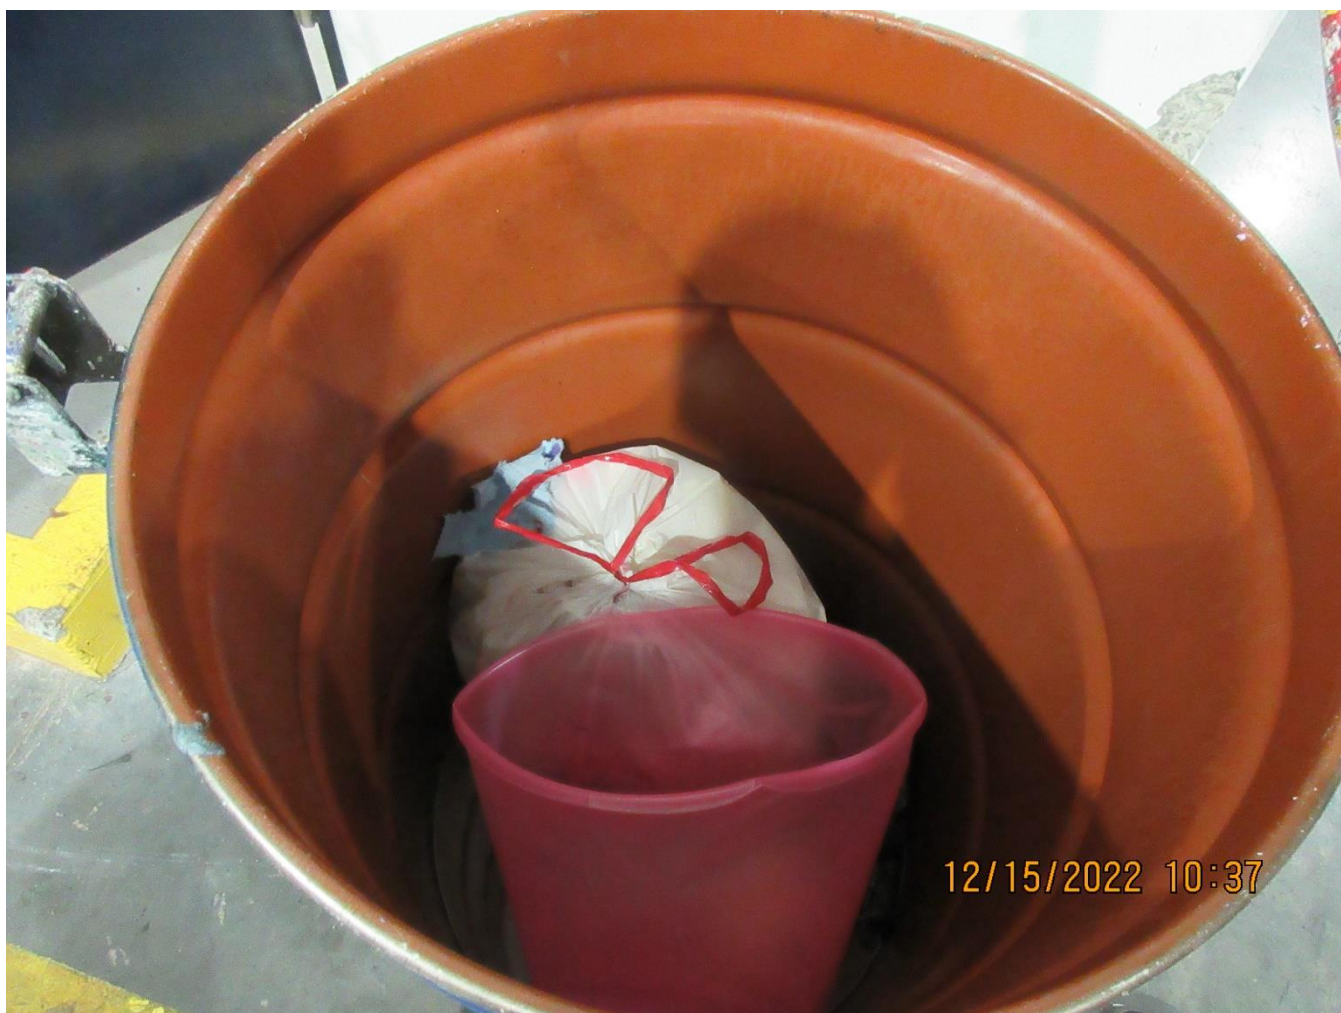
One 55-gallon container of hazardous waste solids was observed within a SAA in this area. Photo 6 shows the contents of the container. Photo 7 shows the exterior of the container which was not labeled with the words "Hazardous Waste" or with an indication of the hazards of the contents.

Photo 6 – Contents of 55-gallon drum of hazardous waste solids in Scratch-On Production Area

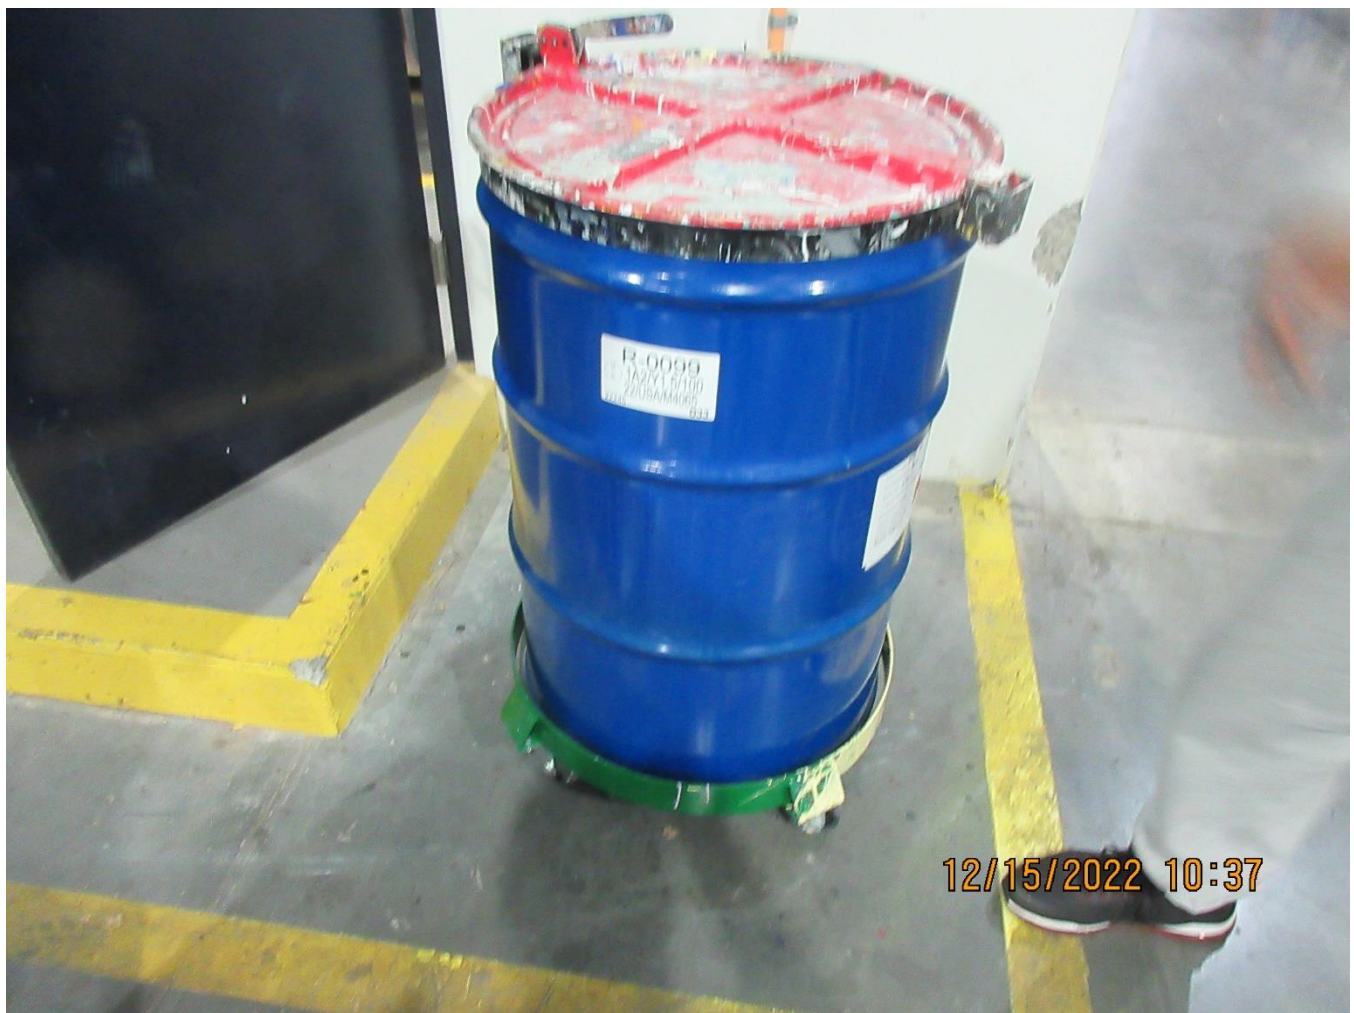
Photo 7 – Outside of 55-gallon drum of hazardous waste solids in Scratch-On Production Area

**Pursuant to S.C. Code Ann. Regs. 61-79.262.15(a)(5) [40 C.F.R. § 262.15(a)(5)], which is a condition of the SAA Permit Exemption, a generator is required to mark or label its containers (i) with the words "Hazardous Waste" and (ii) with an indication of the hazards of the contents.**

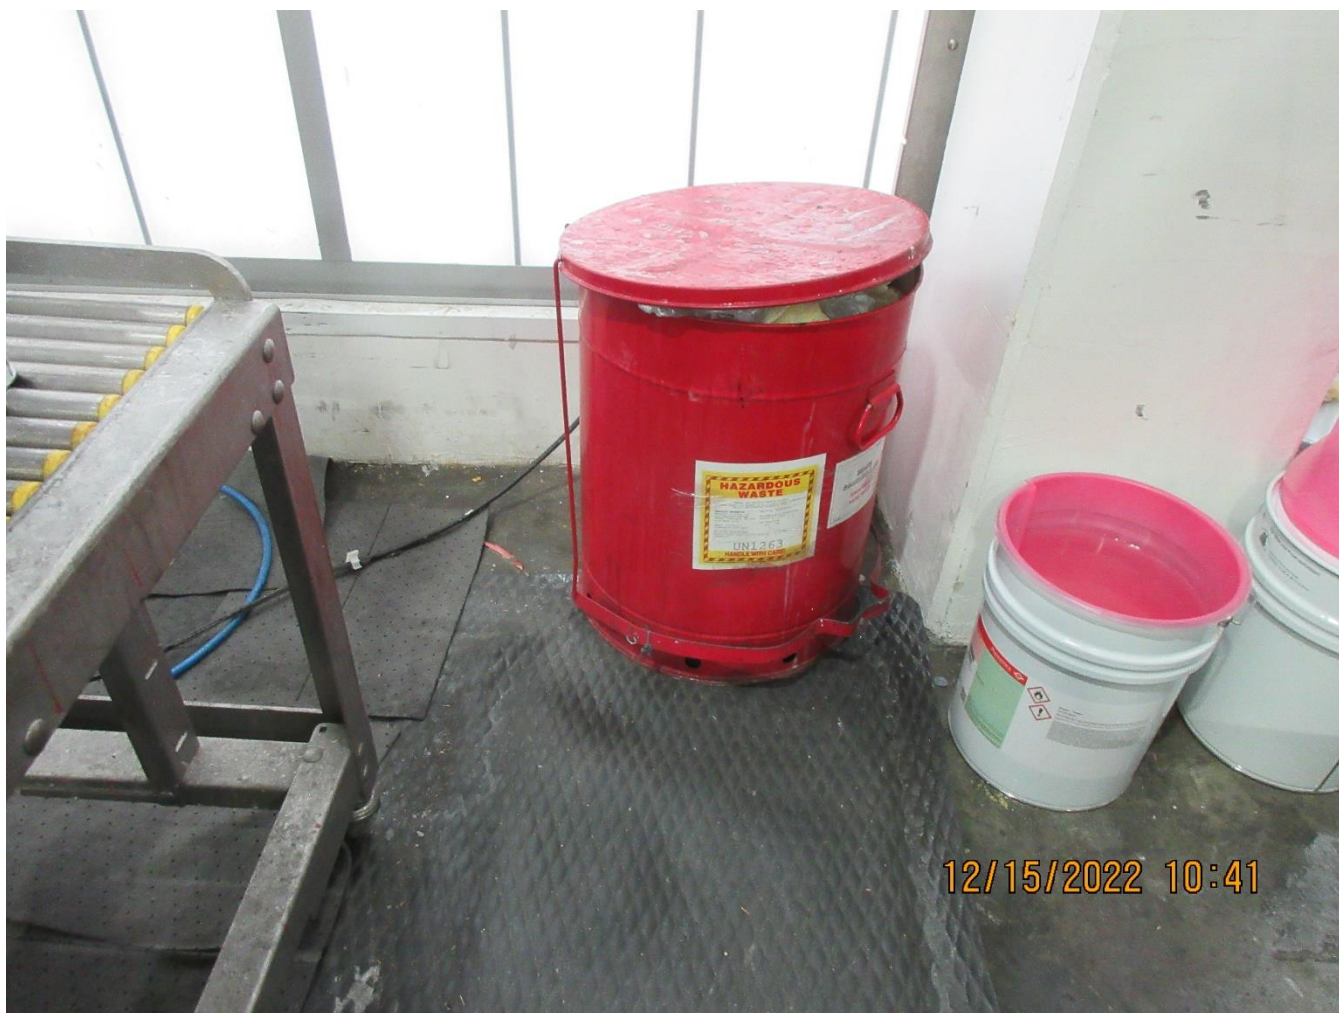
One 25-gallon (18-inch diameter, 23-inch height) container of hazardous waste solids (Photo 8) was observed to be open within a SAA this area.

Photo 8 – 25-gallon container of hazardous waste solids in Hardener/Thinner Production Area

**Pursuant to S.C. Code Ann. Regs. 61-79.262.15(a)(4) [40 C.F.R. § 262.15(a)(4)], which is a condition of the SAA Permit Exemption, a generator is required to keep containers of hazardous waste closed at all times during accumulation, except when adding, removing, or consolidating waste; or when temporary venting of a container is necessary for the proper operation of equipment, or to prevent dangerous situations, such as build-up of extreme pressure.**

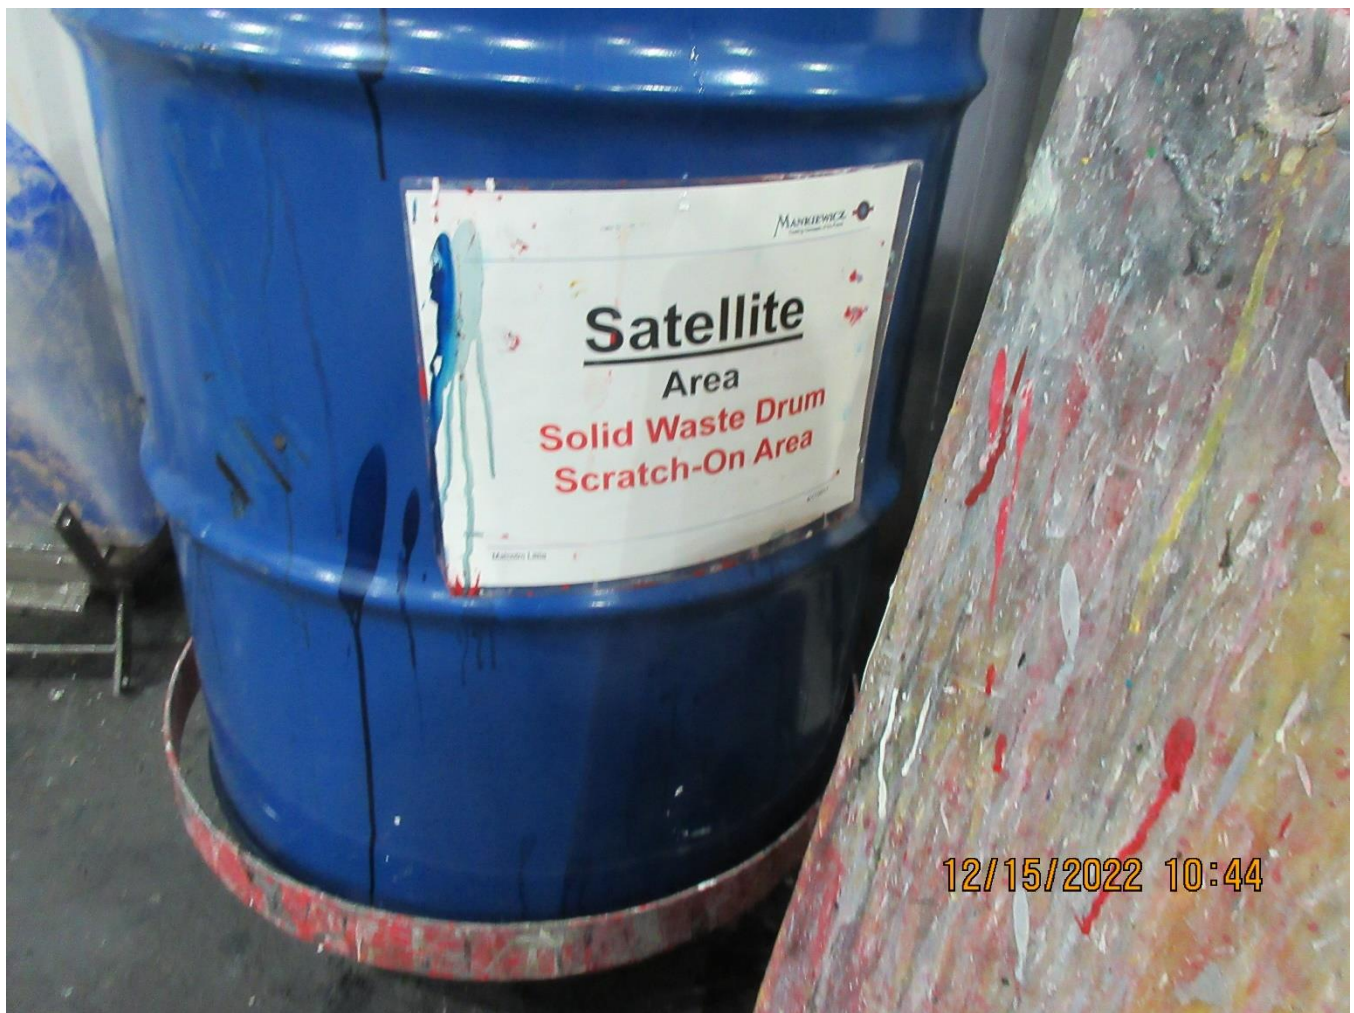
One 55-gallon container of hazardous waste solids was observed within a SAA in this area. Photo 9 shows the label on the container. Photo 10 shows the container which was not labeled with the words "Hazardous Waste" or with an indication of the hazards of the contents.

Photo 9 - Label on Drum of Hazardous Waste in Hardener/Thinner Production Area

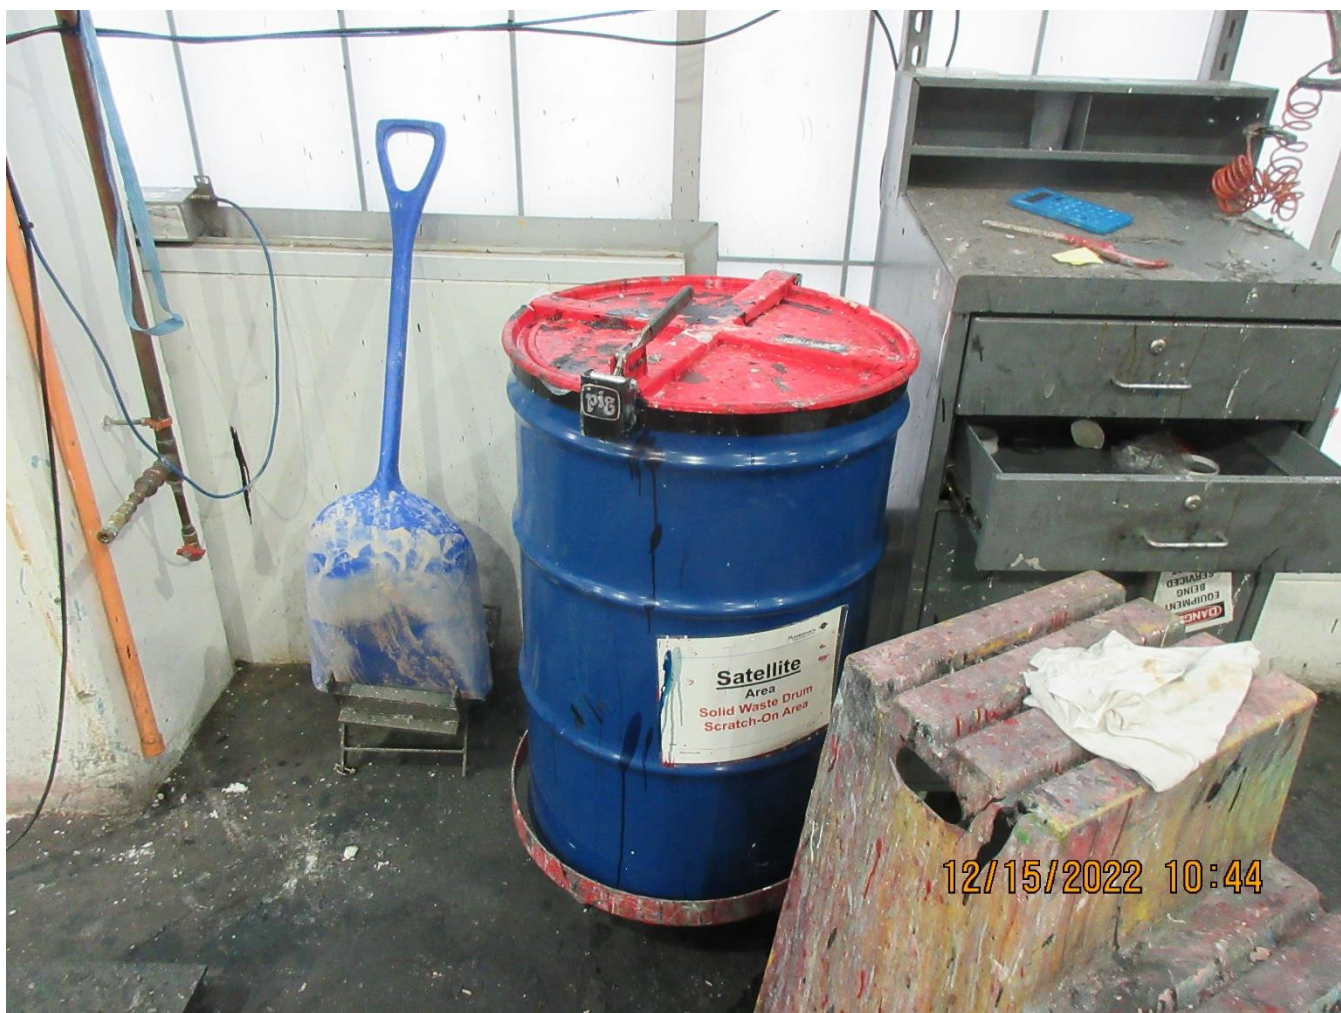
Photo 10 - Drum of Hazardous Waste in Hardener/Thinner Production Area

**Pursuant to S.C. Code Ann. Regs. 61-79.262.15(a)(5) [40 C.F.R. § 262.15(a)(5)], which is a condition of the SAA Permit Exemption, a generator is required to mark or label its containers (i) with the words "Hazardous Waste" and (ii) with an indication of the hazards of the contents.**

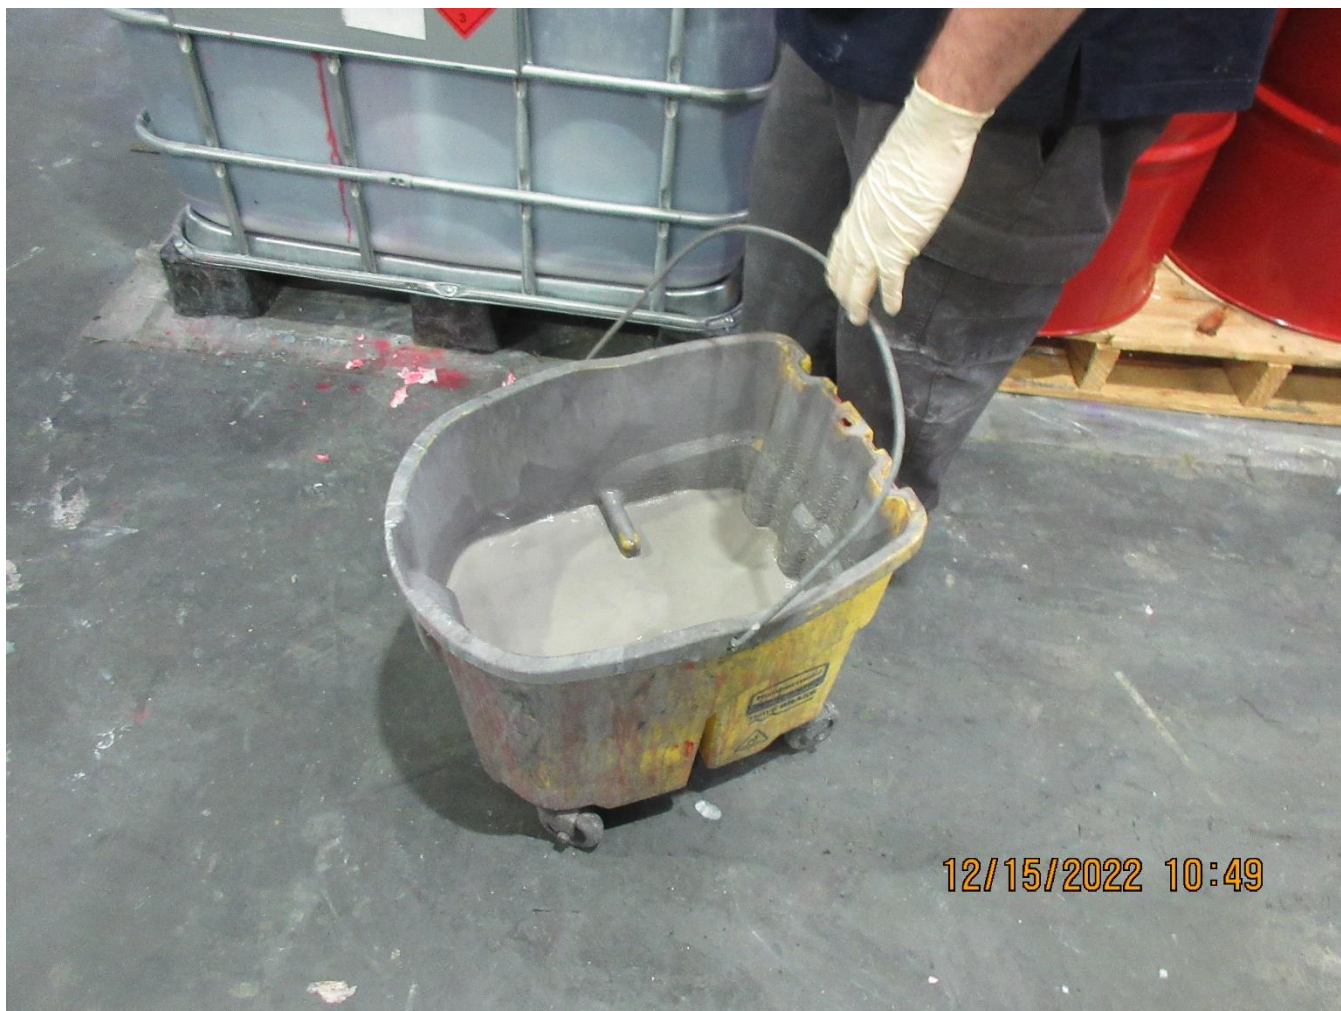
One employee was observed bringing an open 5-gallon mop bucket of spent acetone into the area to be deposited into an accumulation container (Photo 11). The container was not labeled with the words hazardous waste or with an indication of the hazards of the contents.

Photo 11 – Mop bucket of spent acetone within facility's Cleaning Area

**Pursuant to S.C. Code Ann. Regs. 61-79.262.15(a)(5) [40 C.F.R. § 262.15(a)(5)], which is a condition of the SAA Permit Exemption, a generator is required to mark or label its containers (i) with the words “Hazardous Waste” and (ii) with an indication of the hazards of the contents.**

**Pursuant to S.C. Code Ann. Regs. 61-79.262.15(a)(4) [40 C.F.R. § 262.15(a)(4)], which is a condition of the SAA Permit Exemption, a generator is required to keep containers of hazardous waste closed at all times during accumulation, except when adding, removing, or consolidating waste; or when temporary venting of a container is necessary for the proper operation of equipment, or to prevent dangerous situations, such as build-up of extreme pressure.**

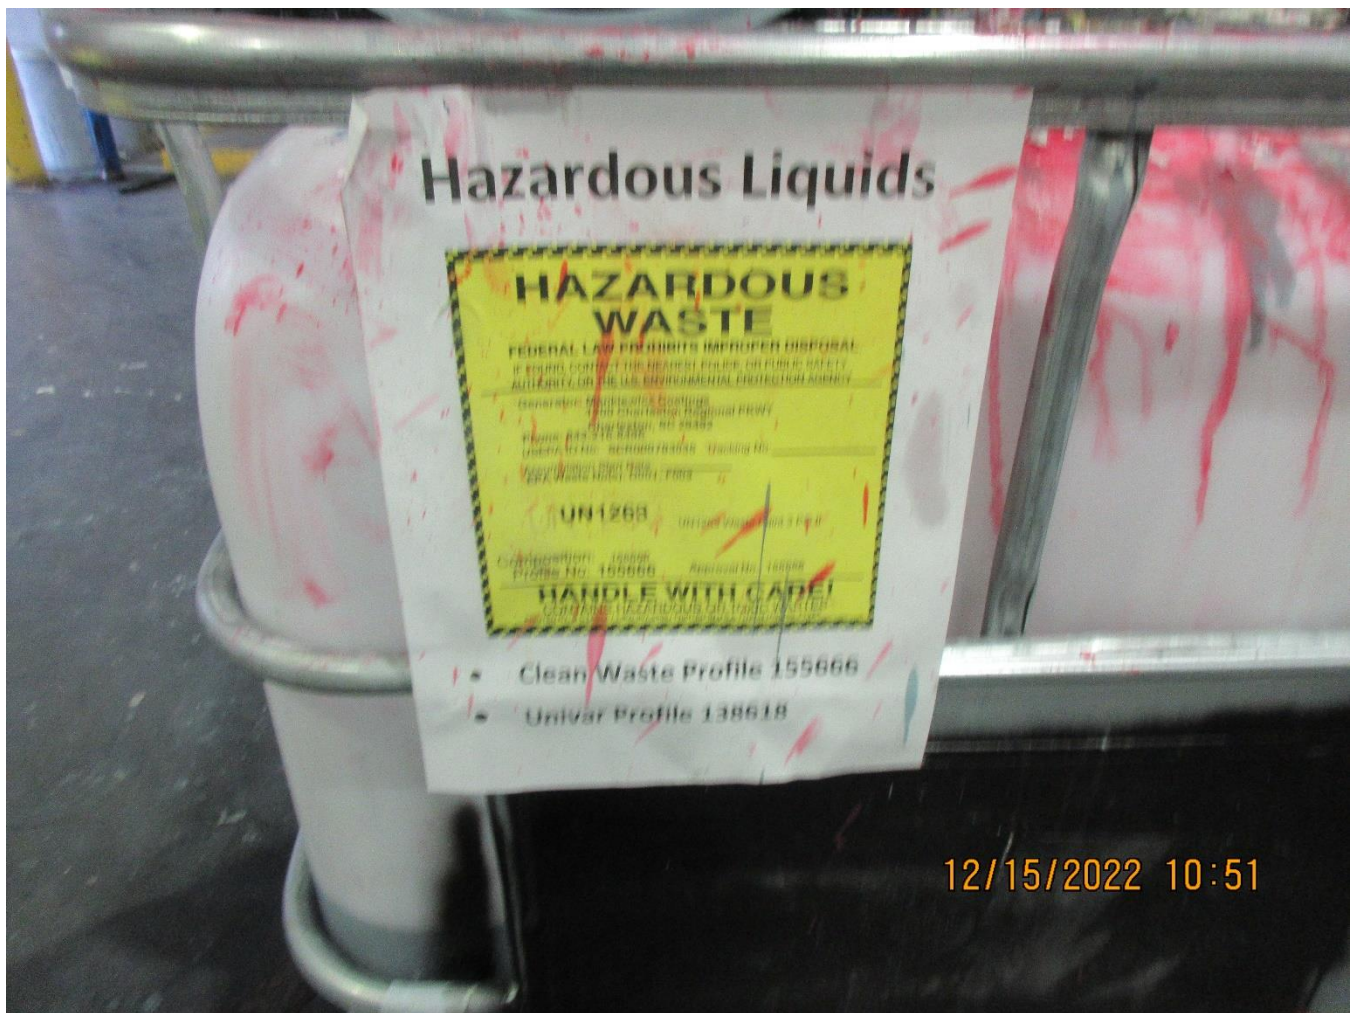
Two 275-gallon totes of hazardous waste spent acetone solvents were observed in this area (Photos 13 and 14). One of the totes was not marked with an accumulation start date (Photo 12).

Photo 12 – Label on 275-gallon tote of hazardous waste in Cleaning Area

**Pursuant to S.C. Code Ann. Regs. 61-79.262.17(a)(5)(i) [40 C.F.R. § 262.17(a)(5)(i)], which is a condition of the LQG Permit Exemption, a generator must mark or label its containers with the following: the words “Hazardous Waste”; an indication of the hazards of the contents; and the date upon which each period of accumulation begins clearly visible for inspection on each container.**

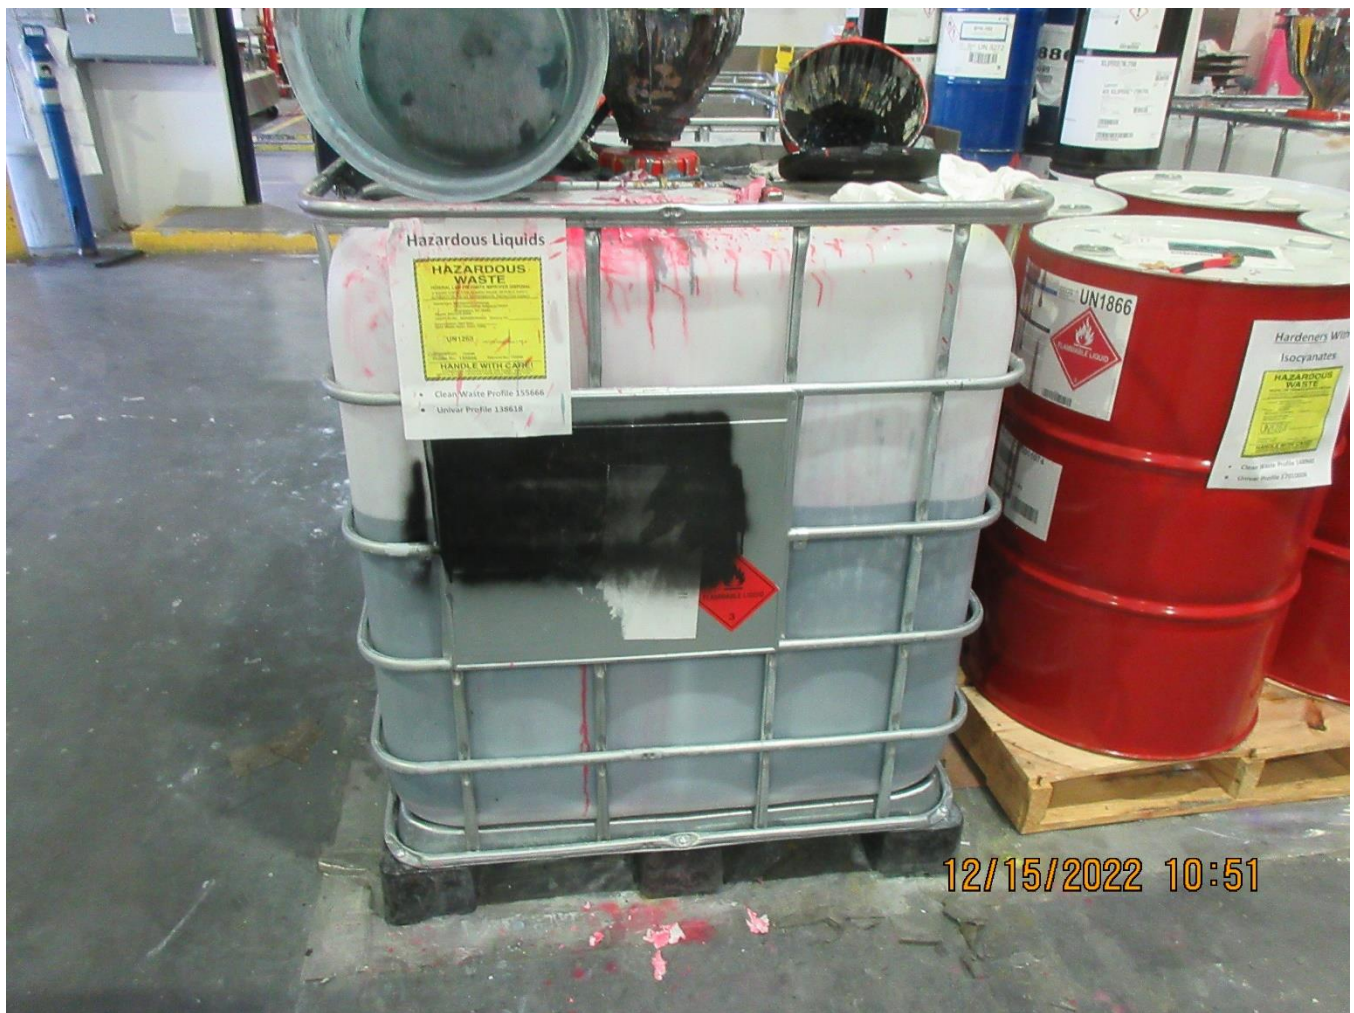
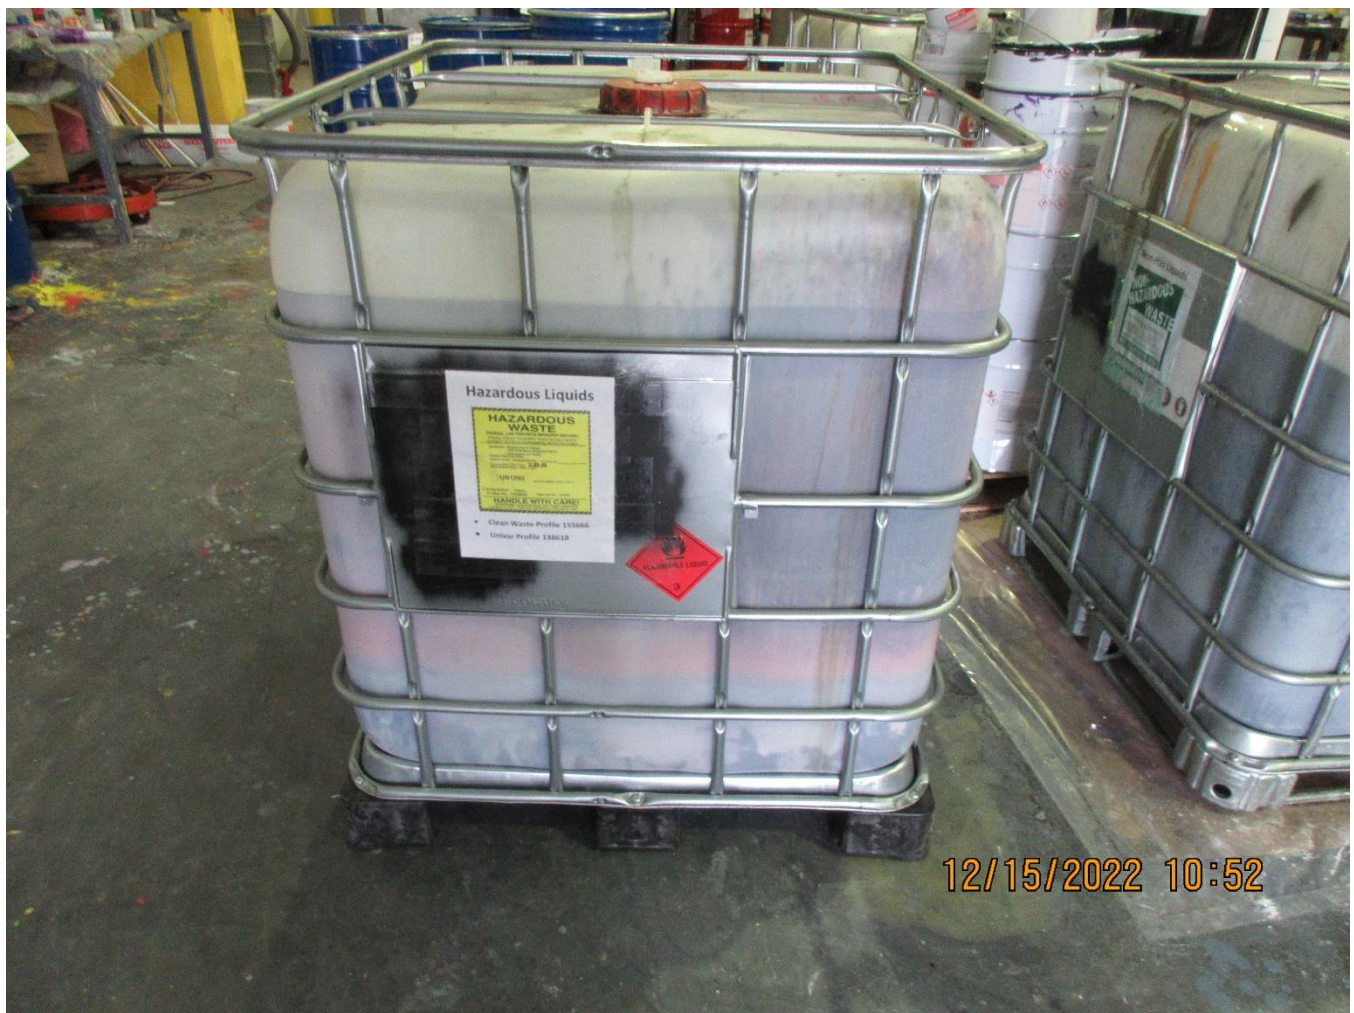
Photo 13 - 275-gallon tote of hazardous waste in Cleaning Area.

Photo 14 - 275-gallon tote of hazardous waste in Cleaning Area.
