## **RCRA Inspection Report**

Mankiewicz Coatings LLC  
1200 Charleston Regional Parkway  
Charleston, South Carolina 29492

EPA ID# SCR000783035

December 15, 2022, at 9:15 a.m. EDT

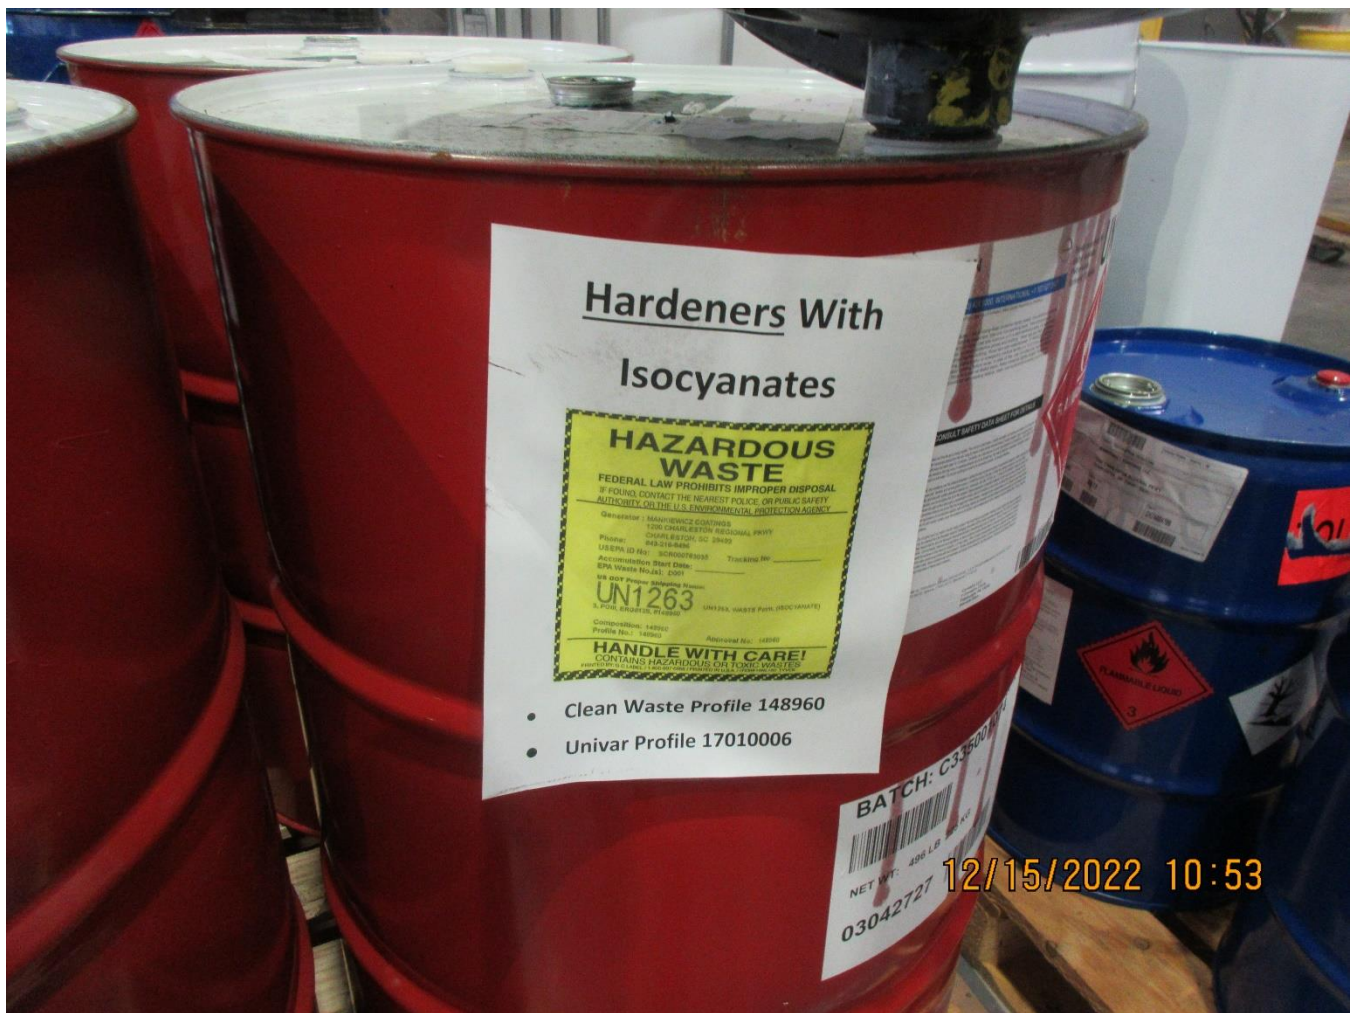
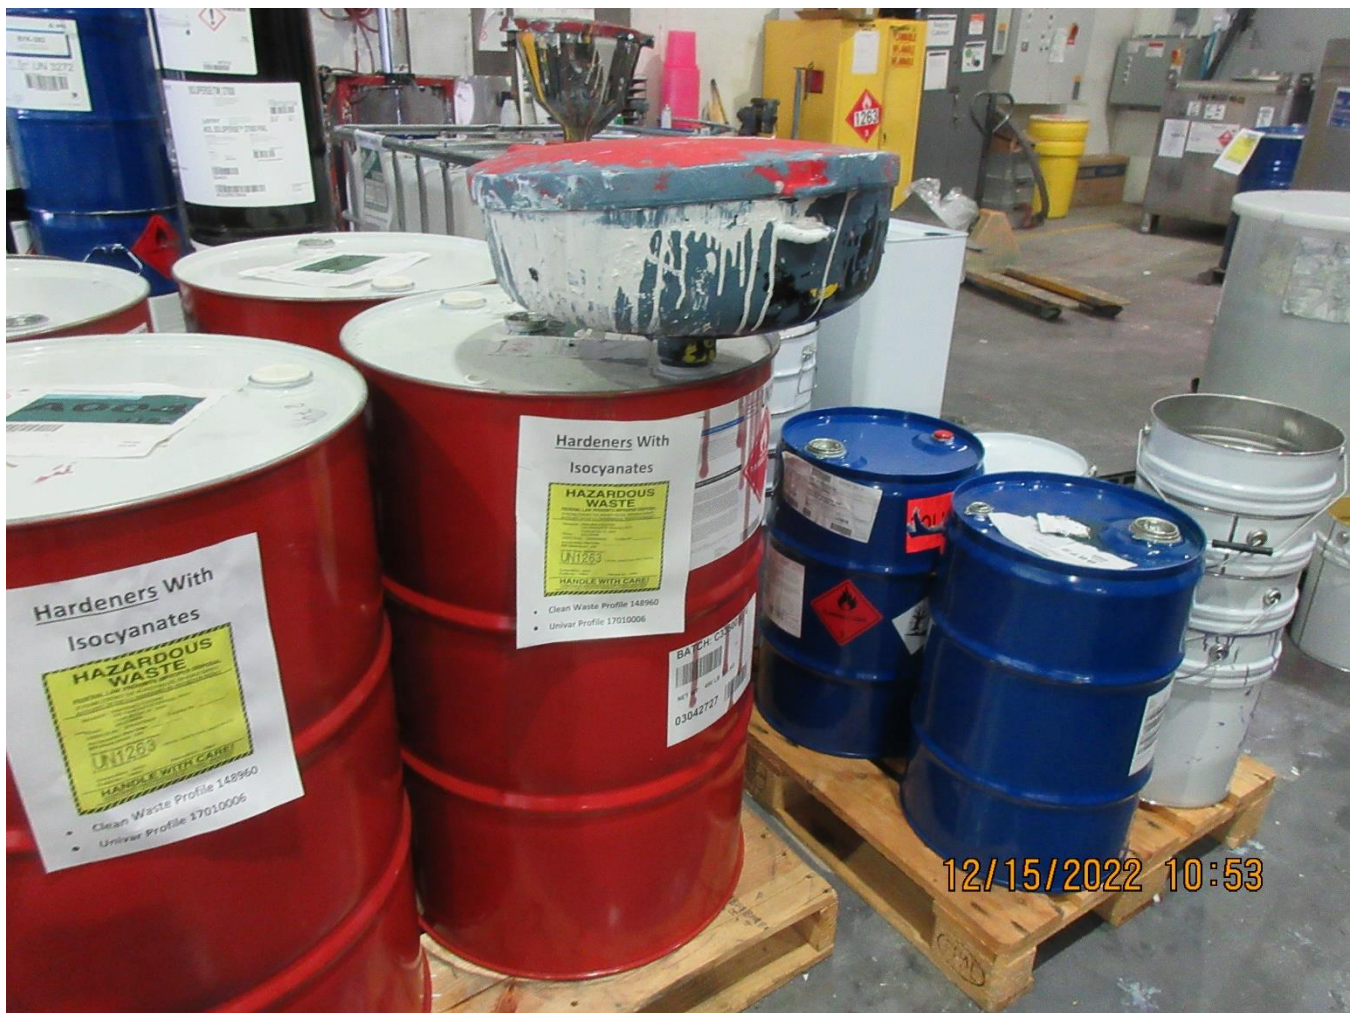
Two 55-gallon drums of hazardous waste hardeners with isocyanates were observed in this area on a pallet in the central part of the area. The labels on the containers were not marked with accumulation start dates (Photos 15 and 16).

Photo 15 –Label on 55-gallon drum of hazardous waste hardeners with isocyanates w/o accumulation start dates.

Photo 16 – Pallet with two red 55-gallon drum of hazardous waste hardeners with isocyanates w/o accumulation start dates.

**Pursuant to S.C. Code Ann. Regs. 61-79.262.17(a)(5)(i) [40 C.F.R. § 262.17(a)(5)(i)], which is a condition of the LQG Permit Exemption, a generator must mark or label its containers with the following: the words “Hazardous Waste”; an indication of the hazards of the contents; and the date upon which each period of accumulation begins clearly visible for inspection on each container.**

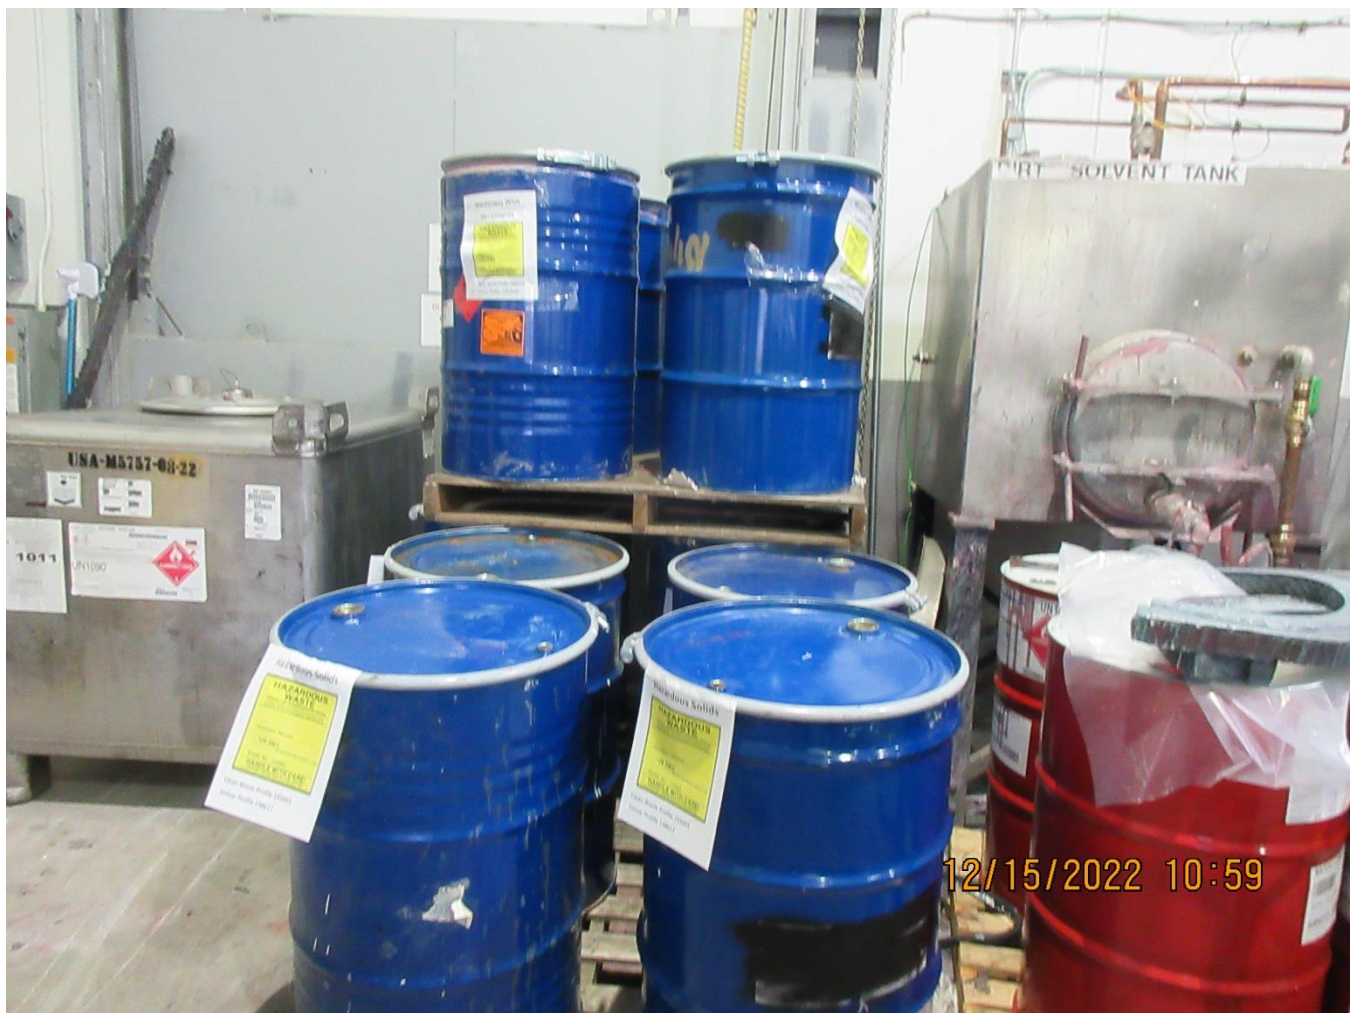
Twelve 55-gallon drums (blue) of hazardous waste spent solvents were observed on three pallets against the western interior wall of the facility in this area (Photo 17). Eleven of the containers were observed to be without accumulation start dates.

Photo 17 – Twelve 55-gallon drums (blue) of hazardous waste spent solvents observed on pallets on western interior wall.

**Pursuant to S.C. Code Ann. Regs. 61-79.262.17(a)(5)(i) [40 C.F.R. § 262.17(a)(5)(i)], which is a condition of the LQG Permit Exemption, a generator must mark or label its containers with the following: the words “Hazardous Waste”; an indication of the hazards of the contents; and the date upon which each period of accumulation begins clearly visible for inspection on each container.**

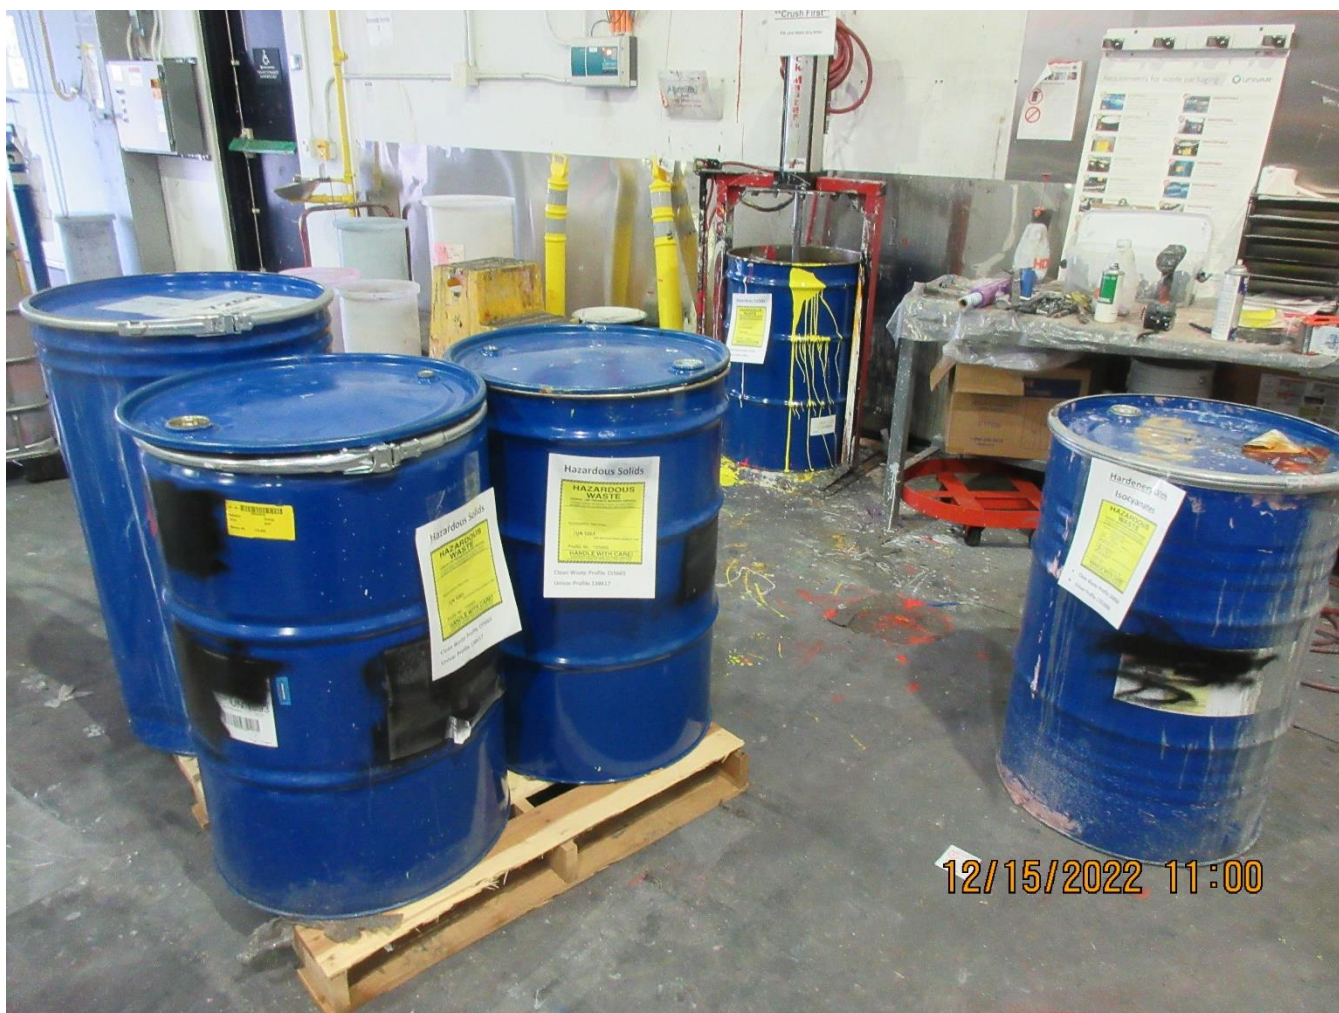
Four 55-gallon blue drums of hazardous waste (three contained spent solvents and one with solids) were also observed in the central area of the cleaning area (Photo 18). Three of the drums, as seen in Photo 18, were observed on a pallet to the left of the fourth container which was observed on the floor. One of the three drums observed on the right side of the pallet, as shown in Photo 18, was open with its bung not in its hole (Photo 19) and its lid ajar (Photo 20).

In addition, three of the drums discussed immediately above, which can be seen with the yellow “Hazardous Waste” labels were not marked with an accumulation start dates.

Photo 18 – Four blue drums of hazardous waste spent solvent observed in the central area of the Cleaning Area.

**Pursuant to S.C. Code Ann. Regs. 61-79.262.17(a)(5)(i) [40 C.F.R. § 262.17(a)(5)(i)], which is a condition of the LQG Permit Exemption, a generator must mark or label its containers with the following: the words “Hazardous Waste”; an indication of the hazards of the contents; and the date upon which each period of accumulation begins clearly visible for inspection on each container.**

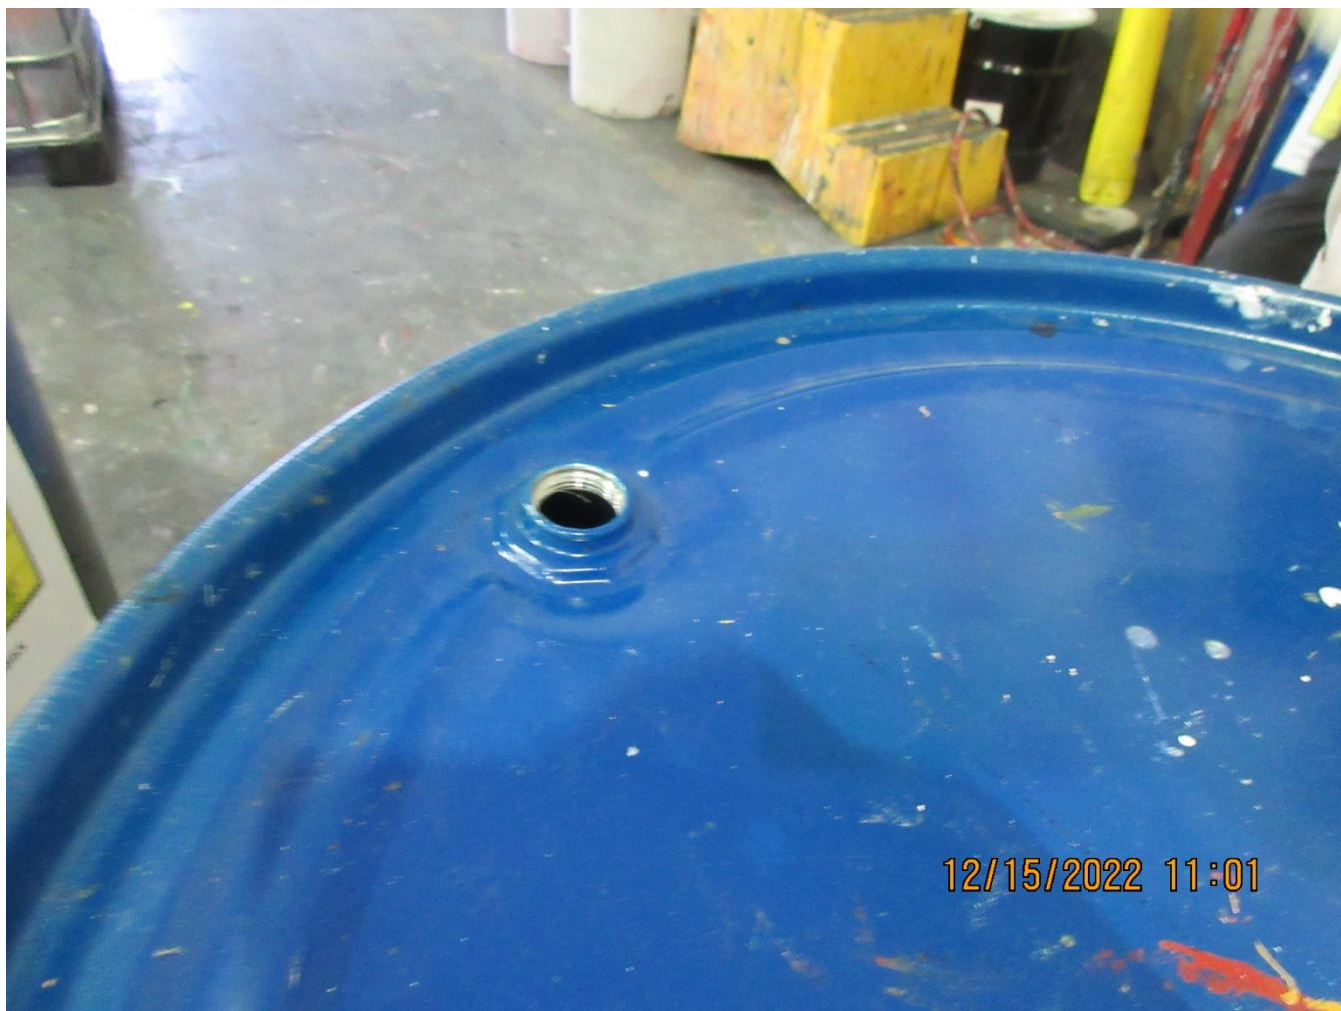
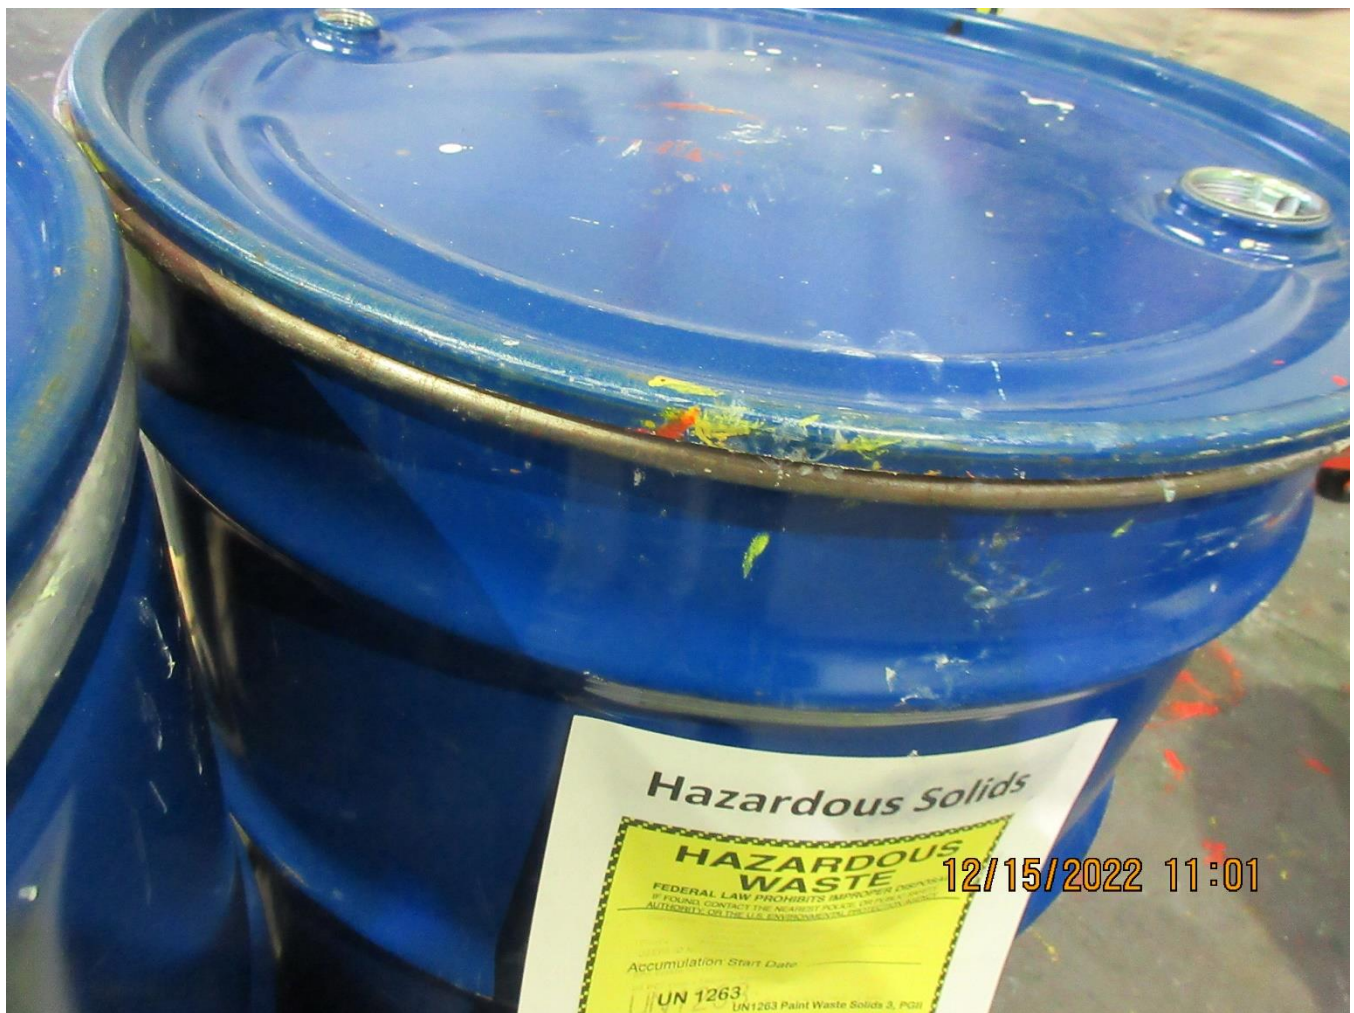
Photo 19 – Open drum (missing bung) of hazardous waste spent solvents on right side of pallet as shown in Photo 18.

Photo 20 – Open drum (lid open) of hazardous waste spent solvents on right side of pallet as shown in Photo 18.

**Pursuant to S.C. Code Ann. Regs. 61-79.262.17(a)(1)(iv) [40 C.F.R. § 262.17(a)(1)(iv)], which is a condition of the LQG Permit Exemption, (A) a container holding hazardous waste must always be closed during accumulation, except when it is necessary to add or remove waste; and (B) A container holding hazardous waste must not be opened, handled, or stored in a manner that may rupture the container or cause it to leak.**

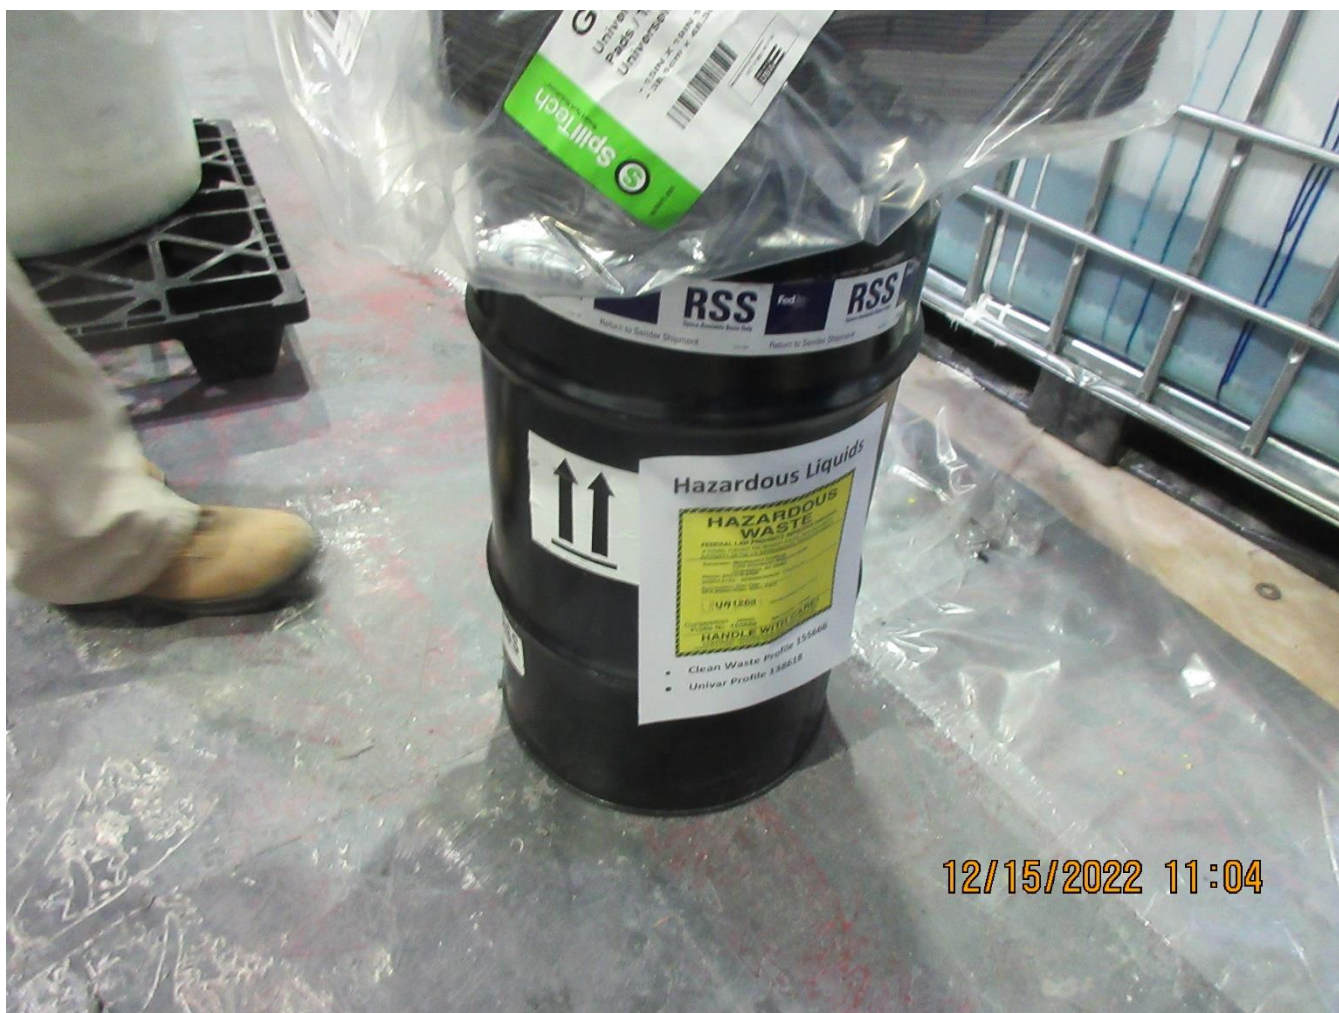
One 15-gallon container of hazardous waste liquids observed in the CAA of the cleaning area (Photo 22) was not marked with an accumulation start date.

Photo 22 – 15-gallon container of hazardous waste liquids in central area of cleaning area w/o an accumulation start date.

**Pursuant to S.C. Code Ann. Regs. 61-79.262.17(a)(5)(i) [40 C.F.R. § 262.17(a)(5)(i)], which is a condition of the LQG Permit Exemption, a generator must mark or label its containers with the following: the words “Hazardous Waste”; an indication of the hazards of the contents; and the date upon which each period of accumulation begins clearly visible for inspection on each container.**

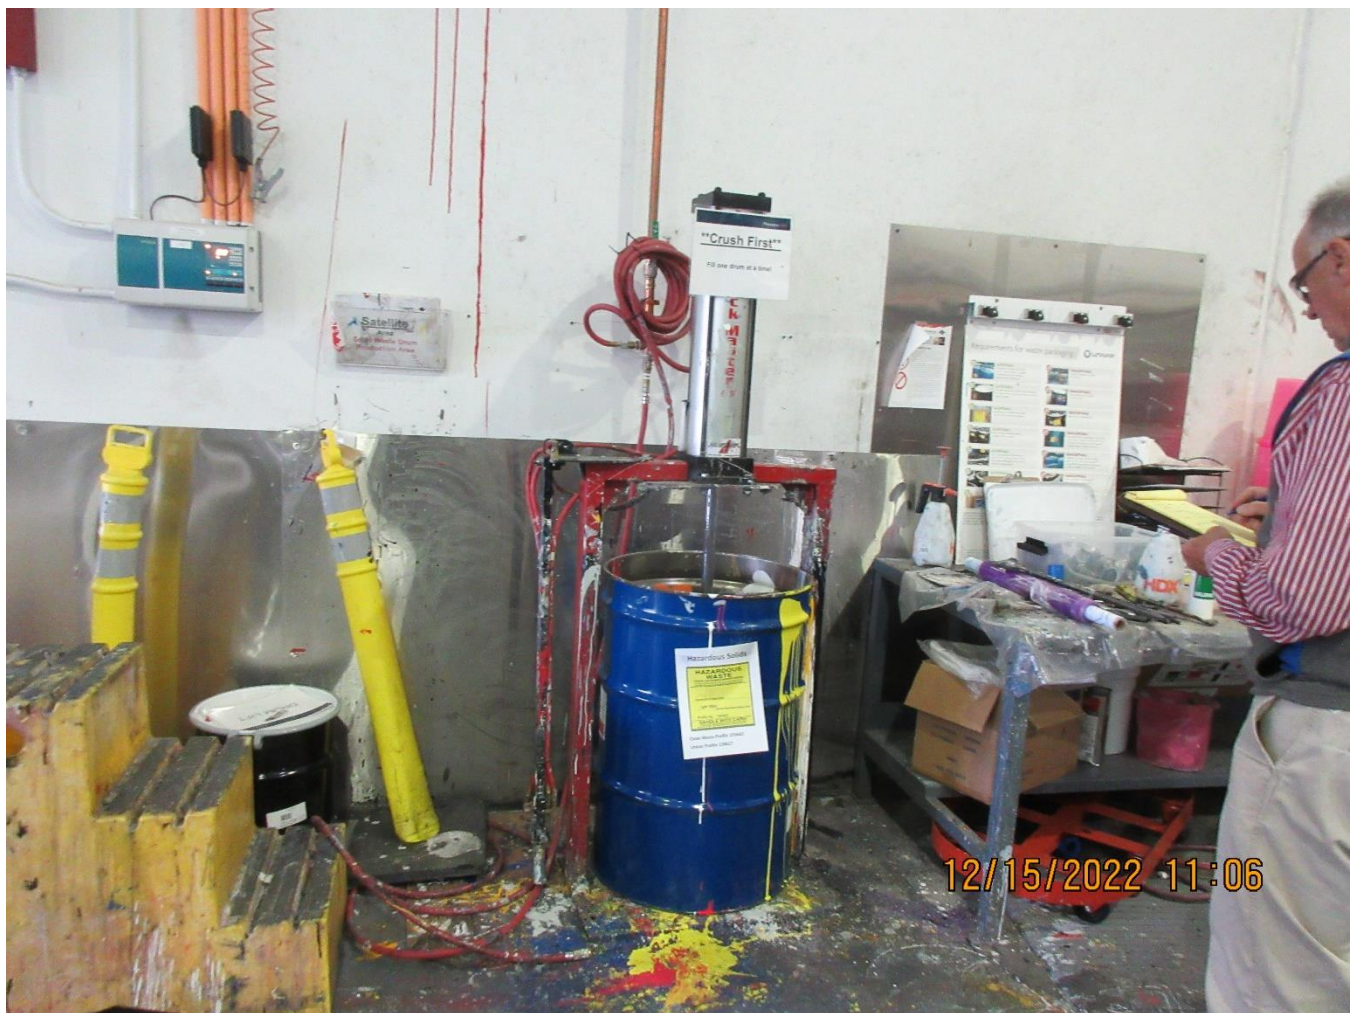
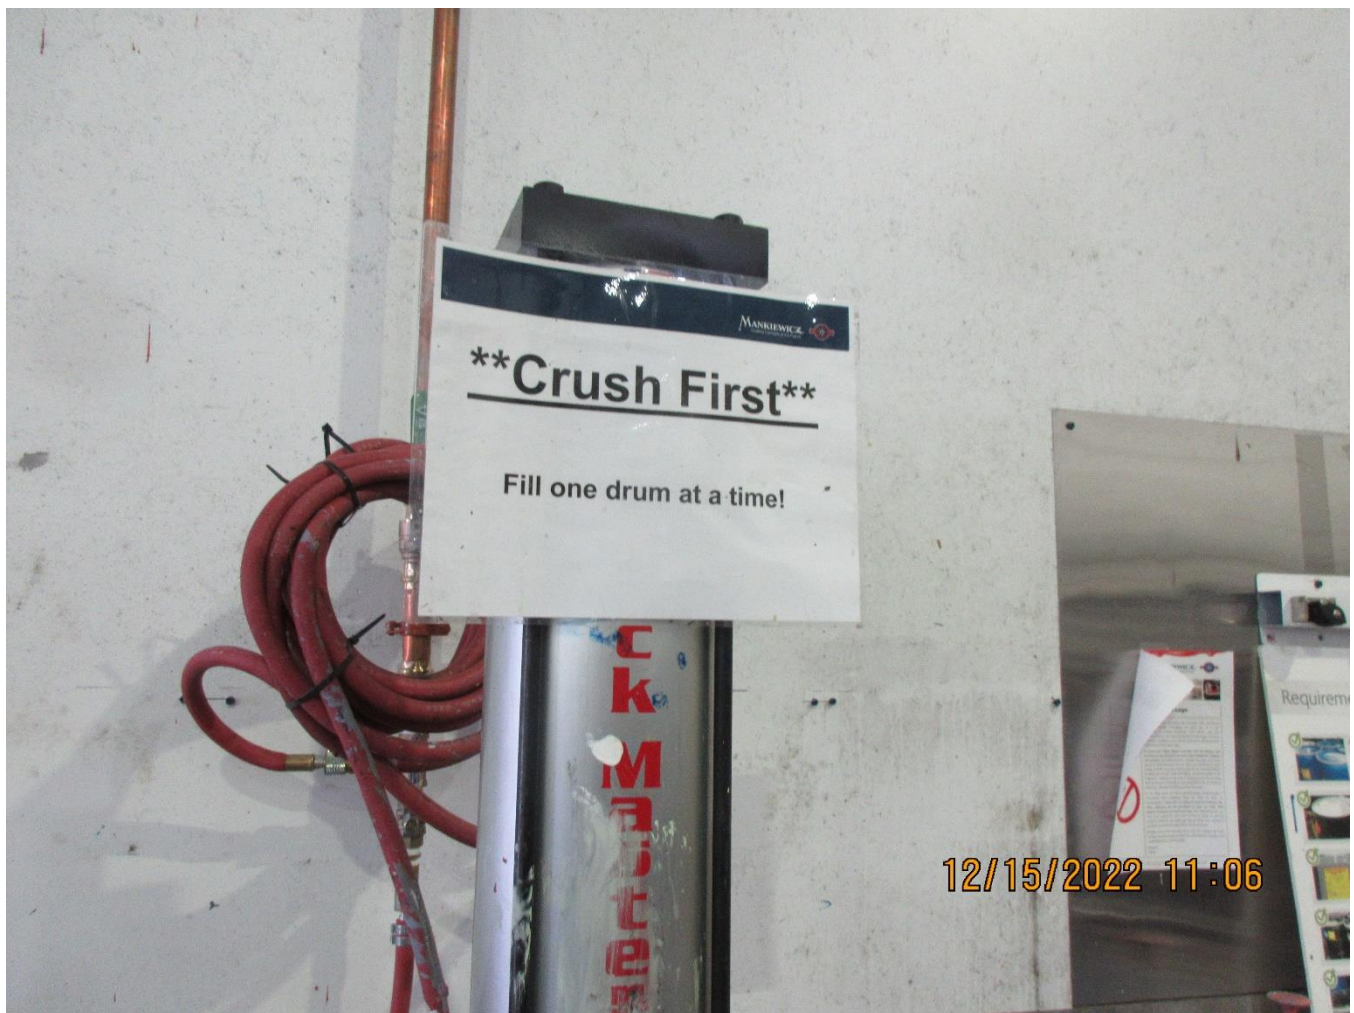
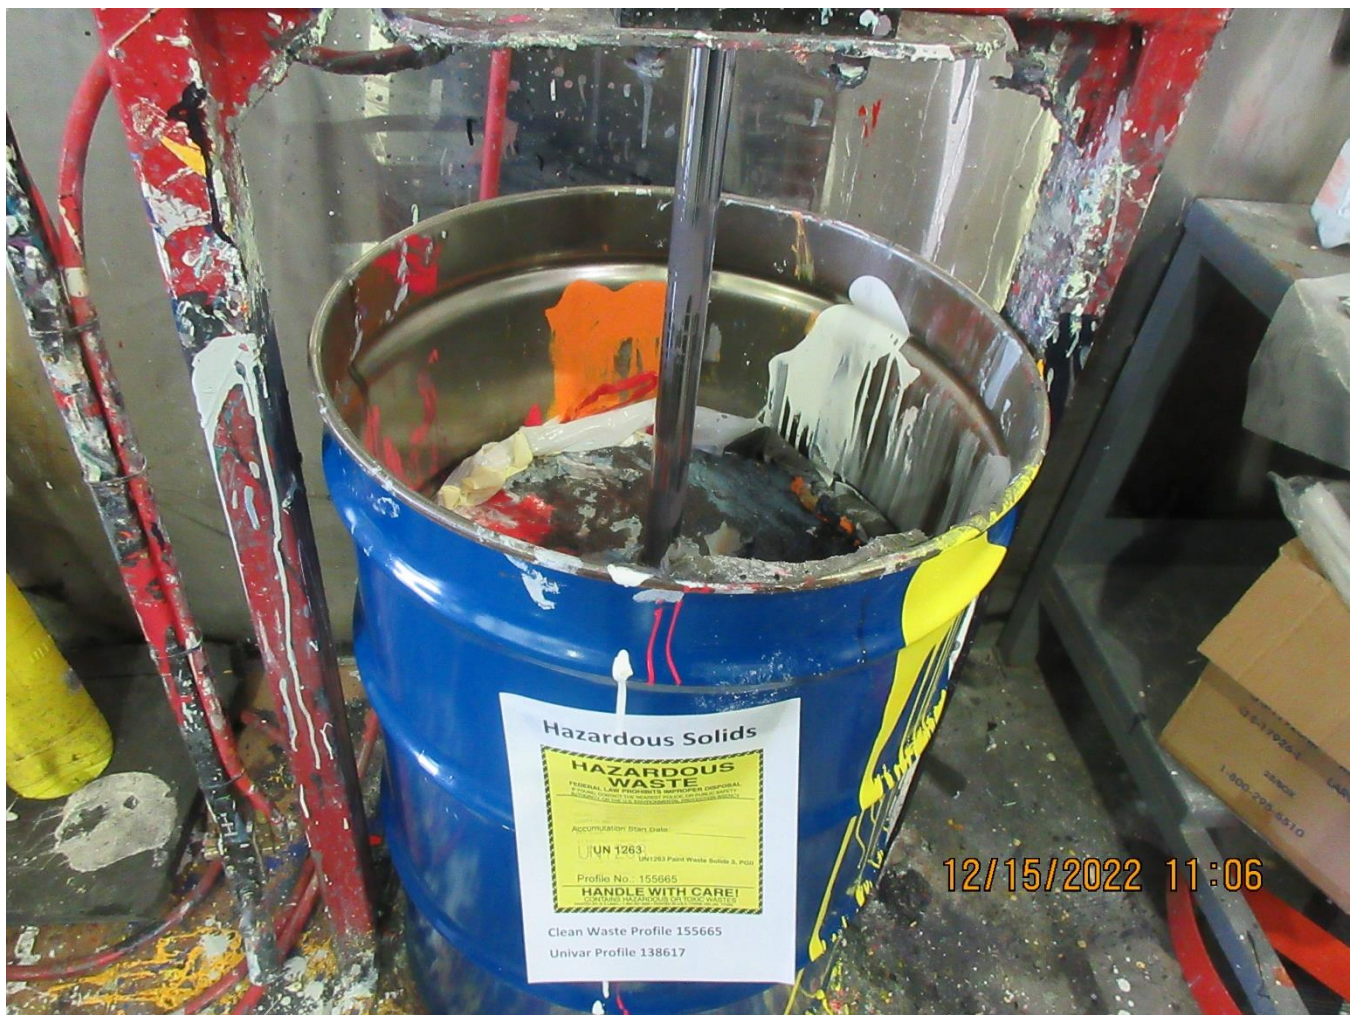
One 55-gallon drum of hazardous waste solids shown in Photos 23 and 25 was observed along the southern wall of the facility’s cleaning area. The drum was being used to accumulate crushed solids at the time of the inspection. A sign shown in Photo 24 was attached to the top of the drum

crushing device. The drum of hazardous waste solids was observed to be open at the time of the inspection and was not marked with an accumulation start date or an indication of the hazards of the contents.

Photo 23 – Drum of hazardous waste solids and crushing device along the southern wall of the Cleaning Area.

Photo 24 – Sign attached to device used to crush hazardous waste solids into drum along the southern wall of the facility's Cleaning Area.

Photo 25 – Top of drum of hazardous waste solids and crushing device along the southern wall of the Cleaning Area.

**Pursuant to S.C. Code Ann. Regs. 61-79.262.17(a)(5)(i) [40 C.F.R. § 262.17(a)(5)(i)], which is a condition of the LQG Permit Exemption, a generator must mark or label its containers with the following: the words “Hazardous Waste”; an indication of the hazards of the contents; and the date upon which each period of accumulation begins clearly visible for inspection on each container.**

**Pursuant to S.C. Code Ann. Regs. 61-79.262.17(a)(1)(iv) [40 C.F.R. § 262.17(a)(1)(iv)], which is a condition of the LQG Permit Exemption, (A) a container holding hazardous waste must always be closed during accumulation, except when it is necessary to add or remove waste; and (B) A container holding hazardous waste must not be opened, handled, or stored in a manner that may rupture the container or cause it to leak.**

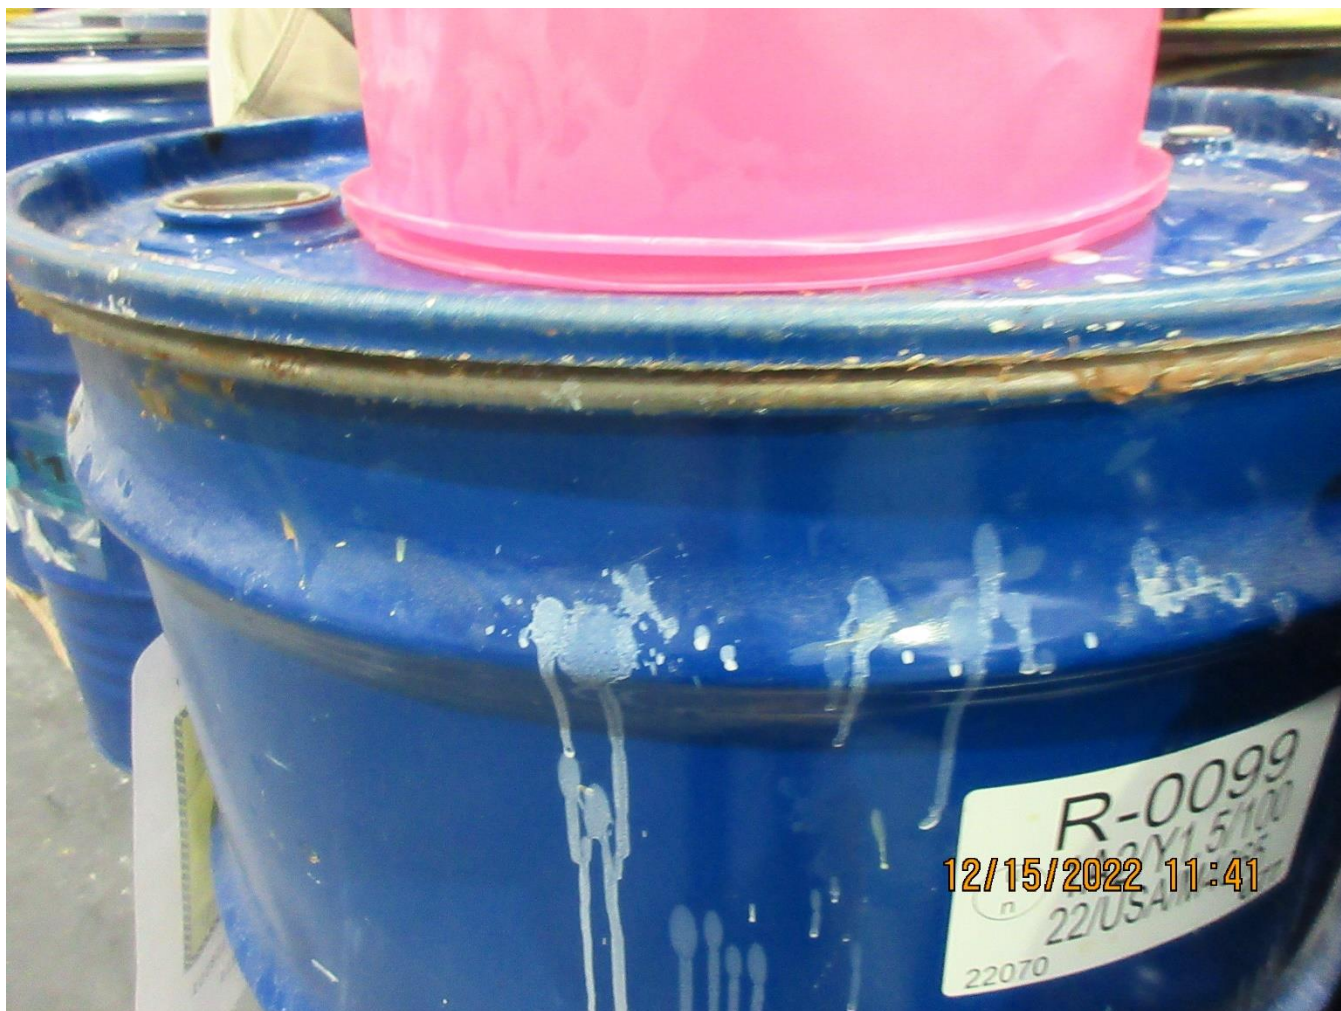
Photo 31 – Lid ajar on FLD drum on Pallet FB5

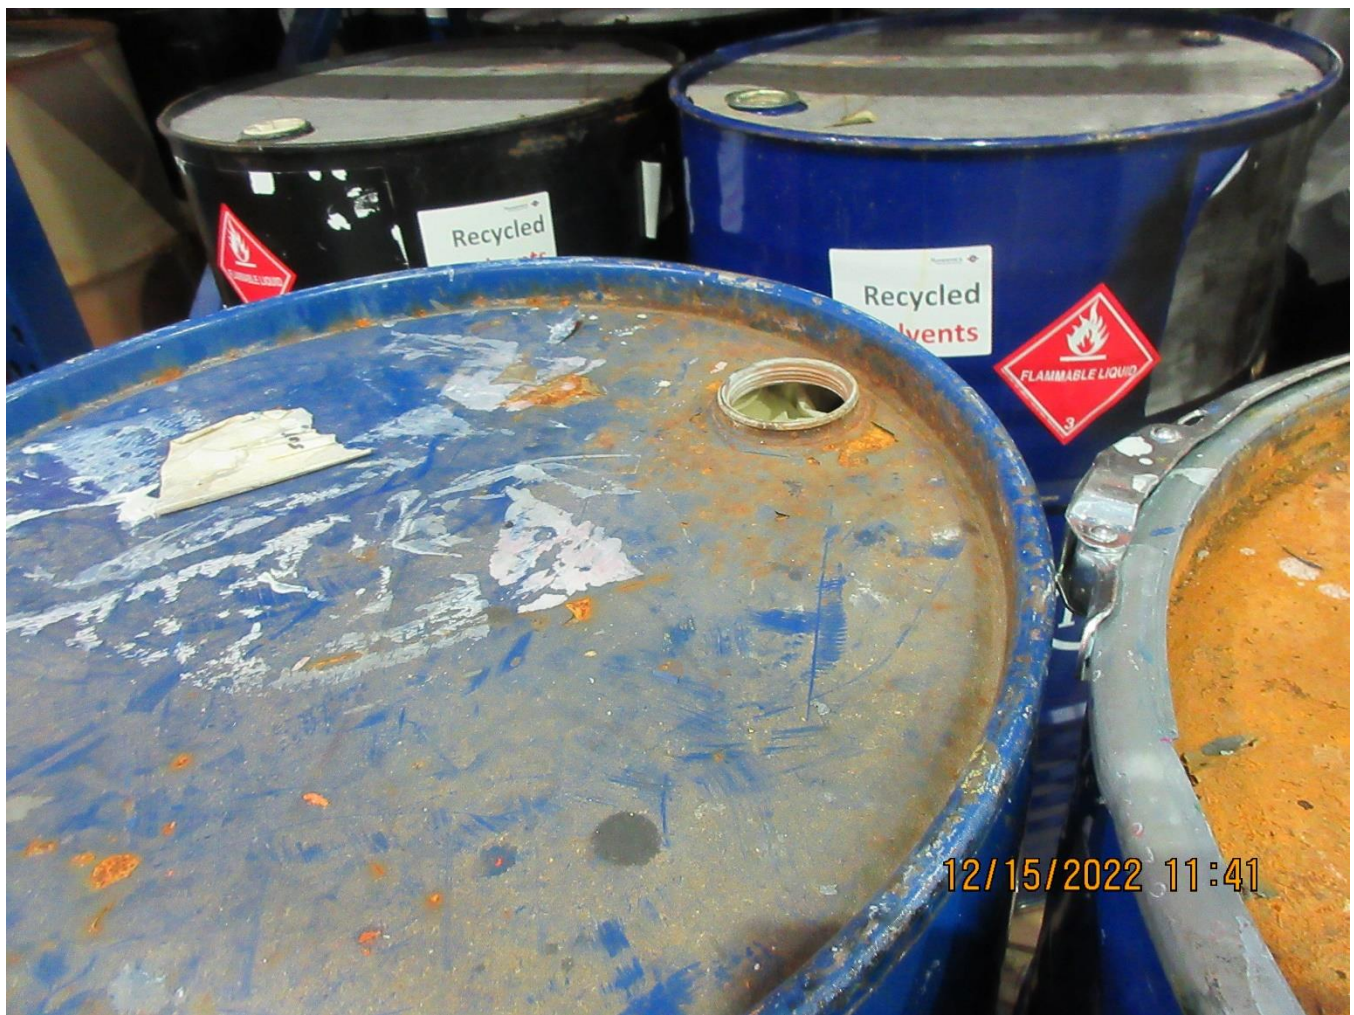
Photo 32 – Bung missing on RLD drum on Pallet FB5

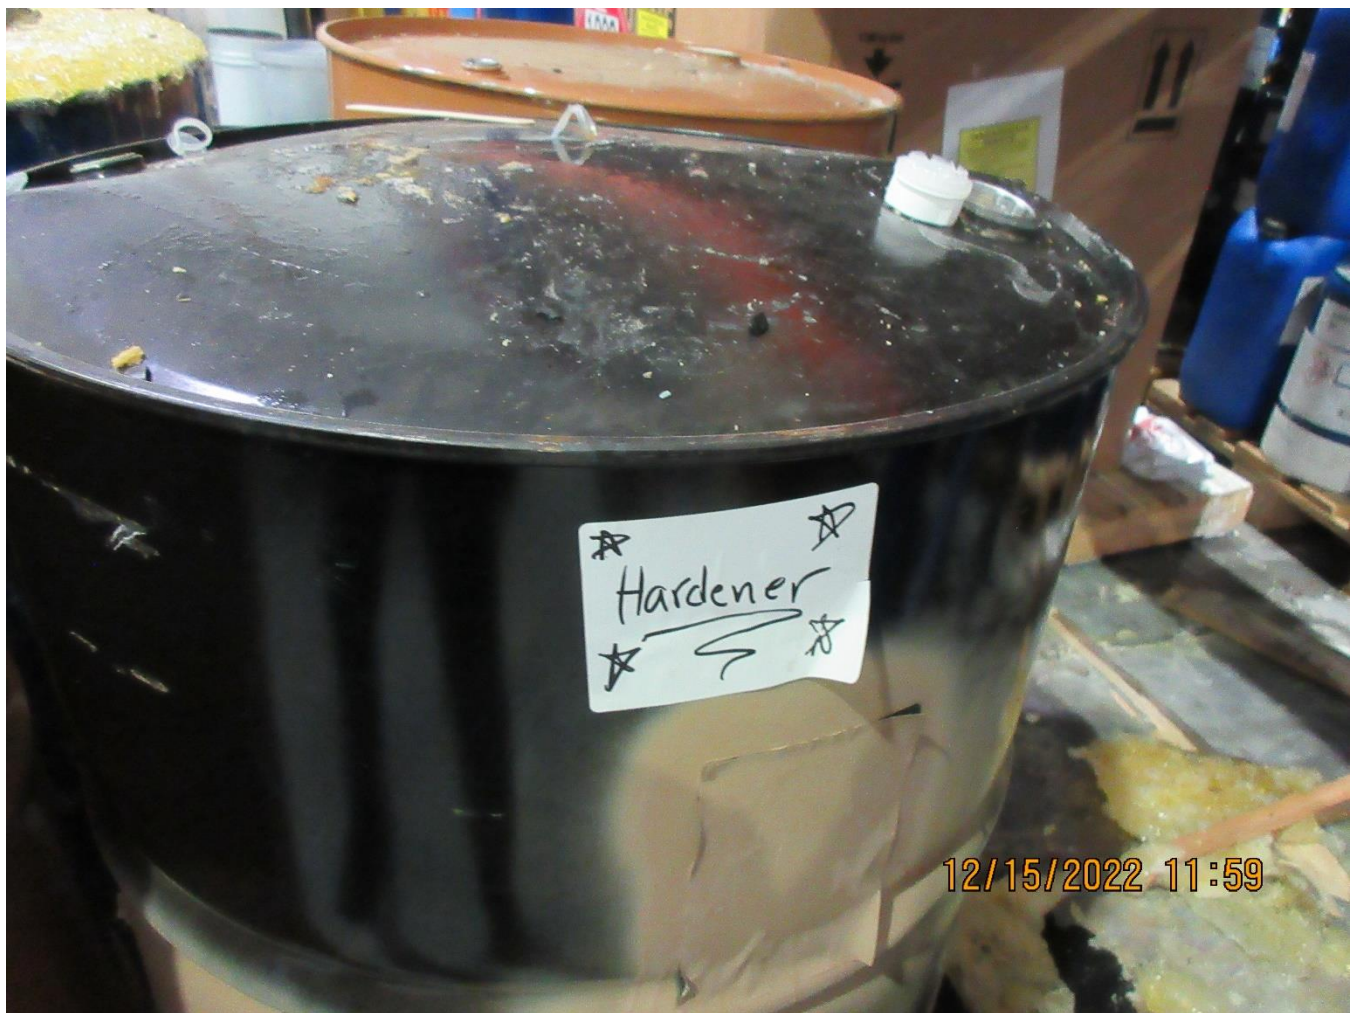
Photo 34 – Drum of Hardener with bulging lid in BRD drum position on pallet B4.

**Pursuant to S.C. Code Ann. Regs. 61-79.262.17(a)(1)(ii) [40 C.F.R. § 262.17(a)(1)(ii)], which is a condition of the LQG Permit Exemption, if a container holding hazardous waste is not in good condition, or if it begins to leak, the generator must immediately transfer the hazardous waste from this container to a container that is in good condition, or immediately manage the waste in some other way that complies with the LQG Permit Exemption.**

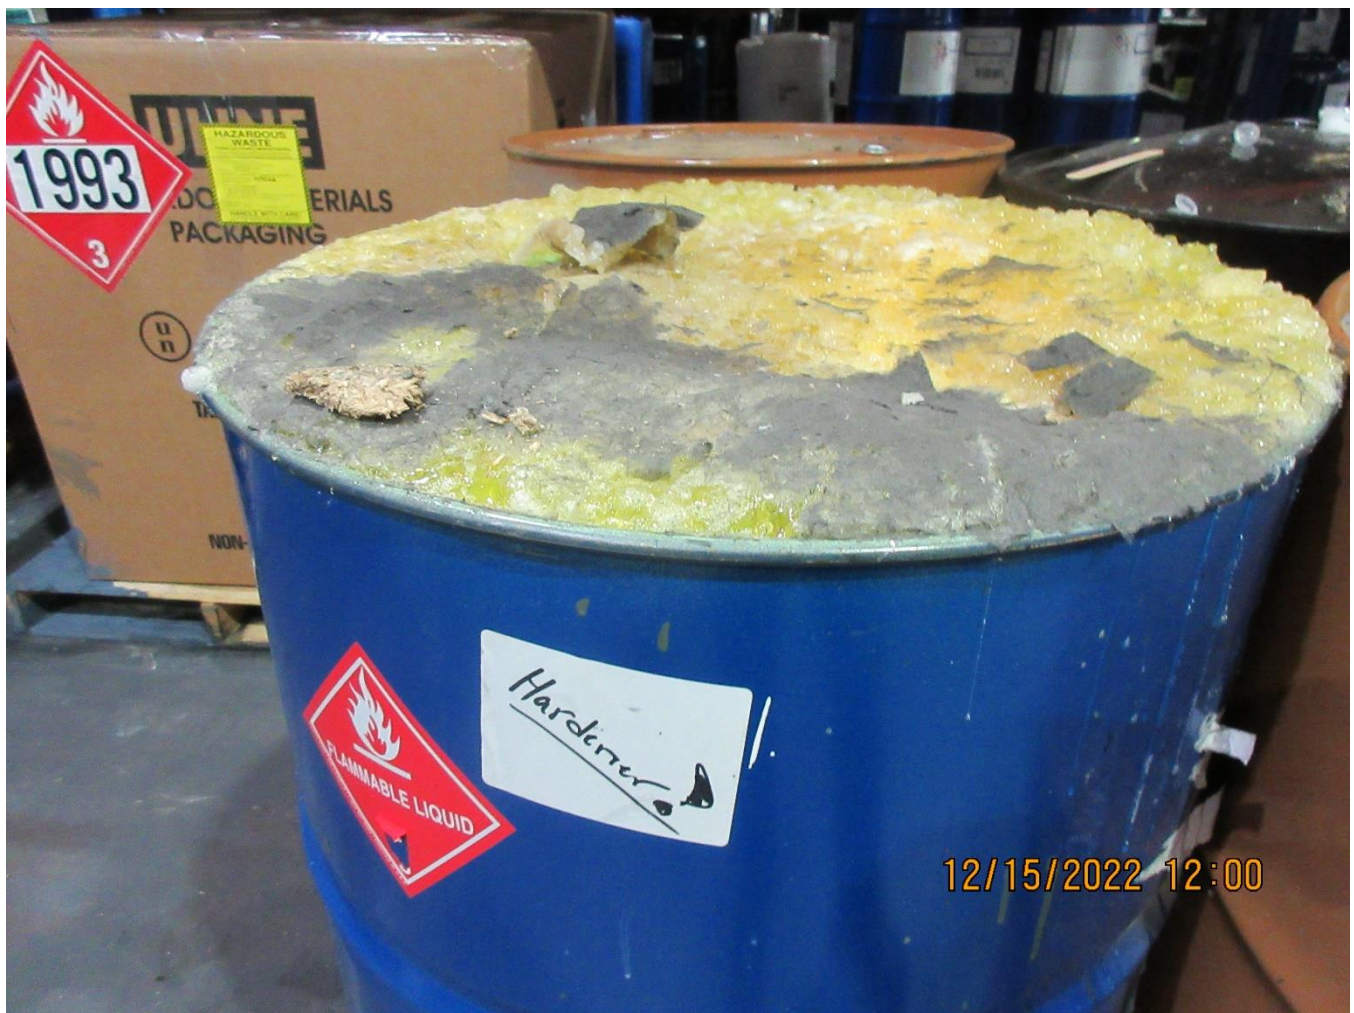
Photo 35 - Drum of Hardener with compromised lid in FLD drum position on pallet B4
