## **RCRA Inspection Report**

Mankiewicz Coatings LLC  
1200 Charleston Regional Parkway  
Charleston, South Carolina 29492

EPA ID# SCR000783035

December 15, 2022, at 9:15 a.m. EDT

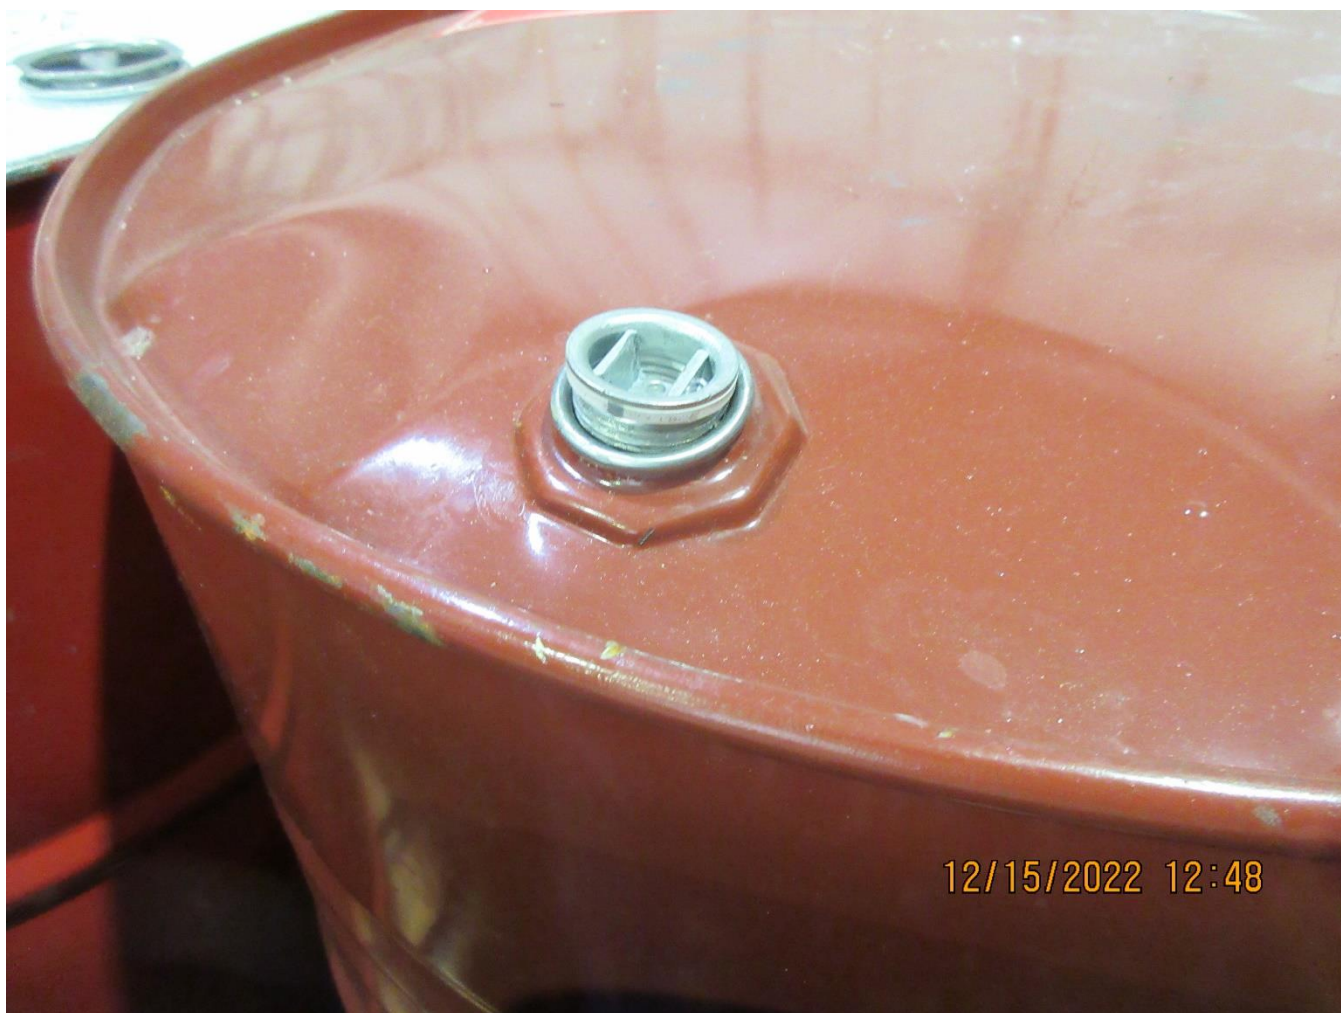
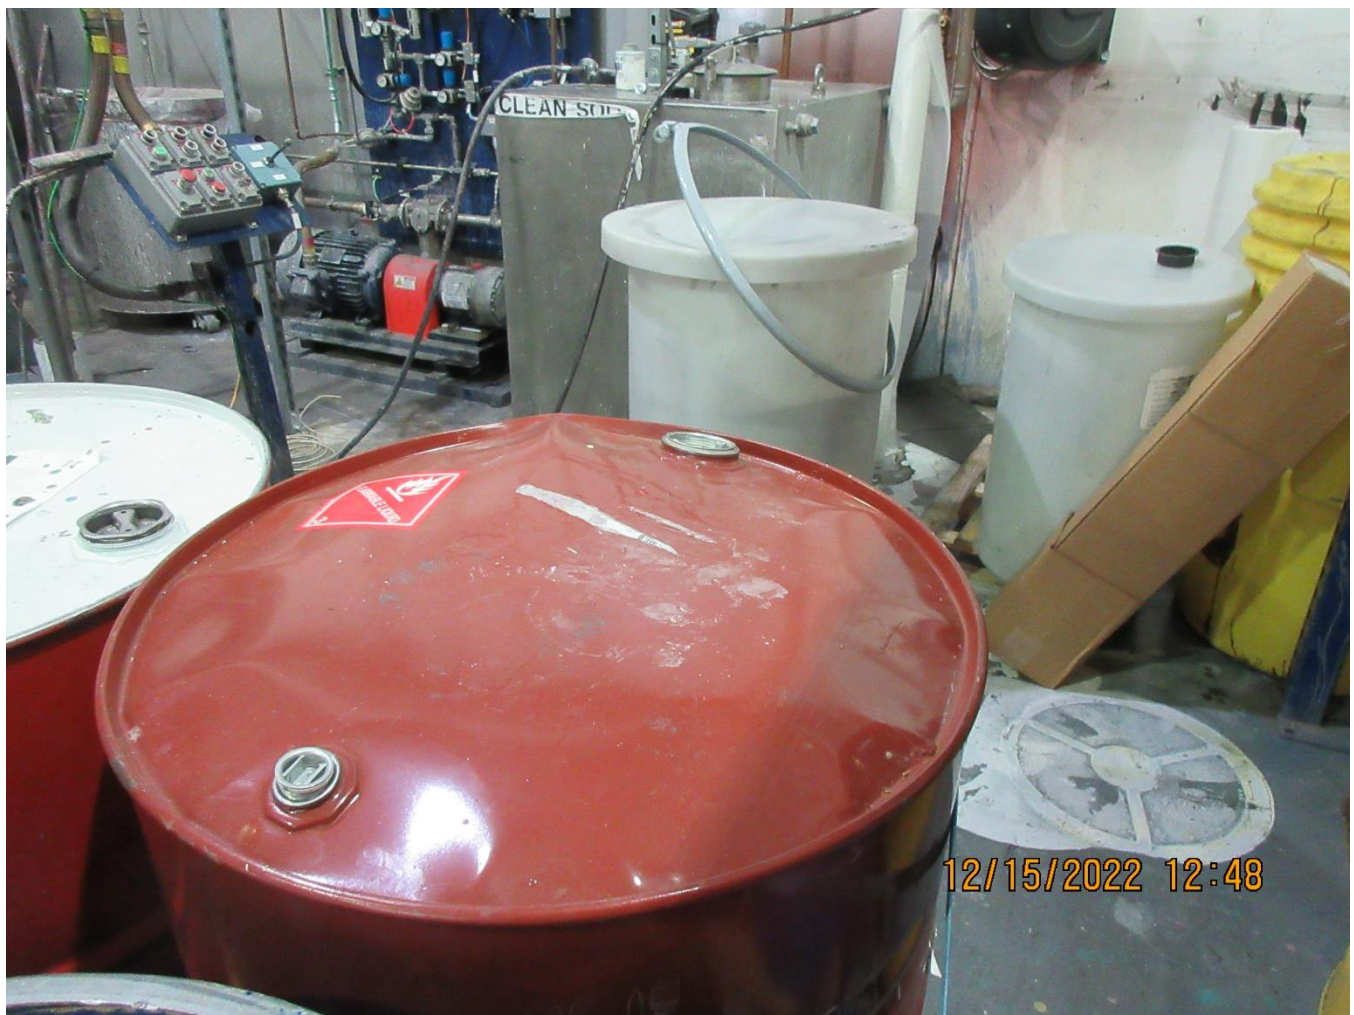
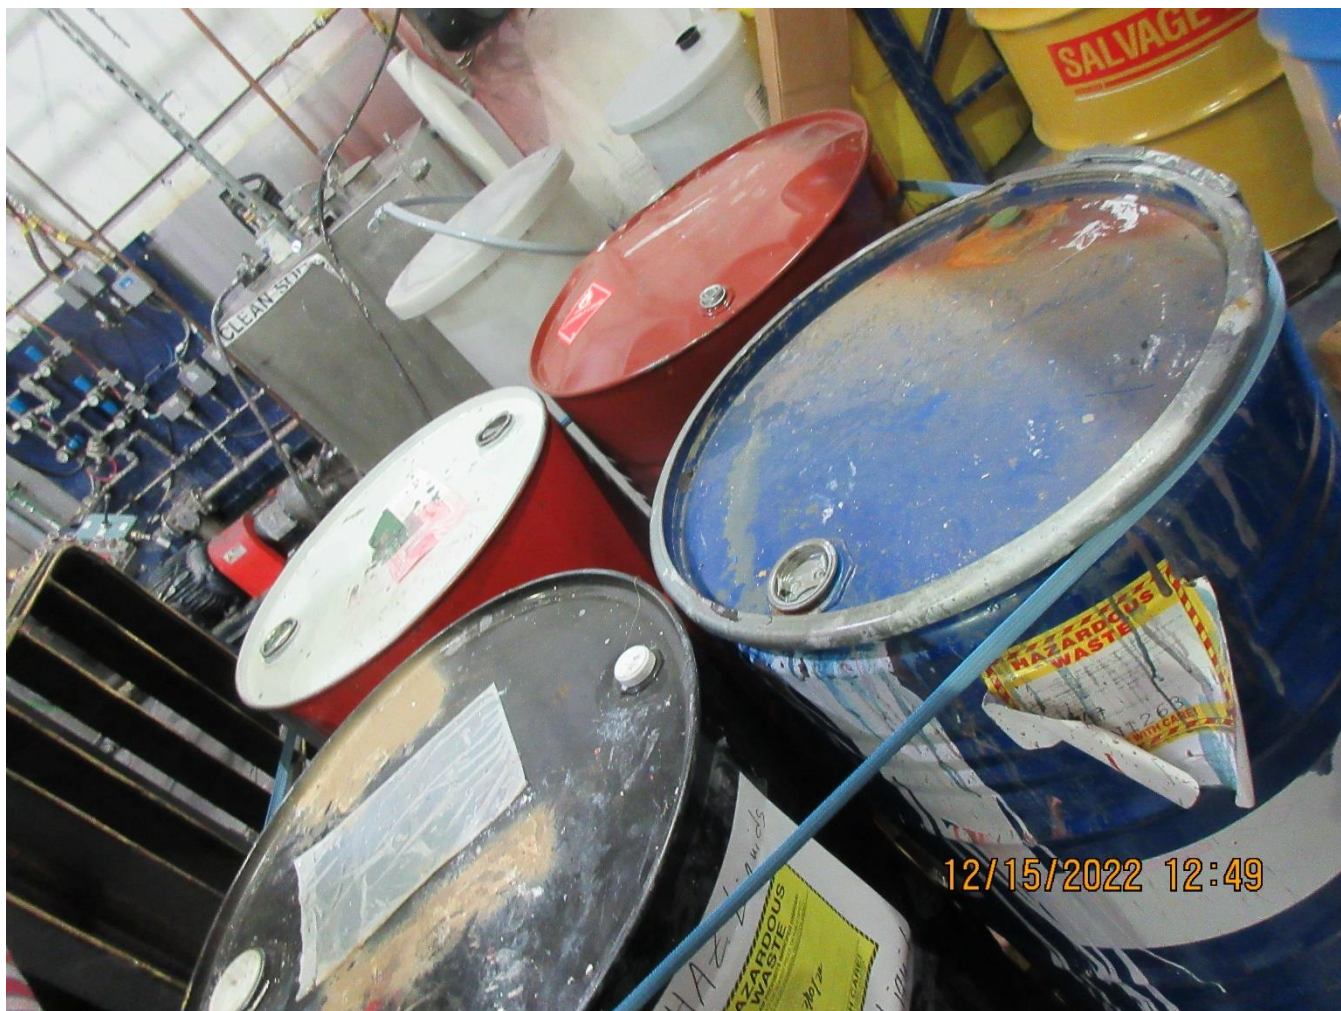
Photo 47 - Bung missing on bulging drum in BLD drum position on pallet in T2 pallet position

Photo 48 - Bung missing on bulging drum in BLD drum position on pallet in T2 pallet position

Photo 49 – Drums on pallet in T2 pallet position. Bung missing on bulging drum in BRD drum position on pallet in T2 pallet position

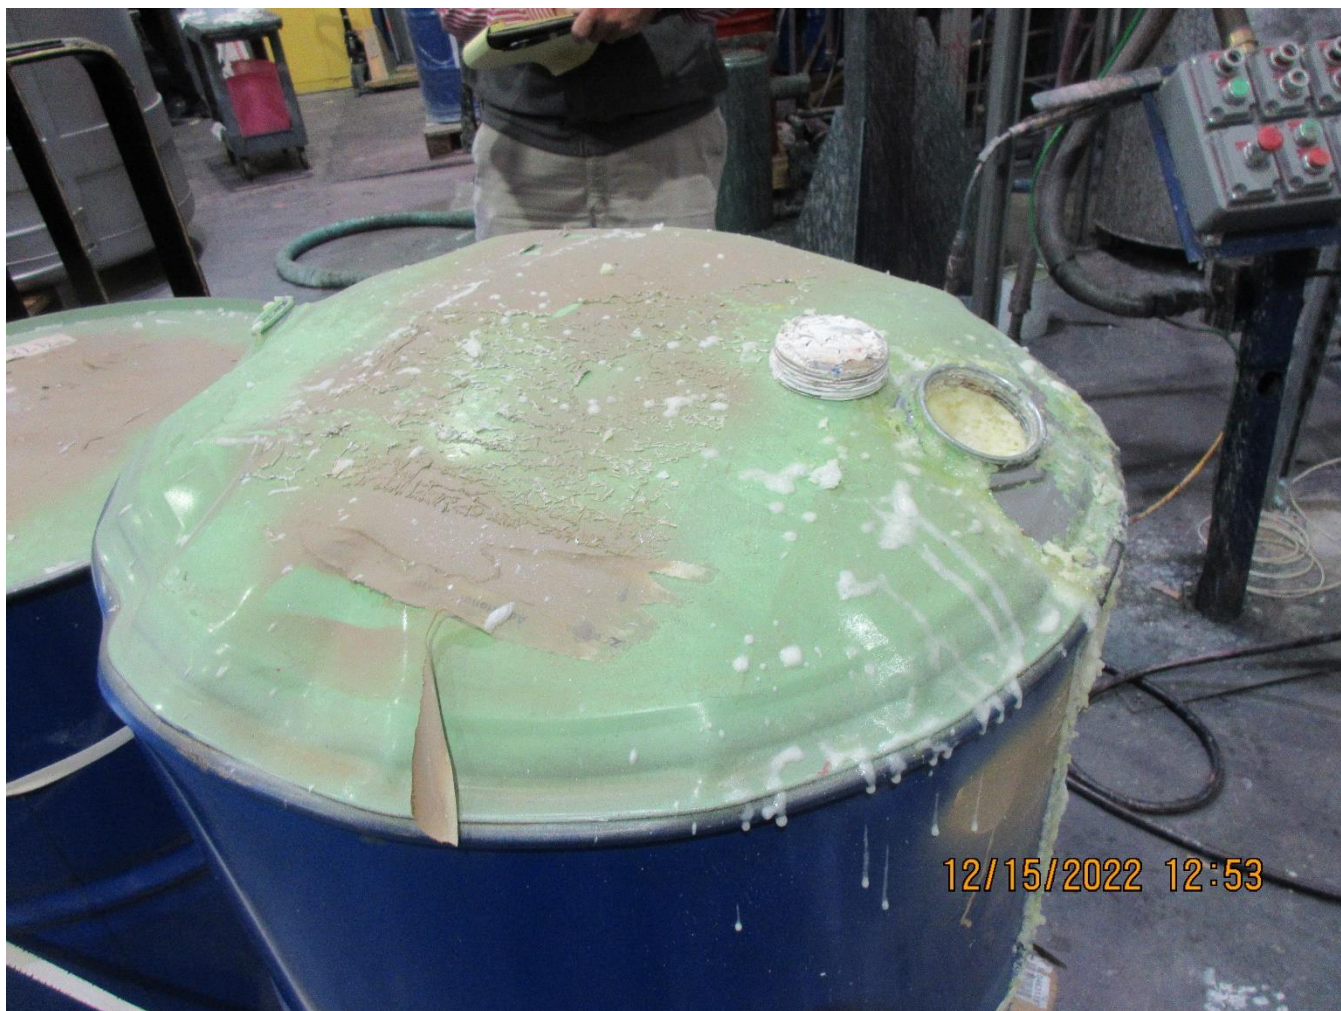
Photo 50 - Bung missing on bulging drum in BRD drum position on pallet in T1 pallet position

Photo 51 - Bung missing on bulging drum in BRD drum position on pallet in T1 pallet position

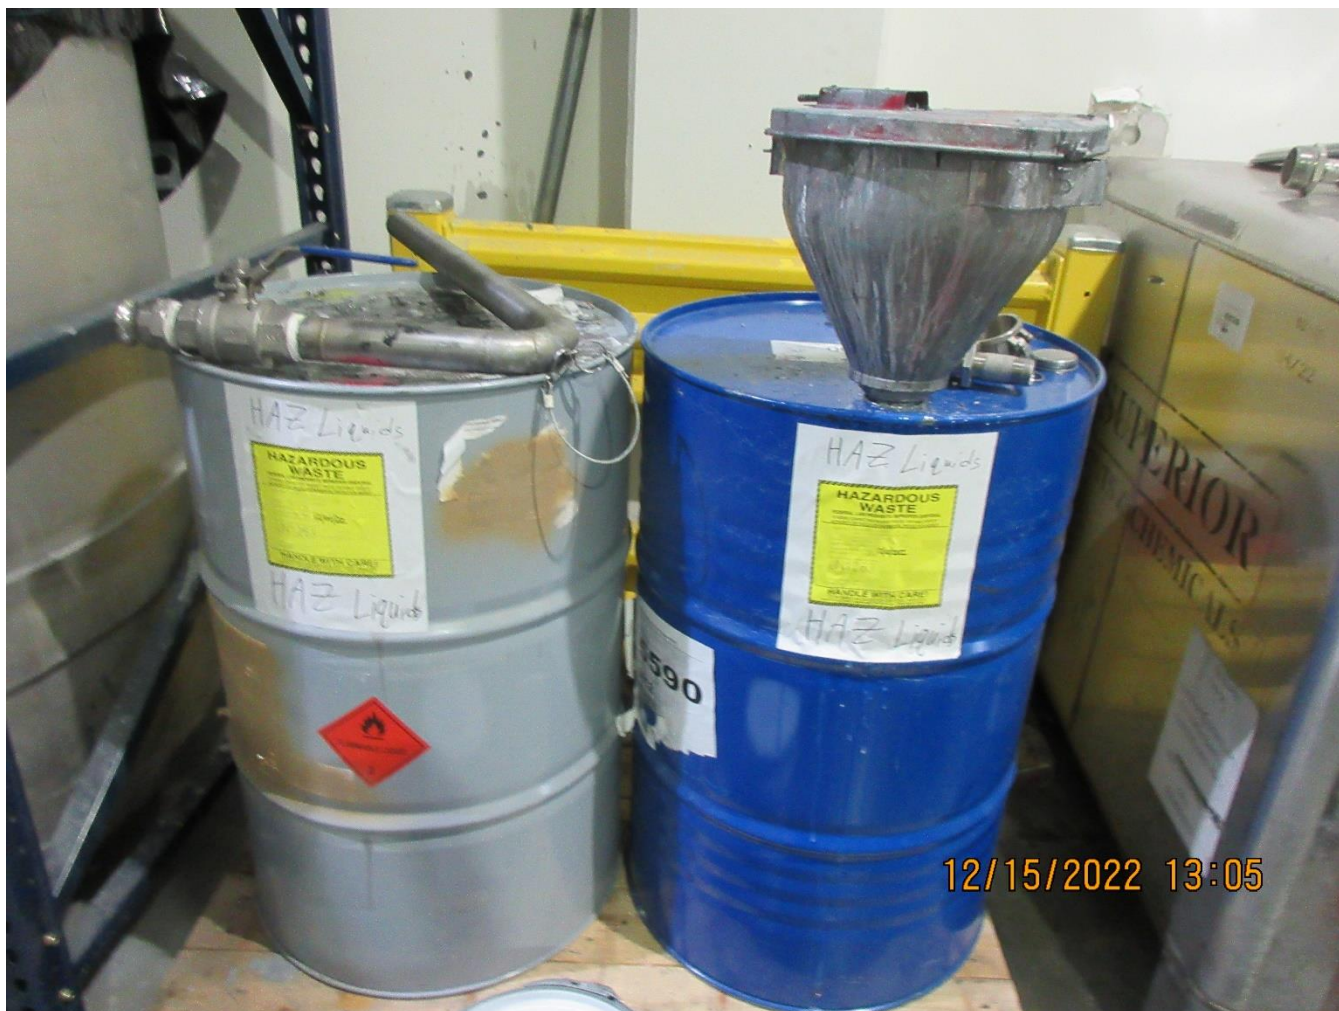
Two 55-gallon containers of ignitable hazardous wastes were observed in this area (Photo 53). One of the drums (gray drum on left in Photo 53) was full and marked with an accumulation start date of “12/01/2022.” The other 55-gallon drum (blue drum on right in Photo 53) was not marked with an indication of the hazards of the contents, or an accumulation start date as the facility had failed to move the gray drum from this area within three days of becoming full. In addition, the funnel in the blue drum was not closed as the latch was broken which would close its lid (Photo 54).

Photo 53 – Drums in SAA in Metallic Area

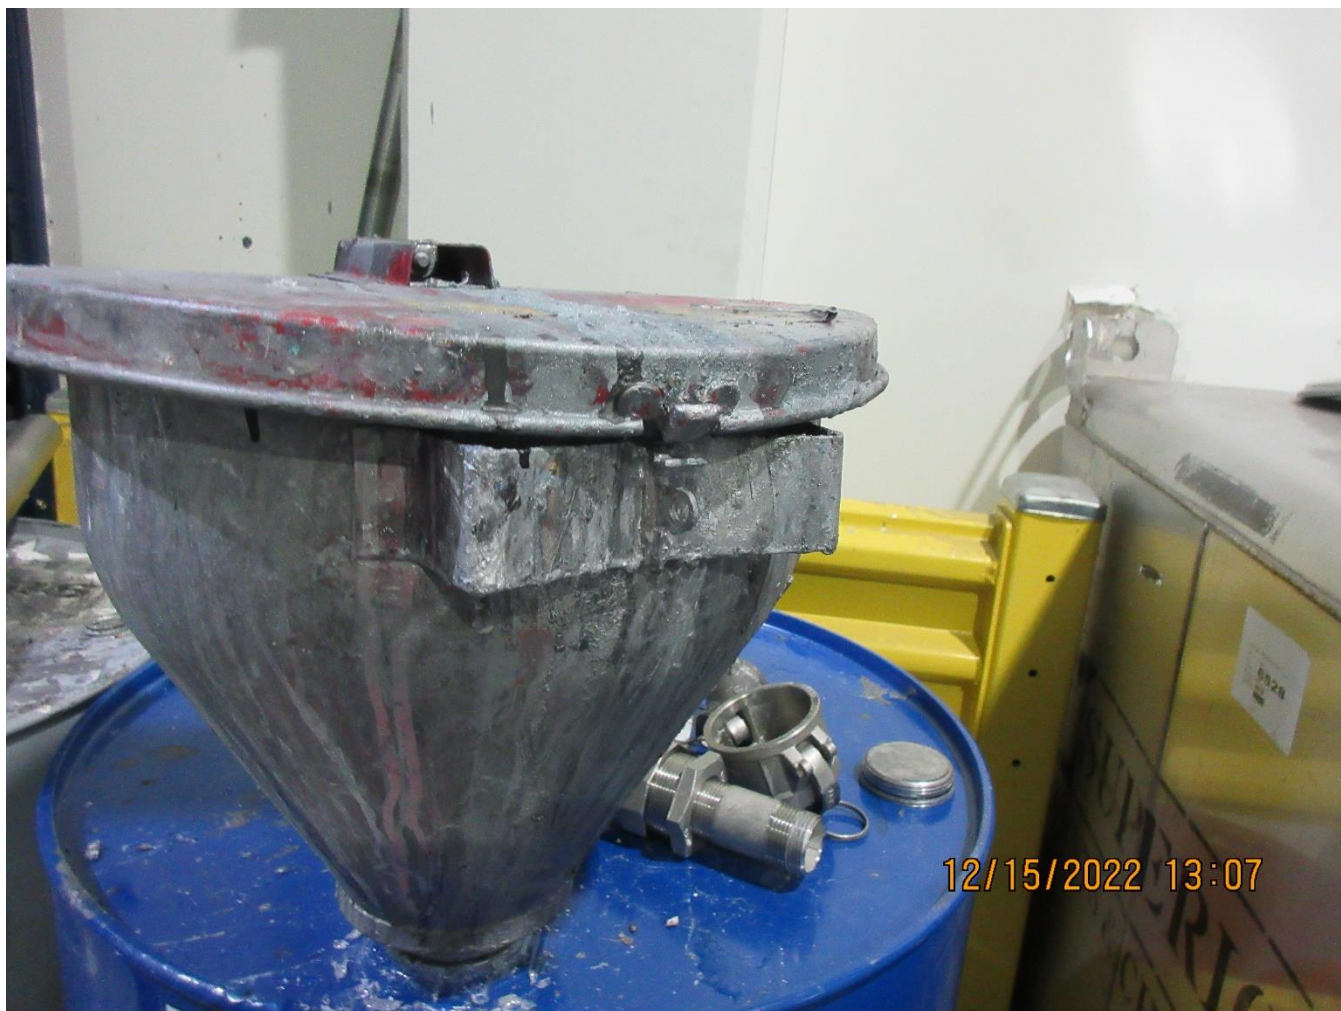
Photo 54 – Funnel with no latch on 55-gallon drum in Metallic Area
