**U.S. ENVIRONMENTAL PROTECTION AGENCY  
REGION III WATER BRANCH, ENFORCEMENT  
AND COMPLIANCE ASSURANCE DIVISION  
CLEAN WATER ACT  
COMPLIANCE INSPECTION REPORT**

**Name of Facility:** Summersville Lake—Long Point WWTP  
**Facility Address:** 502 8<sup>th</sup> St, Huntington, WV 25701  
**Mailing Address:** 502 8<sup>th</sup> St., Huntington, WV 25701

| <b>Type of Inspection:</b> | Wastewater Treatment Facility CEI |

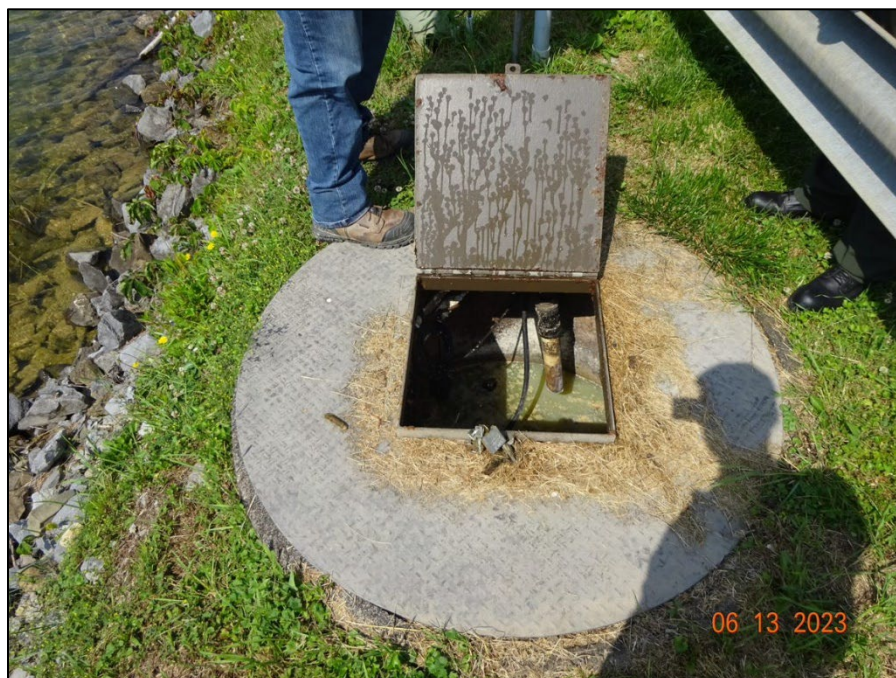
**Photograph 2.** View, facing west, of the lift station which pumps wastewater from the boat pump-out to the manhole behind the comfort station.

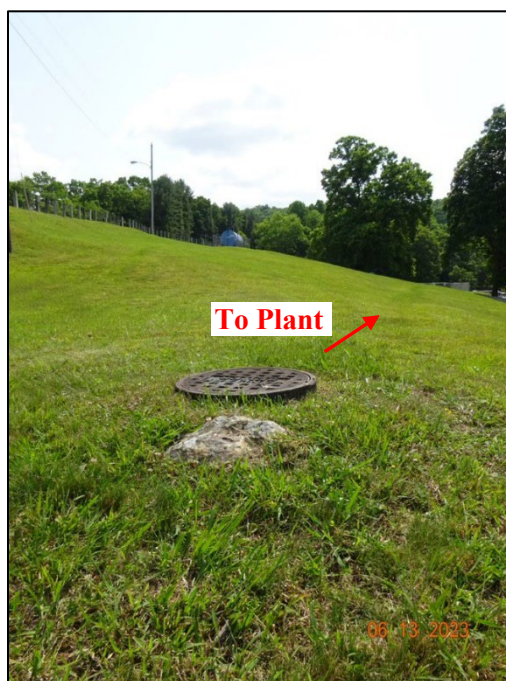
**Photograph 4.** View, facing east, of confluence manhole where wastewater from the boat pump-out and comfort station meet.

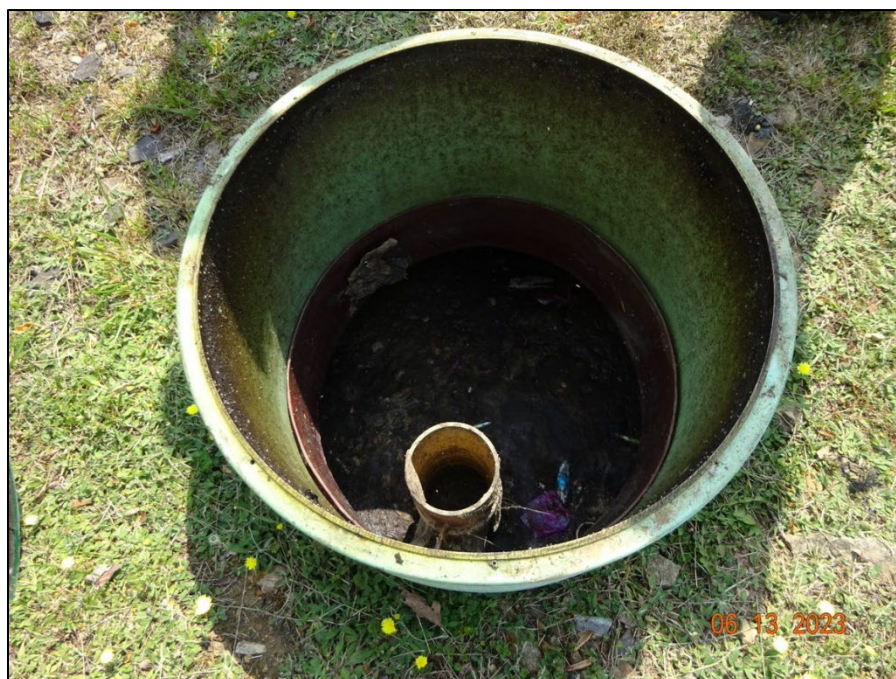
**Photograph 6.** View into the first opening of the primary tank. Note some trash and floating debris.

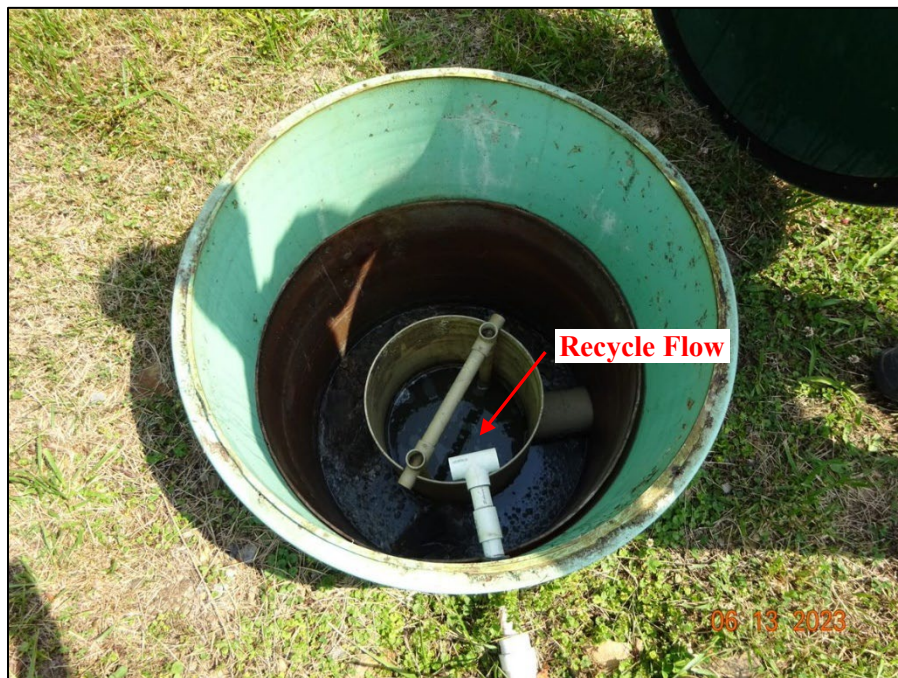
**Photograph 7.** View into the second opening of the primary tank. Note the white plastic recycle flow pipe at the edge of the opening.

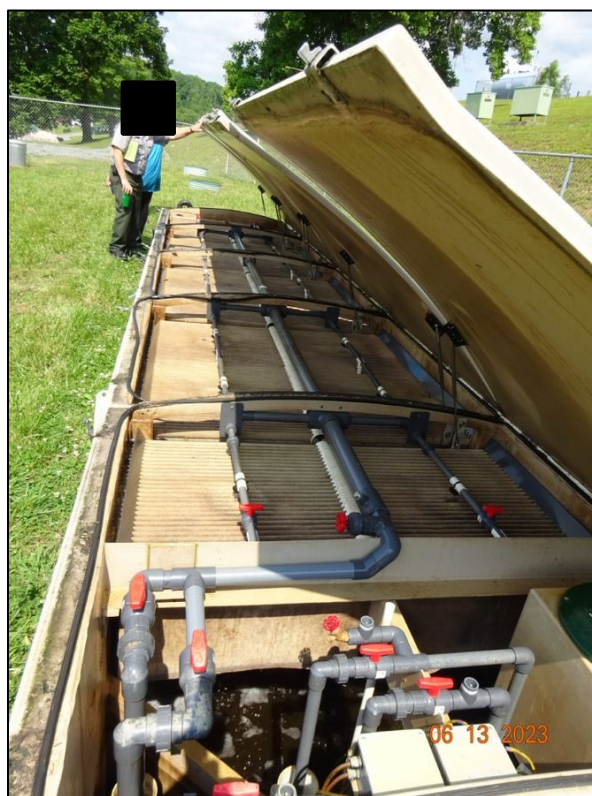
The plant has an Orenco AdvanTex® recirculating media filter (refer to [Appendix A, Photograph 8](#)). Spinners spray recirculated flow across the fixed film and a fan moves air through the system (refer to [Appendix A, Photograph 9](#)). The plant supervisor stated there are no adjustment capabilities for the recirculation rate and the control panel for the Orenco system is very simple and does not allow plant operators to adjust based on variations in usage (refer to [Appendix A, Photograph 10](#)). Current USACE security restrictions do not allow remote access to assets and restrict the use of external devices for

**Photograph 8.** View, facing west, of the Orenco AdvanTex® recirculating media filter.

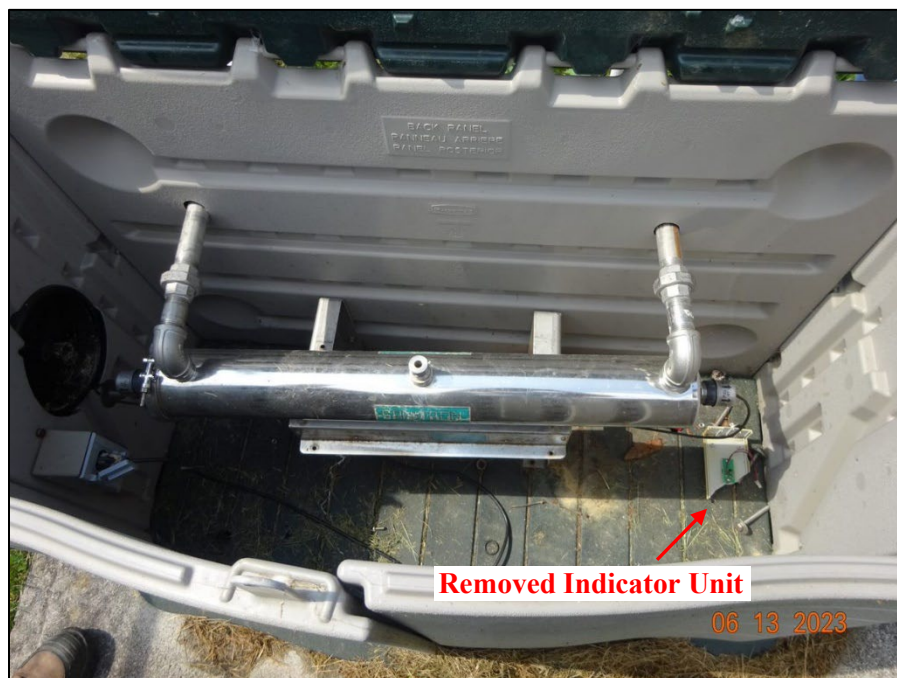
The UV contact chamber is housed within a small plastic shed (refer to [Appendix A, Photograph 11](#)). The plant operator stated that they replace the UV bulb every year, but replacement is done as needed and not on a set timeline. The plant operator noted that they have had problems with the UV indicator on the unit not working properly. The indicator sensor was removed at the time of the visit (refer to [Appendix A, Photograph 11](#)). The sample tap is located just outside of the UV system shed (refer to [Appendix A, Photograph 12](#)). Flow continues from that point to the outfall located in the lake approximately 17 feet underwater (refer to [Appendix A, Photograph 13](#)). The sign for the outfall is located on the plant perimeter fencing (refer to [Appendix A, Photograph 14](#)). The operator said the outfall signage was previously located closer to the outfall itself, but the sign was consistently being tampered with, needing replacement.

- Observation 7.** The UV contact chamber did not have an alert system to indicate failure and cannot be visually inspected without opening the housing (refer to Appendix A, Photograph 11).

**Photograph 11.** View of the UV contact chamber inside its housing. Note debris and removed indicator unit on the floor of the housing.

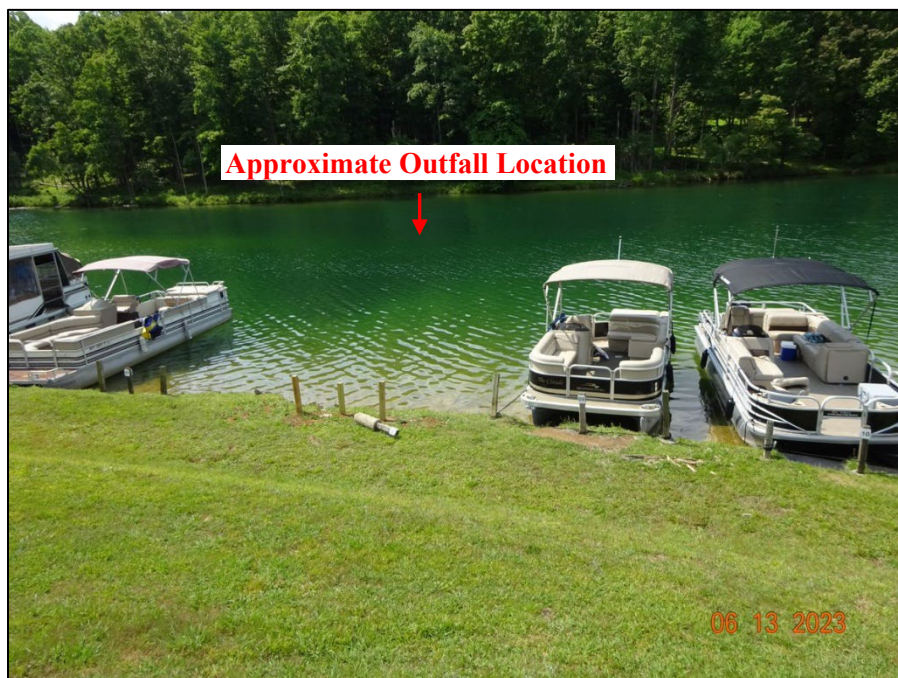
**Photograph 13.** View, facing south, of approximately where Outfall 001 is located. Note the outfall could not be visually inspected due to depth of lake at the time of inspection.

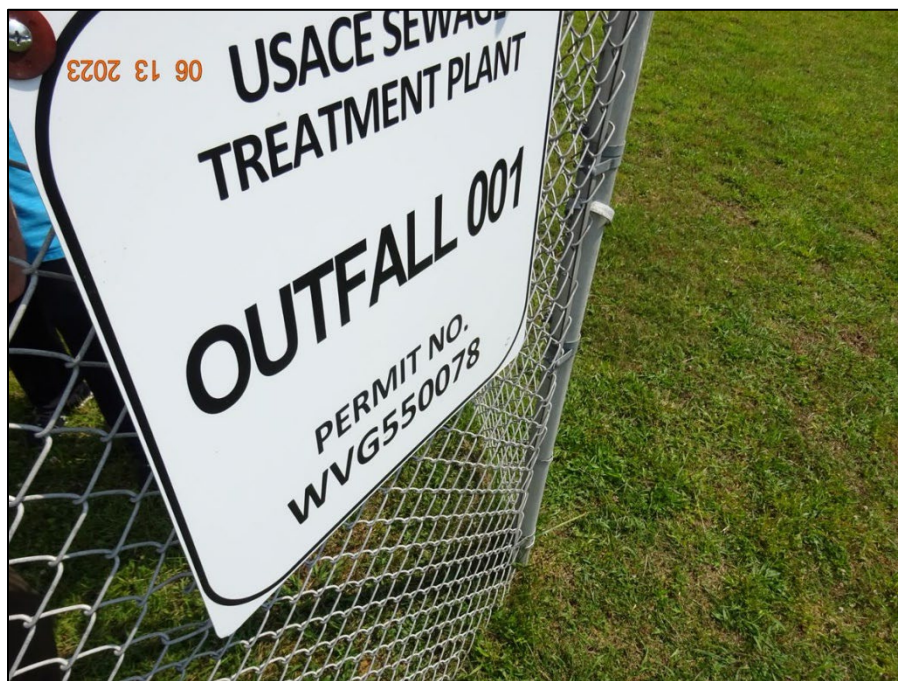
**Photograph 14.** View of outfall signage on outside of plant gate.

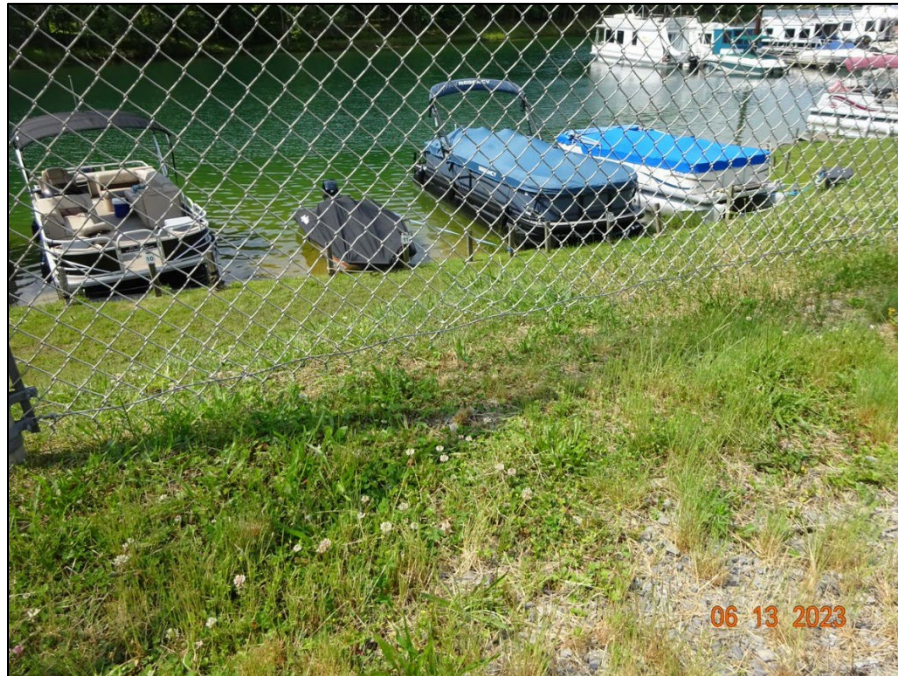
- Observation 11.** The Inspectors observed a gap along the bottom of the WWTP’s south fence line (refer to Appendix A, Photograph 15).

**Photograph 15.** View, facing south, of gap in plant perimeter fencing.
