## **RCRA Inspection Report**

Linvatec Corporation  
11311 Concept Blvd  
Largo, Florida 33773

March 12, 2024, at 9:30 AM

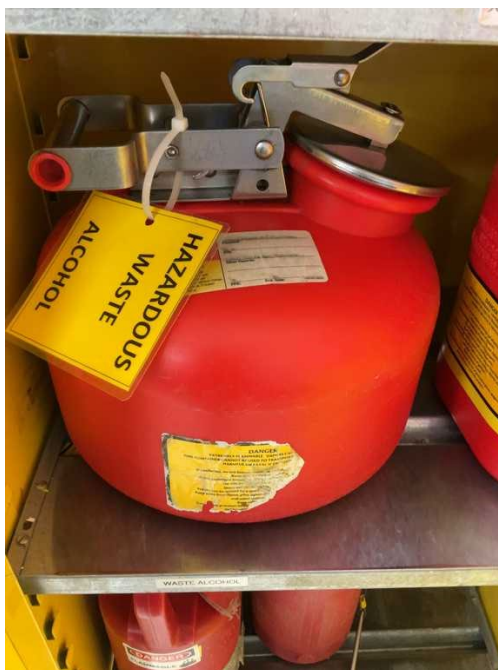
| Photo 3 | | | IMG-202403121023012312098469.jpg |

The Implants Department contains a satellite accumulation area (SAA) for waste alcohol. The inspectors observed two 3-gallon red containers of waste alcohol (Photo 3). The containers were labeled “Hazardous Waste—Alcohol” and marked with an indication of the hazard of the contents.

| 3-gallon red containers of waste alcohol. | | | |

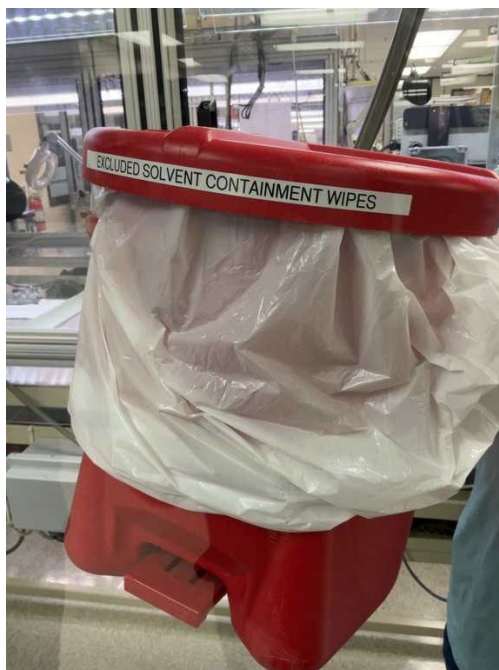
| Photos 4 | | | IMG-2024031210255725572407816.jpg |

This room is located next to the Implants Department and serves as a sterile clean room with an SAA for excluded solvent-contaminated wipes. The inspectors observed one 5-gallon container of excluded solvent-contaminated wipes (Photo 4). The container was closed and labeled “Excluded Solvent Wipes”. Excluded solvent-contaminated wipes are disposed of on a weekly basis pursuant to the facility’s documented standard operating procedures (SOP).

| 5-gallon container of excluded solvent-contaminated wipes. | | | |

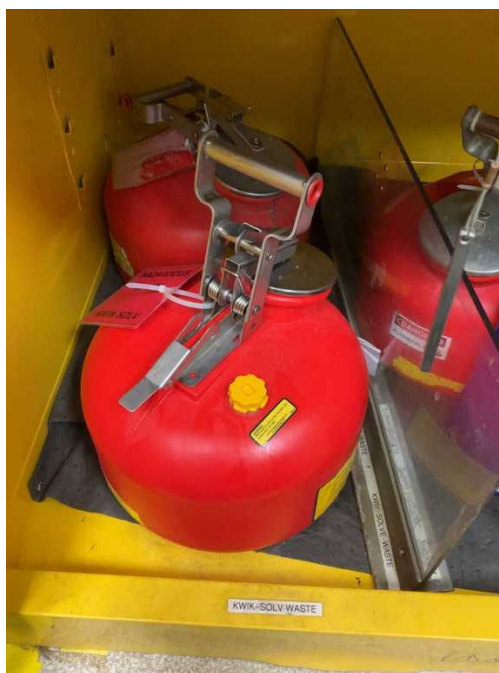
| Photo 5 | IMG-2024031210313831382302002.jpg |

- Two 3-gallon containers of Kwik Solv waste. The containers were closed, labeled “Hazardous Waste—Kwik Solve”, and marked with an indication of the hazard of the contents.
- One 3-gallon container of acetone waste. The container was closed, labeled “Hazardous Waste—Acetone”, and marked with an indication of the hazard of the contents.
- Three 3-gallon containers of alcohol waste. The containers were closed, labeled “Hazardous Waste—Alcohol”, and marked with an indication of the hazard of the contents.

| 3-gallon containers of Kwik Solv waste. | |

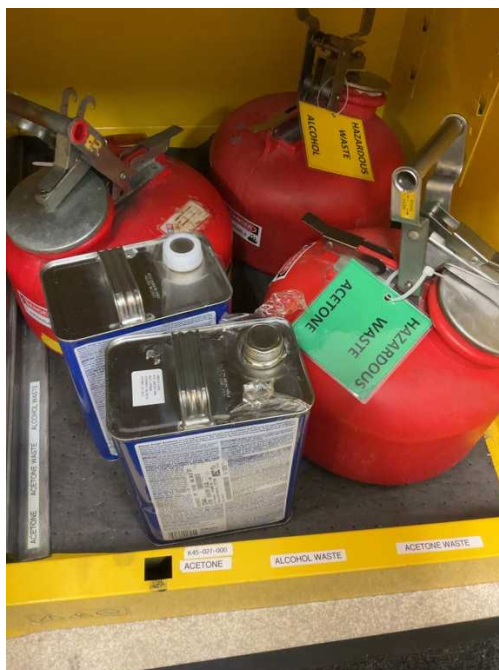
| Photo 6 | IMG-2024031210314431442657366.jpg |

| 3-gallon container of acetone waste. | |

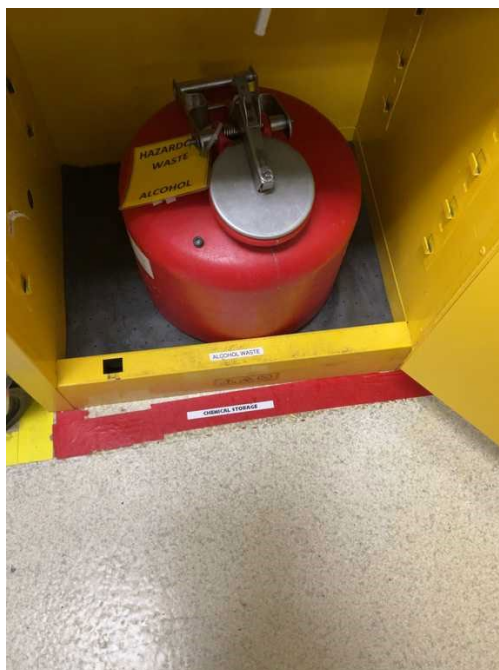
| Photo 7 | IMG-2024031210354435442374750.jpg |

| Three 3-gallon containers of alcohol waste. | |

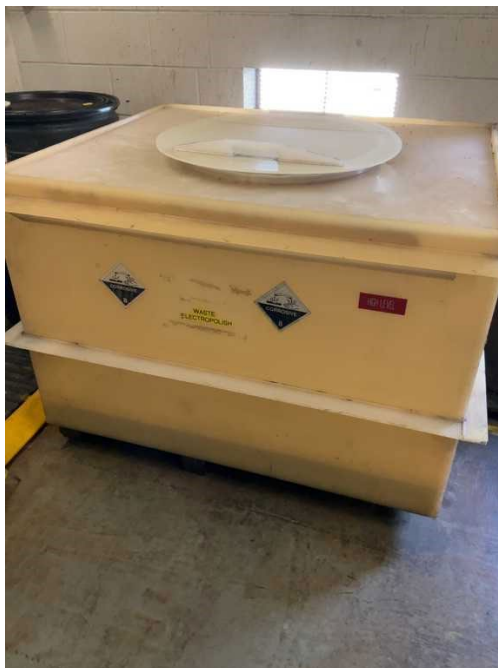
| Photo 8 | IMG-202403121100170172071002.jpg |

- One 289-gallon tank of waste electro-polish wastewater from Building 4. The tank was less than 25% full. The tank was marked with an indication of the hazard of the contents but did not have a Hazardous Waste label (Photo 8).
- One 180-gallon tank of OSW from Building 4. The tank was labeled “Used Oil, Soap, and Water” (Photo 9).

| 289-gallon tank of waste electro-polish wastewater. | |

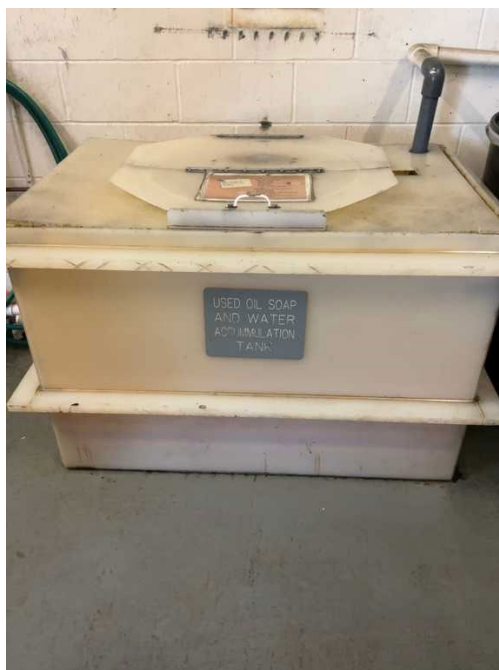
| Photo 9 | IMG-202403121101321322208405.jpg |

| 180-gallon tank of Used Oil, Soap, and Water (OSW). | |

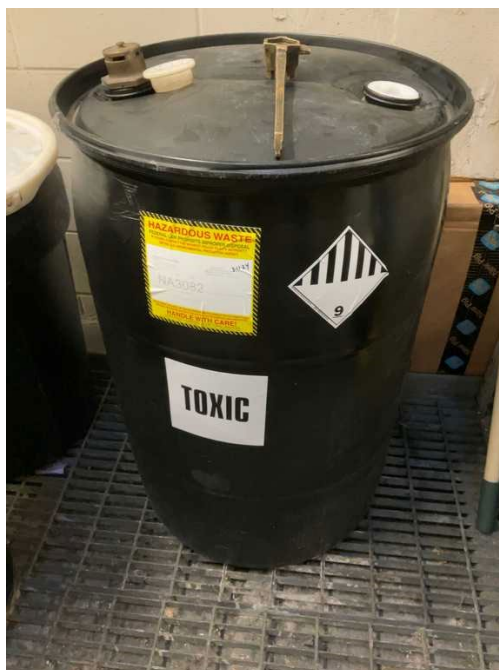
| Photo 10 | IMG-202403121104564562402741.jpg |

- One 55-gallon container of hazardous waste electro-polish sludge. The container was closed, missing a hazardous waste label, not dated, and missing an indication of the hazard of the contents. This was corrected onsite (Photo 10).
- One 55-gallon SAA container of used aerosol cans managed as hazardous waste. The container was not securely closed with a locked ring, missing a hazardous waste label, and missing an indication of the hazard of the contents. This was corrected onsite (Photo 11).
- One 10-gallon container of universal waste batteries. The container was closed but missing a universal waste label and an accumulation start date. This was corrected onsite (Photo 12).
- One 20-gallon container of used lithium-ion batteries. The container was closed but missing a universal waste label and an accumulation start date. This was corrected onsite (Photo 12).

| 55-gallon container of hazardous waste electro-polish sludge. | |

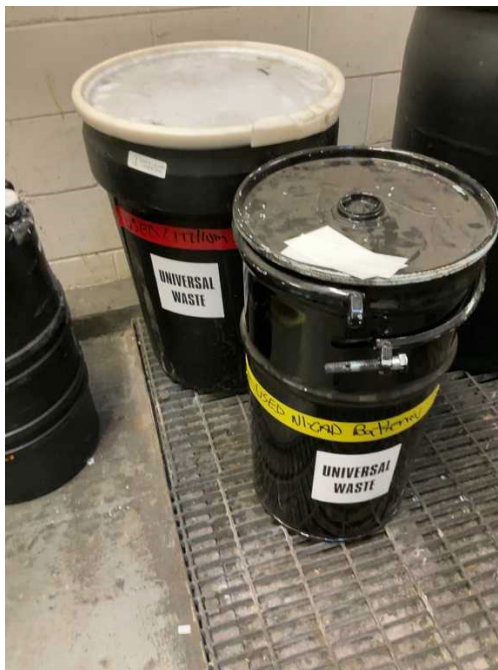
| Photo 11 | | | IMG-202403121107217212282445.jpg |

| 10-gallon container of universal waste batteries and 20-gallon container of universal waste lithium-ion batteries. | | | |

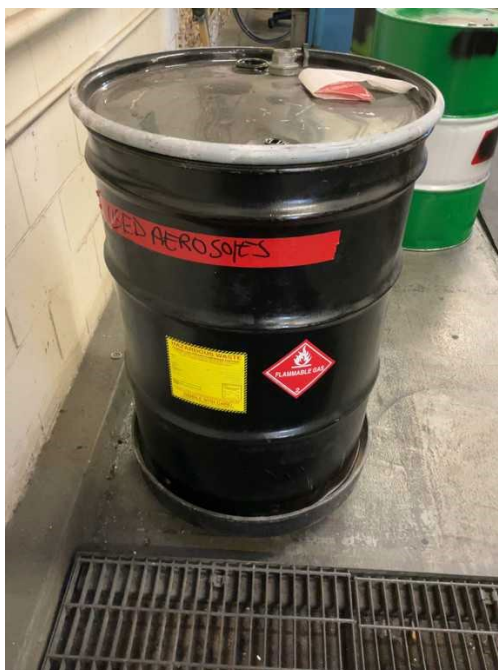
| Photo 12 | IMG-2024031211104510452306710.jpg |

| 55-gallon container of use aerosol cans managed as hazardous waste. | |

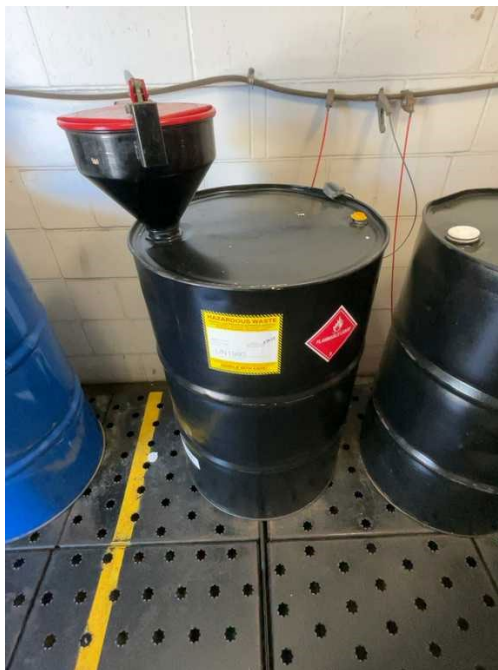
| Photo 13 | IMG-2024031211214421441293800.jpg |

- One 55-gallon container of waste ethanol heptane. The container was closed, labeled “Hazardous Waste—Ethanol Heptane”, marked with an indication of the hazard of the contents, and dated 02/29/24.
- Two 55-gallon containers of isopropyl alcohol (IPA) waste. The containers were closed, labeled “Hazardous Waste”, marked with an indication of the hazard of the contents, and dated 03/11/24 and 03/06/2024 respectively.

| 55-gallon container of hazardous waste ethanol. | |

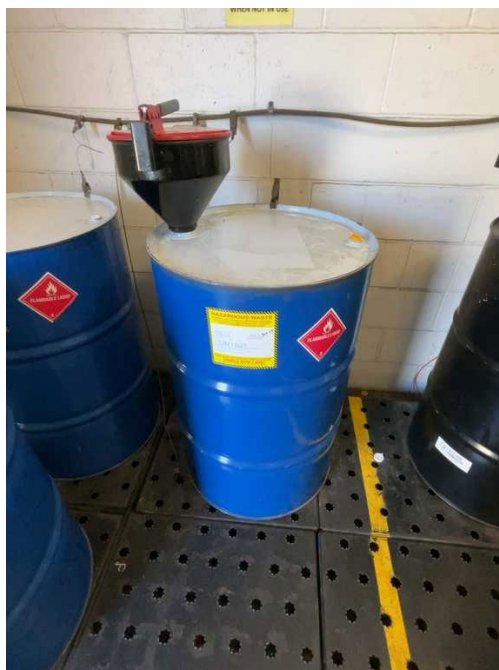
| Photo 14 | IMG-2024031211215021501240495.jpg |

| 55-gallon container of hazardous waste IPA. | |

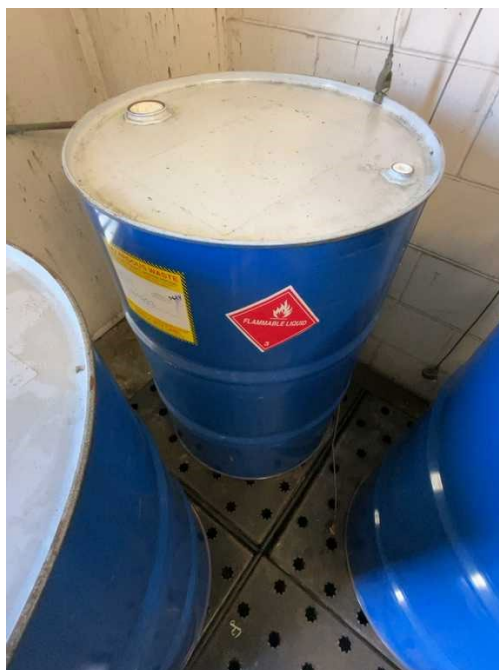
| Photo 15 | IMG-202403121122032231185137.jpg |

| 55-gallon container of hazardous waste IPA. | |

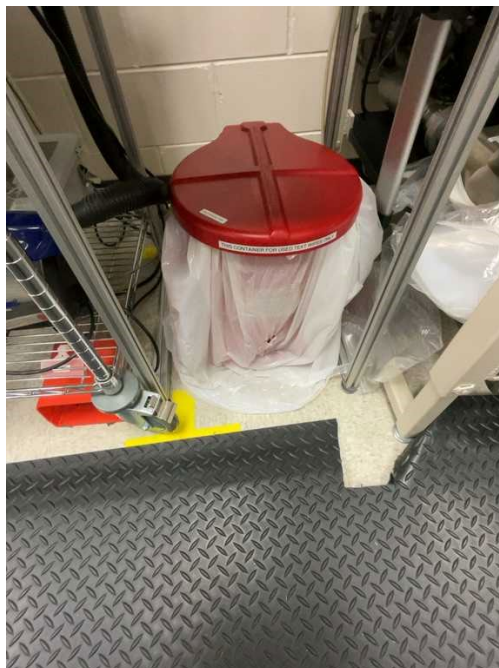
| Photo 16 | IMG-2024031211334433441493638.jpg |

In the battery assembly room, the inspectors observed one 5-gallon container of excluded solvent-contaminated wipes. The container was closed and labeled “Excluded Solvent-contaminated Wipes” (Photo 16).

| 5-gallon container of excluded solvent-contaminated wipes. | |

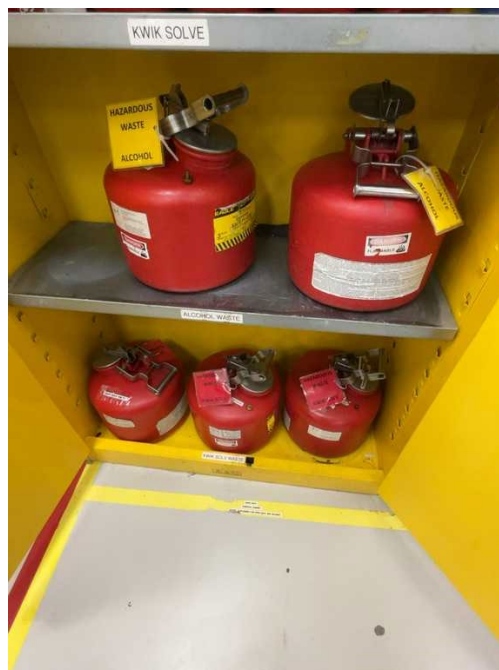
| Photo 17 | IMG-2024031211374437441161990.jpg |

In the Machining Area, the inspectors observed an SAA for two 3-gallon containers labeled Kwik-Solve and two 3-gallon containers labeled waste alcohol. The containers were closed, labeled “Hazardous Waste”, and marked with an indication of the hazard of the contents (Photo 17).

| Two 3-gallon containers of Kwik-Solve and two 3-gallon containers of waste alcohol. | |

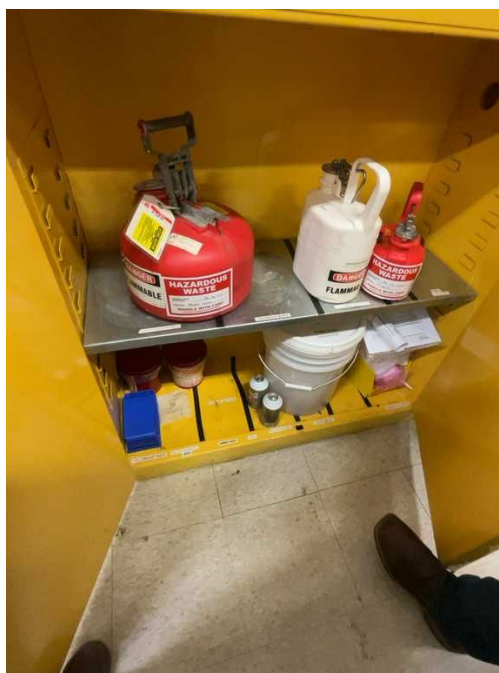
| Photo 18 | IMG-202403121203533531263898.jpg |

This department has an SAA for electro-polish wastewater and waste IPA. The inspectors observed the following wastes (Photos 18):

- One 30-gallon container used to collect electro-polish wastewater. The container was closed and empty at the time of the inspection.
- Five 5-gallon containers of excluded solvent-contaminated wipes. The containers were all closed and labeled “Excluded Solvent-Contaminated Wipes”.
- One half-gallon container of IPA waste. The container was closed, labeled “Hazardous Waste—IPA”, and marked with an indication of the hazard of the contents.

| SAA for IPA waste. | |

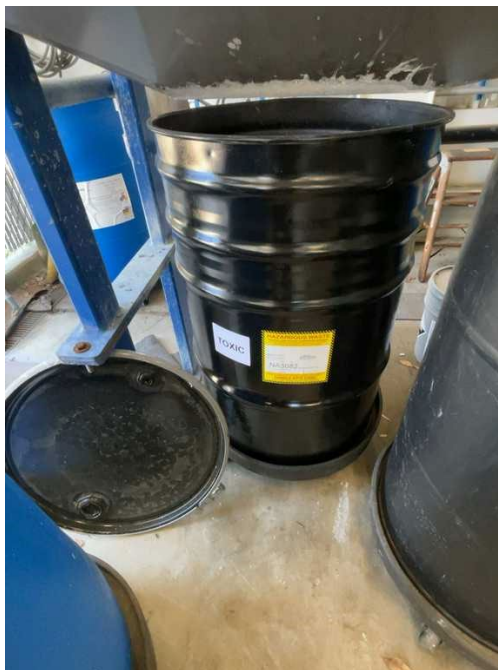
| Photo 19 | | | IMG-2024031212131613161306041.jpg |

The inspectors observed one 55-gallon SAA container of hazardous waste wastewater treatment sludge under the filter press for hazardous waste sludge (Photo 19). The container was open but was actively in use. The container was missing a hazardous waste label and an indication of the hazard of the contents. This was corrected onsite.

| 55-gallon container of hazardous waste sludge from wastewater treatment plant. | | | |

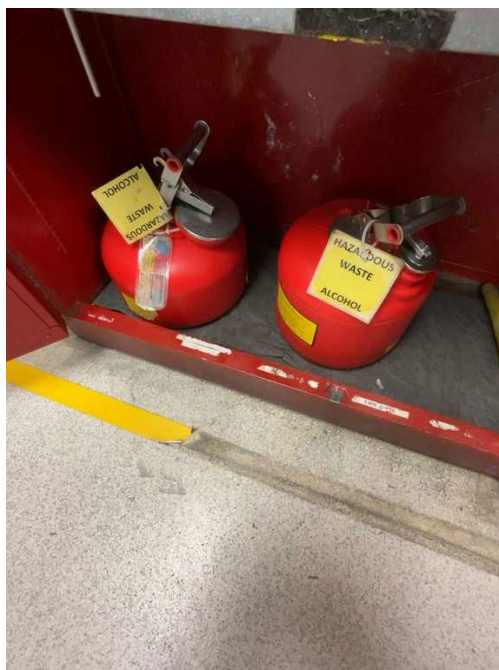
| Photo 20 | IMG-2024031212265126511487390.jpg |

- Two 3-gallon SAA containers of waste alcohol. The containers were labeled “Hazardous Waste—Alcohol” and marked with an indication of the hazard of the contents.
- One 5-gallon container of excluded solvent contaminated wipes. The containers were all closed and labeled “Excluded Solvent-Contaminated Wipes”.
- One 55-gallon closed container of non-hazardous waste spent blast media.

| Two 3-gallon containers of hazardous waste alcohol. | |

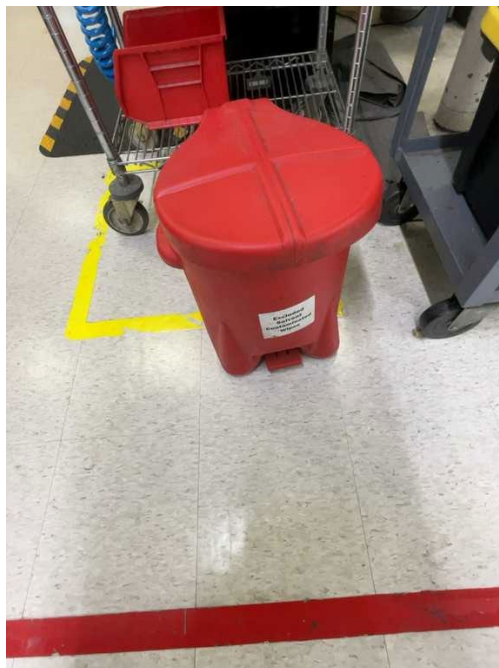
| Photo 21 | IMG-2024031212282028201271690.jpg |

| 5-gallon container of excluded solvent-contaminated wipes. | |

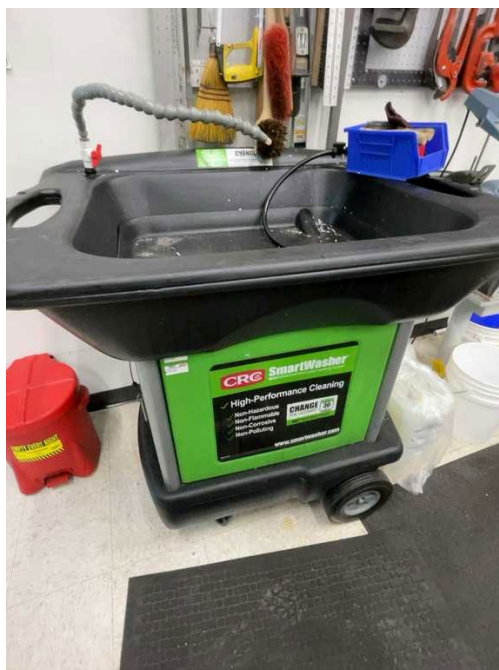
| Photo 22 | IMG-2024031212352435241320328.jpg |

The facilities maintenance department utilizes a CRC SmartWasher which is a bio-remediation parts washer. The bio-remediation solution is added as needed (Photo 22).
