**Region 6 - Enforcement & Compliance Assurance Division**  
**INSPECTION REPORT**

| Inspection Date(s): | 03/19/2025 | |
| Company Name: | <b>Novy Oil and Gas Inc.</b> | |
| Facility Name: | <b>Osage B Lease</b> | |

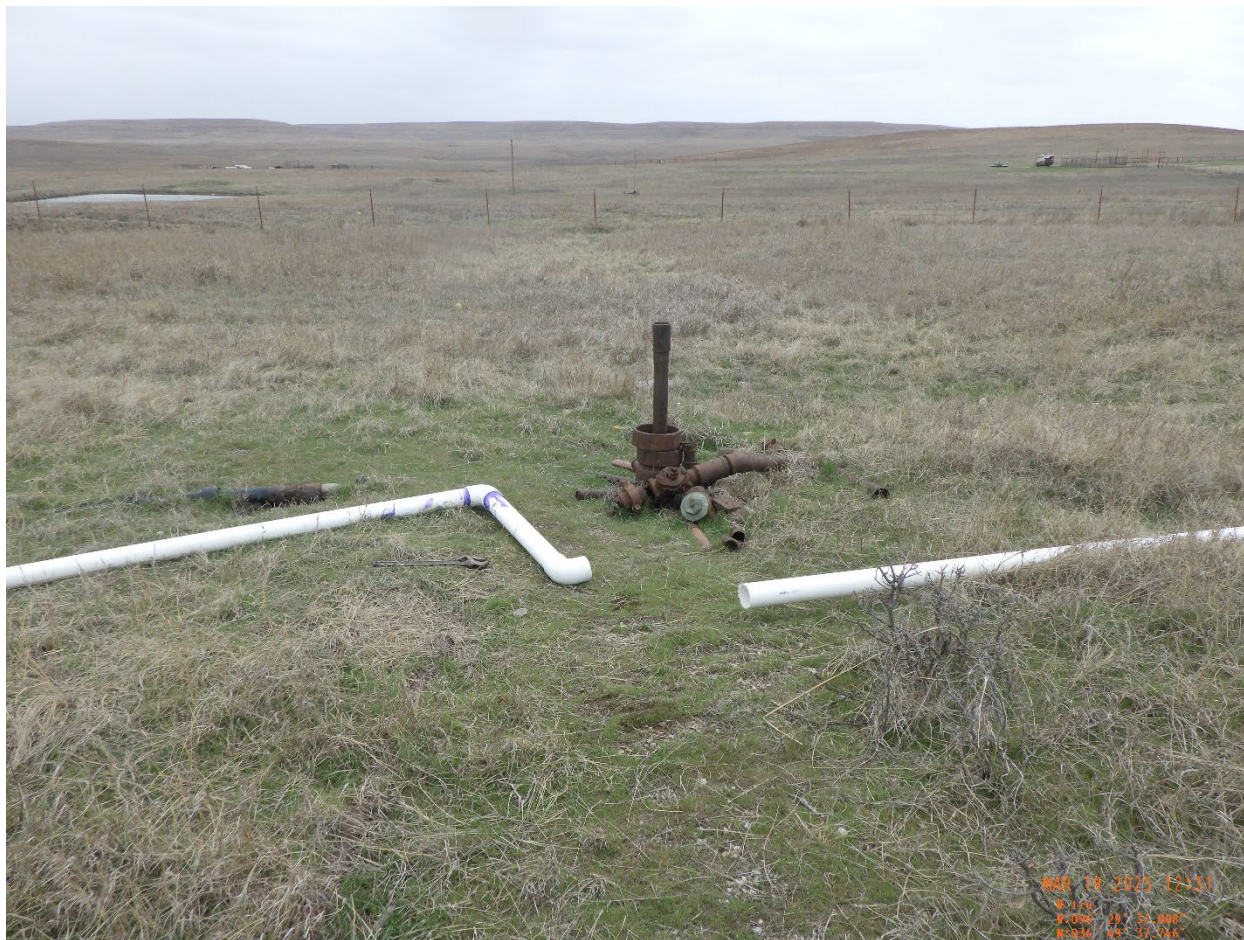
Photo No. 1

I observed a temporarily abandoned oil well with a 3" PVC line beginning approximately 3 feet from the well, extending southeast toward the impacted stock pond. See photo No. 1. For additional GPS location information and photo metadata, please see Appendix 1 (photo log) attached to this report.

**Description:** This was an unidentified, temporarily abandoned oil well referenced in the complaint as the possible site for unauthorized injection of impacted waters from the nearby oil/brine spill.

EPA inspector contacted Mike Novy with Novy Oil and Gas Inc. via phone call to explain the temporarily abandoned oil well could not be used to inject/dispose brine/oil impacted pond water, only permitted or authorized injection wells are suitable for underground injection. EPA inspector explained the impacted water in the stock pond should be contained and removed to prevent downstream migration into North Bird Creek.

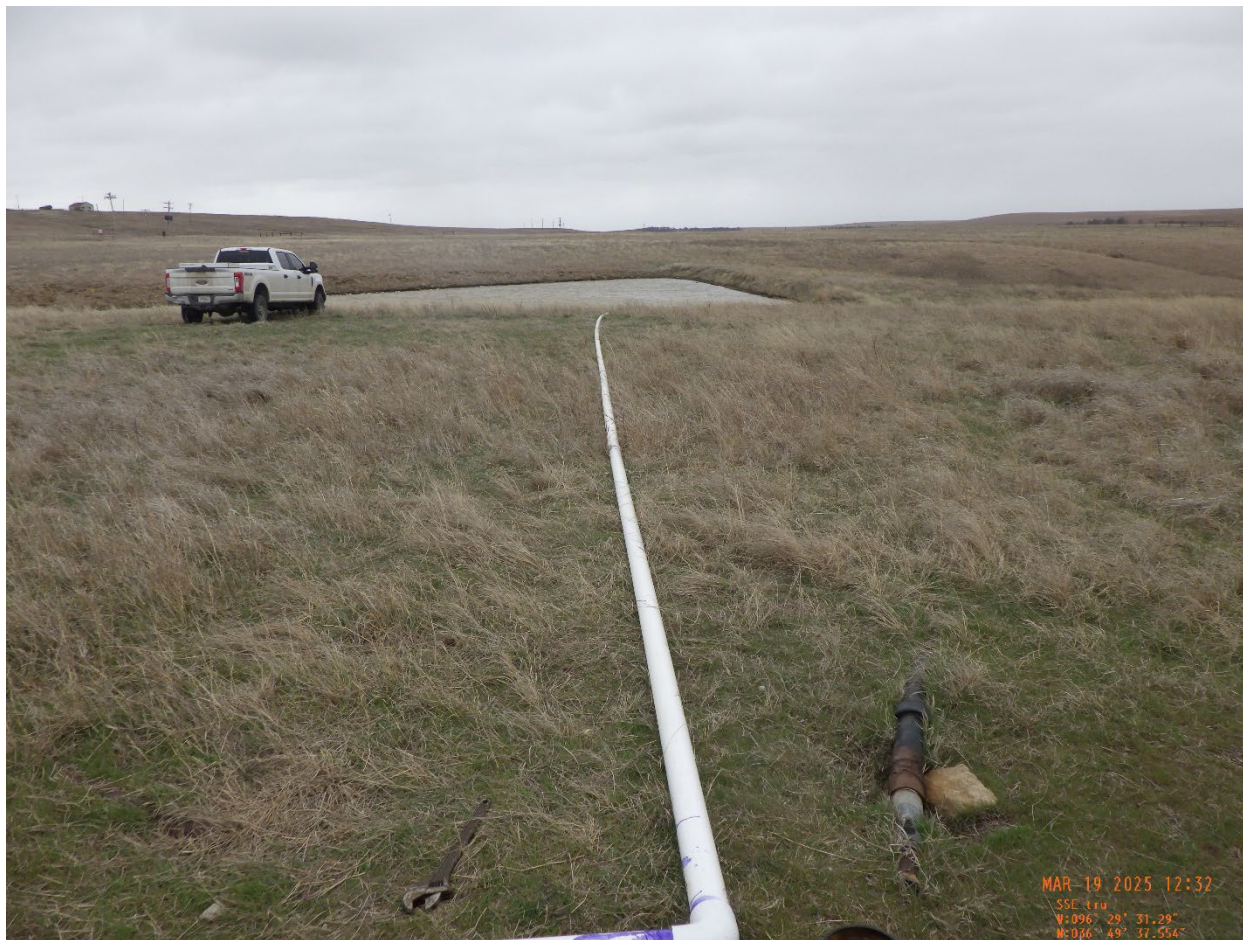
Photo No. 2

From the well location, looking to the SSE, I observed the PVC line which had been installed between the well and the impacted stock pond. See photo No. 2.

**Description:** This was a view from the temporarily abandoned well to the SSE, toward the stock pond which was impacted by the recent brine spill. The PVC line extended from the temporarily abandoned well to the pond, but the line was not connected to the well and there was no evidence the line had been connected to the well.

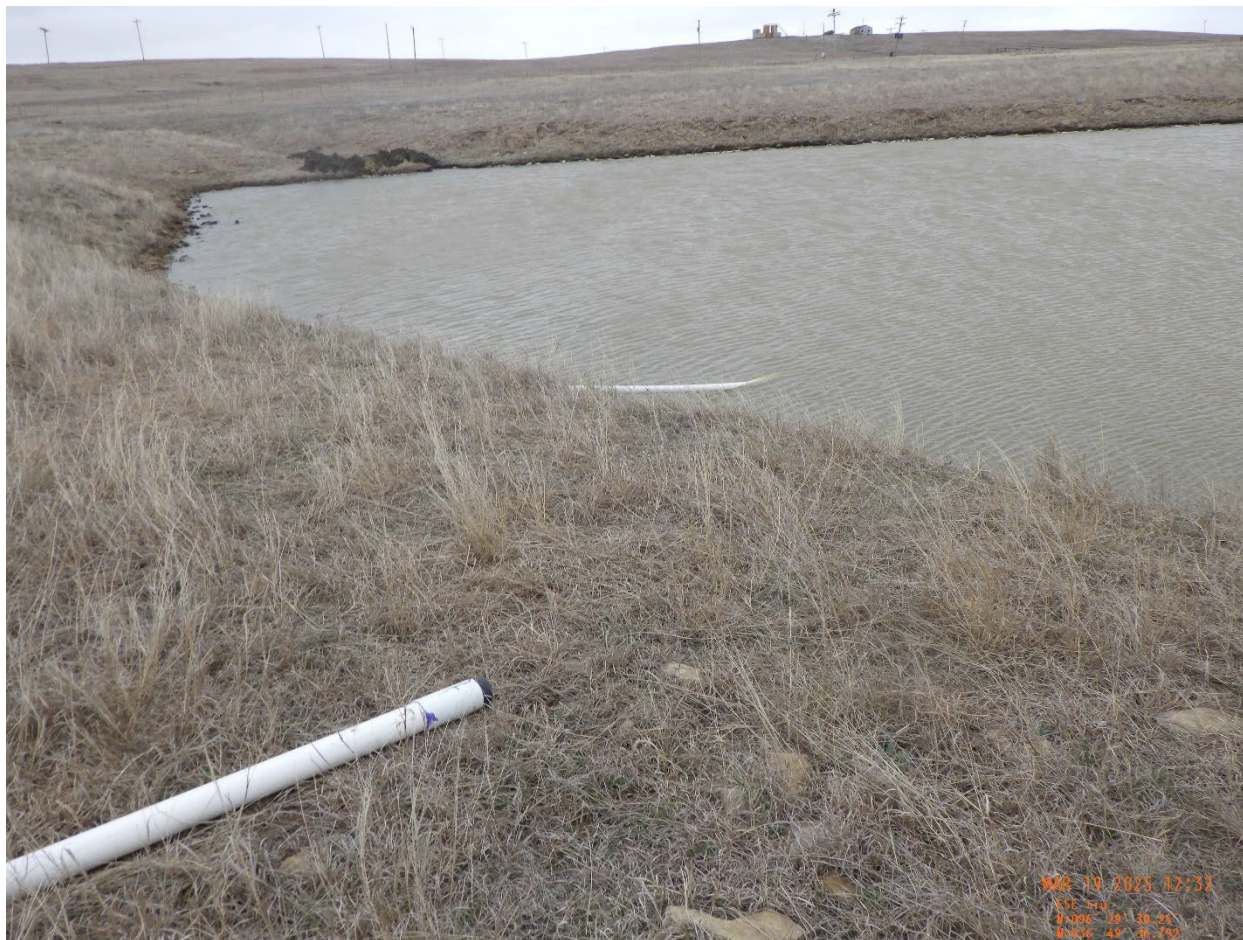
Photo No. 3

I observed the end of the PVC line near the stock pond. At the time of the inspection, the line was not connected to the pond or a pump. There was no evidence the line had been put into service. See photo No. 3.

**Description:** This was the end of the PVC line which extended to the nearby oil well. The line terminated approximately 20 feet from the impacted stock pond. At the time of the inspection the well and pond were not connected via the PVC line.
