**Photograph 1.** Weber Auto & Truck Parts, Inc. 11/6/2023 01:52 DSCN0566.JPG  
Description: View of the Facility sign.

The Environmental Protection Agency (EPA) has received a Notice of Intent (NOI) requesting coverage under the [EPA 2021 Multi-Sector General Permit \(2021 MSGP\)](#). A copy of the NOI can be found [here](#). The discharge authorization date for Weber Auto Parts to discharge stormwater and allowable non-stormwater associated with industrial activity at WEBER AUTO & TRUCK PARTS located at 135 ISLAND POND ROAD, DERRY, NH 03038 under the 2021 MSGP is 05/26/2021. For tracking and inquiry purposes, your NPDES ID is NHR053298.

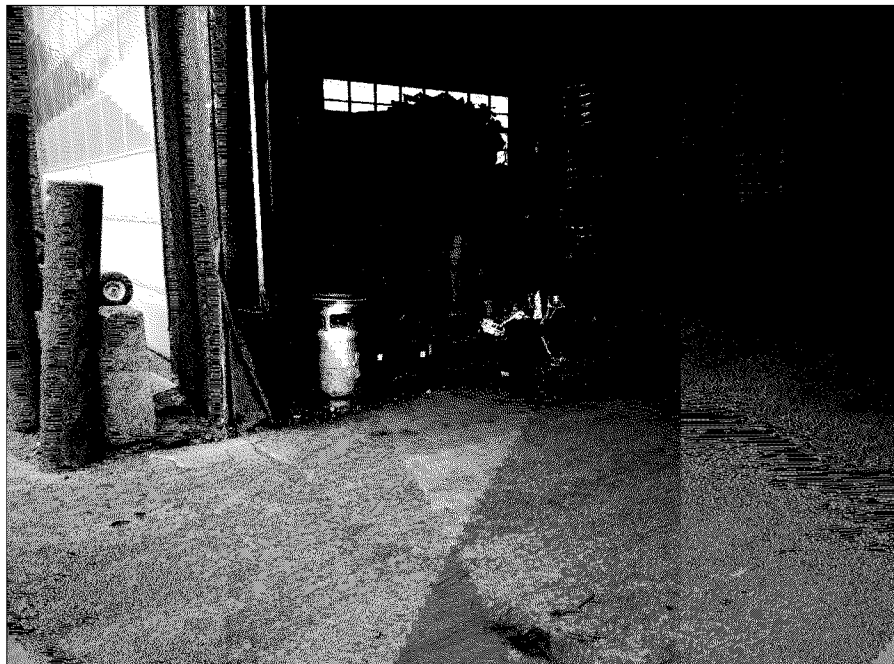
**Photograph 2.** Weber Auto & Truck Parts, Inc. 11/6/2023 02:18 DSCN0567.JPG  
Description: General view looking south into the fluid recovery building.

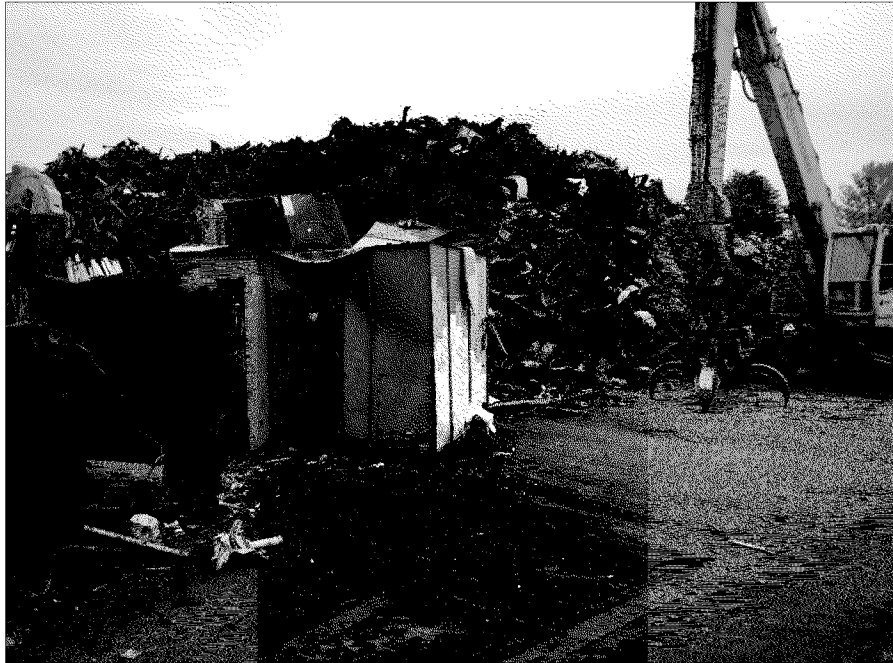
**Photograph 3.** Weber Auto & Truck Parts, Inc. 11/6/2023 02:20 DSCN0568.JPG  
Description: View looking south at a metal recycling stockpile on the south side of the fluid recovery building.

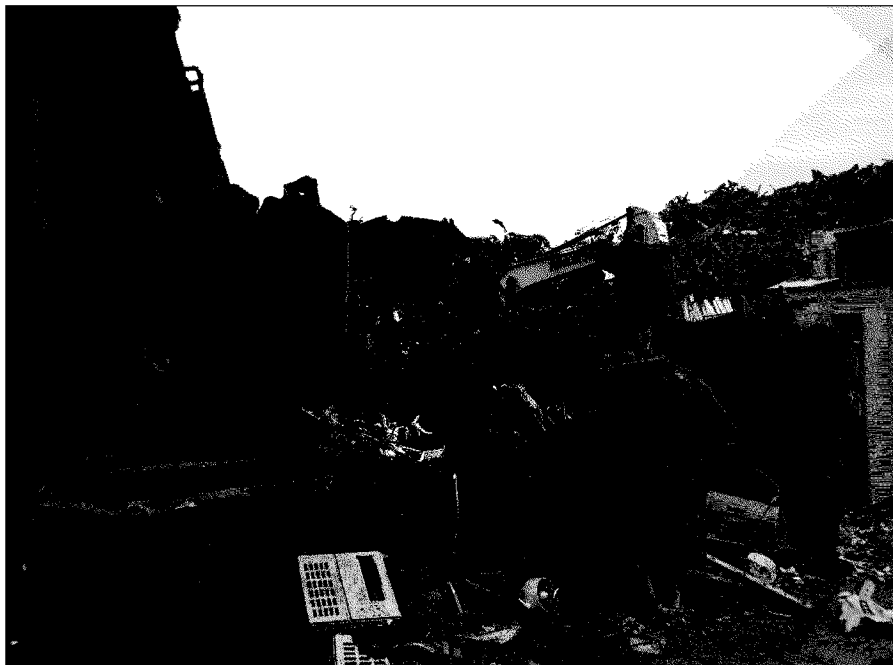
**Photograph 4.** Weber Auto & Truck Parts, Inc. 11/6/2023 02:20 DSCN0569.JPG  
Description: View of a metal recycling stockpile on the south side of the fluid recovery building.

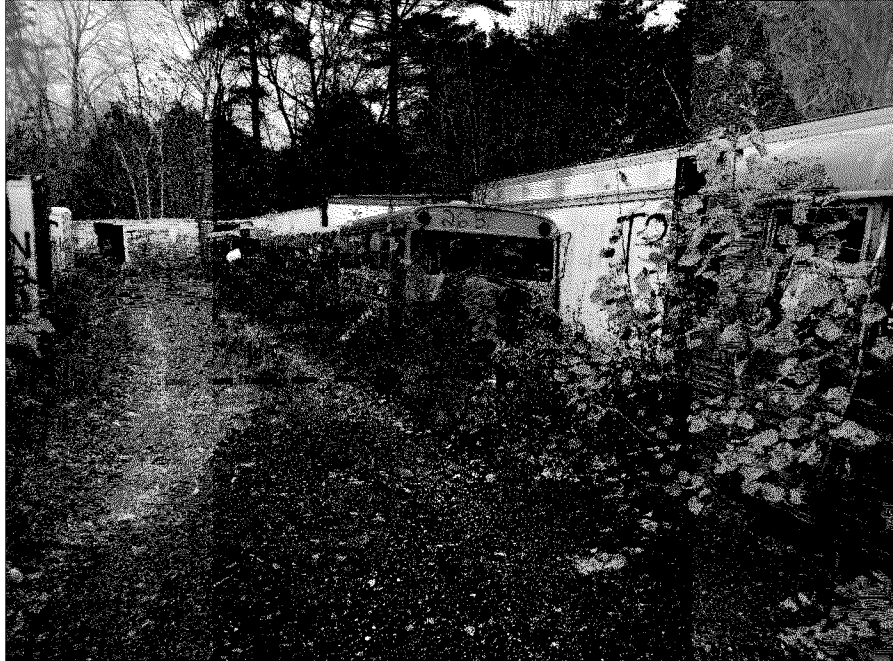
**Photograph 5.** Weber Auto & Truck Parts, Inc. 11/6/2023 02:23 DSCN0570.JPG  
Description: View looking north at school bus bodies and shipping containers that comprise the perimeter between the Facility and the wetland and unnamed surface water to the east and southeast. The dashed blue line depicts the estimated direction of stormwater flow.

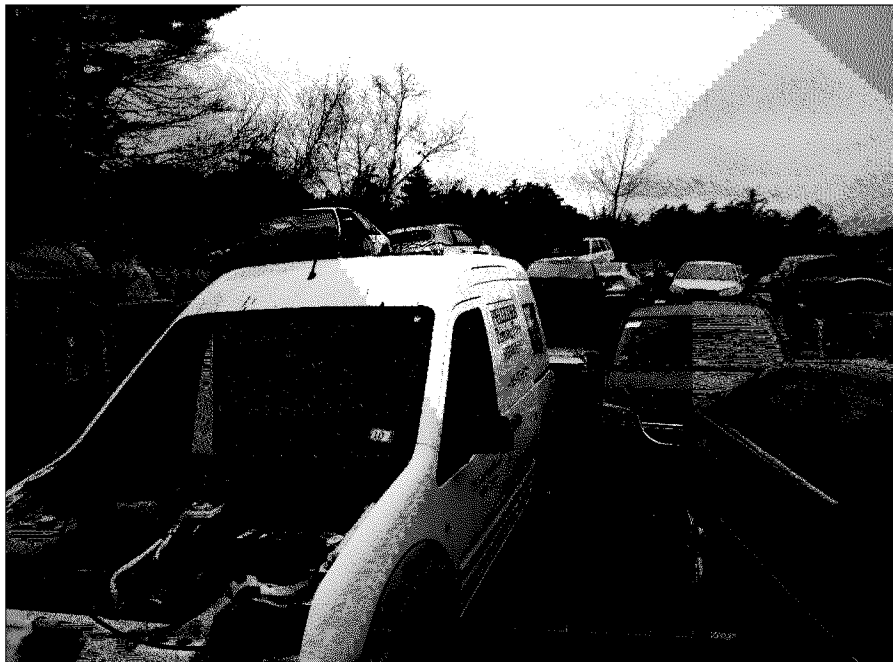
**Photograph 6.** Weber Auto & Truck Parts, Inc. 11/6/2023 02:23 DSCN0571.JPG  
Description: View looking south at end of life vehicles (ELVs) parked on the southeastern portion of the Facility. The van at the front of the photo has an engine.

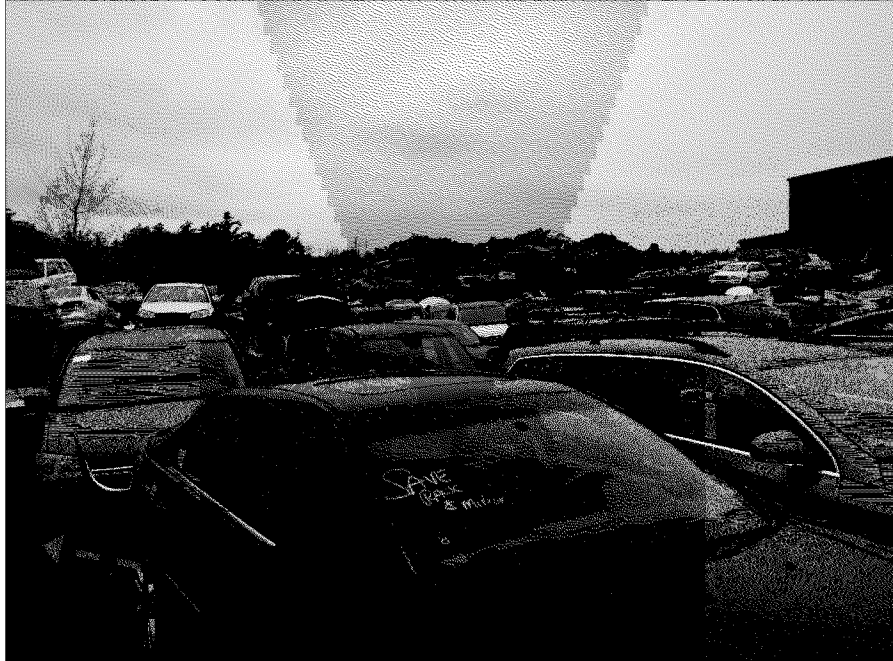
**Photograph 7.** Weber Auto & Truck Parts, Inc. 11/6/2023 02:23 DSCN0572.JPG

Description: View looking south over the ELVs parked on the southeastern portion of the Facility toward the metal recycling stockpiles behind the fluid recovery building.

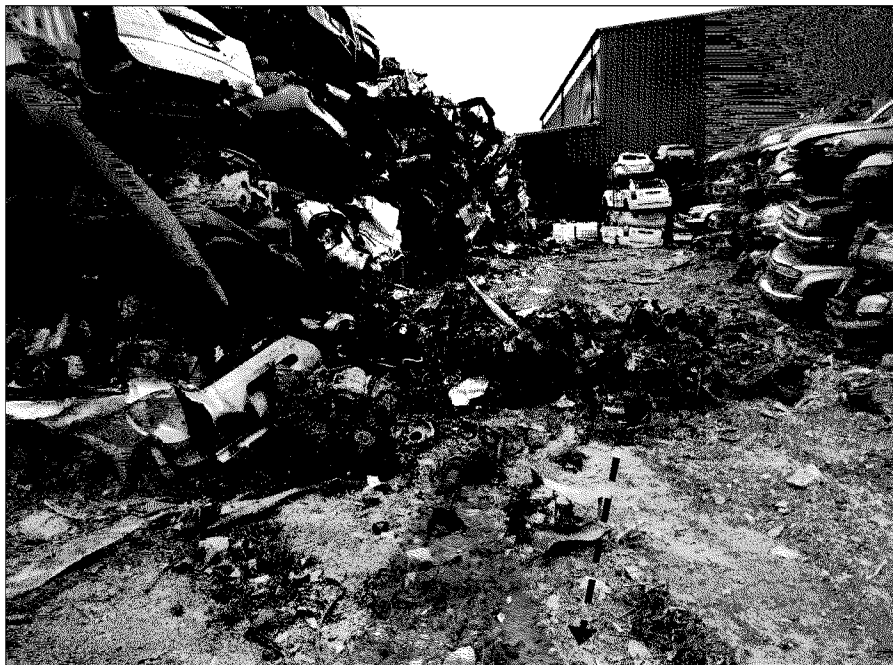
**Photograph 8.** Weber Auto & Truck Parts, Inc. 11/6/2023 02:26 DSCN0573.JPG

Description: View of motors and other automotive parts on the ground, without cover, looking west at the east side of the fluid recovery building.

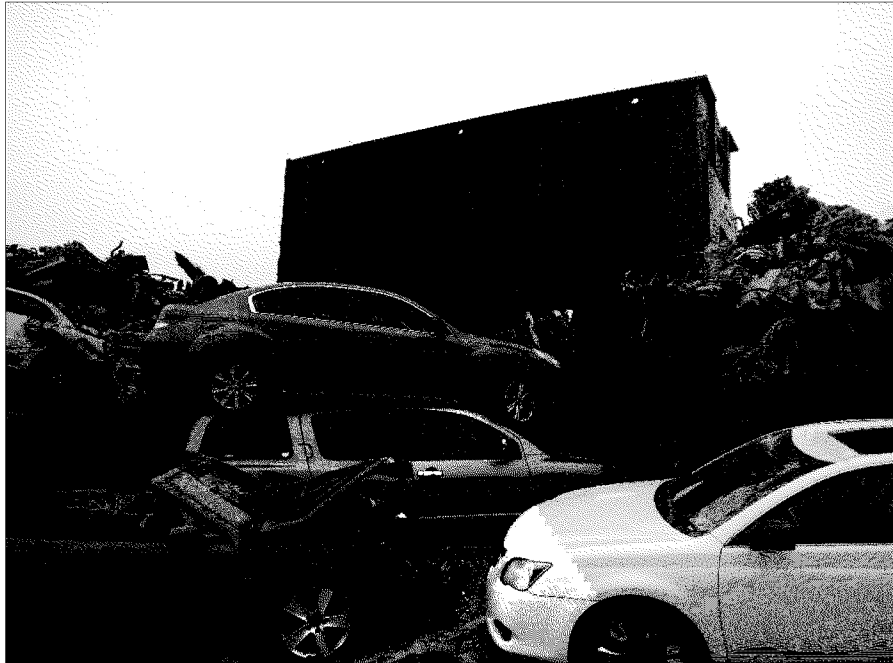
**Photograph 9.** Weber Auto & Truck Parts, Inc. 11/6/2023 02:26 DSCN0574.JPG  
Description: ELVs stacked on the north side of the metal recycling stockpiles.

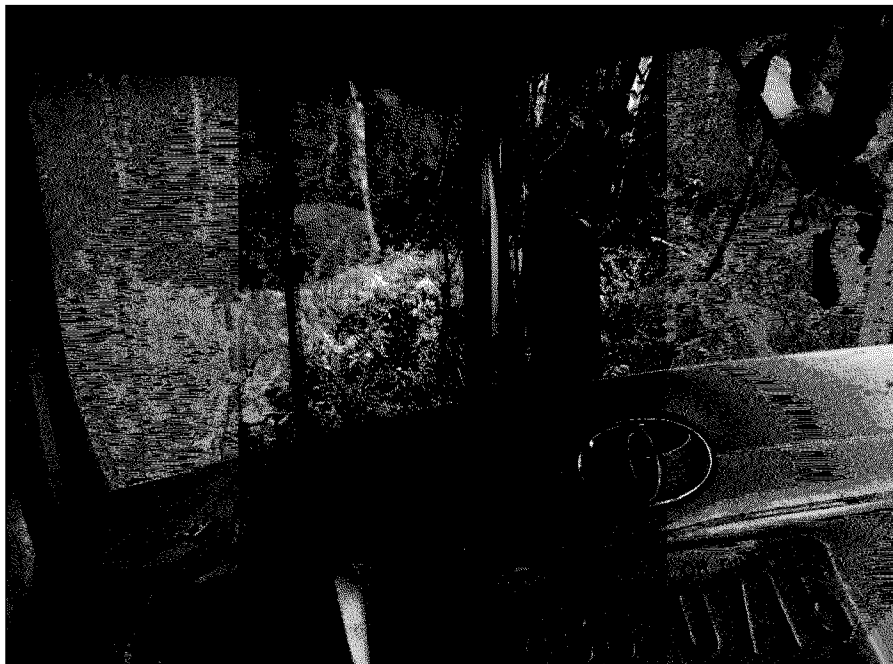
**Photograph 10.** Weber Auto & Truck Parts, Inc. 11/6/2023 02:27 DSCN0575.JPG  
Description: View looking east toward the wetland area and unnamed surface water on the east side of the Facility. The photograph was taken from inside one of the perimeter school bus bodies. The unnamed surface water is no more than 100 feet east and southeast of the Facility perimeter.

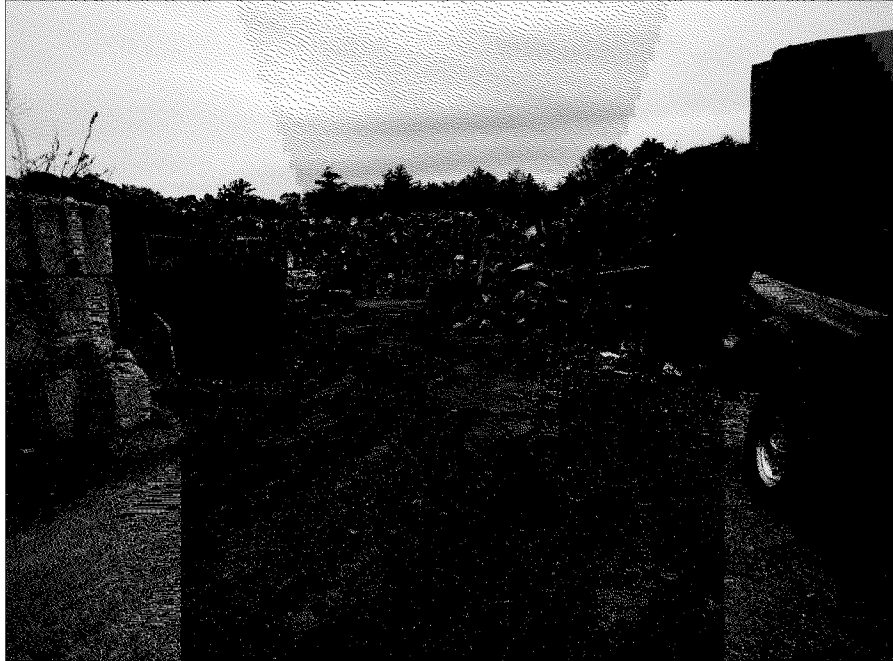
**Photograph 11.** Weber Auto & Truck Parts, Inc. 11/6/2023 02:31 DSCN0576.JPG

Description: View looking east at metal recycling stockpiles between the fluid recovery building and the Facility's southern perimeter.

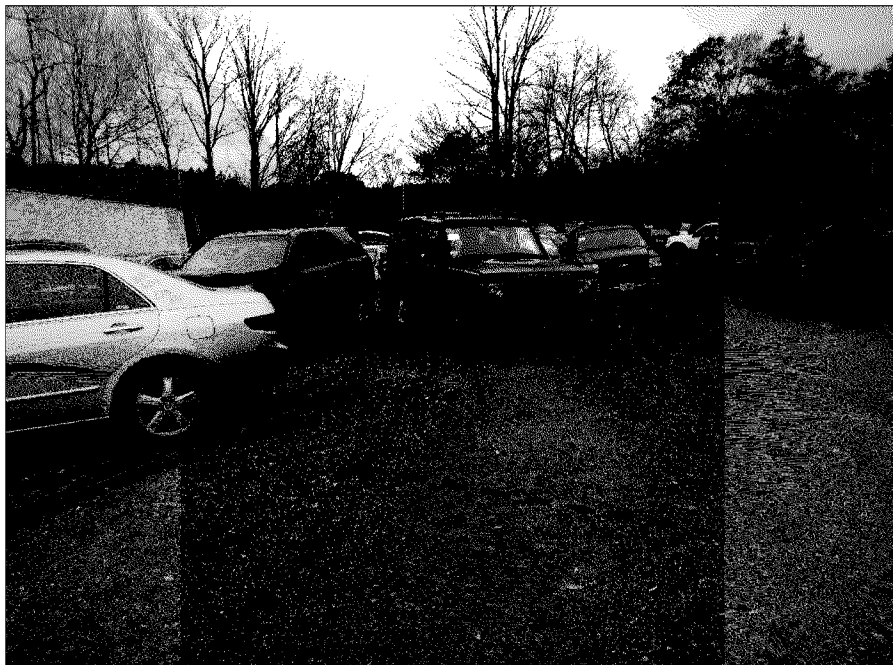
**Photograph 12.** Weber Auto & Truck Parts, Inc. 11/6/2023 02:35 DSCN0577.JPG

Description: General view of the incoming vehicle storage area on the west side of the Facility. These vehicles are parked pending fluid removal and dismantling.

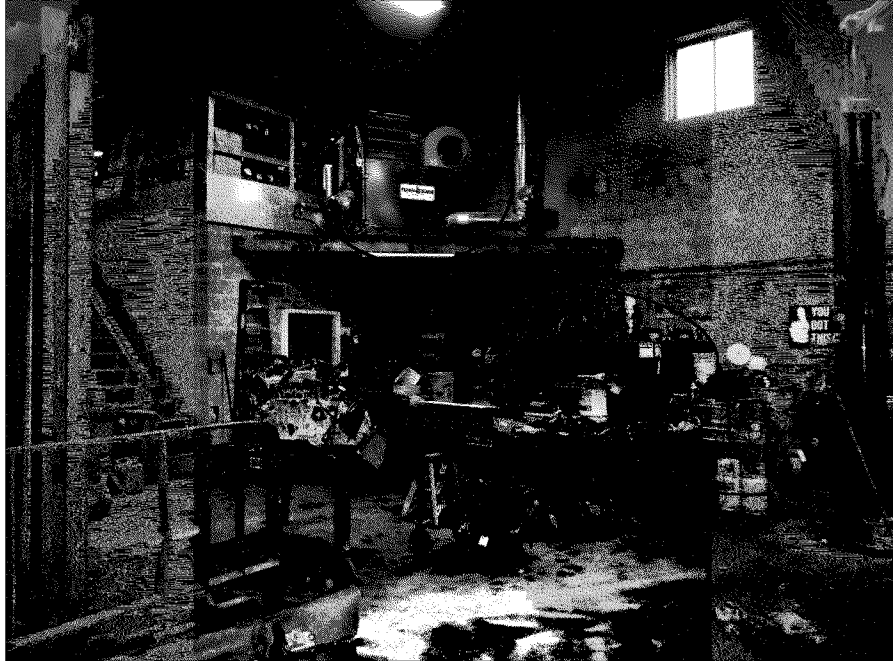
**Photograph 13.** Weber Auto & Truck Parts, Inc. 11/6/2023 02:36 DSCN0578.JPG

Description: General view of the parts warehouse behind the office. The used oil storage tank and the oil burner are circled.

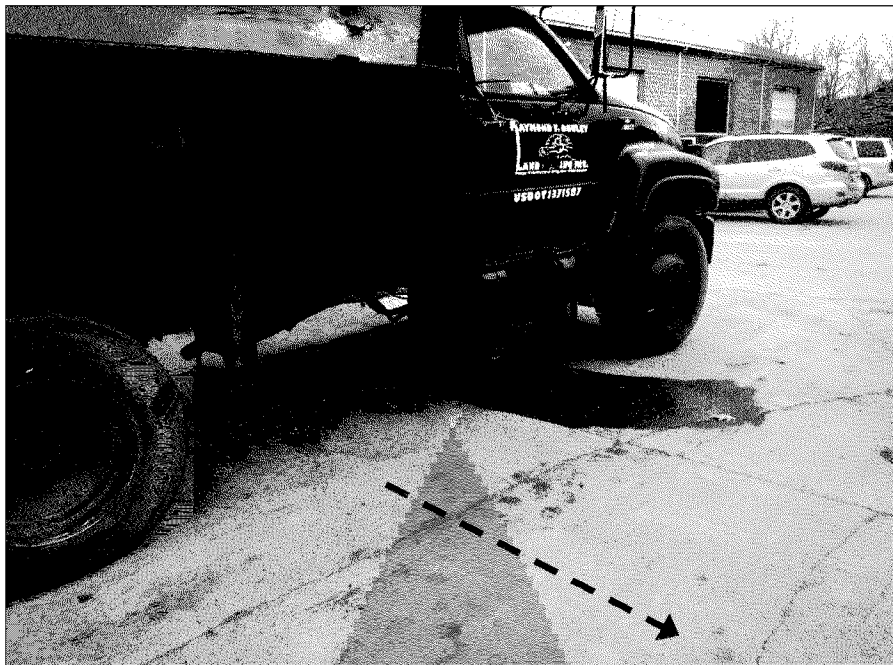
**Photograph 14.** Weber Auto & Truck Parts, Inc. 11/6/2023 02:39 DSCN0579.JPG

Description: A truck leaking fuel in the parking area between the office and Island Pond Road.

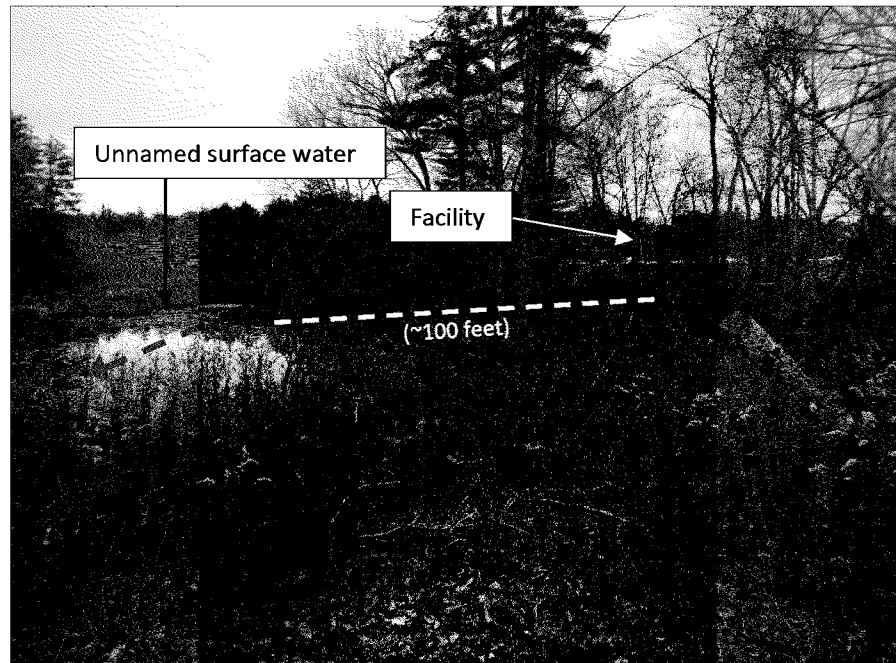
**Photograph 15.** Weber Auto & Truck Parts, Inc. 11/6/2023 02:42 DSCN0580.JPG

Description: View looking south from Island Pond Road at the unnamed surface water on the east and southeast side of the Facility. The shipping containers in [Photograph 5](#) are visible in the upper right corner of this photograph. The 100 foot distance between the Facility and the unnamed surface water was estimated with Google Earth.

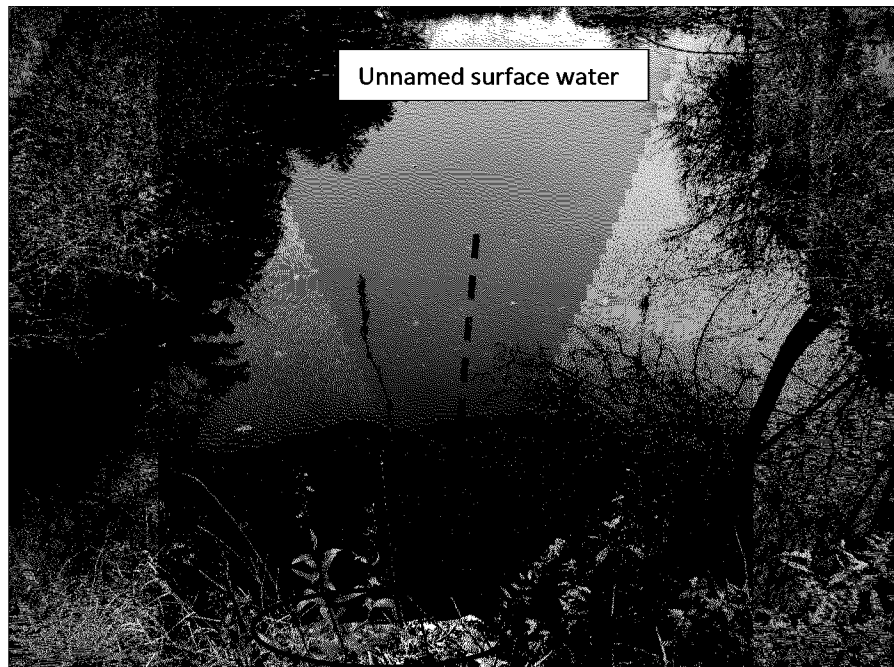
**Photograph 17.** Weber Auto & Truck Parts, Inc. 11/6/2023 02:42 DSCN0582.JPG  
Description: View looking south from Island Pond Road at the unnamed surface water on the east and southeast side of the Facility. The pipe under Island Pond Road is circled.

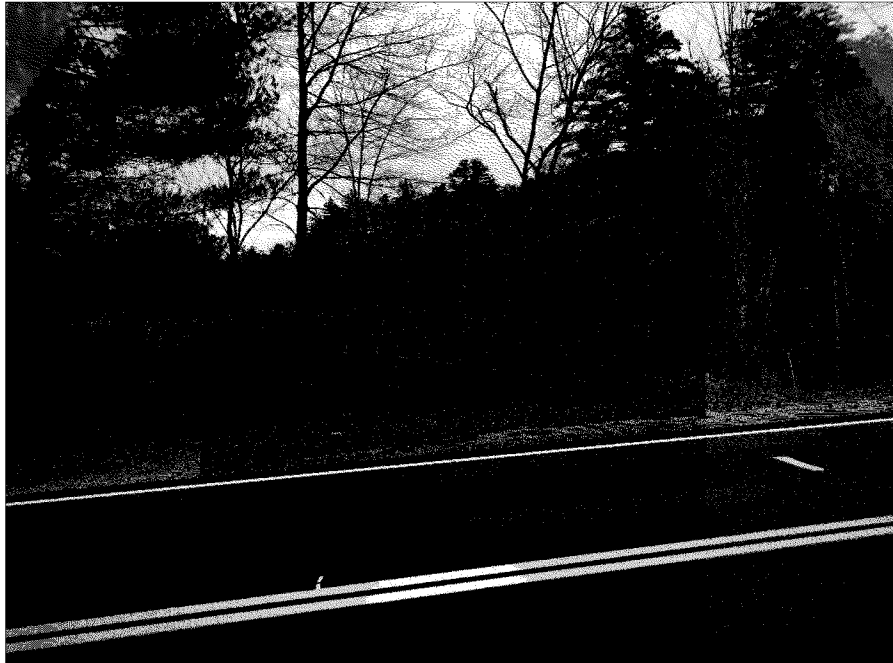
**Photograph 18.** Weber Auto & Truck Parts, Inc. 11/6/2023 02:42 DSCN0583.JPG  
Description: View looking south from Island Pond Road at the unnamed surface water on the east and southeast side of the Facility.

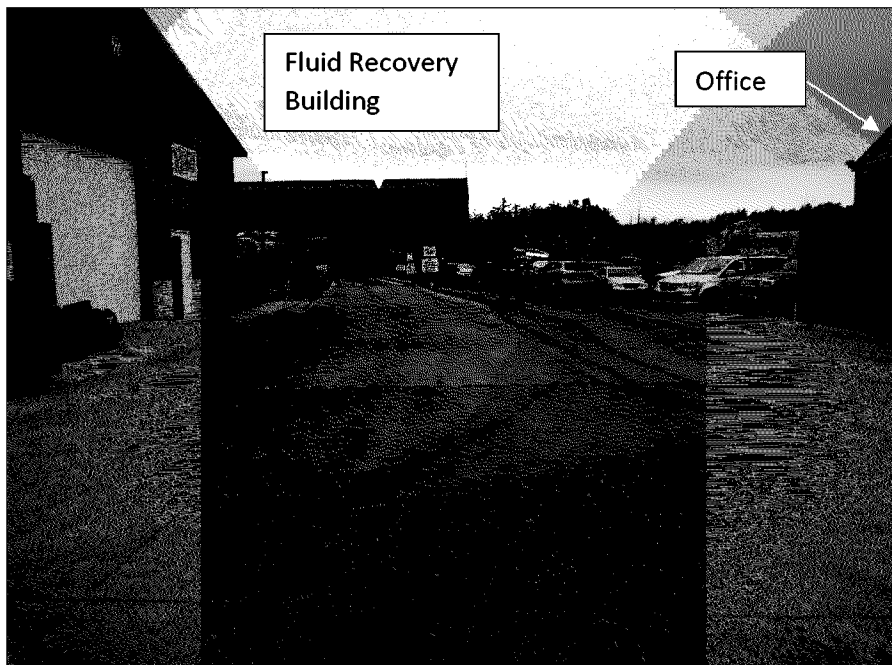
**Photograph 20.** Weber Auto & Truck Parts, Inc. 11/6/2023 02:45 DSCN0585.JPG  
Description: General view looking south from the Facility entrance toward the fluid recovery building. The building on the left side of the photograph was not identified during the inspection or in the SWPPP.
