**Region 6 - Enforcement & Compliance Assurance Division**  
**INSPECTION REPORT**

| Company Name: | <b>Stolt-Nielsen USA, Inc.</b> | |
| Facility Name: | <b>Stolt Tank Cleaning Facility and Depot</b> | |

### **August 23, 2023**

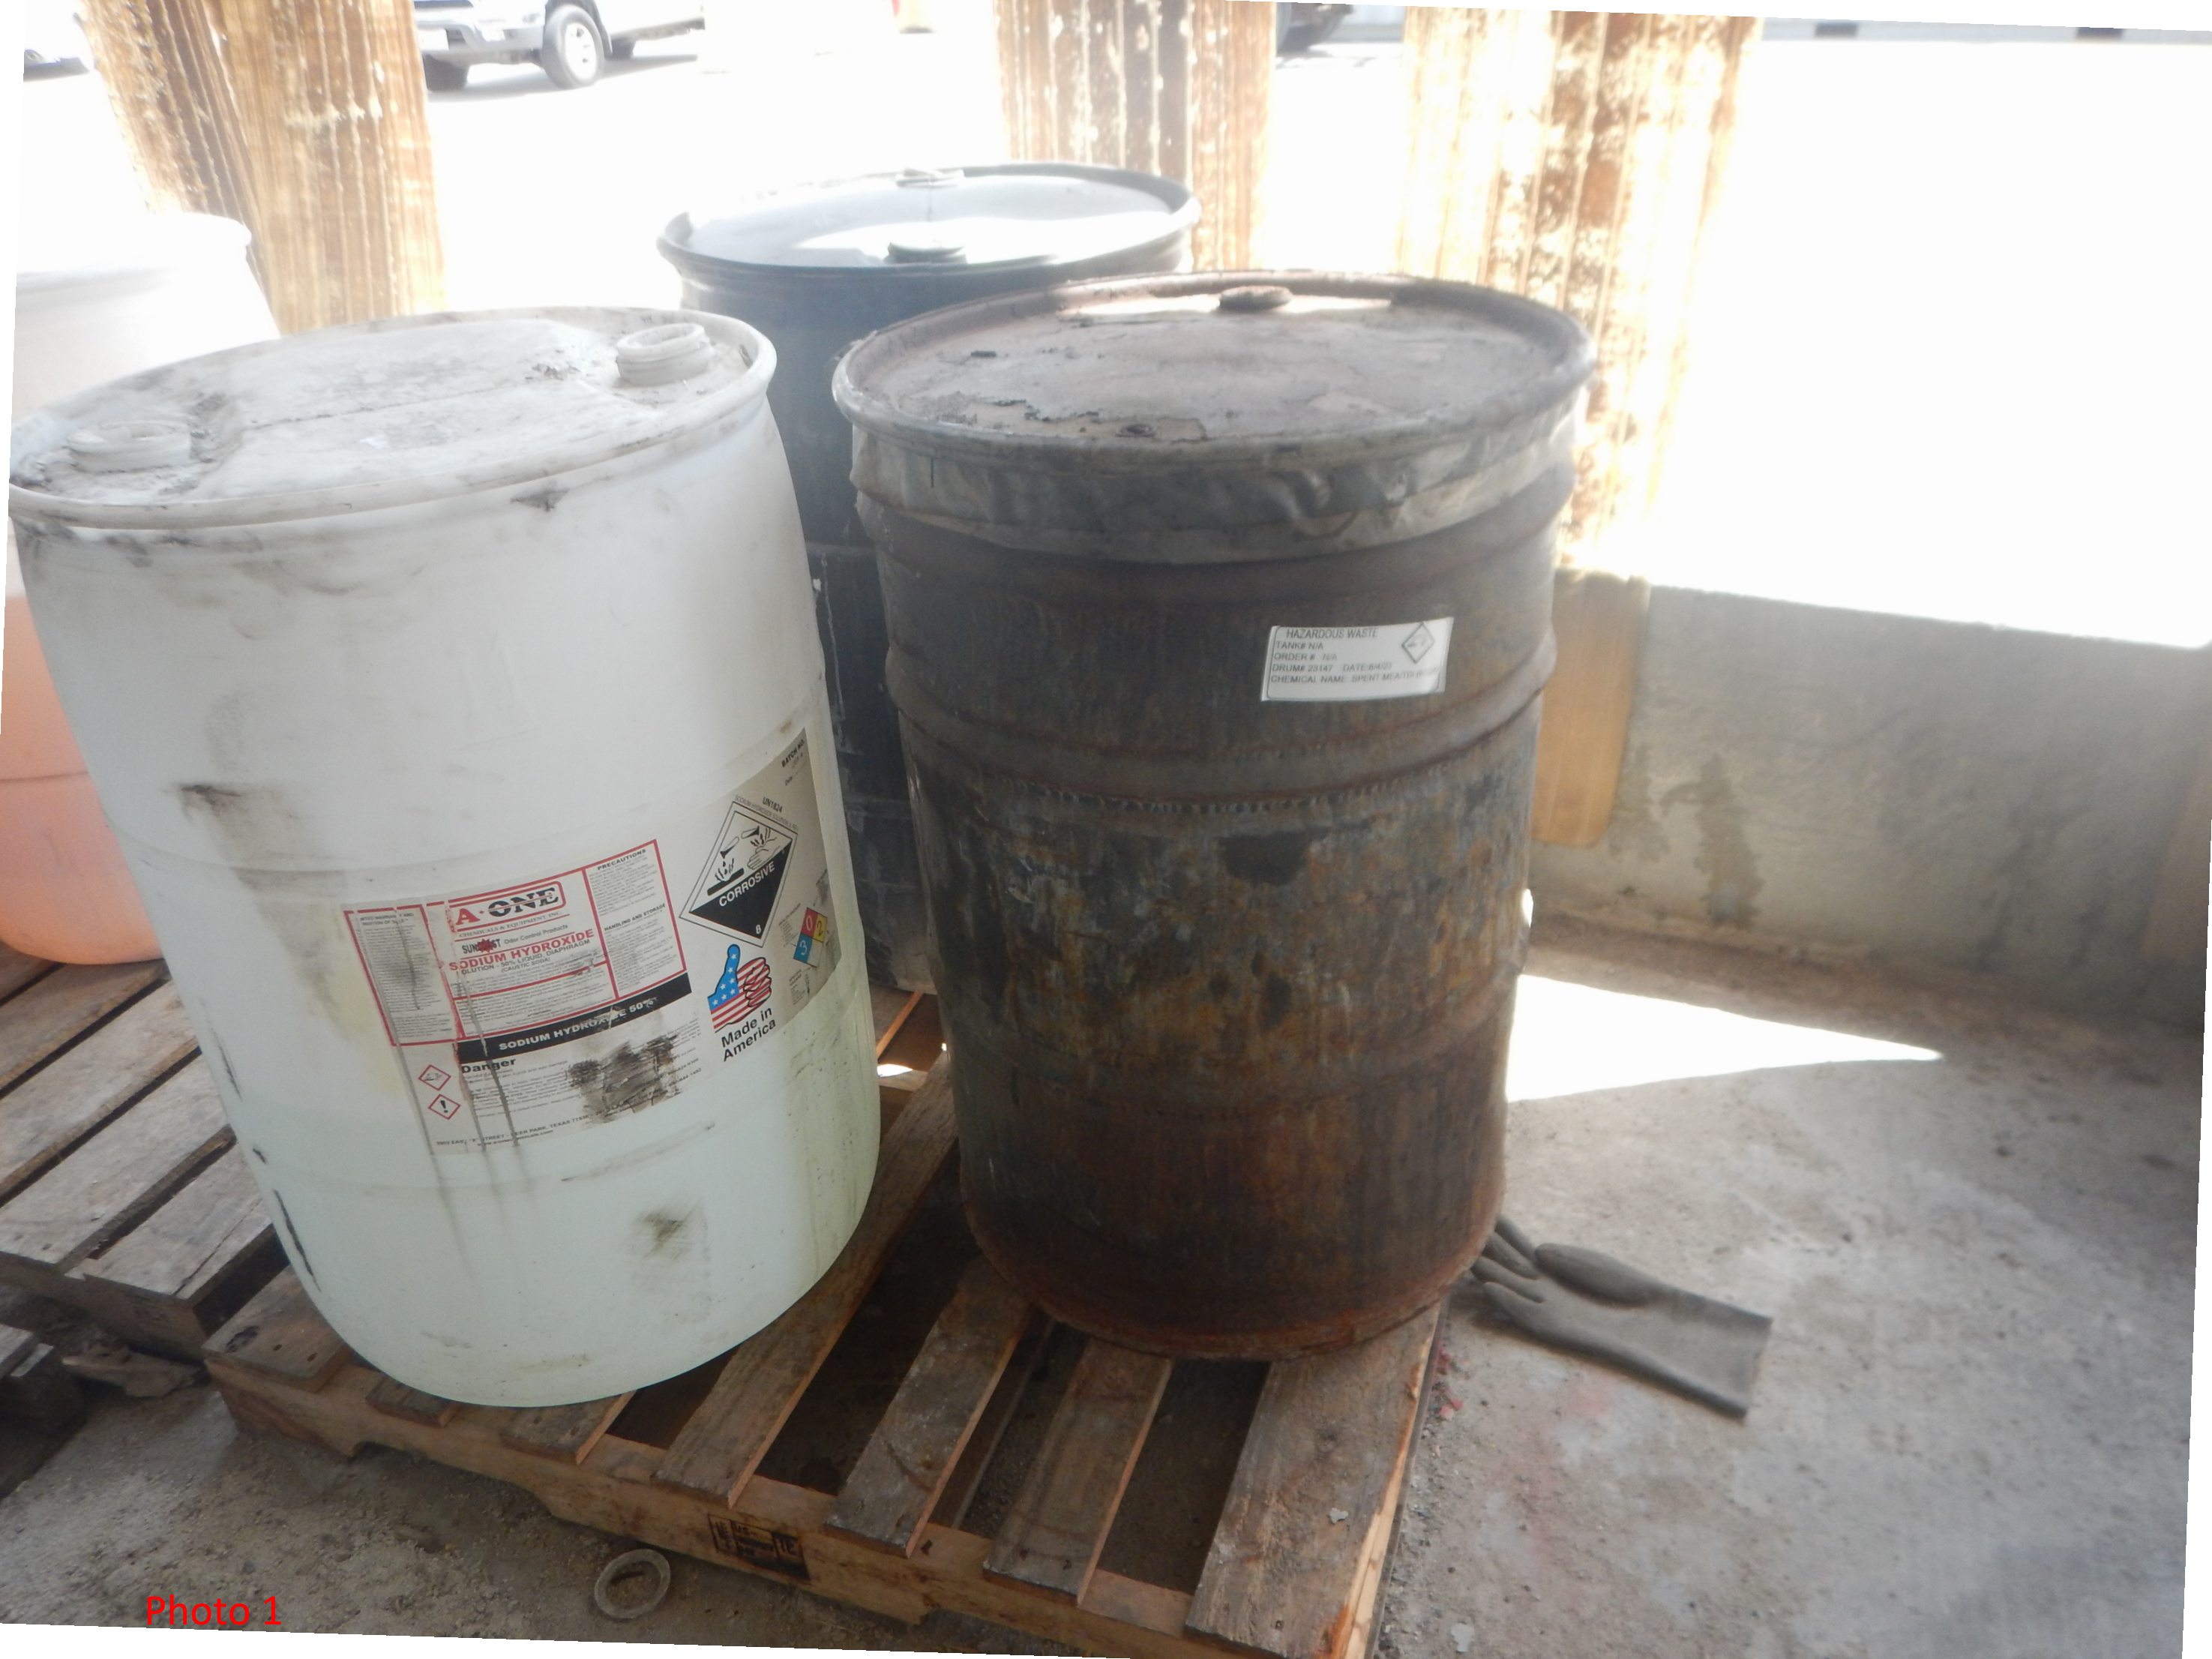
Photo 1

The large container management standards require large quantity generators to immediately transfer hazardous waste out of containers which are leaking or found to be in poor condition. During this inspection we observed one container located near the wastewater treatment unit which was compromised by corrosion. The container was marked with an accumulation start date of August 4, 2023, but we were unable to determine how long the container had been in hazardous waste service or its condition prior to our inspection. See photos 1 through 3.

HAZARDOUS WASTE  
TANK# N/A  
ORDER # N/A  
DRUM# 23147 DATE: 8/4/23  
CHEMICAL NAME: SPENT MEA/TDI (80/20)

- Wastewater treatment area
    - During our inspection of the wastewater treatment area we found one 55-gallon drum marked as containing hazardous waste which was severely corroded.

**Photograph “drum#23148 overpack: shows this drum has been overpacked and moved into our drum storage area. This action was taken on Thursday August 24<sup>th</sup>**

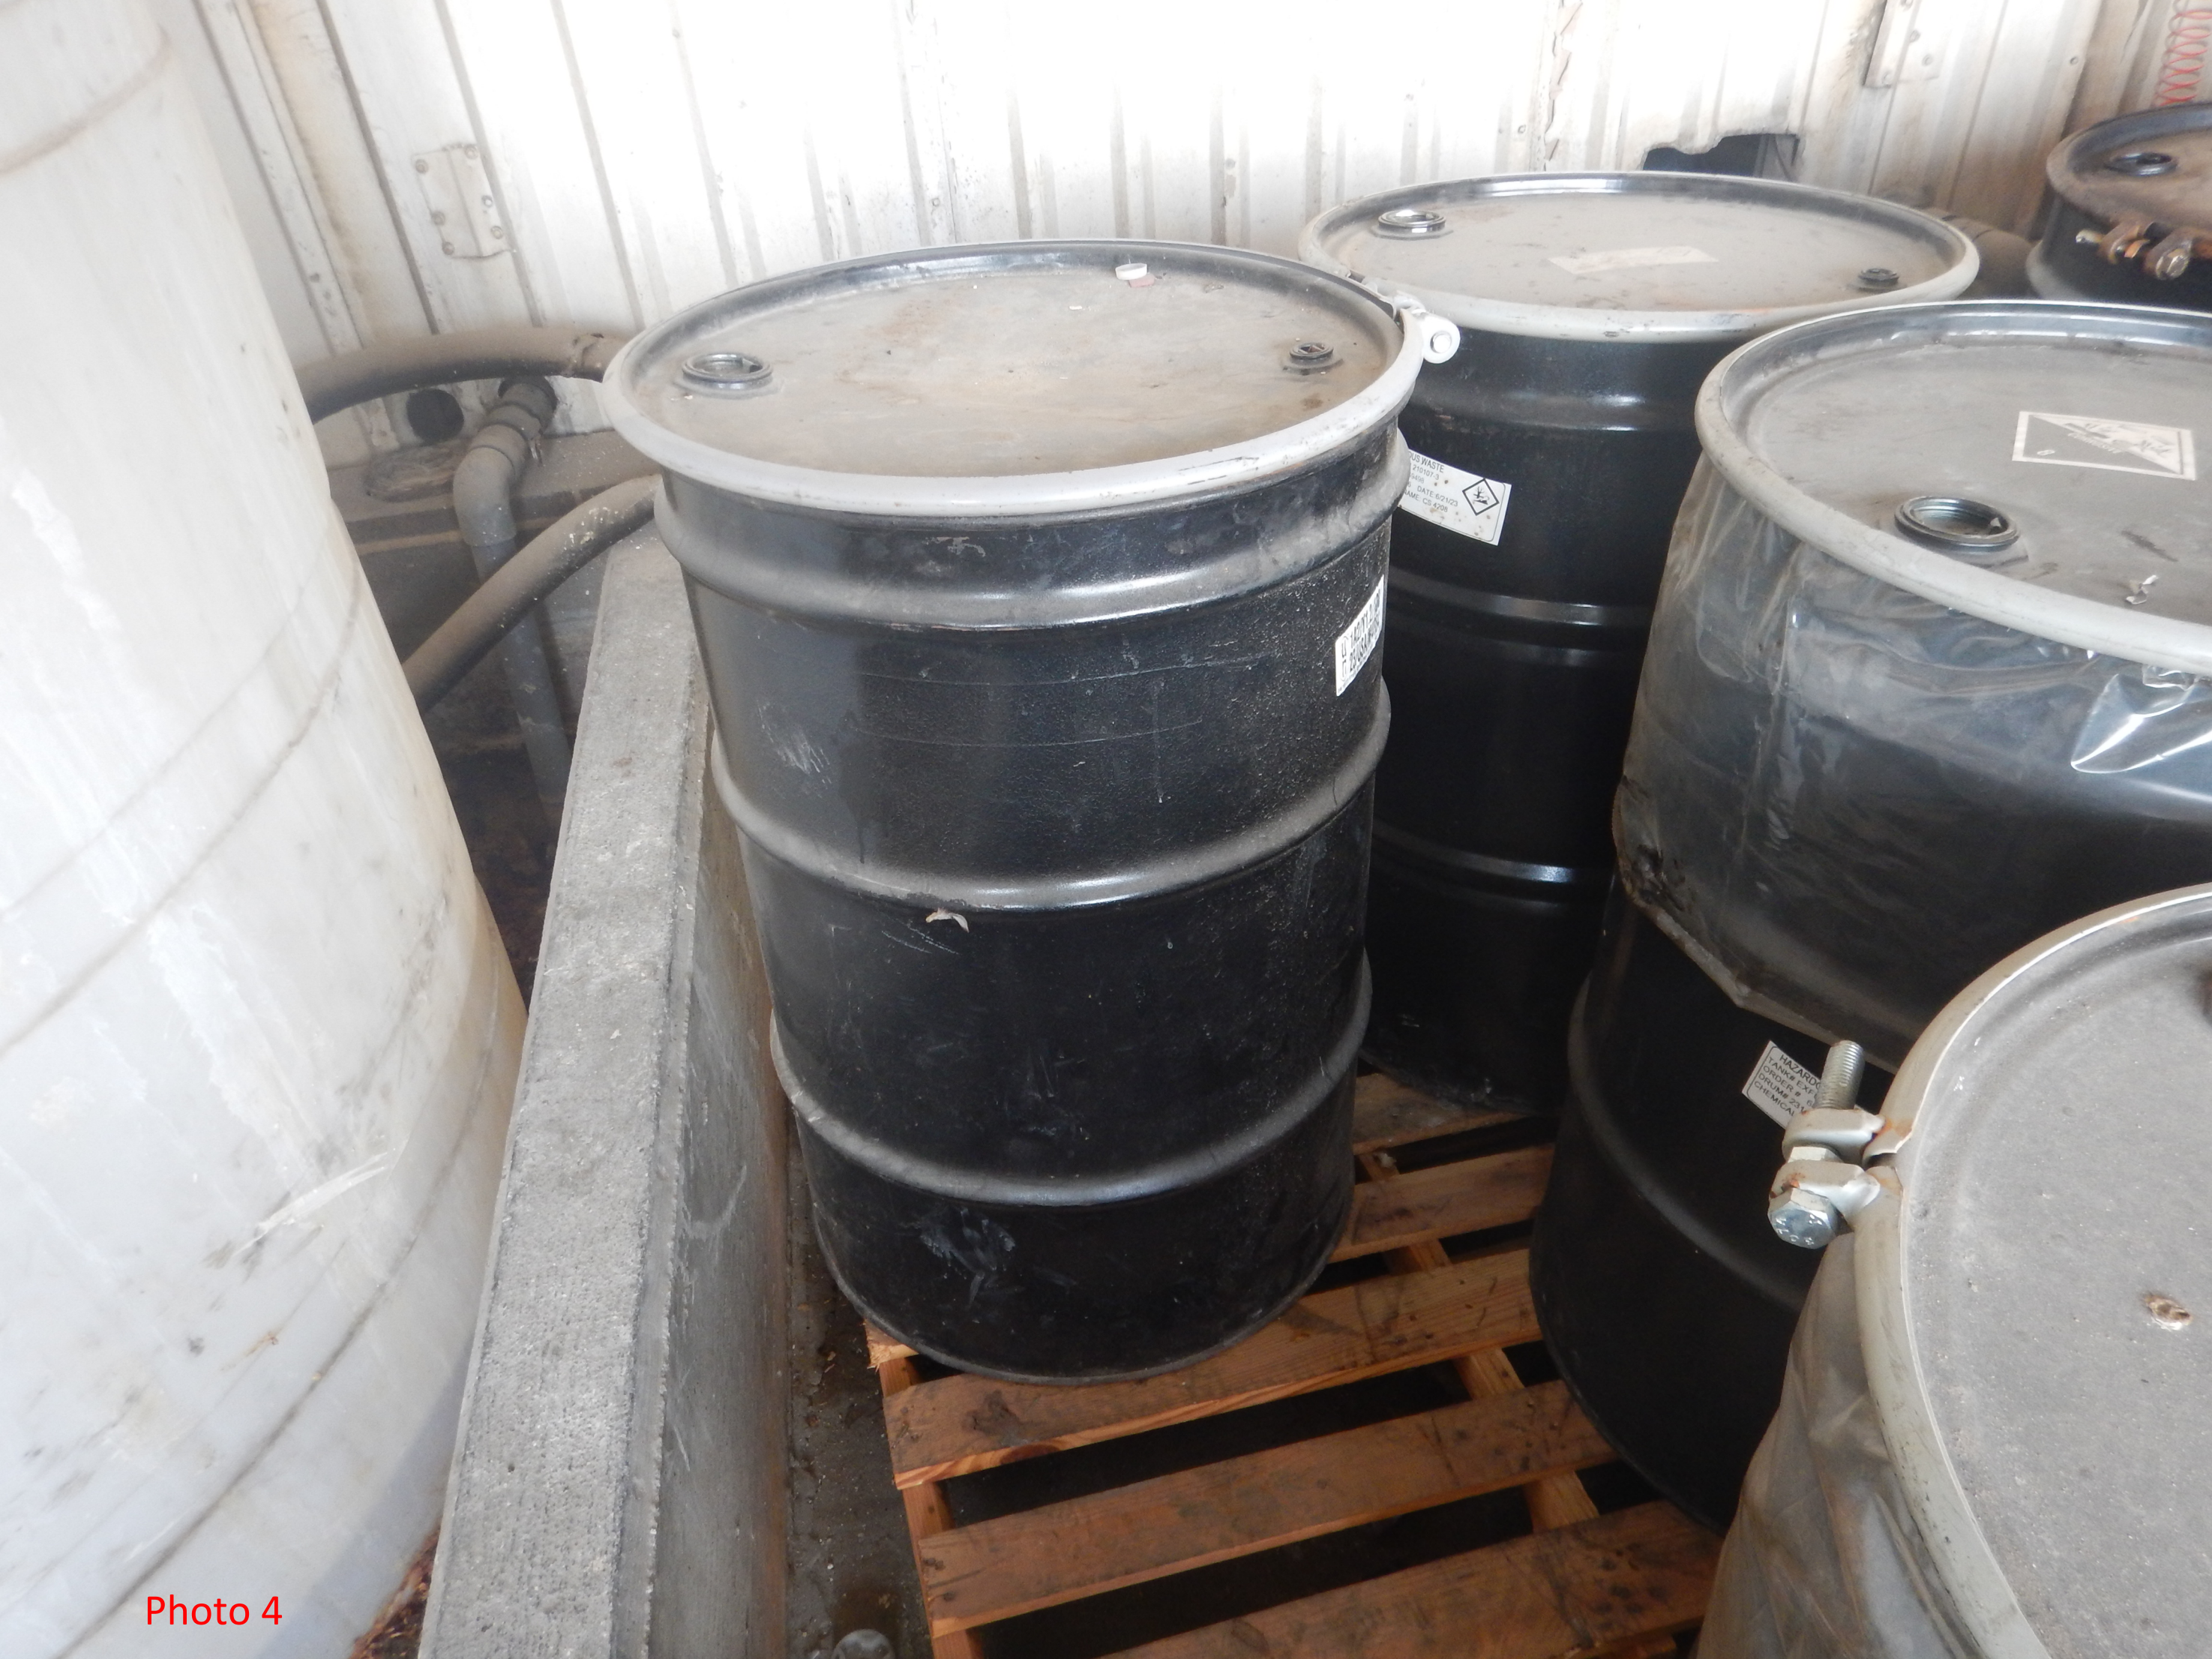
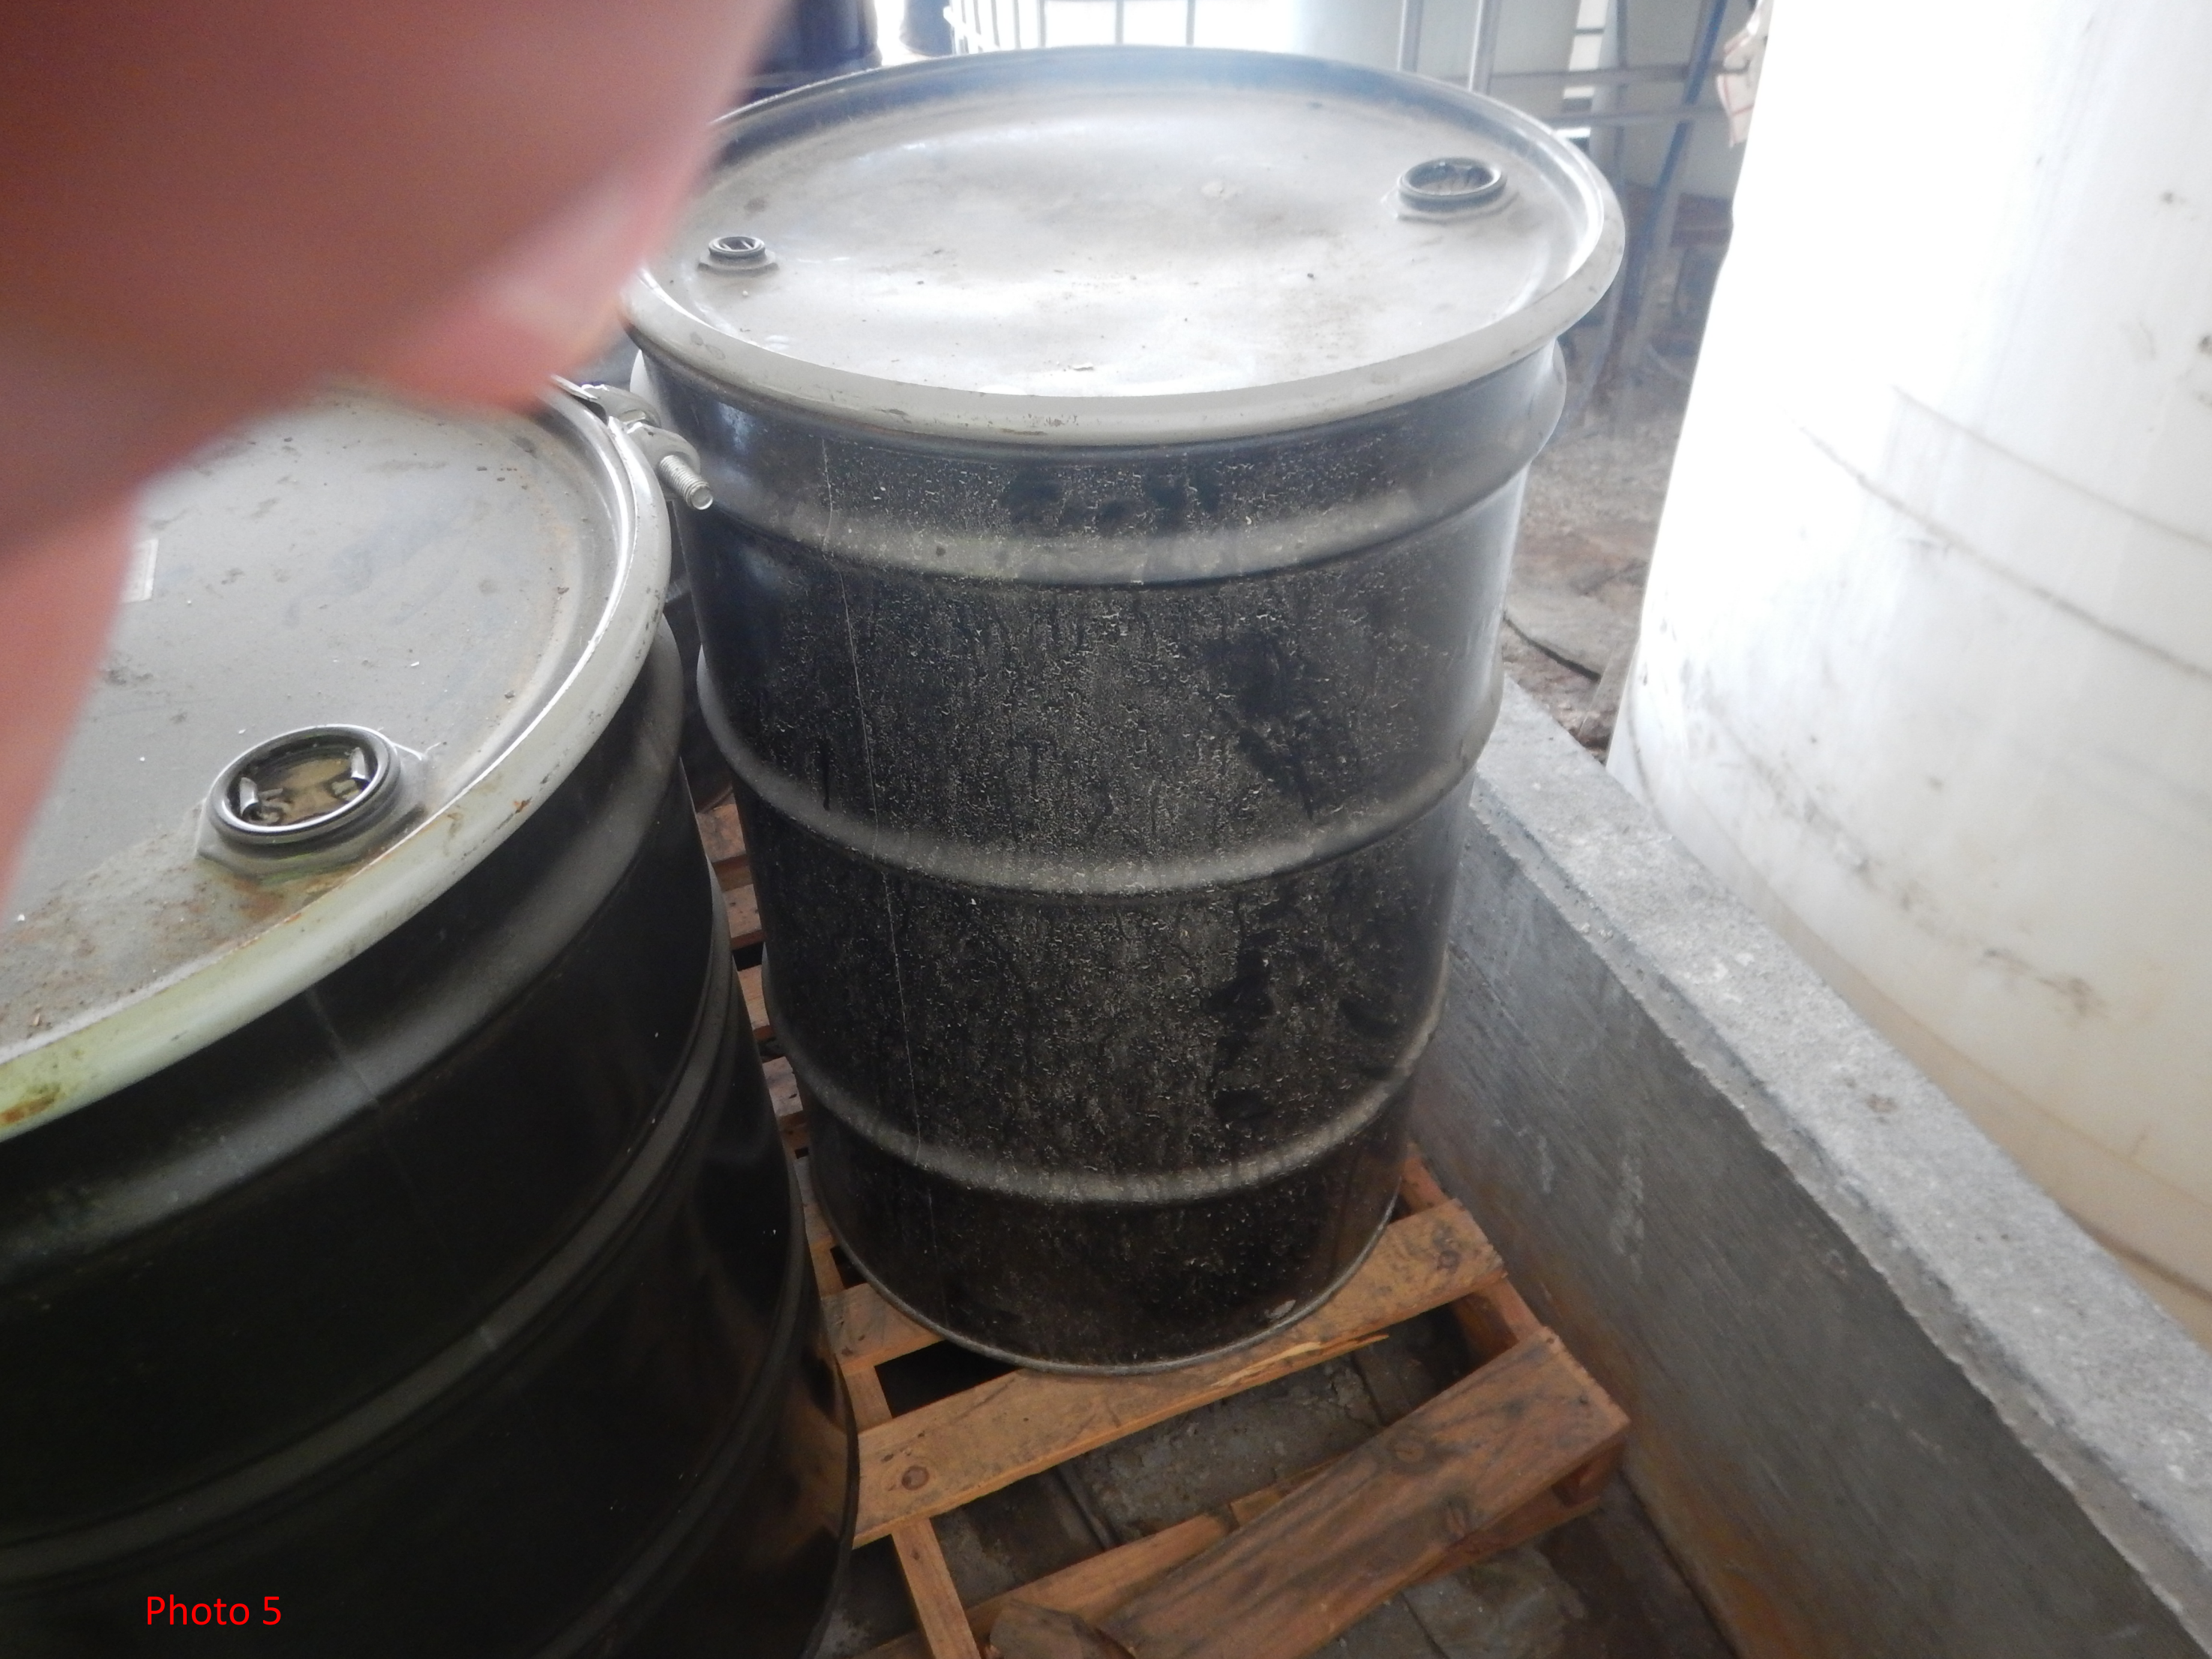
Photo 4

The container management standards for large quantity generators require containers accumulating hazardous waste to be kept closed unless waste is actively being added or removed. During this inspection we observed one container which was in hazardous waste service and open when unattended and not being filled or emptied. This container was located in the Stolt Tank facility's <90-day container central accumulation area (NOR Unit 001) and contained a D001 ignitable hazardous waste. The container was immediately closed by facility personnel. See photos 4 and 5.

The container management standards require large quantity generators to mark containers used for the accumulation of hazardous waste with: the words "hazardous waste"; an indication of the hazards associated with the waste; and, except for satellite accumulation containers, the date when accumulation of the waste began. The same container identified in finding #1 above was also unlabeled at the time of this inspection. The container was immediately labeled by facility personnel after identification. See photos 4 and 5.

- Central Accumulation Area
    - The spacing of the drums did not allow the unobstructed movement of personnel and emergency equipment.
    - Identified one open and unlabeled 55-gallon drum. This drum was later confirmed to contain a D001 hazardous waste. According to Mr. Wilkerson this waste was generated on August 1, 2023.

**Photograph “drum#23151 closed,labeled” shows this drum, mentioned in the two bullet points above, has been identified, labelled, and closed. This action was taken on Wednesday August 23<sup>rd</sup>**

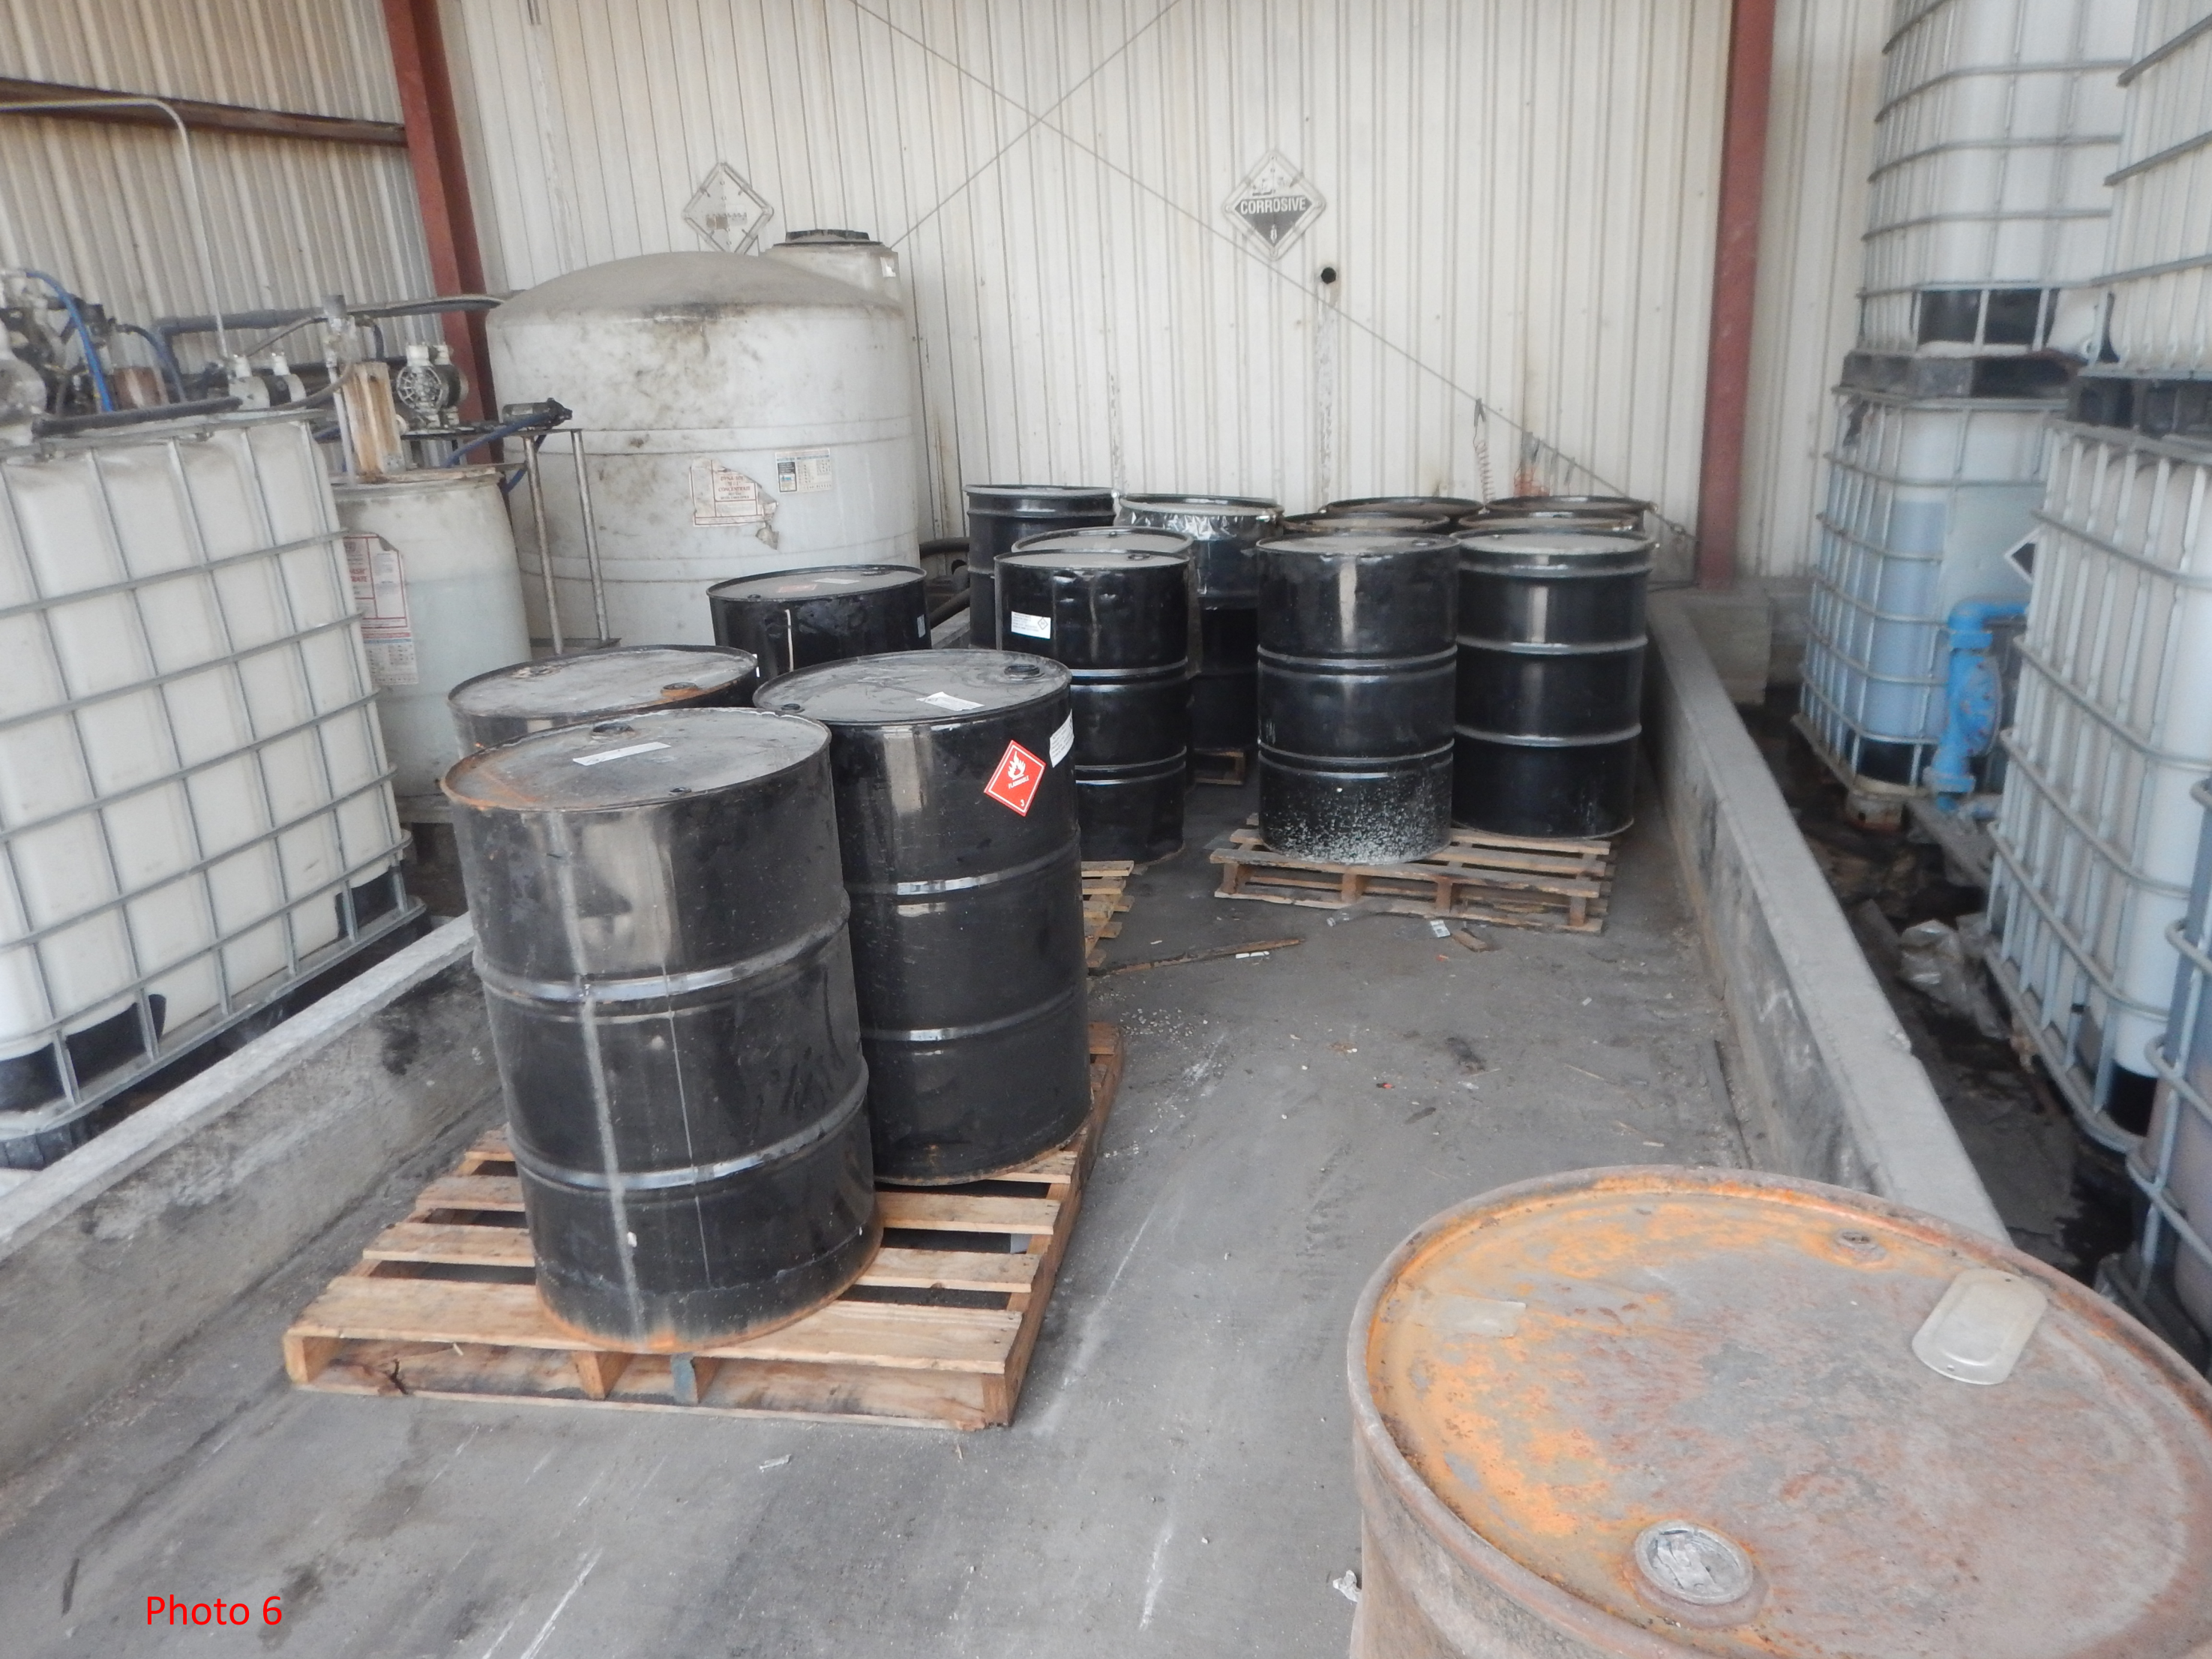
Photo 6

Large quantity generators must maintain aisle space to allow the unobstructed movement of personnel, fire protection equipment, spill control equipment, and decontamination equipment to any area of facility operation in an emergency. During our inspection we observed that the <90-day container central accumulation area lacked sufficient aisle space to allow the inspectors to access all of the containers. See photo 6.

**Photographs “drum spacing” 1 & 2 show we have rearranged our drums to create aisle spacing that will allow access to all drums. This action was taken on Wednesday August 23<sup>rd</sup>**
