## Clean Water Act Section 404: Site Visit/Case Development

| Site Name | Paradise Valley, LLC (Rick Ferguson) | | | | |

| Inspection Purpose | The purpose of this inspection was to discuss and evaluate steps to developing a restoration plan | | |

| Inspection Purpose | Initial site visit | | |

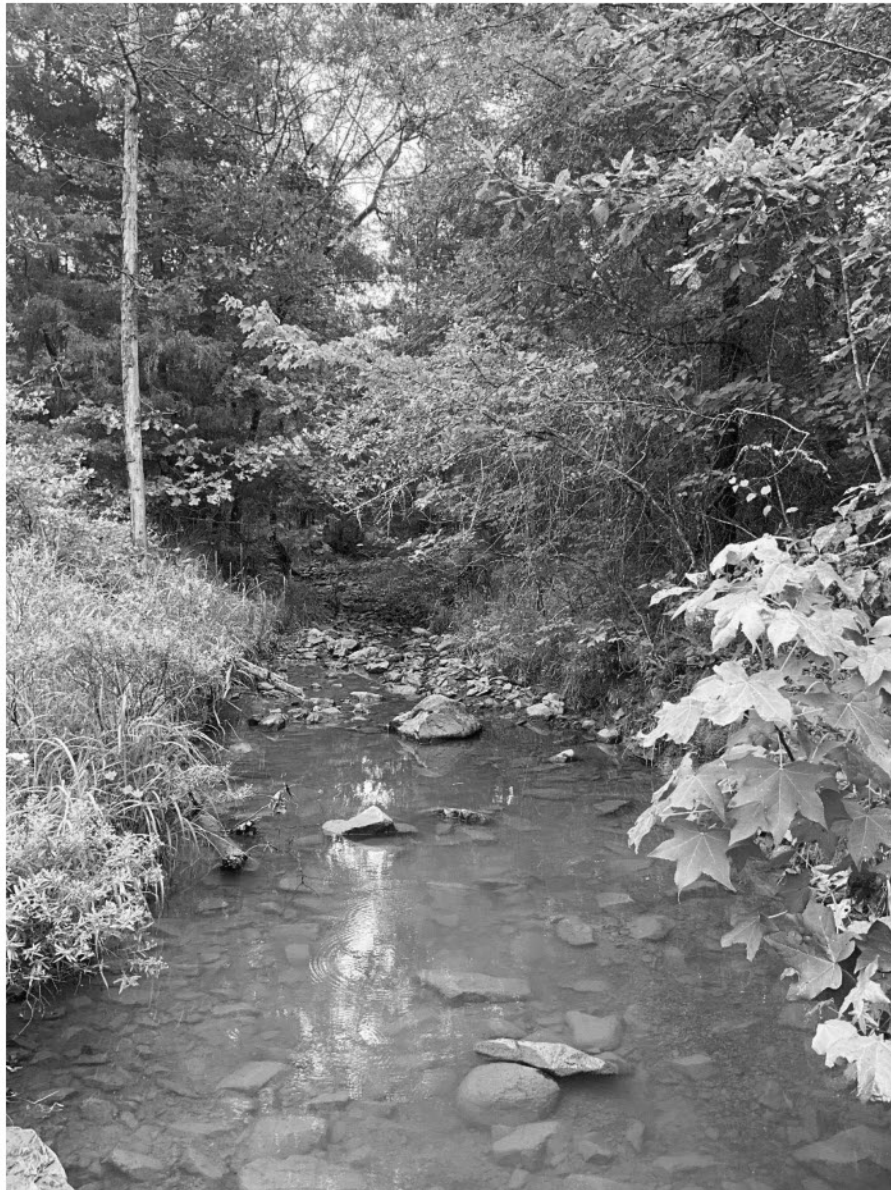
Photo No. 1

| Photo File Name | Date and Time of Photo | Photographer | Description |
|---|---|---|---|
| 100.jpg | 06/18/2024, 11:23 AM | Chelsey Sherwood | Showing a reference reach for stream restoration. Picture taken facing upstream, southeast. |

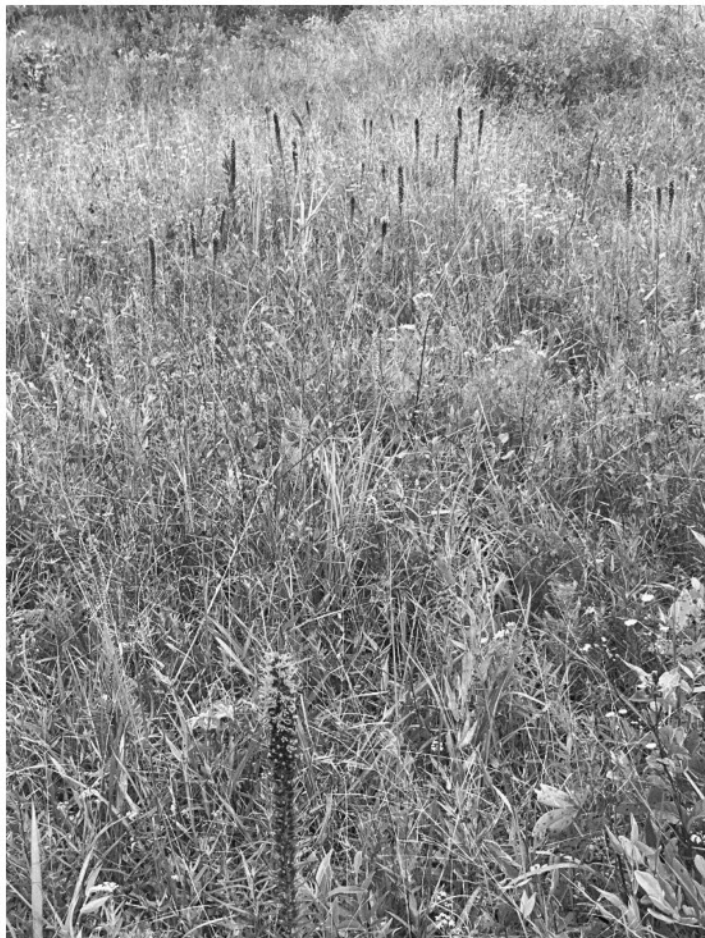
Photo No. 2

| Photo File Name | Date and Time of Photo | Photographer | Description |
|---|---|---|---|
| 101.jpg | 06/18/2024, 11:38 AM | Chelsey Sherwood | Showing revegetation of site such as this native wildflower <i>Liatris sp.</i> |

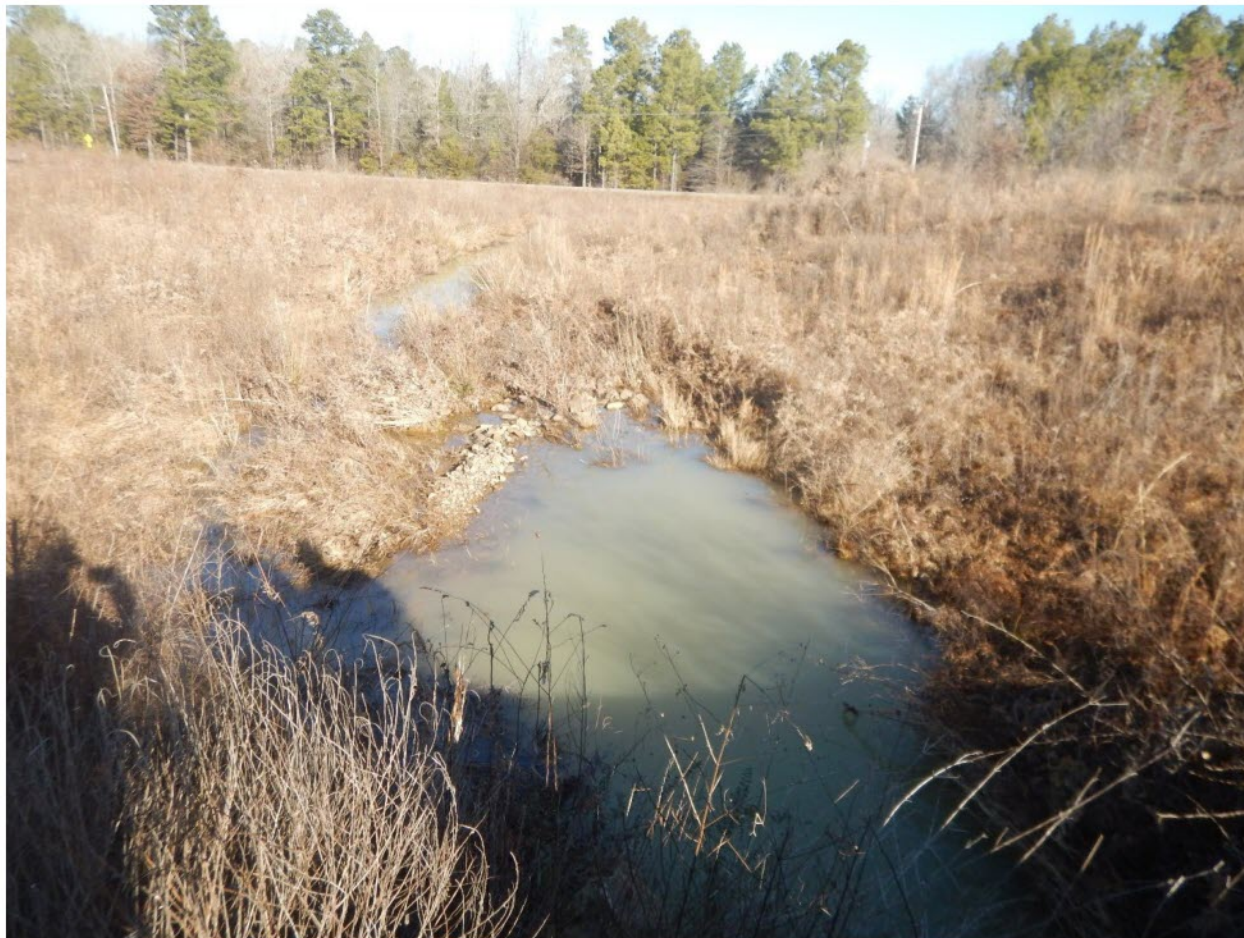
| Photo File Name | Date and Time of Photo | Photographer | Description |
|---|---|---|---|
| DSCN6250 | 01/31/2024, 9:31 AM | Chelsey Sherwood | Showing check dams in stream A and turbid water. Picture taken from road facing downstream, north. |

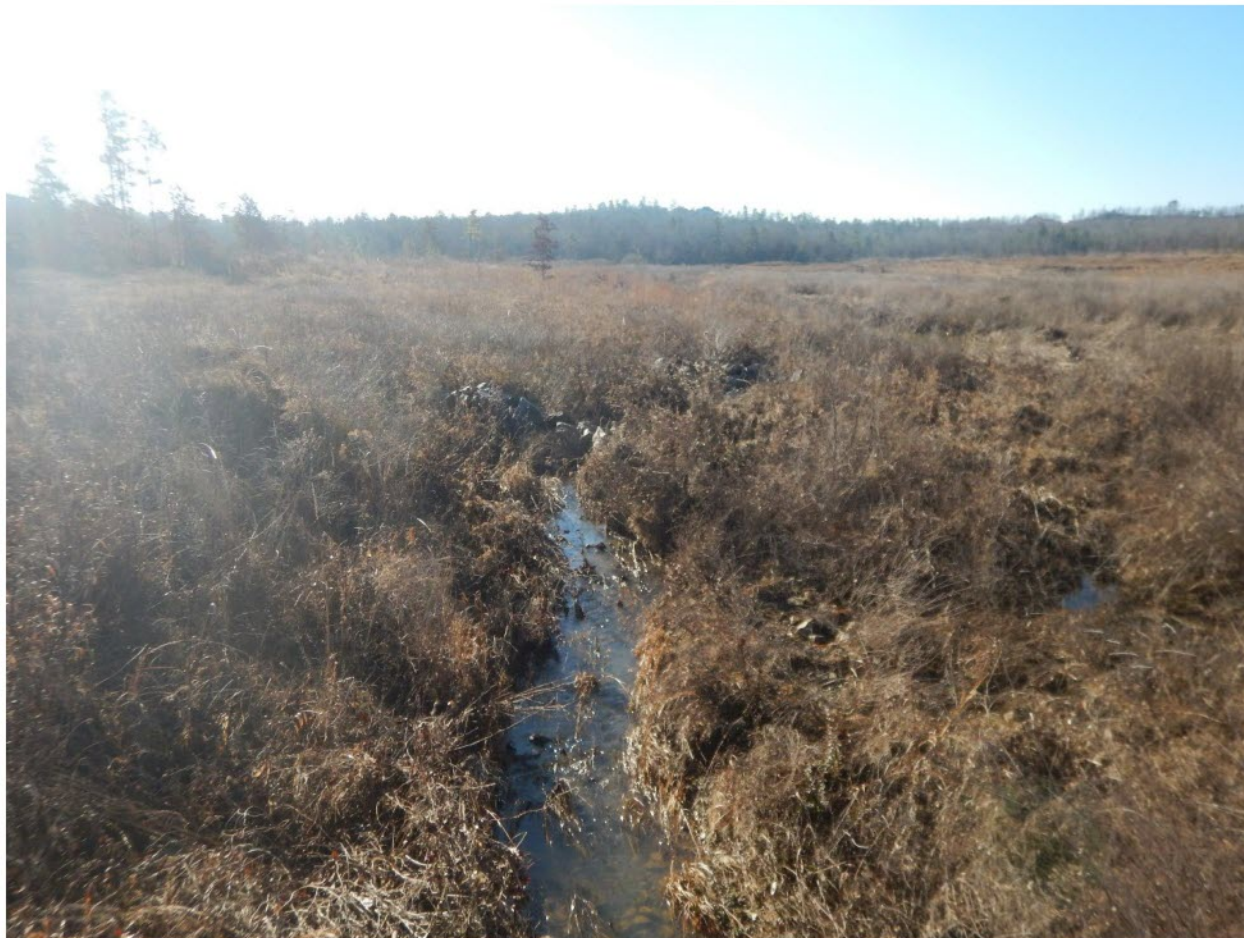
| Photo File Name | Date and Time of Photo | Photographer | Description |
|---|---|---|---|
| DSCN6251 | 01/31/2024, 9:33 AM | Chelsey Sherwood | Showing check dams in stream A. Picture taken from road facing upstream, south. |

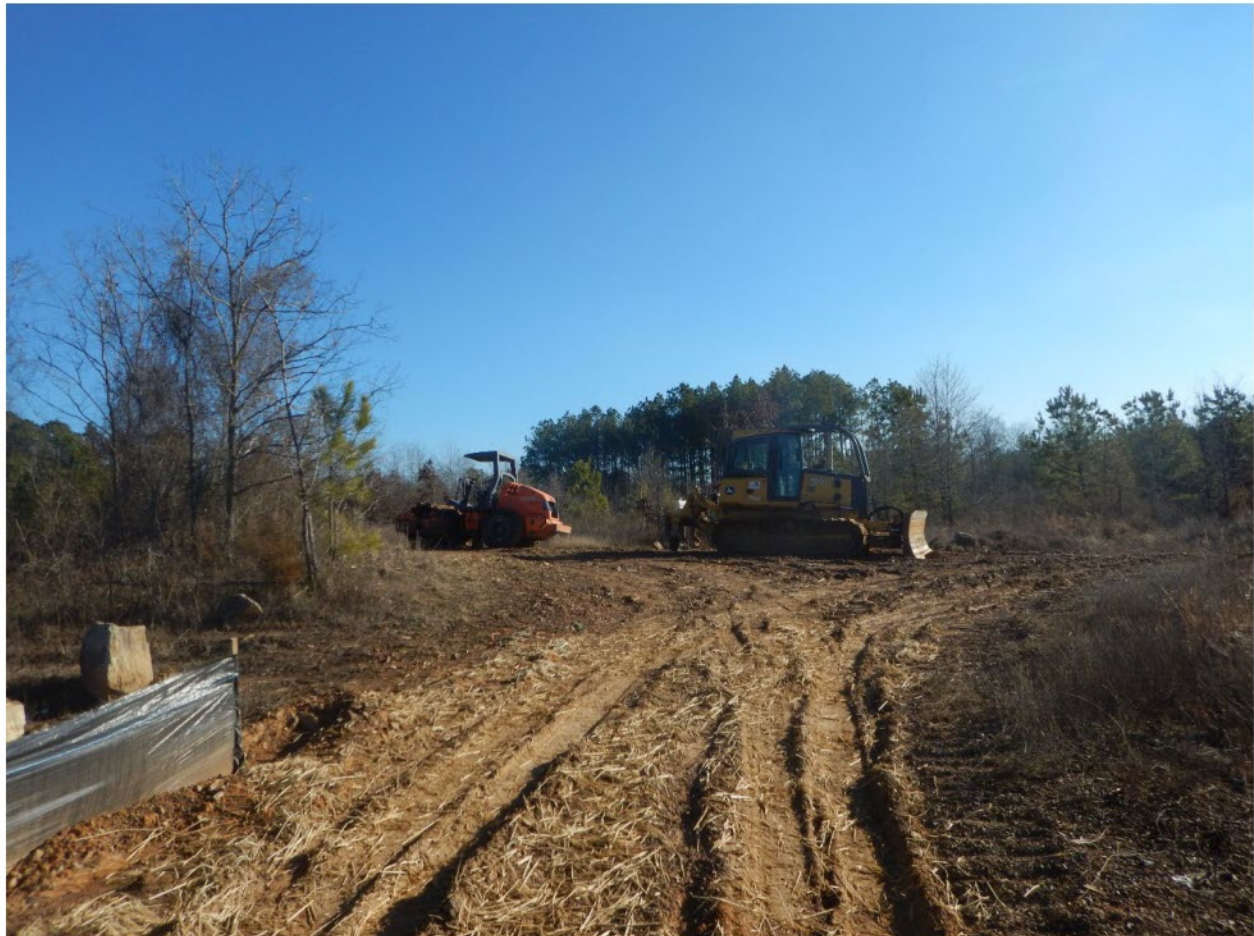
| Photo File Name | Date and Time of Photo | Photographer | Description |
|---|---|---|---|
| DSCN6252 | 01/31/2024, 9:33 AM | Chelsey Sherwood | Showing heavy equipment at site. Picture taken facing east. |

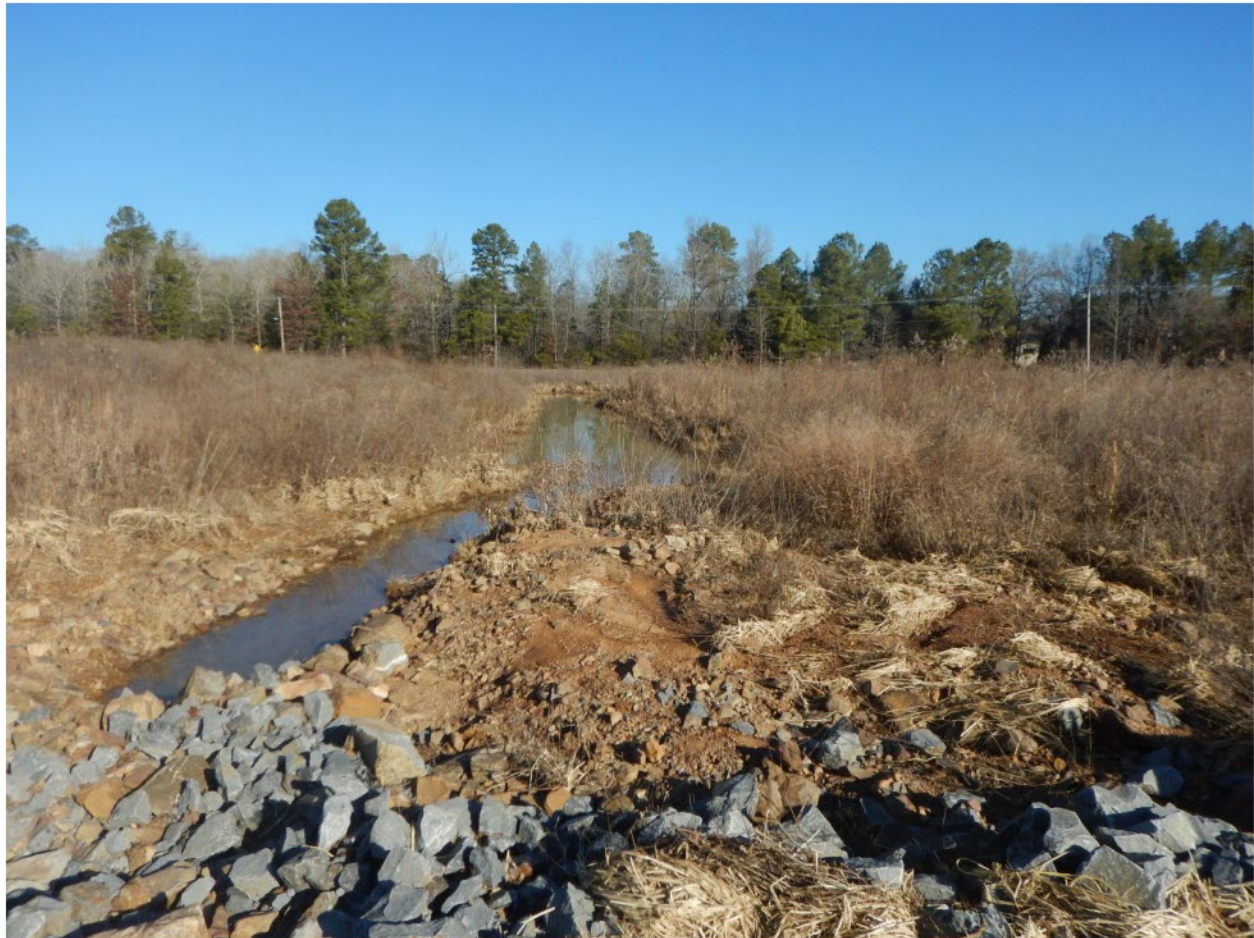
| Photo File Name | Date and Time of Photo | Photographer | Description |
|---|---|---|---|
| DSCN6253 | 01/31/2024, 9:35 AM | Chelsey Sherwood | Showing fill material in stream C. Picture taken from road facing downstream, north. |

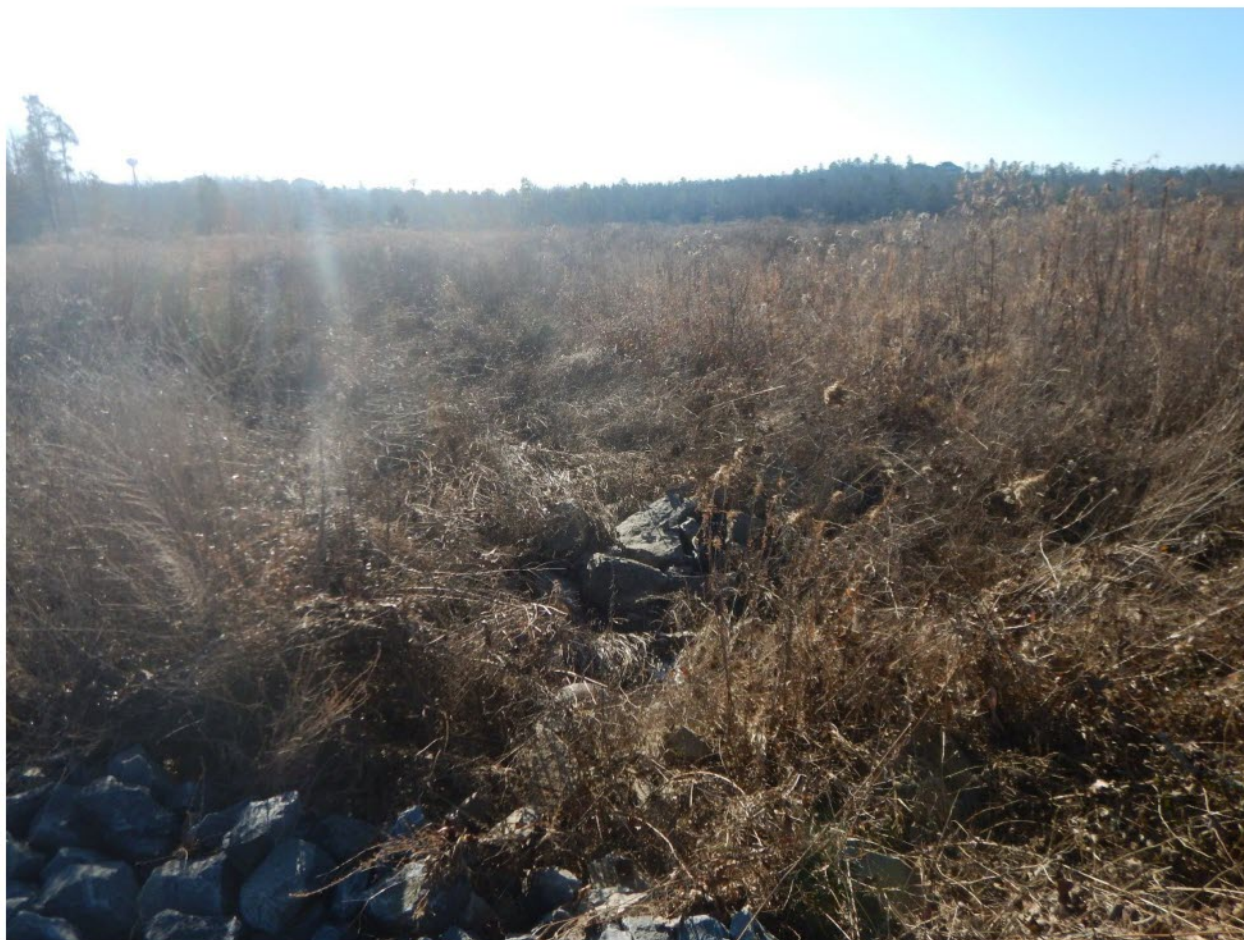
| Photo File Name | Date and Time of Photo | Photographer | Description |
|---|---|---|---|
| DSCN6254 | 01/31/2024, 9:37 AM | Chelsey Sherwood | Showing fill material in stream C. Picture taken from road facing upstream, south. |

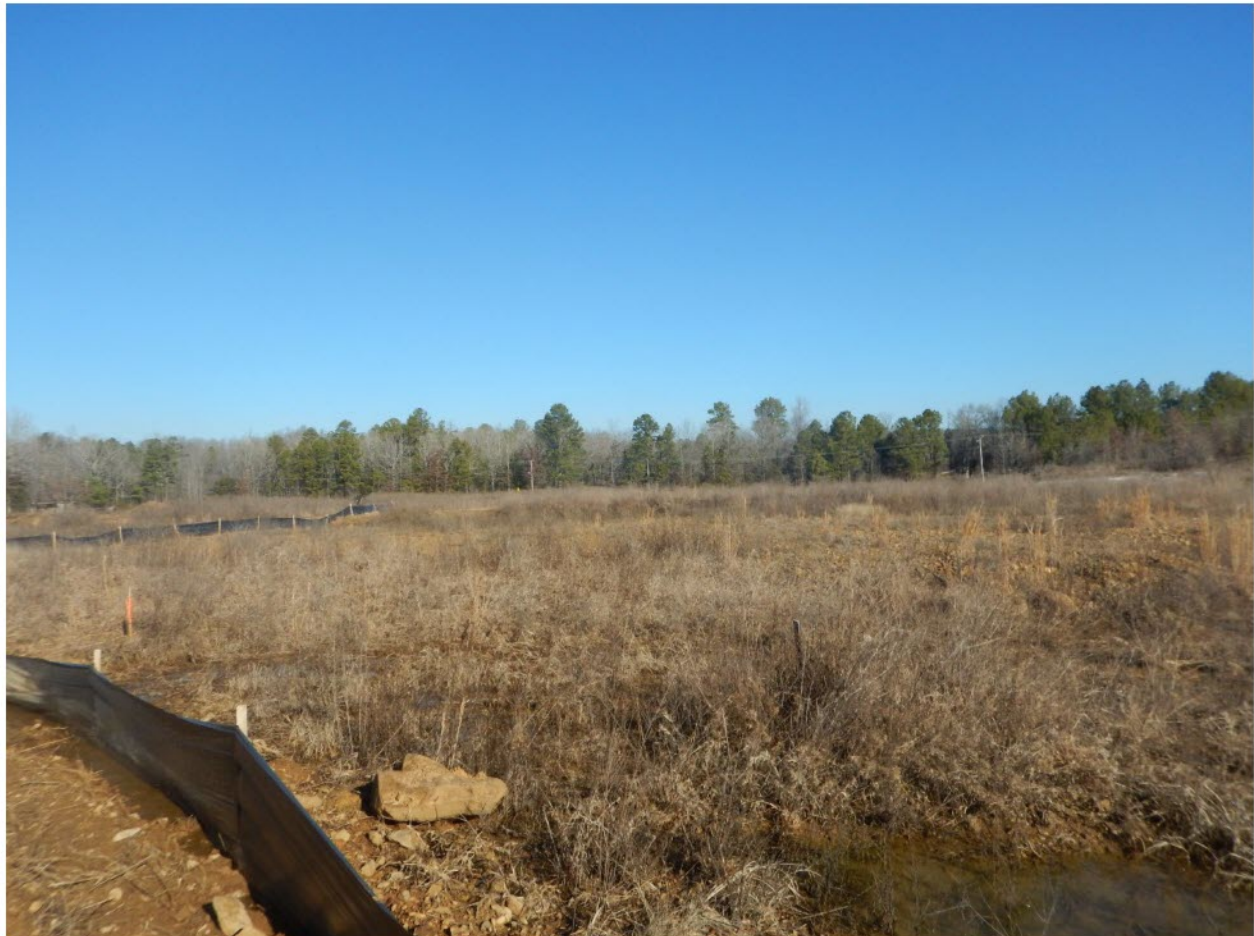
| Photo File Name | Date and Time of Photo | Photographer | Description |
|---|---|---|---|
| DSCN6255 | 01/31/2024, 9:41 AM | Chelsey Sherwood | Showing overview of project site. Picture taken facing north. |

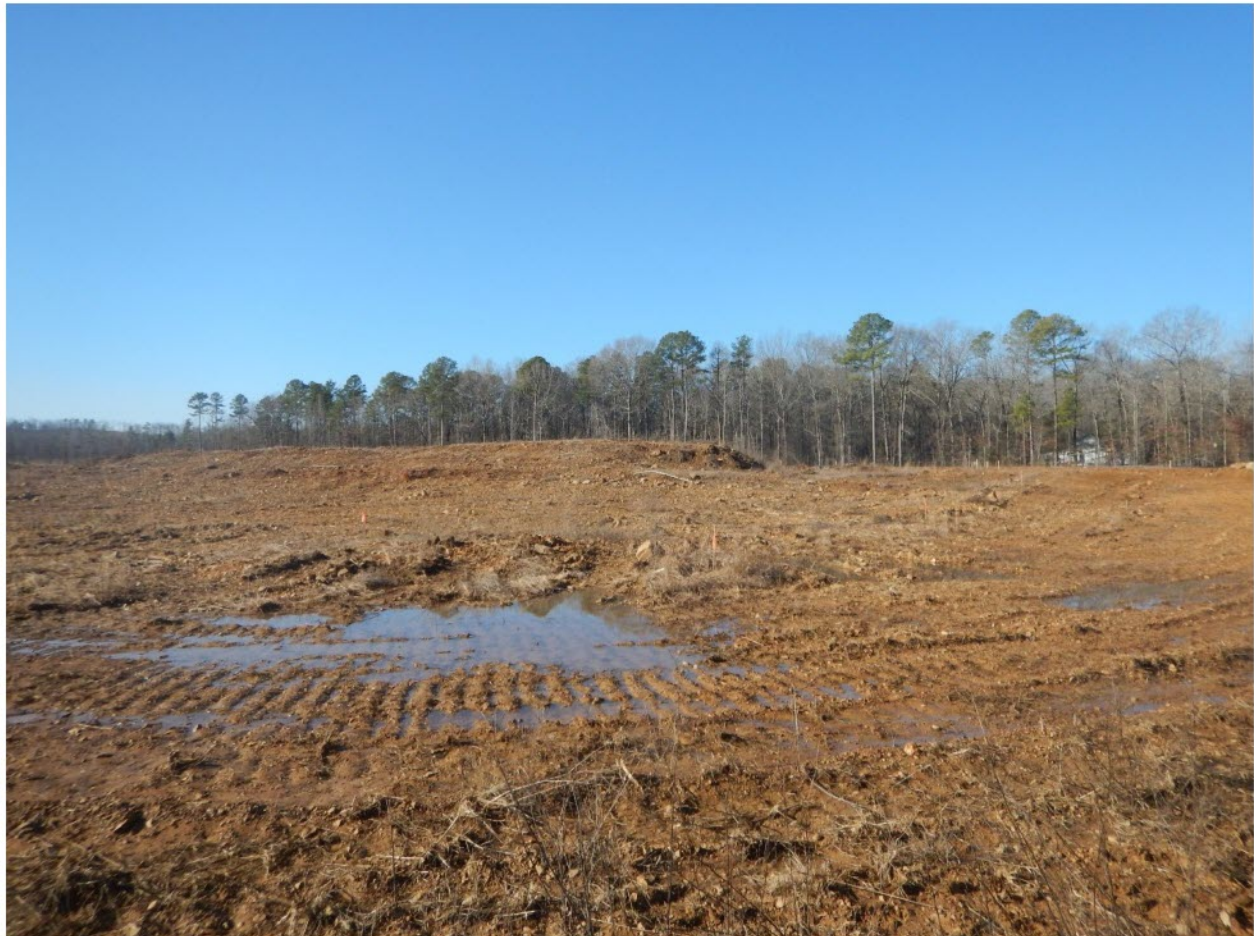
| Photo File Name | Date and Time of Photo | Photographer | Description |
|---|---|---|---|
| DSCN6256 | 01/31/2024, 9:41 AM | Chelsey Sherwood | Showing overview of project site. Picture taken facing west. |

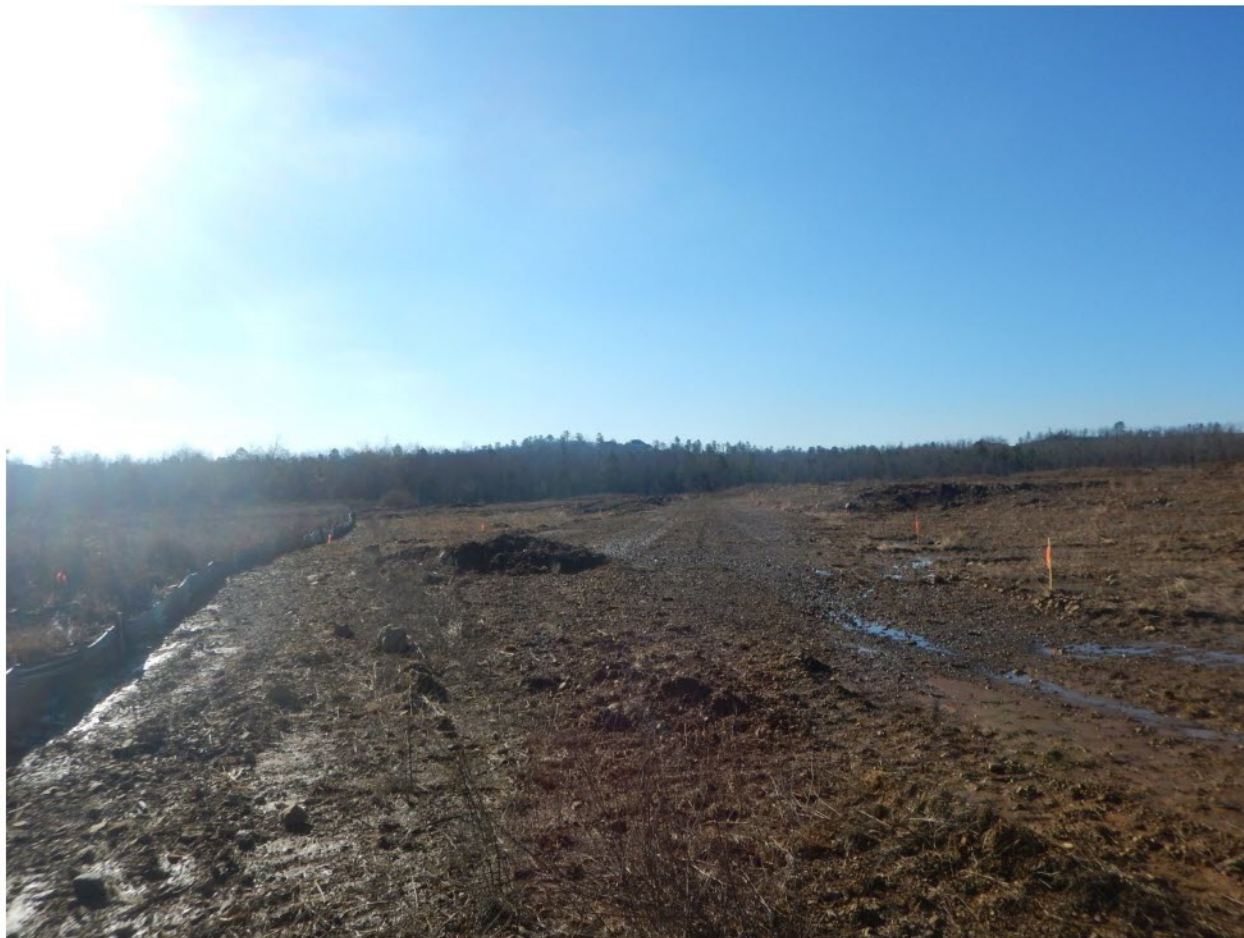
| Photo File Name | Date and Time of Photo | Photographer | Description |
|---|---|---|---|
| DSCN6257 | 01/31/2024, 9:42 AM | Chelsey Sherwood | Showing overview of project site. Picture taken facing south. |

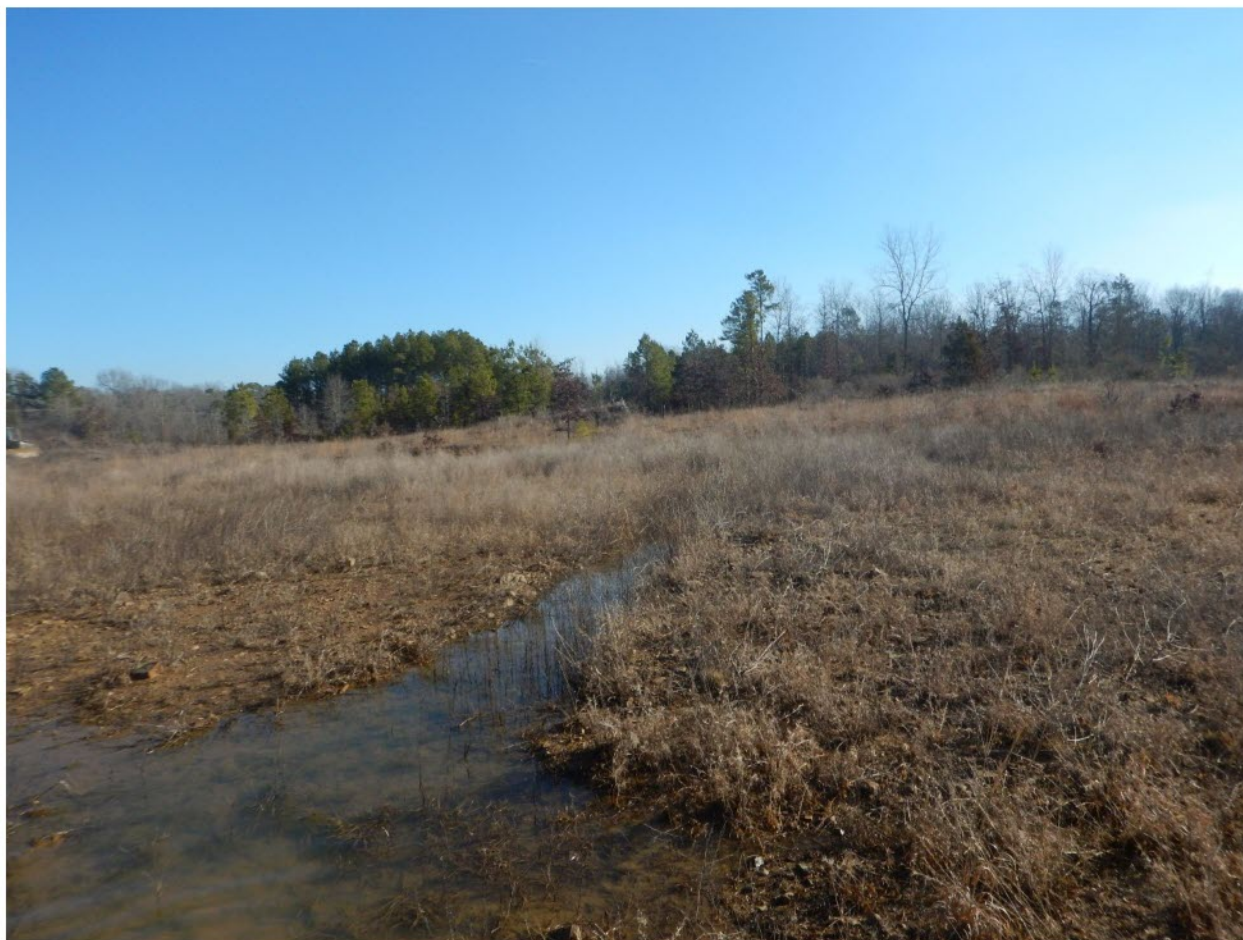
| Photo File Name | Date and Time of Photo | Photographer | Description |
|---|---|---|---|
| DSCN6258 | 01/31/2024, 9:42 AM | Chelsey Sherwood | Showing overview of project site. Picture taken facing east. |

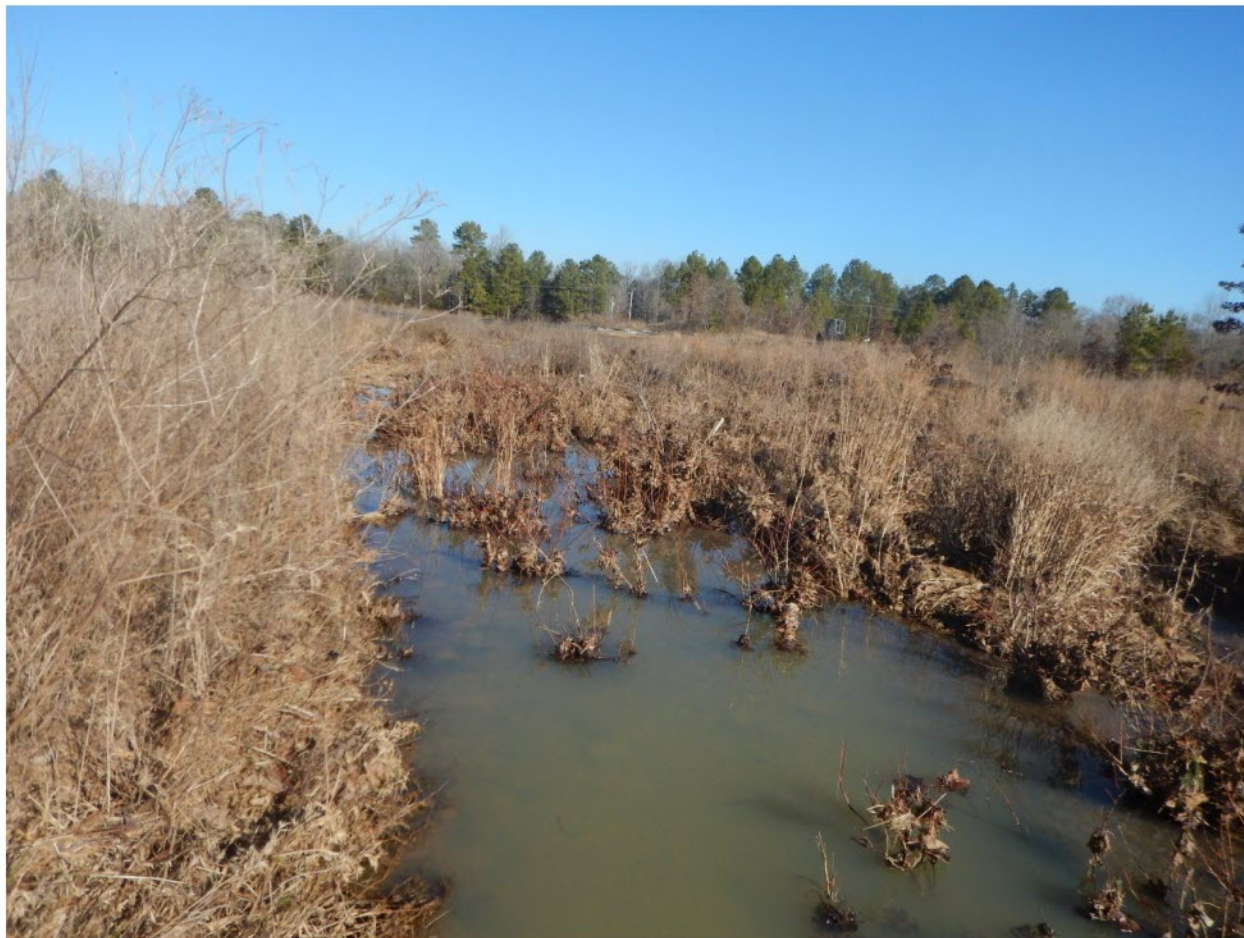
| Photo File Name | Date and Time of Photo | Photographer | Description |
|---|---|---|---|
| DSCN6259 | 01/31/2024, 9:44 AM | Chelsey Sherwood | Showing wack lines of leaves and turbidity in stream A. Picture taken from stream bed facing downstream, north. |

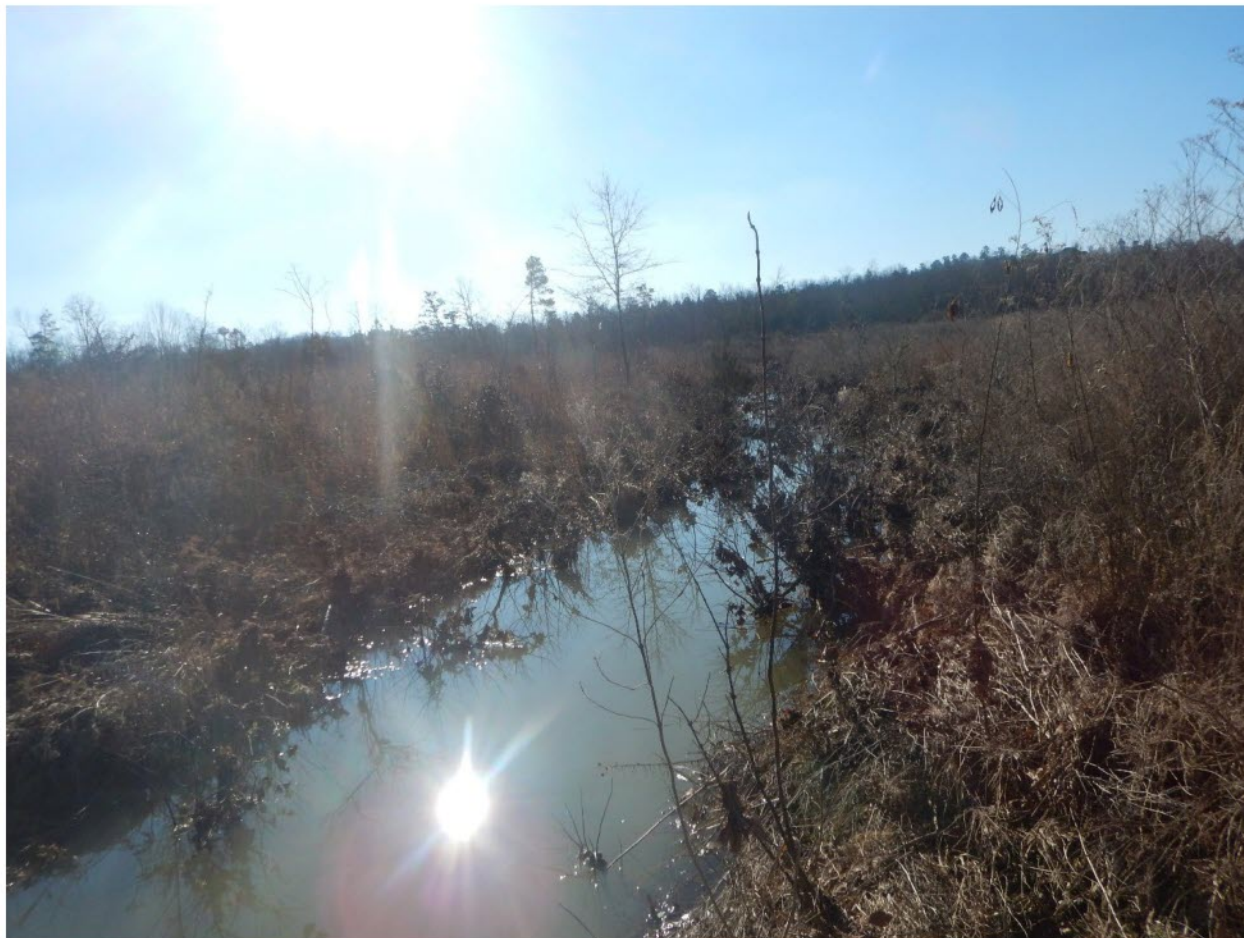
| Photo File Name | Date and Time of Photo | Photographer | Description |
|---|---|---|---|
| DSCN6260 | 01/31/2024, 9:44 AM | Chelsey Sherwood | Showing stream A. Picture taken from stream bed facing upstream, south. |

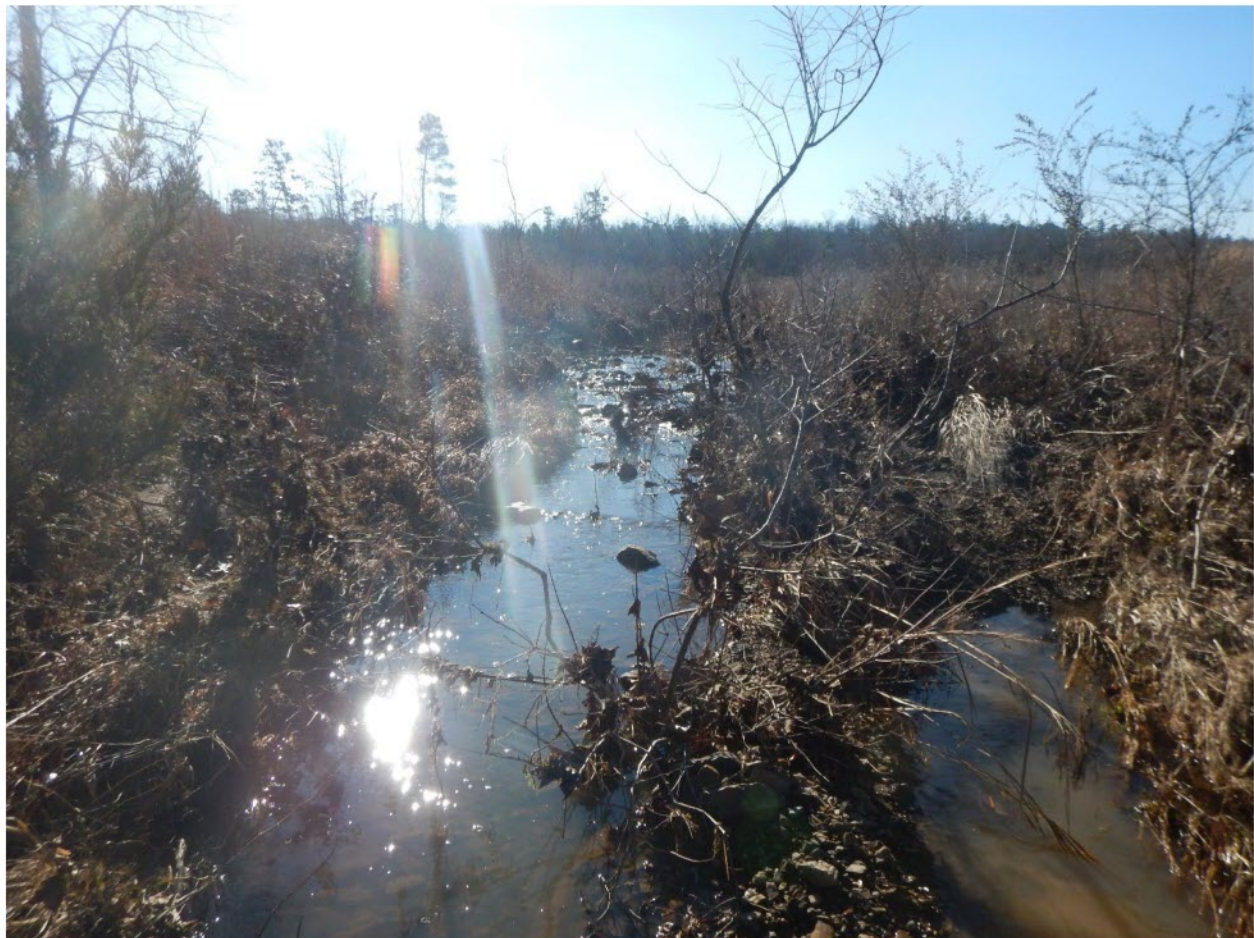
| Photo File Name | Date and Time of Photo | Photographer | Description |
|---|---|---|---|
| DSCN6261 | 01/31/2024, 9:48 AM | Chelsey Sherwood | Showing wrack lines on vegetation in stream A. Picture taken from stream bed facing upstream, south. |

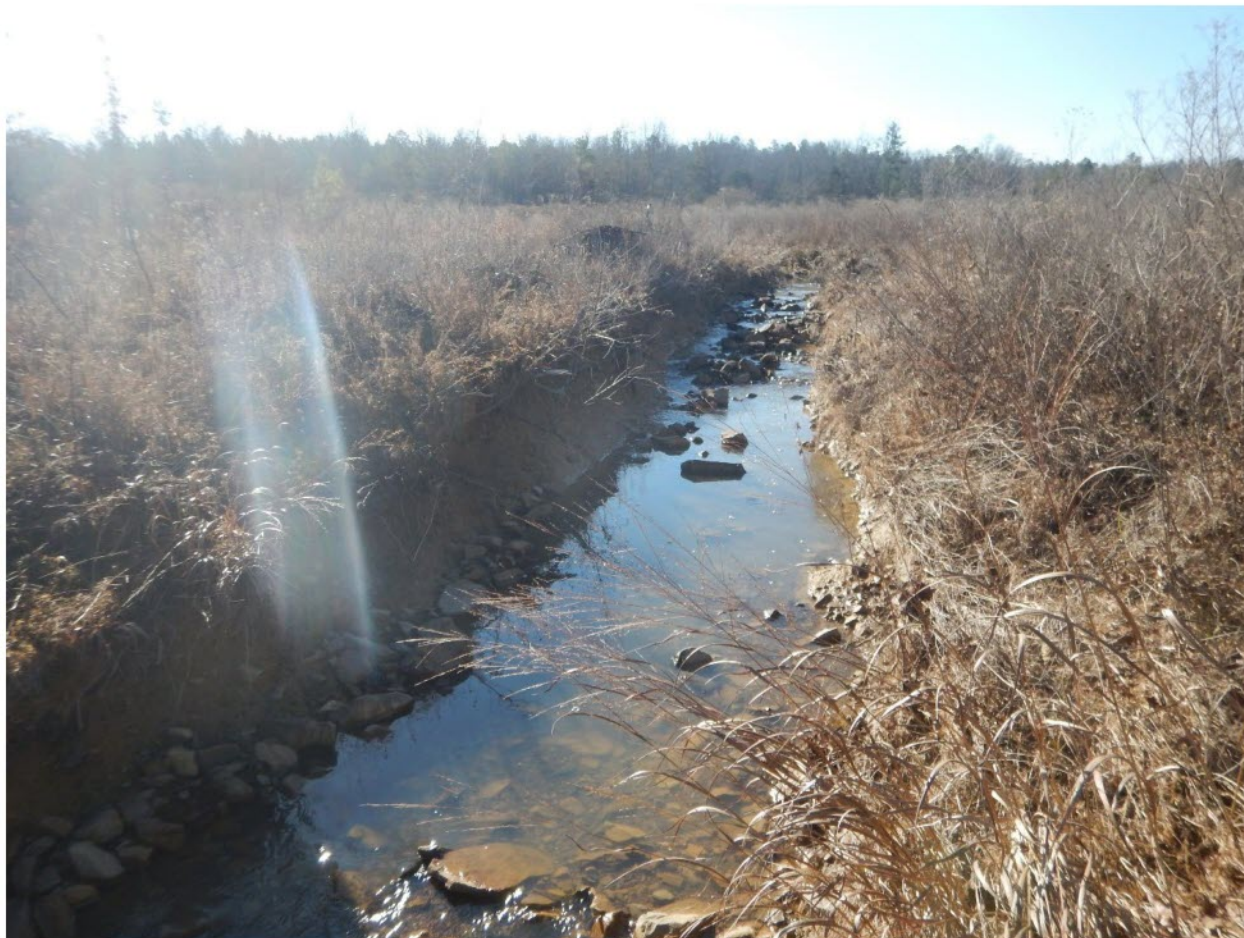
| Photo File Name | Date and Time of Photo | Photographer | Description |
|---|---|---|---|
| DSCN6262 | 01/31/2024, 9:51 AM | Chelsey Sherwood | Showing stream bank erosion approximately 2.5 feet high from stream bed in stream A. Picture taken from stream bed facing upstream, south. |

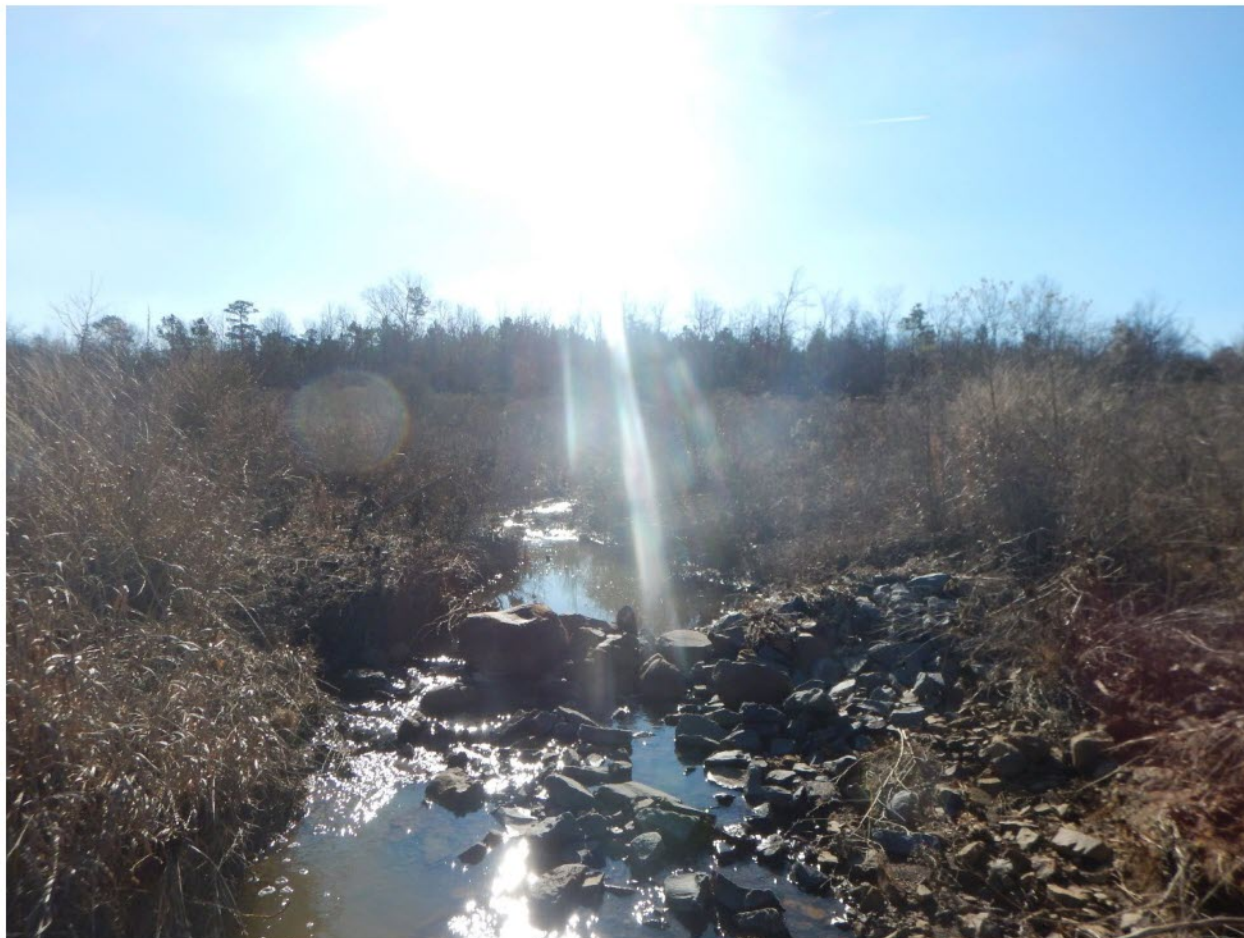
| Photo File Name | Date and Time of Photo | Photographer | Description |
|---|---|---|---|
| DSCN6263 | 01/31/2024, 9:55 AM | Chelsey Sherwood | Showing check dam placed in stream A. Picture taken from stream bed facing upstream, south. |

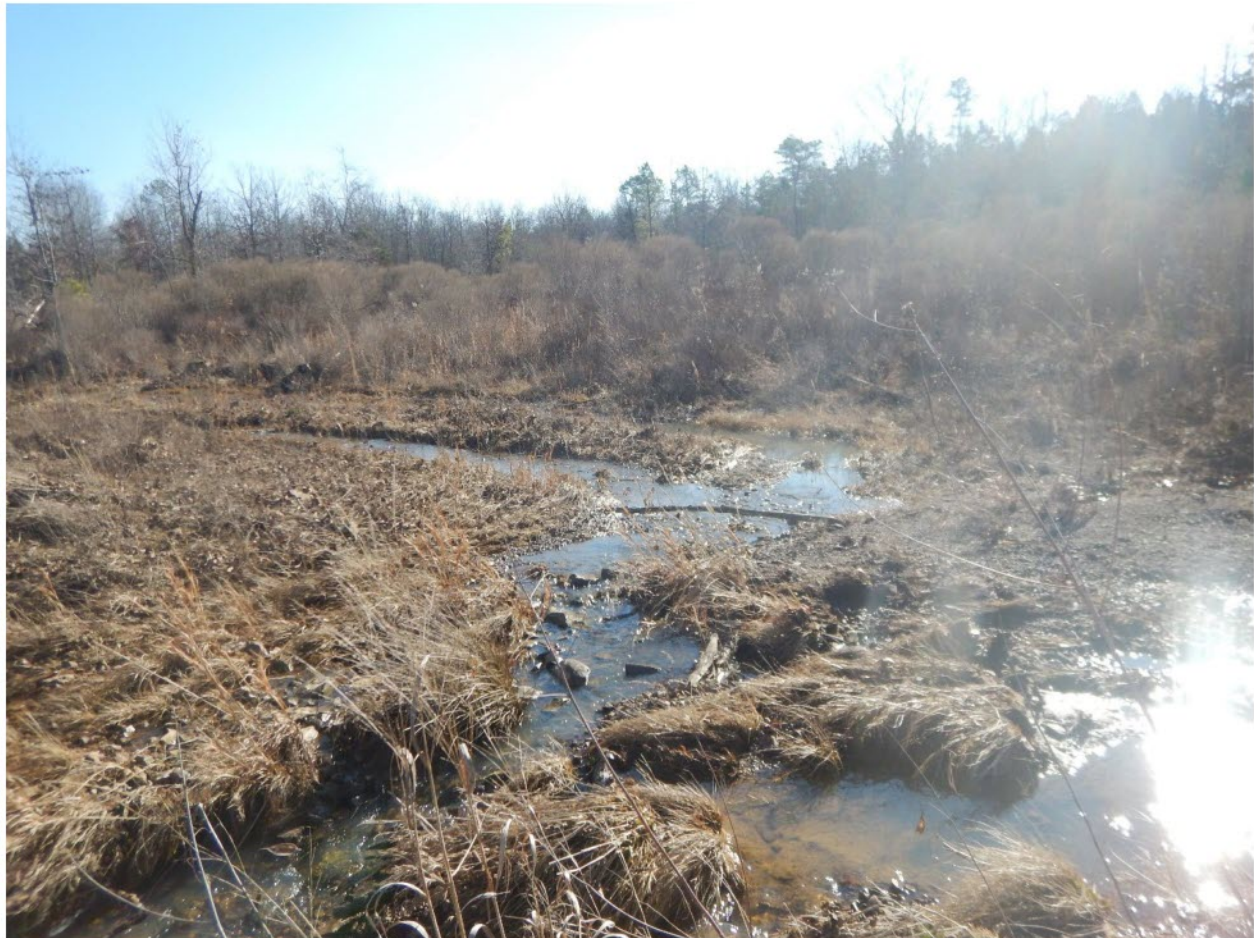
| Photo File Name | Date and Time of Photo | Photographer | Description |
|---|---|---|---|
| DSCN6264 | 01/31/2024, 9:58 AM | Chelsey Sherwood | Showing confluence of stream A and stream B. Picture taken facing upstream, southeast. |

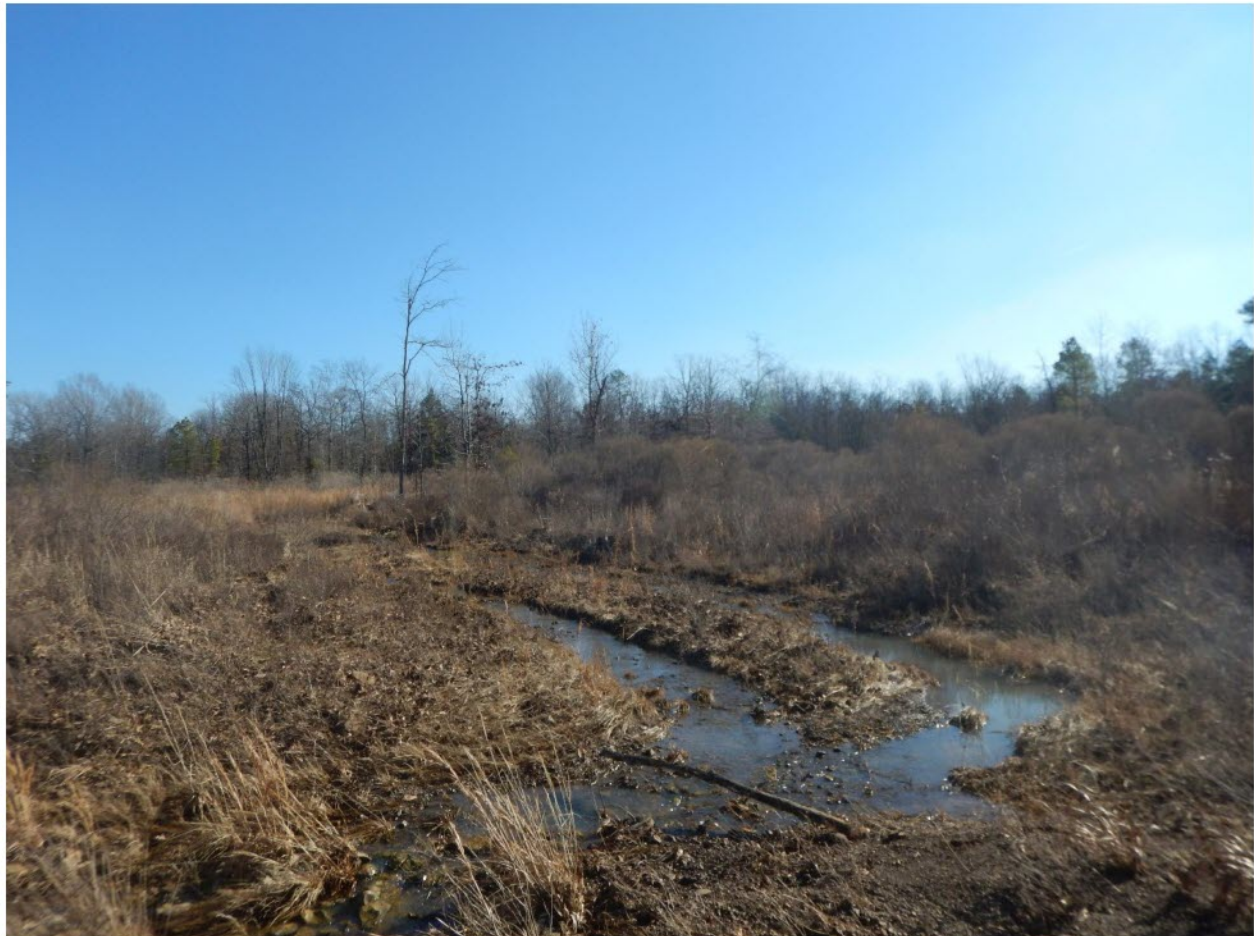
| Photo File Name | Date and Time of Photo | Photographer | Description |
|---|---|---|---|
| DSCN6265 | 01/31/2024, 9:59 AM | Chelsey Sherwood | Showing tire tracks in stream B. Picture taken facing upstream, southeast. |

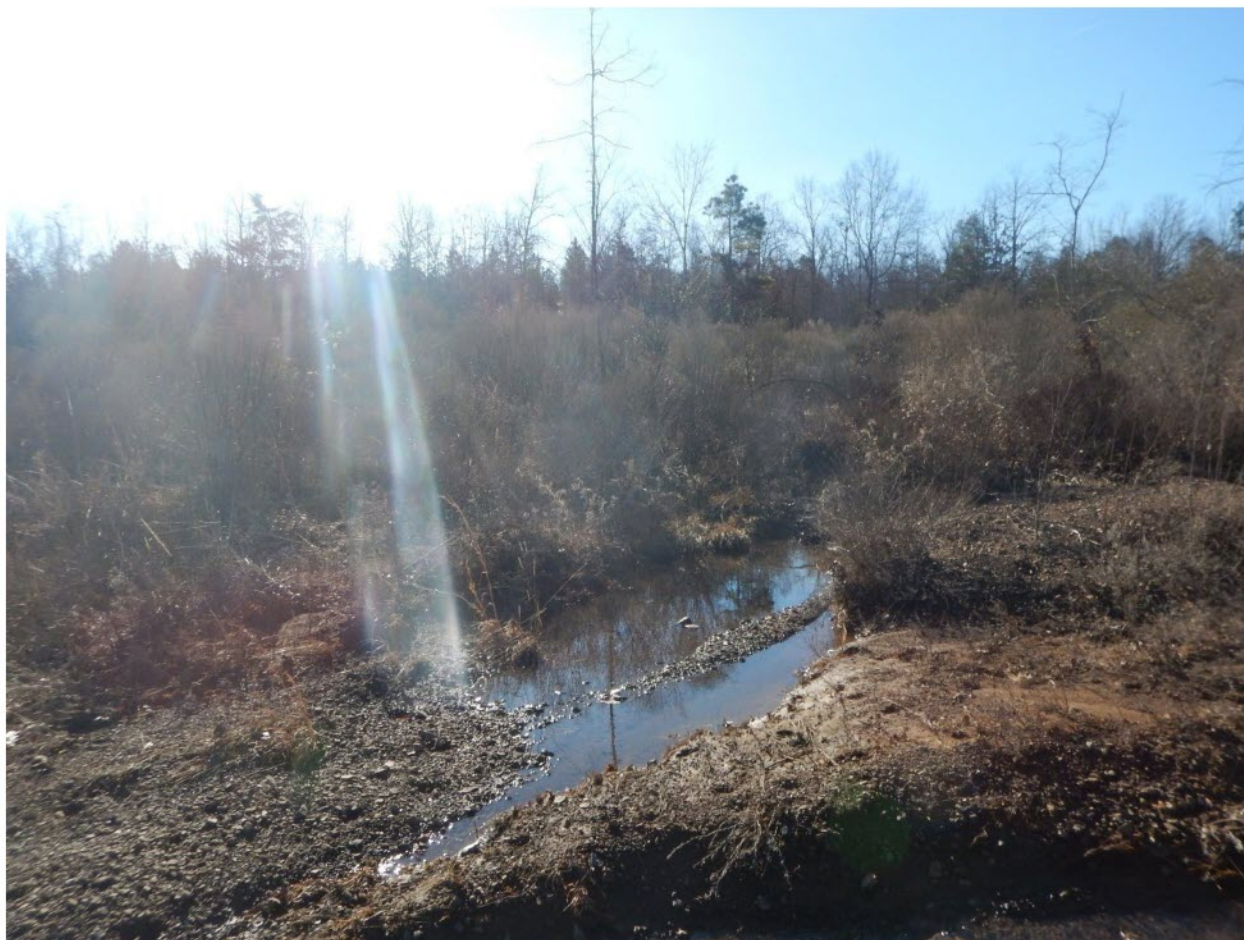
| Photo File Name | Date and Time of Photo | Photographer | Description |
|---|---|---|---|
| DSCN6266 | 01/31/2024, 9:59 AM | Chelsey Sherwood | Showing braided channel of stream A. Note streambed appears to have been altered impeding flow. Picture taken facing upstream, south. |
