## Clean Water Act Section 404: Site Visit/Case Development

| Site Name | Paradise Valley, LLC (Rick Ferguson) | | | | |

| Inspection Purpose | The purpose of this inspection was to discuss and evaluate steps to developing a restoration plan | | |

| Inspection Purpose | Initial site visit | | |

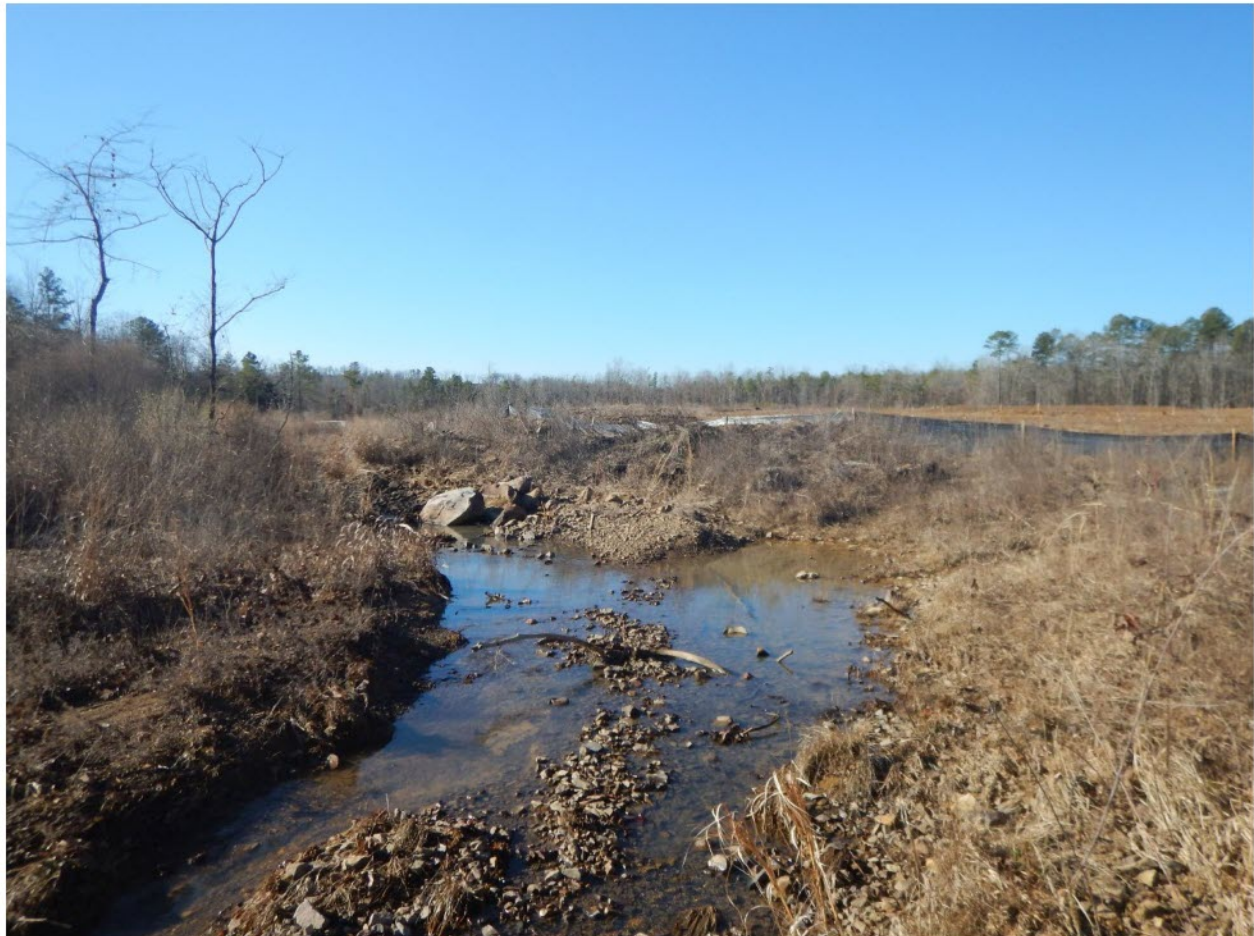
| Photo File Name | Date and Time of Photo | Photographer | Description |
|---|---|---|---|
| DSCN6267 | 01/31/2024, 9:59 AM | Chelsey Sherwood | Showing main channel of stream A and fill material. Picture taken facing upstream, southwest. |

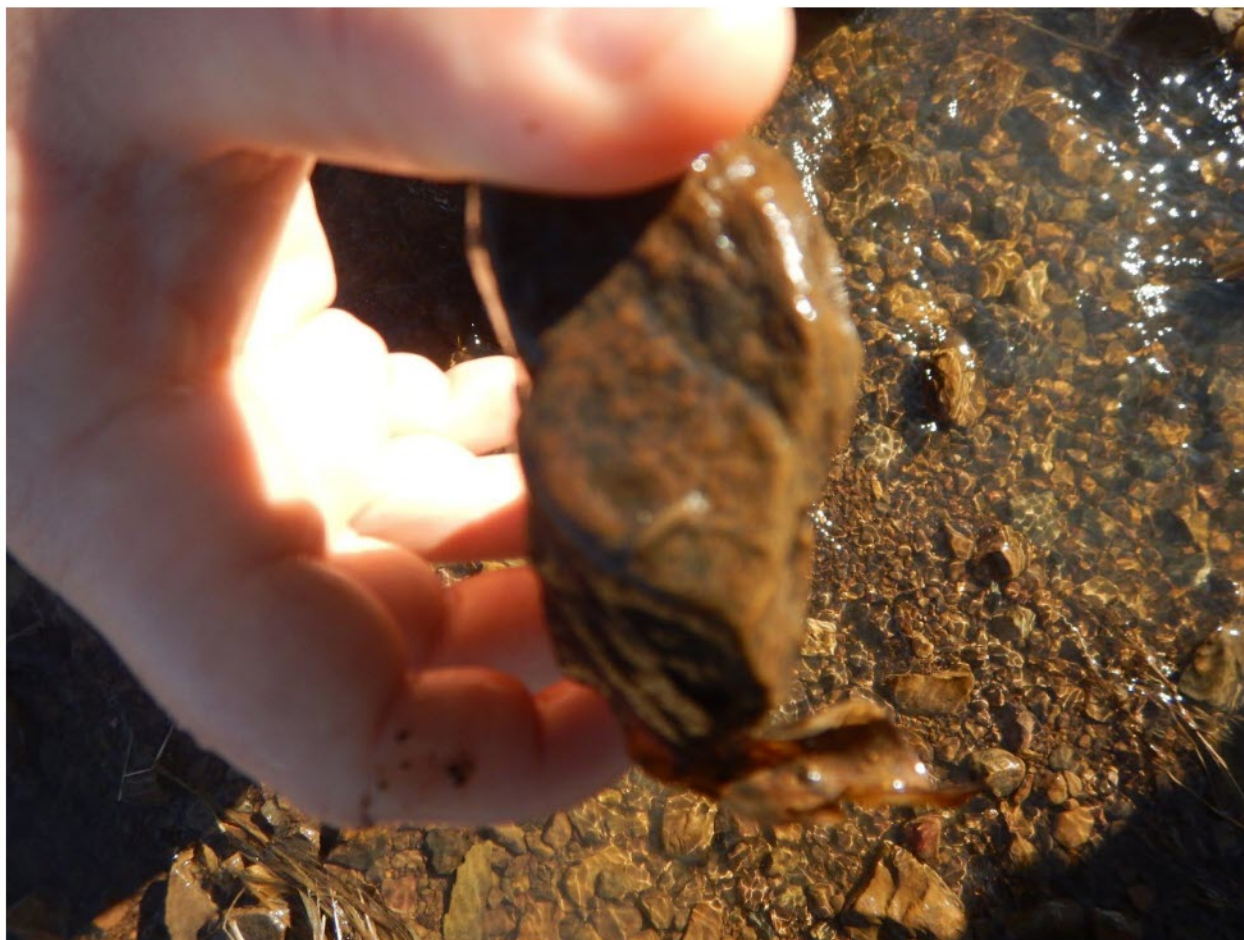
| Photo File Name | Date and Time of Photo | Photographer | Description |
|---|---|---|---|
| DSCN6268 | 01/31/2024, 10:03 AM | Chelsey Sherwood | Showing one of the aquatic macroinvertebrates found in stream A. |

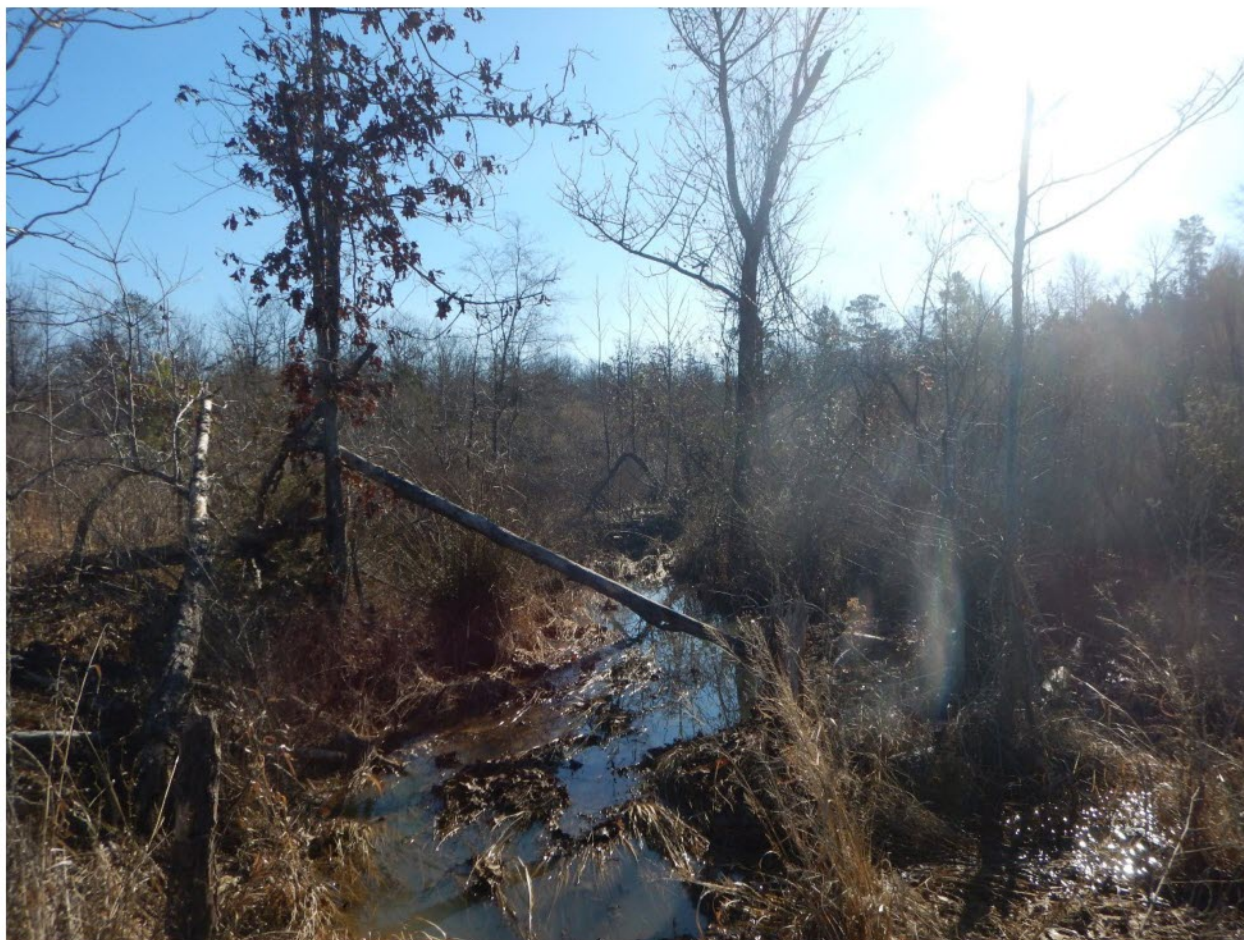
| Photo File Name | Date and Time of Photo | Photographer | Description |
|---|---|---|---|
| DSCN6269 | 01/31/2024, 10:04 AM | Chelsey Sherwood | Showing stream B above the impacts shown in photo 16 and 21. Picture taken facing upstream, east. |

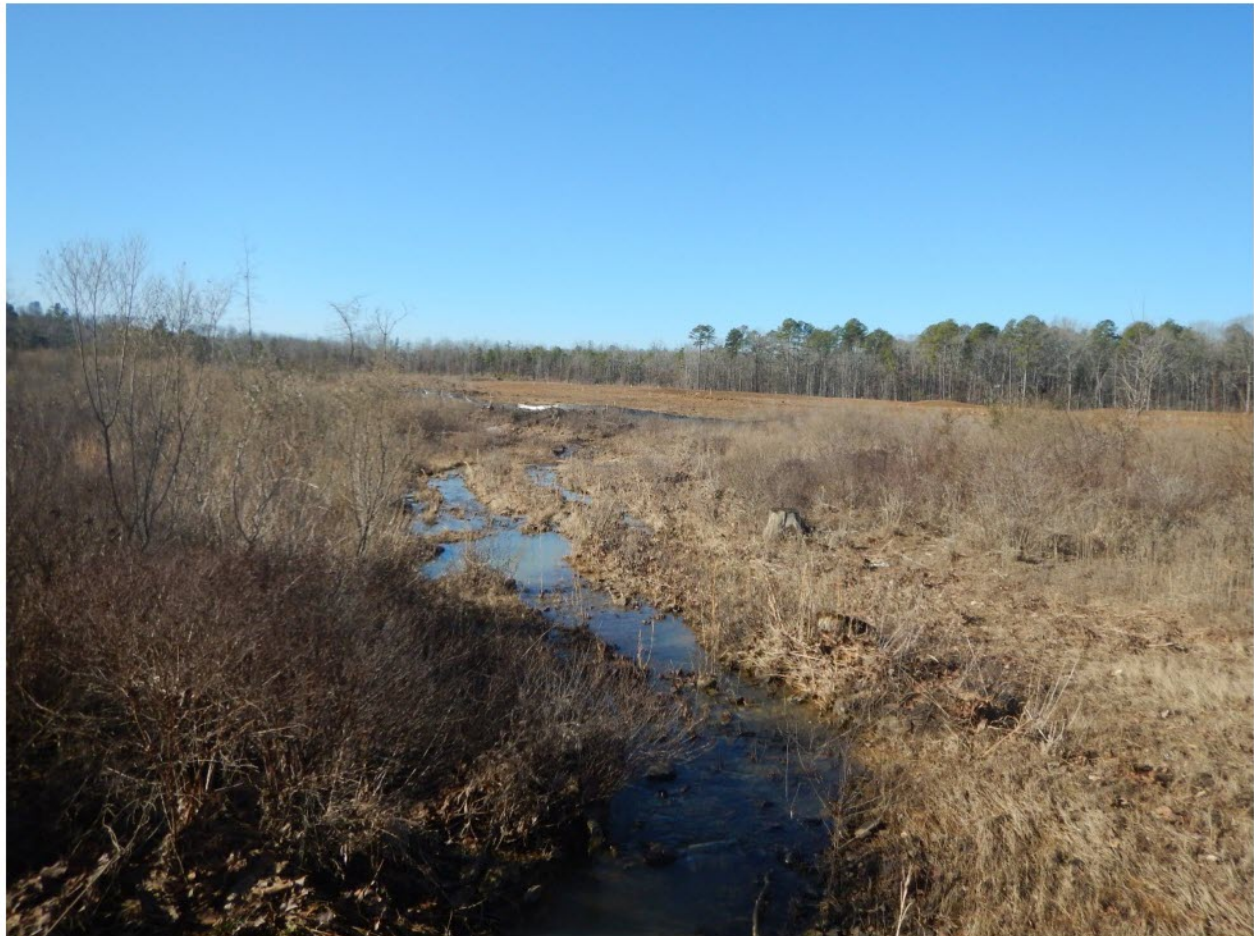
| Photo File Name | Date and Time of Photo | Photographer | Description |
|---|---|---|---|
| DSCN6270 | 01/31/2024, 10:05 AM | Chelsey Sherwood | Showing stream B facing downstream from photo 20. Note riparian area removed and stream channel appears to have been altered. Picture taken facing west. |

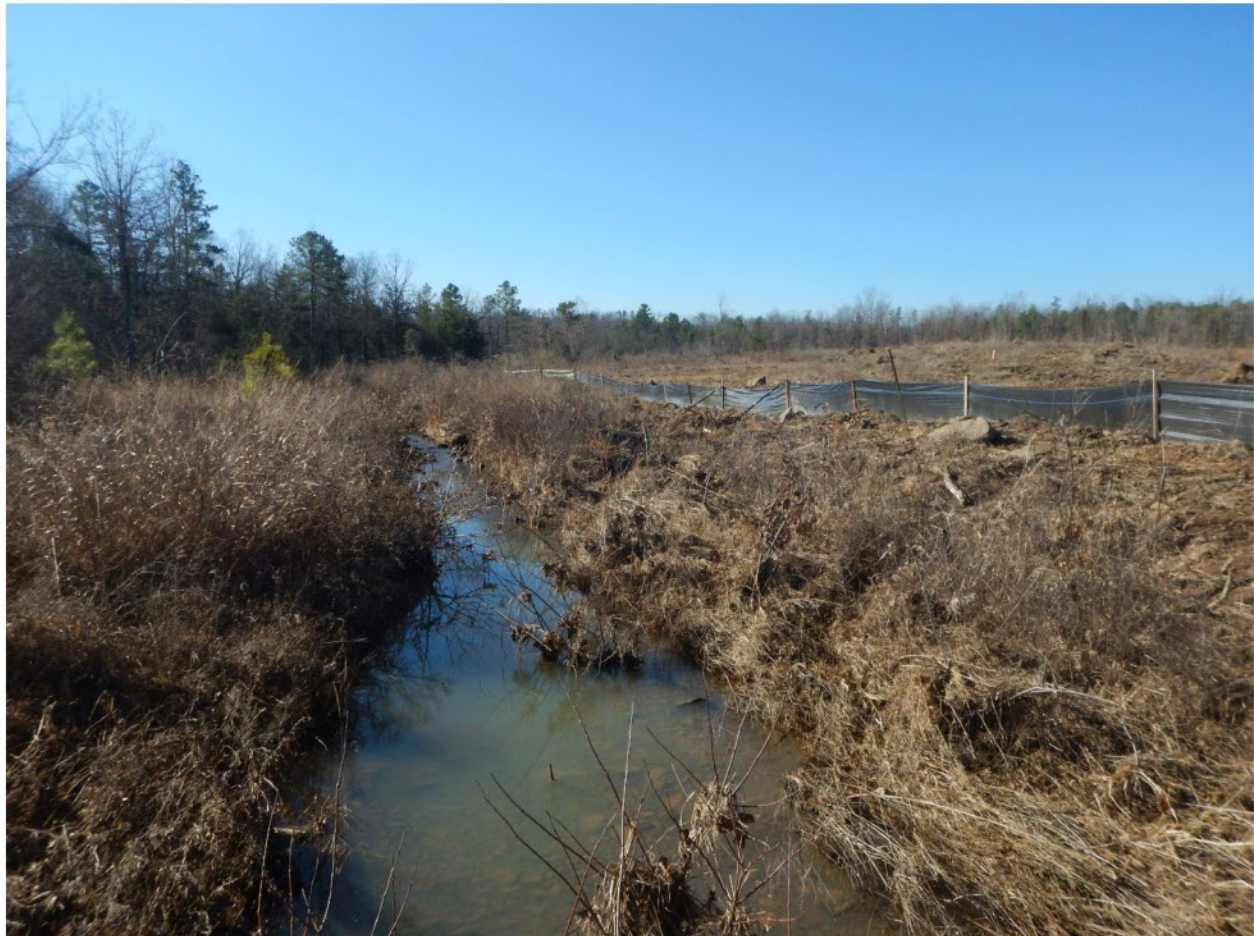
| Photo File Name | Date and Time of Photo | Photographer | Description |
|---|---|---|---|
| DSCN6271 | 01/31/2024, 10:12 AM | Chelsey Sherwood | Showing riparian area removed, tire tracks along bank, and excessive sediment built up along fencing. Picture taken facing upstream, southwest in stream A. |

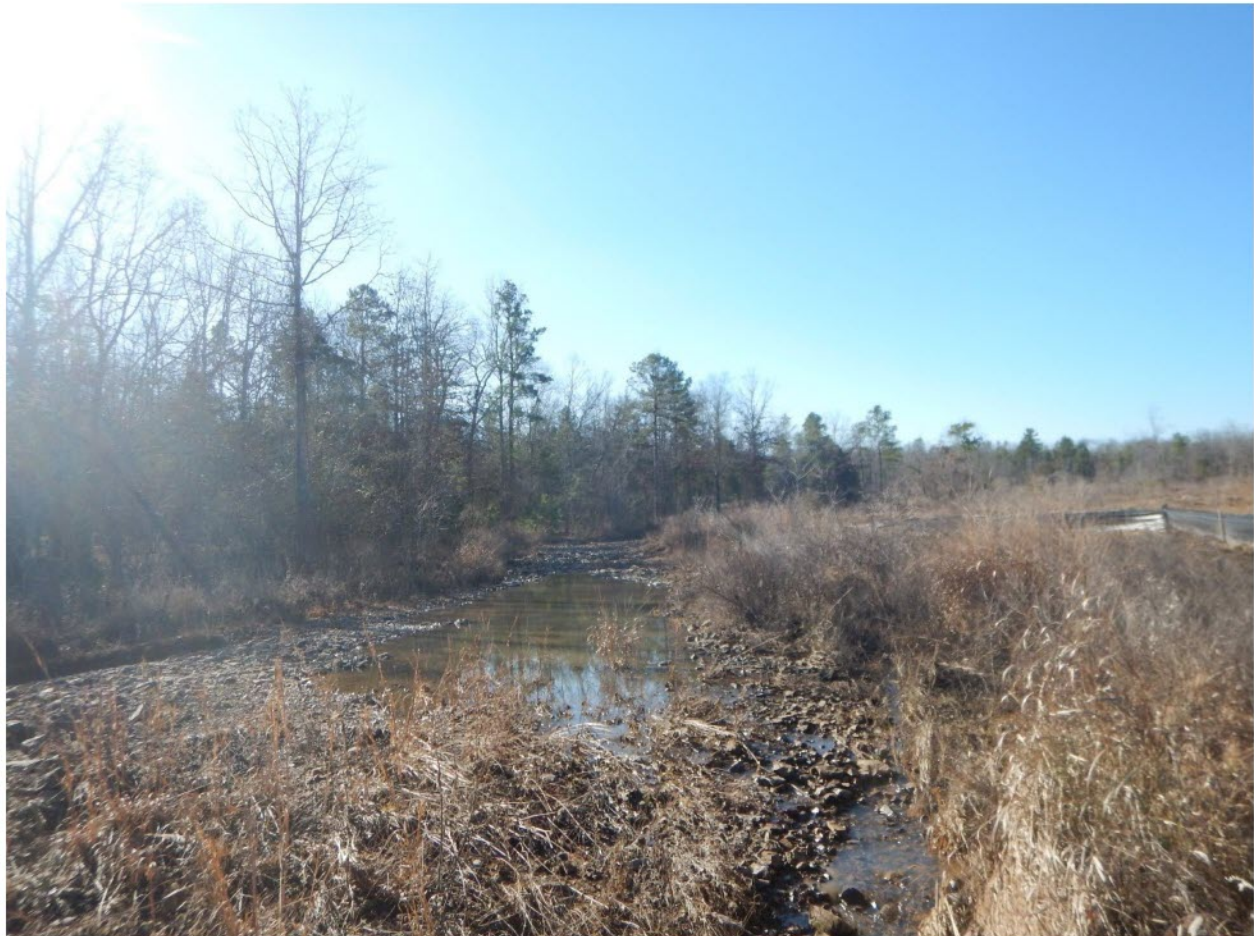
| Photo File Name | Date and Time of Photo | Photographer | Description |
|---|---|---|---|
| DSCN6272 | 01/31/2024, 10:16 AM | Chelsey Sherwood | Showing where stream A channel should be parallel to the road but has been altered. Picture taken facing upstream, southwest. |

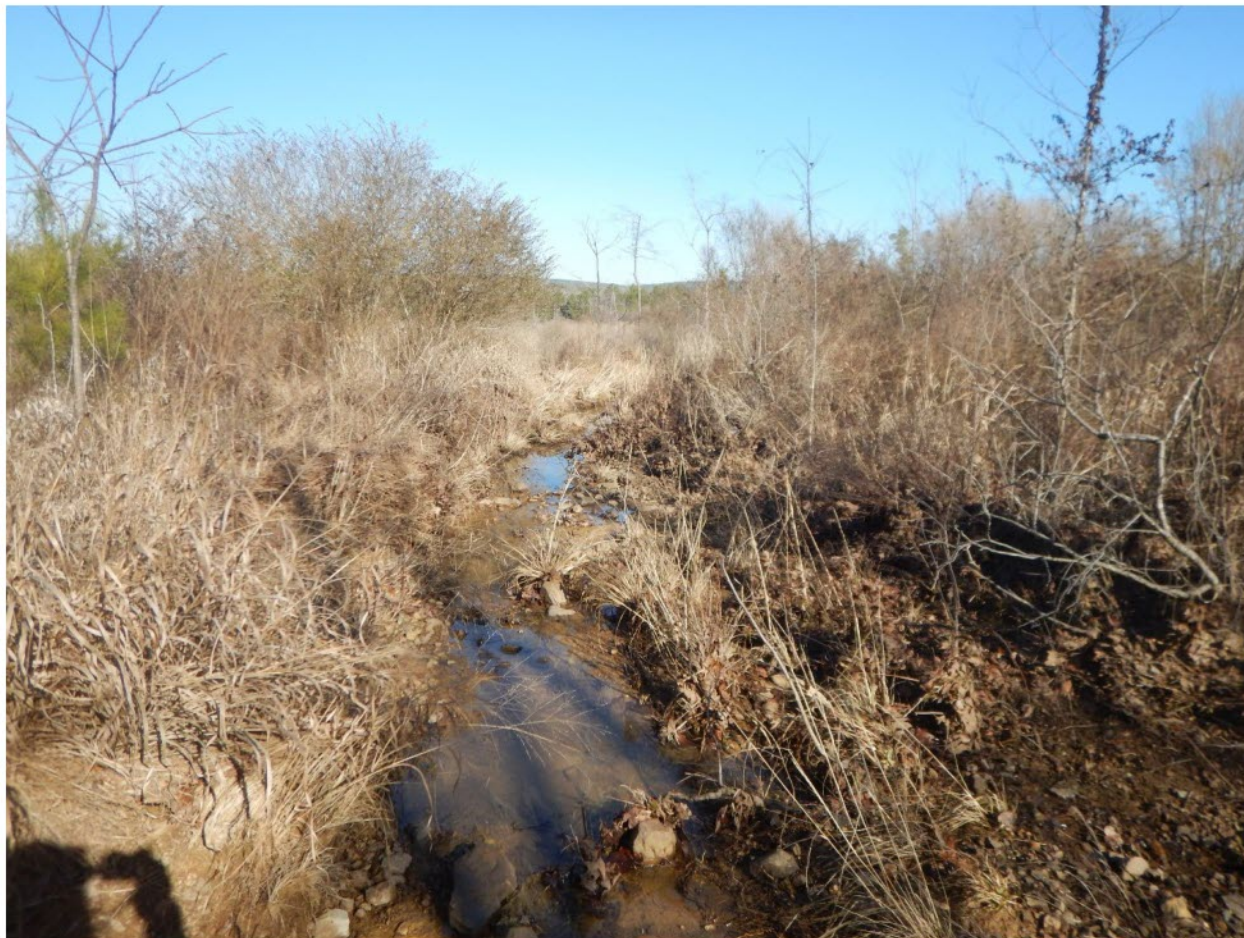
| Photo File Name | Date and Time of Photo | Photographer | Description |
|---|---|---|---|
| DSCN6273 | 01/31/2024, 10:19 AM | Chelsey Sherwood | Showing braided channel of stream A. Note wrack lines on vegetation. Picture taken facing downstream, north. |

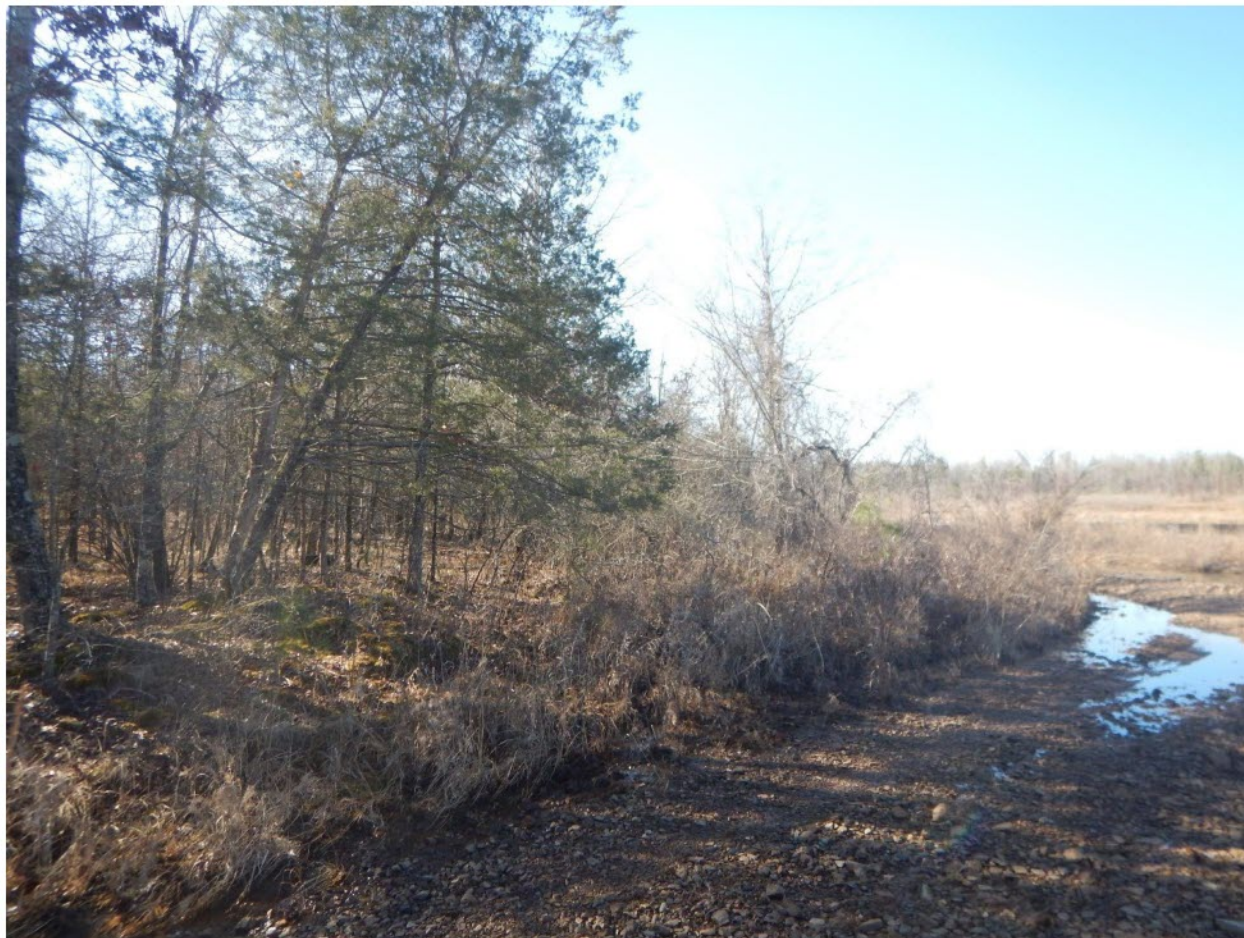
| Photo File Name | Date and Time of Photo | Photographer | Description |
|---|---|---|---|
| DSCN6274 | 01/31/2024, 10:19 AM | Chelsey Sherwood | Showing braided channel of stream A upstream from photo 24. Note road severing connection. Picture taken facing upstream, south. |

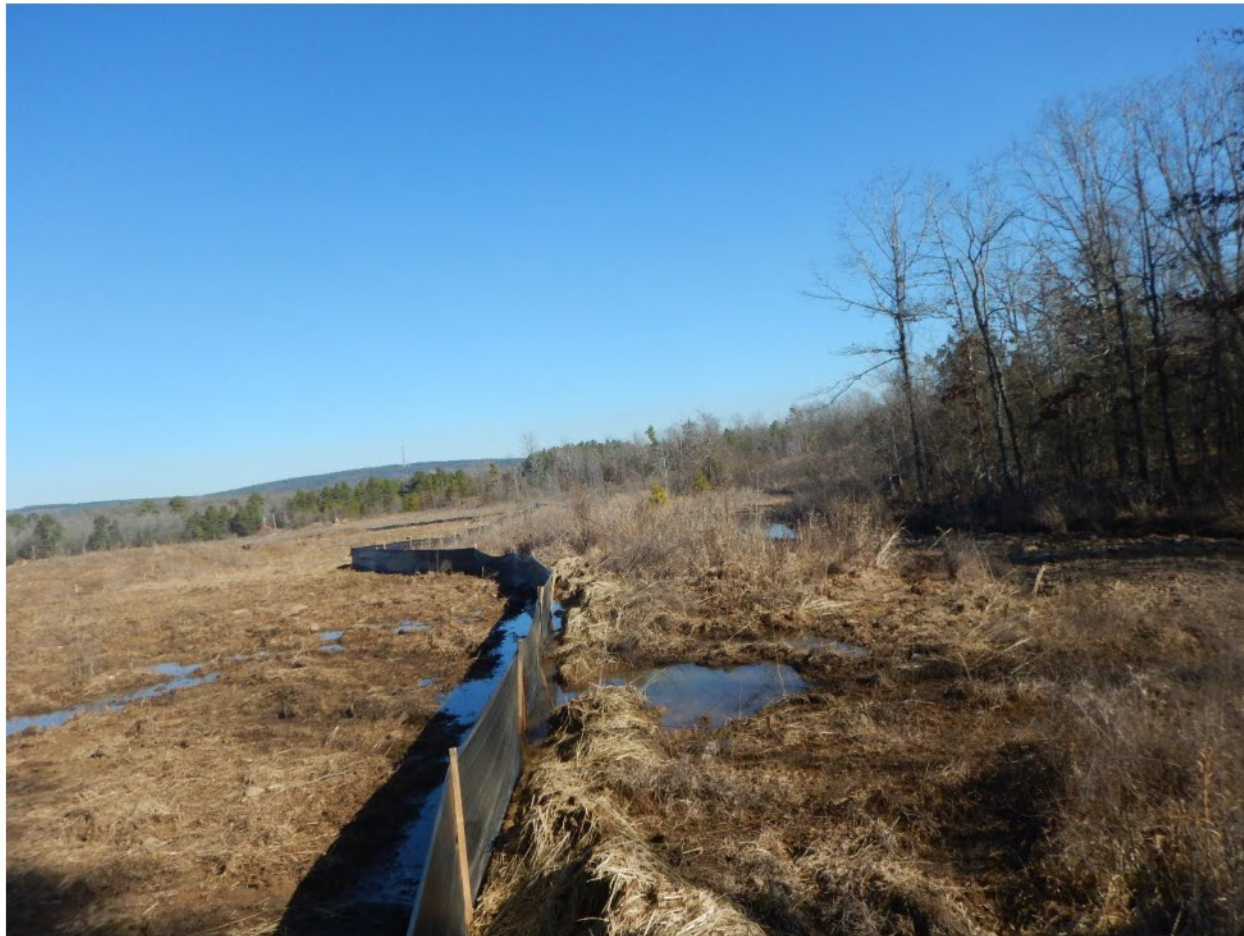
| Photo File Name | Date and Time of Photo | Photographer | Description |
|---|---|---|---|
| DSCN6275 | 01/31/2024, 10:23 AM | Chelsey Sherwood | Showing where stream A was apparently altered and sediment piled along silt fence. Picture taken facing downstream, northeast. |

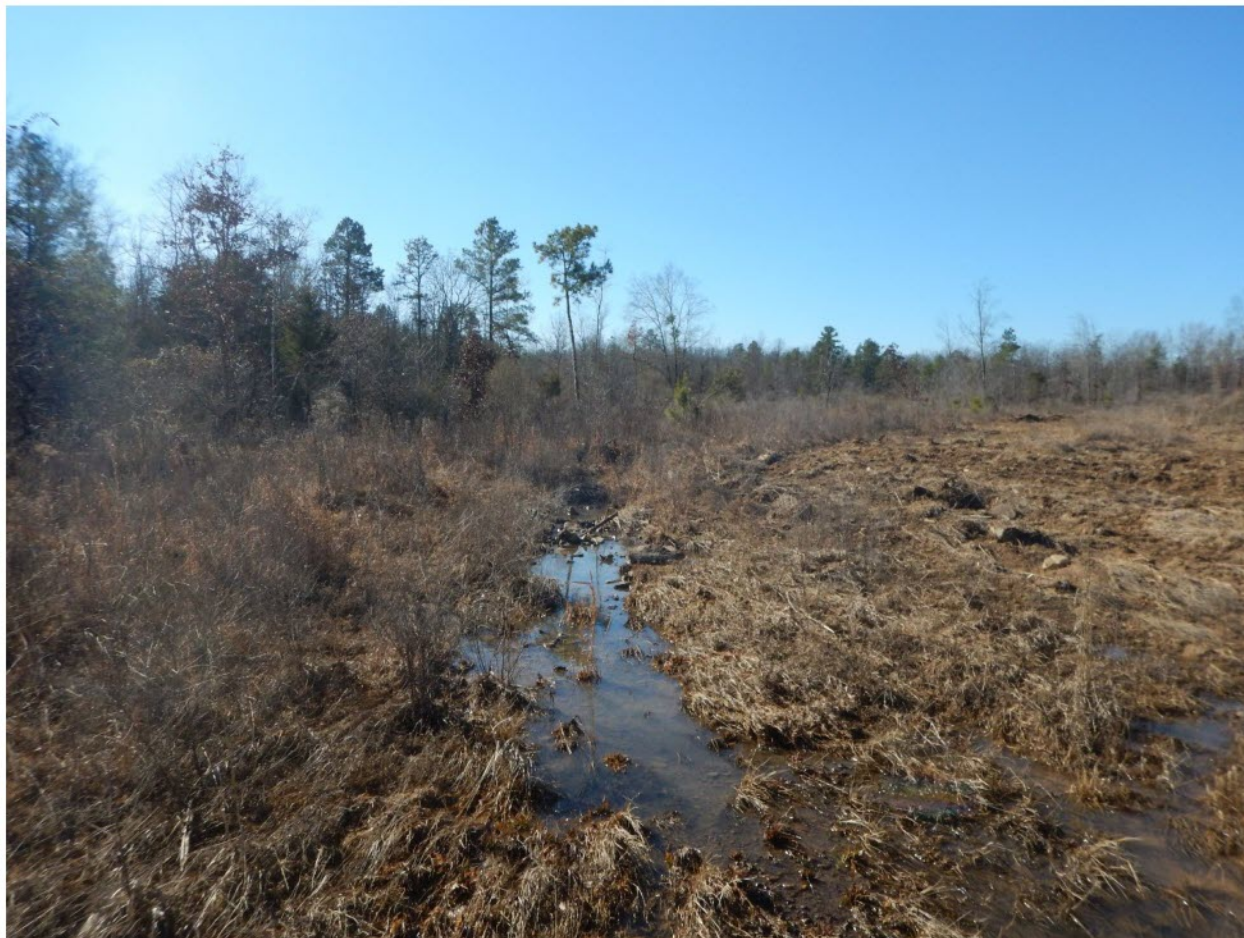
| Photo File Name | Date and Time of Photo | Photographer | Description |
|---|---|---|---|
| DSCN6276 | 01/31/2024, 10:26 AM | Chelsey Sherwood | Showing riparian area removed on river left bank. Picture taken facing upstream, southwest. |

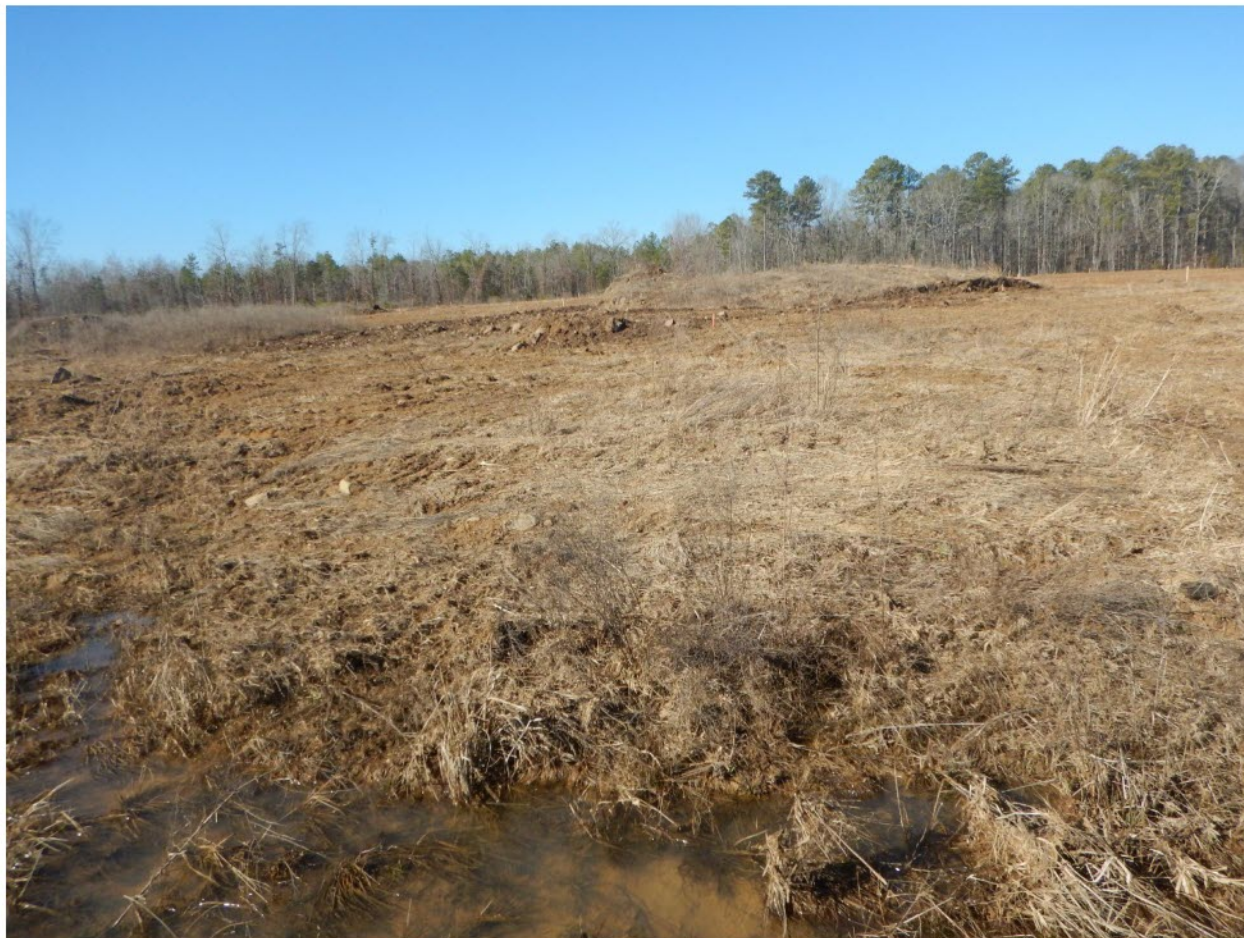
| Photo File Name | Date and Time of Photo | Photographer | Description |
|---|---|---|---|
| DSCN6277 | 01/31/2024, 10:27 AM | Chelsey Sherwood | Showing riparian area removed on right bank and sediment deposition in stream. Picture taken facing west towards river left bank. |

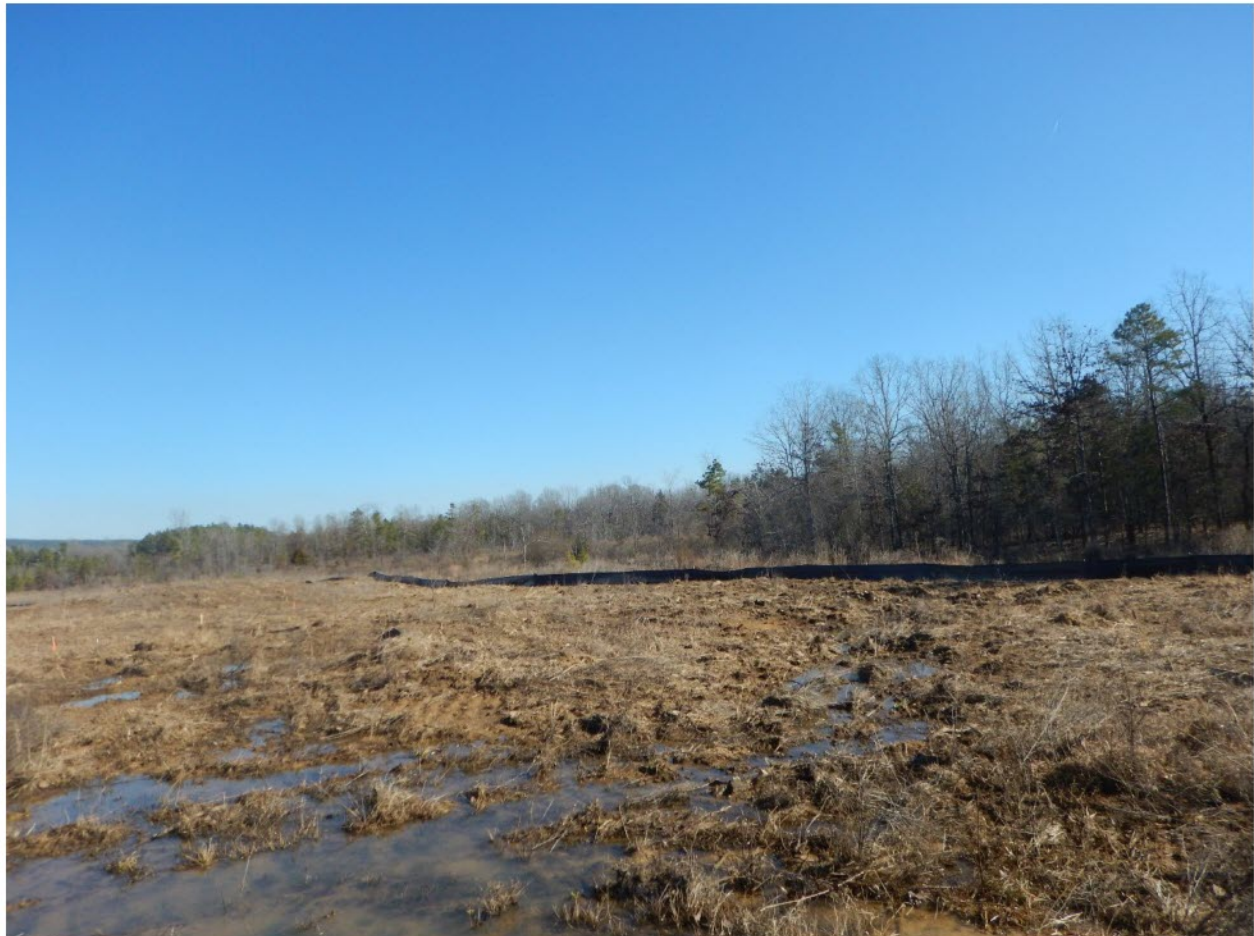
| Photo File Name | Date and Time of Photo | Photographer | Description |
|---|---|---|---|
| DSCN6278 | 01/31/2024, 10:28 AM | Chelsey Sherwood | Showing where stream A former channel has been filled. Picture taken facing downstream, northeast. |

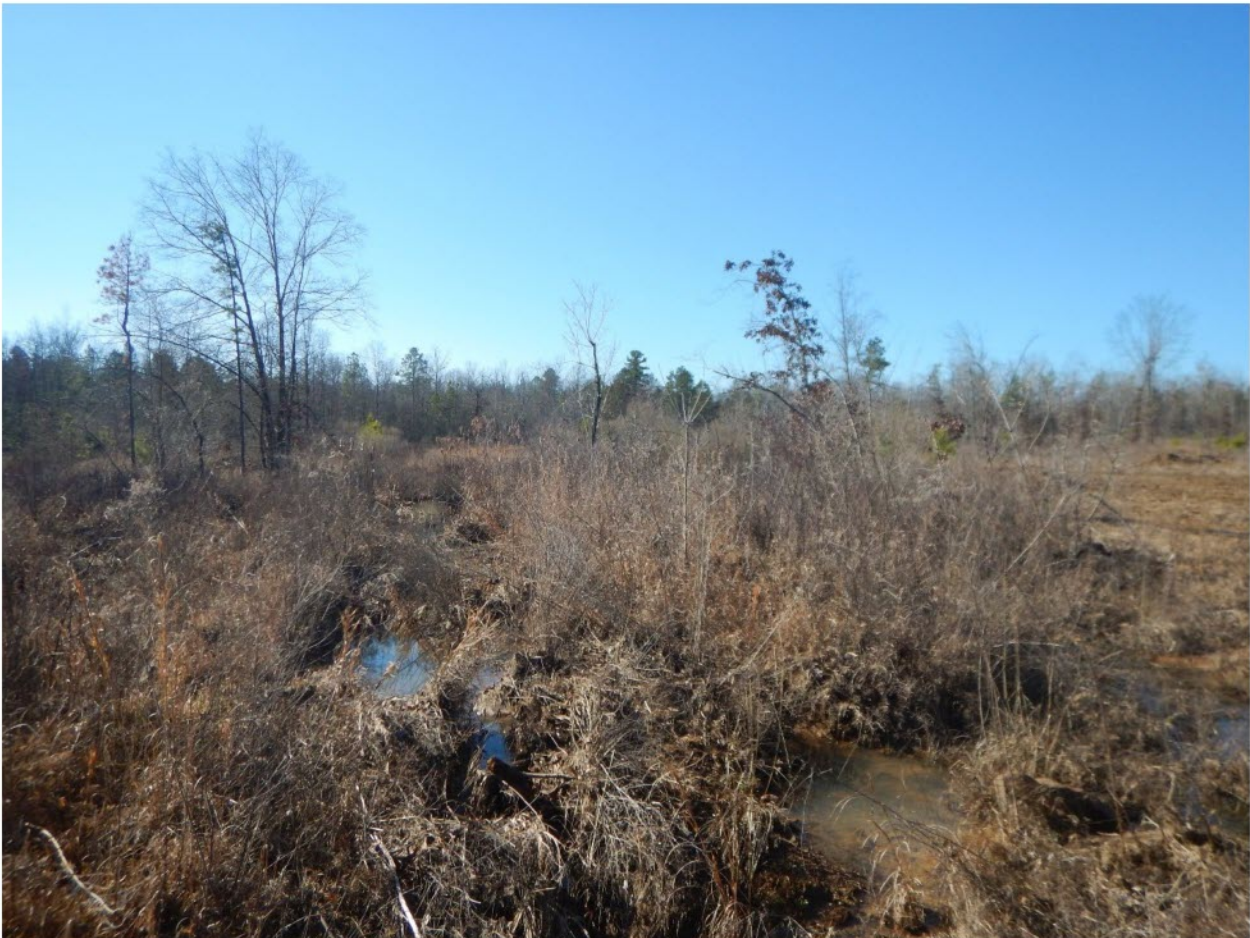
| Photo File Name | Date and Time of Photo | Photographer | Description |
|---|---|---|---|
| DSCN6279 | 01/31/2024, 10:32 AM | Chelsey Sherwood | Showing stream A upstream of filled area in photo 29. Picture taken facing upstream, south. |

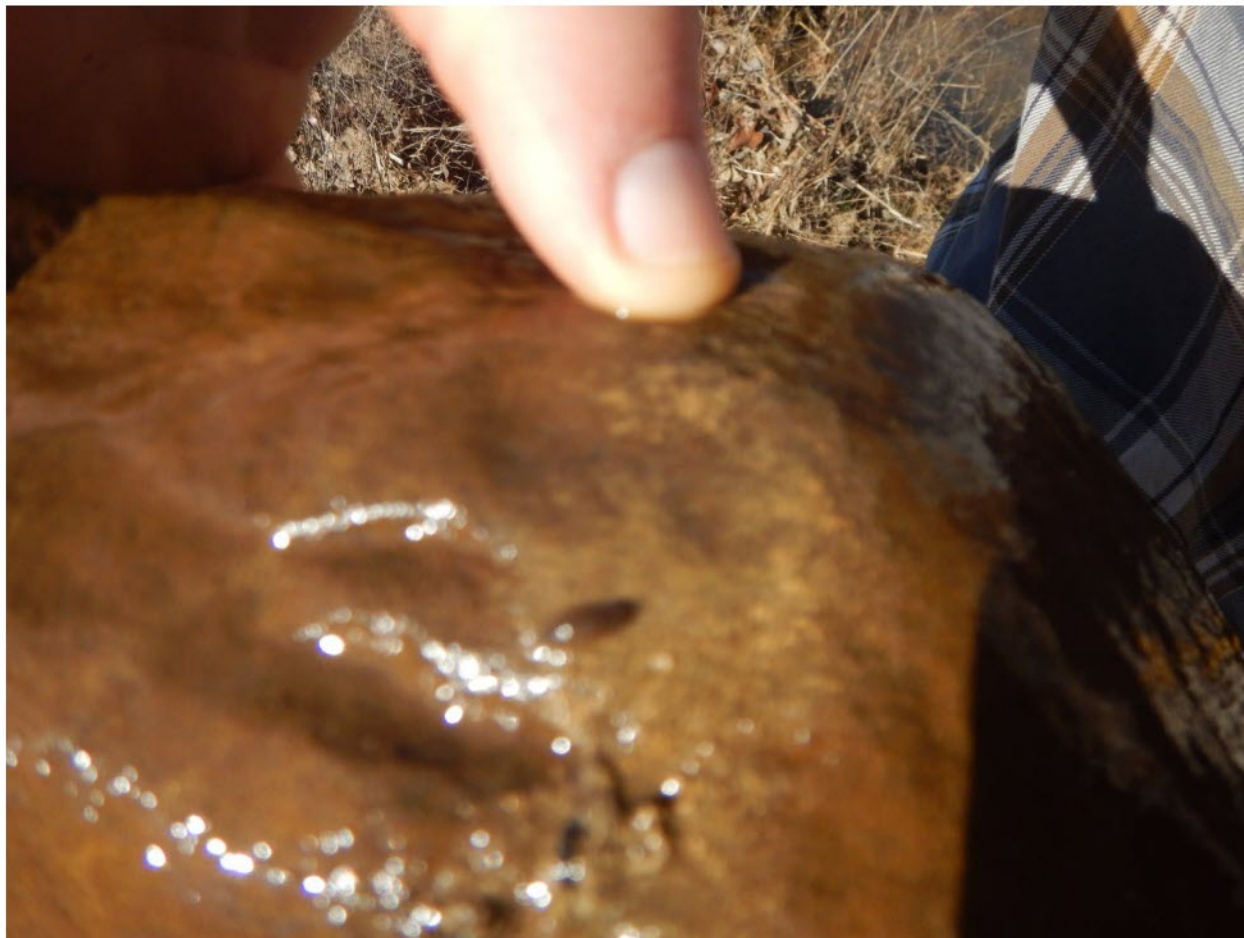
| Photo File Name | Date and Time of Photo | Photographer | Description |
|---|---|---|---|
| DSCN6280 | 01/31/2024, 10:35 AM | Chelsey Sherwood | Showing Isopoda found in stream. |

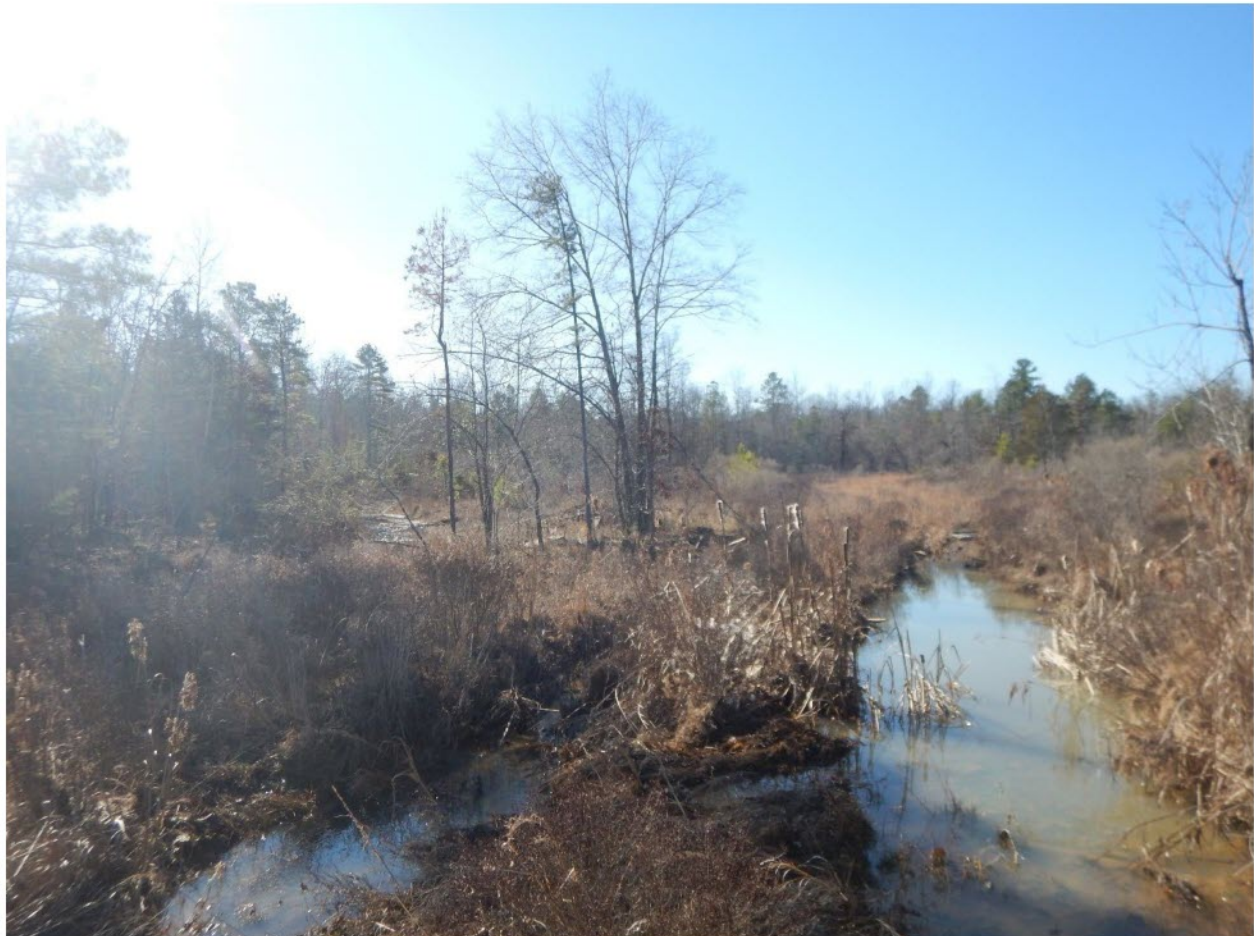
| Photo File Name | Date and Time of Photo | Photographer | Description |
|---|---|---|---|
| DSCN6283 | 01/31/2024, 10:40 AM | Chelsey Sherwood | Showing <i>Typha spp.</i> in stream A/wetland area. Picture taken facing upstream, south. |

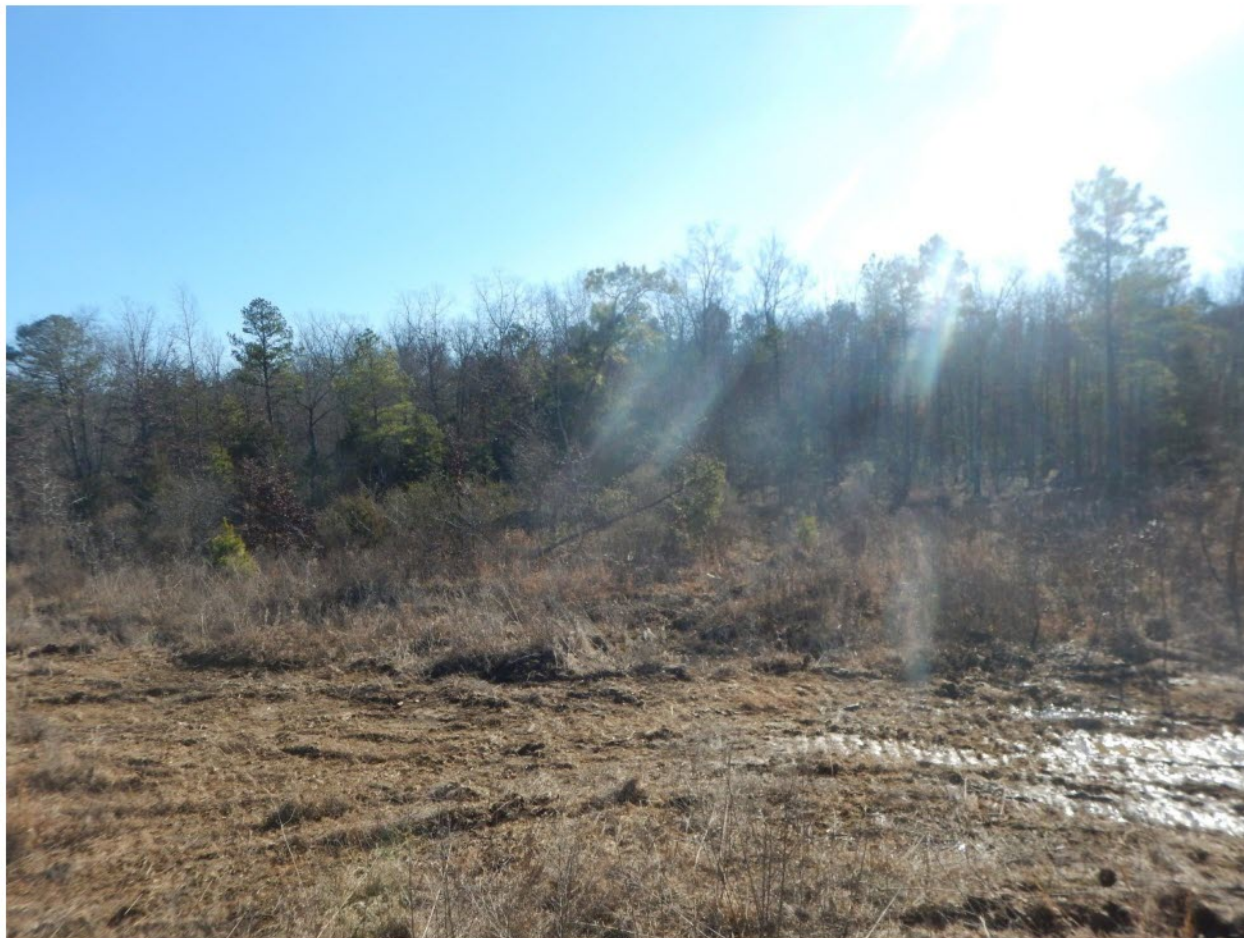
| Photo File Name | Date and Time of Photo | Photographer | Description |
|---|---|---|---|
| DSCN6284 | 01/31/2024, 10:42 AM | Chelsey Sherwood | Overview of project area towards stream. Picture taken facing east. |

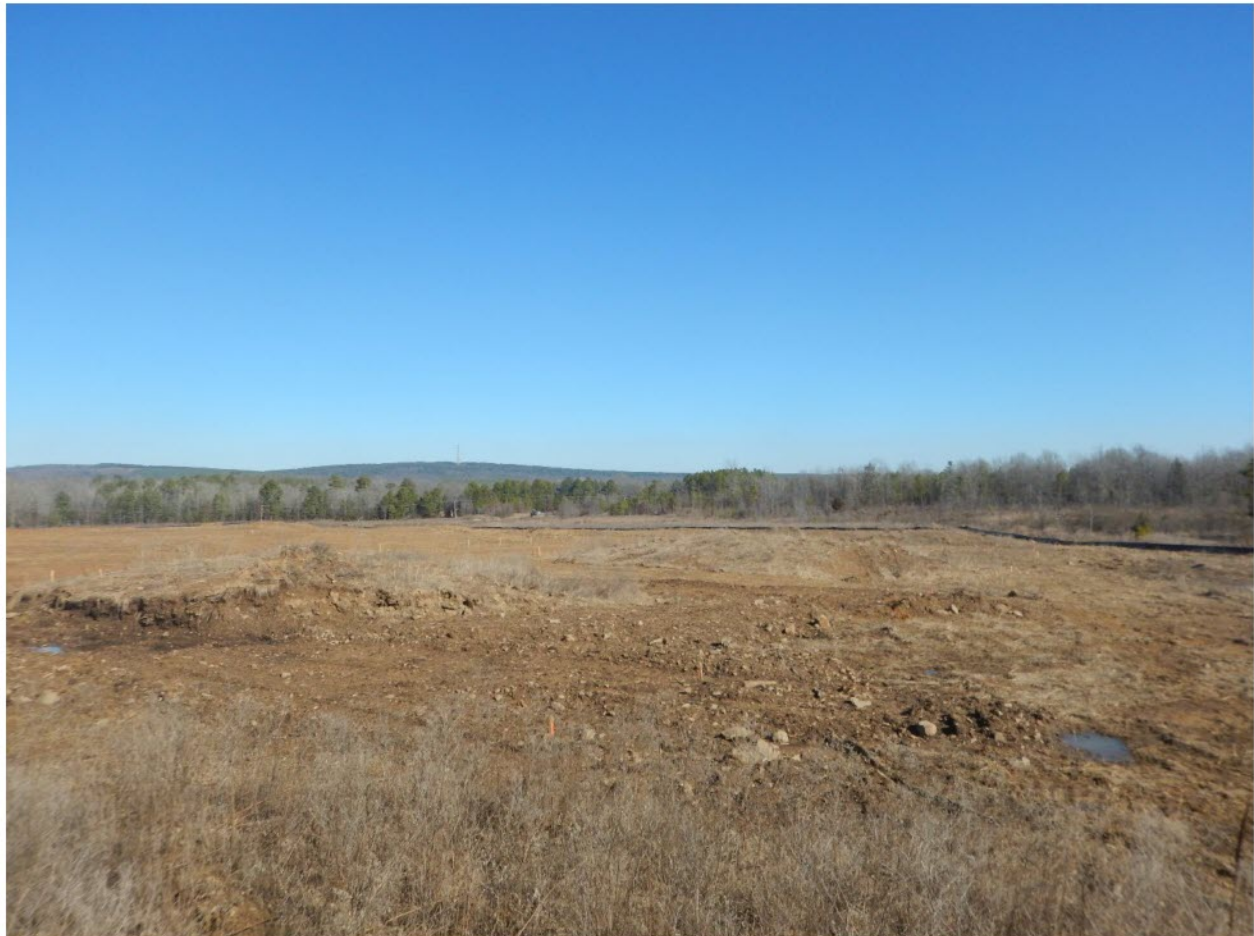
| Photo File Name | Date and Time of Photo | Photographer | Description |
|---|---|---|---|
| DSCN6285 | 01/31/2024, 10:42 AM | Chelsey Sherwood | Overview of project area. Note riparian vegetation removed up to stream bank edge and replaced with silt fence. Picture taken facing north. |

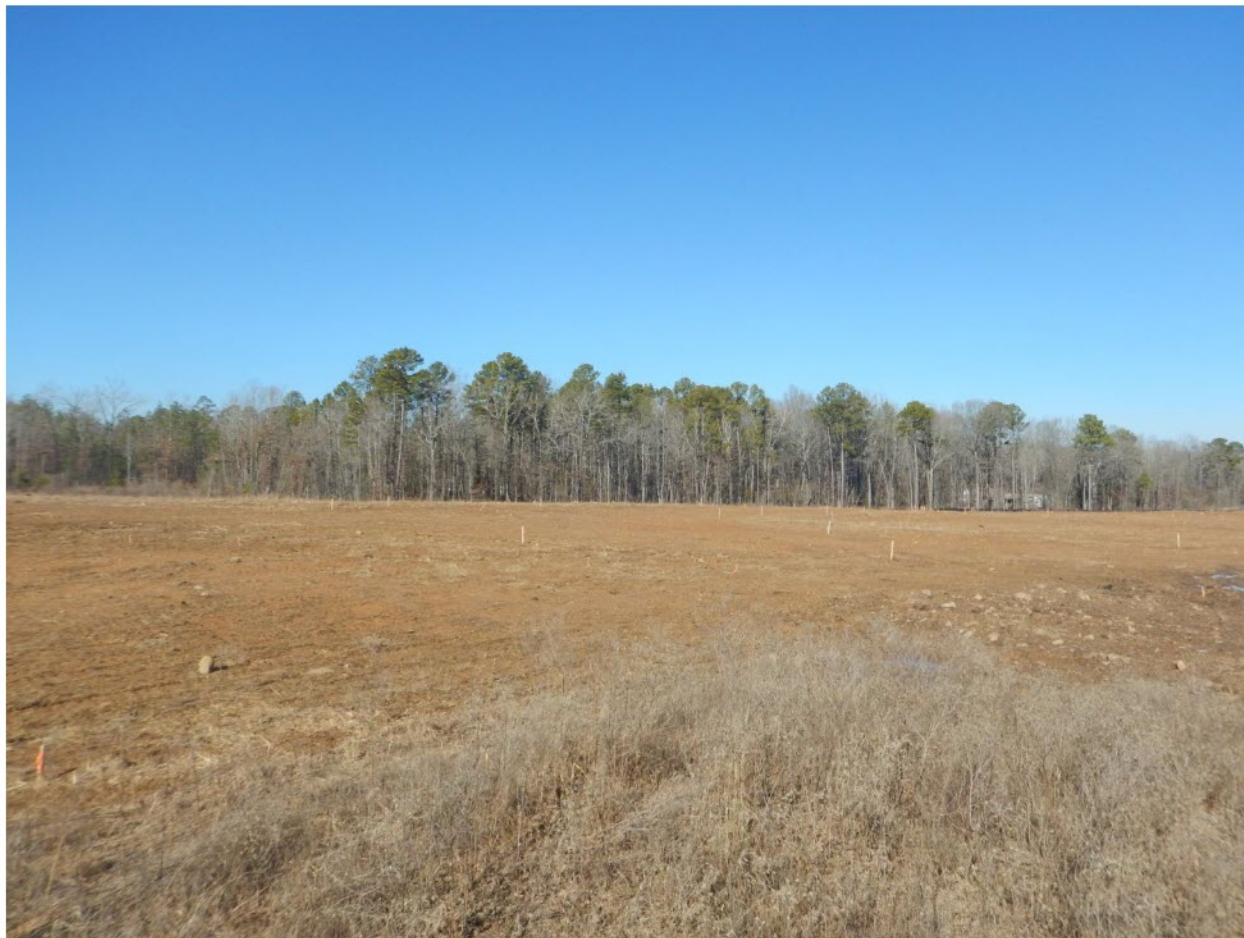
| Photo File Name | Date and Time of Photo | Photographer | Description |
|---|---|---|---|
| DSCN6286 | 01/31/2024, 10:42 AM | Chelsey Sherwood | Overview of project area. Picture taken facing west. |
