## Clean Water Act Section 404: Site Visit/Case Development

| Site Name | Paradise Valley, LLC (Rick Ferguson) | | | | |

| Inspection Purpose | The purpose of this inspection was to discuss and evaluate steps to developing a restoration plan | | |

| Inspection Purpose | Initial site visit | | |

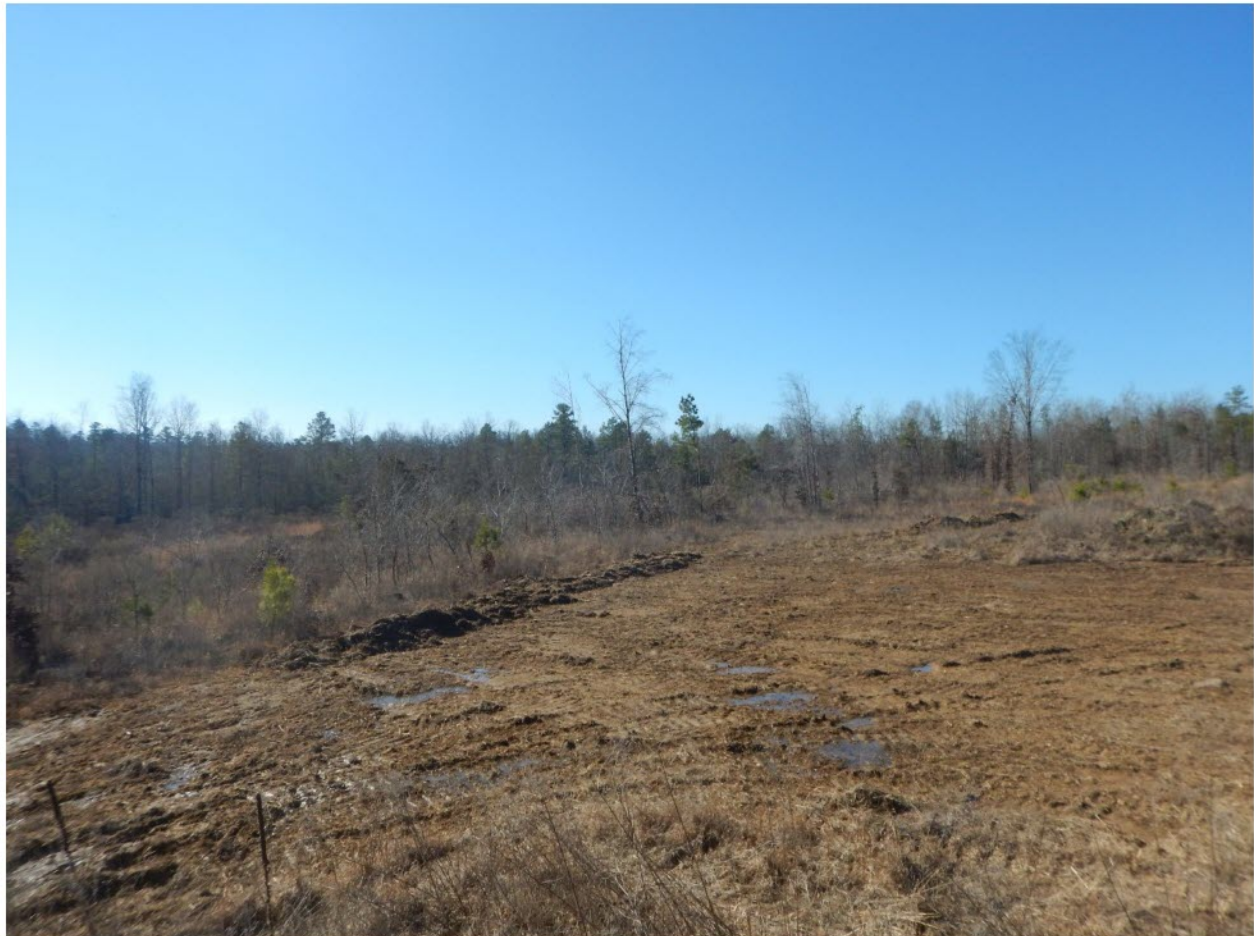
| Photo File Name | Date and Time of Photo | Photographer | Description |
|---|---|---|---|
| DSCN6287 | 01/31/2024, 10:42 AM | Chelsey Sherwood | Overview of project area. Picture taken facing south |

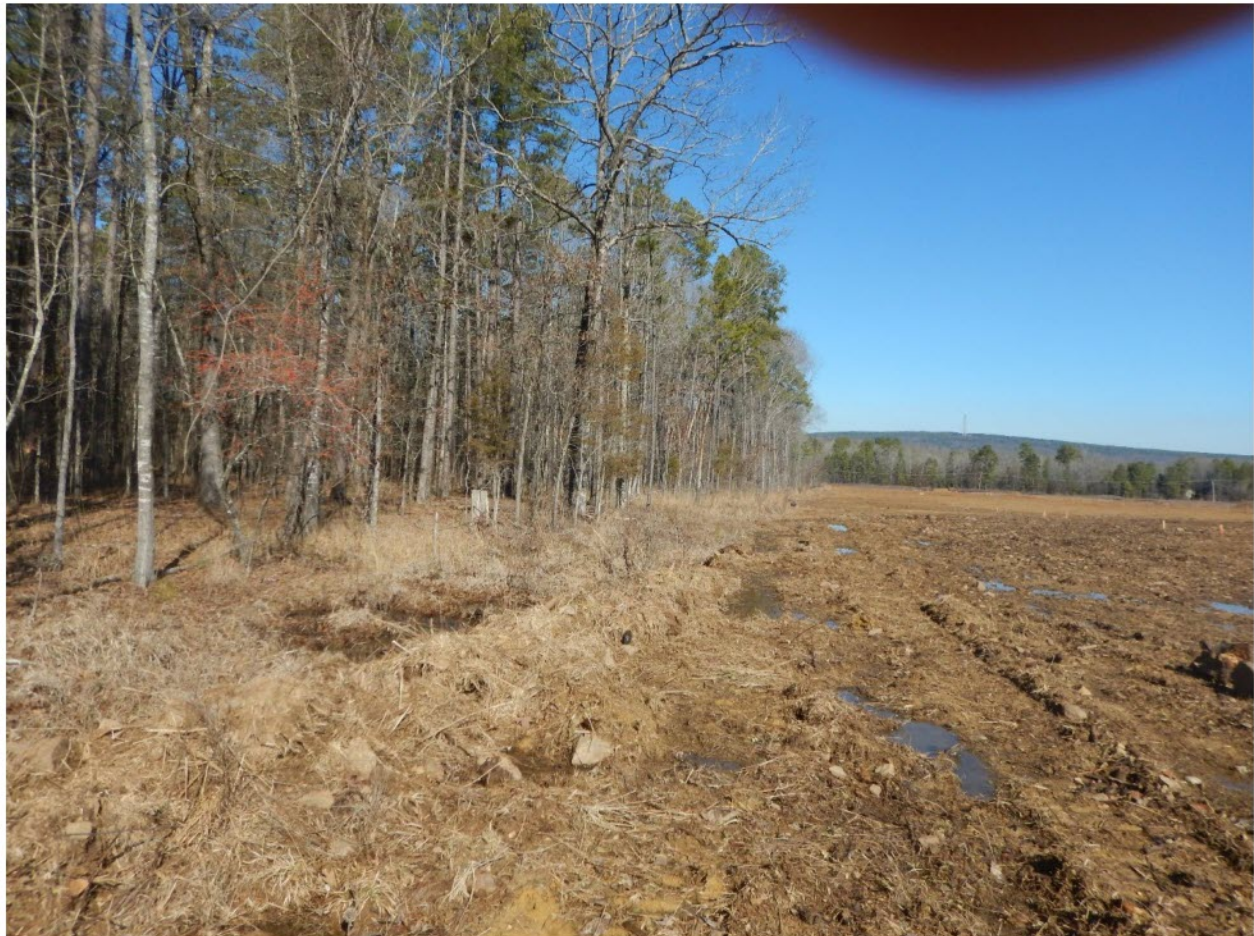
Photo No. 37

| Photo File Name | Date and Time of Photo | Photographer | Description |
|---|---|---|---|
| DSCN6288 | 01/31/2024, 10:48 AM | Chelsey Sherwood | Showing where a stream channel parallel to woods existed, but now filled. Picture taken facing downstream, north. |

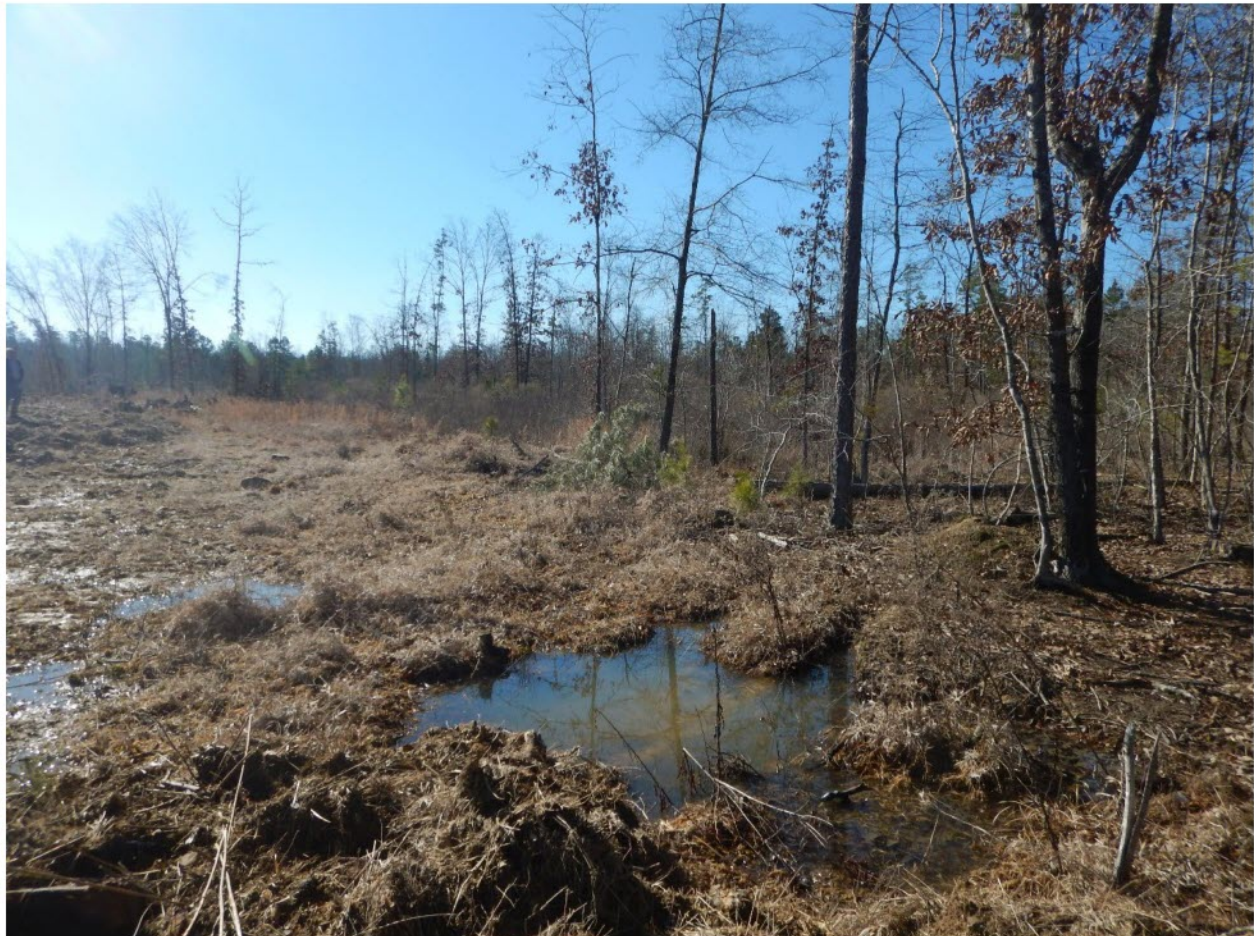
| Photo File Name | Date and Time of Photo | Photographer | Description |
|---|---|---|---|
| DSCN6289 | 01/31/2024, 10:48 AM | Chelsey Sherwood | Showing spoil piles and wet area. Picture taken facing upstream, south. |

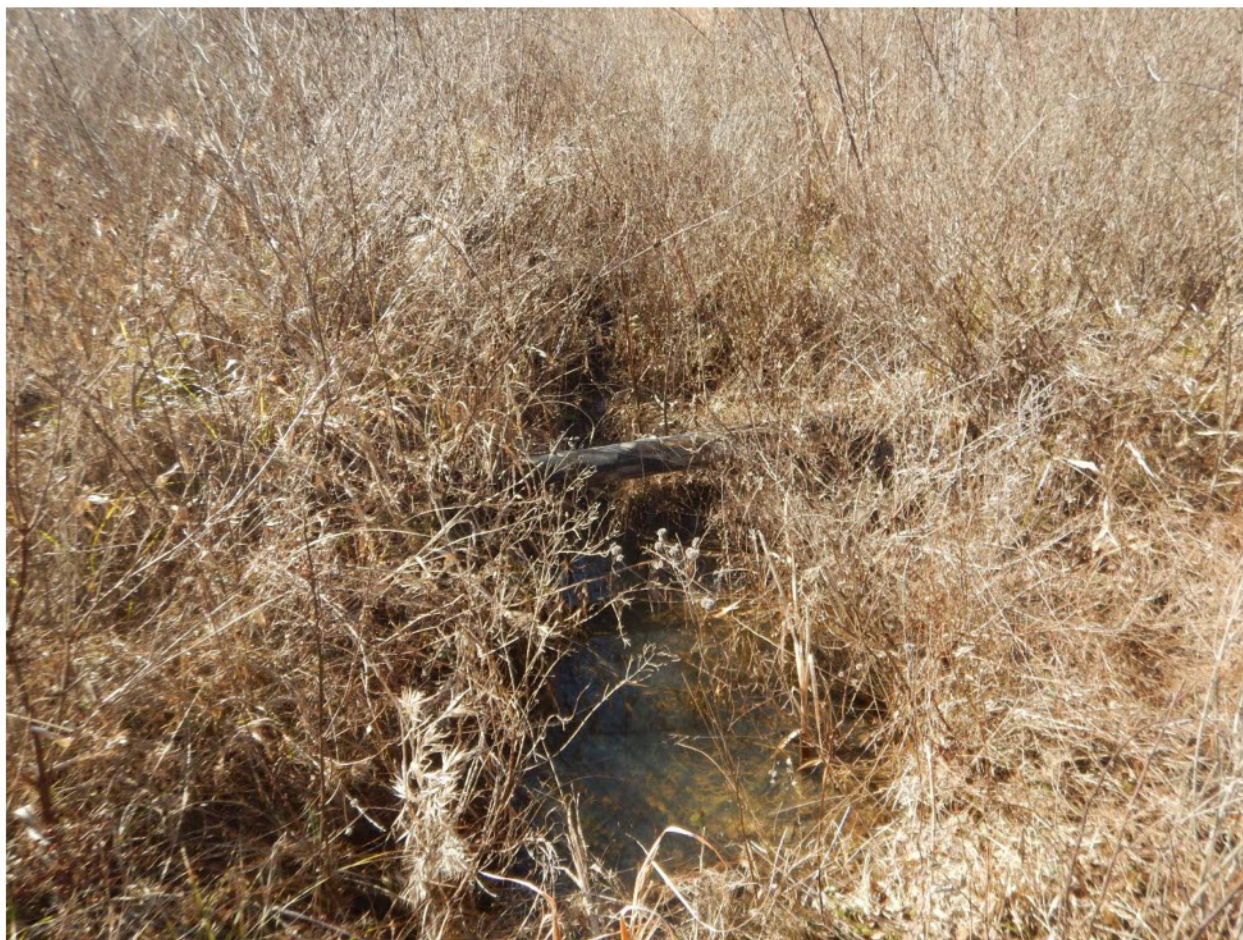
| Photo File Name | Date and Time of Photo | Photographer | Description |
|---|---|---|---|
| DSCN6290 | 01/31/2024, 10:52 AM | Chelsey Sherwood | Showing stream/wet area above photo 37. Picture taken facing upstream, southwest. |

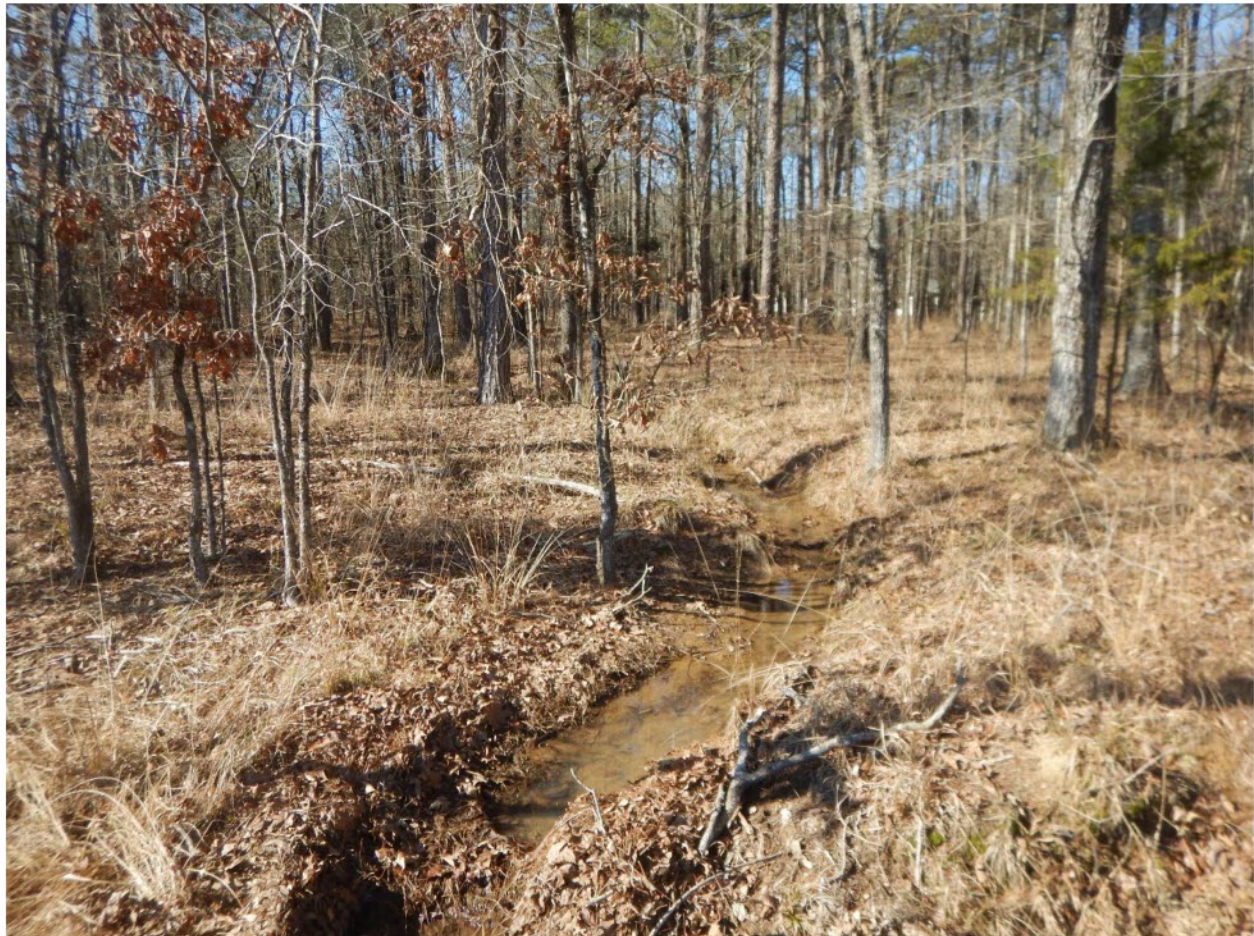
Photo No. 40

| Photo File Name | Date and Time of Photo | Photographer | Description |
|---|---|---|---|
| DSCN6291 | 01/31/2024, 10:56 AM | Chelsey Sherwood | Showing undisturbed stream D channel at property line. Picture taken facing upstream, west. |

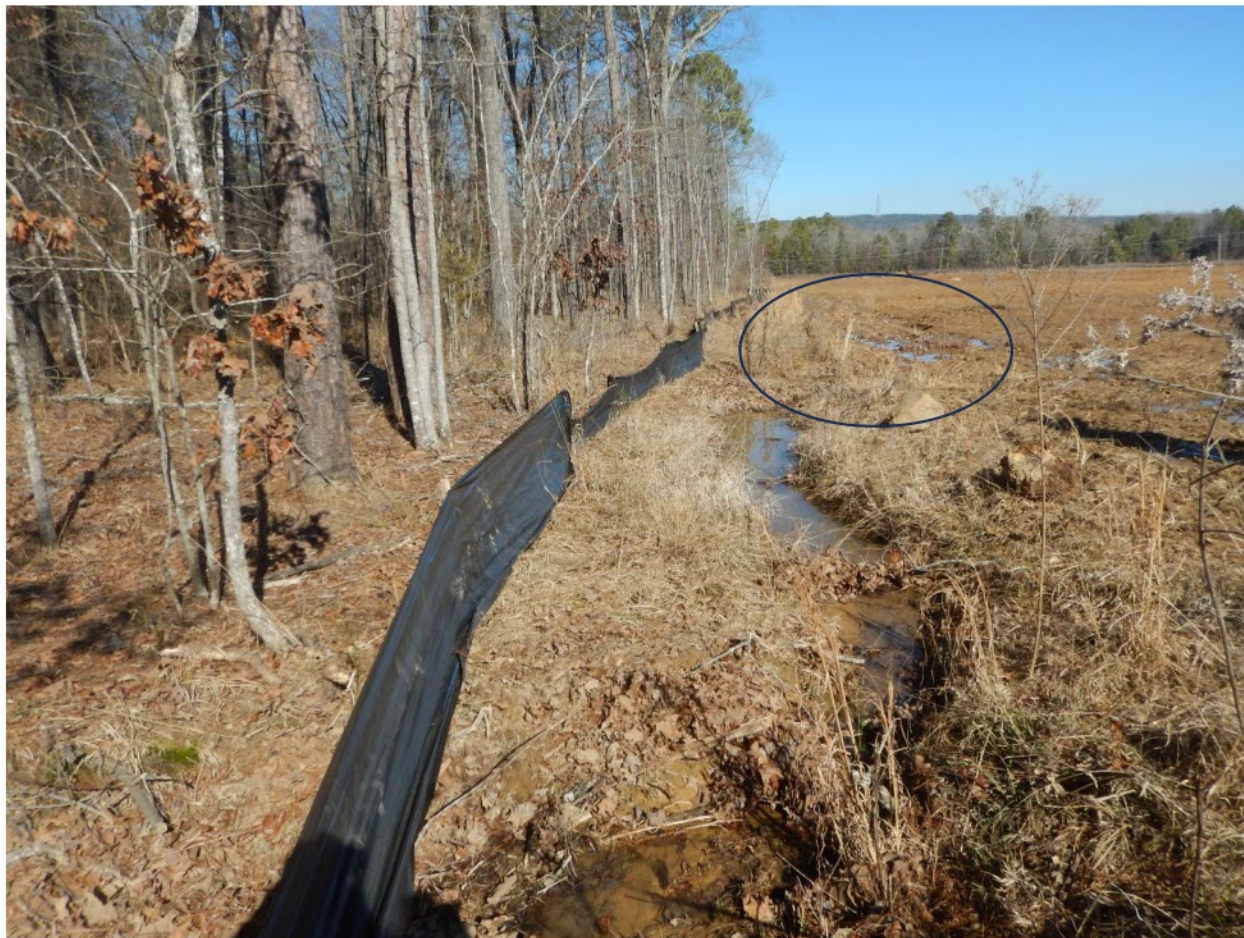
Photo No. 41

| Photo File Name | Date and Time of Photo | Photographer | Description |
|---|---|---|---|
| DSCN6292 | 01/31/2024, 10:56 AM | Chelsey Sherwood | Showing where stream D from photo 40 enters project site. Note: 1) silt fence running through stream and on wrong side; 2) sediment deposition and wrack lines in stream channel; and 3) circle is apparently altered channel. Picture taken facing downstream, north. |

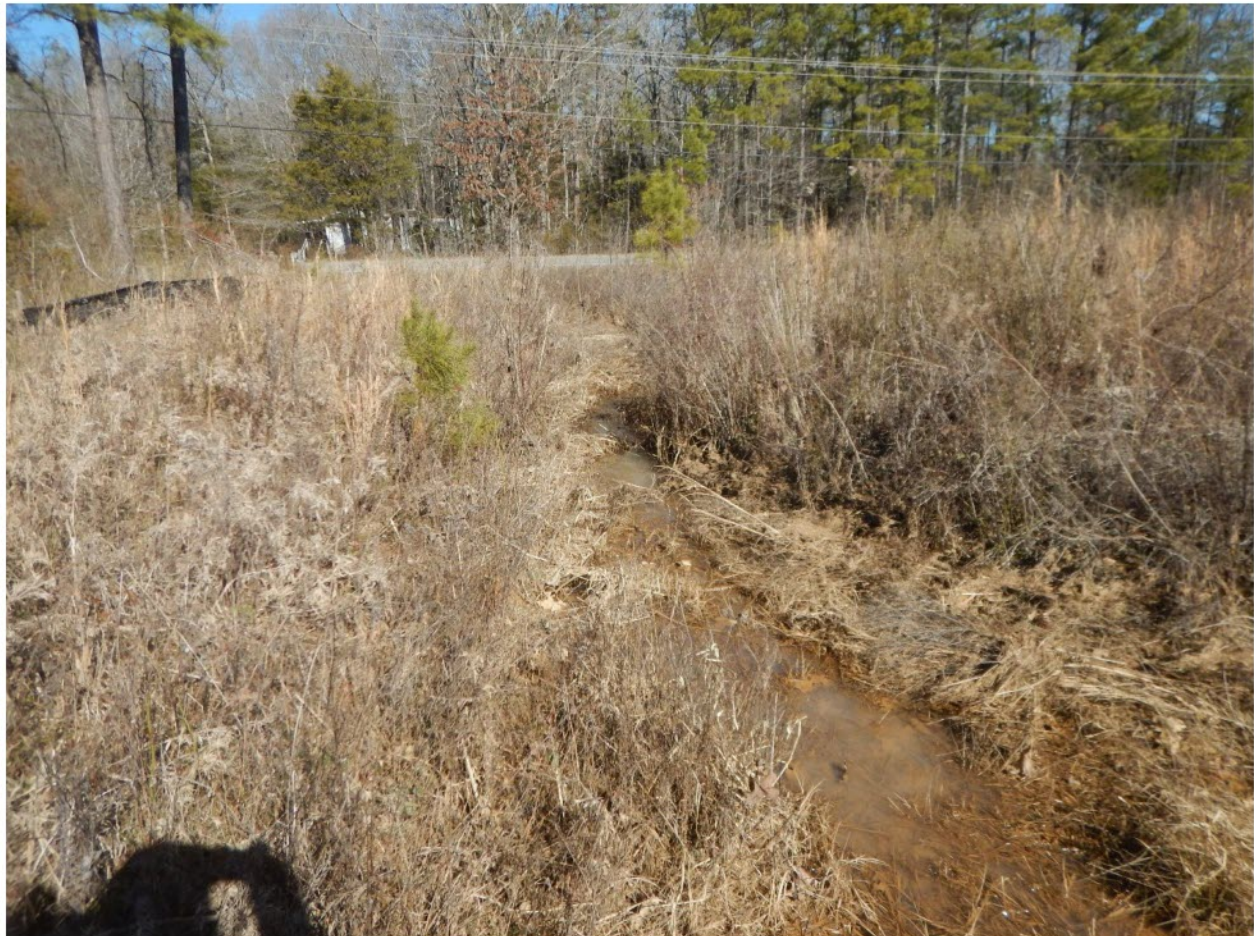
| Photo File Name | Date and Time of Photo | Photographer | Description |
|---|---|---|---|
| DSCN6293 | 01/31/2024, 11:04 AM | Chelsey Sherwood | Showing stream D downstream from photo 41. Picture taken facing downstream, north. |

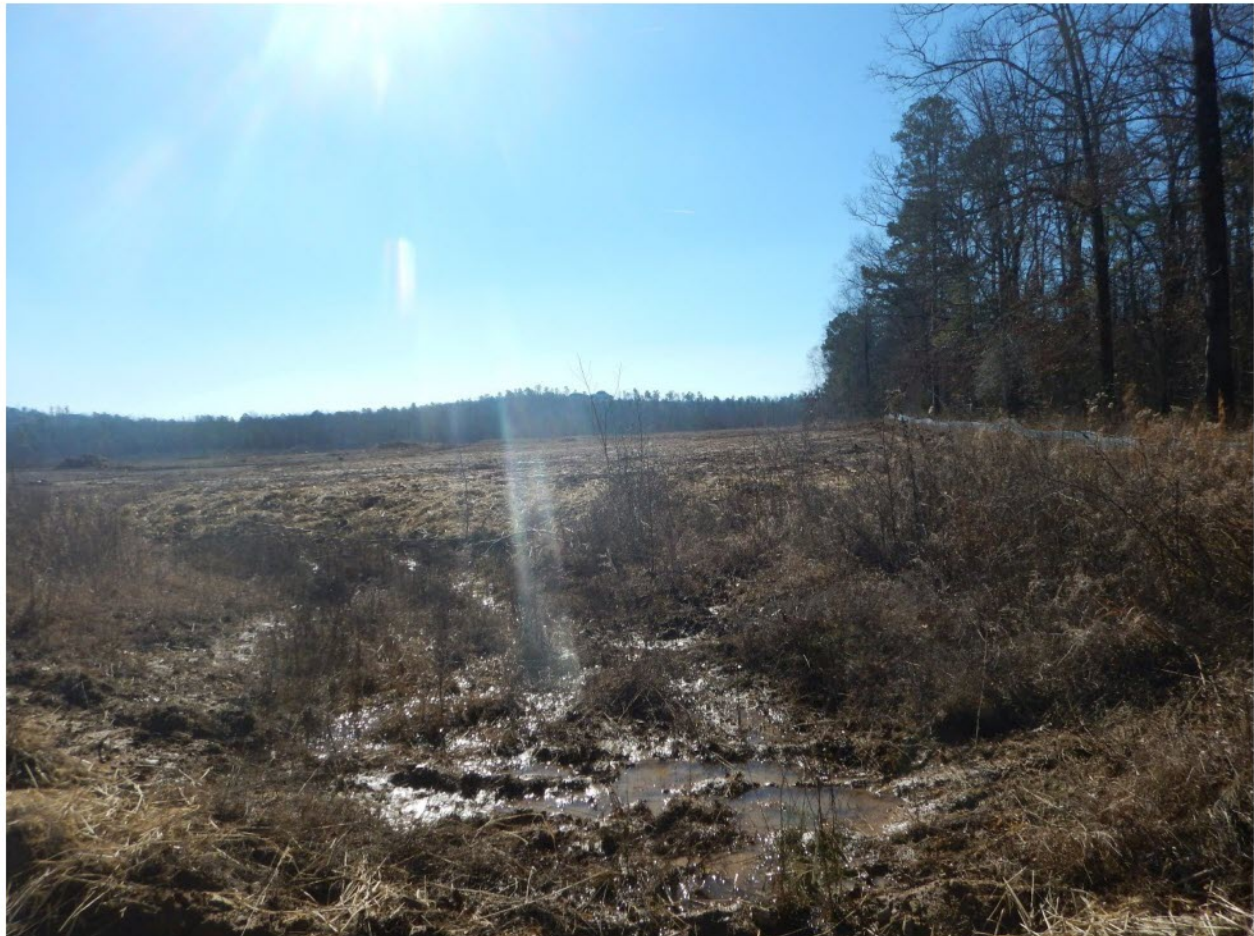
| Photo File Name | Date and Time of Photo | Photographer | Description |
|---|---|---|---|
| DSCN6294 | 01/31/2024, 11:04 AM | Chelsey Sherwood | Showing fill material in stream D. Picture taken facing upstream, south. |

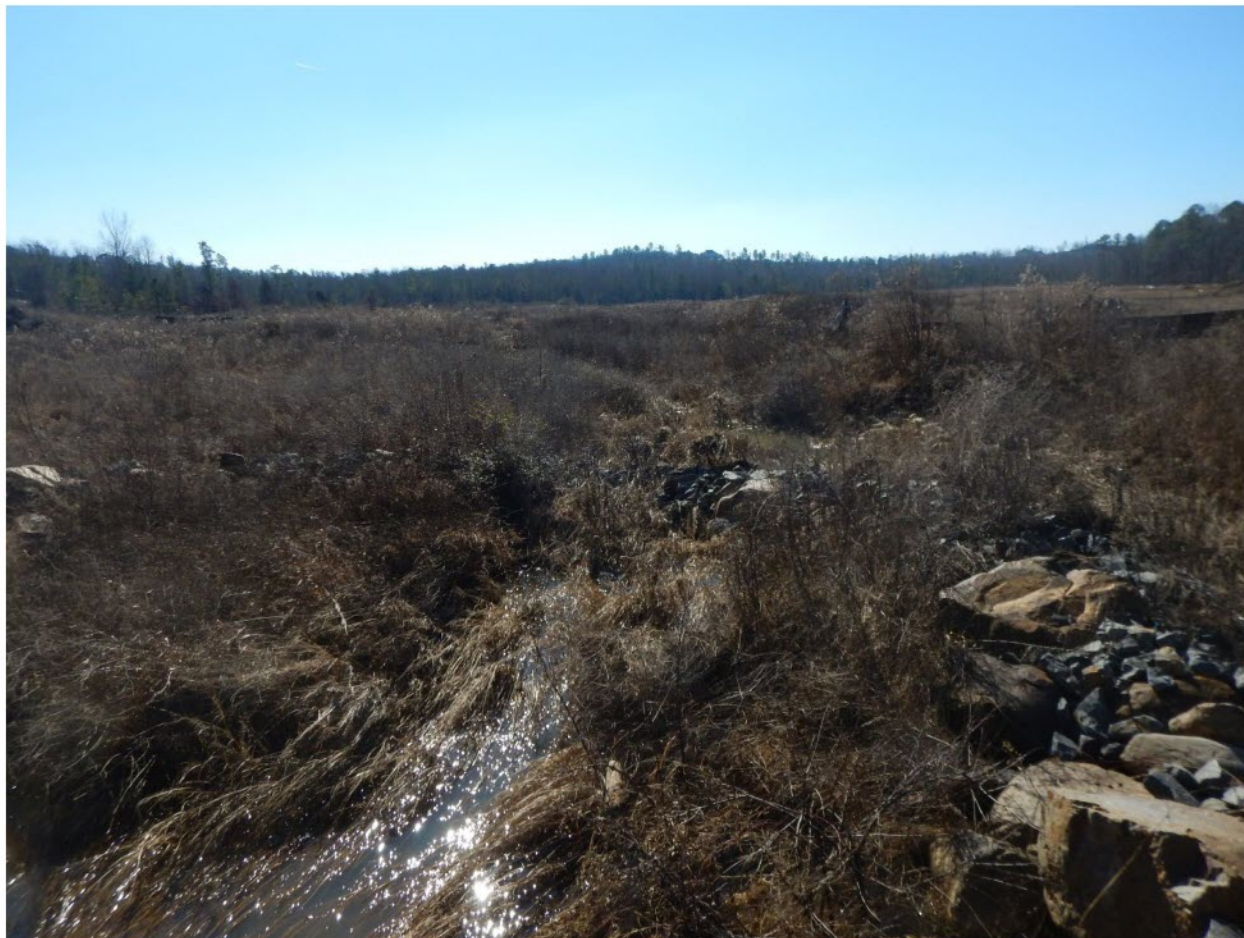
| Photo File Name | Date and Time of Photo | Photographer | Description |
|---|---|---|---|
| DSCN6295 | 01/31/2024, 11:10 AM | Chelsey Sherwood | Showing lots of check dams in stream C appear to be impeding flow. Picture taken facing upstream, south. |

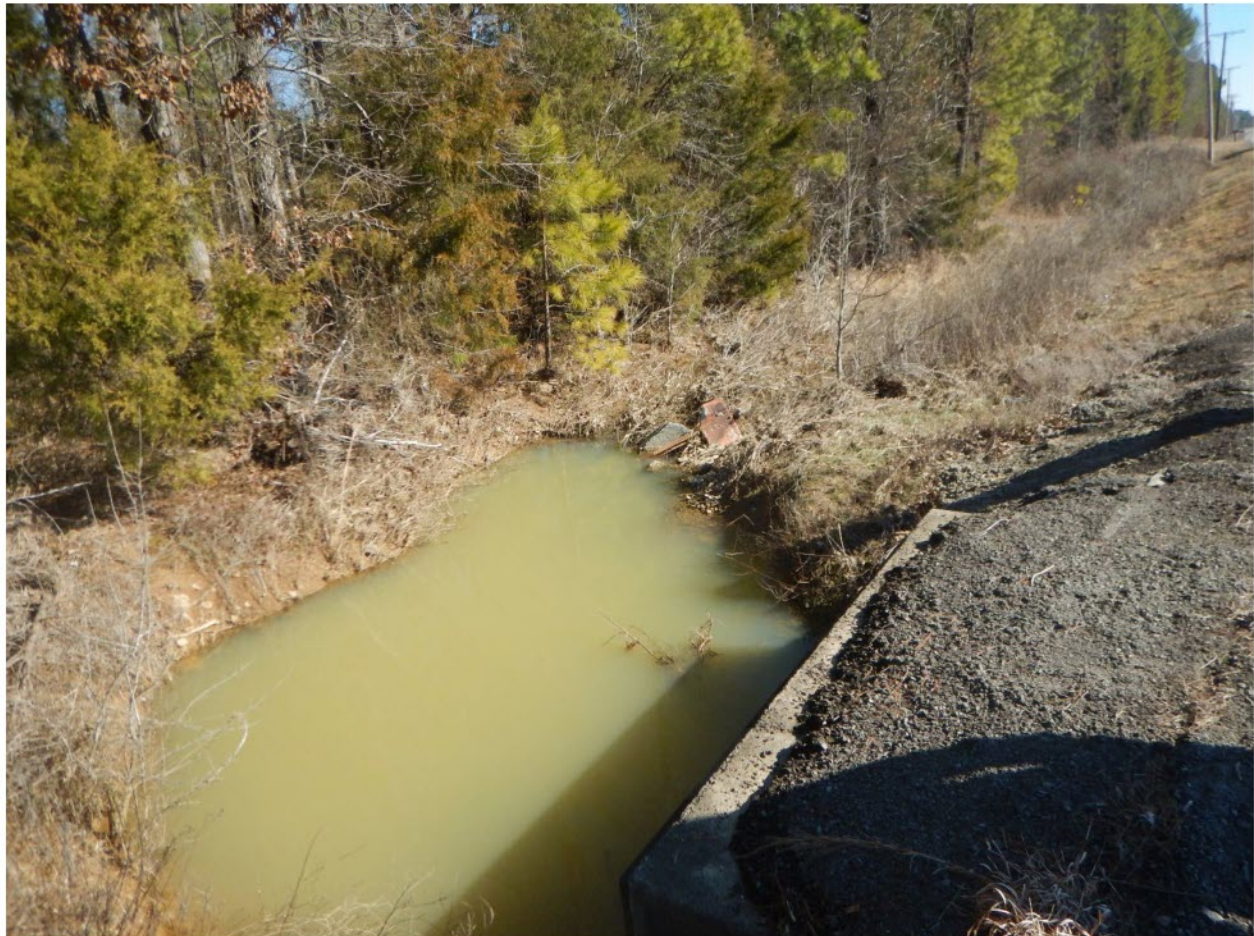
| Photo File Name | Date and Time of Photo | Photographer | Description |
|---|---|---|---|
| DSCN6296 | 01/31/2024, 11:12 AM | Chelsey Sherwood | Showing stream C downstream of project site. Note: turbidity. Picture taken facing downstream, northeast. |

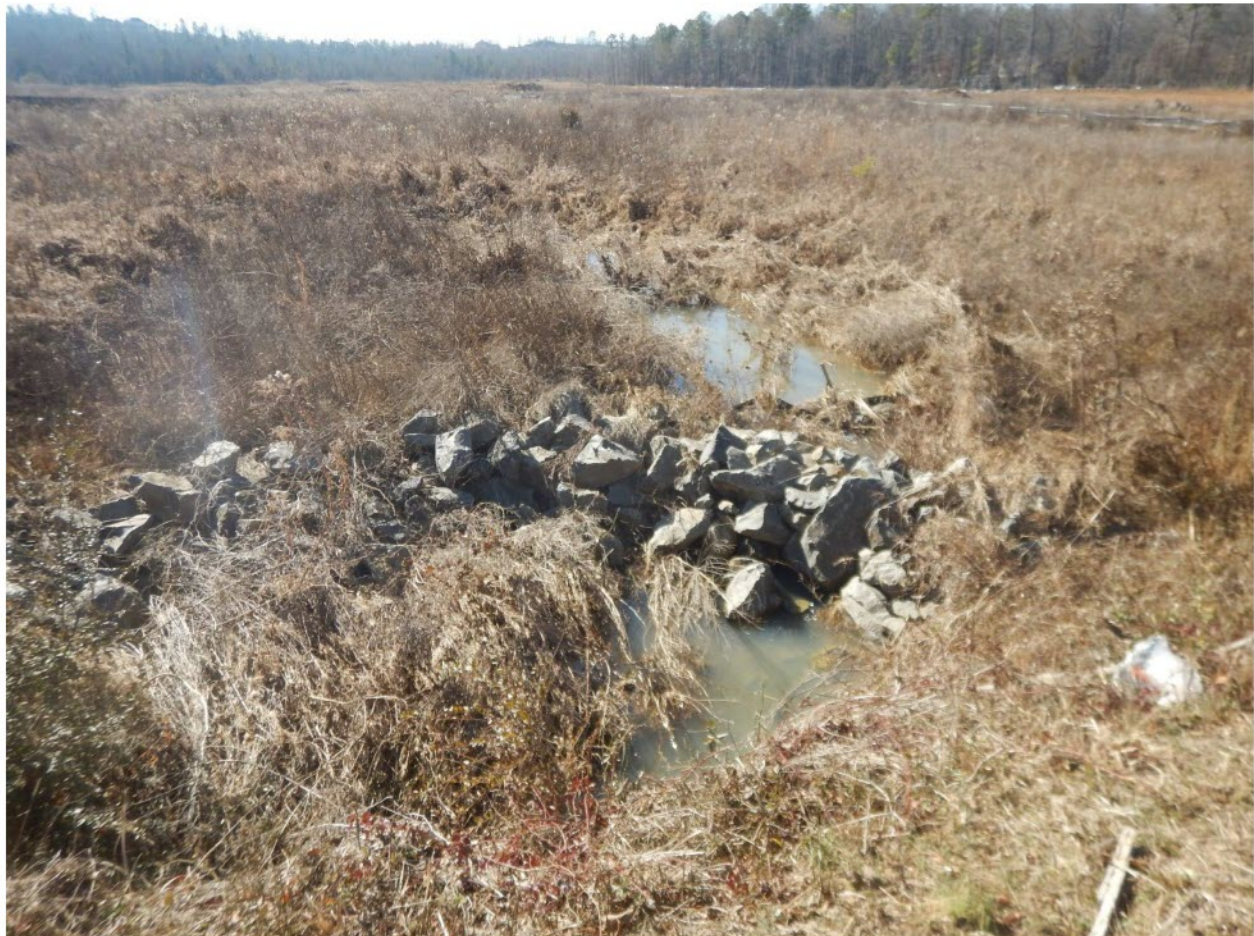
| Photo File Name | Date and Time of Photo | Photographer | Description |
|---|---|---|---|
| DSCN6297 | 01/31/2024, 11:14 AM | Chelsey Sherwood | Showing check dams in stream A that appear to be impeding flow. Picture taken from road facing upstream, south. |

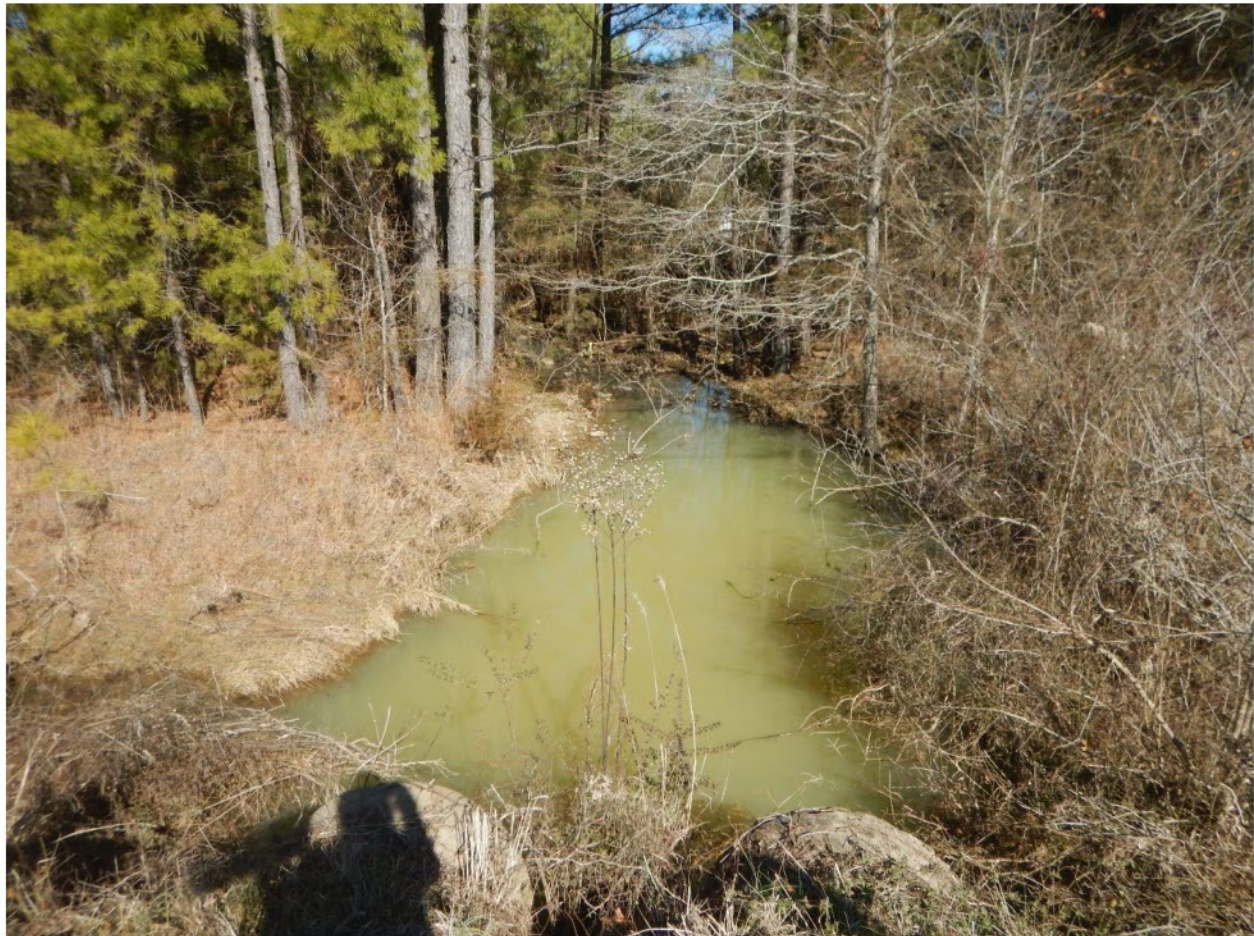
| Photo File Name | Date and Time of Photo | Photographer | Description |
|---|---|---|---|
| DSCN6298 | 01/31/2024, 11:16 AM | Chelsey Sherwood | Showing stream A downstream of project site. Note: turbidity. Picture taken from road facing downstream, north. |

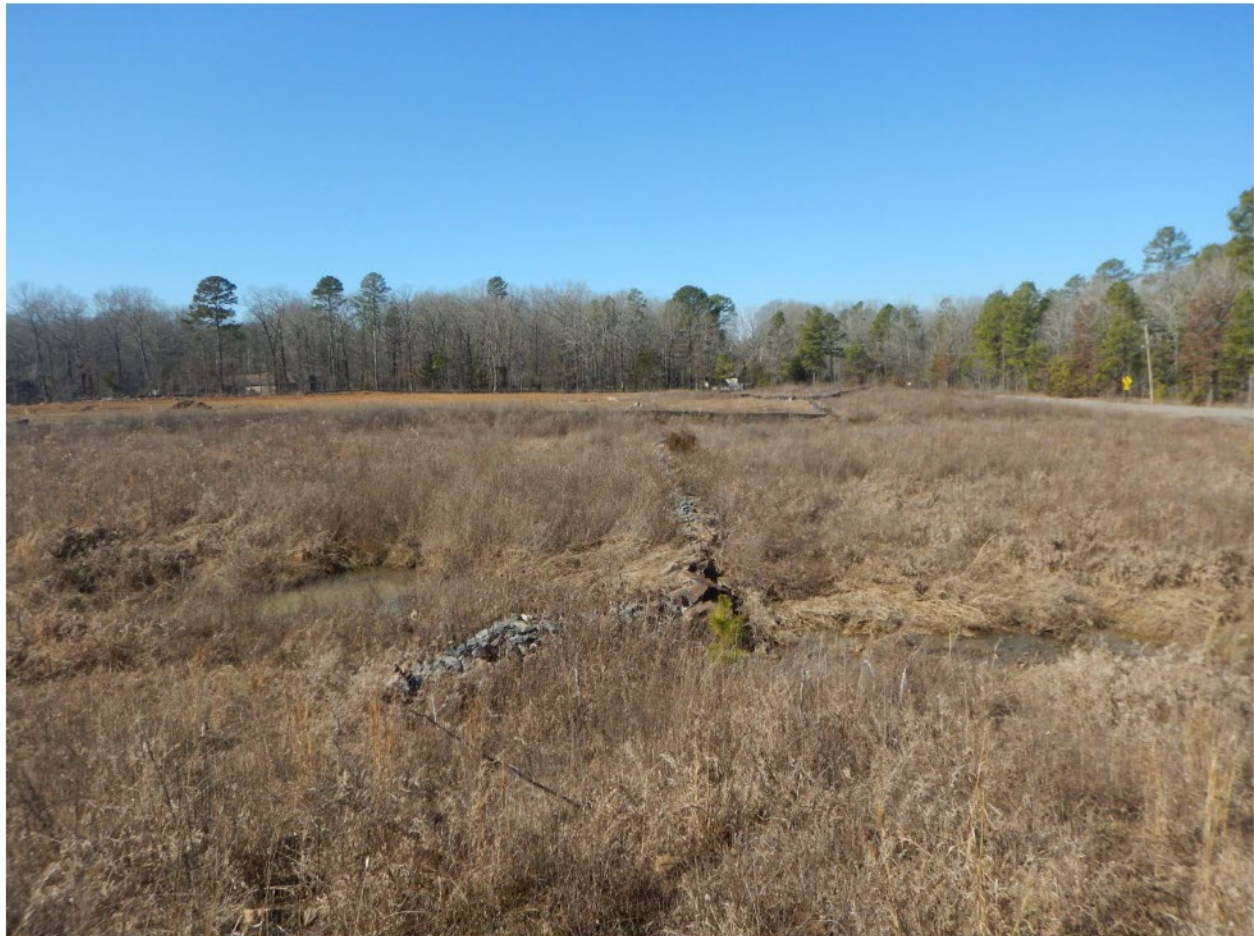
| Photo File Name | Date and Time of Photo | Photographer | Description |
|---|---|---|---|
| DSCN6299 | 01/31/2024, 11:17 AM | Chelsey Sherwood | Showing all the check dams through stream A and C, which appear to be impeding flow and creating a wetland. It was approximately 146 feet long. Picture taken facing west from river right bank. |

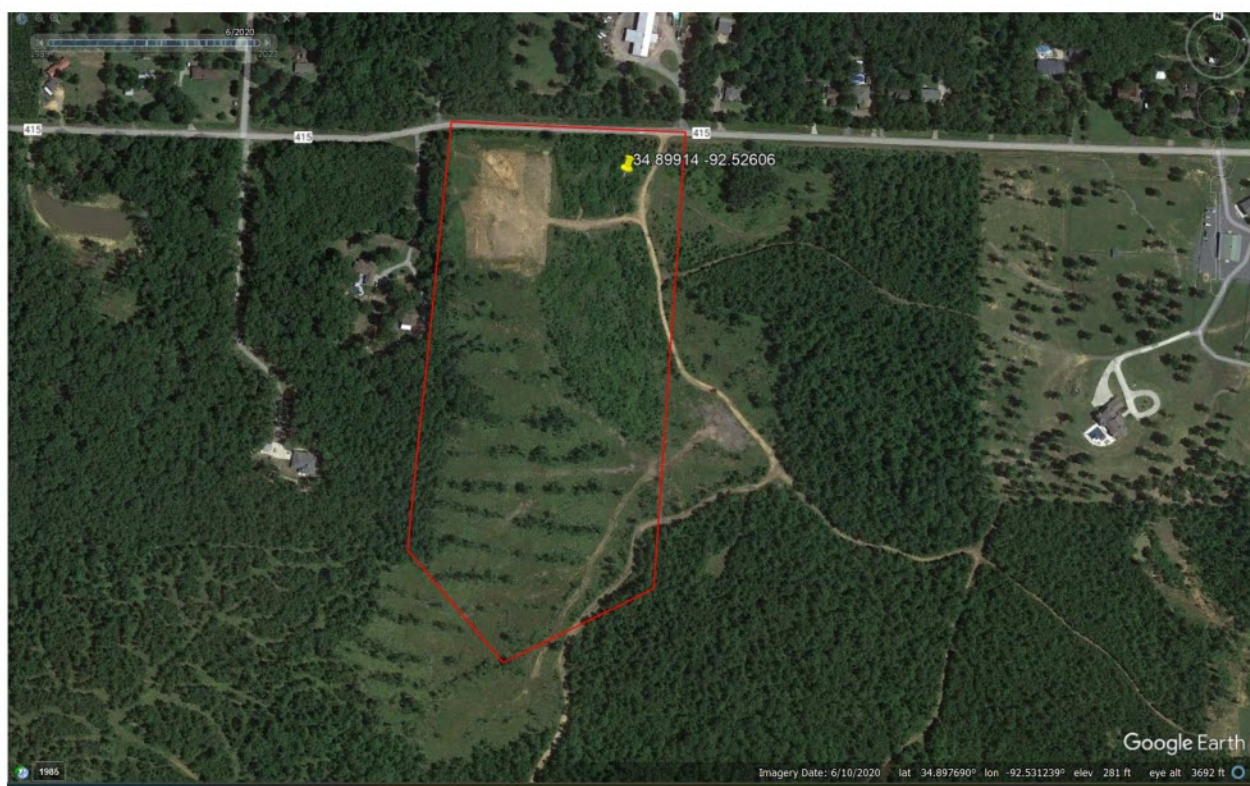
Figure 2. Aerial Imagery from June 2020.

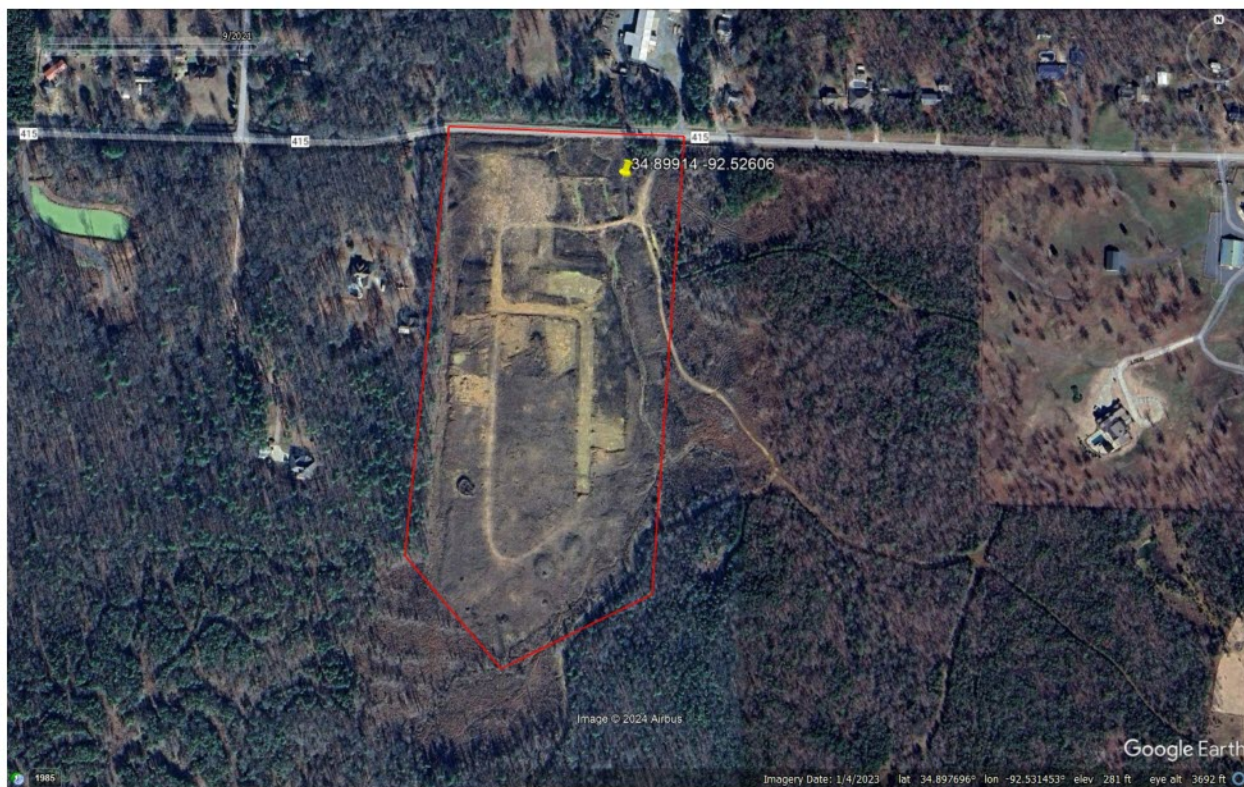
Figure 3. Aerial Imagery from September 2021.

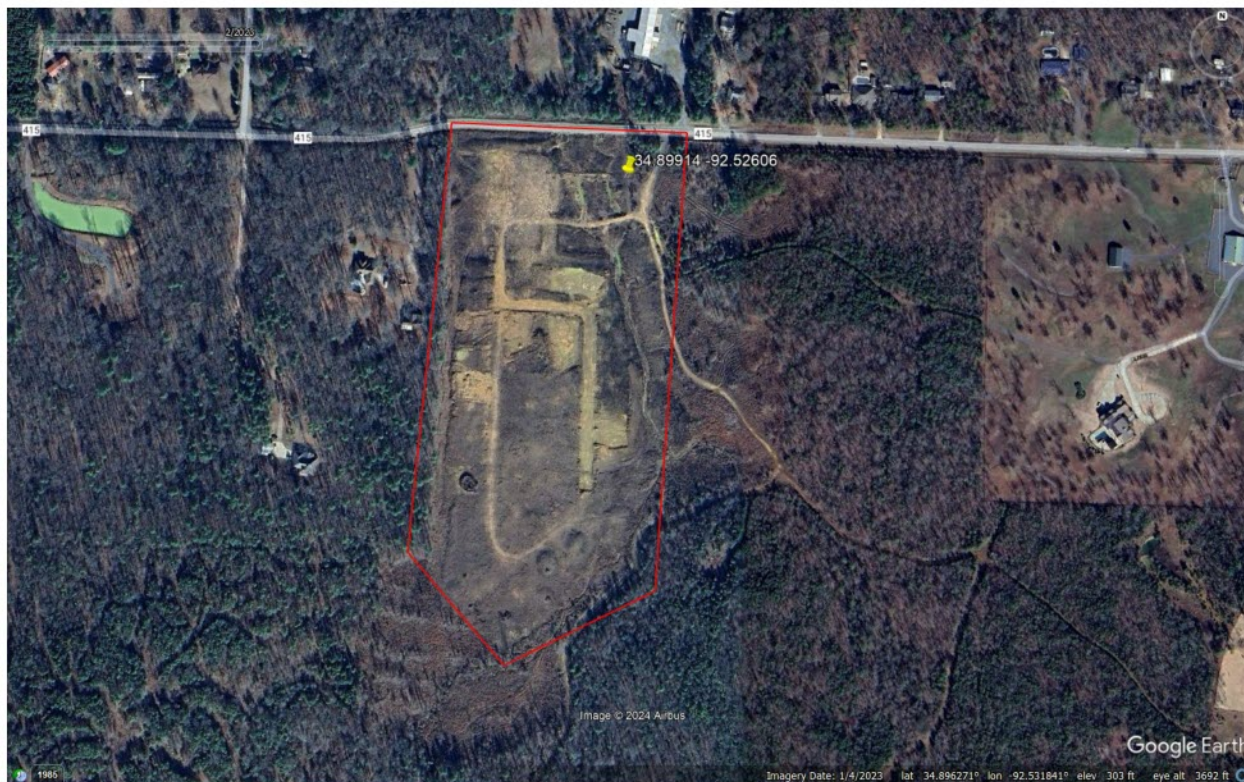
Figure 4. Aerial Imagery from February 2023.
