## **RCRA Inspection Report**

Piedmont Aviation Component  
Services  
7102 Cessna Dr., Greensboro, NC  
27409

December 7, 2023

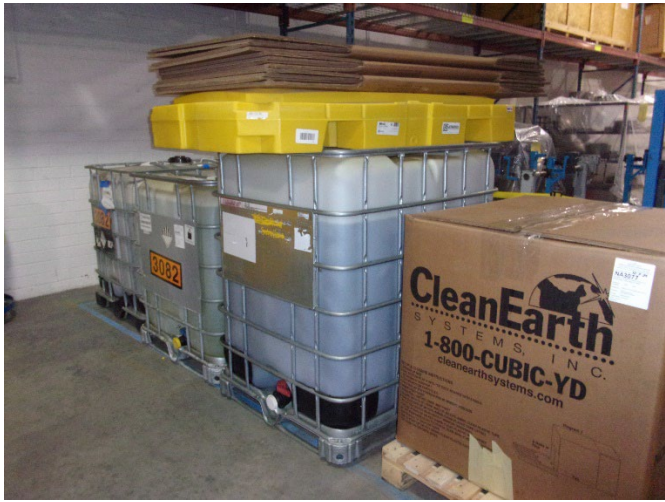
The shipping CAA was created due to overflow of the other CAAs throughout the facility (Photo 1). Most waste goes to other CAAs in the facility as this CAA is not near a point of waste generation. This CAA also holds totes of waste generated from off-spec electroplating material. Facility representatives informed inspectors that Piedmont recently shipped six totes of off-spec material off site. Inspectors observed eye wash stations and spill kits in this area, as well as a fire sprinkler and alarm system throughout the facility. Signs reading "Danger" and "No Smoking" were observed outside of the shipping CAA.

| | <p>Photo 1 – Containers stored in the Shipping Area CAA.</p> |

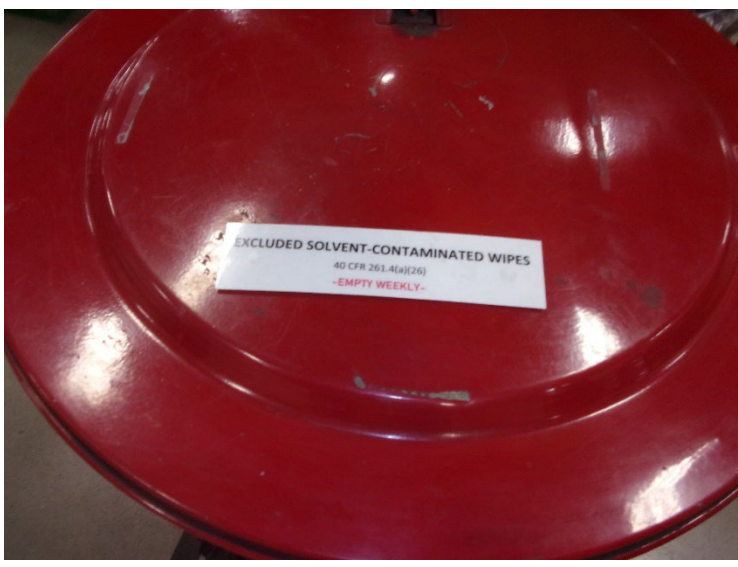
- One 275-gallon tote labeled “Hazardous waste, liquid, chromium, toxic, 11/30/2023.”
- One 55-gallon container labeled “Excluded solvent contaminated wipes” (Photo 3). This container was empty at the time of the inspection, but several other solvent contaminated wipes containers were observed throughout the facility walk through. Facility representatives informed inspectors that Unifirst launders and returns the facility’s solvent contaminated wipes.

| | <p>Photo 3 – Excluded solvent contaminated wipes container observed near the teardown CAA.</p> |

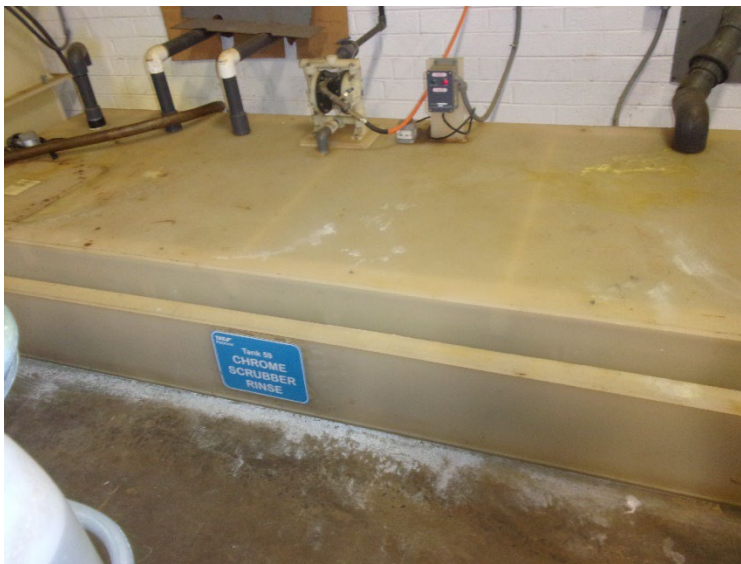
The rinse water tank was in the electroplating area. The tank is aboveground, but in the basement area of the facility so the top of the tank is visible from the floor of the electroplating area (Photo 5). The tank was labeled “NA3082, toxic hazardous waste, liquid, N.O.S. (Chromium), 9, PGII, ERG#171 (D007) (Photo 6). Waste in this tank is generated from the air exhaust scrubber system in the electroplating area. When vapor evaporates from the tank, air is passed through filters which are washed down in a self-contained system. Water is pumped through the system in the wash process and the rinse water is accumulated in the tank.

Photo 5 – 450-Gallon above ground tank accumulating exhaust scrubber rinse water in the electroplating area.

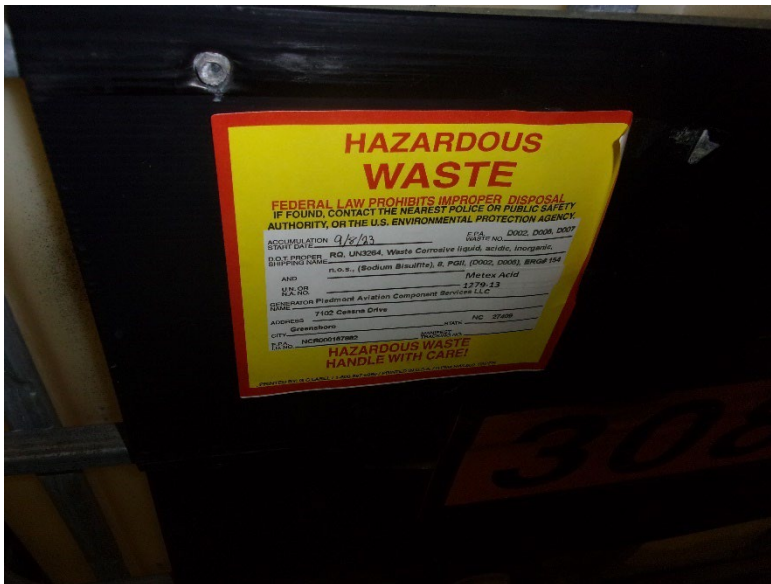
- One 275-gallon partially full tote labeled “Hazardous waste, corrosive liquid, acidic, inorganic, 9/08/2023” (Photo 8) Mark Spence was unsure why the material was stored in this CAA if partially full. This container was one day away from the 90-day accumulation time limit. Mark Spence explained that material is usually reused, however since they had a shipment coming the day of the inspection, he decided he would ship the material for disposal.

Photo 7 – Hazardous waste label on acid material in main CAA. Facility representatives claimed this material was not hazardous waste and should be moved.

**Pursuant to 15A NCAC 13A .0107(a) [40 C.F.R. § 262.11], a person who generates a solid waste, as defined in 15A NCAC 13A .0106 [40 C.F.R. § 261.2], must make an accurate determination as to whether that waste is a hazardous waste in order to ensure wastes are properly managed according to applicable RCRA regulations articulated in 15A NCAC 13A .0107(a) [40 C.F.R. § 262.11].**

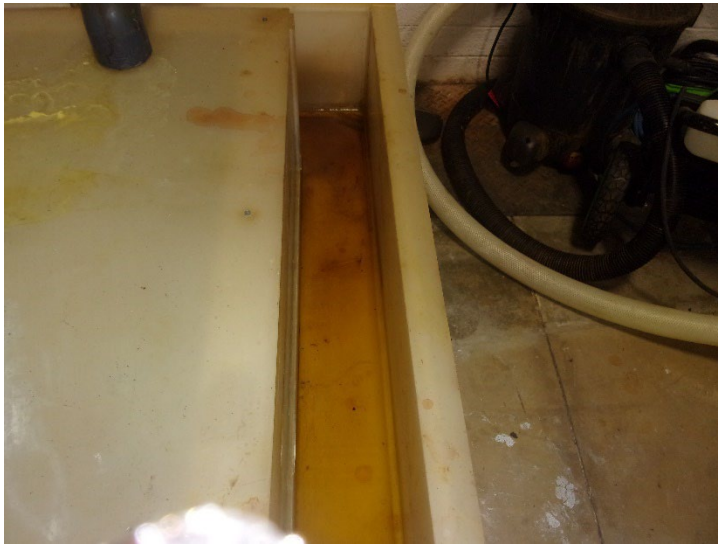
Inspectors observed free liquids standing in the secondary containment surrounding the tank lid (Photo 9). The daily inspection log for the day of the inspection did not document any free liquids in the secondary containment. Facility representatives informed inspectors that this liquid was spilled over during a transfer of material into totes that occurred before inspectors arrived. This was an area of concern for the facility.

Photo 8 – Free liquid observed in aboveground tank secondary containment.

Pursuant to 15A NCAC 13A .0109(k) [40 CFR 264.196(b)(1)] which is a condition of the Tank Systems Permit Exemption, if leaked material released was to a secondary containment system, all released materials must be removed within 24 hours or in as timely a manner as is possible to prevent harm to human health and the environment.

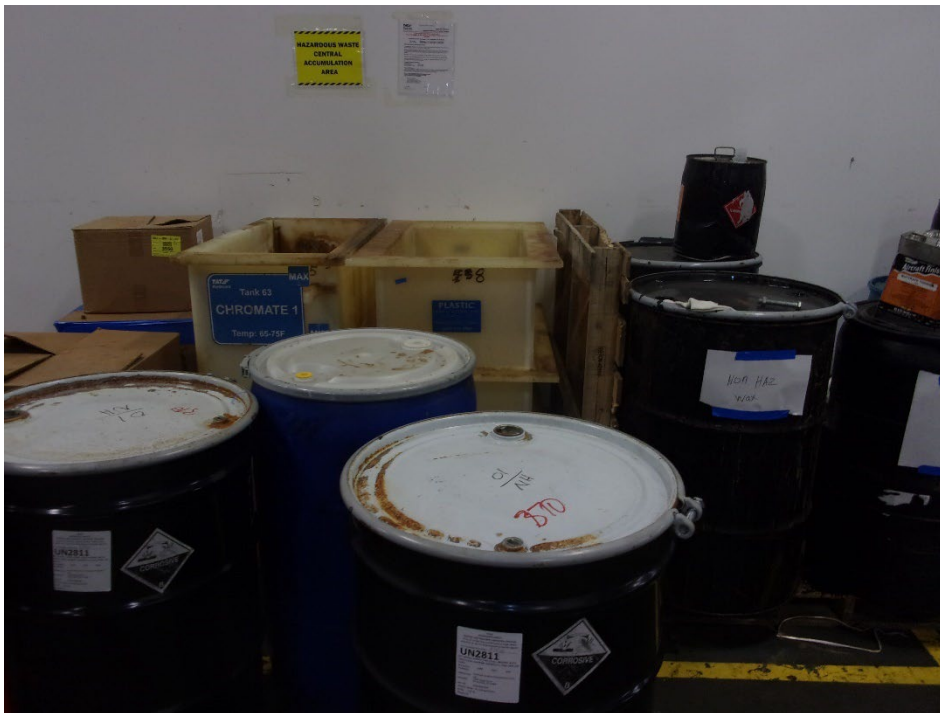
The East Wall CAA stored both hazardous waste and product on opposite sides of the CAA.

Photo 9 – East wall CAA.

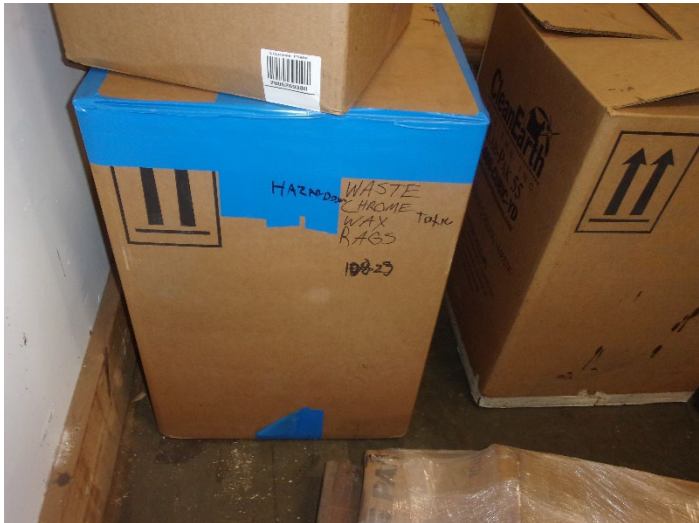
- Three 55-gallon drums of nonhazardous waste
- Two 55-gallon drums labeled “UN2811 hazardous waste, toxic solid, Methylene Chloride, Phenol, 12/05/2023”
- One approximately 55-gallon labeled “hazardous waste, solid, chromium, toxic, 10/30/2023”
- One 12 by 18-inch box labeled “hazardous waste, solid, toxic, chrome, 10/18/2023.”
- One 55-gallon drum labeled “Nonhazardous wax rags”
- One approximately 55-gallon box labeled “waste chrome wax rags 10/08/2023” (Photo 10). This label was corrected on site to include the words hazardous waste and toxic.

| | <p>Photo 10 – container of wax rags in East Wall CAA. The container label was corrected on site to include the words “Hazardous waste” and an indication of the hazards of its contents.</p> |

**Pursuant to 15A NCAC 13A .0107(a) [40 CFR 262.17(a)(5)(i)(B)-(C)] which is a condition of the LQG Permit Exemption, a large quantity generator is required to mark or label its containers (A) with the words “hazardous waste” and (B) an indication of the hazards of the contents.**
