Re: NPDES Permit No. MSS062171, Reconnaissance Inspection Report

**United States Environmental Protection Agency****Region 4****CV-MSS062171-8-3-2021****Reconnaissance Inspection Report****SECTION A: National Data System Coding**

On August 3, 2021, the EPA conducted a Reconnaissance Inspection (RI) at the Jaxon Energy Processing Plant located at 455 Industrial Dr, Jackson, MS. EPA met with the following Jaxon Energy representatives: Bryan Olier, Corey Funk, and Craig Ellison. EPA inspectors reviewed the facility's monitoring records and discussed the facility's self-monitoring program. The following is a summary of RI findings and observations.

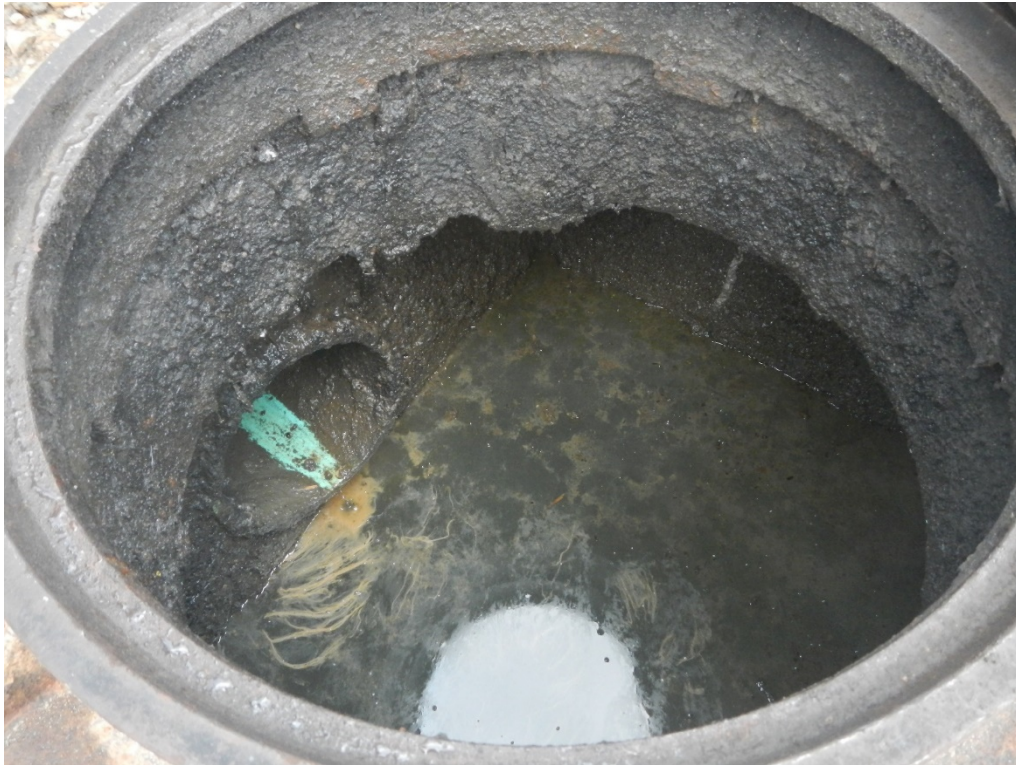
Jaxon Energy Processing Plant produces biodiesel from corn oil. The facility is located on a 6-acre lot. Most of the facility area is asphalt with a one-acre metal roof building for office and warehouse space. Stormwater is collected in two drainage systems. In each system water passes through an oil and grease separator before discharging into surrounding waters. In system 1 (Photos 1 and 2) water is discharged through outfall 001 into a receiving ditch that also collects runoff from other surrounding facilities (Photos 3 and 4). In system 2 (Photo 5) water is discharged through outfall 002 into Town Creek (Photos 6-9).

*Photo 1 Inside of oil and grease separator 1.*

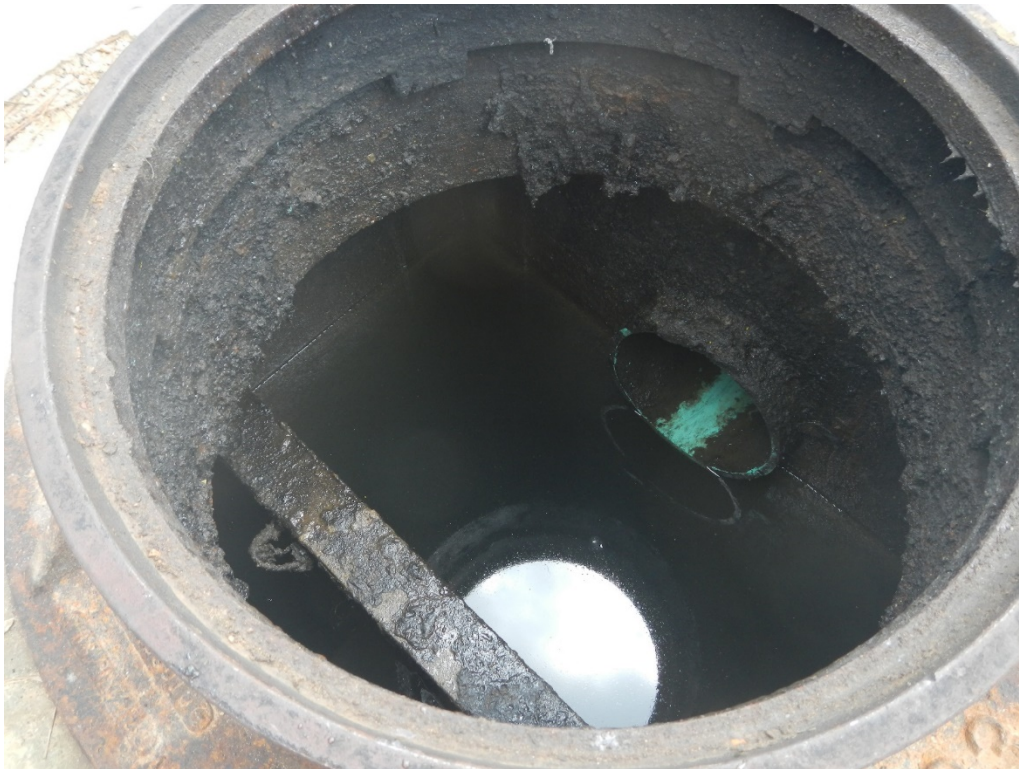
*Photo 2 Influent pipe for oil and grease separator 1*

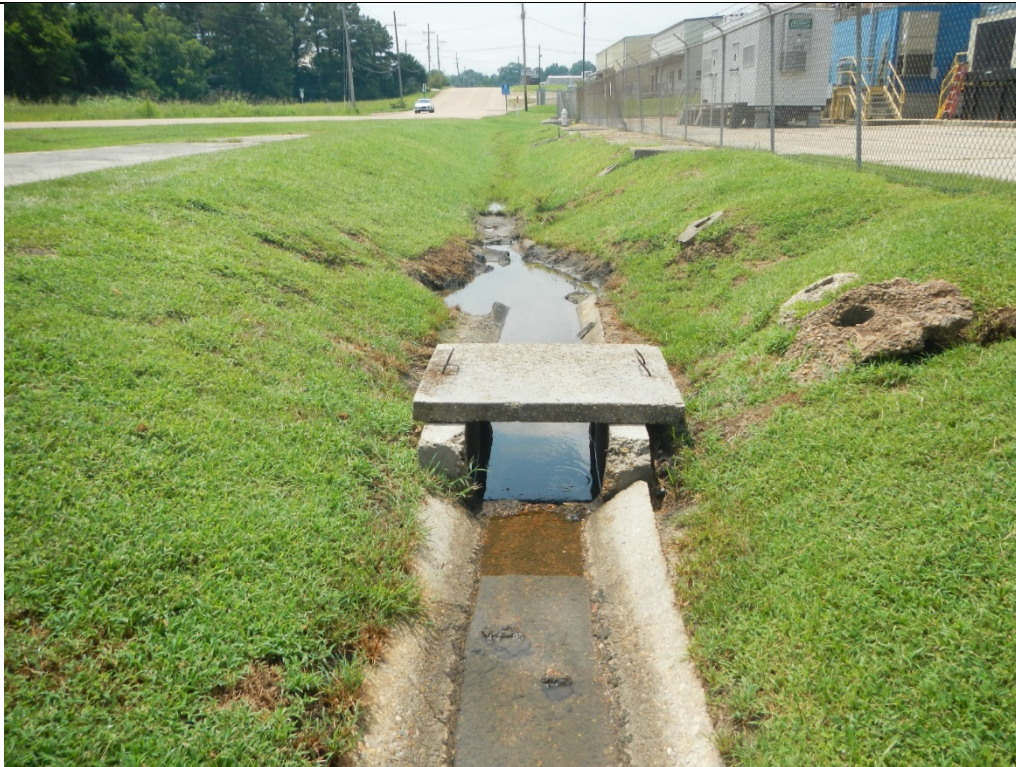
Water samples are collected by the facility engineer and sent to Waypoint Analytical. Chain of custody forms and water quality sampling results were available on site. Facility personnel raised concern regarding the location of sampling sites regarding actual outfall locations. Sampling locations were located far downstream from actual discharge sites (Photos 6-9). The compliance sample locations have the potential to receive effluent from nearby facilities. The potential for mixing/combination of discharges from other properties, renders the chosen sample locations unrepresentative of the permittee's discharge. In addition, the surrounding sites are registered Brownfield locations. Therefore, it is likely that discharges from the surrounding sites will negatively affect the permittee's effluent quality. Currently, the facility's permit is in review/public notice by MDEQ.

*Photo 3 Sampling site for outfall 1. Area receives effluent from neighboring facilities.*

The EPA recommends that the facility contact MDEQ as soon as possible to modify the sampling locations for outfalls 001 and 002. The NPDES program requires that the discharge from a permittee be representative of the facility's effluent. Given that the facility's permit has been finalized, the recommended changes should be addressed in the current permit cycle.

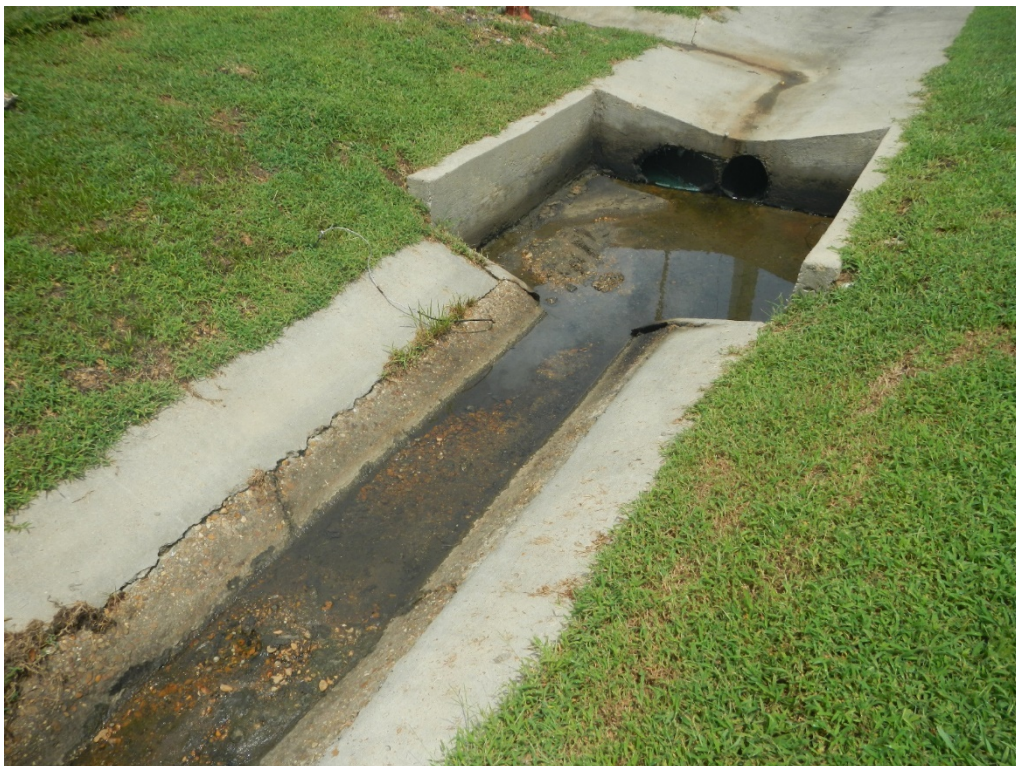
*Photo 4 Actual location of discharge for outfall 001*

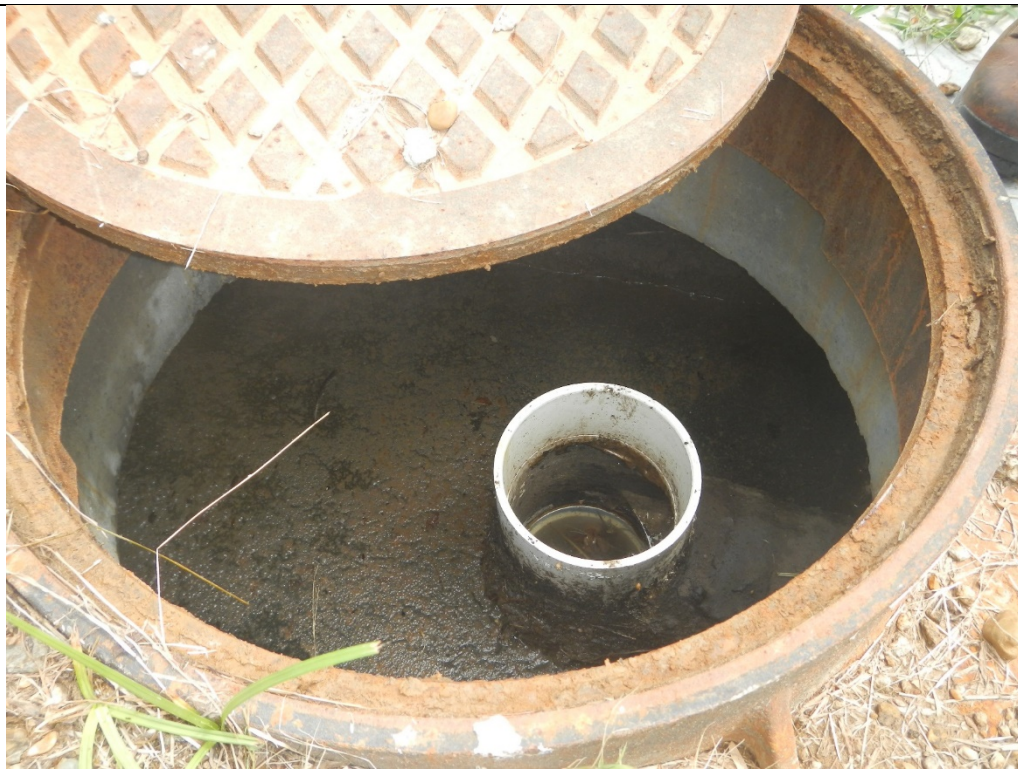
*Photo 5 Oil and grease separator 2*

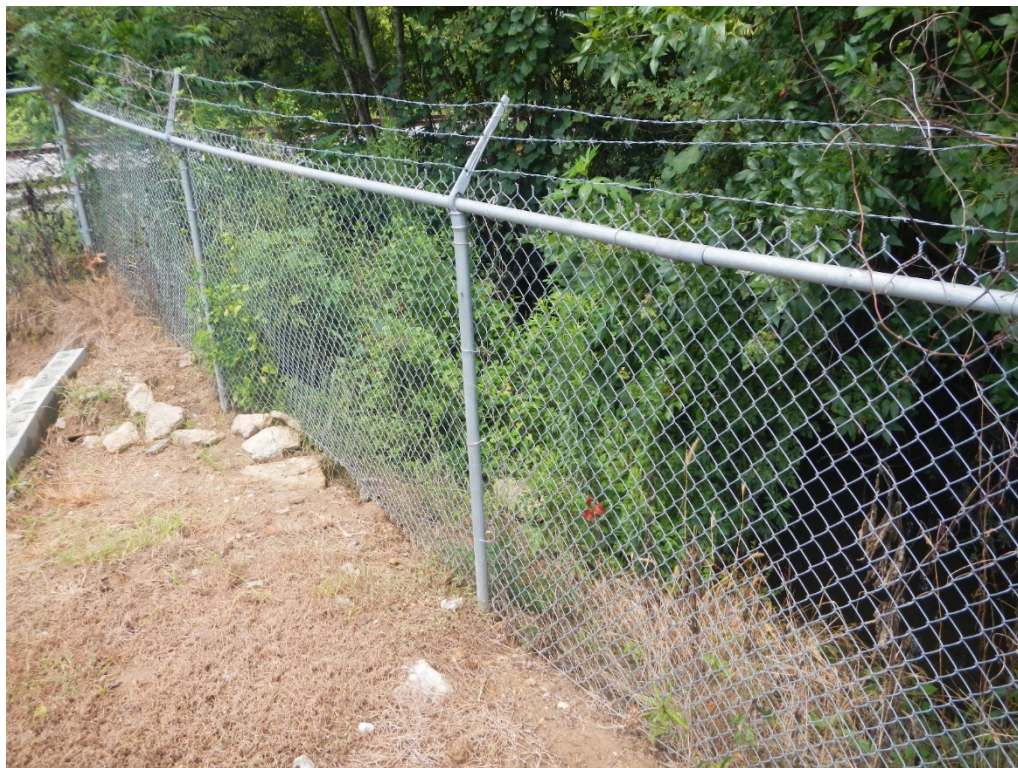
*Photo 6 Actual location of discharge for outfall 002. Effluent pipe is located behind brush and discharges directly into Town creek (Downstream of other facilities and Brownfields)*

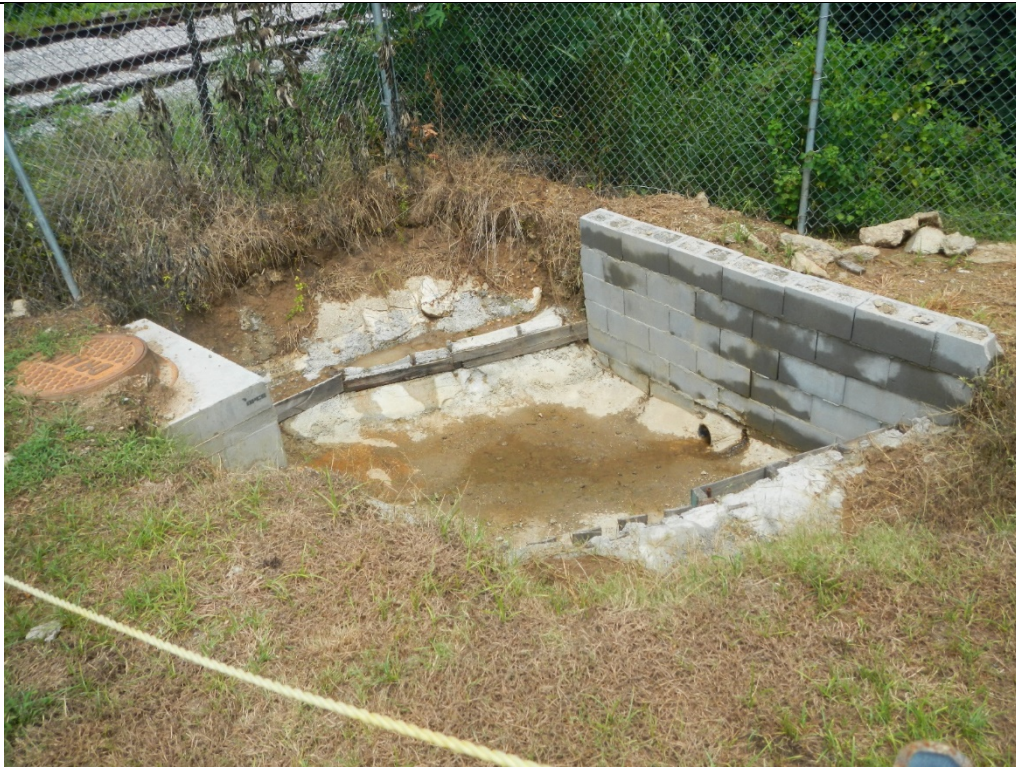
*Photo 7 Water storage after oil and grease separator and before outfall.*

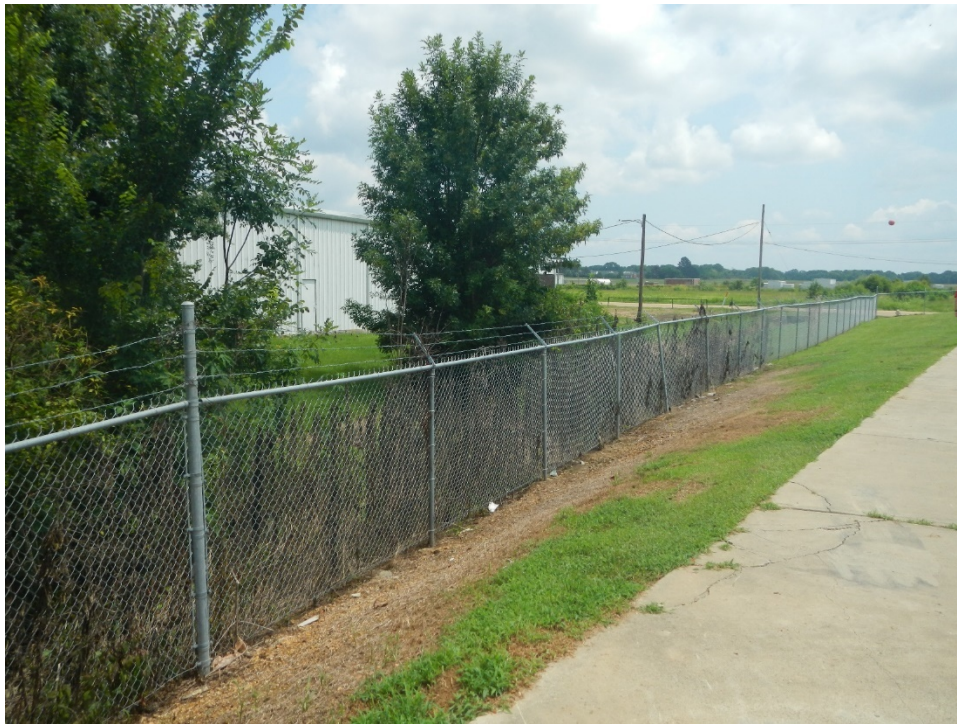
*Photo 8 Chainlink fence showing distance from actual discharge point to sampling point. Distances between fence posts are estimated at 10 feet. For 22 segments this shows that the sampling point is located 220ft downstream of discharge point.*

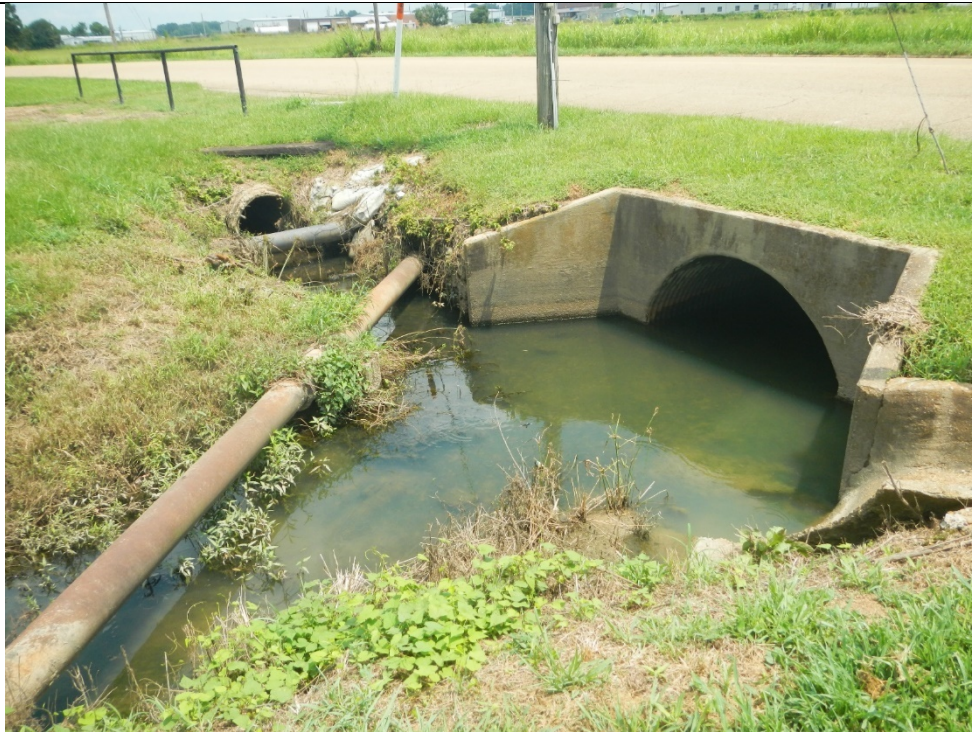
As stated previously, receiving waters are shared with multiple other facilities and Brownfields. During the inspection, facility personnel raised concern of an incident which occurred on January 5, 2021 in which a vacuum truck from the City of Jackson was cleaned out into the sampling point of the Jaxon Energy Processing Plant. This incident was documented by Jaxon personnel and a complaint was made to MDEQ.

*Photo 9 Sampling point for outfall 002. This point also receives effluent from neighboring facilities and Brownfield sites.*
