INSPECTION REPORT

| Type of Inspection | Compliance Evaluation Inspection (CEI) | | |
| Permittee Name | Lafayette Consolidated Government - East WWTP | | |

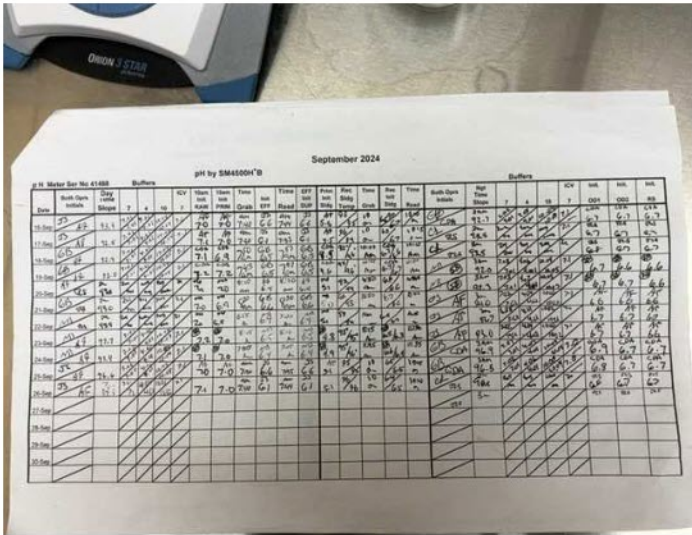
| September pH Calibration Log | | | IMG-202409261225302530123915.jpg |

| September pH Calibration Log | | | |

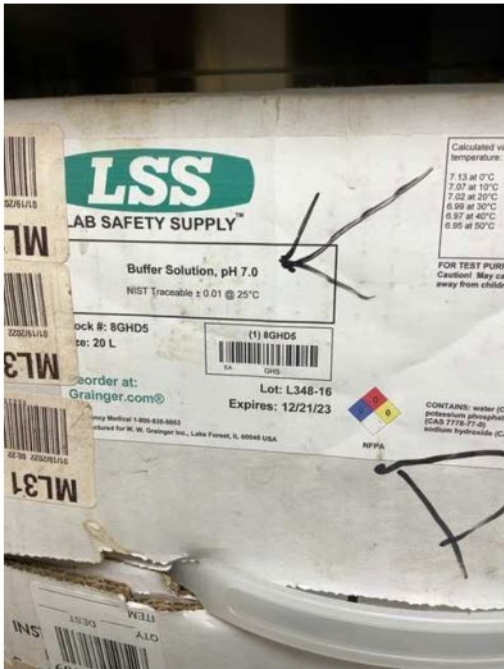
| Buffer Solution pH 7.0 | | | IMG-20240926122820282085465.jpg |

1. Buffer solutions used for pH calibration were not demonstrated to be within expectation dates. See photos:

| Expired Buffer Solution pH 7.0. All expired pH buffers were disposed of before exiting the facility. | | | |

**Additional Notes:** All expired pH buffer solutions were disposed of before exiting the facility.

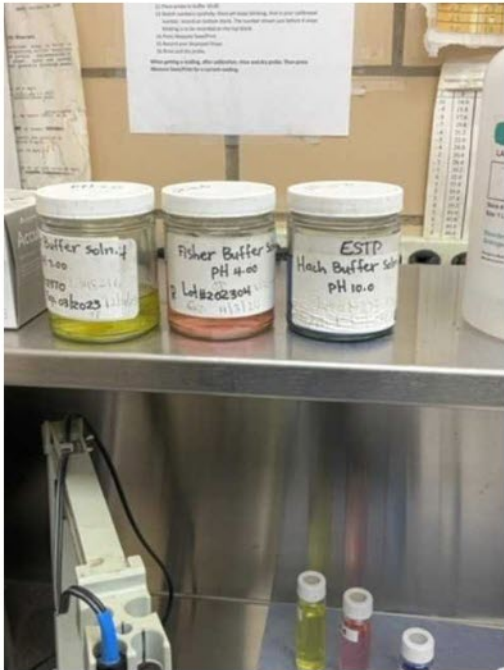
| Buffer Solutions | | | IMG-2024092612290829865117.jpg |

| Expired Buffer Solutions. All expired pH buffers were disposed of before exiting the facility. | | | |

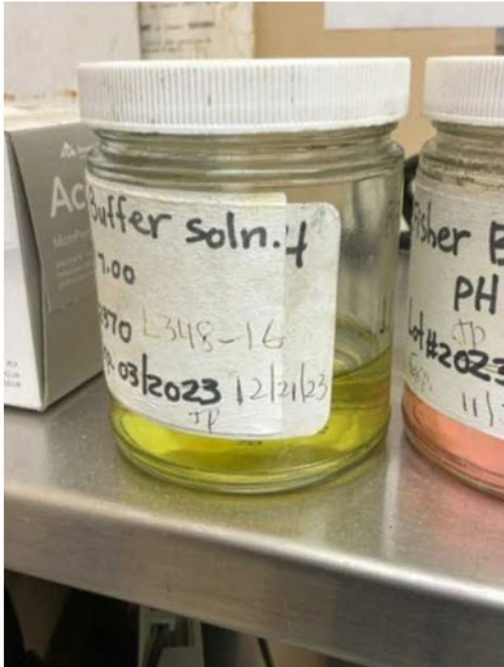
| Buffer Solutions | | | IMG-20240926122957295766282.jpg |

| Expired Buffer Solution. All expired pH buffers were disposed of before exiting the facility. | | | |

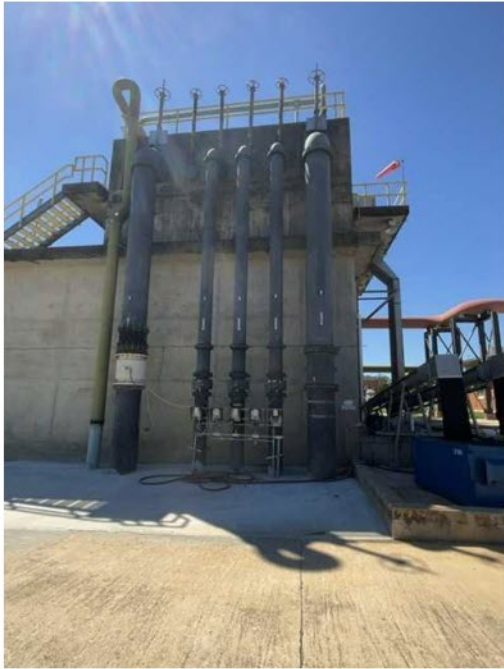
| Plant Influent Force Mains | | | IMG-20240926123926392677938.jpg |

| 5 forced mains entering headworks of the facility. | | | |

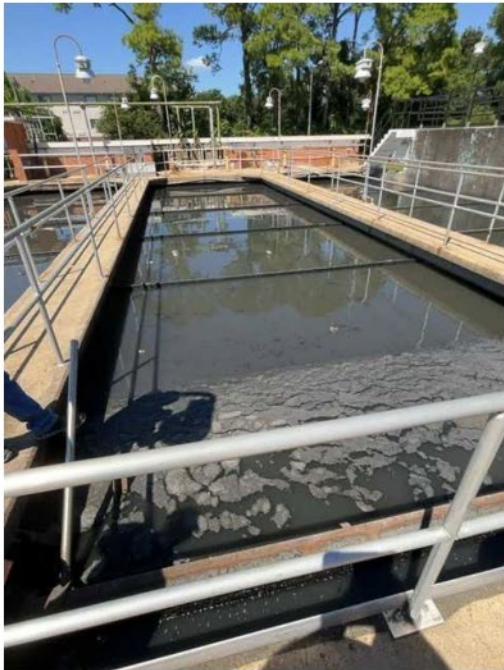
| Plant Clarifier | | | IMG-202409261249164916119019.jpg |

| One of six plant clarifiers used at the facility. | | | |

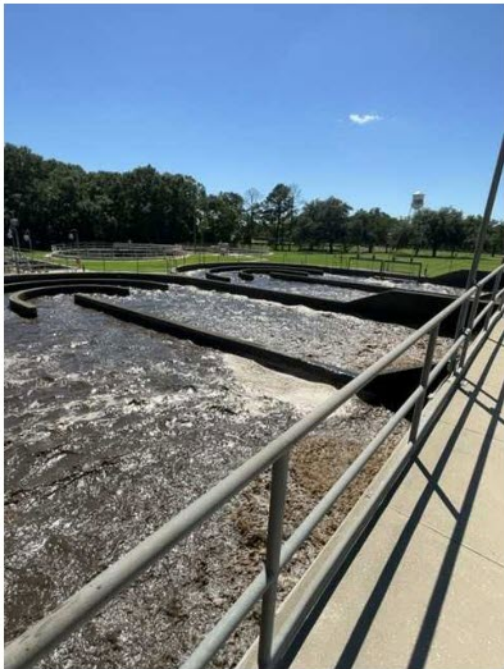
| Oxidation Ditch | | | IMG-202409261257485748120255.jpg |

| Oxidation Ditch used the facility for biological treatment. | | | |

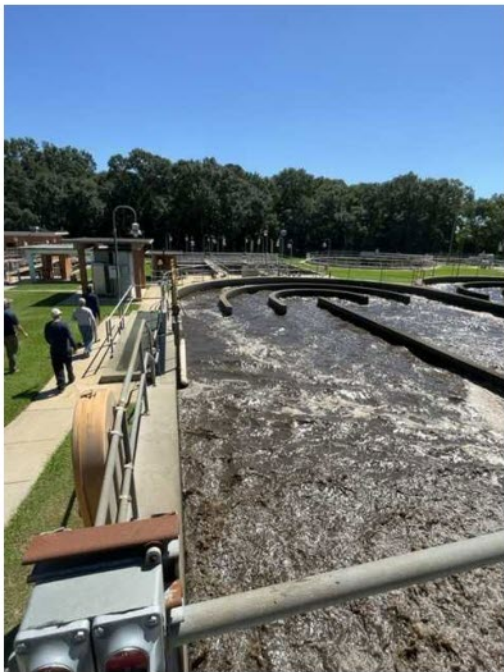
| Oxidation Ditch | | | IMG-202409261257515751122705.jpg |

| Oxidation Ditch used the facility for biological treatment. | | | |

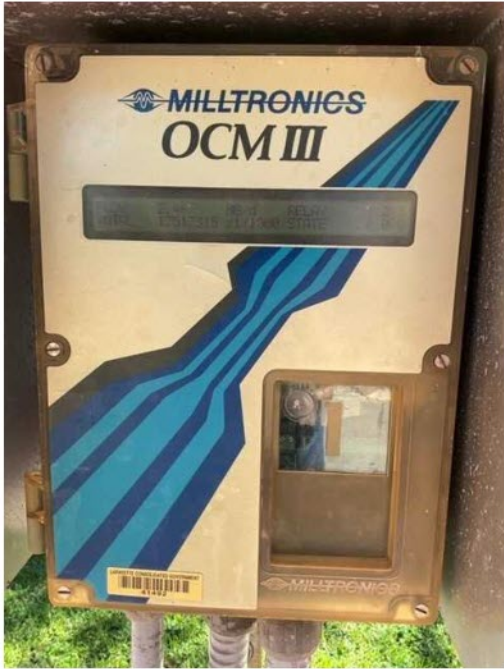
| Flow meter | | | IMG-2024092613130013095039.jpg |

| Flow meter used to determine discharge. | | | |

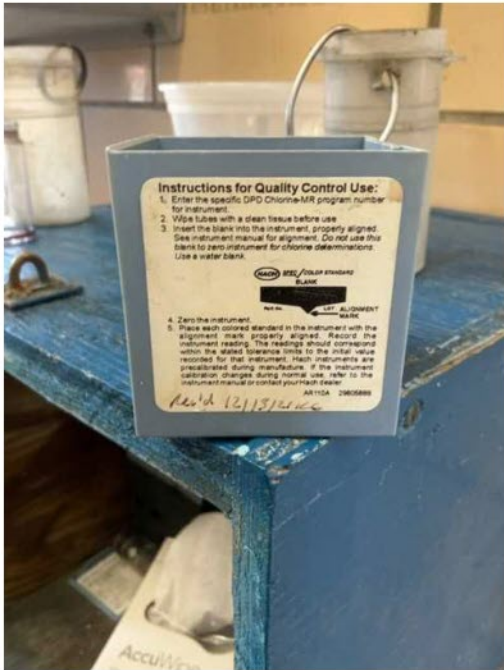
| DPD Chlorine Standards | | | IMG-20240926131826182674652.jpg |

2. The DPD Chlorine standards used to verify DPD Chlorine meter calibration were expired. See photos:

| Expired DPD Chlorine Standards used for calibration of chlorine meter. | | | |

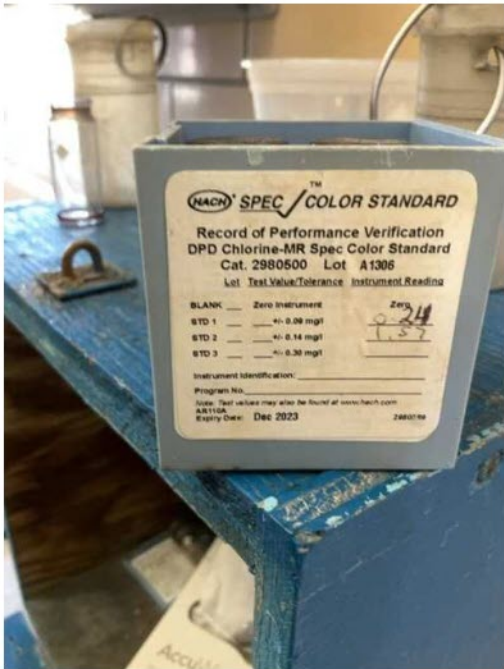
| DPD Chlorine Standards | | | IMG-20240926131834183474686.jpg |

| Expired DPD Chlorine Standards used for calibration of chlorine meter. | | | |
