**Region 6 - Enforcement & Compliance Assurance Division**  
**INSPECTION REPORT**

| Regulatory Program(s) | Water (CWA) Brine Program (Oil & Gas inspection) | |
| Company Name: | <b>C12: Arkansas Oil, LLC</b> | |
| Facility Name: | <b>Midway Smackover Unit Tract #17 Tank Battery</b> | |

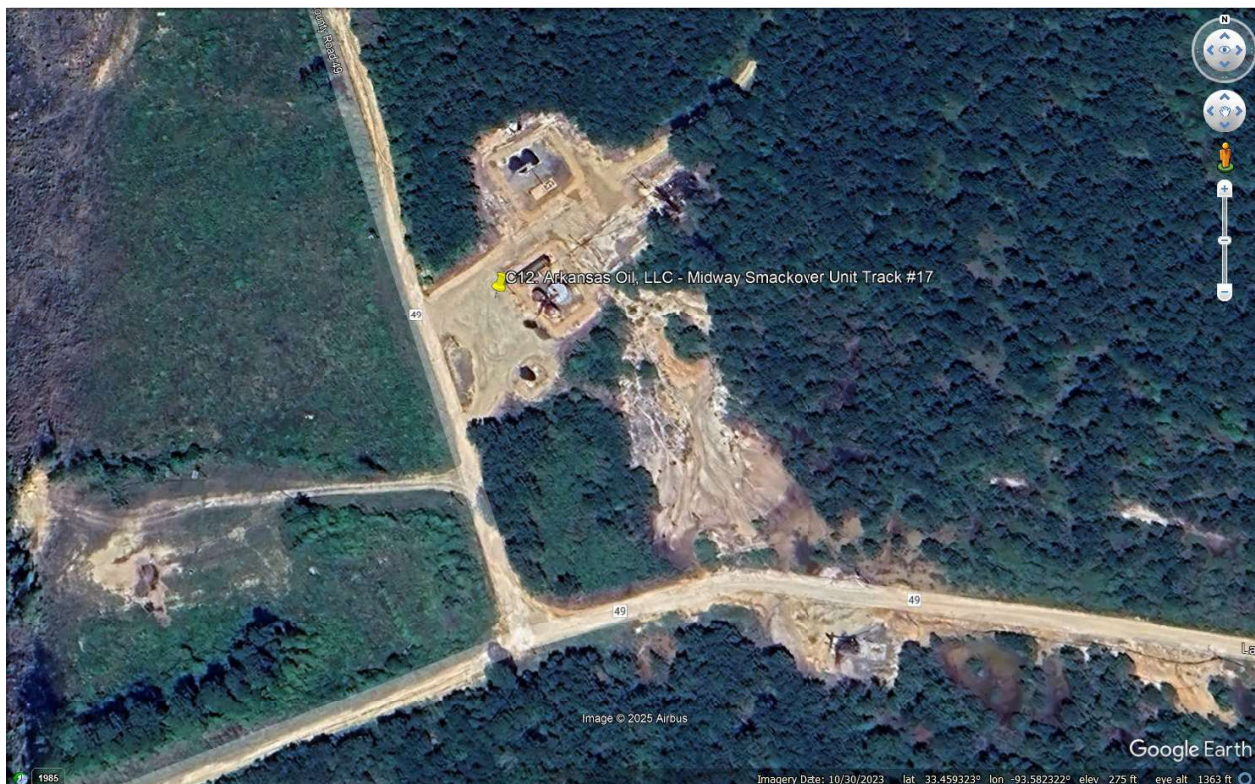
**Map 1.** Aerial imagery (Google Earth dated 10/30/2023) of the C12: Arkansas Oil, LLC / Midway Smackover Unit Tract #17 Tank Battery facility.

EPA conducted an inspection on the C12: Arkansas Oil, LLC / Midway Smackover Unit Tract #17 Tank Battery facility, which contains four (4) tank batteries with a total of ten (10) tanks that include storage, separation, and free water knock out (FWKO) for crude oil and saltwater processing and storage.

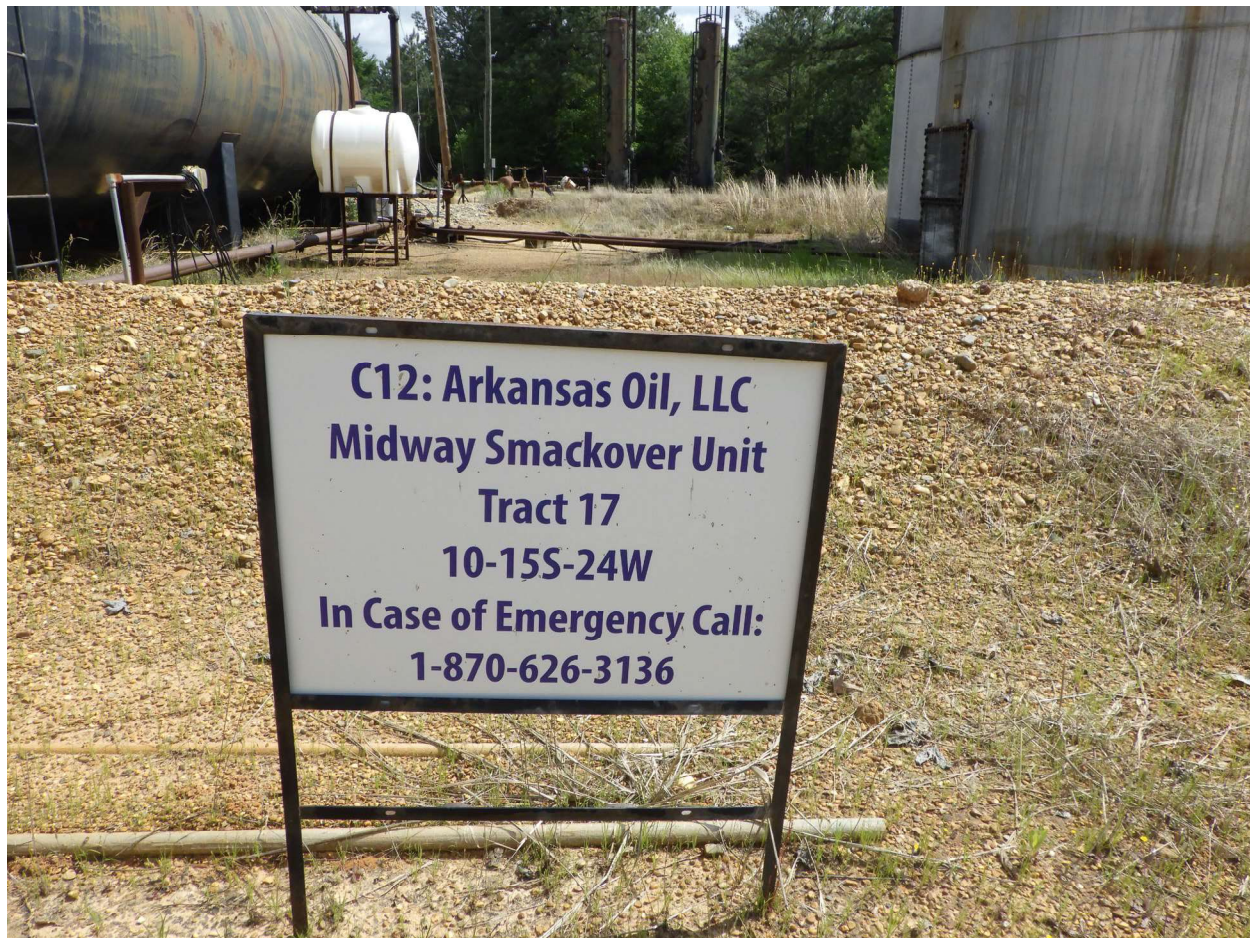
Photo No. 1

I observed the facility signage, secondary containment, pipes and valves, storage tanks, and separators/treaters; see Appendix 1 (Photographs Log), Photos No. 1 and No. 2. For additional GPS location and photo metadata, see Appendix 1.

**Description:** Looking NE, this photo shows the signage for the C12: Arkansas Oil, LLC – Midway Smackover Unit Tract #17 Tank Battery ("facility").

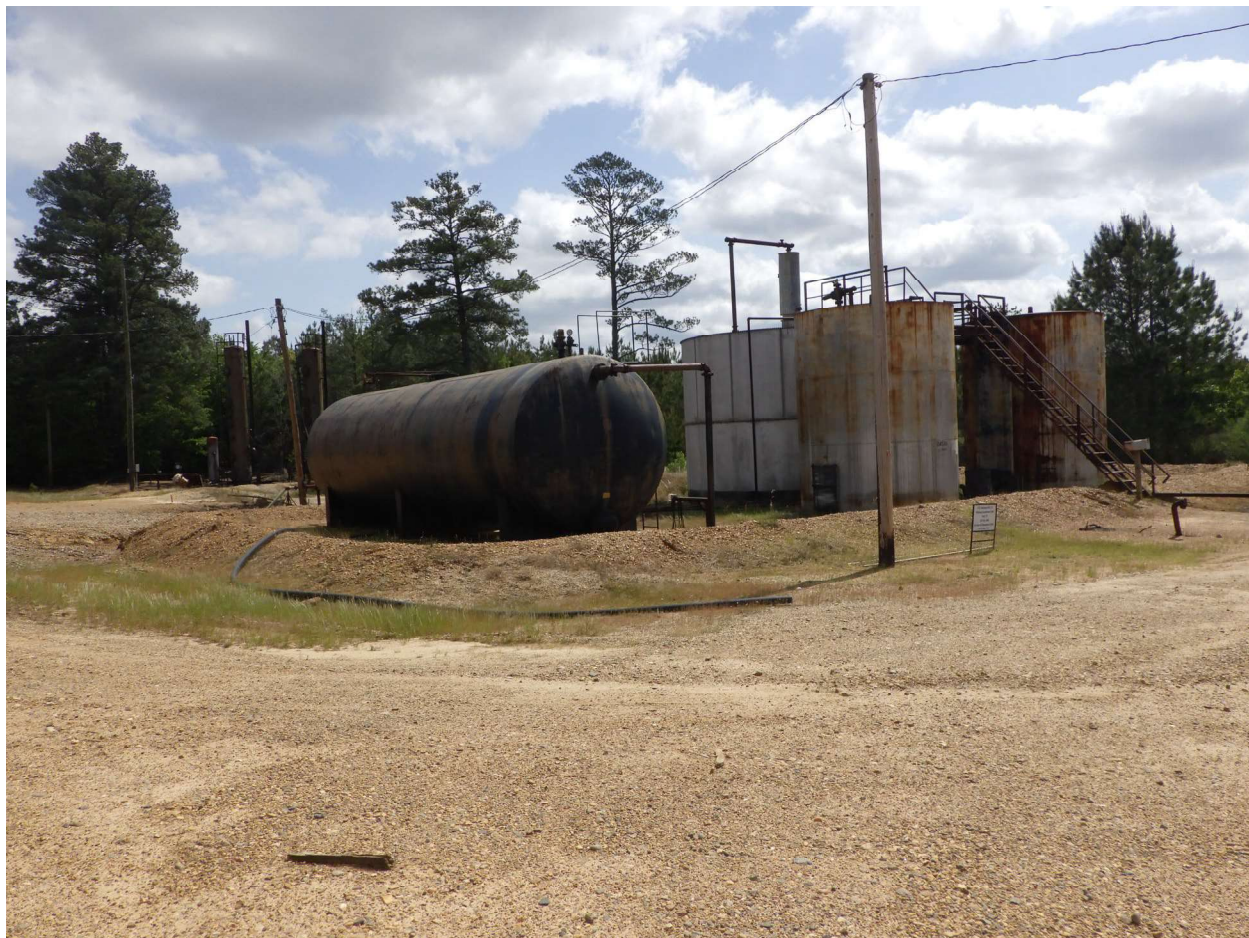
Photo No. 2

**Description:** Looking ENE, this photo shows an overview of the facility.

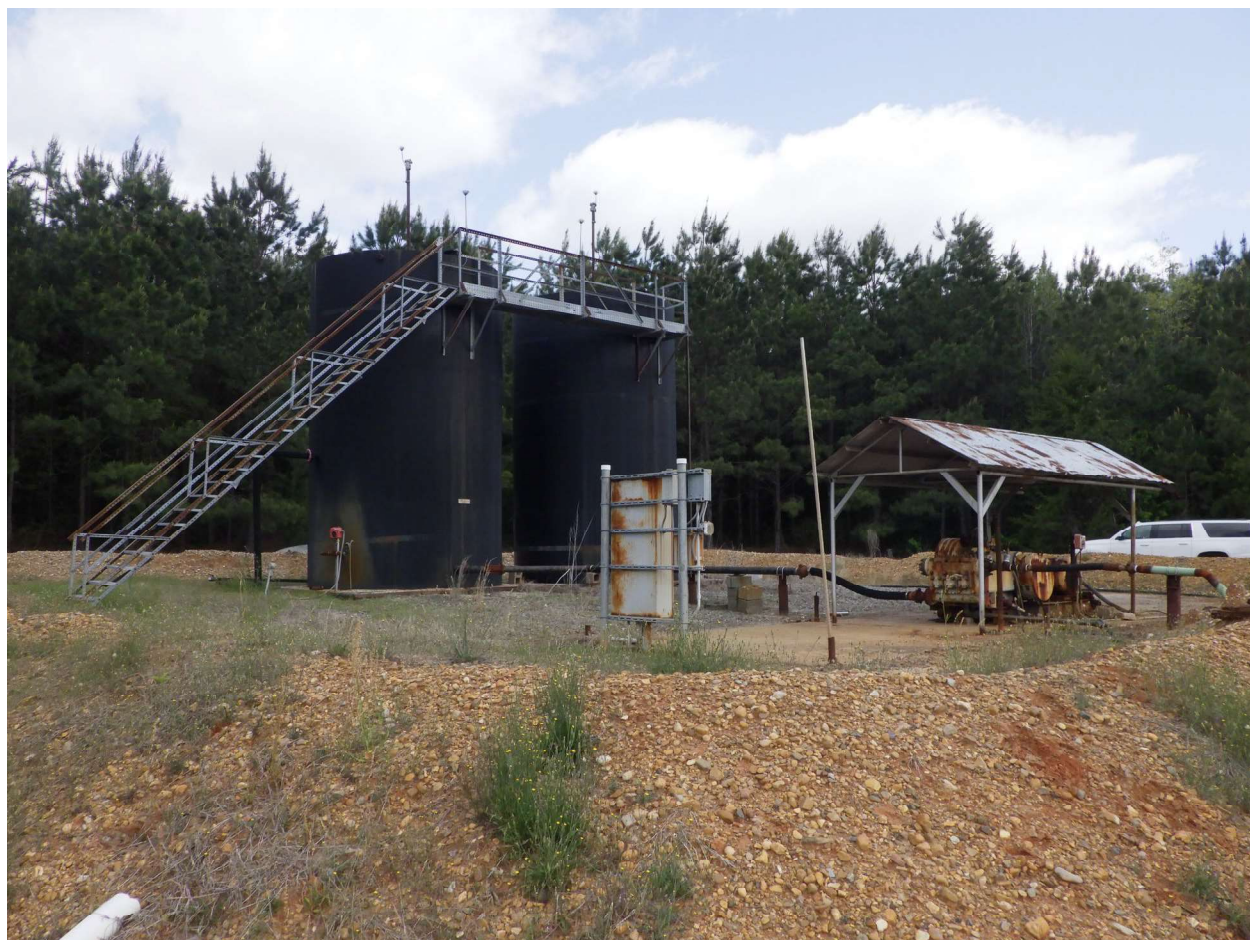
Photo No. 3

I observed a tank battery with two (2) saltwater storage tanks and a pump, a drainpipe with no shutoff valve or cap, and an erosion gully through the berm; see Photos No. 3 through No. 5.

**Description:** Looking N, this photo shows one of four tank batteries (saltwater storage and pump) observed at the facility.

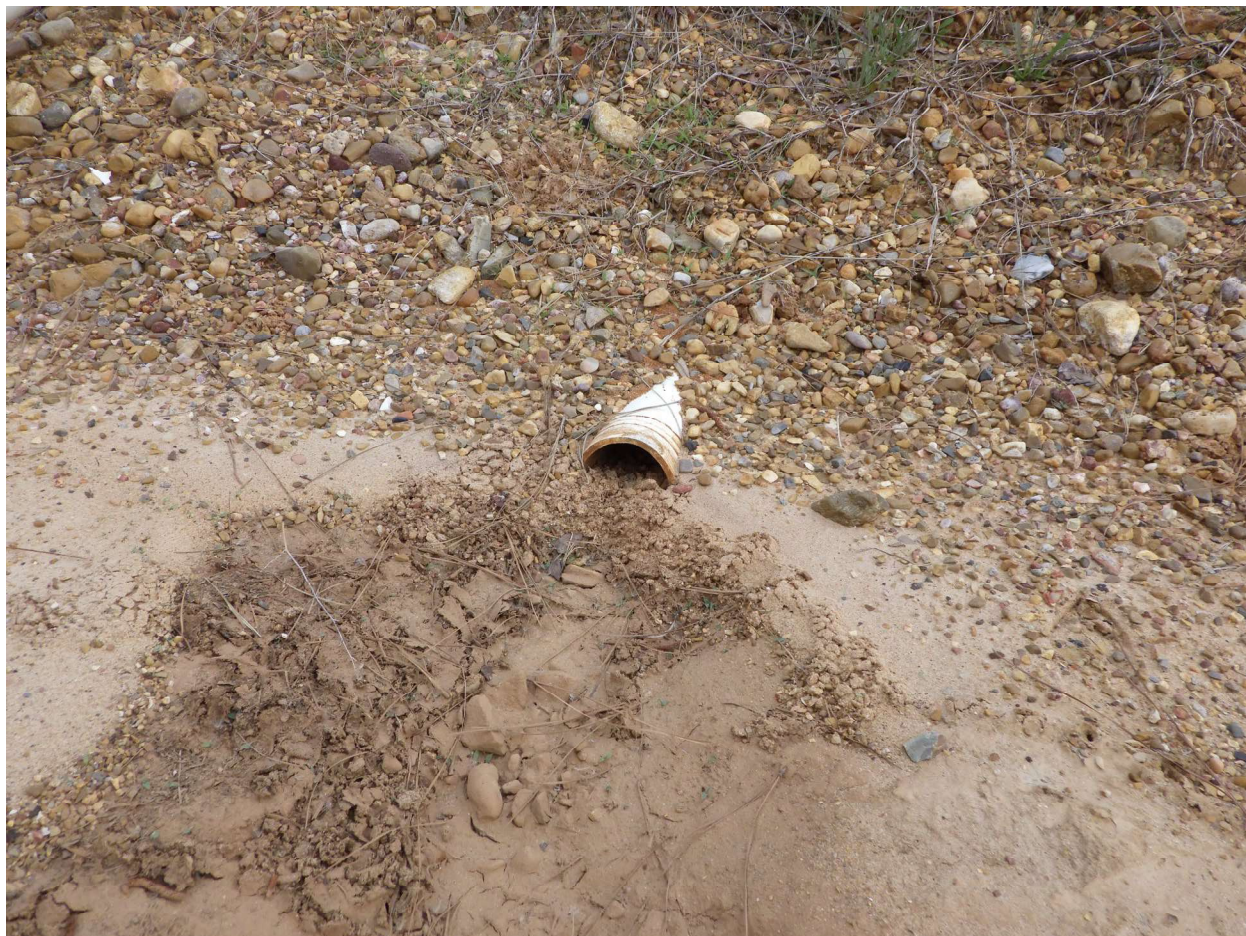
Photo No. 4

- Drainpipes for tank batteries that did not have shutoff valves or caps (Photos No. 4, No. 11, and No. 14),
- An erosion gully in the berm for the saltwater storage tank battery (Photo No. 5 and No. 7),
- Loose crude oil on the ground outside the crude oil storage tank battery (Photo No. 9),
- No catchment bucket for the transfer line outside secondary containment for the crude oil storage tank battery (Photo No. 9), and
- Evidence of a historic saltwater release that has not been properly remediated (Photo No. 12).

**Description:** Looking NNW, this photo shows the drainpipe for the tank battery in Photo No. 3 without a shutoff valve or cap.

Inspector will conduct follow-up phone calls with the company representative(s) over the coming weeks and months to ensure areas of concern are properly addressed.

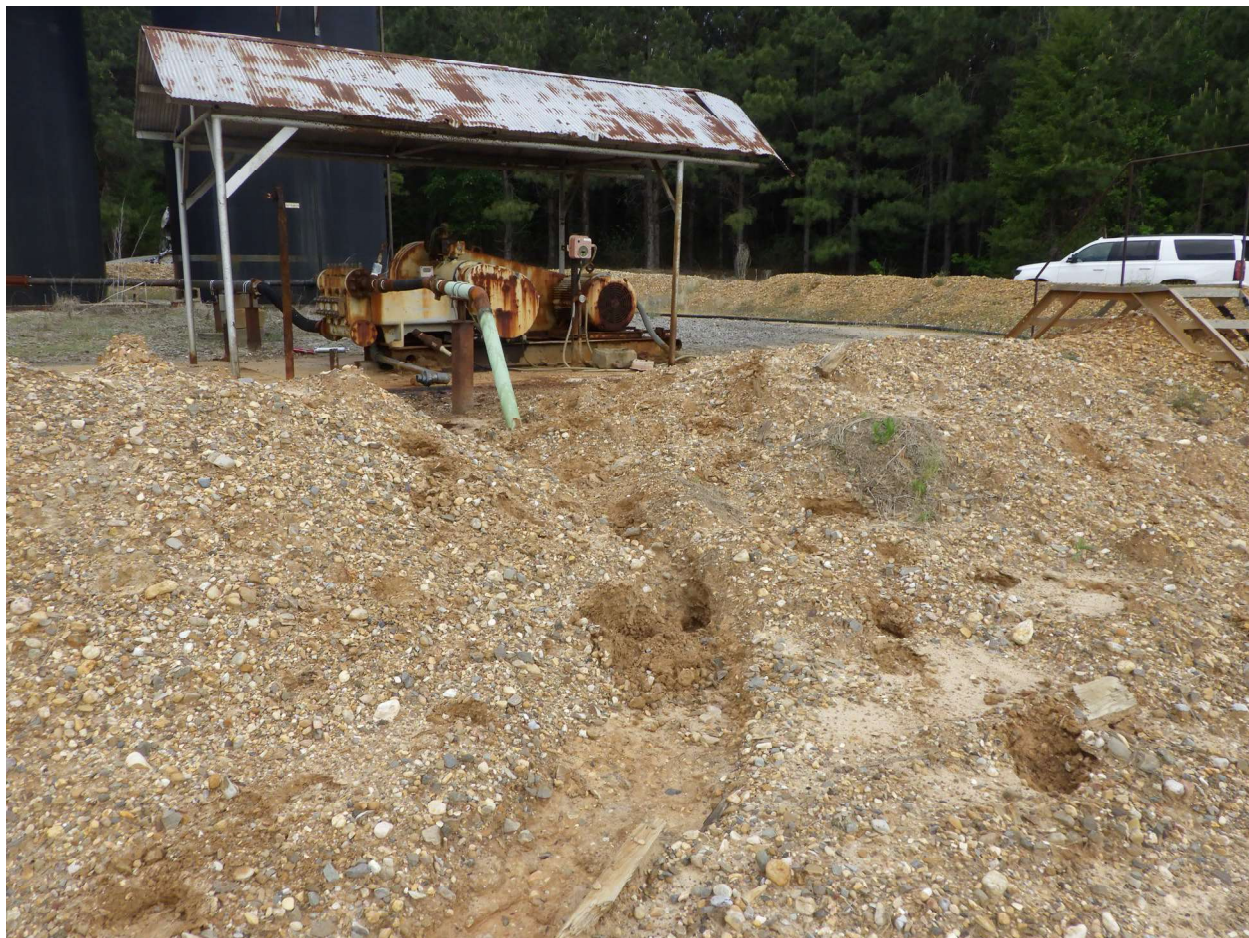
Photo No. 5

**Description:** Looking NNW, this photo shows an erosion gully in the berm of the tank battery from Photo No. 3.

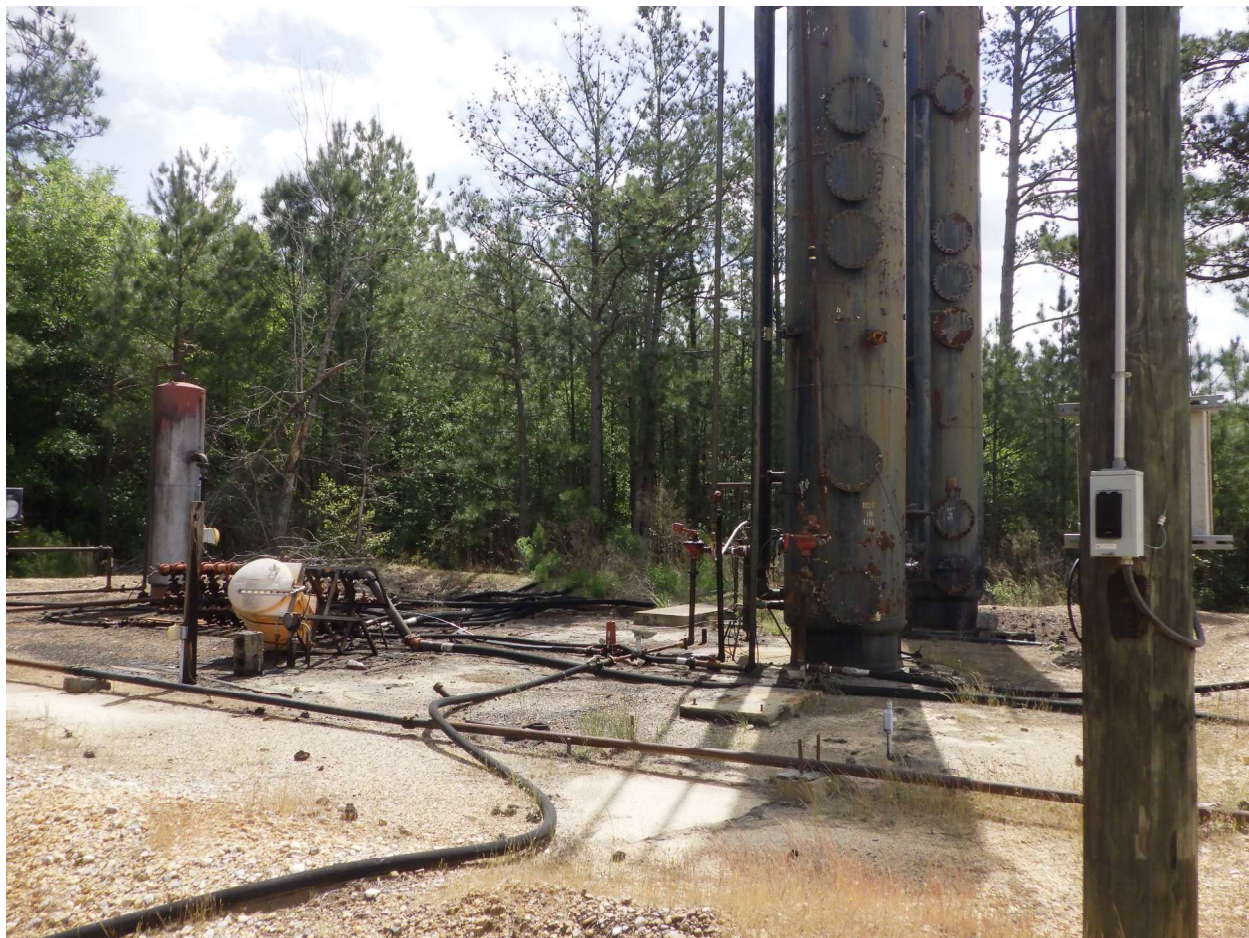
Photo No. 6

I observed a tank battery with three (3) separators and numerous flowlines, see Photo No. 6.

**Description:** Looking SE, this photo shows two of four tank batteries (separators) observed at the facility.

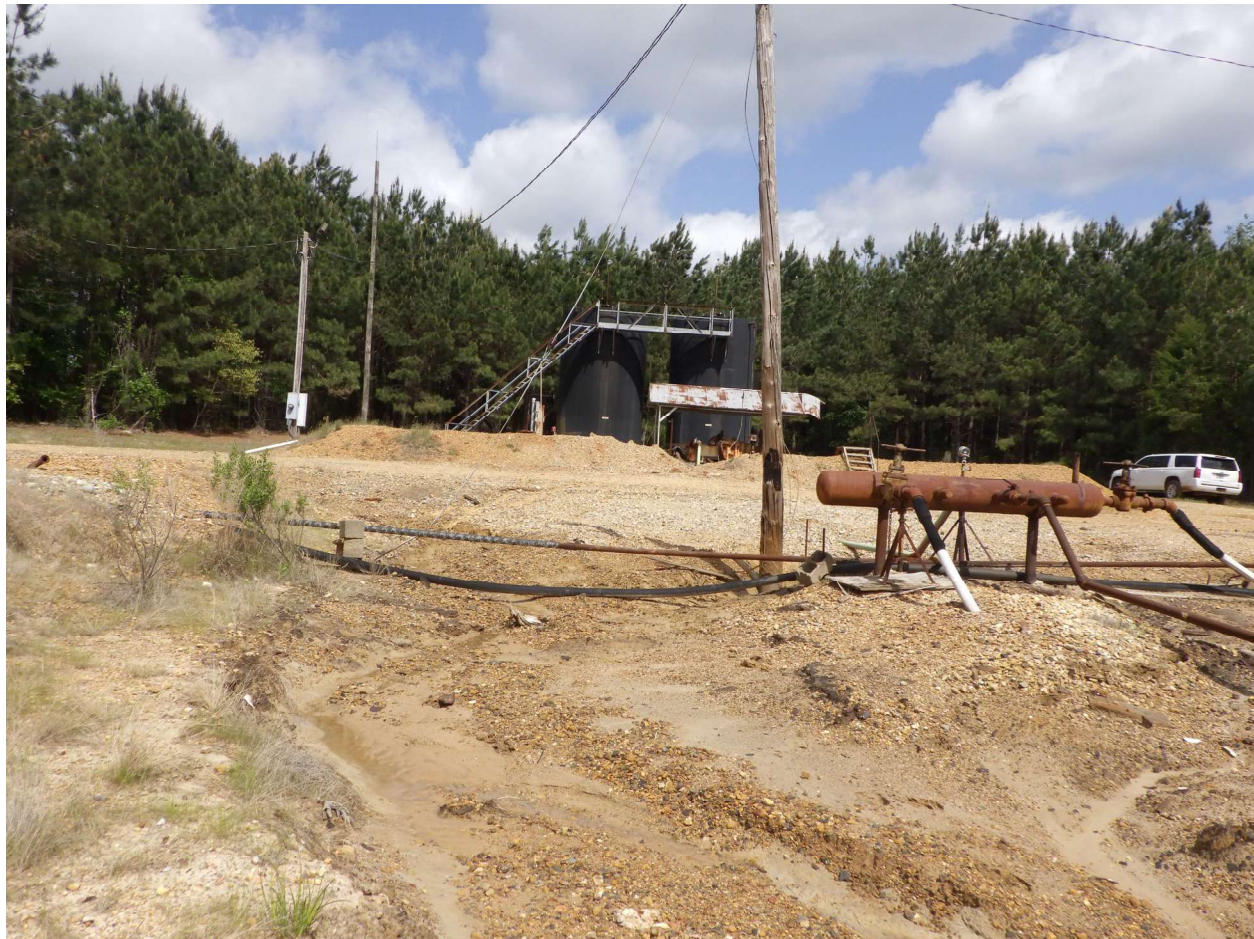
Photo No. 7

I observed the upstream and downstream drainage area for the facility, see Photos No. 7, No. 8, and No. 12.

**Description:** Looking N, this photo shows the upstream drainage area from the tank battery in Photo No. 3.

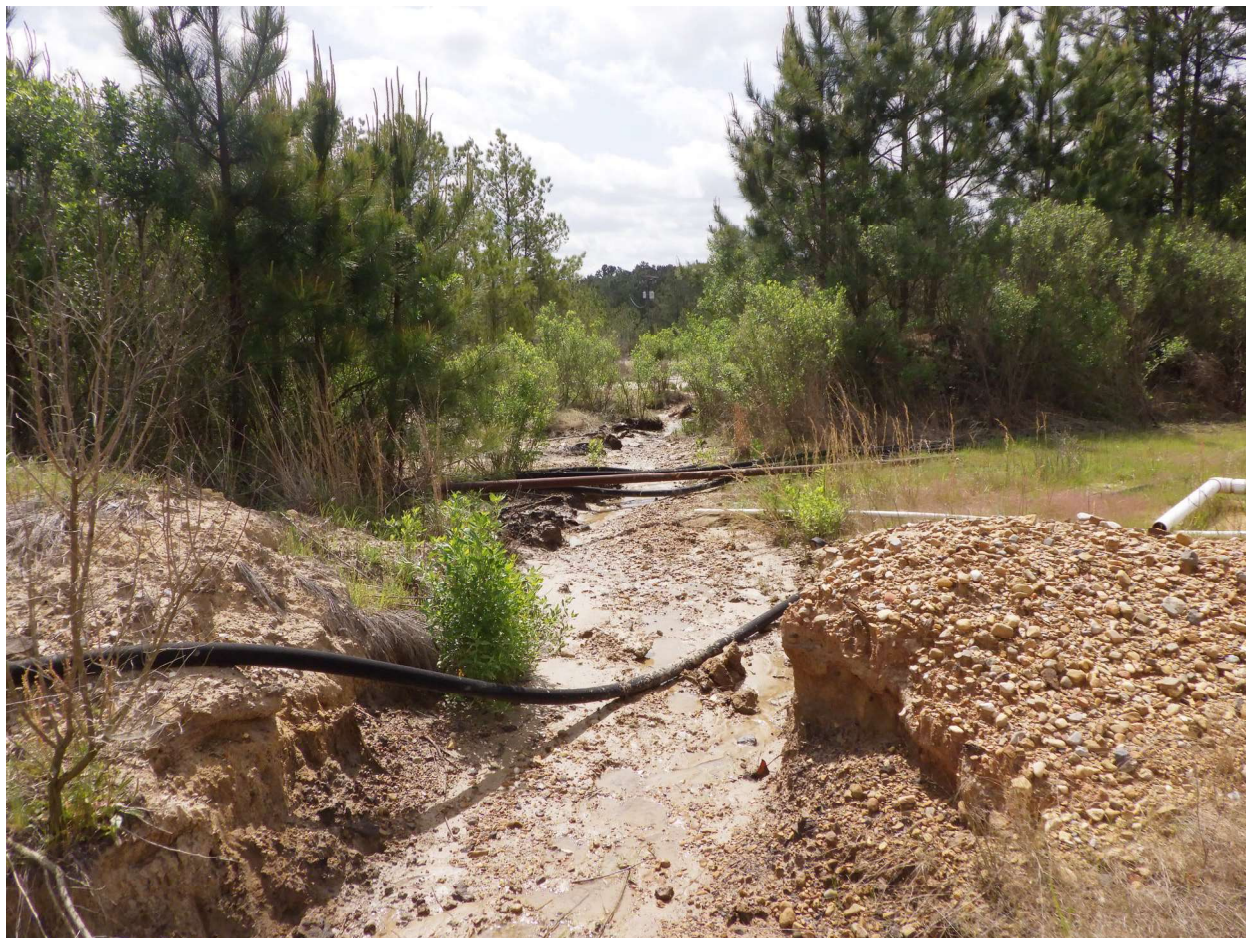
Photo No. 8

**Description:** Looking E, this photo shows the downstream drainage area from the tank battery in Photo No. 3.

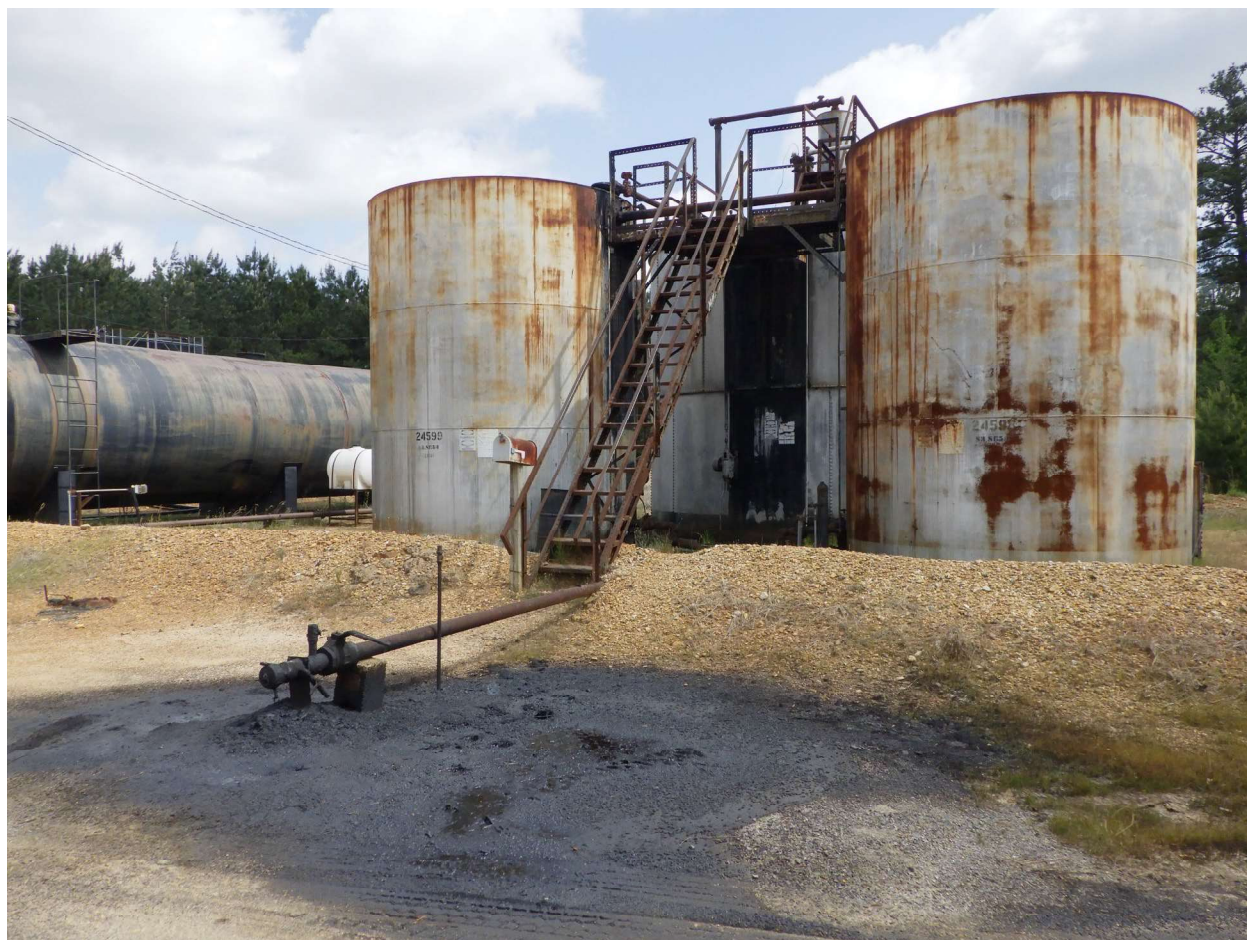
Photo No. 9

I observed a tank battery with two (2) crude oil storage tanks, one (1) gun barrel, and one FWKO tank; a transfer line without a catchment bucket, loose crude oil on the ground outside secondary containment, and a drainpipe without a shutoff valve or cap; see Photos No. 9 through No. 11.

**Description:** Looking NNE, this photo shows three of four tank batteries (crude oil storage) observed at the facility.

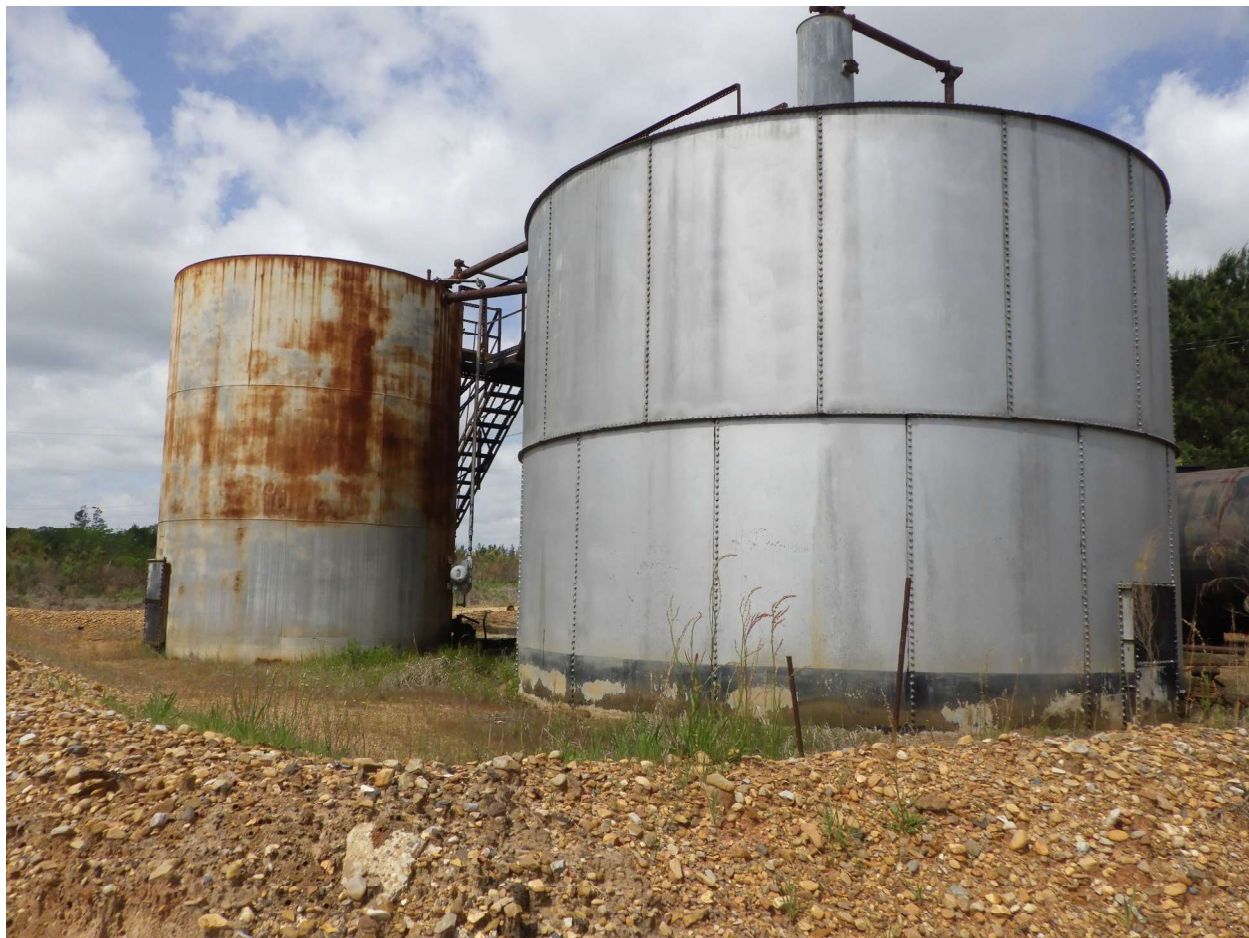
Photo No. 10

**Description:** Looking NNW, this photo shows the backside of the tank battery from Photo No. 9.

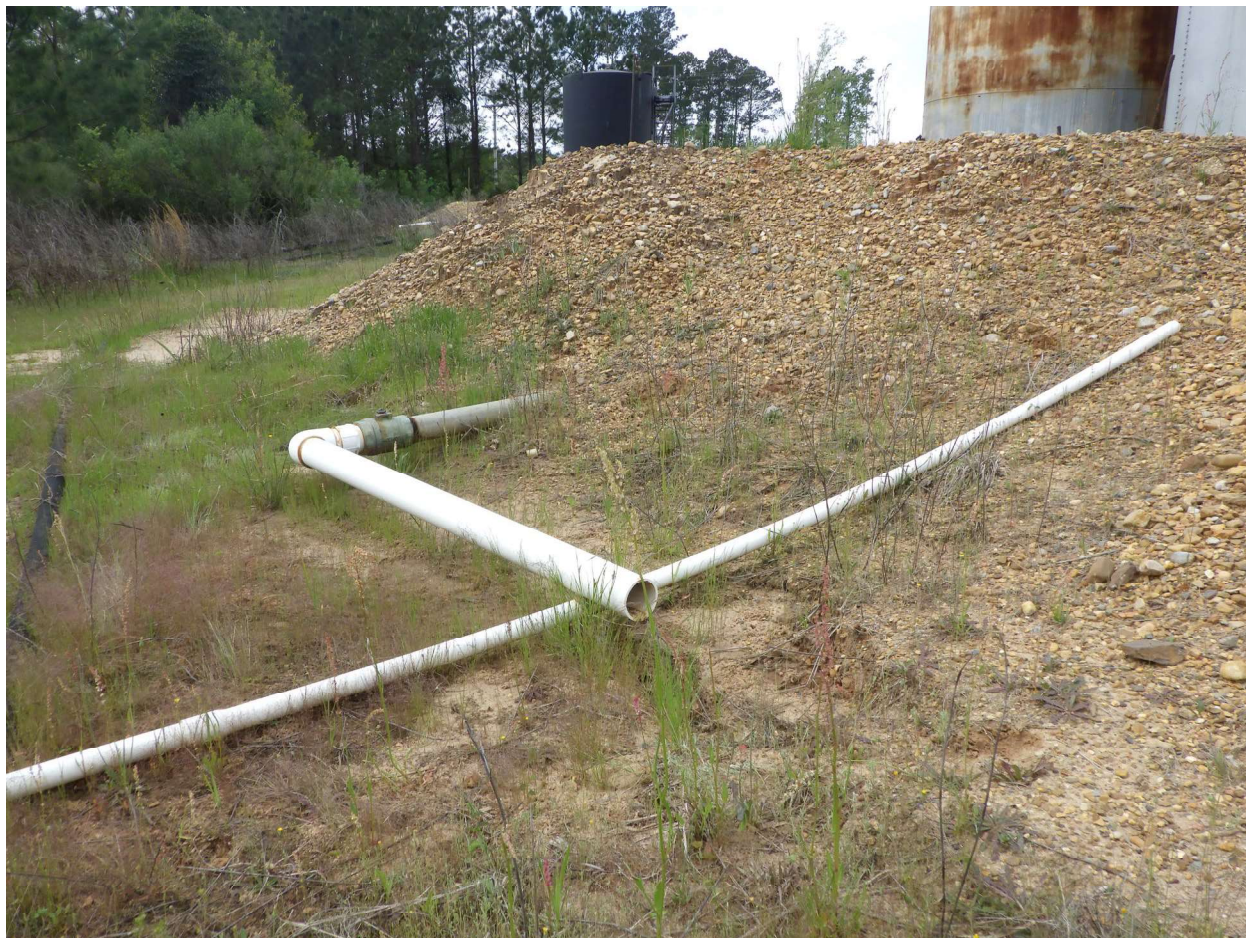
Photo No. 11

**Description:** Looking S, this photo shows the drainpipe for the tank battery in Photo No. 9 without a shutoff valve or cap.

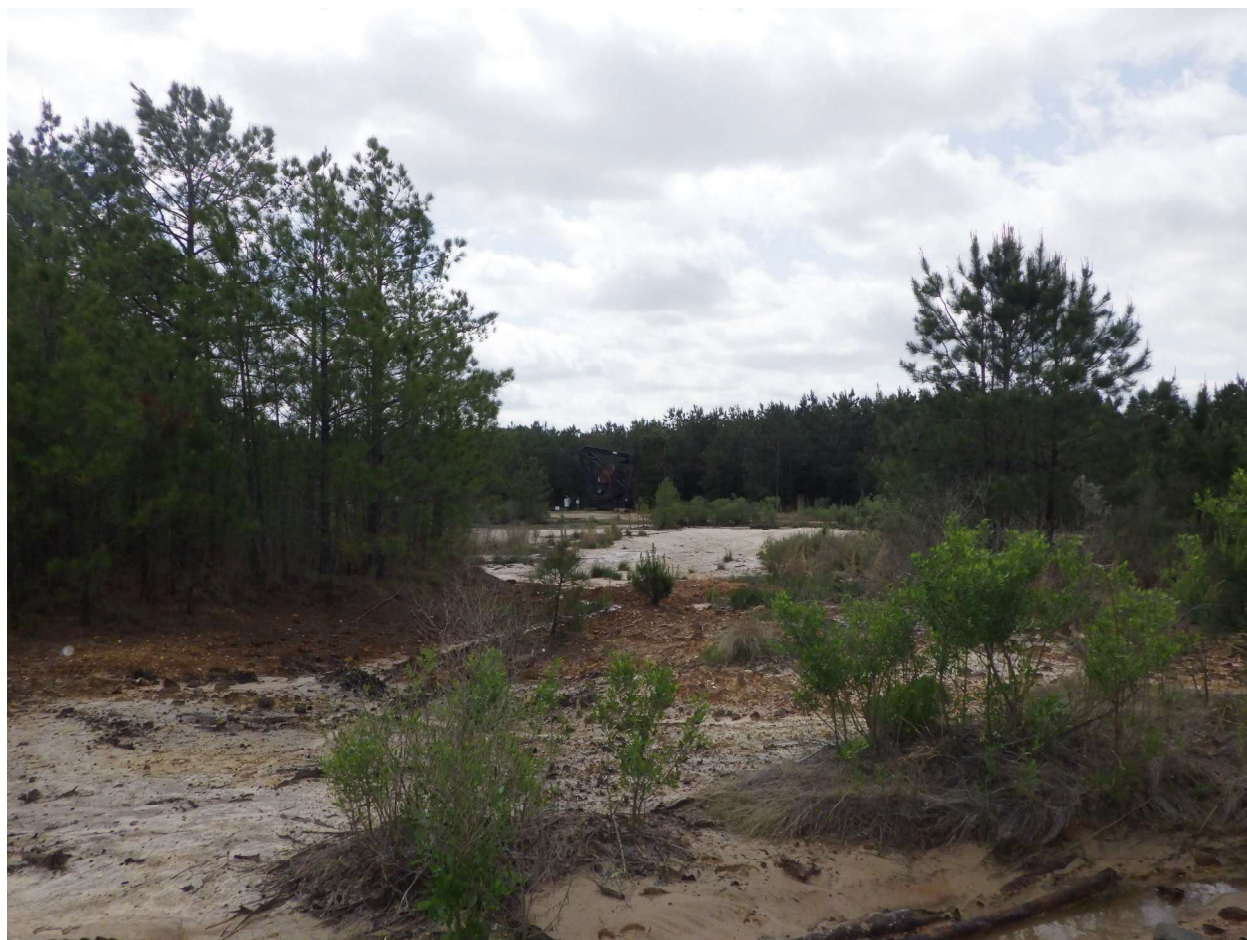
Photo No. 12

**Description:** Looking E, this photo shows an area downstream of the facility that appeared to be impacted by a historic saltwater kill.

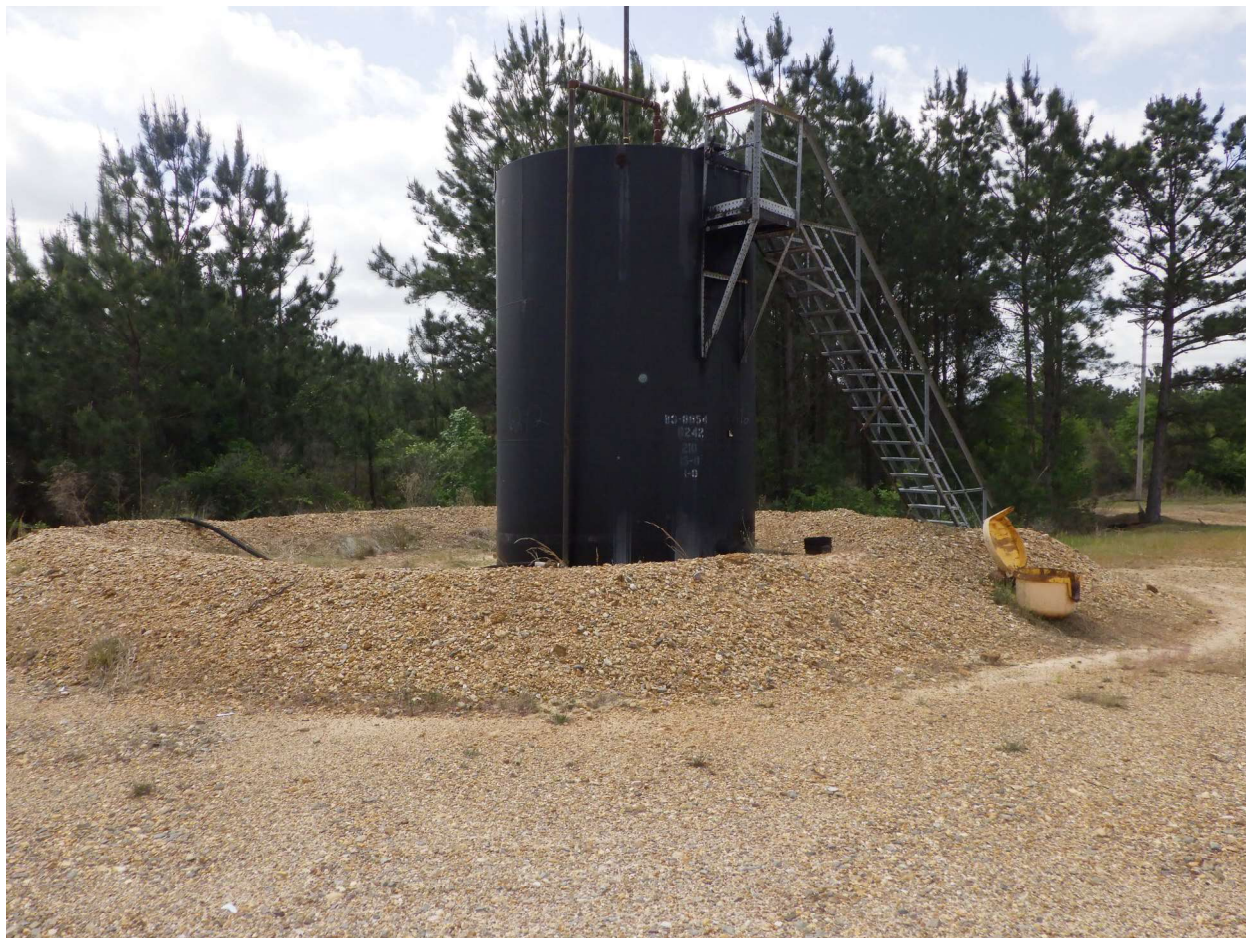
Photo No. 13

I observed a tank battery with one (1) crude oil storage tank and a drainpipe without a shutoff valve or cap, see Photos No. 13 and No. 14.

**Description:** Looking ESE, this photo shows four of four tank batteries observed at the facility.

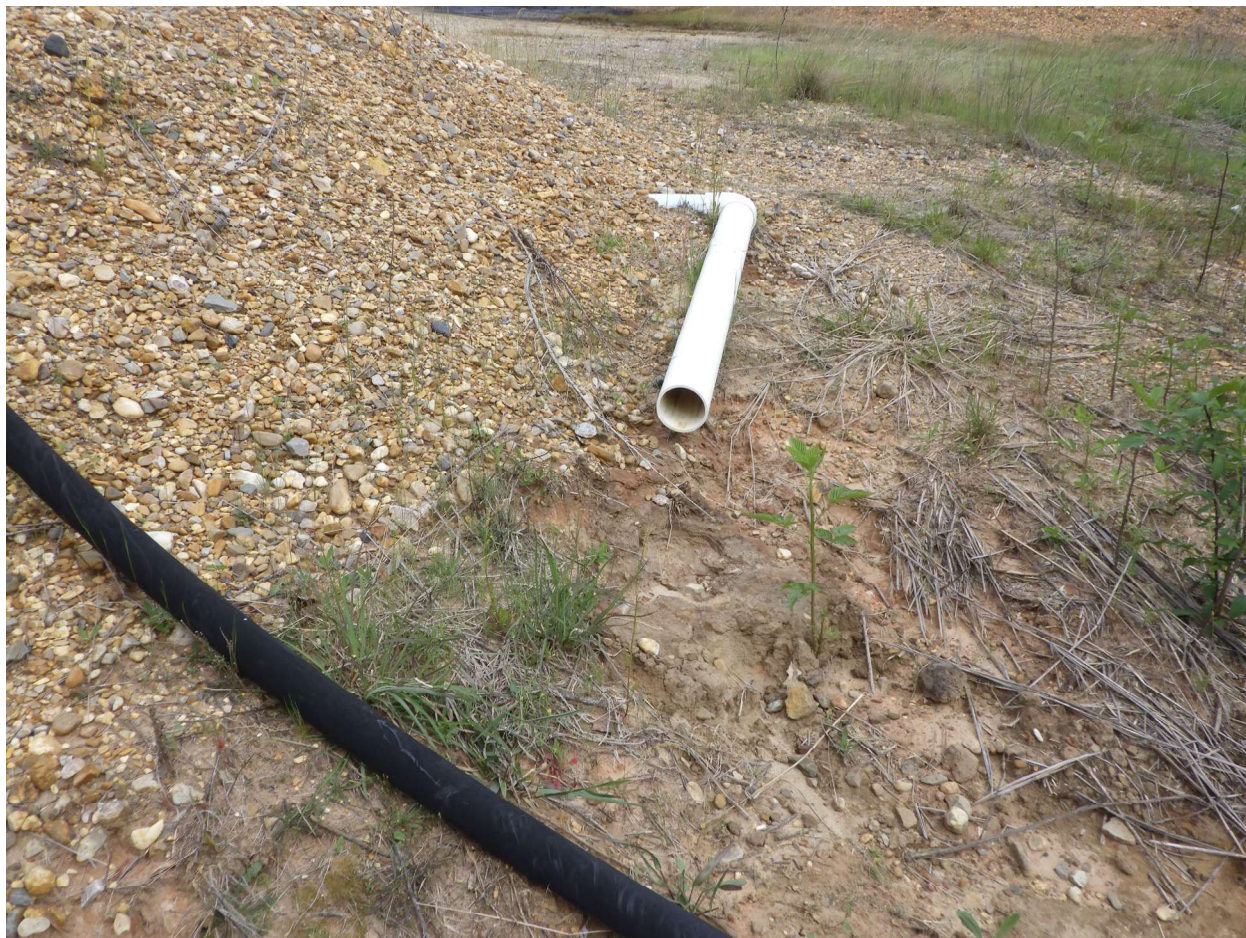
Photo No. 14

**Description:** Looking N, this photo shows the drainpipe for the tank battery in Photo No. 13 without a shutoff valve or cap.
