**Region 6 Compliance Assurance and Enforcement Division  
INSPECTION REPORT**

| Regulatory Program(s) | NPDES - Oil and Gas, Produced/Brine Water | | |
| Company Name: | <b>Perdue Commercial Disposal, LLC</b> | | |
| Facility Name: | <b>Townsend 6 SWD Lease</b> | | |

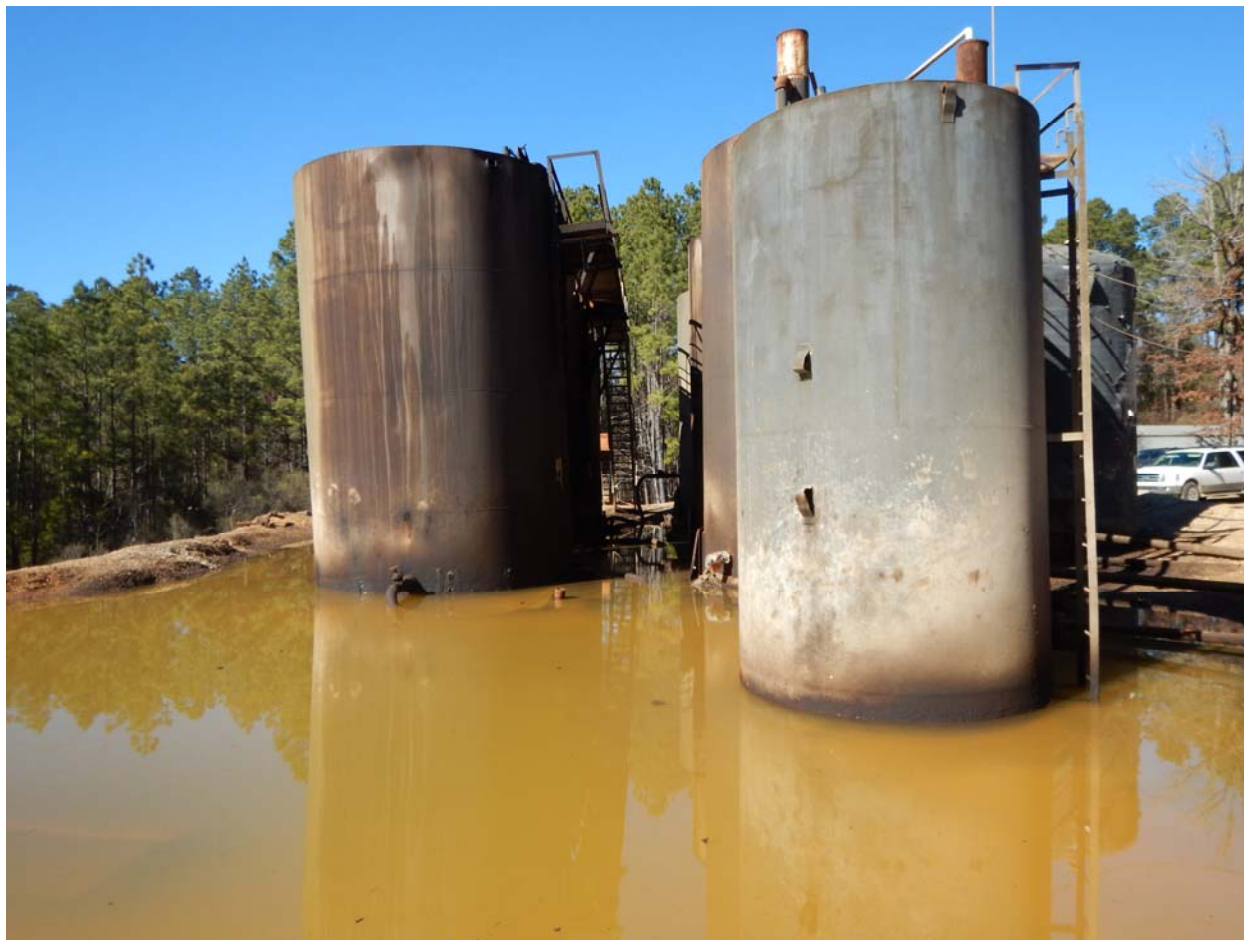
Photo No. 2

Description: This image shows 6 produced water storage tanks, and two oil storage tanks. The facility had a visible erosion on the containment wall, oil staining in the containment area, and visible leaks, corrosion on tanks and flowlines.

The facility is known as the Perdue Commercial Disposal, LLC – Townsend 6 SWD Lease and is located in a remote zone in Strong, Union County, Arkansas (See Photo No. 1 in Appendix 1). The facility consisted of six produced water storage tanks, and two oil storage tanks (See Photo Nos. 2 - 3 in Appendix 1). The tanks were surrounded by a secondary containment wall constructed of compacted soil. The capacity of the tanks to store produced water and oil was approximately 600 barrels. The tanks were connected to production wells, vessels, flow lines, collection points, and other equipment used for the production of crude oil and disposal of produced water. Production wells produce a mixture of produced water and crude oil (well fluids). Flow lines are used to transport well fluids from various locations on the leases. Collection points known as tank batteries consist of various tanks, vessels, and equipment used to separate and store the produced water, brine water, and crude oil. Produced water or brine water is typically high in salts and is commonly known as brine.

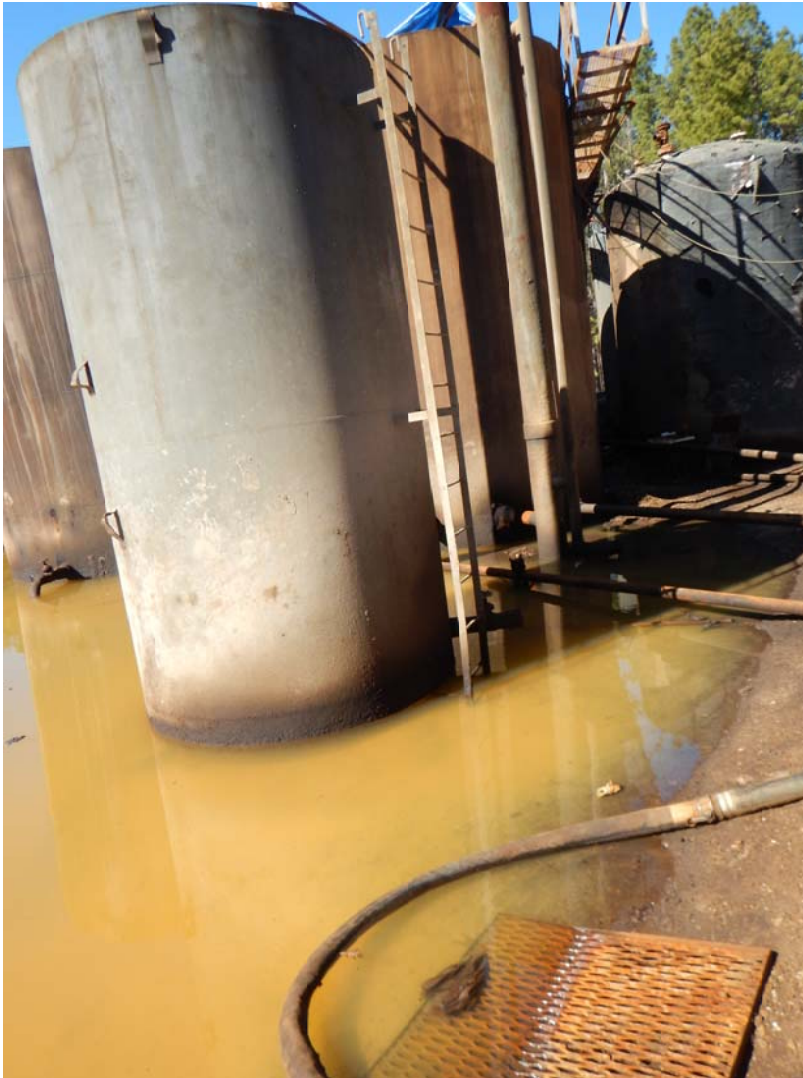
Photo No. 3

Photograph File Name: DSCN3221.JPG  
Date of Photograph: 02/08/2018  
Latitude: 33. 256739 N  
Longitude: -92. 536727 W  
Orientation: W  
Map Datum: WGS-84  
Time of Photo: 2:59 PM  
Photographer: Jack Arias  
Description: This image shows tanks and fluids around tanks.

At the time of the inspection, at approximately five feet from the tanks, using a calibrated YSI 30 Pro Conductivity Meter, at latitude 33.256739 N and longitude -92.536727 W, we took a Total Dissolved Solids (TDS) measurement of 19,581 ppm in the containment area near the oil and produced water storage tanks (See Photo Nos. 3 - 4 in Appendix 1).

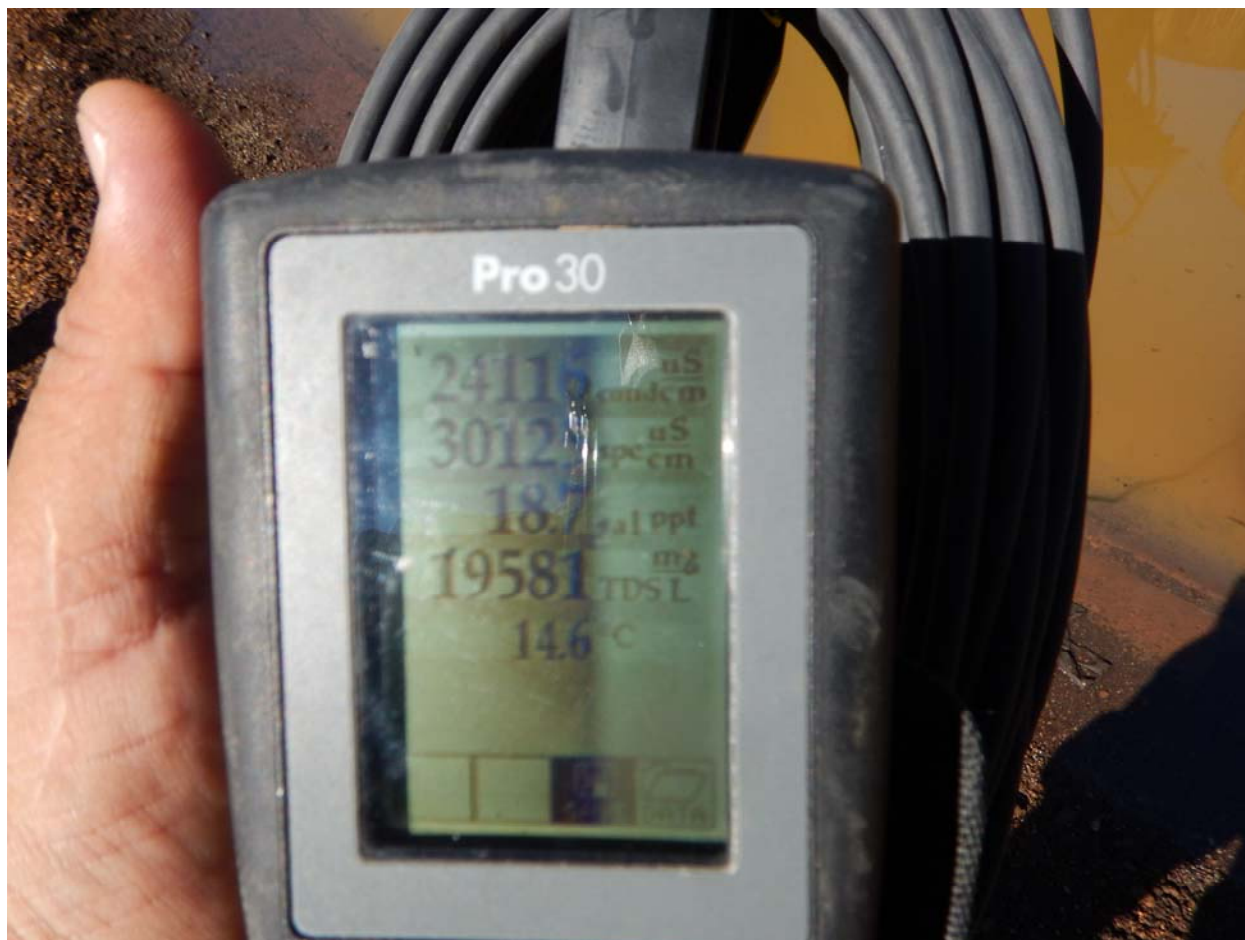
Photo No. 4

Description: This image shows a Total Dissolved Solids (TDS) measurement of 19,581 ppm in the containment area near the oil and produced water storage tanks.

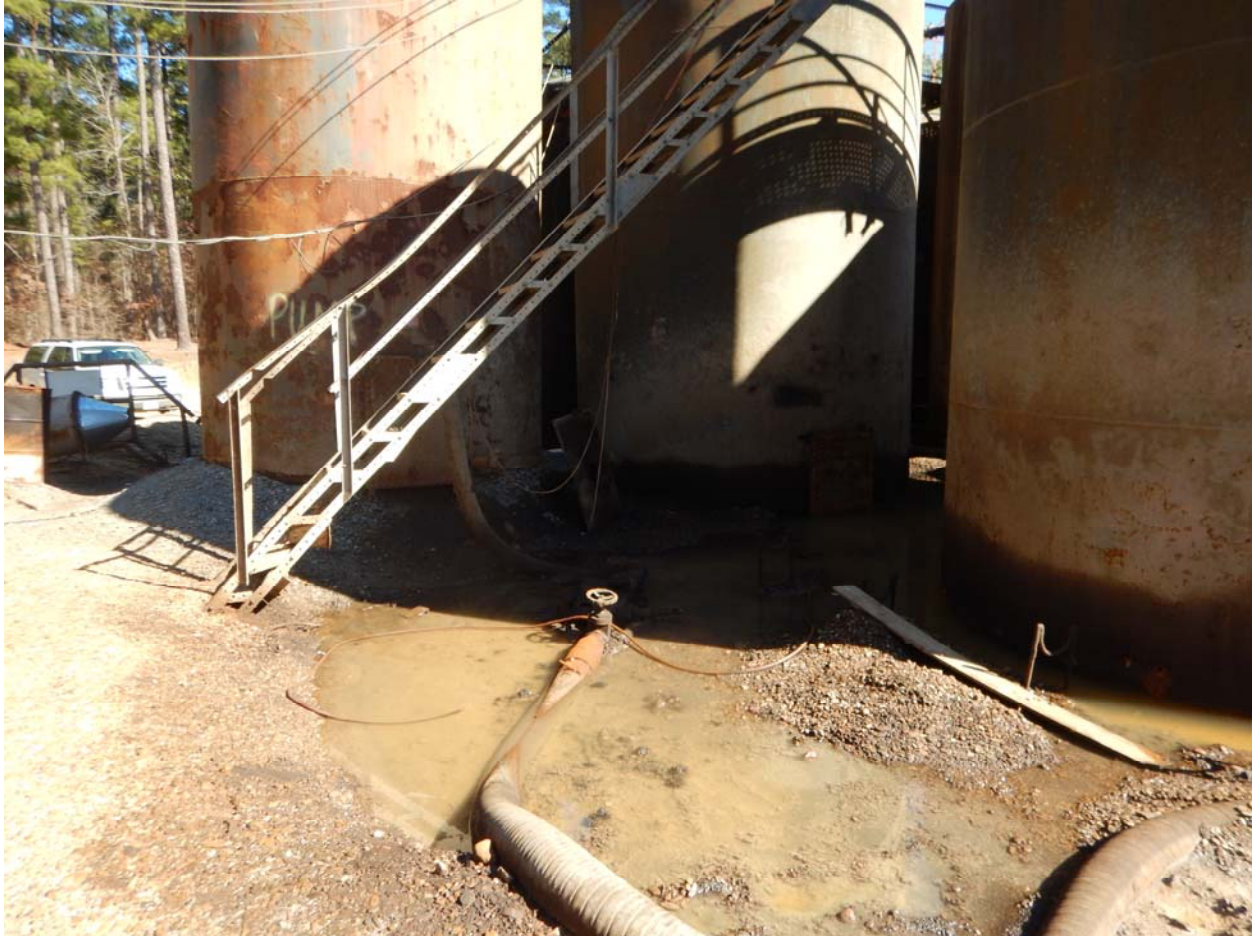
Photo No. 5

Description: This image shows tanks, flowlines, and fluids in the containment area near the oil and produced water storage tanks.

At the time of the inspection, at the north east and north west corners of the containment area, we observed that the fluids nearly overflow and reach the level of the secondary containment wall around the oil and produced water storage tanks (See Photo Nos. 4 – 5 in Appendix 1). At this point at latitude 33.256500 N and longitude -92.536778 W, using a calibrated YSI 30 Pro Conductivity Meter, I took a TDS measurement of 17,676 ppm. (See Photo Nos. 5 – 8 in Appendix 1).

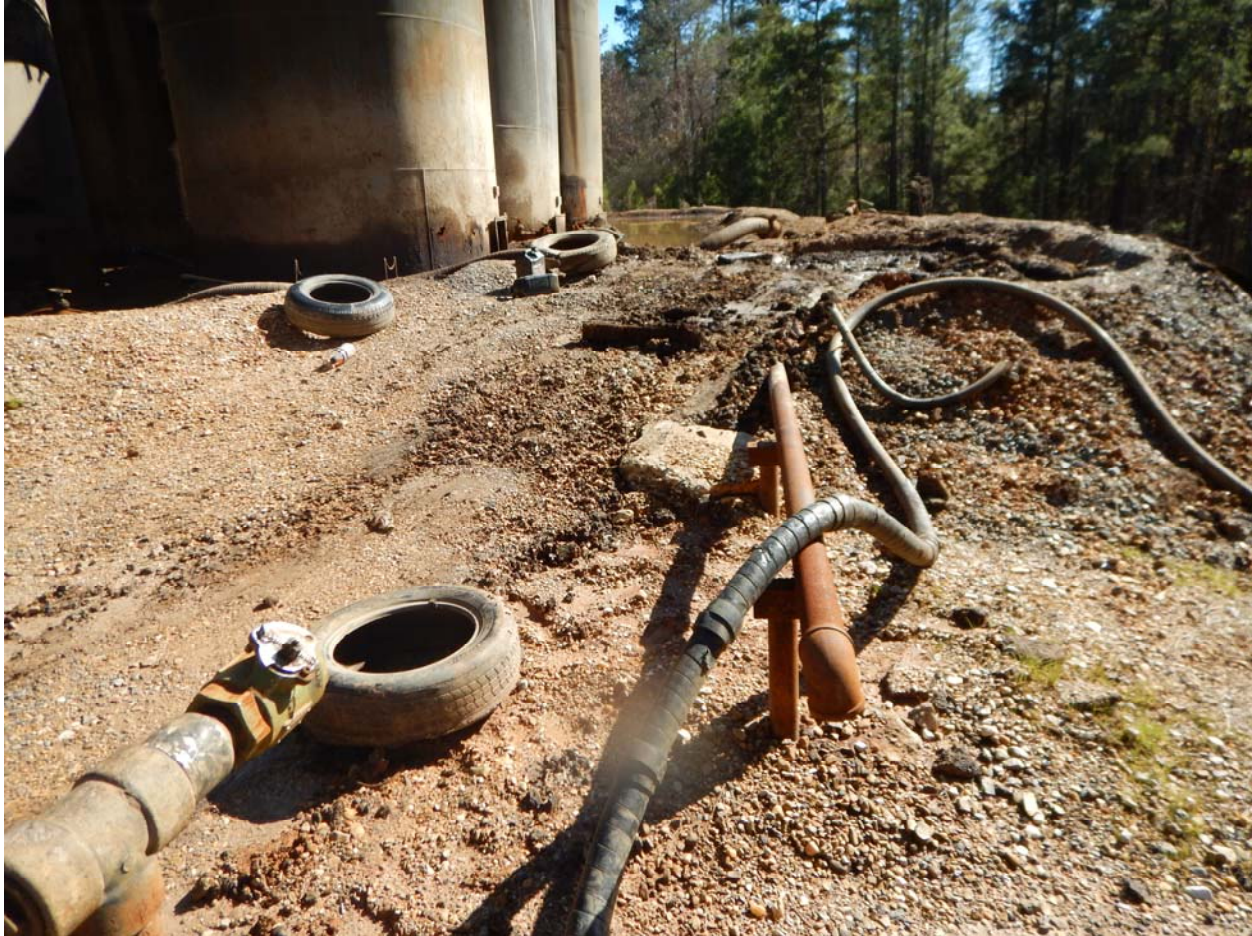
Photo No. 6

Description: This image shows flowlines and fluids nearly overflowing the secondary containment wall around the oil and produced water storage tanks.

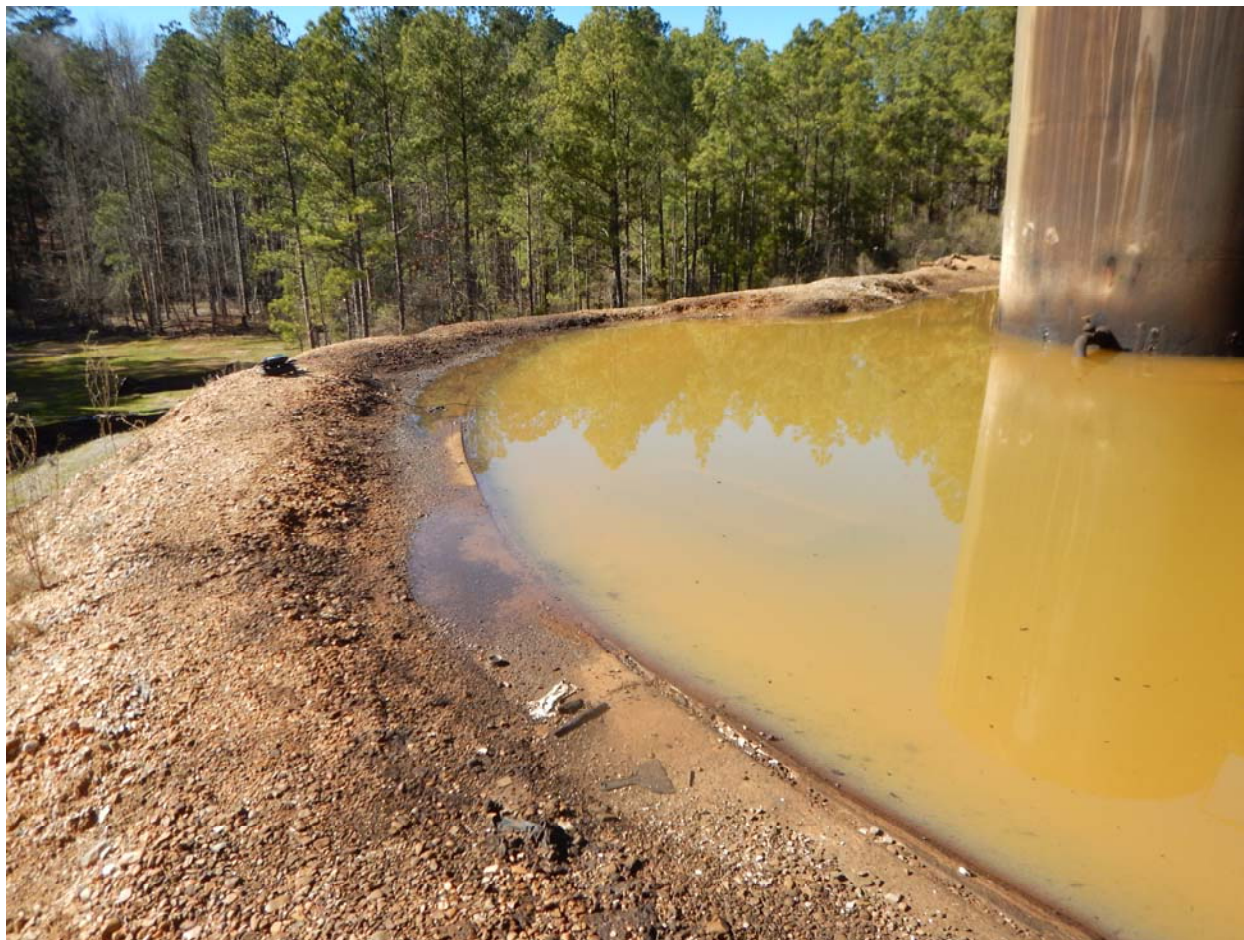
Photo No. 7

Description: This image shows fluids nearly overflowing the secondary containment wall around the oil and produced water storage tanks.

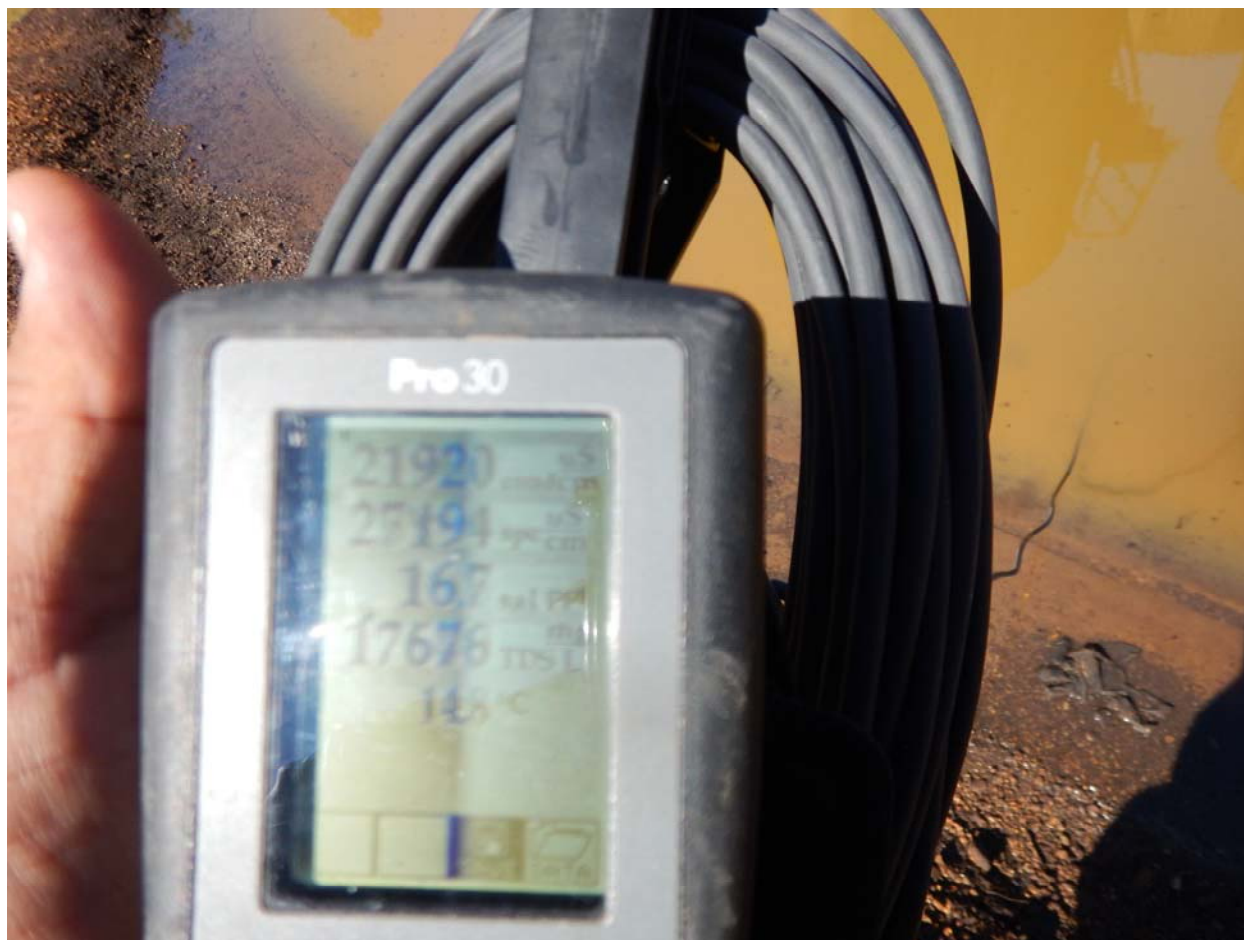
Photo No. 8

Description: This image shows a Total Dissolved Solids (TDS) measurement of 17,676 ppm in the containment area near the oil and produced water storage tanks.

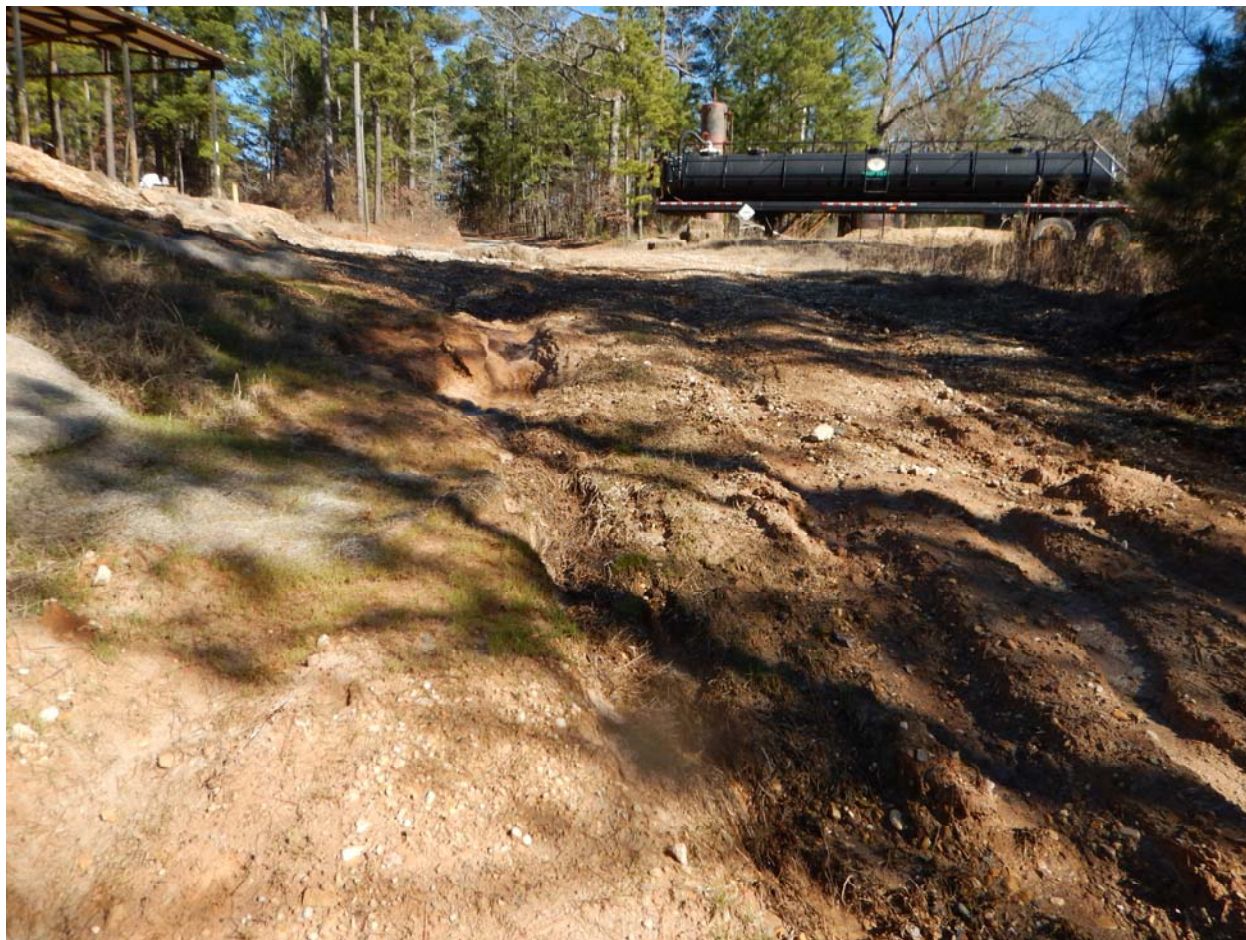
Photo No. 9

Description: This image shows a flow path of fluids going downstream to the tributary of Mill Creek. This point is located at the west corner of the containment area at approximately 10 feet from the containment area.

Next to the west corner of the containment area at approximately 10 feet from the containment area, we observed a flow path of fluids going downstream to the tributary of Mill Creek. At this point at latitude 33.256444 N and longitude -92.536750 W, using a calibrated YSI 30 Pro Conductivity Meter, we took a TDS measurement of 7,177 ppm. (See Photo Nos. 9 – 10 in Appendix 1).

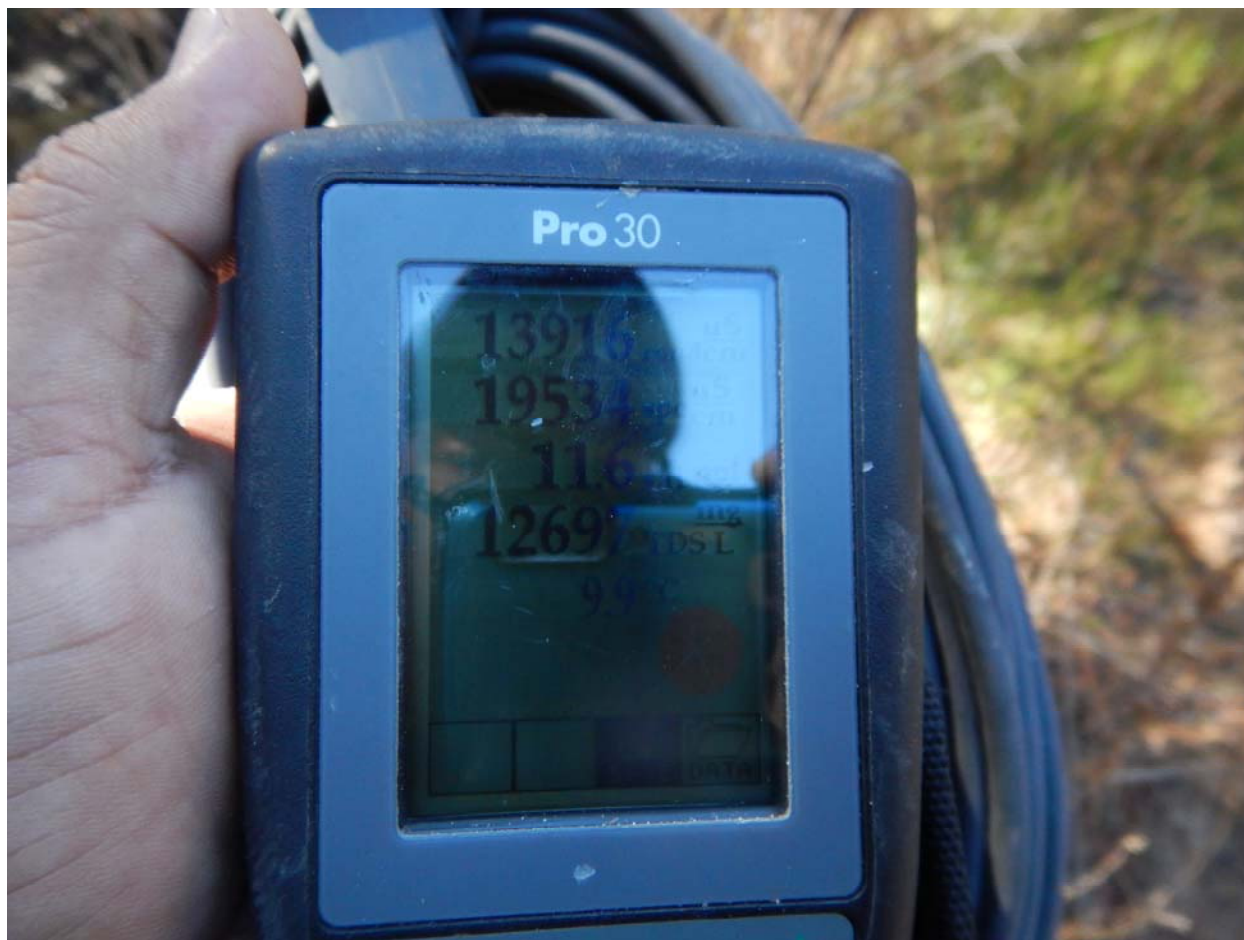
Photo No. 12

Description: This image shows a Total Dissolved Solids (TDS) measurement of 12,697 ppm at the POE to the tributary of Mill Creek.

we followed the flow path downstream from the facility to tributary of Mill Creek and at approximately 180 feet from the facility to the tributary, we identified the Point of Entry (POE) at latitude 33.256375 N and longitude -92.537334 W. At this point, using a calibrated YSI 30 Pro Conductivity Meter, we took a Total Dissolved Solids (TDS) measurement of 12,697 ppm. At this point, we observed dead vegetation, defined bed and bank, high water marks, debris, and riparian vegetation growing along the tributary. (See Photo Nos. 11 – 12 in Appendix 1).

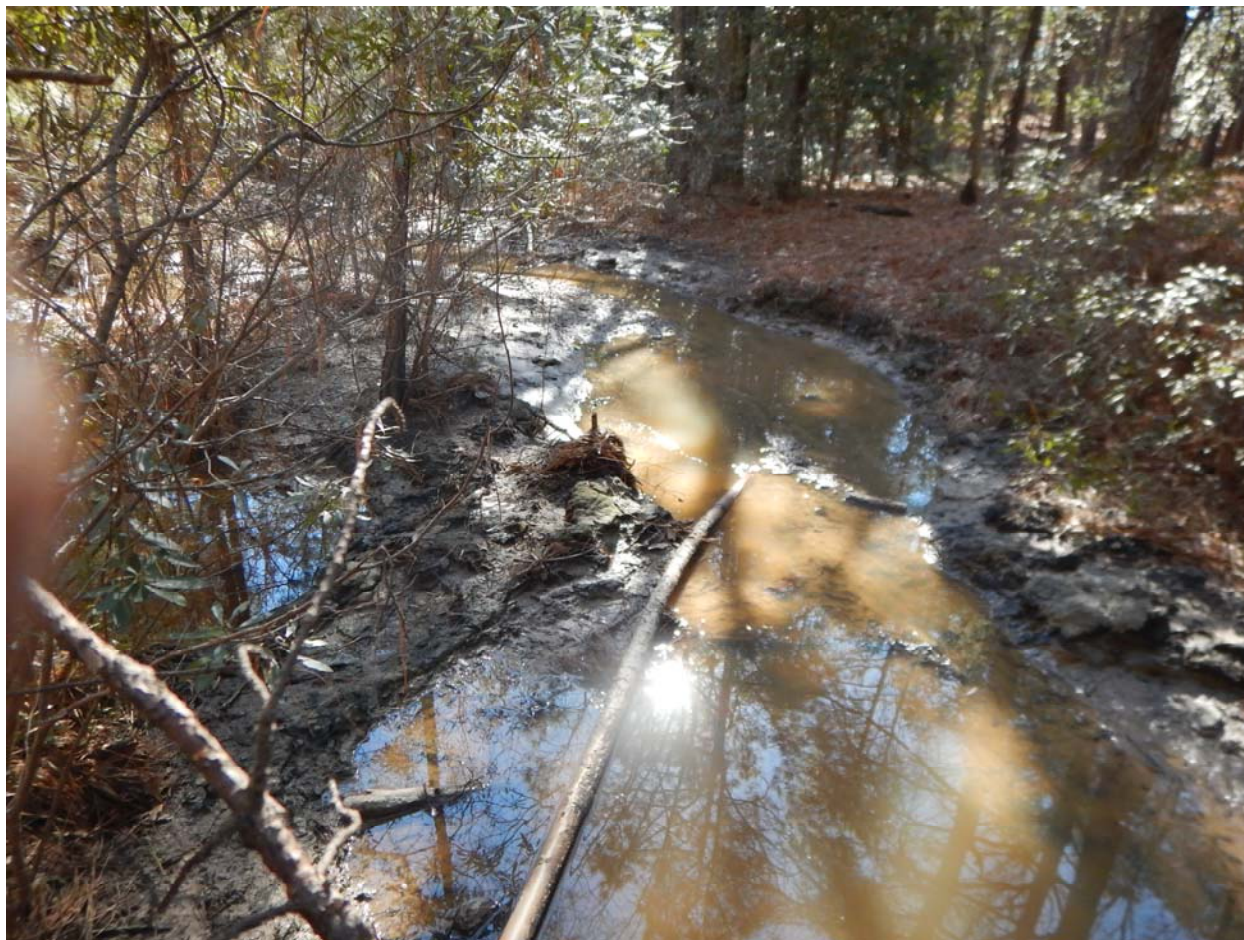
Description: This image shows a flow path of fluids and a downstream low lying areas and impacted vegetation along the tributary of Mill Creek.

We followed the tributary downstream to determine if low lying areas and potential vegetation along the tributary were impacted by oil and produced water discharges. At approximately 200 feet downstream from the POE at latitude 33.255917 N and longitude -92.537286 W, we found a flow path of fluids with oil staining on vegetation and debris, dead vegetation, and debris along the tributary. At this point, using a calibrated YSI 30 Pro Conductivity Meter, we took a TDS measurement of 7,638 ppm (See Photo No. 13 – 15 in Appendix 1).

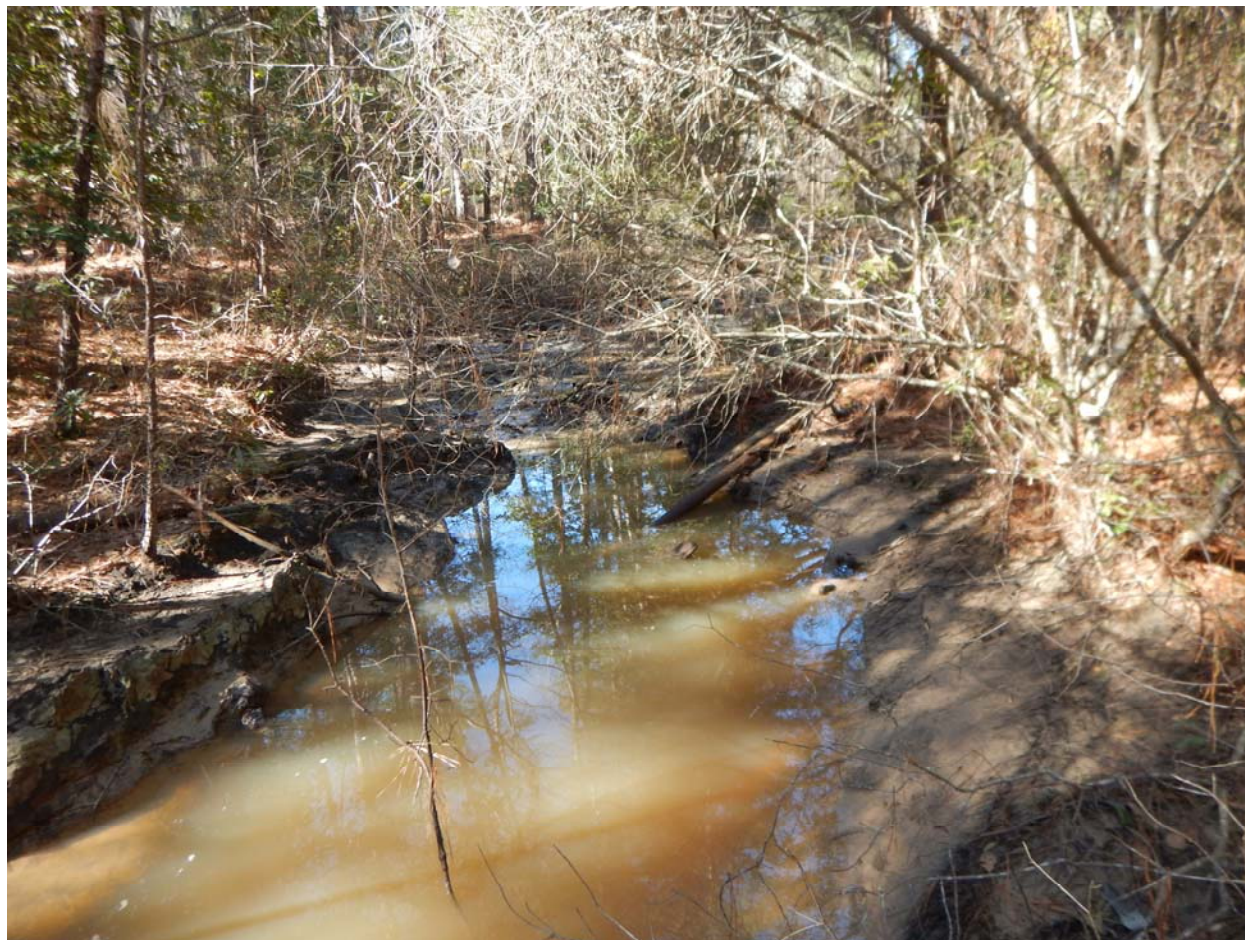
Photo No. 14

Description: This image shows a flow path of fluids and a downstream area with impacted vegetation along the tributary of Mill Creek.

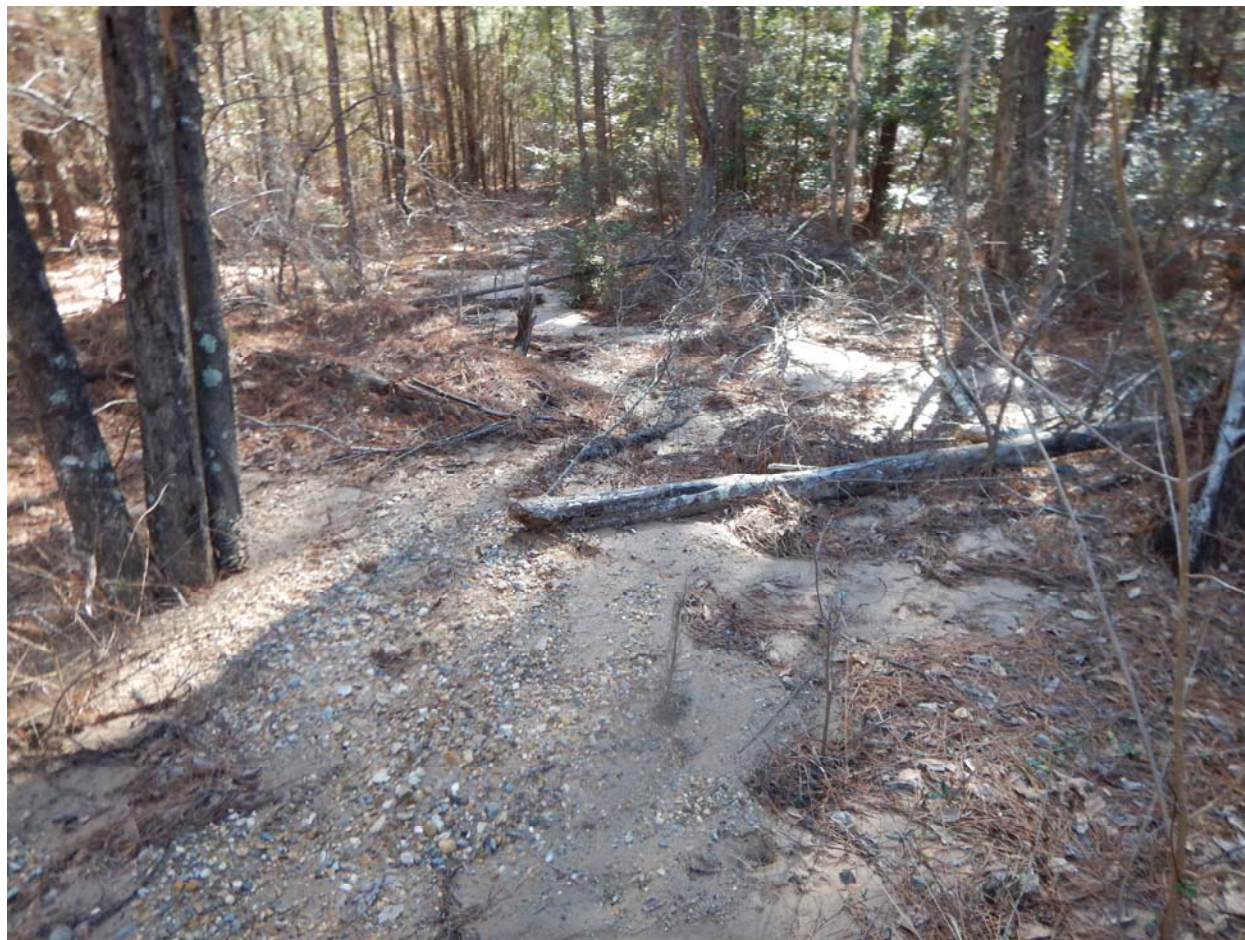
Photo No. 16

Description: This image shows a flowpath of the tributary of Mill Creek with dead vegetation.

We followed the tributary of North Lapile Creek approximately 700 feet downstream from the POE and we still observed fluids, dead vegetation along the tributary, and a high TDS measurement (See Photo No. 15 - 16 in Appendix 1).
