## **RCRA Inspection Report**

Stella-Jones Corporation  
13539 Highway 45  
Scooba, Mississippi 39358  
EPA ID# MSD985980846  
NAICS: 321114 – Wood Preservation

March 9, 2021, 10:15 hours

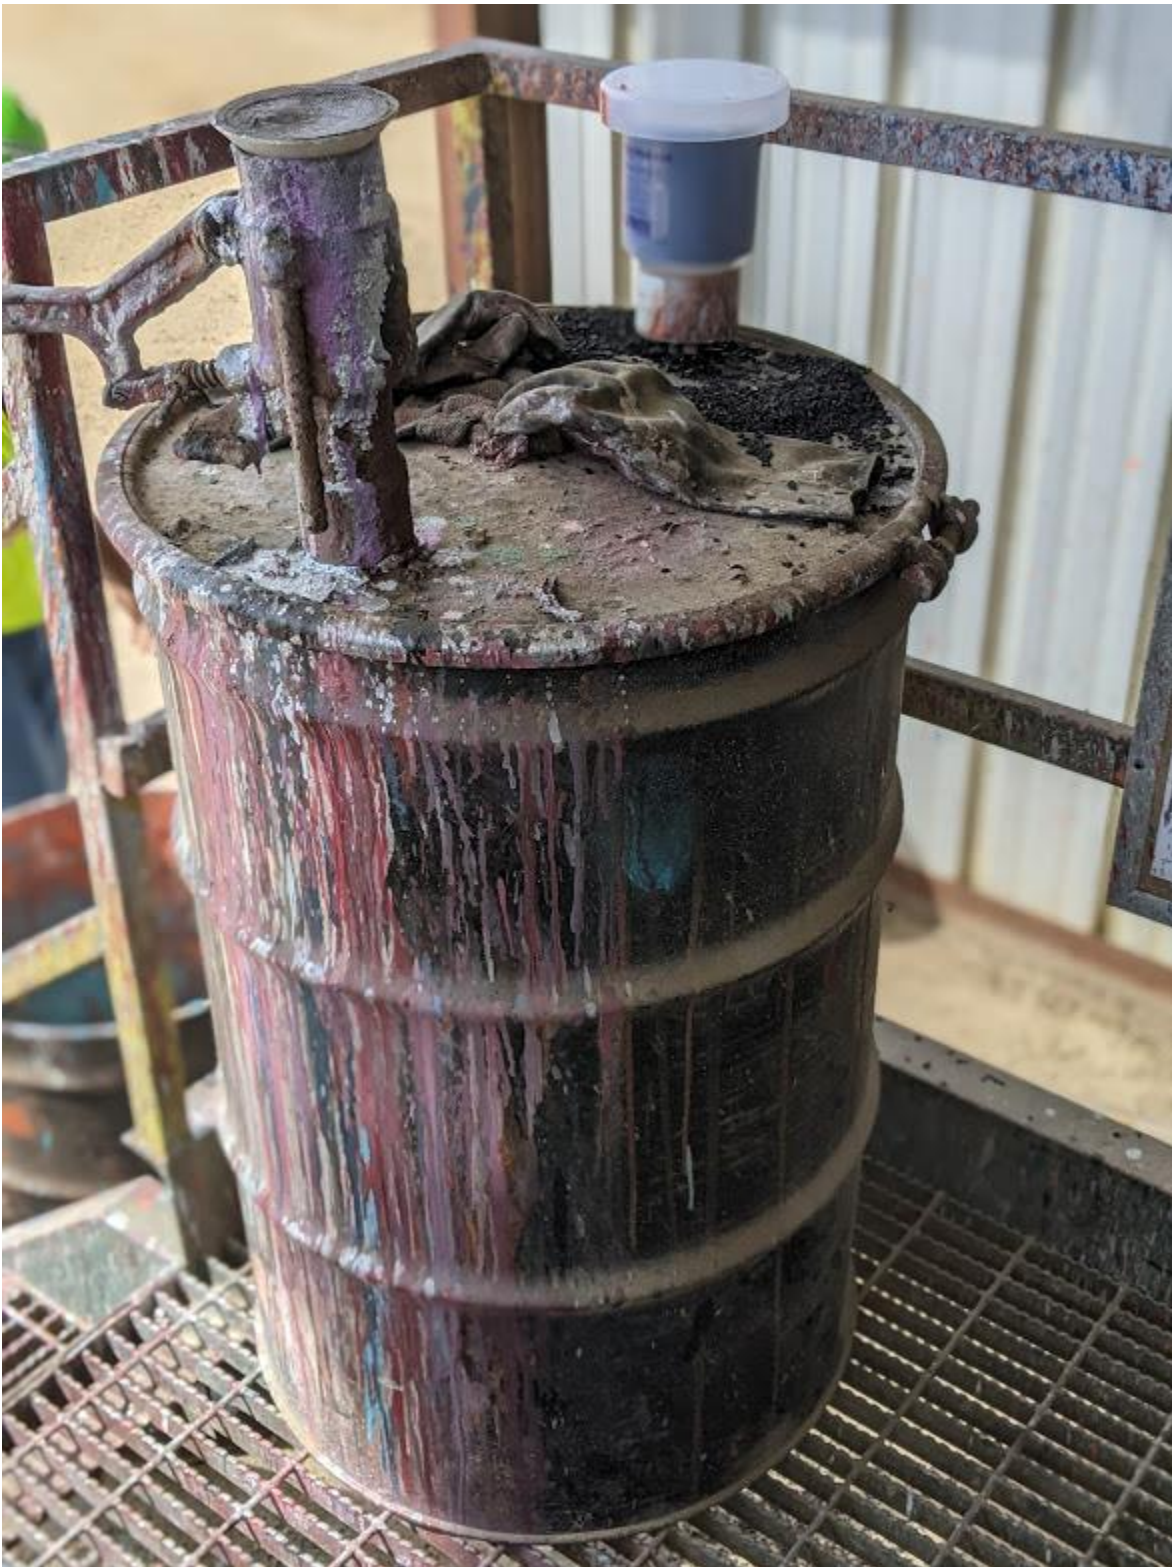
The facility has two 10 ft<sup>3</sup> kilns, a 400-horsepower boiler and 100-horsepowered diesel boiler to aid or act as a backup for the drying process of the poles. The drying process takes about 8 hours from start to finish. This area has a 55-gallon SAA container used to collect hazardous waste from punctured aerosol cans. This container was not labeled "Hazardous Waste" (Photograph 1 of 3).

Photograph 1 of 3: SAA Container for hazardous waste from punctured aerosols

**Pursuant to 11 Miss. Admin. Code Pt. 3, R. 1.3 [40 C.F.R. § 262.15(a)(5)], which is a condition of the SAA Permit Exemption, a generator is required to mark or label its containers (i) with the words “Hazardous Waste”.**

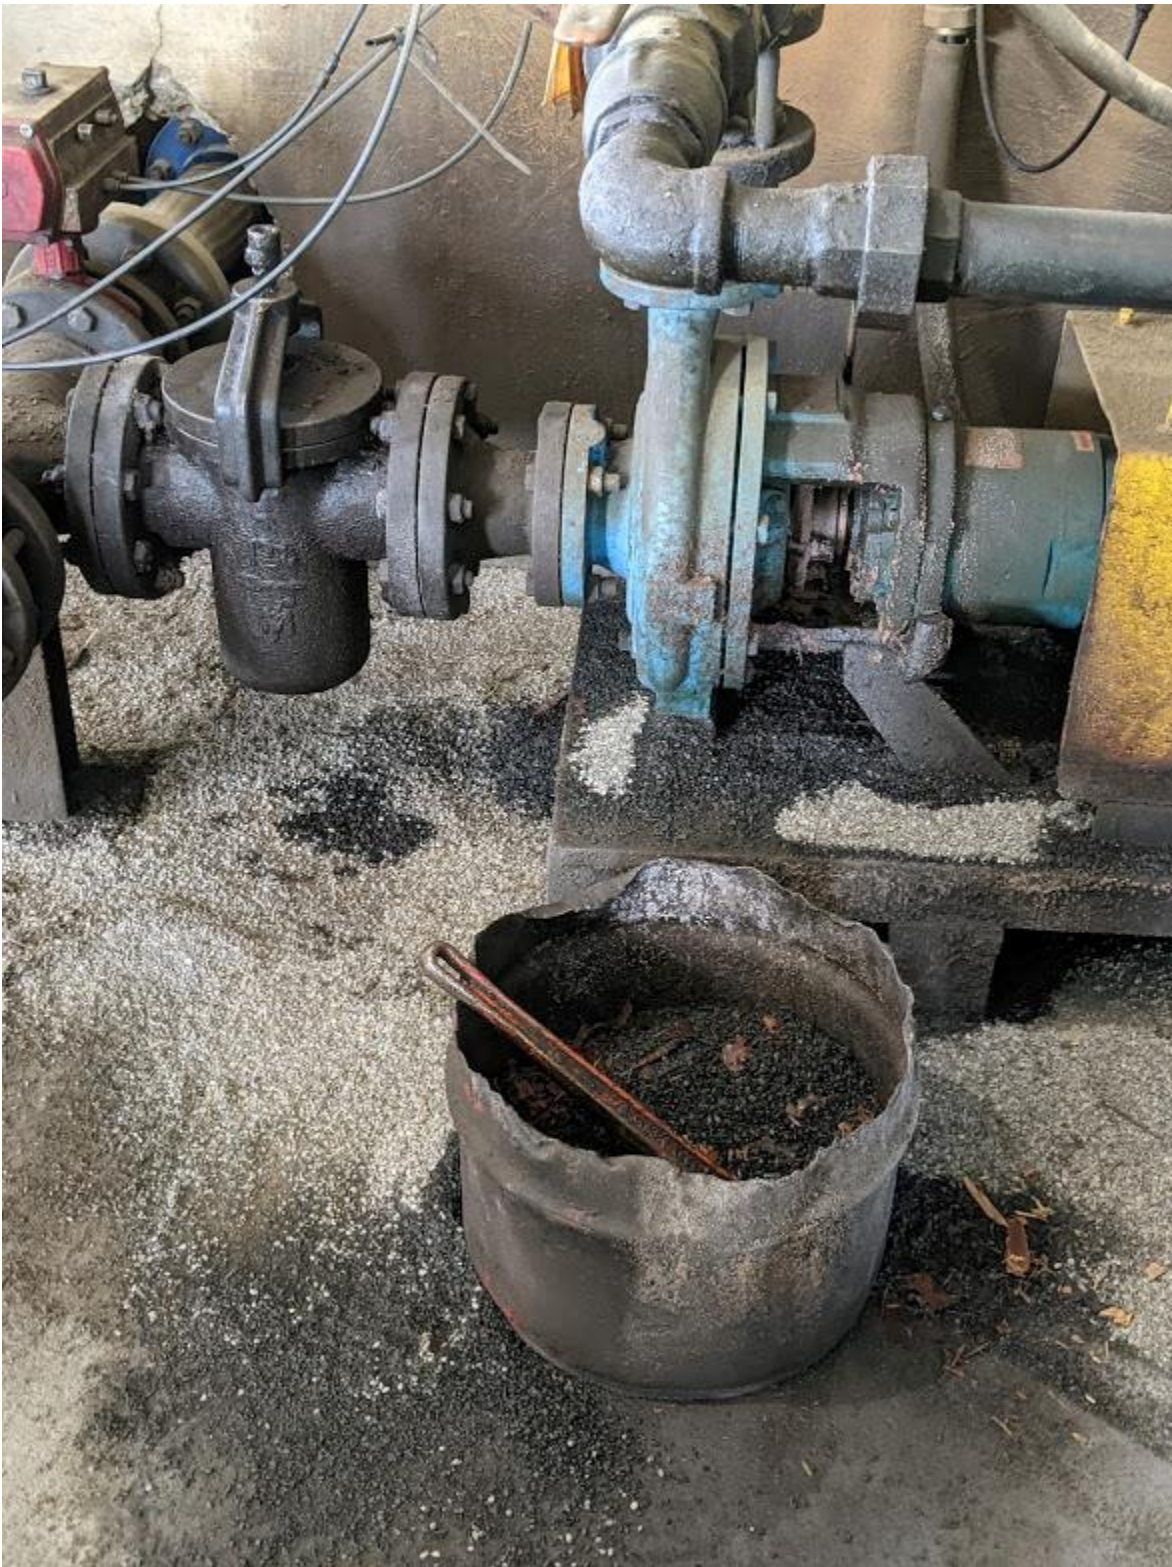
Located adjacent to the filter where pentachlorophenol-diesel mixture passes through, one 55-gallon SAA container storing F032 hazardous waste was being used to collect any incidental spills. This container was closed, labeled “Hazardous Waste” and labeled with the characteristic of the hazardous contents. One approximate 2.5-gallon transfer container used to catch incidental spills from filter change outs contained F032 hazardous waste. This 2.5-gallon SAA container was not labeled “Hazardous Waste” or labeled with the hazardous contents of the container, and the container was not closed (Photograph 2 of 3).

Photograph 2 of 3: SAA container used to collect incidental spills from filtration of hazardous material

**Pursuant to 11 Miss. Admin. Code Pt. 3, R. 1.3 [40 C.F.R. § 262.15(a)(4)], which is a condition of the SAA Permit Exemption, a generator is required to keep containers of hazardous waste closed at all times during accumulation, except when adding, removing, or consolidating waste; or when temporary venting of a container is necessary for the proper operation of equipment, or to prevent dangerous situations, such as build-up of extreme pressure.**

**Pursuant to 11 Miss. Admin. Code Pt. 3, R. 1.3 [40 C.F.R. § 262.15(a)(5)], which is a condition of the SAA Permit Exemption, a generator is required to mark or label its containers (i) with the words “Hazardous Waste” and (ii) with an indication of the hazards of the contents.**

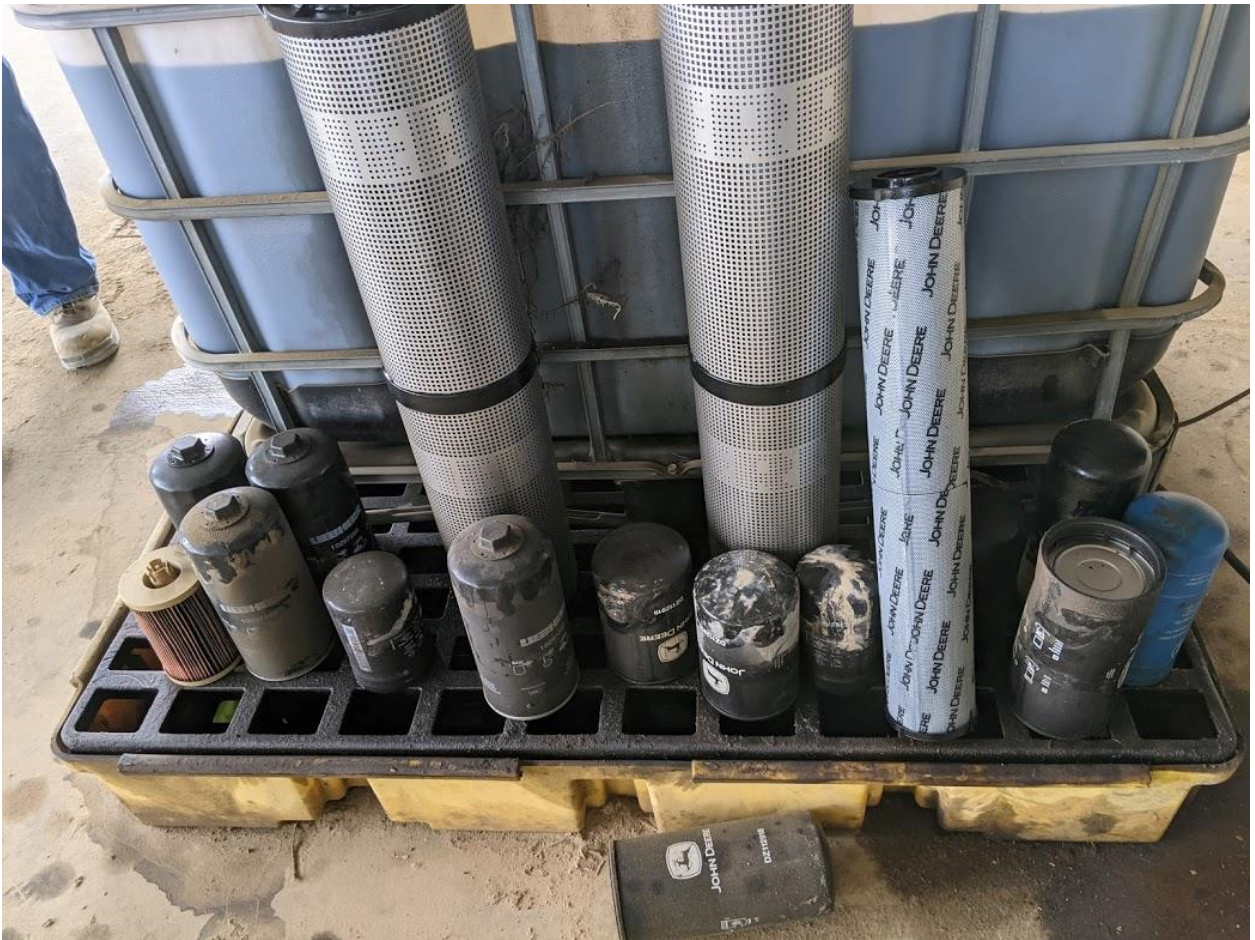
Also located in the treatment area is a 250-gallon tote for the collection of used oil. At the time of the inspection, this container was labeled. A yellow secondary container was being used to collect used oil from oil filter canisters. This container was not labeled “Used Oil” (Photograph 3 of 3).

Photograph 3 of 3: Yellow secondary containment for used oil

**Pursuant to 11 Miss. Admin. Code Pt. 3, R. 1.22 [40 C.F.R. § 279.22(c)(1)], containers and aboveground tanks used to store used oil at generator facilities must be labeled or marked clearly with the words “Used Oil.”**
