## Clean Water Act Section 404: Site Visit/Case Development

| Site Name | SVG Holdings, LLC Property - 260 Bruyn Turnpike | | | | |

| Inspection Purpose | Follow-up site visit | | |

CWA 404 Inspection  
SVG Holdings Property  
260 Bruyn Turnpike  
Wallkill, Ulster County, NY

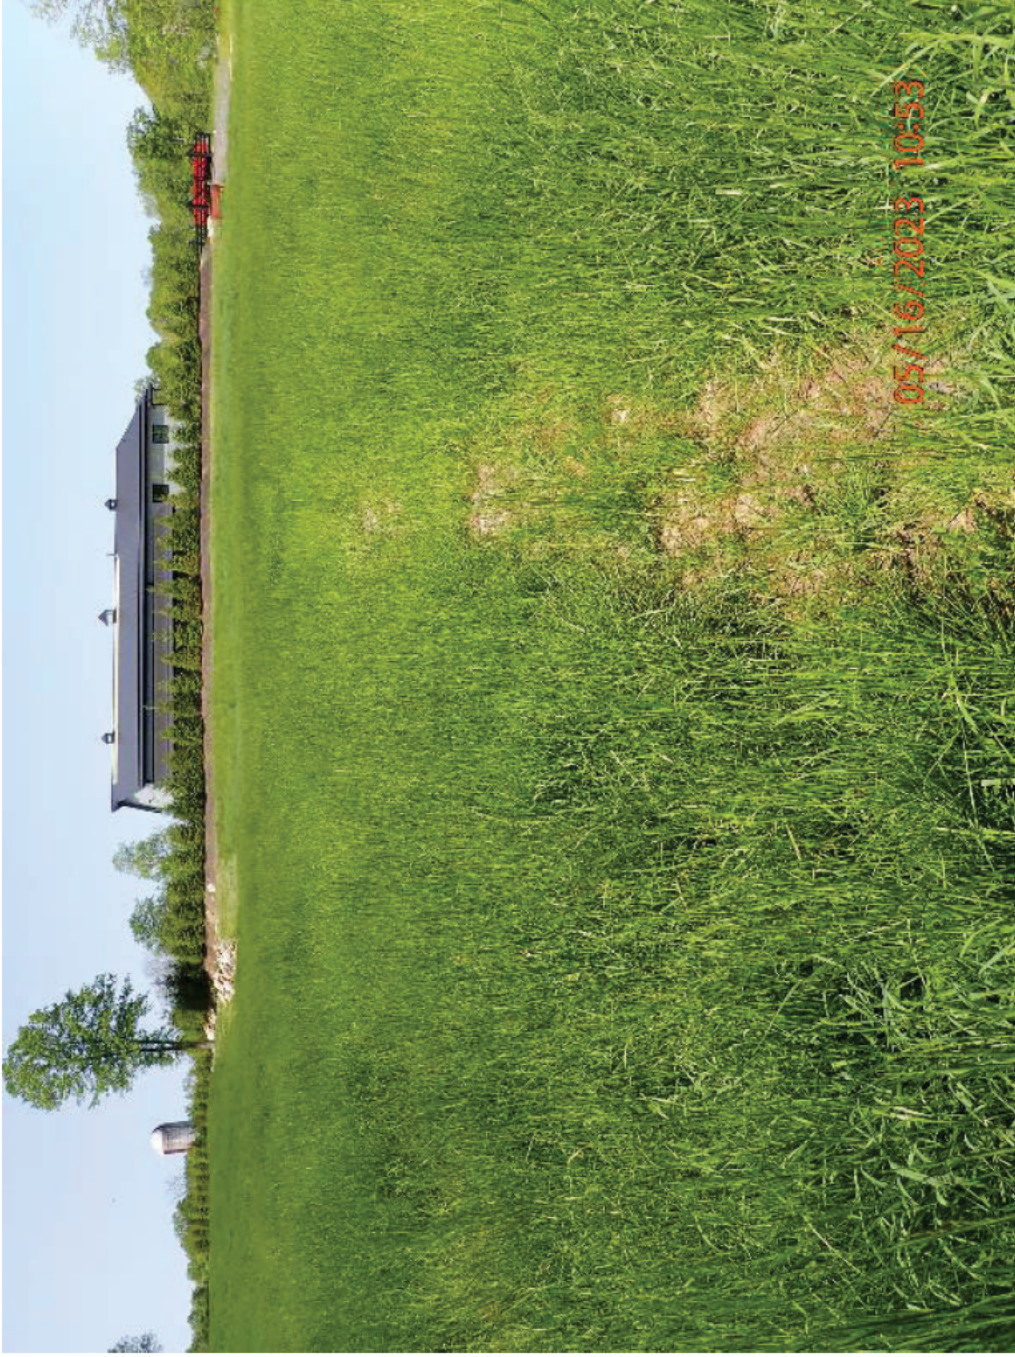
**Date:** 5/16/2023  
**Time:** 10:53 AM  
**Photographer:** SSA  
**Photo ID:** 1 – P5160001

Unvegetated areas in hayfield

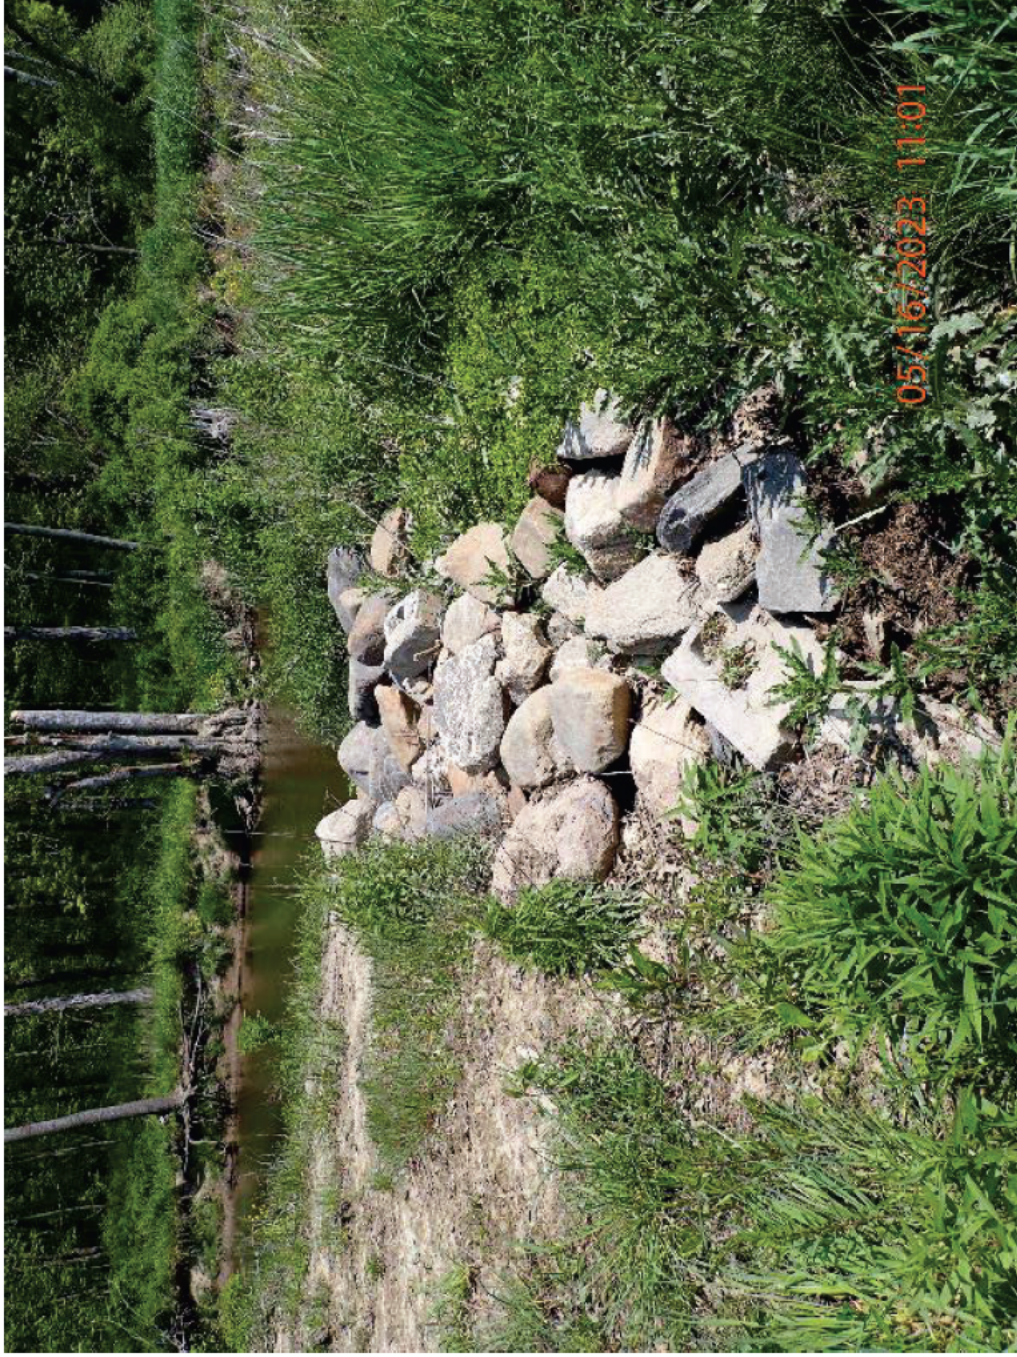
**Date:** 5/16/2023  
**Time:** 11:01 AM  
**Photographer:** SSA  
**Photo ID:** 2 – P5160002

Boulder-filled outlet to Dwaar Kill

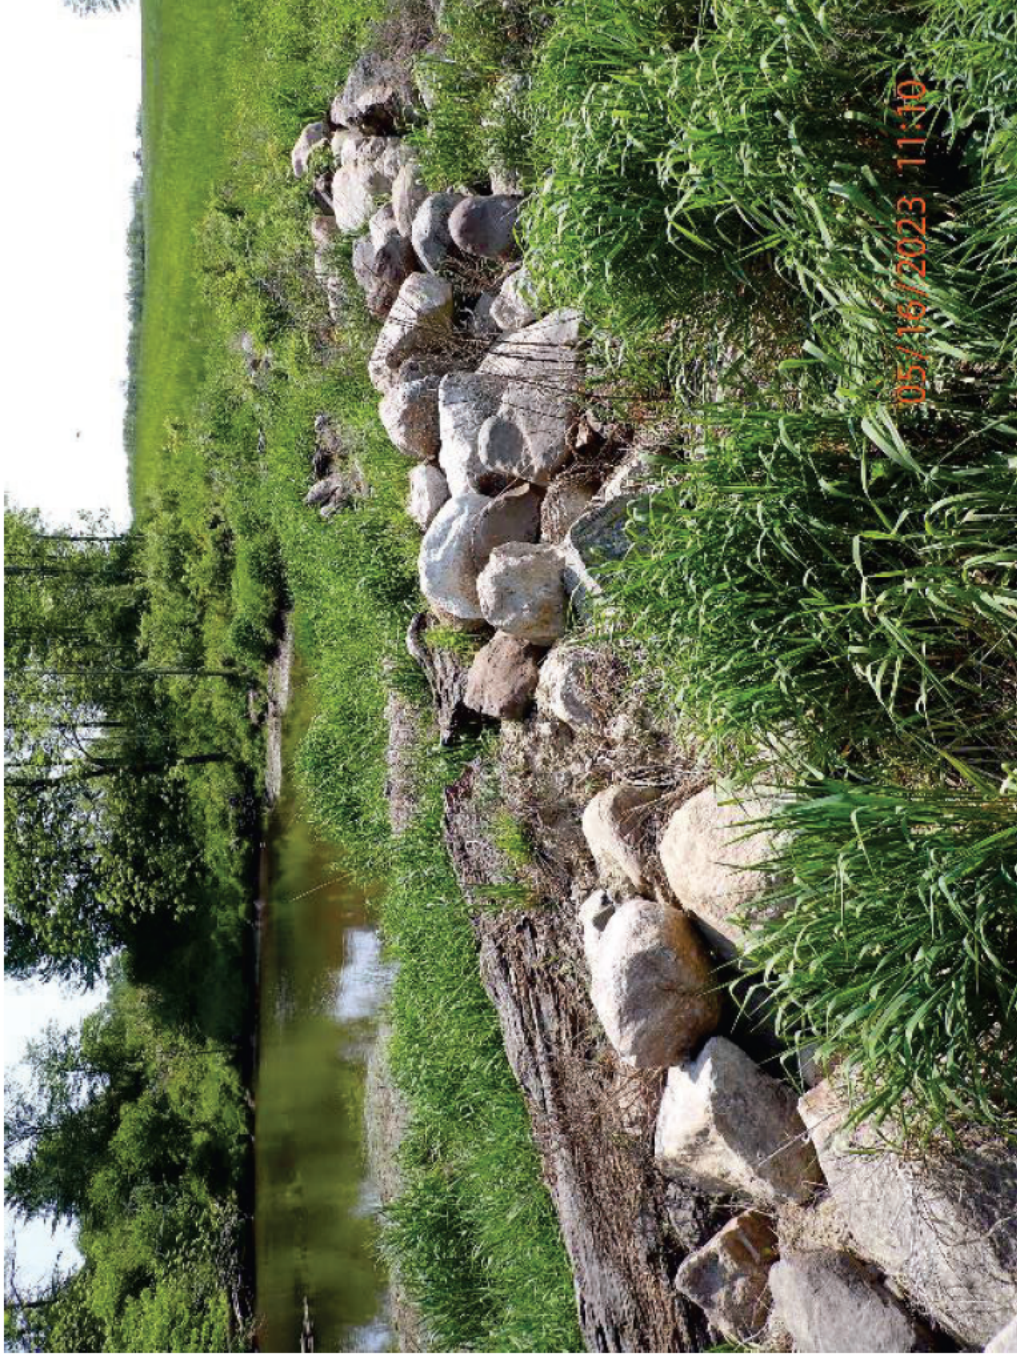
**Date:** 5/16/2023  
**Time:** 11:10 AM  
**Photographer:** SSA  
**Photo ID:** 3 – P51600003

**Description:**  
Boulder berm across outlet to  
Dwaar Kill

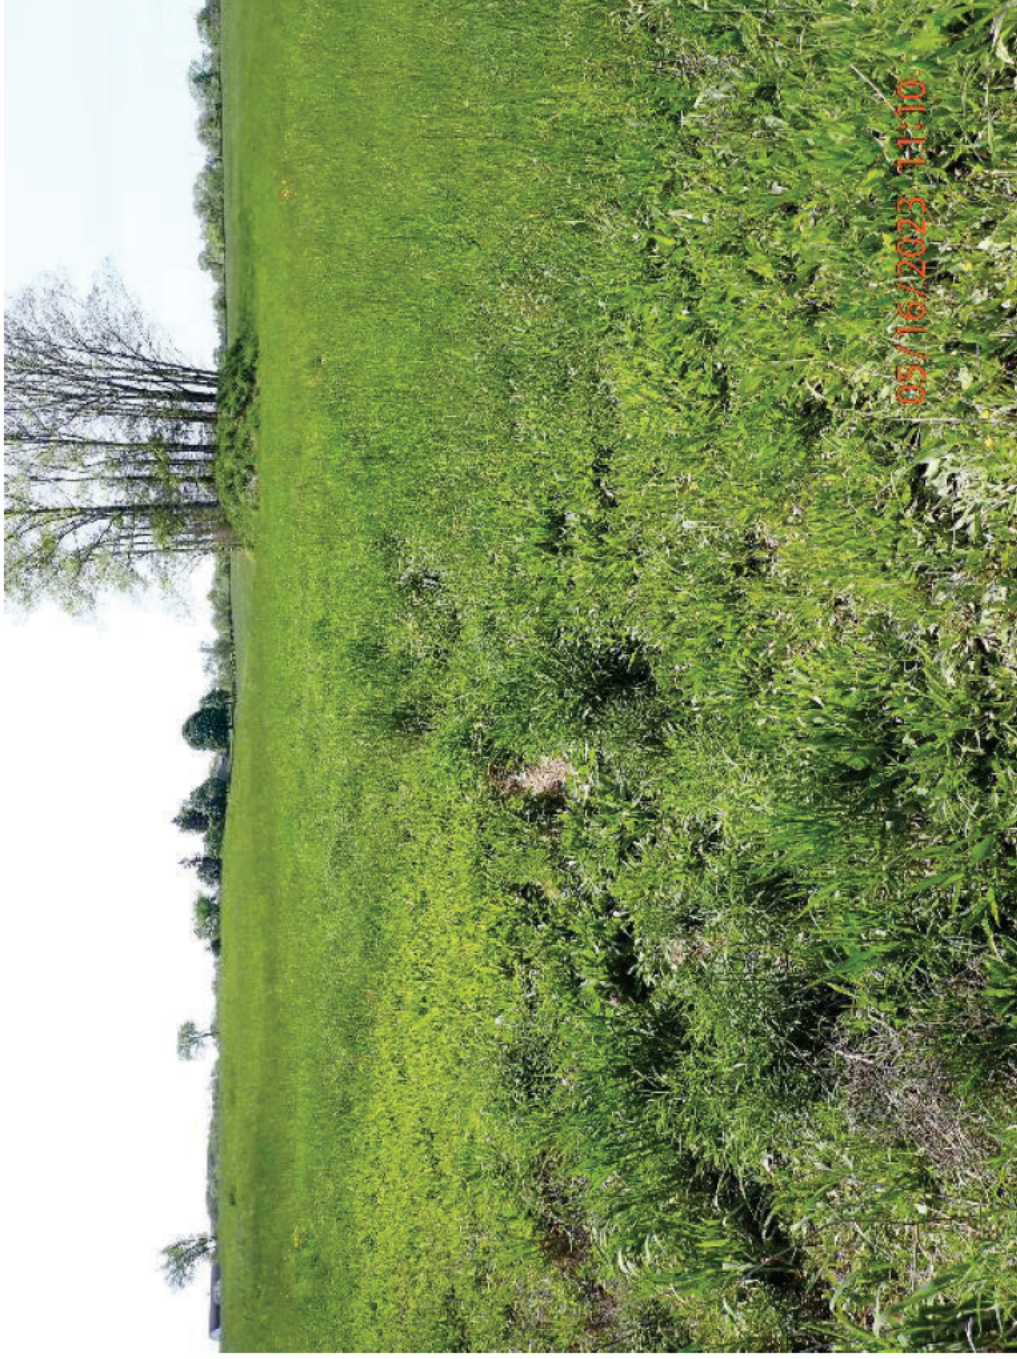
**Date:** 5/16/2023  
**Time:** 11:10 AM  
**Photographer:** SSA  
**Photo ID:** 4 – P51600004

Low spots in hayfield draining  
towards rock outlet to Dwaar  
Kill

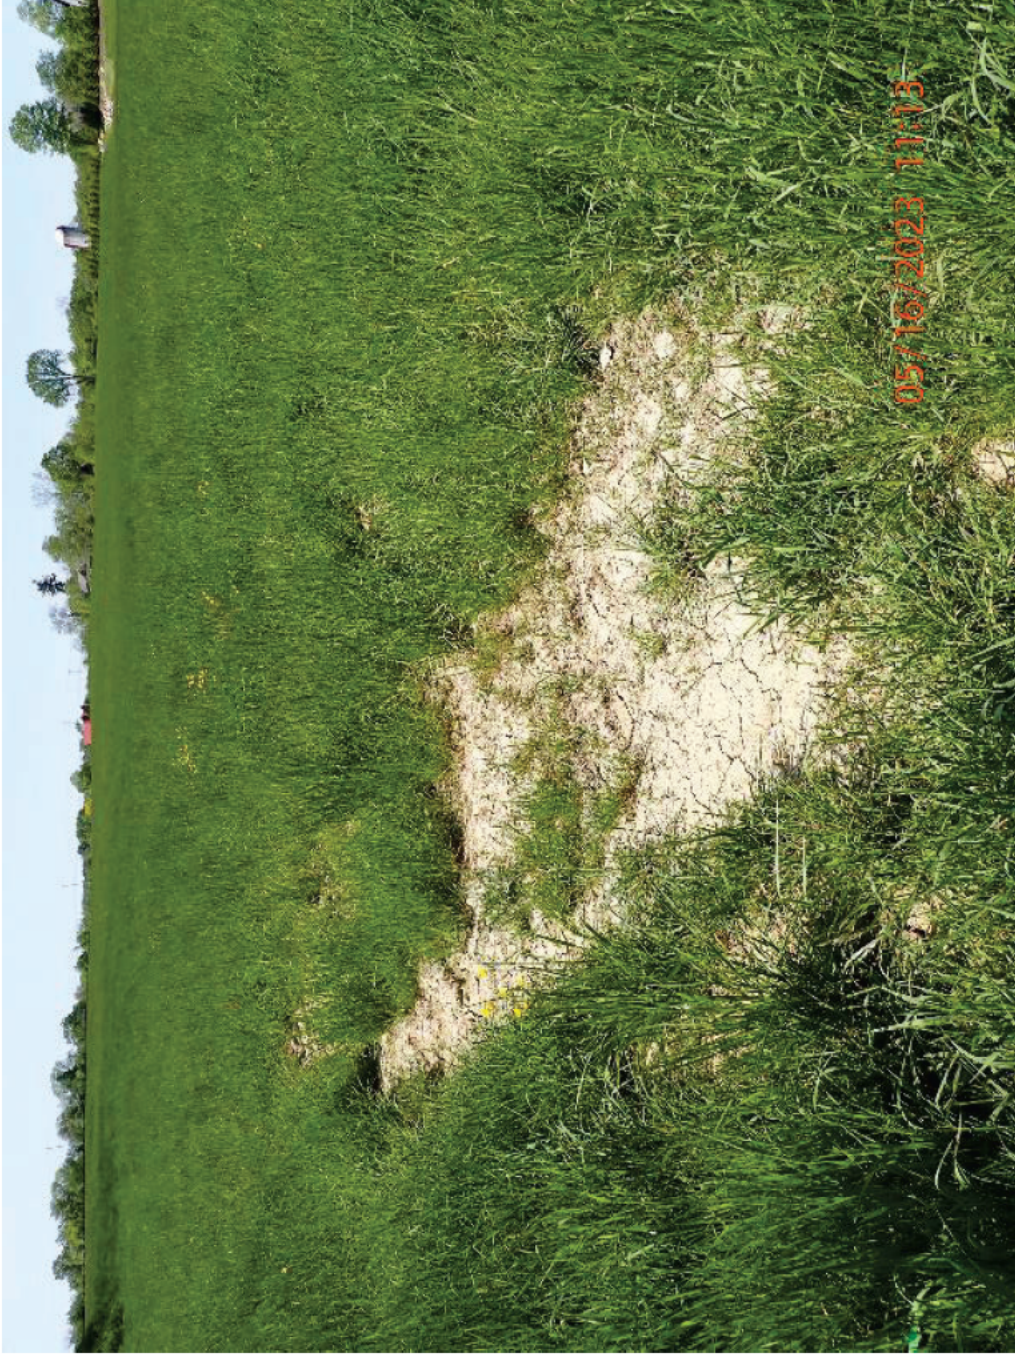
**Date:** 5/16/2023  
**Time:** 11:13 AM  
**Photographer:** SSA  
**Photo ID:** 5 – P51600005

Unvegetated areas/low spots in  
hayfield draining towards rock  
outlet to Dwaar Kill

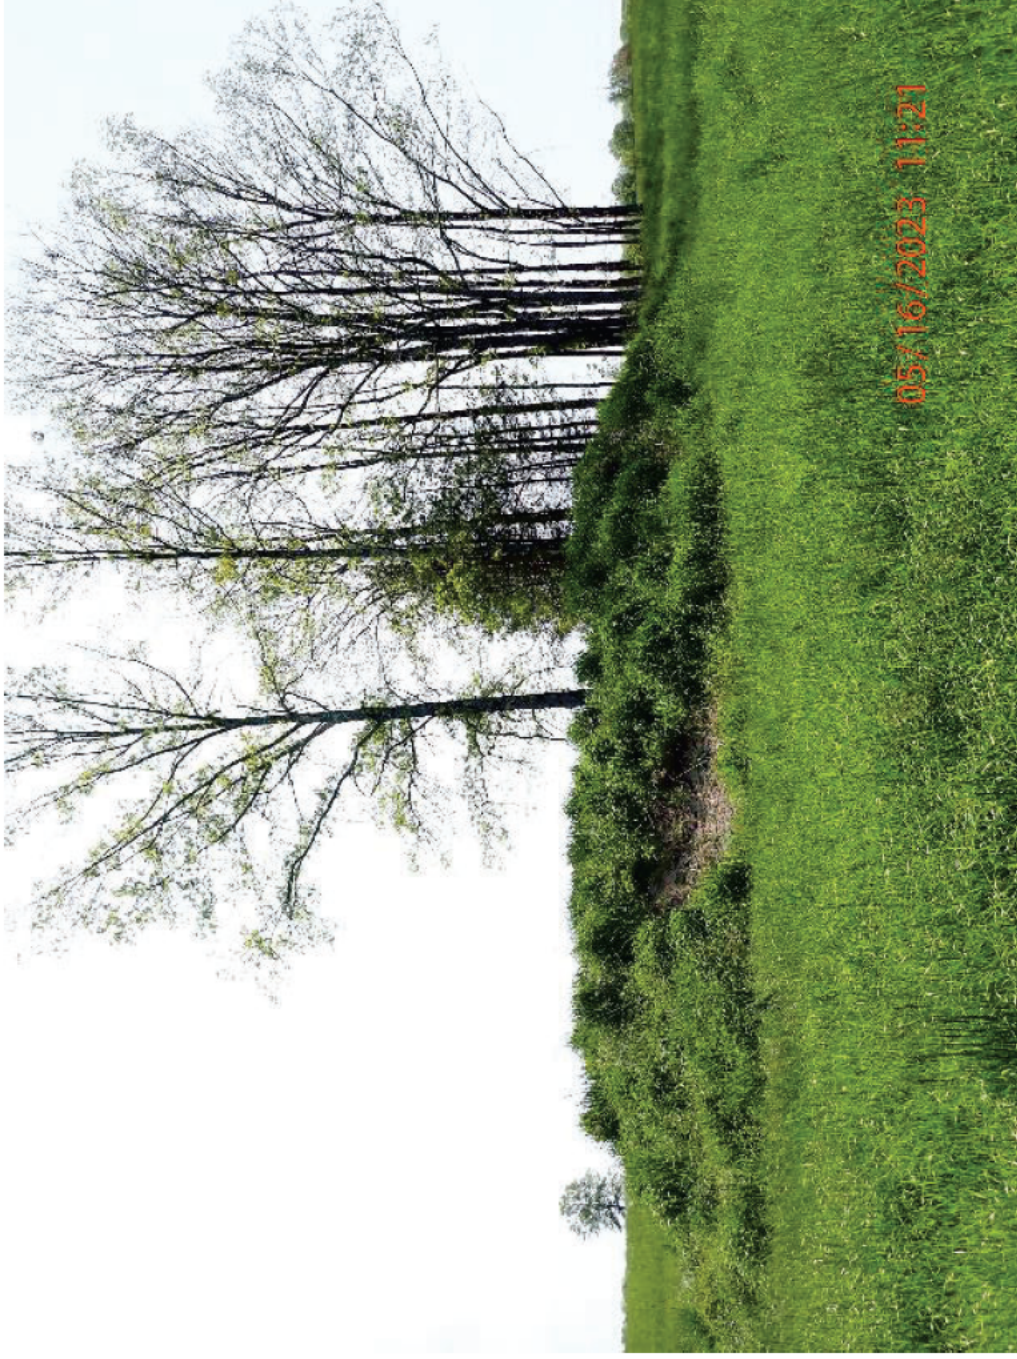
**Date:** 5/16/2023  
**Time:** 11:21 AM  
**Photographer:** SSA  
**Photo ID:** 6 – P5160006  
**Description:**  
Fill pile in hayfield

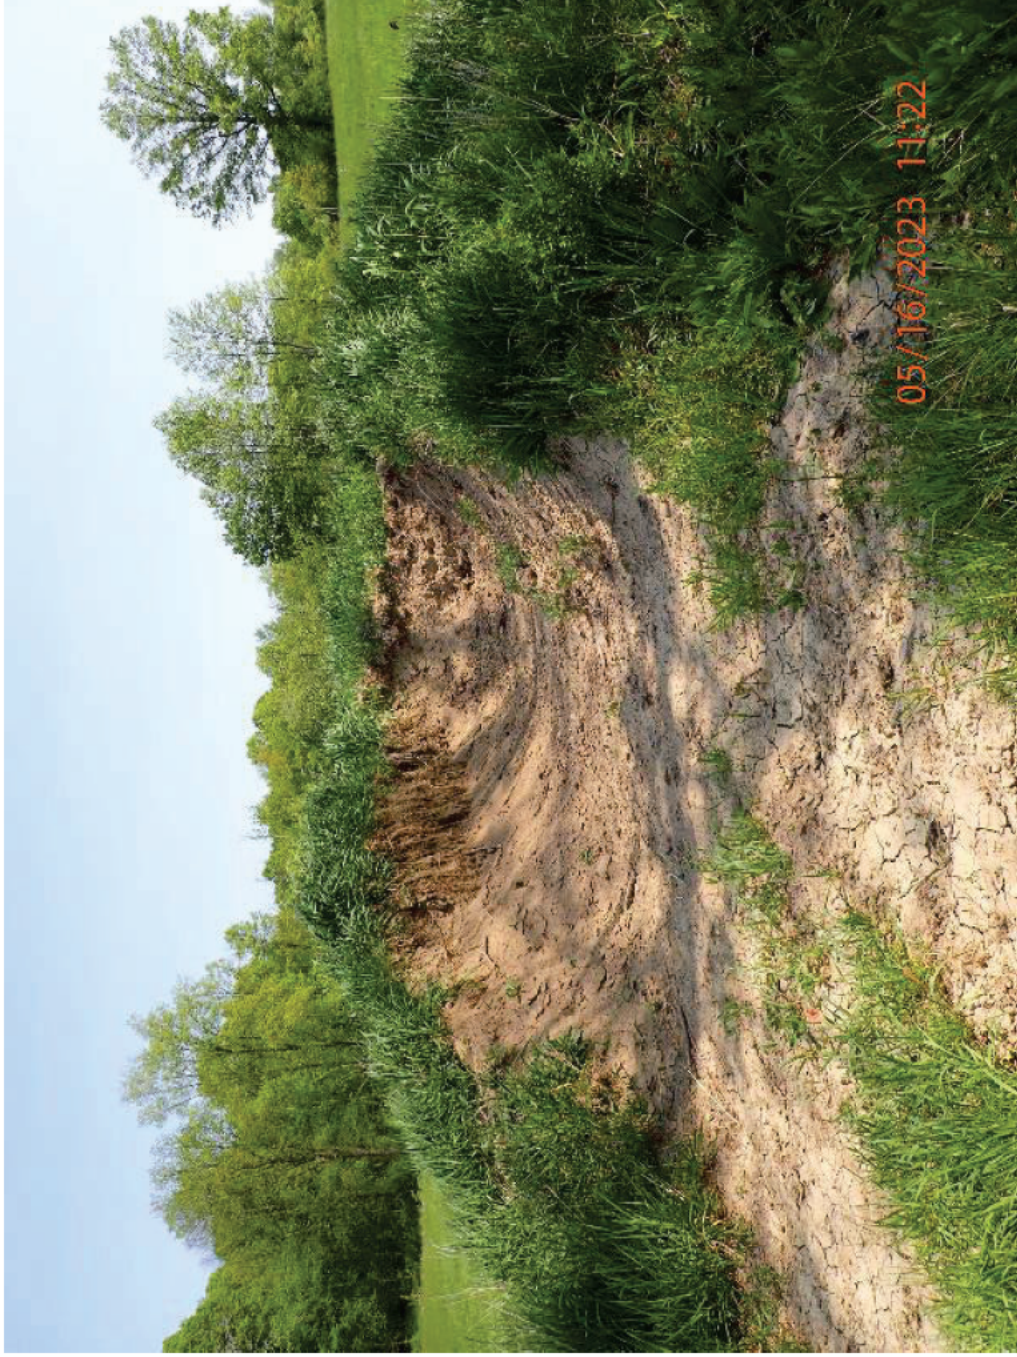
**Date:** 5/16/2023  
**Time:** 11:22 AM  
**Photographer:** SSA  
**Photo ID:** 7 – P5160007  
**Description:**  
Fill pile in hayfield

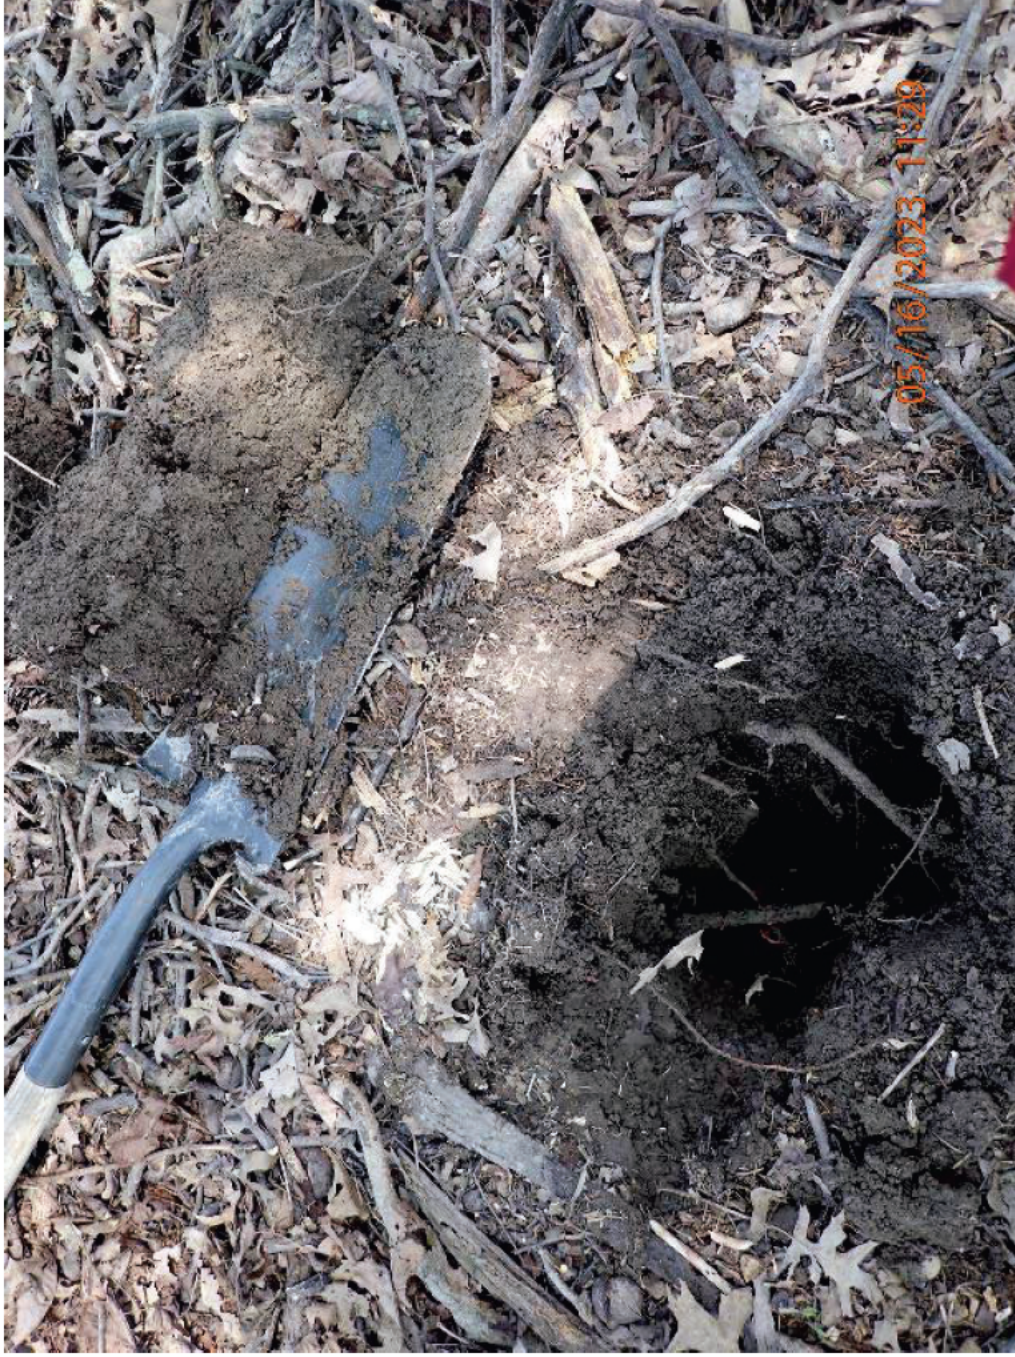
**Date:** 5/16/2023  
**Time:** 11:29 AM  
**Photographer:** SSA  
**Photo ID:** 8 – P51600008

Soil profile within remaining  
tree area in hayfield

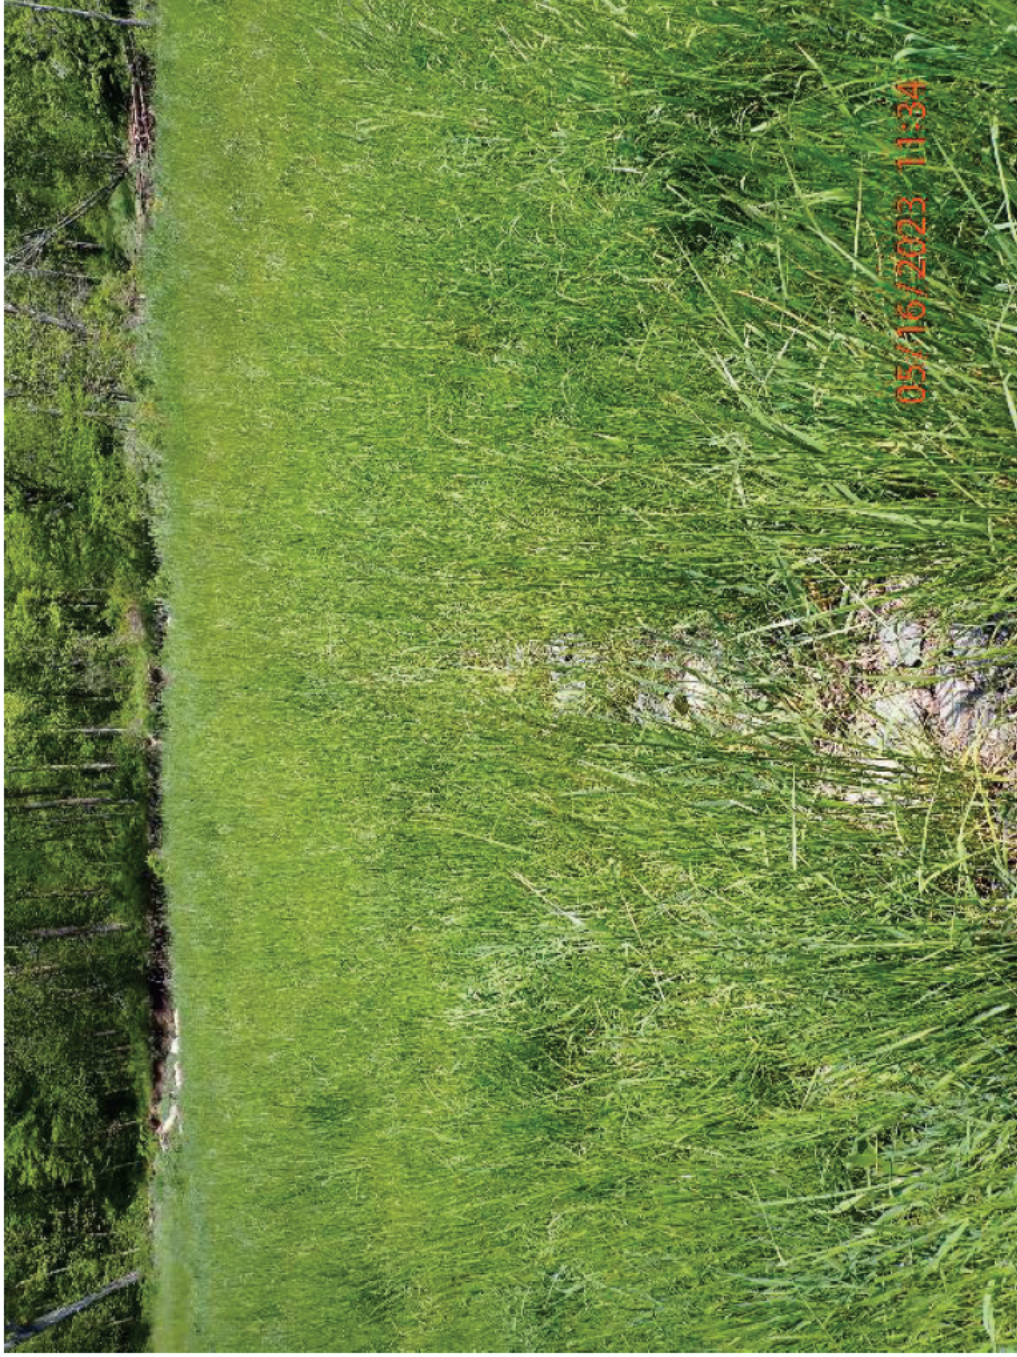
**Date:** 5/16/2023  
**Time:** 11:34 AM  
**Photographer:** SSA  
**Photo ID:** 9 – P51600009

Rock-lined drainage to Dwaar Kill
