## **RCRA Inspection Report**

Murakami Manufacturing, USA, Inc.  
575 Water Tower Bypass  
Campbellsville, Kentucky 42718

EPA ID#: KYR000033001  
NAICS #: 33639 – Other Motor Vehicle Parts  
Manufacturing

August 2, 2023, at 9:00 AM

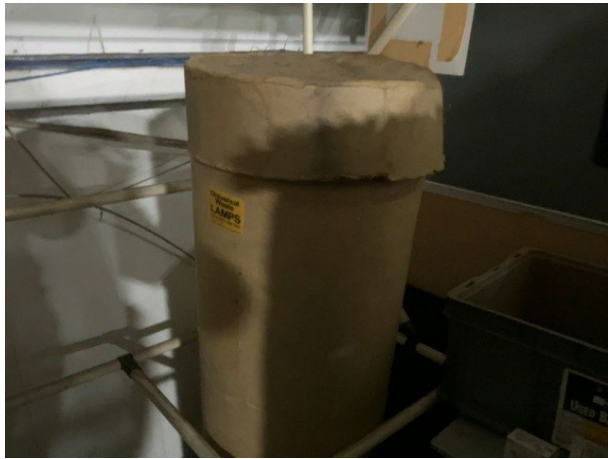
- Five containers of universal waste lamps, closed, labeled Universal Waste, and dated 11/6/2022, 12/2/2022, 01/05/2023, 02/24/2023, and 05/03/2023 (Photos 1-3).

**Photo 1:** Universal Waste – Fluorescent Lamps

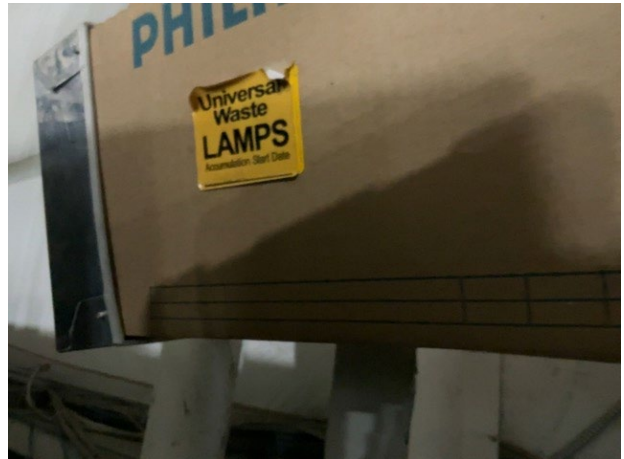
**Photo 2:** Universal Waste – Fluorescent Lamps

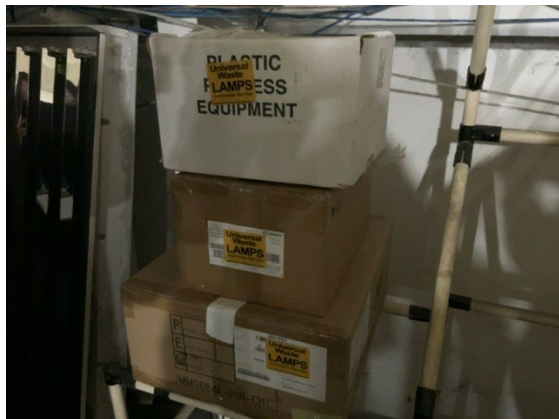
**Photo 3:** Universal Waste – Fluorescent Lamps

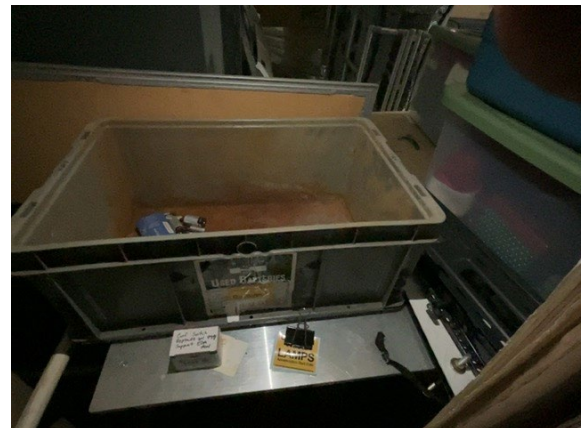
- One container of universal waste batteries, labeled Universal Waste and dated 11/14/2022. The container was not closed with a lid; however only used batteries that show evidence of leakage, spillage, or damage are required to be closed pursuant to 40 C.F.R. § 273.13(a)(1). There appeared to be no evidence of leakage, spillage, or damage to universal waste batteries in the container (Photo 4).

**Photo 4:** Universal Waste –Batteries

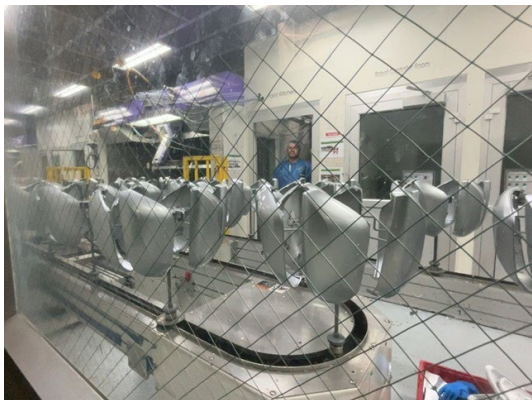
There are three paint booths that are designated for primer, base coat, and clear coat respectively (Photo 5). Murakami manages a satellite accumulation area (SAA) in the Paint Department by Paint line 3 for paint-related waste and non-hazardous sludge. The inspectors observed the following hazardous wastes in the Paint Department:

**Photo 5:** Side mirrors being painted in paint booths.

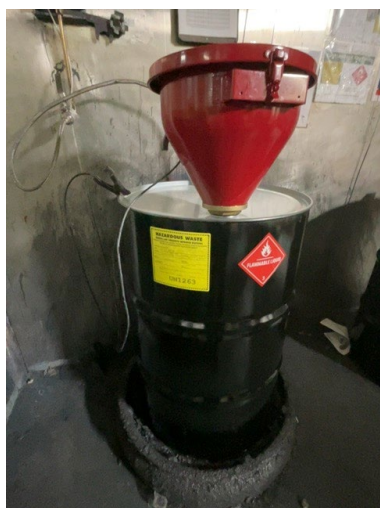
- One (1) 55-gallon container of paint waste. The container was closed, labeled “Hazardous Waste”, and marked with an indication of the hazards of the contents (Photo 6).
- One (1) 55-gallon container of excluded solvent-contaminated wipes. The container was closed, labeled “excluded solvent-contaminated wipes” (Photo 7). Accumulation date is tracked through a monthly inspection sheet to ensure facility is not storing excluded solvent-contaminated wipes past the 180-day storage limit pursuant to 40 C.F.R. § 261.4(b)(18)(ii).

**Photo 7:** SAA—Hazardous Waste Paint-related Waste

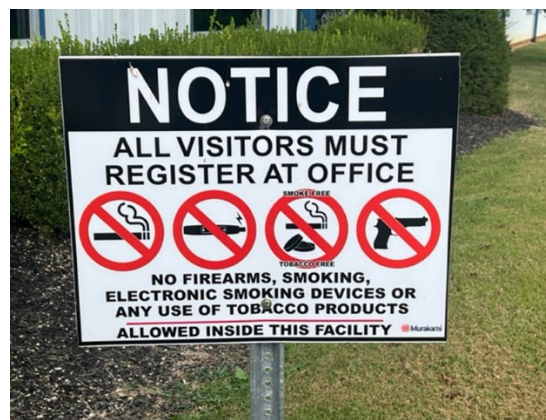
Murakami manages a hazardous waste CAA in the Chemical Storage Room which is an enclosed room located inside of the manufacturing building. The area was identified with signs which read “Caution, Hazardous Waste Area.” The facility manages ignitable waste in the CAA, and the inspectors observed “No Smoking” signs throughout the facility (Photo 8).

**Photo 8:** No Smoking signs located throughout facility.

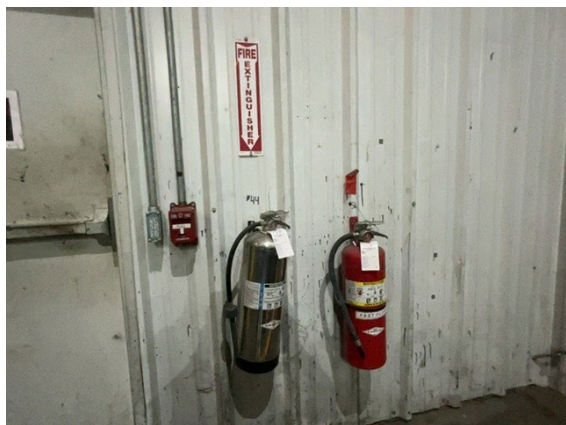
The CAA is equipped with an internal communications or alarm system capable of providing immediate emergency instruction to facility personnel; it is equipped with a device capable of summoning emergency assistance from local police departments, fire departments, or state or local emergency response teams; it is equipped with portable fire extinguishers, fire control equipment, and spill control equipment, and it is equipped with automatic sprinklers (Photos 9, 10, and 11).

**Photo 9:** Fire alarms and extinguishers located in CAA and throughout facility.

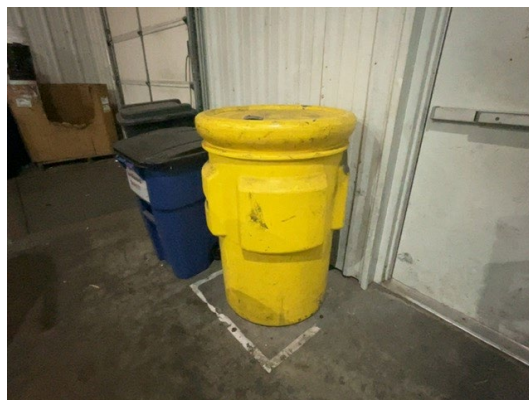
**Photo 10:** Spill control equipment located in CAA.

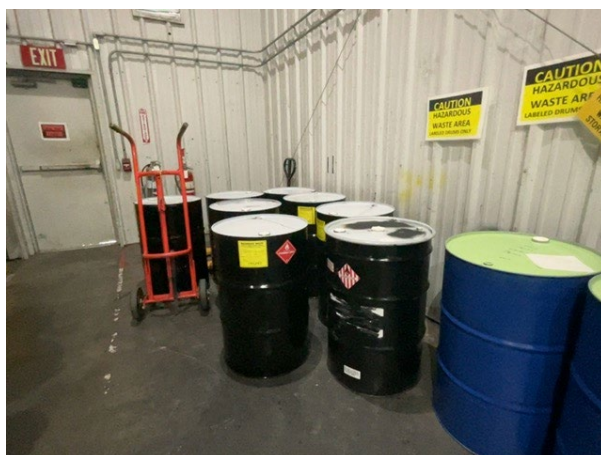
- Seven (7) 55-gallon containers of hazardous waste (Photo 12). All containers were closed, labeled with the words “Hazardous Waste”, marked with an indication of the hazard of the contents, and dated. The oldest accumulation date was 07/27/2023.
- One (1) 55-gallon container of excluded solvent contaminated rags to be sent for disposal (Photo 13). The container was closed and labeled “Excluded Solvent-contaminated Wipes”. The accumulation start date is tracked via a monthly inspection check list.

**Photo 12:** 90-Day CAA. All containers were closed, labeled, marked with an indication of the hazard of the contents, and dated.

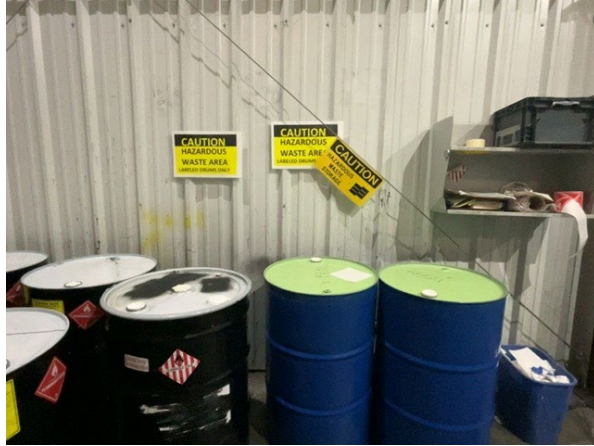
**Photo 13:** One (1) excluded solvent-contaminated wipes container in CAA.
