## INDEX

## OLD CASE HISTORIES

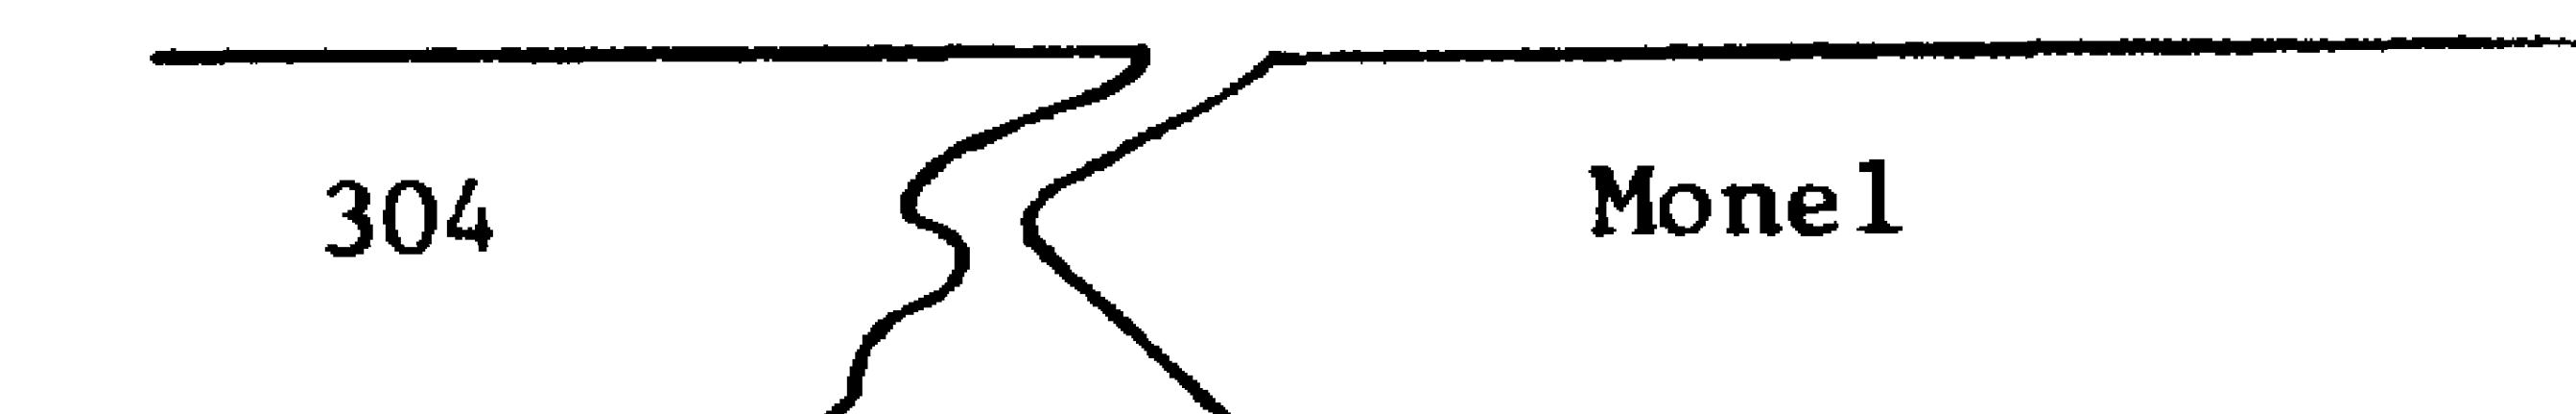
Cross Section of the Weld

Afterwards someone kicked the line and the leaking flange to pipe weld completely failed. The flange was monel. The 304 stainless steel line had suffered galvanic corrosion at the weld.

The flange had been installed by a contractor. He did not have a two-inch flange so he used a monel flange figuring that it would be even better than stainless steel.

Esso is now using more stringent inspection procedures to make sure the right metallurgy is used.
