## **RCRA Inspection Report**

Sanders Lead Company  
P.O. Box 707  
1 Sanders Road  
Troy, Alabama 36079  
EPA ID No.: ALD046481032  
Permit Number: ALD046 481 032  
Primary NAICS: 331492: Secondary Smelting, Refining, and Alloying of Non-Ferrous Metal

The purpose of this inspection was to conduct an unannounced compliance evaluation inspection to determine Sanders Lead Company's compliance with the applicable requirements of RCRA and the corresponding Alabama Department of Environmental Management (ADEM) regulations and hazardous waste permit number ALD 046 481 032. This was an EPA lead inspection.

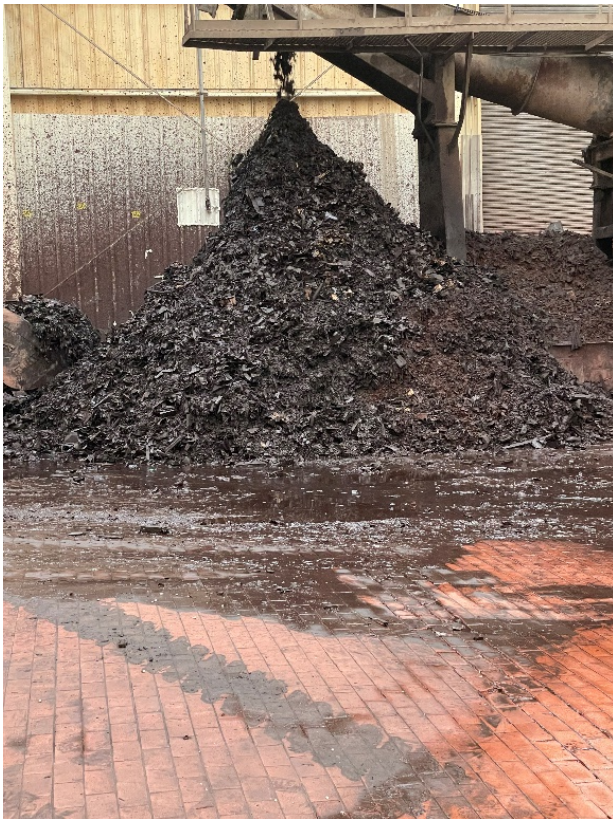
The BCB is comprised of a corrugated metal structure with a concrete floor where the hammer mill, floatation separator, and the baghouse systems are located. Waste generated in the hammer mill are placed on the floor of the building (Photo 1), then transported by front end loaders via a corridor to the enclosed Containment Building (CB). Liquids generated in the hammer mill are pumped into the floatation separator. Spilled liquids are collected in a grated pit located in the center of the BCB where they are periodically pumped into the WWTP. Lead-rich solids generated in the agglomeration system are collected in the floor of the BCB and then transported to the CB. Liquid generated in the agglomeration system is filtered using a plate filter press and pumped to the WWTP.

Photo 1: Lead Bearing battery pieces from Hammer Mill System.

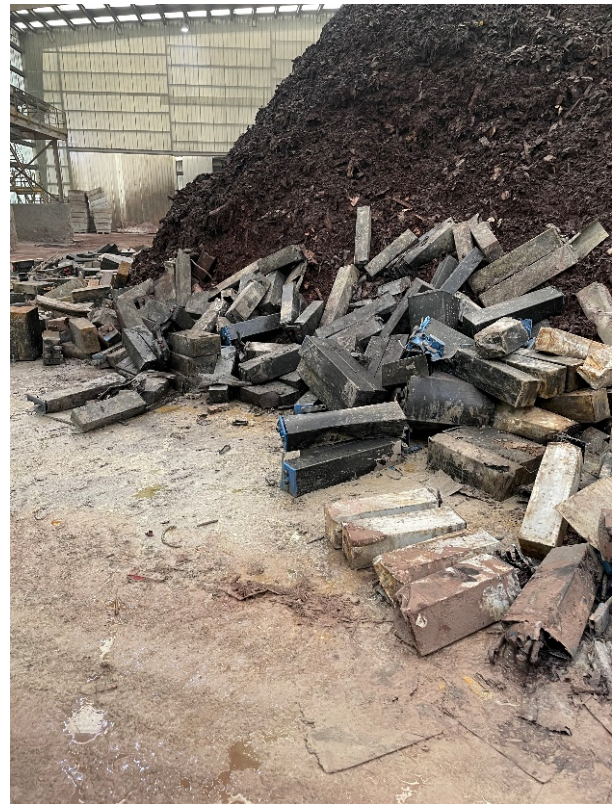
The CB is a corrugated metal building with a concrete floor that Sanders uses to store the lead-containing material (Photos 2-3). This permitted hazardous waste storage unit has an overhead

Photo 3: Lead bearing waste in Containment Building.

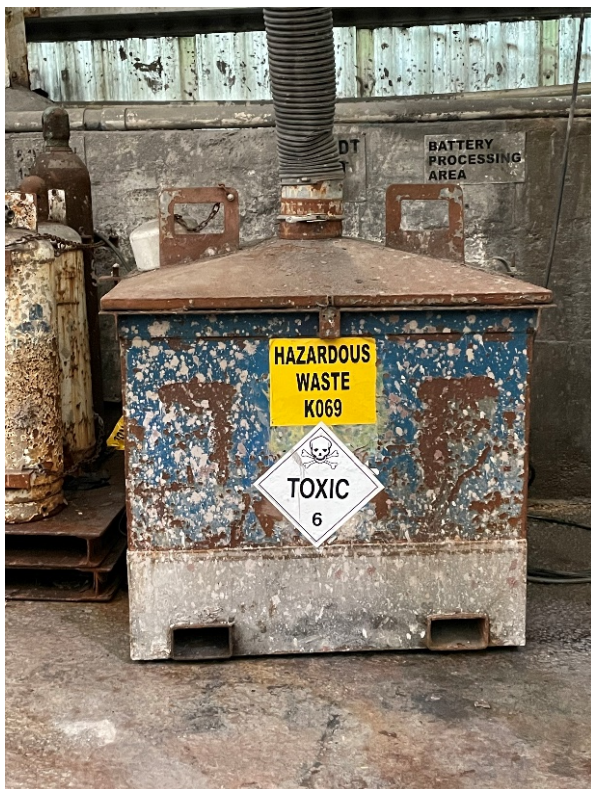
During the inspection, the inspection team noted a 55-gallon container and several 250-gallon blue metal totes storing K069 listed hazardous waste from the baghouse collection system (Photos 4-5). The K069 is reintroduced in the furnace to reclaim the lead. The containers are managed as SAAs containers. Facility personnel inspect these SAAs daily to determine if there is more than 55 gallons of waste in the containers. If so, they are emptied within three days and the waste is placed into the permitted waste pile to recover the lead.

Photo 5: One 250-gallon K069 SAA bin located in CB.

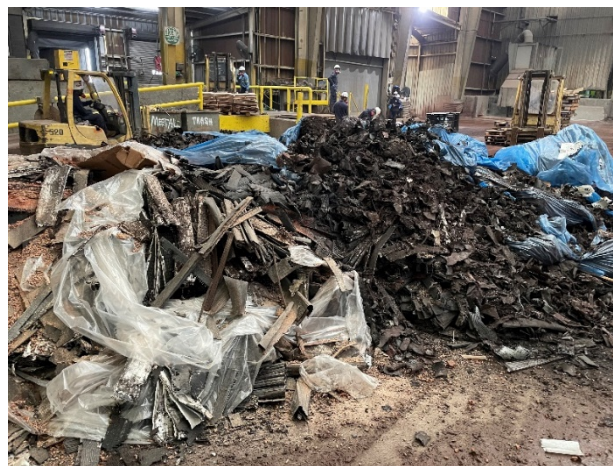
SLC is accumulating lead contaminated plastic wrap and cardboard used for packaging material for incoming batteries at the receiving dock and along the wall of the containment building (Photo 6-7). Packaging material including wooden pallets and cardboard that do not come in contact with leaded waste are considered clean and sent offsite for recycling.

Photo 7: Debris at Receiving.

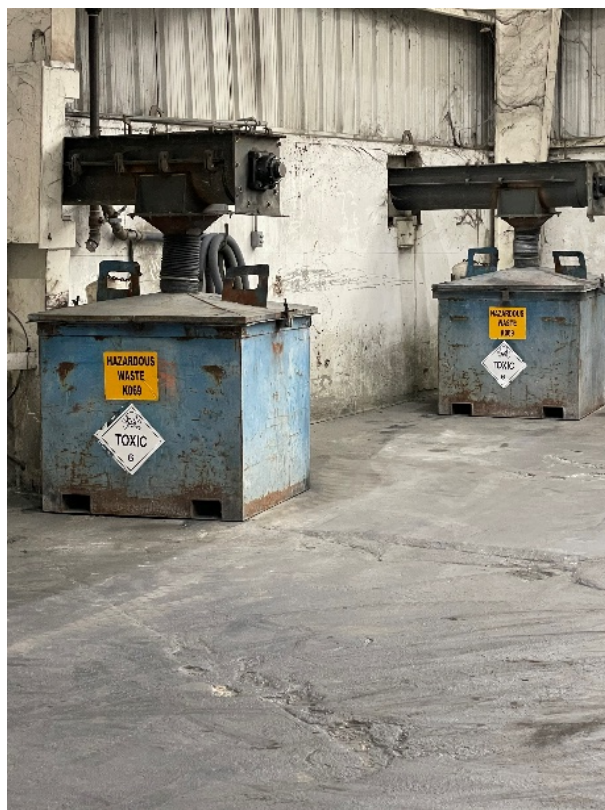
The blast furnace building (BFB), attached to the CB, is the area where SLC melts lead-containing material in one of four furnaces (burned at 2,600°F) to recover the lead. The melted lead is cast into ingots and reworked per customers demands. Finished ingots are stored in the shipping area before being shipped to customers. At the time of the inspection, the area was storing two 250-gallon totes containing K069 listed hazardous waste from the ECS (Photo 8). These containers were managed as SAAs.

Photo 8: SAA containers in Shipping/Product Storage Area.

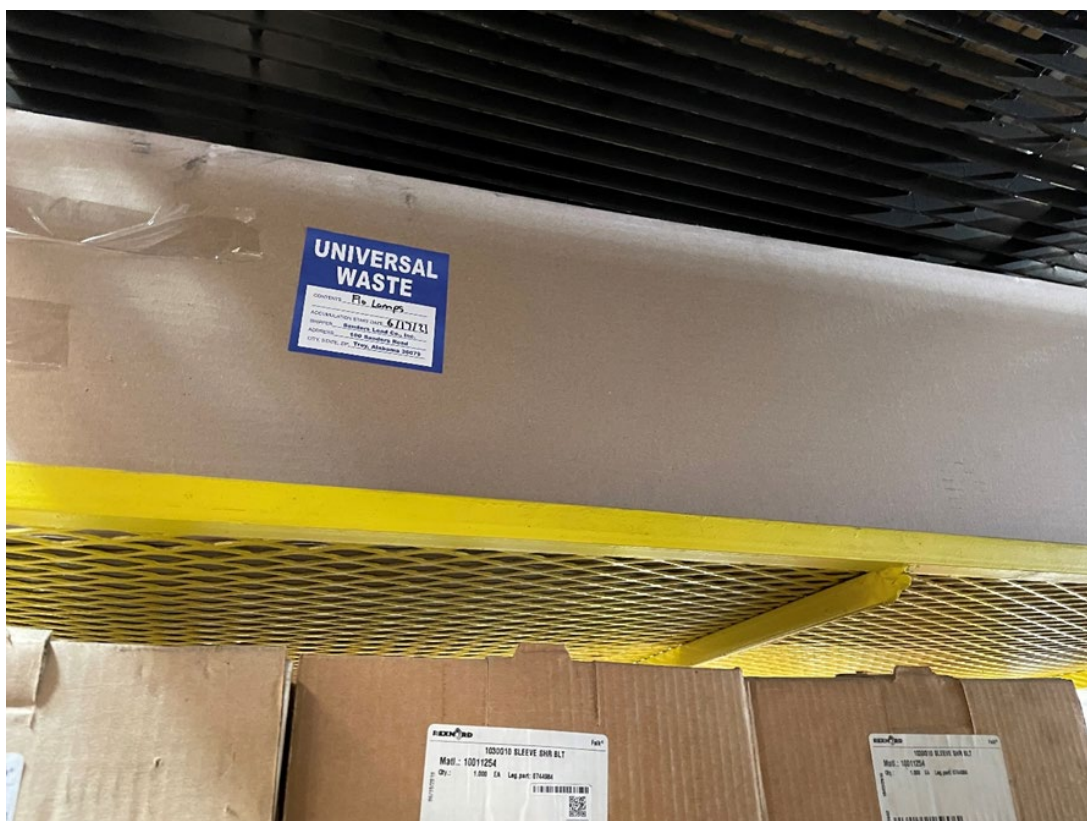
This warehouse stores supplies, and chemicals used around the facility. In addition, this is the area where universal waste lamps (UWL) are stored. At the time of the inspection, the area was storing: one box of 8-foot UWL dated 7/30/2021 and one box of 4-foot UWL dated 6/17/2021 (Photos 16-17). The boxes were closed and labeled.

Photo 16: Universal Waste Lamps Storage.

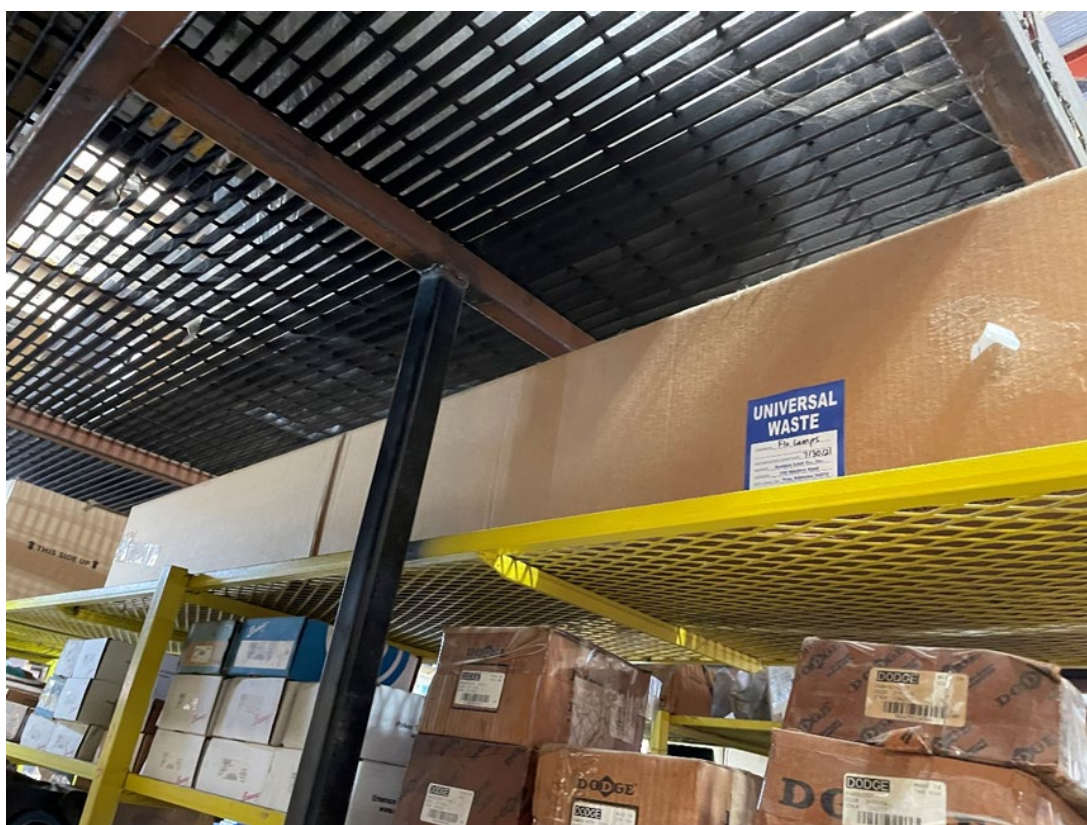
Photo 17: Universal Waste Lamps Storage.

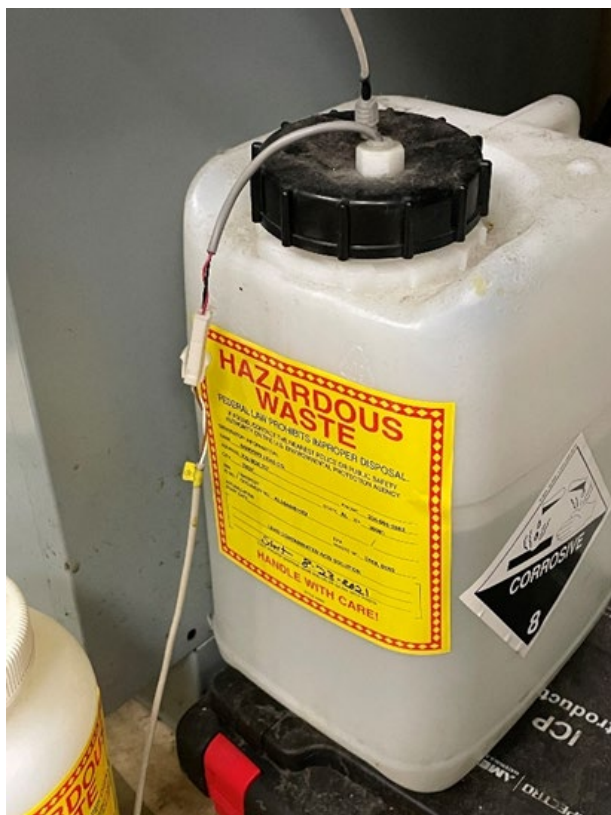
SLC has three working laboratories: the metallurgic laboratory, the environmental laboratory (conducts air monitoring, wastewater testing, etc.), and a plastic assays laboratory. We observed 10 satellite accumulation containers for the various laboratory rooms ranging in capacities from one liter to three gallons (Photos 18-20). All of the containers were closed and labeled with the words “Hazardous Waste” and marked with an indication of the hazards.

Photo 18: Laboratory Waste SAA.

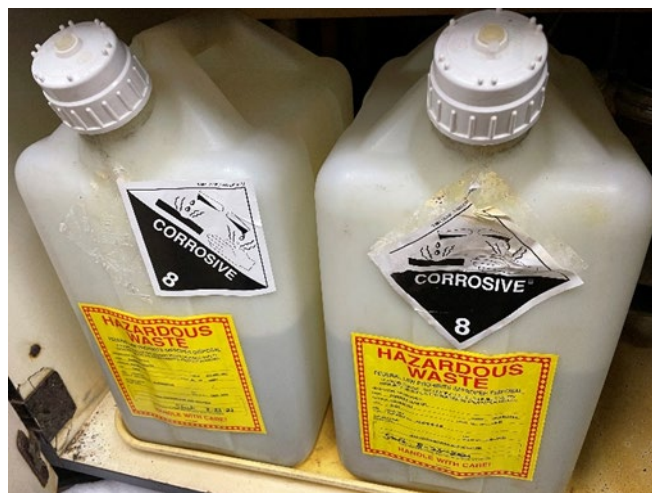
Photo 21: Laboratory Waste SAA.

Outside the laboratory, SLC is storing two 55-gallon containers that accumulate consolidated wastes from inside the laboratories. These containers were being managed as an extension of the SAA from inside the laboratory. This container was labeled, closed, and dated 9/24/2021 (Photo 21). The second 55-gallon container was staged to accept consolidated laboratory waste once the first one was full. According to Mr. Rutherford, all of the waste generated in the Satellite containers inside the laboratory are transferred into the 55-gallon container outside of the building. Laboratory personnel are the only SLC staff that have access to the keys. The container SLC was filling was placed on top of a secondary containment pallet. The pallet was partially full of water and dirt. SLC would not be able to identify if there was a leak from this container. Subsequent to the inspection, SLC emptied the secondary pallet and replaced it with a clamshell
