**Region 6 - Enforcement & Compliance Assurance Division**  
**INSPECTION REPORT**

| Media Program: | RCRA Compliance Evaluation Inspection | |
| Facility Name: | <b>Albemarle Corp. Process Development Center (PDC)</b> | |

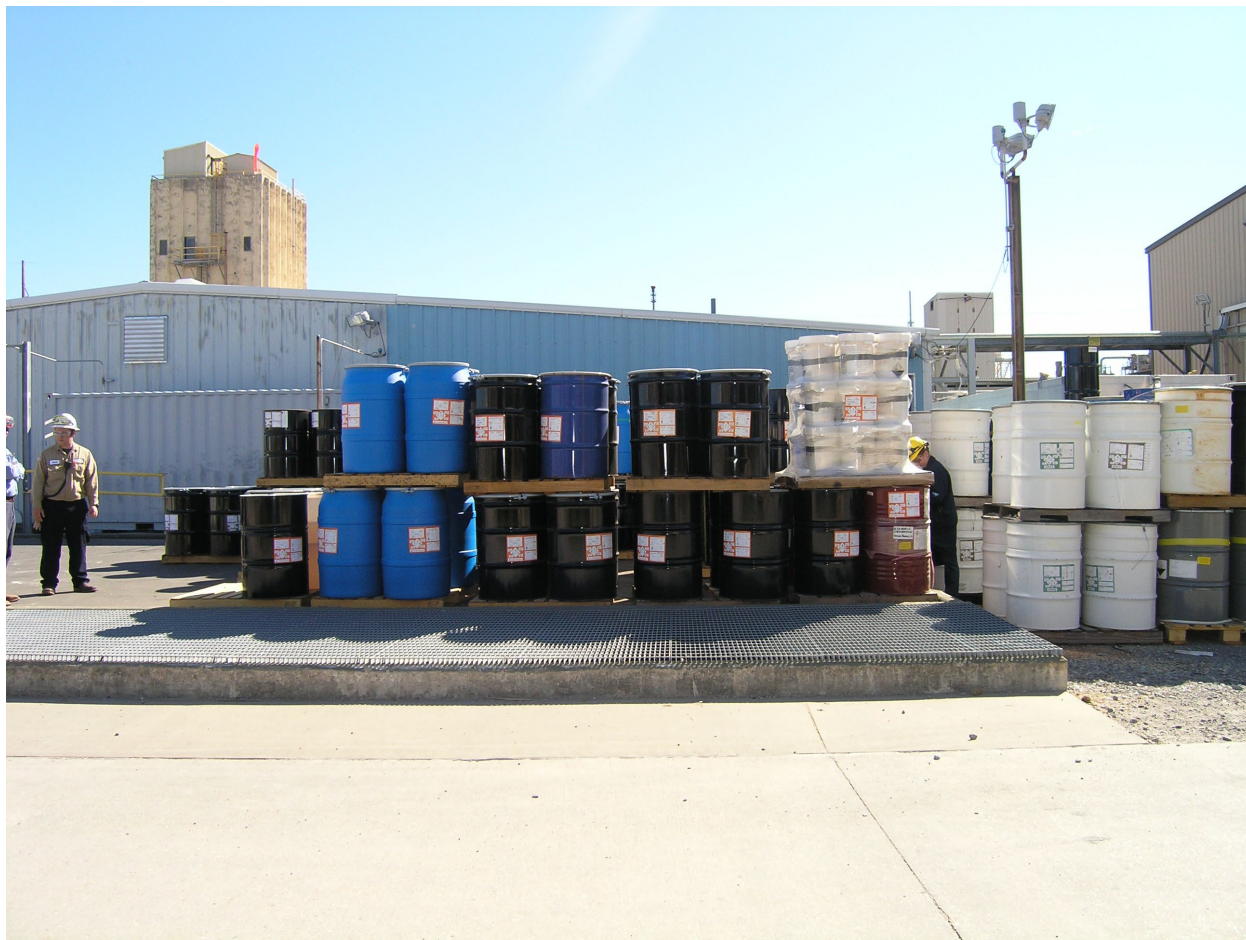
Photo No. 1

| Description:<br>Overview of less than 90-day storage area. Area shared with W.R. Grace. Orange labels are Albemarle waste containers. | | |

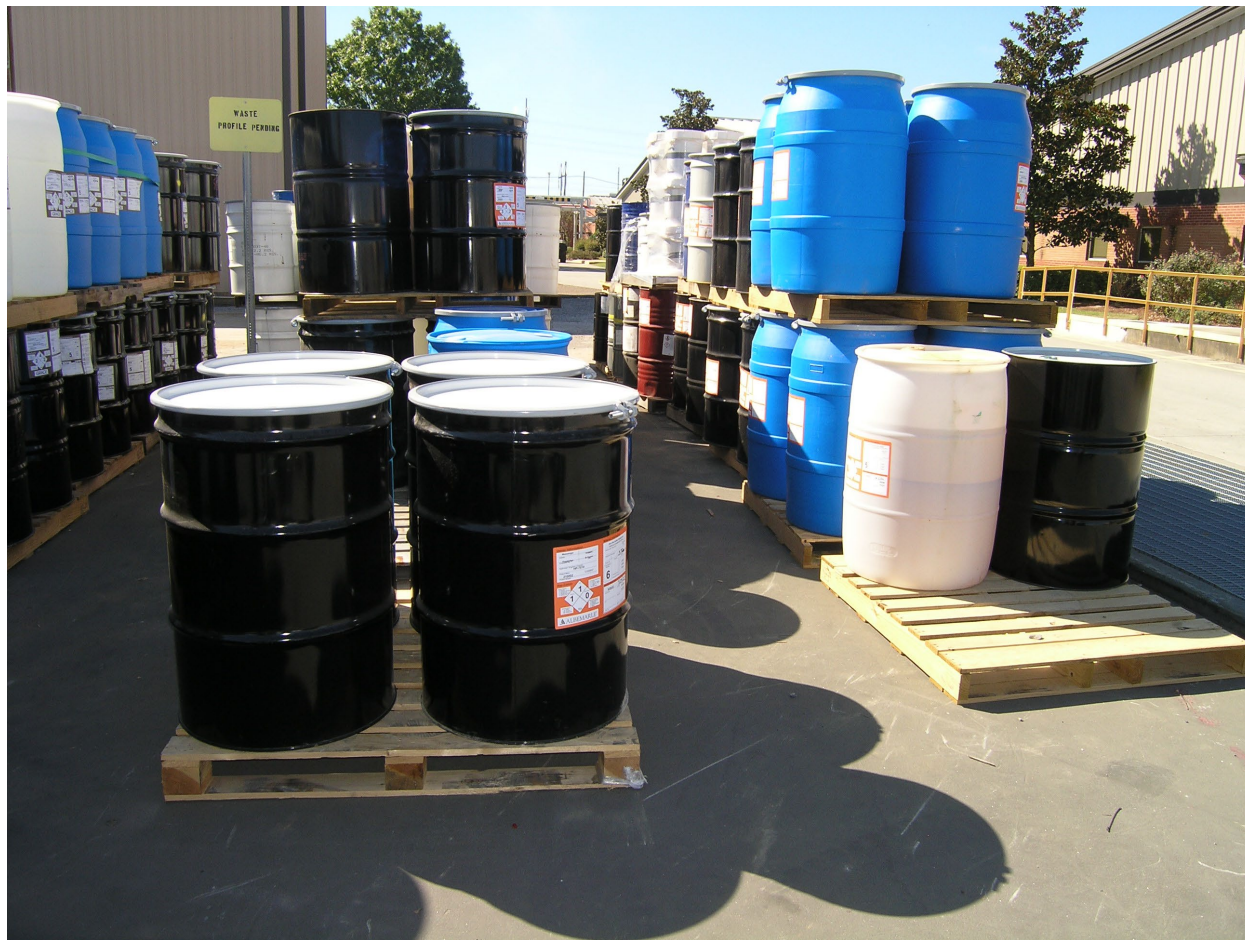
Photo No. 2

| Description:<br>Side view showing aisle spacing of less than 90-day storage area. Containers belong to Albemarle as denoted by orange labels. | | |

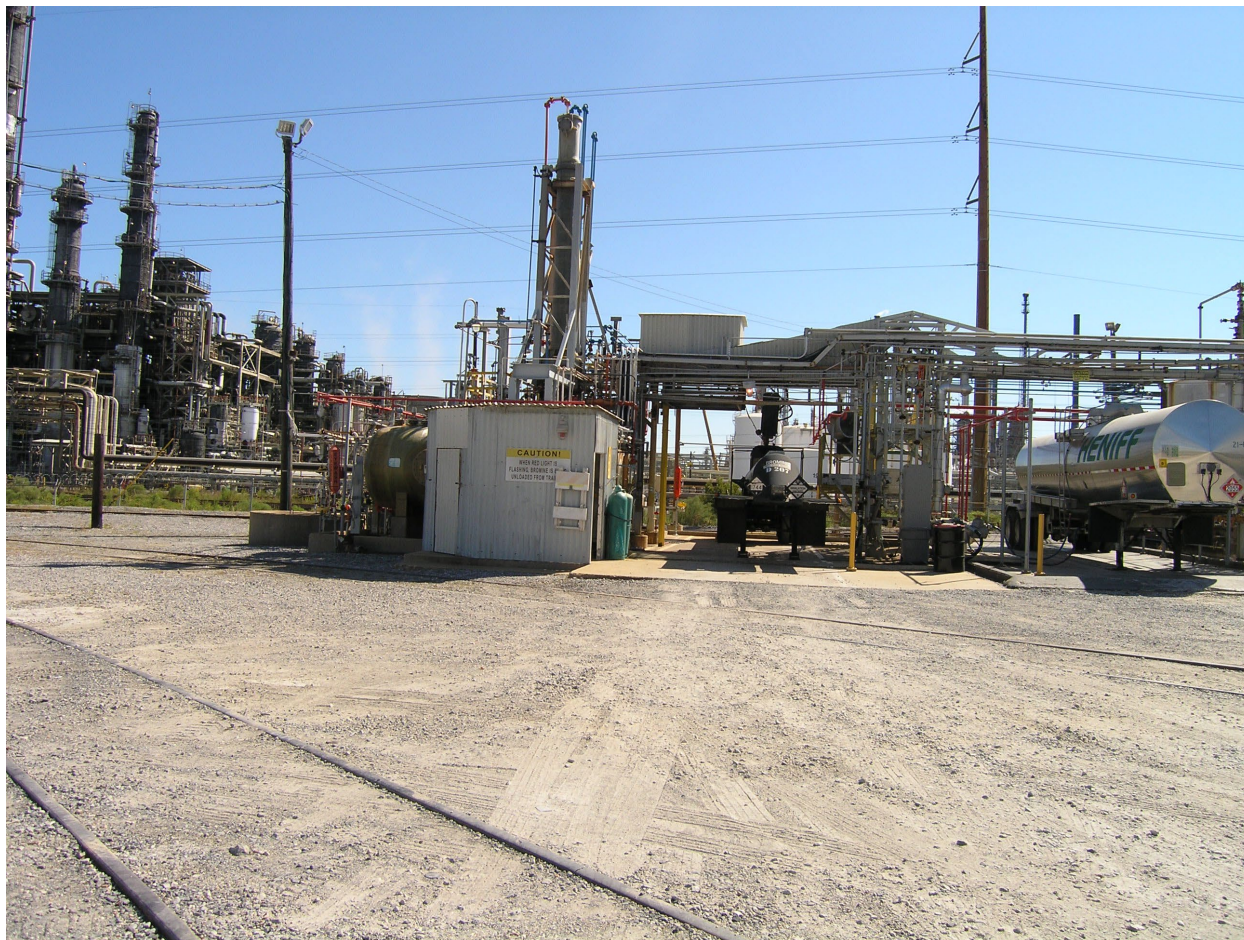
Photo No. 3

| Description:<br>Beginning of the 7010 process where bromine and styrene enter the production process. | | |

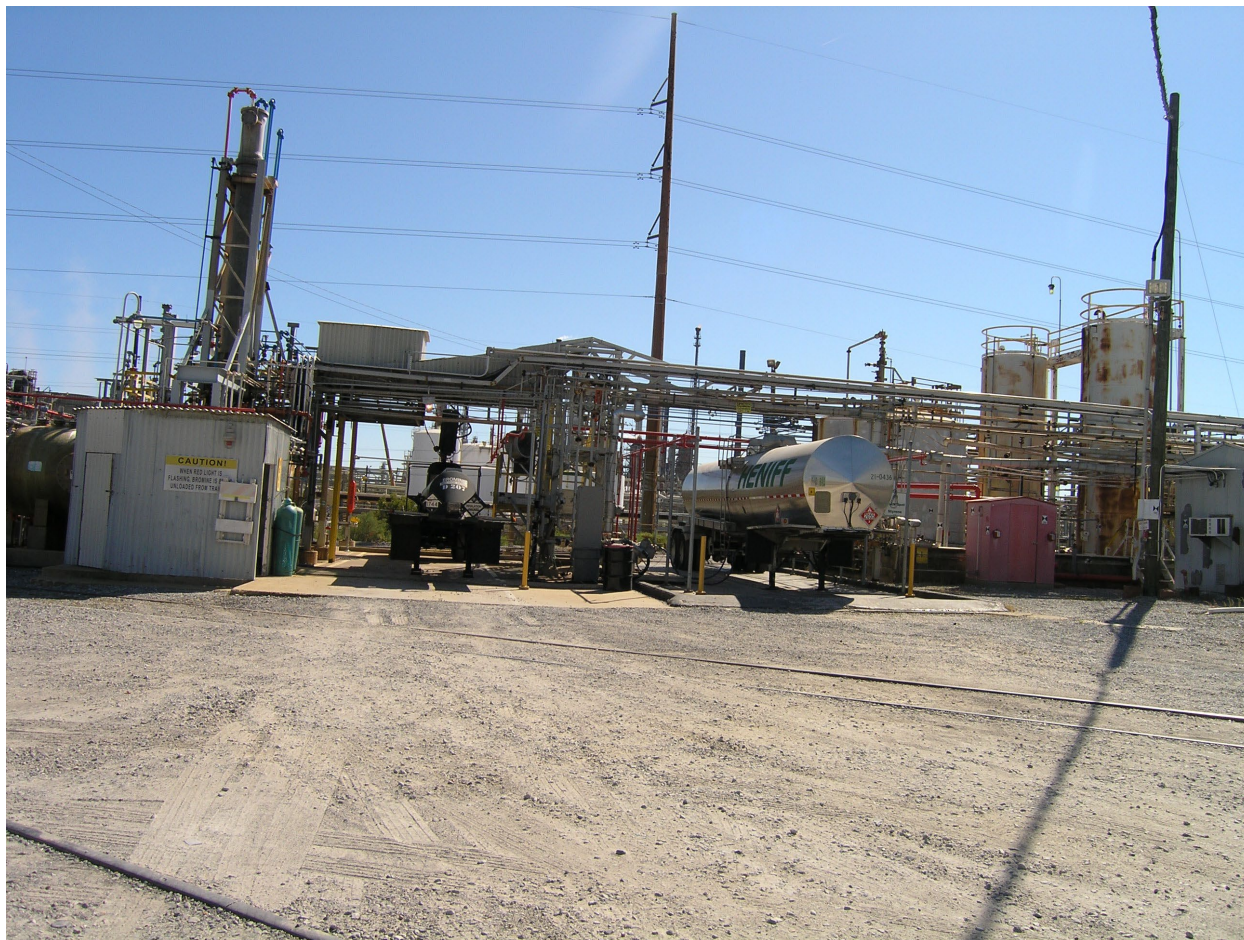
Photo No. 4

| Description:<br>Beginning of the 7010 process where bromine and styrene enter the production process | | |

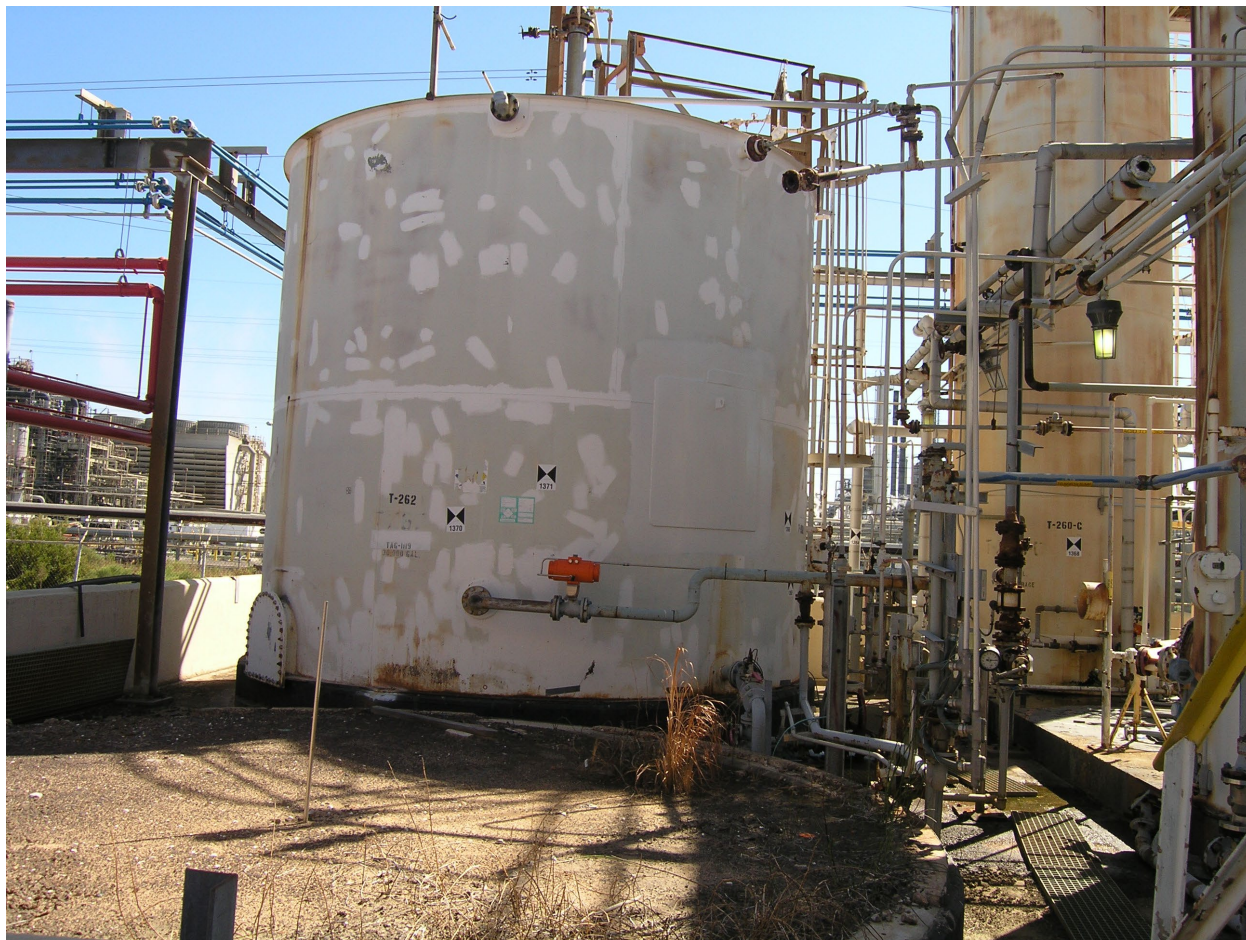
Photo No. 5

I then inspected the neutralization unit used in the brominated flame retardant process. Materials from this unit were said to be high-pH water mixed with sulfuric acid and are pumped to W.R. Grace. Albemarle stated that material from this unit is tested for total organics and is non-hazardous.

| Description:<br>Tank 262 – neutralization tank for wastewater from HP7010 process. | | |

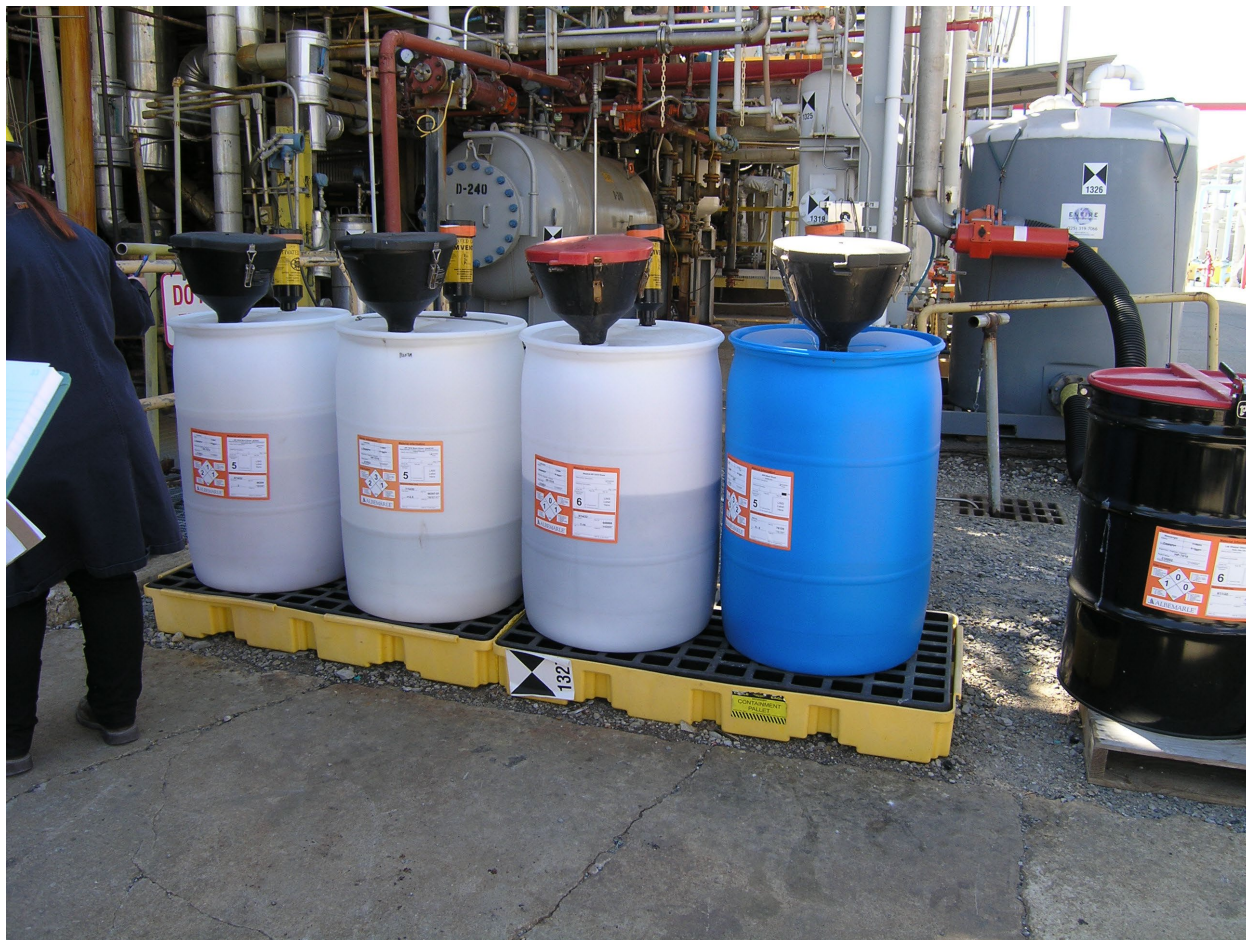
Photo No. 7

| Description:<br>North Sump satellite drum area. | | |

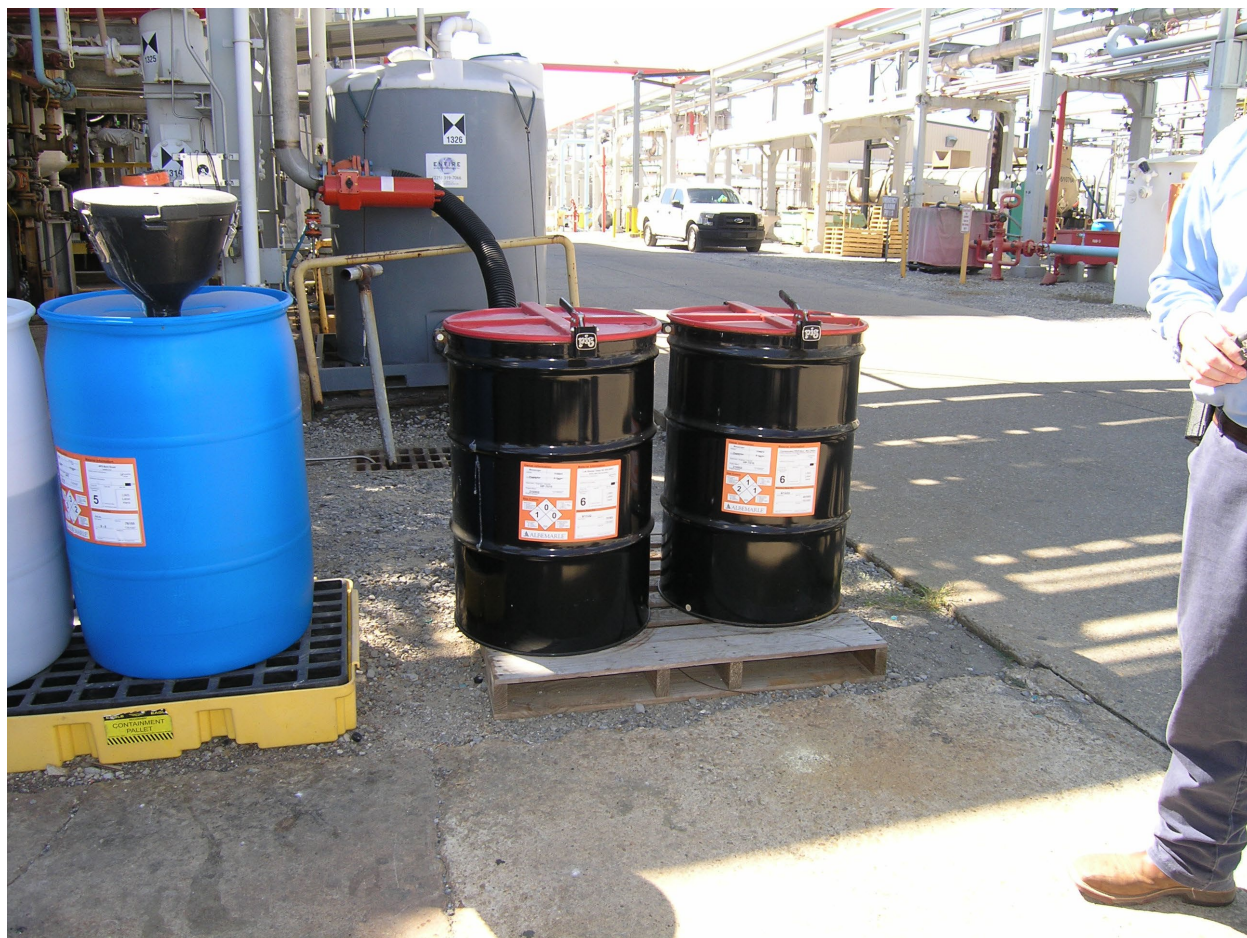
Photo No. 8

| Description:<br>North Sump satellite drum area. | | |

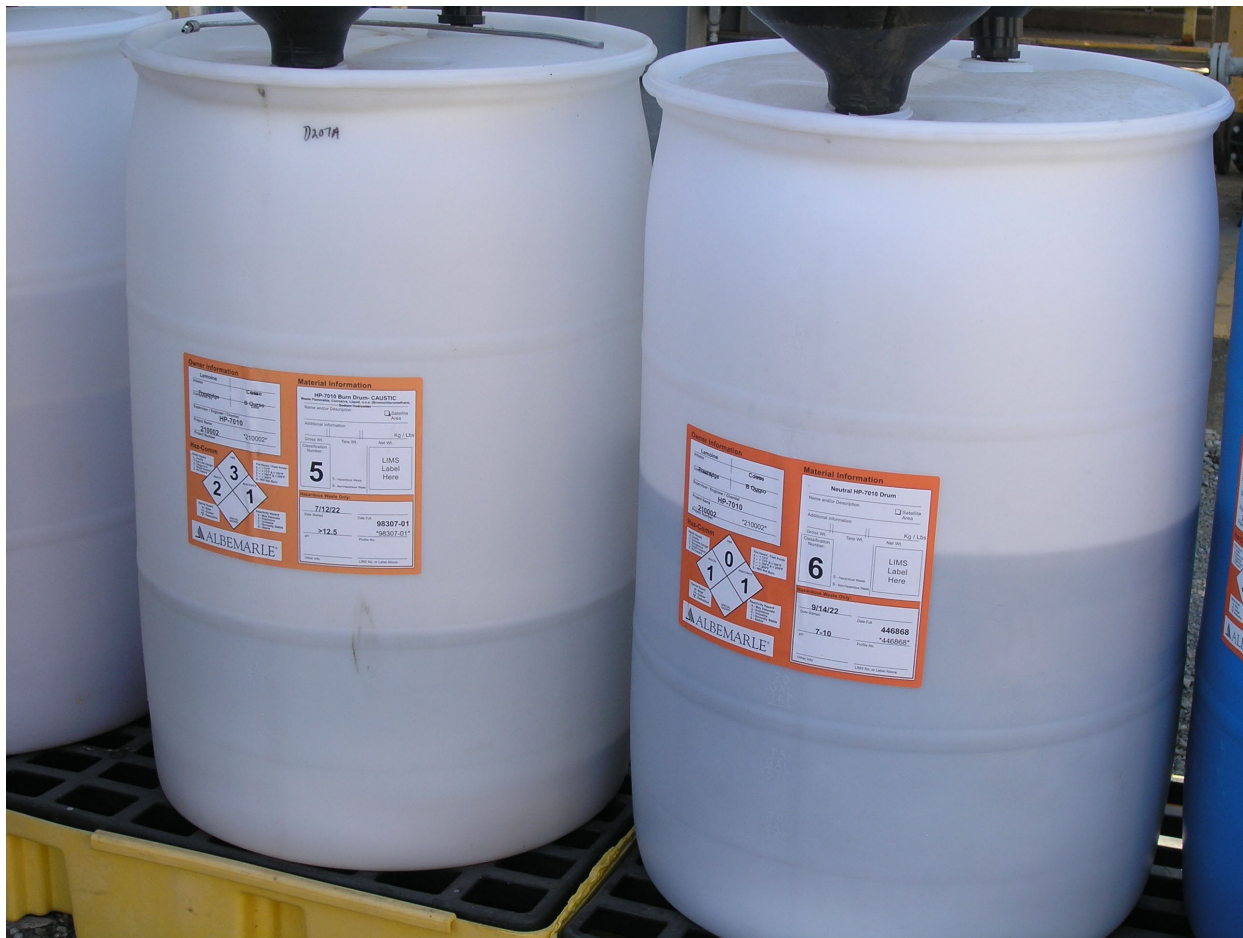
Photo No. 9

Albemarle uses this area as a satellite accumulation area serving the brominated flame retardant and anionic polystyrene production lines. I observed four partially full drums of hazardous waste, each with a closed and secured funnel and a drum air vent. Containers appeared to be in good condition with appropriate labels, included a marking that identified the drums as satellite accumulation containers.

| Description:<br>Closeup of drums in North Sump satellite area showing labeling on drums. | | |

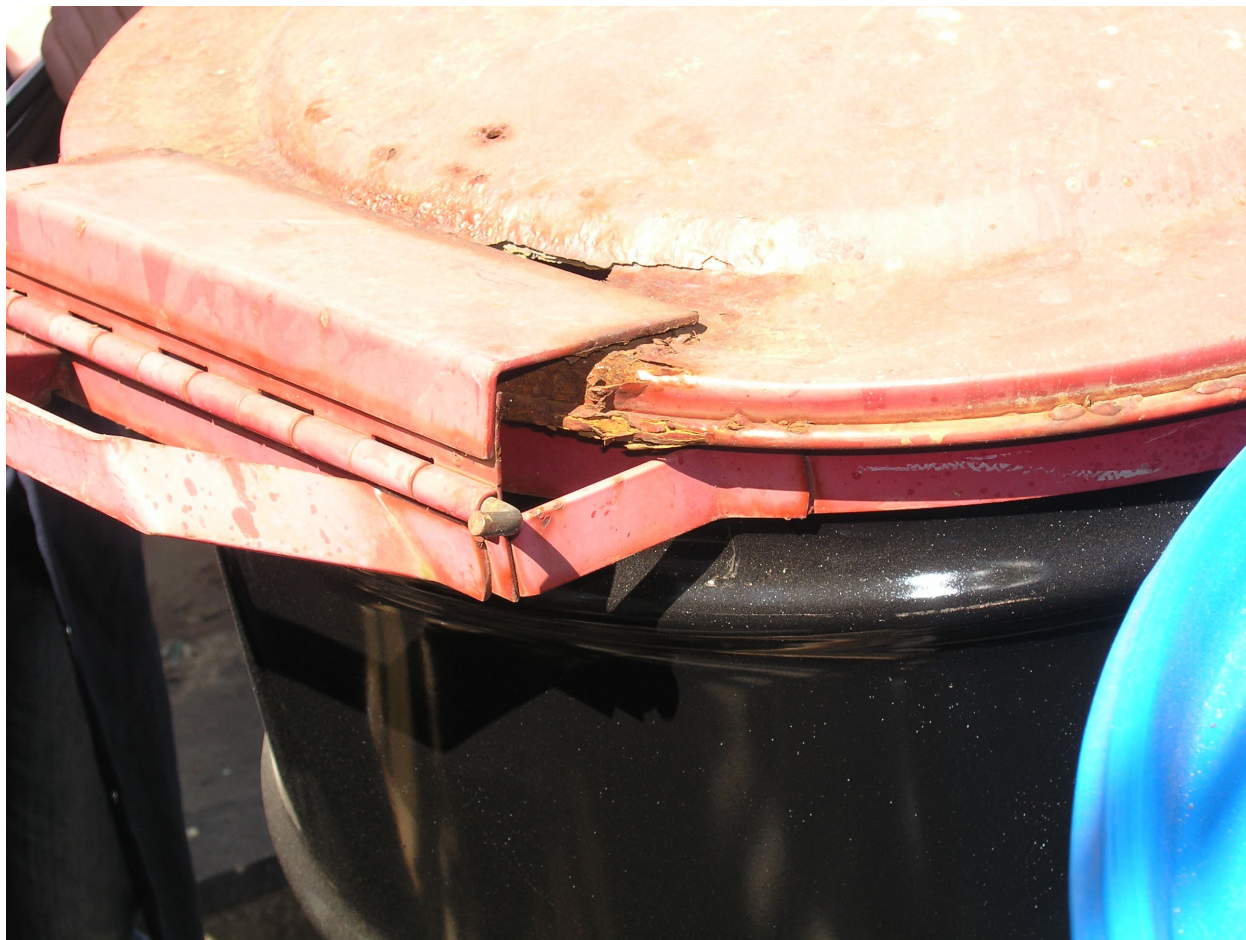
In this area, I observed two satellite drums containing hazardous waste serving the polystyrene process tank. One drum collected samples from the tank to be incinerated, and the other collected PPE contaminated with materials from this process. I noticed visible deterioration of the metal PPE drum; the container was corroded on the hinge, and solvent odors were present in the area.

| <b>Description:</b><br>Satellite area for APS process located near final process tank. PPE drum with rusted top. Hole near hinge goes through the top. | | |

- The PPE drum was corroded on the hinge and visible deterioration of the drum was present. Solvent odors were present in the area.

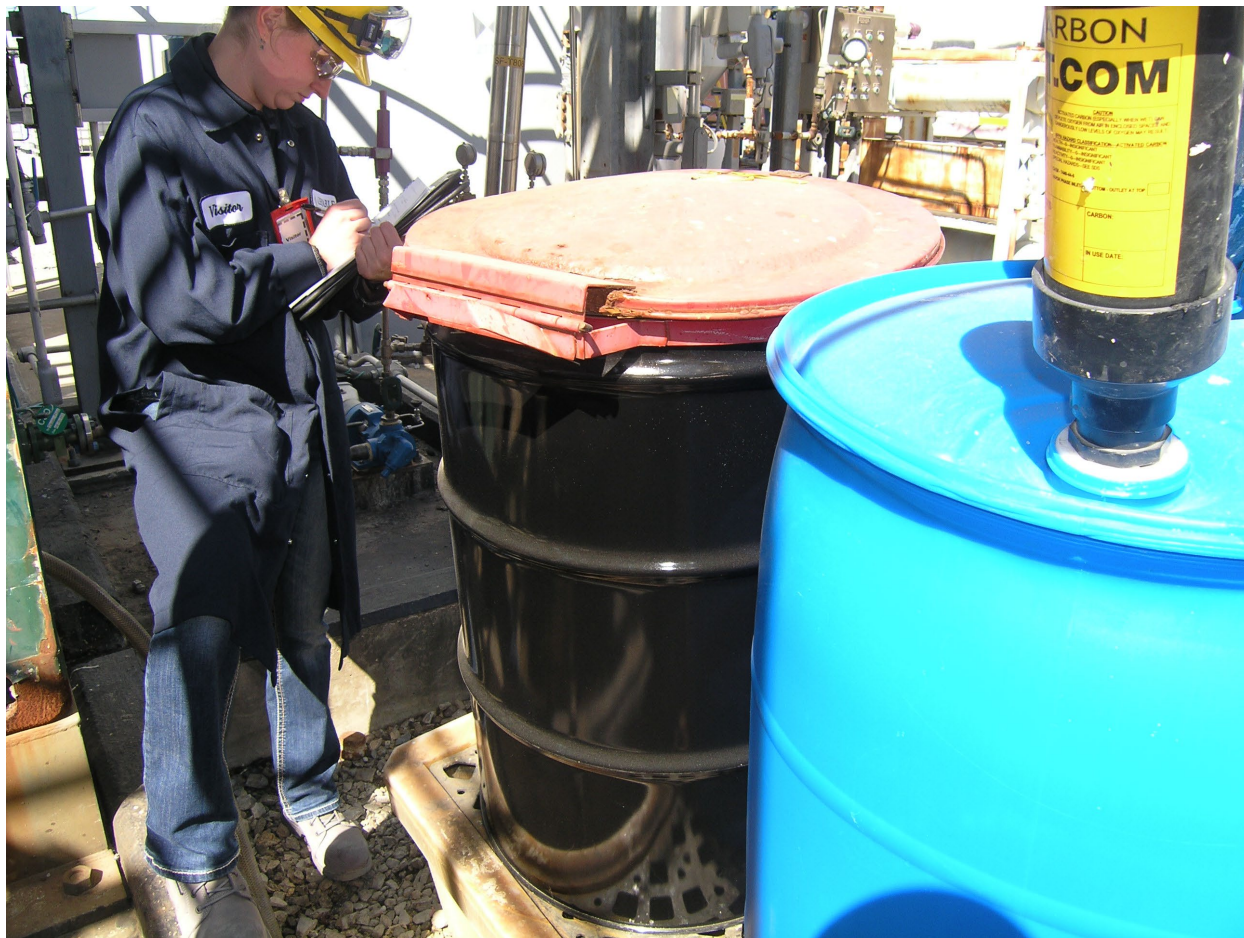
| Description:<br>Satellite area for APS process located near final process tank. PPE drum with rusted top. Hole near hinge goes through the top. | | |

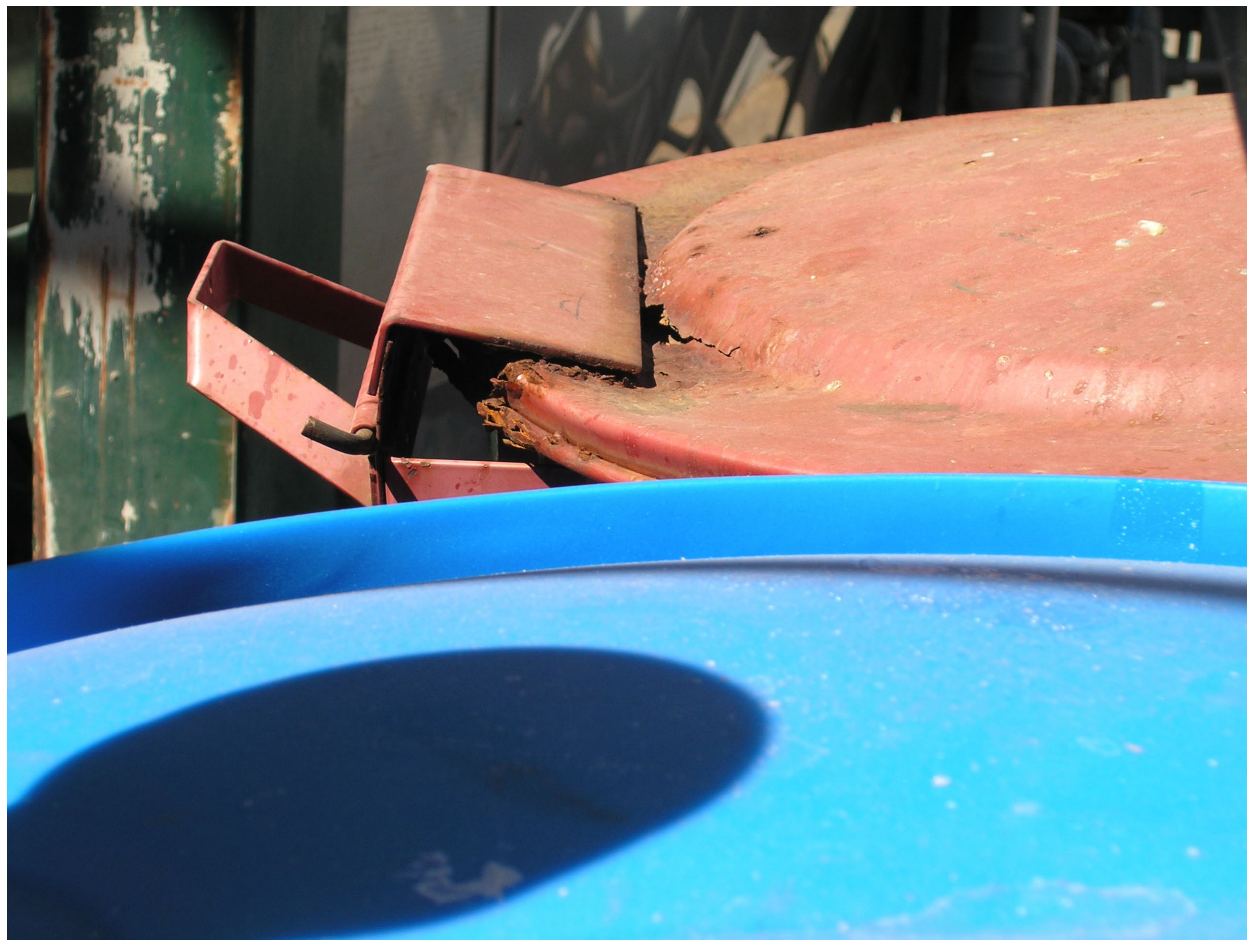
| <b>Description:</b><br>Satellite area for APS process located near final process tank. PPE drum with rusted top. Hole near hinge goes through the top. | | |
