**Arkoma Operations LLC- Helton Well Pad  
Full Compliance Evaluation (FCE)  
On-Site Clean Air Act (CAA) Inspections**

**Inspection Date:** June 27, 2022

**Inspection Report Date:** July 21, 2022

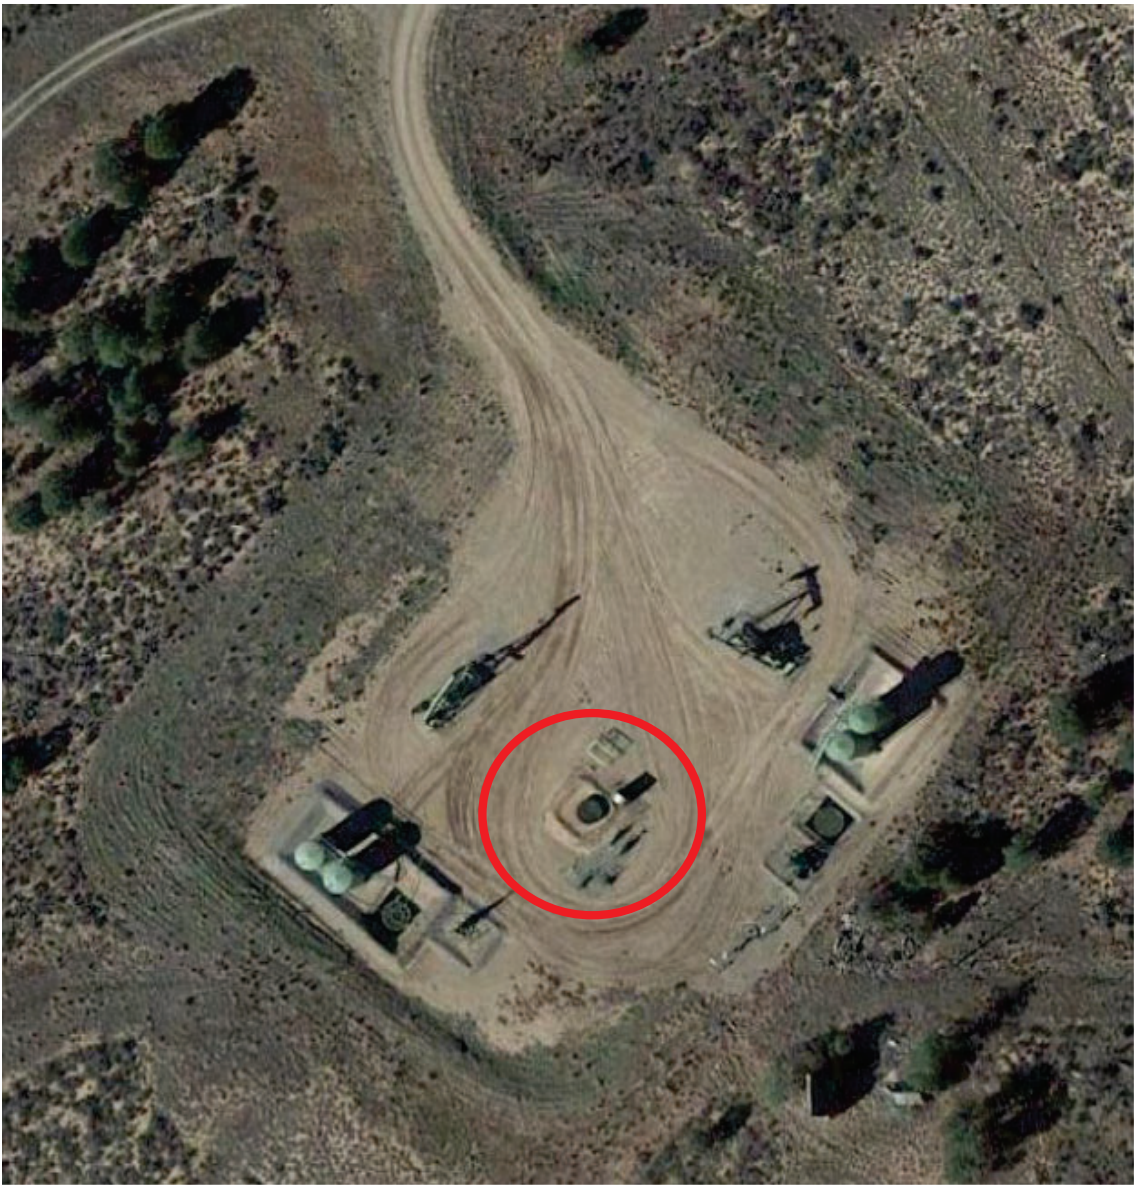
Google Earth Image:

The two Arkoma wells are located in the red circle below, the co-located Advanced Wireless Communications wells are outside the red circle.
