# NPDES Compliance Inspection Report

**Darigold – Rainier  
Seattle, Washington**

**Permit #: WAR000500**

**Inspection Date: January 18, 2022**

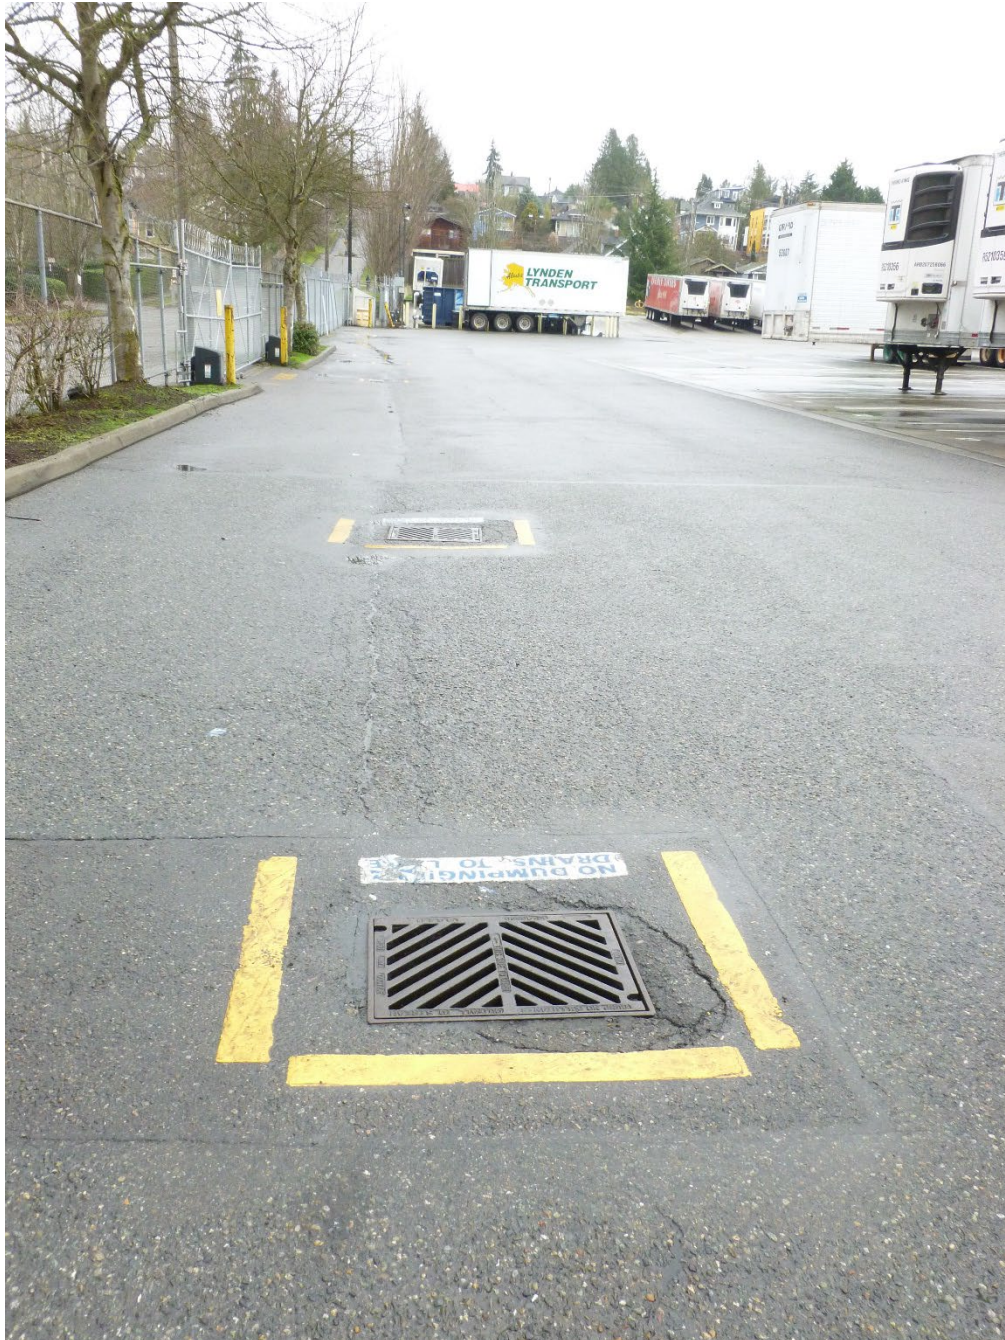
**Photo 1 / P1010174** – Catch Basin Line, facing east

We started the tour in the northwestern side of the site where I observed a "catch basin line" (**Photo 1**). The facility has over 30 catch basins located around the site to collect stormwater. As can be seen in Photo 1, the ground is slightly graded to facilitate the flow of stormwater into the catch basins. The facility uses two types of catch basins, Type 1 (**Photo 2**) and Type 2 (**Photo 3**). The two catch basin types function similarly.

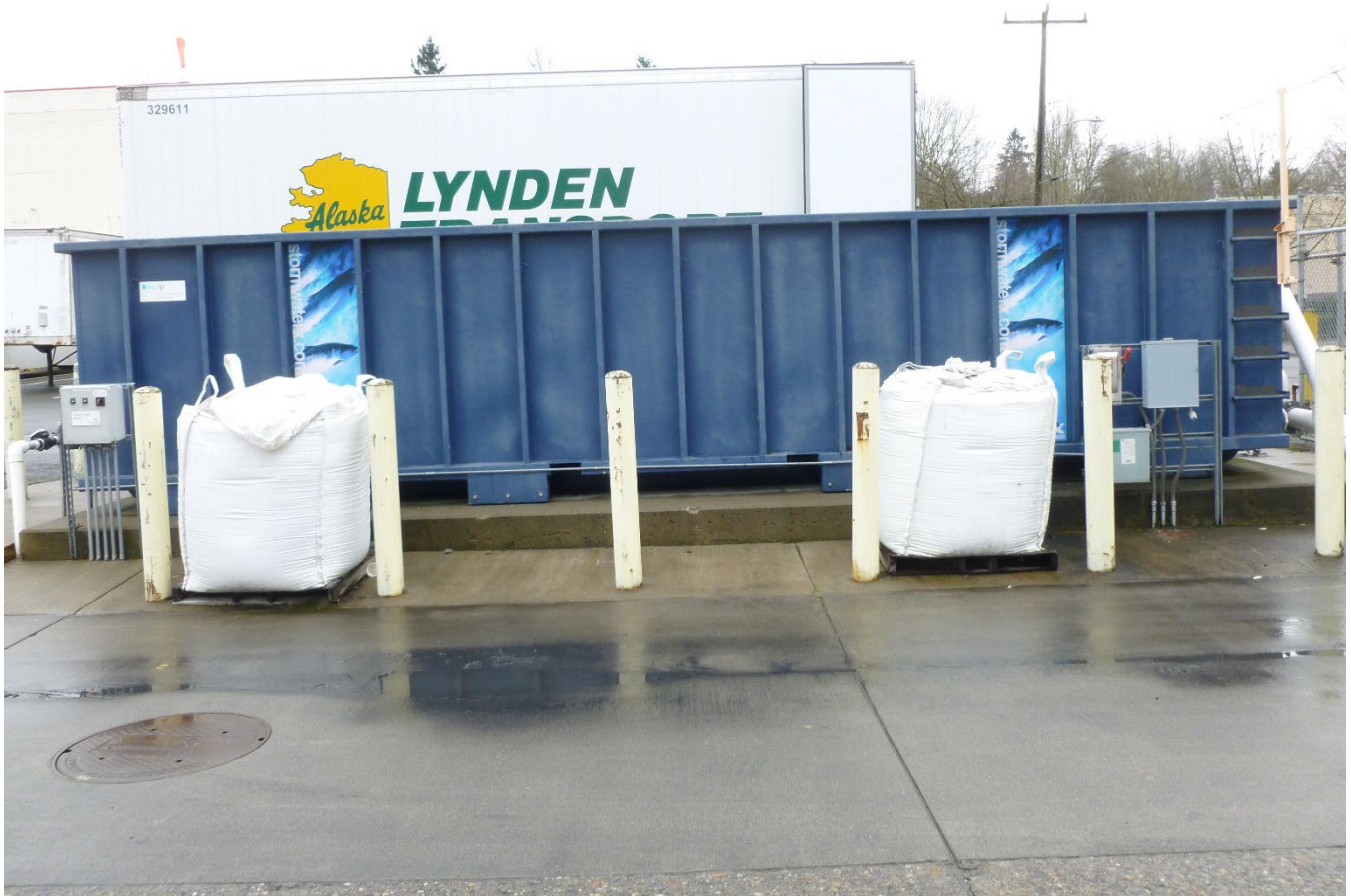
**Photo 4 / P1010181** – Filtration System with totes of clean filtration media

After observing several catch basins, I asked to see the filtration system. The facility uses a stormwaterRx™ Aquip filtration system, which was installed in 2011. The filtration system is located on the northern end of the site. As we came upon the Aquip system, I noted there were two totes in front of the system (**Photo 4**). One of the Representatives said the totes contained clean filter media that would be used to replace media in the filtration unit as it becomes contaminated. All stormwater collected by the catch basins is pumped into the Aquip system. Stormwater enters the system on the southern end (**Photo 5**). The water enters a pre-treatment chamber then flows into the filtration chamber. The water infiltrates down through the media and is discharged through a pipe on the bottom of the northern end of the system (**Photo 6**). The water is sampled from a stopcock (**Photo 7**) prior to discharge through piping to Lake Washington which lies approximately one-half mile northeast of the facility. While observing the filtration system, I noted approximately ten 55-gallon unlabeled barrels lined up on the backside of the system (**Photo 8**). The barrel lids were in place but not secured. One of the Representatives said the barrels contained used filtration media. I asked him to lift the lid of one of the barrels so I could view the contents (**Photo 9**). This was the last stop on the site tour, so we returned to the office for the closing conference.
