# **Georgetown Sewage Treatment Plant #1**

## **NPDES Compliance Evaluation Inspection**

**632 N Broadway Georgetown, KY 40324**

**Project Date(s): July 9<sup>th</sup>, 2024**

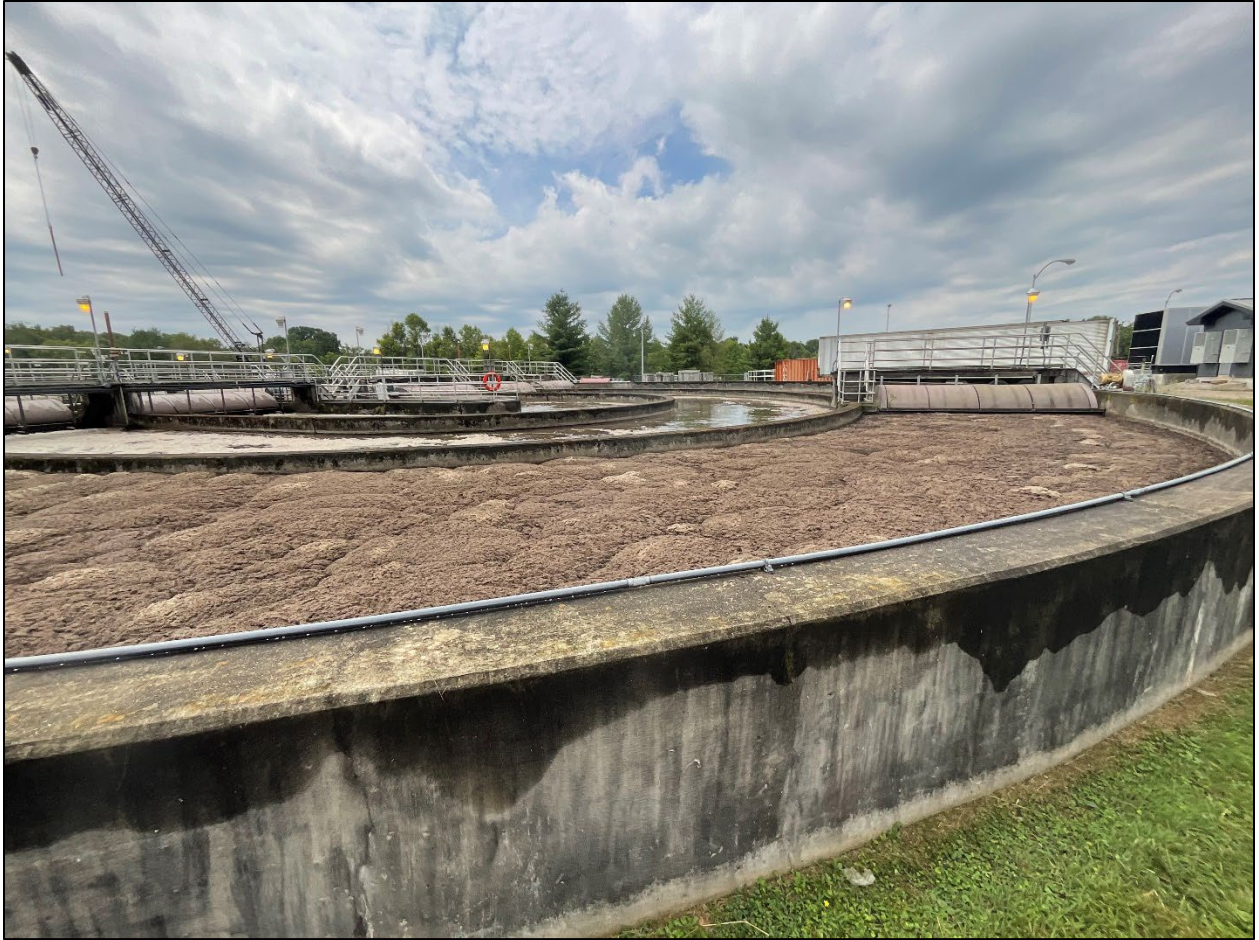
**Figure 1 - Oxidation Ditch**

The rotating biological contact disc was not operational on one side of the oxidation ditch and the sludge appeared to be dark in color with bulking. This could lead to lack of nutrient removal if the dissolved oxygen isn't maintained at the correct range. Facility stated that it was waiting on procurement of necessary parts. (Figure 1).
