**Industrial Site**  
**NPDES Stormwater Reconnaissance Inspection**

**TROPICAL SHIPPING CONSTRUCTION COMPANY LIMITED, LLC**

Inspection Dates: September 8, 2022

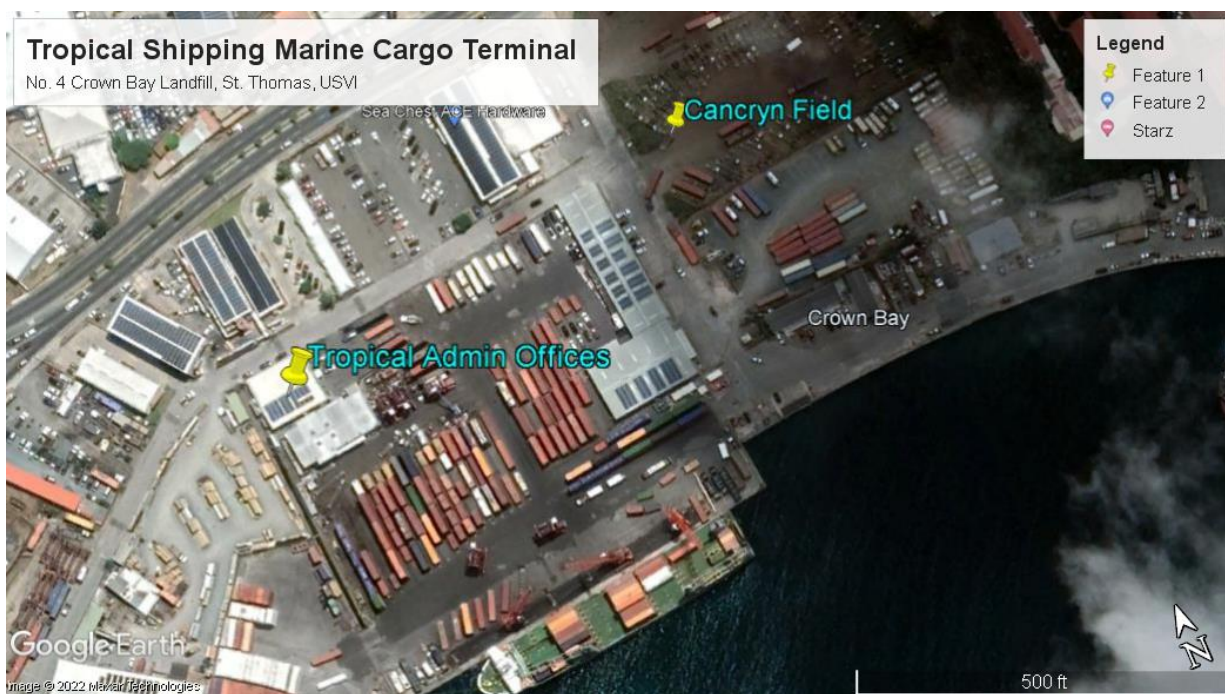
**Figure 1**  
**Tropical’s Marine Cargo Terminal, Crown Bay Landfill, St. Thomas, VI**

The Crown Bay Marine Cargo Terminal (the “Facility”) section of the dock bulkhead and warehouses under the control and operation of Tropical Shipping Construction Company Limited, LLC<sup>2</sup> (“Tropical”) is a maritime shipping operation involving loading and unloading of commercial cargo containers with goods and other bulk items at the marine cargo dock in Crown Bay, St. Thomas, United States Virgin Islands (“USVI”). The Facility is mostly situated on No. 4 Crown Bay Landfill, and three (3) smaller adjacent land parcels in St. Thomas, USVI. The land parcels (referenced above) on which the Facility is situated are owned by the Virgin Islands Port Authority (“VIPA”) but occupied by Tropical through a property lease agreement. An aerial photograph of the Facility<sup>3</sup> is featured as **Figure 1** of this Inspection Report.

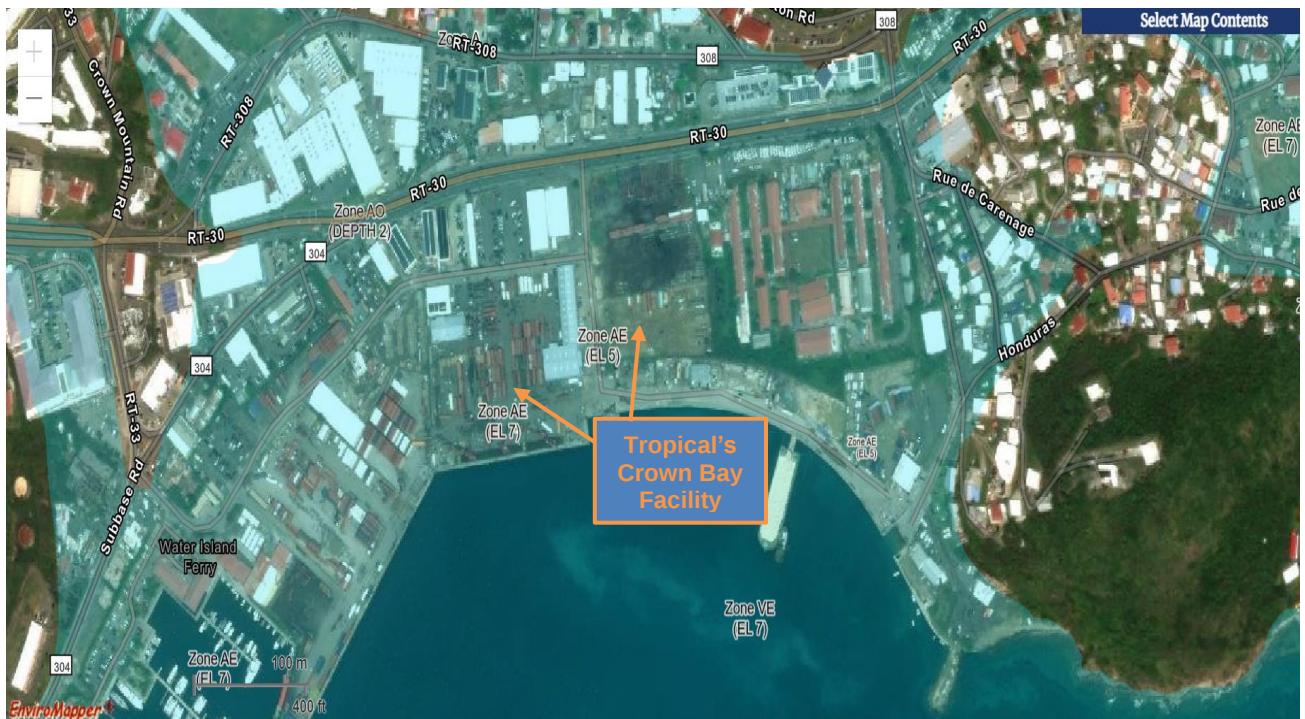
**Figure 2**  
**Tropical’s Facility situated within the northwestern section**  
**of the St. Thomas Harbor Watershed**

The Facility is situated along the northwestern shoreline of Crown Bay, which is within southwestern section of the St. Thomas Harbor Watershed that drains into the Charlotte Amalie Harbor (Caribbean Sea). An aerial view of location of the Facility and immediate surroundings are depicted in satellite imagery of the St. Thomas Harbor Watershed featured in **Figure 2** (Source: <https://nepassisttool.epa.gov/nepassist/nepamap.aspx>), immediately below.
