**Region 6 - Enforcement & Compliance Assurance Division**  
**INSPECTION REPORT**

| Inspection Date(s): | 09/29/2022 | |
| Facility Name: | <b>Santa Rosa Wastewater Treatment Plant</b> | |

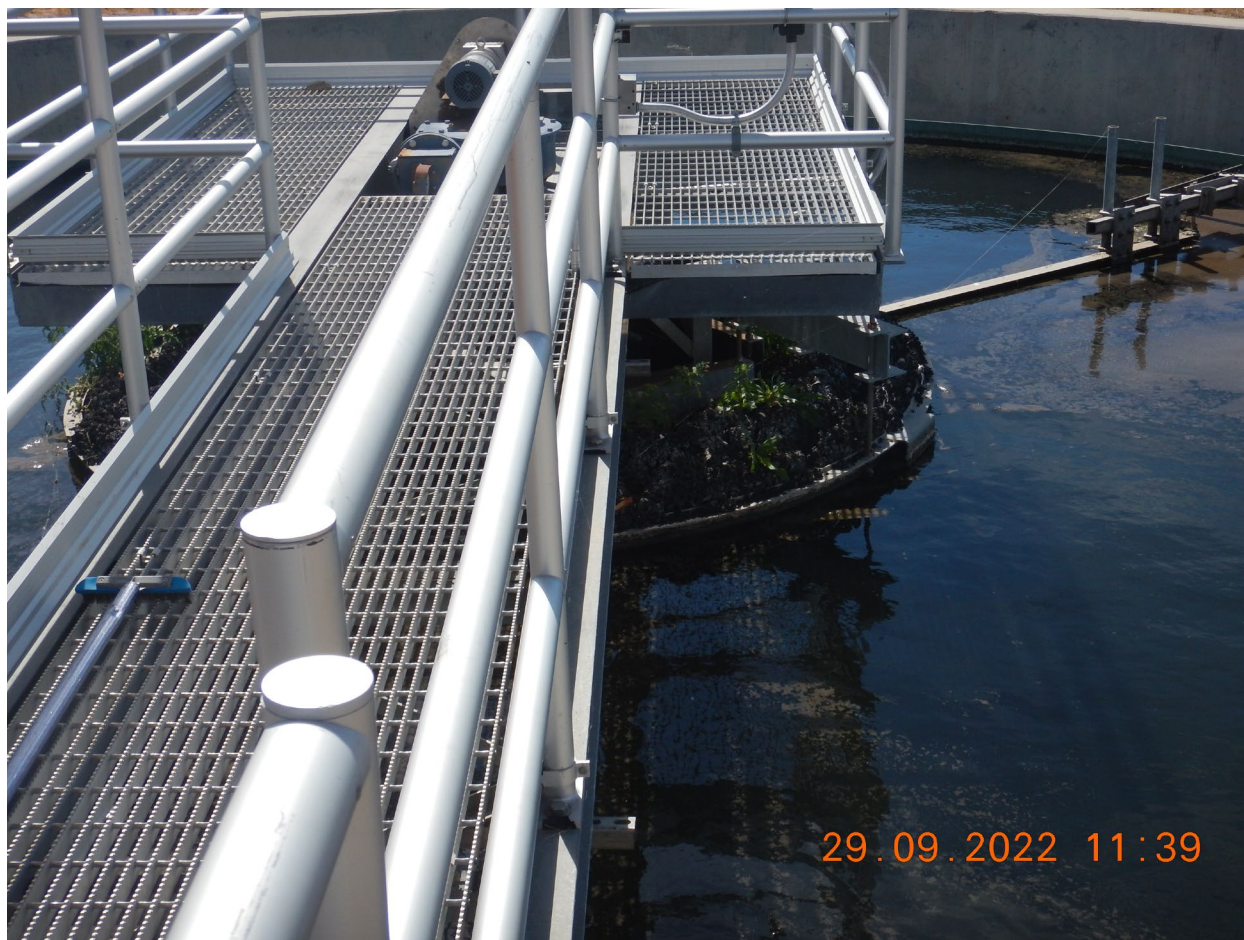
Photo No. 1

- The scum box inside the southside clarifier was not operational and needed cleaning and repair. Note: the Northside clarifier was currently offline.
- The sewage within the aeration basins was extremely dark in color and exhibited floatable solids.

The scum box inside the southside clarifier was not operational and needed cleaning and repair.  
(DSCN2358) Photographed by D. Esparza

- The scum box inside the southside clarifier was not operational and needed cleaning and repair. Note: the Northside clarifier was currently offline. Mr. Cordova stated during a recent telephone that the scum box had been cleaned, and the pump had been replaced with their back-up pump.
- The sewage within the aeration basins was extremely dark in color and exhibited floatable solids. During the above telephone call, Mr. Cordova stated this basin was slowly being drained and was scheduled to be cleaned and repaired as necessary.
- Staffing- initially at the time of the inspection (September 28, 2022)- no operators or WWTP personnel were available. It was necessary to return on the afternoon of September 29, 2022. Given this fact, observation of the LSs was not possible.

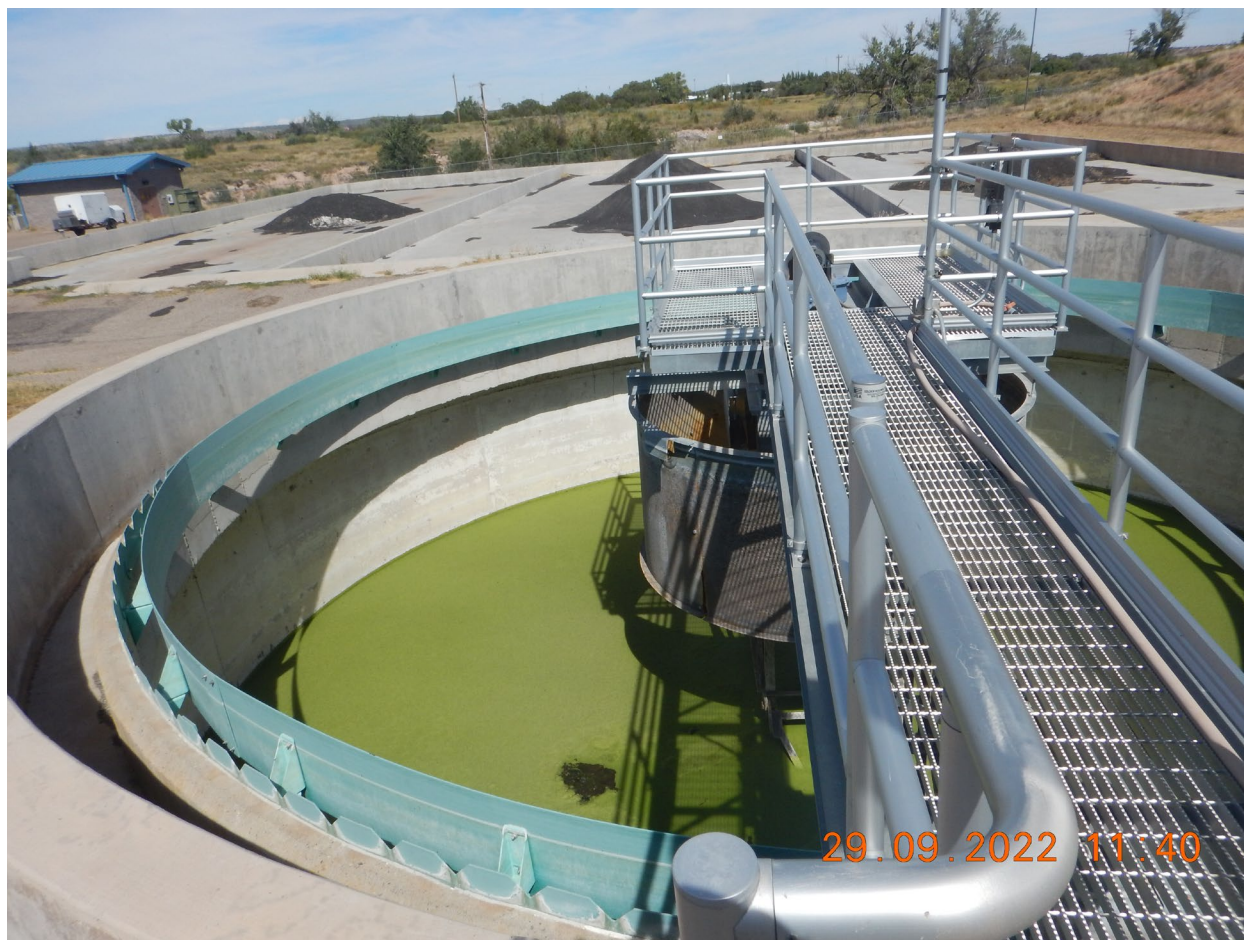
Photo No. 2

View of the Northside clarifier currently offline. (DSCN2359) photographed by D. Esparza.

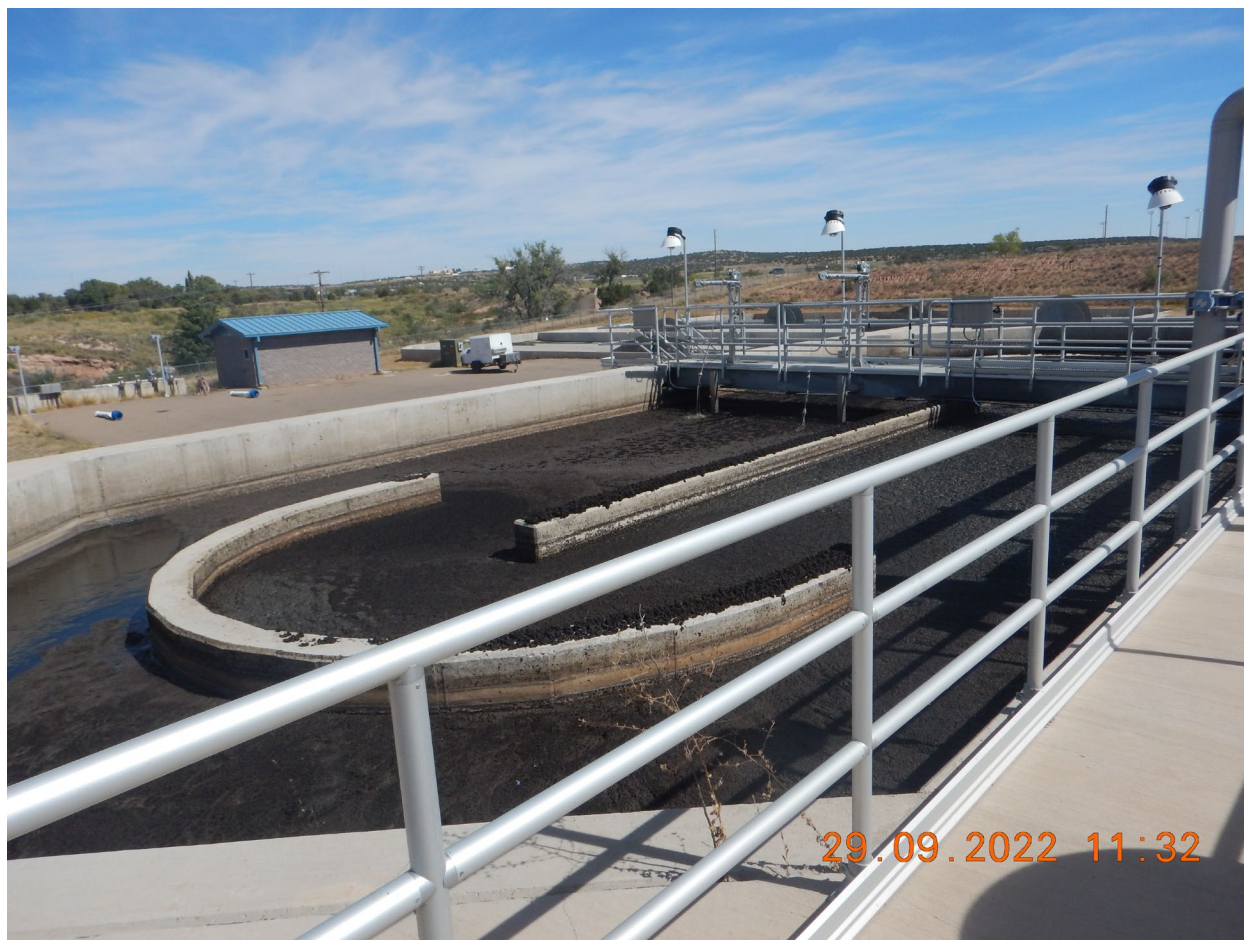
Photo No. 3

View of the sewage within the aeration basins that was extremely dark in color and exhibited floatable solids. (DSCN2354) Photographed by D. Esparza.

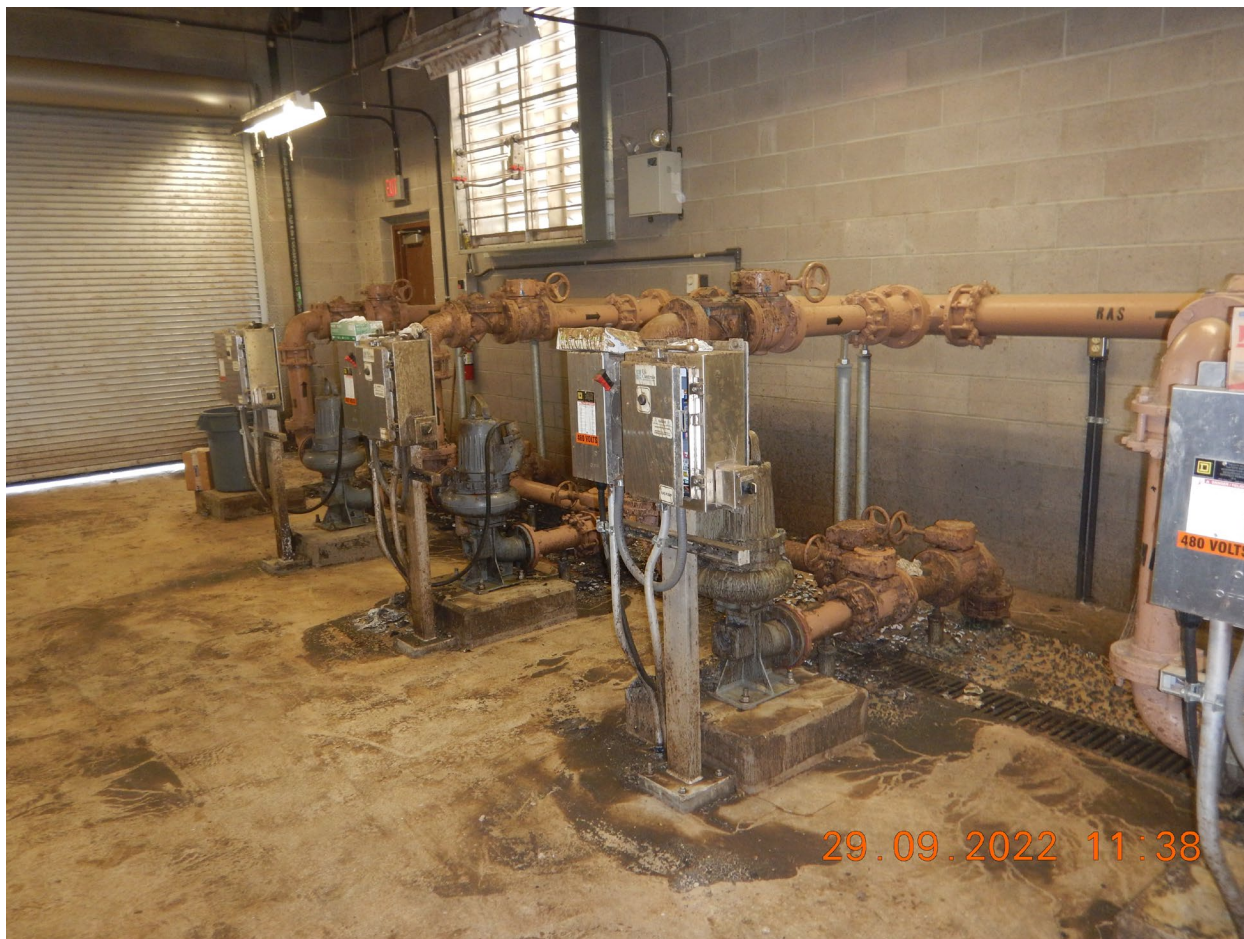
Photo No. 4

- The overall housekeeping of the WWTP of the grounds and ancillary appurtenances appeared to be well maintained and in operational order with exception of the scum box, aeration basin and the visible overflow debris inside the pump room.

View of the visible overflow debris inside the pump room looking approximately Northeast. (DSCN2356)  
Photographed by D. Esparza.

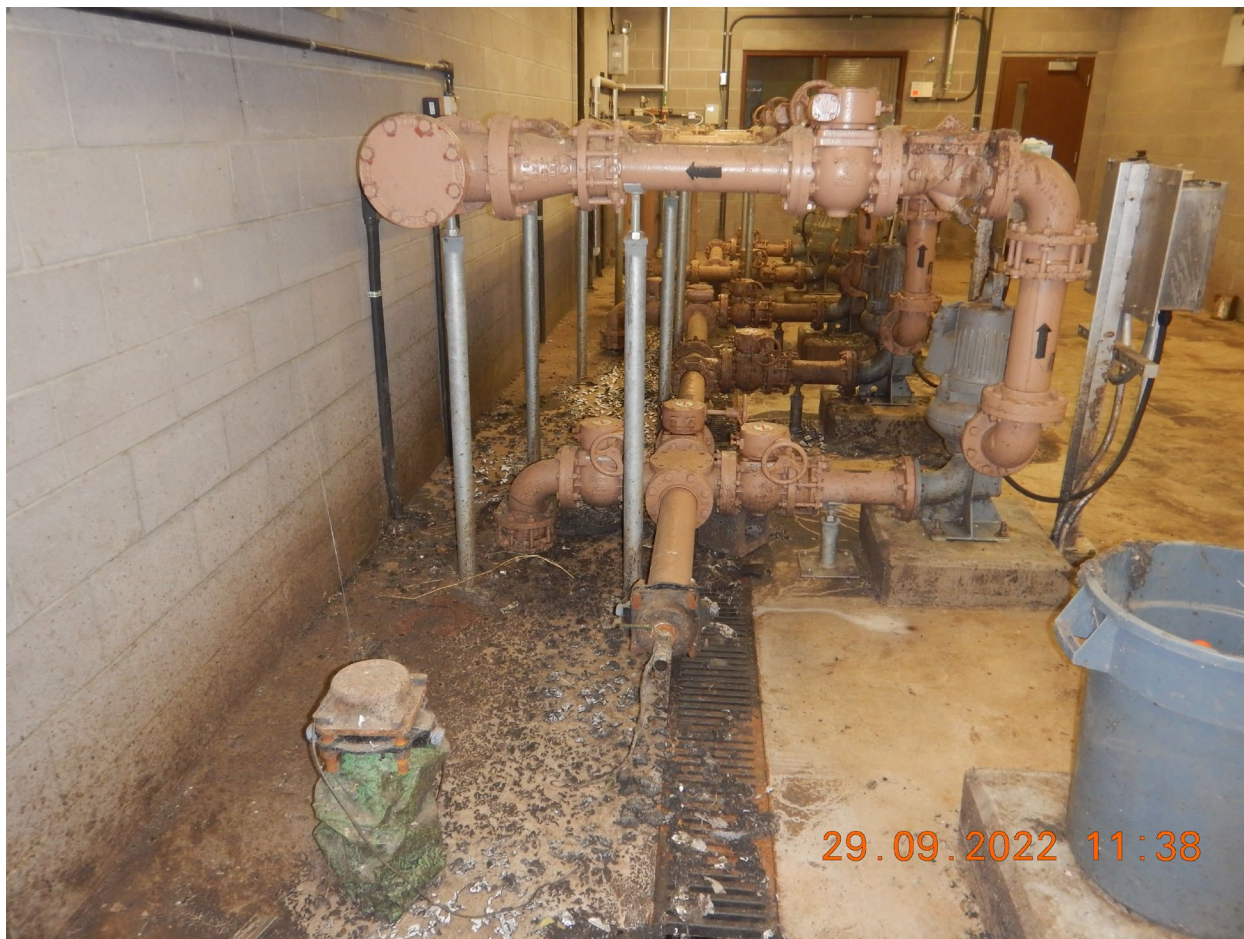
Photo No. 5

Another view of the visible overflow debris inside the pump room looking approximately Southeast. (DSCN2357). Photographed by D. Esparza.

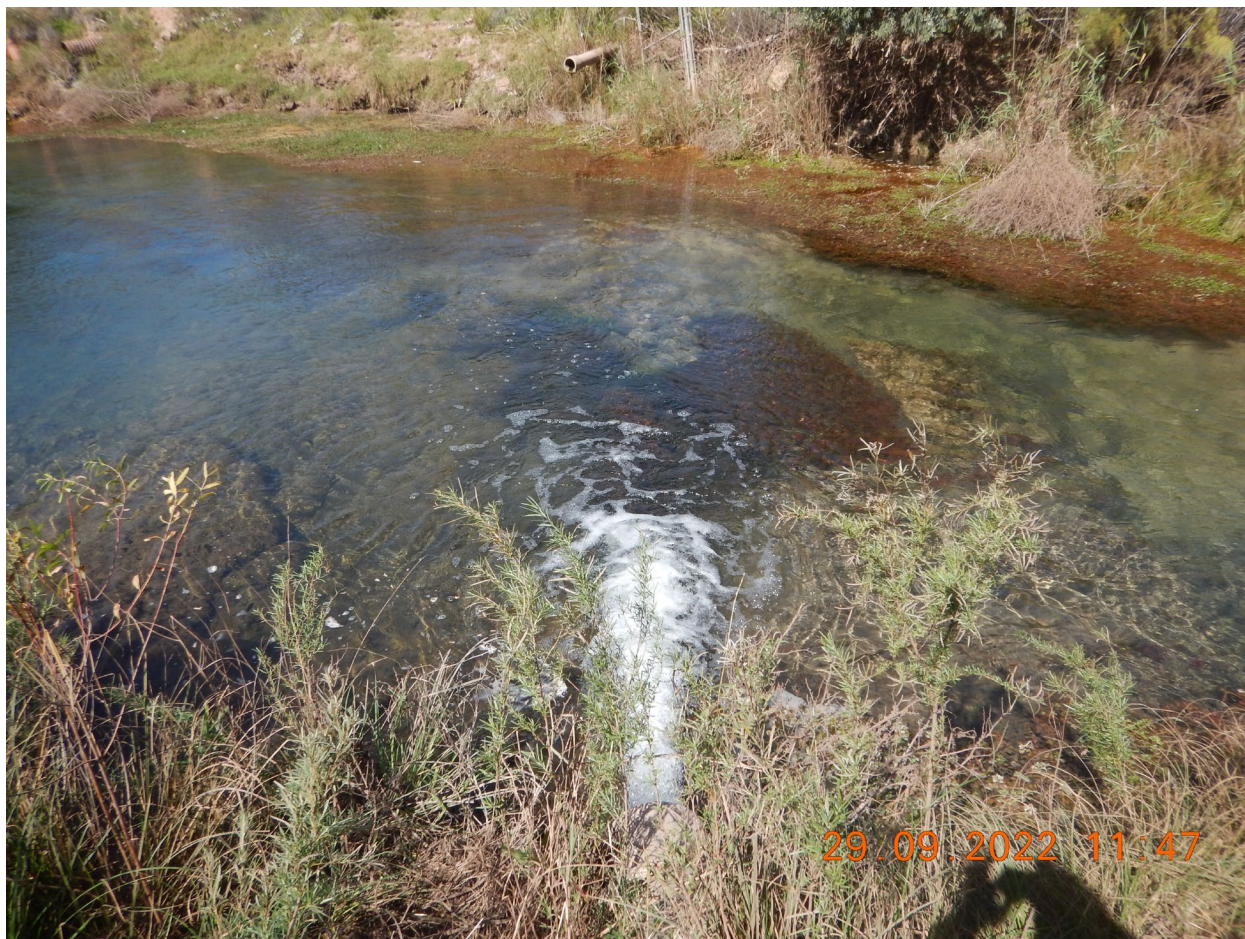
Photo No. 6

View of WWTP's outfall discharge into El Rito Creek. (DSCN2363) Photographed by D. Esparza.
