## Clean Water Act Section 404: Site Visit/Case Development

| Site Name | Sarah Kathe | | | | |

### Photograph Log

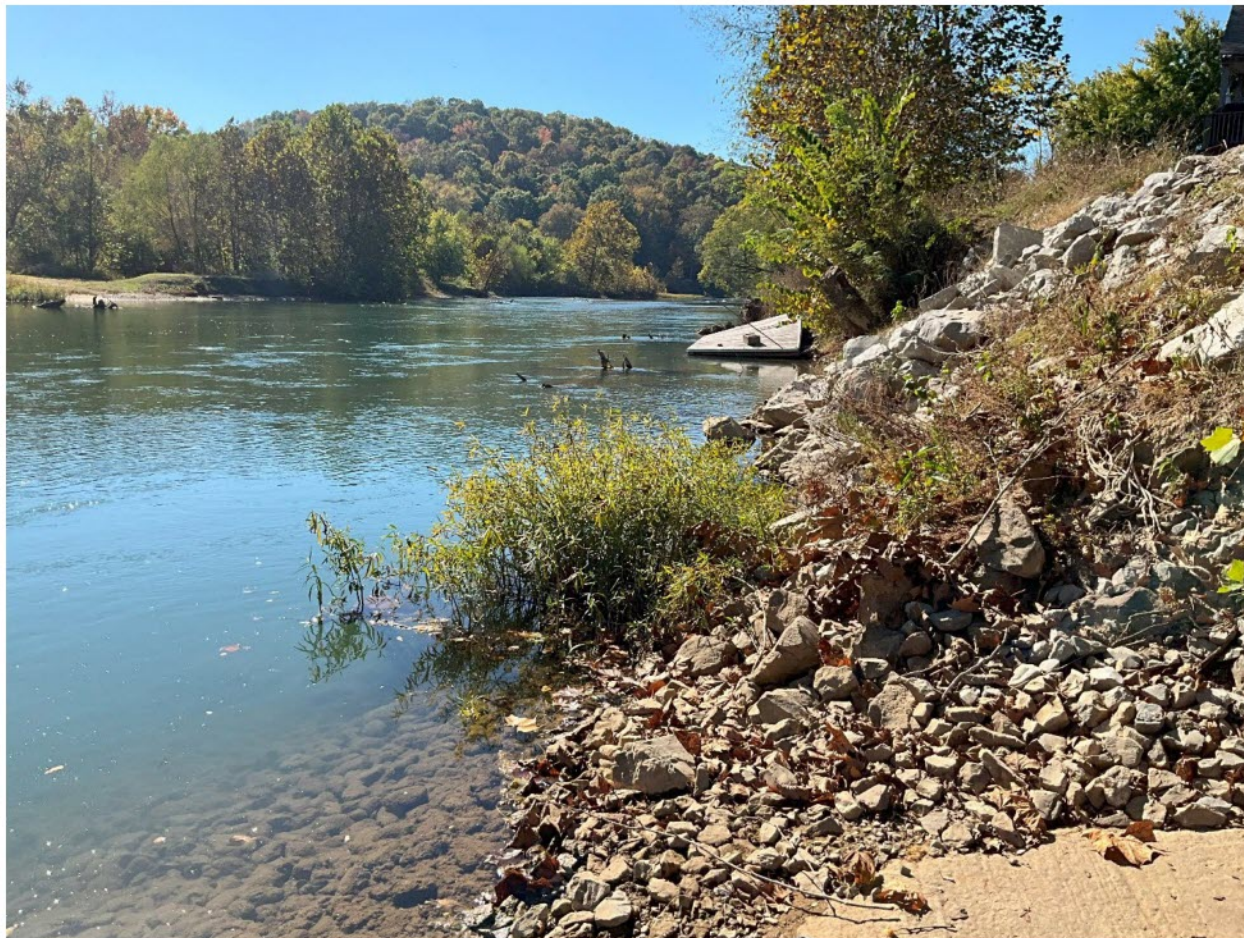
Photo No. 1

| Photo File Name | Date and Time of Photo | Photographer | Description |
|---|---|---|---|
| IMG_0111.HEIC | 10/23/2024, 2:12 PM | Chelsey Sherwood | Showing fill material below Ordinary High Water Mark. Picture taken facing southwest, upstream. |

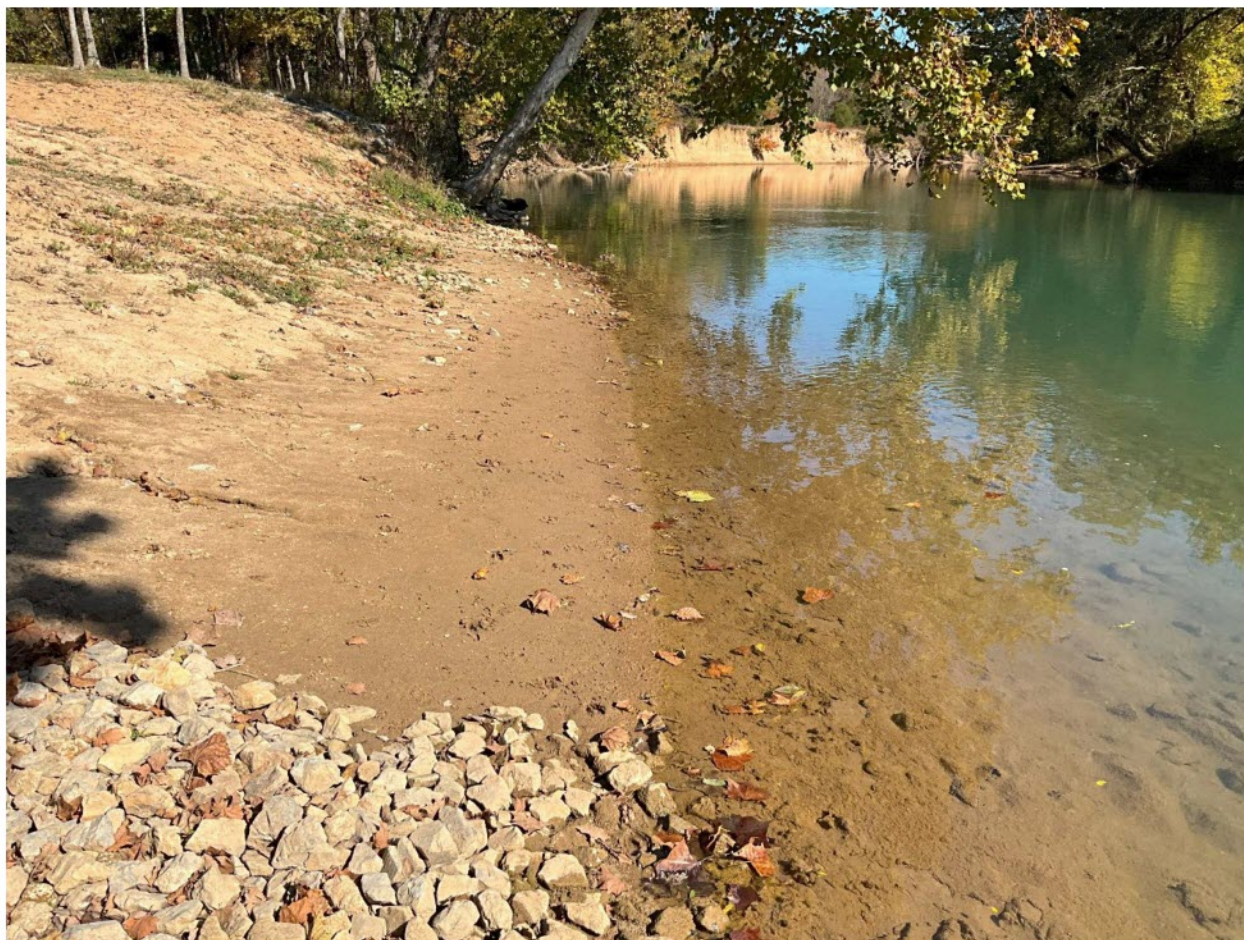
Photo No. 2

| Photo File Name | Date and Time of Photo | Photographer | Description |
|---|---|---|---|
| IMG_0112.HEIC | 10/23/2024, 2:12 PM | Chelsey Sherwood | Showing vegetation removed along stream bank and fill material below Ordinary High Water Mark. Picture taken facing east, downstream. |

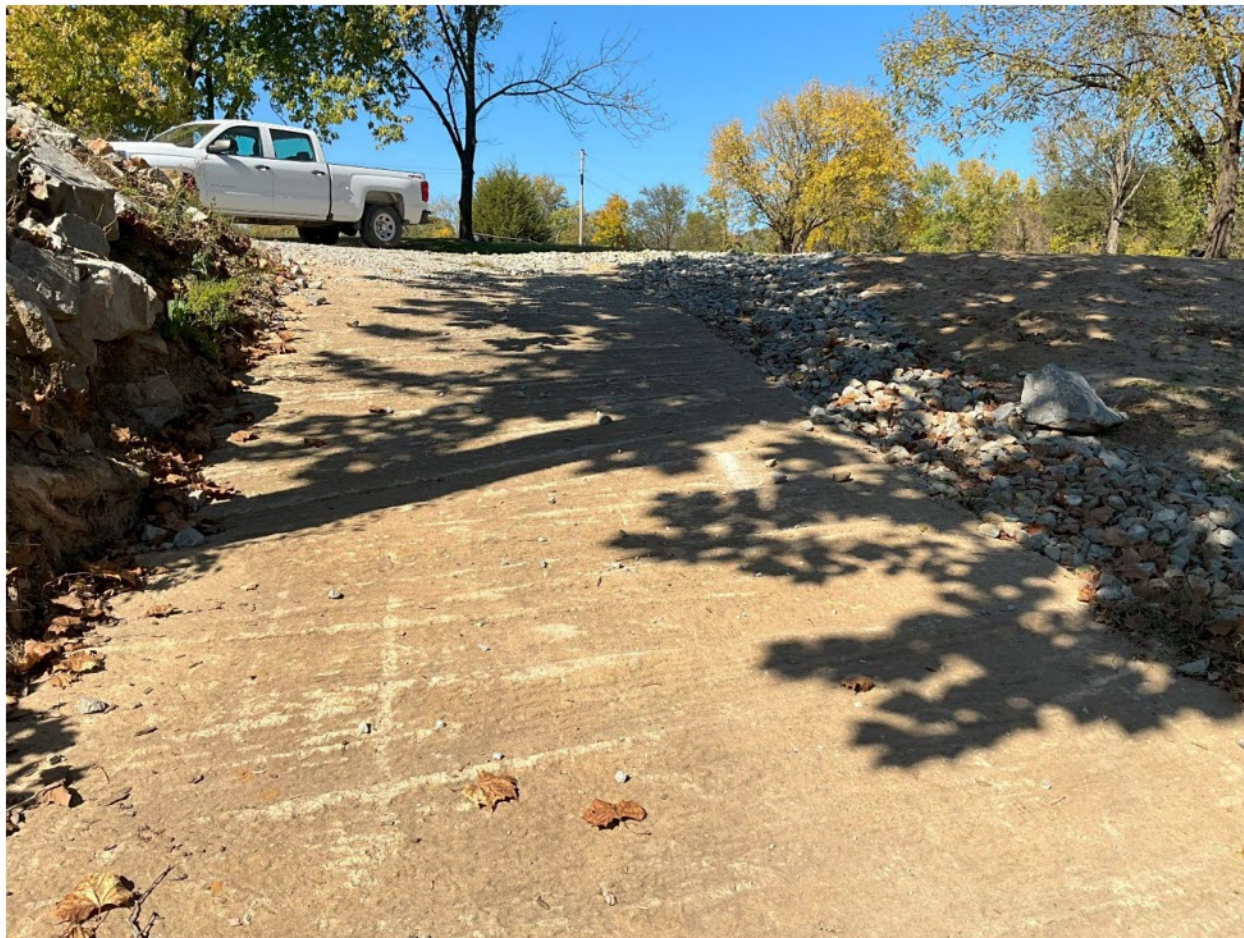
Photo No. 3

| Photo File Name | Date and Time of Photo | Photographer | Description |
|---|---|---|---|
| IMG_0113.HEIC | 10/23/2024, 2:12 PM | Chelsey Sherwood | Showing boat ramp and fill material placed along the ramp. Picture taken facing north. |

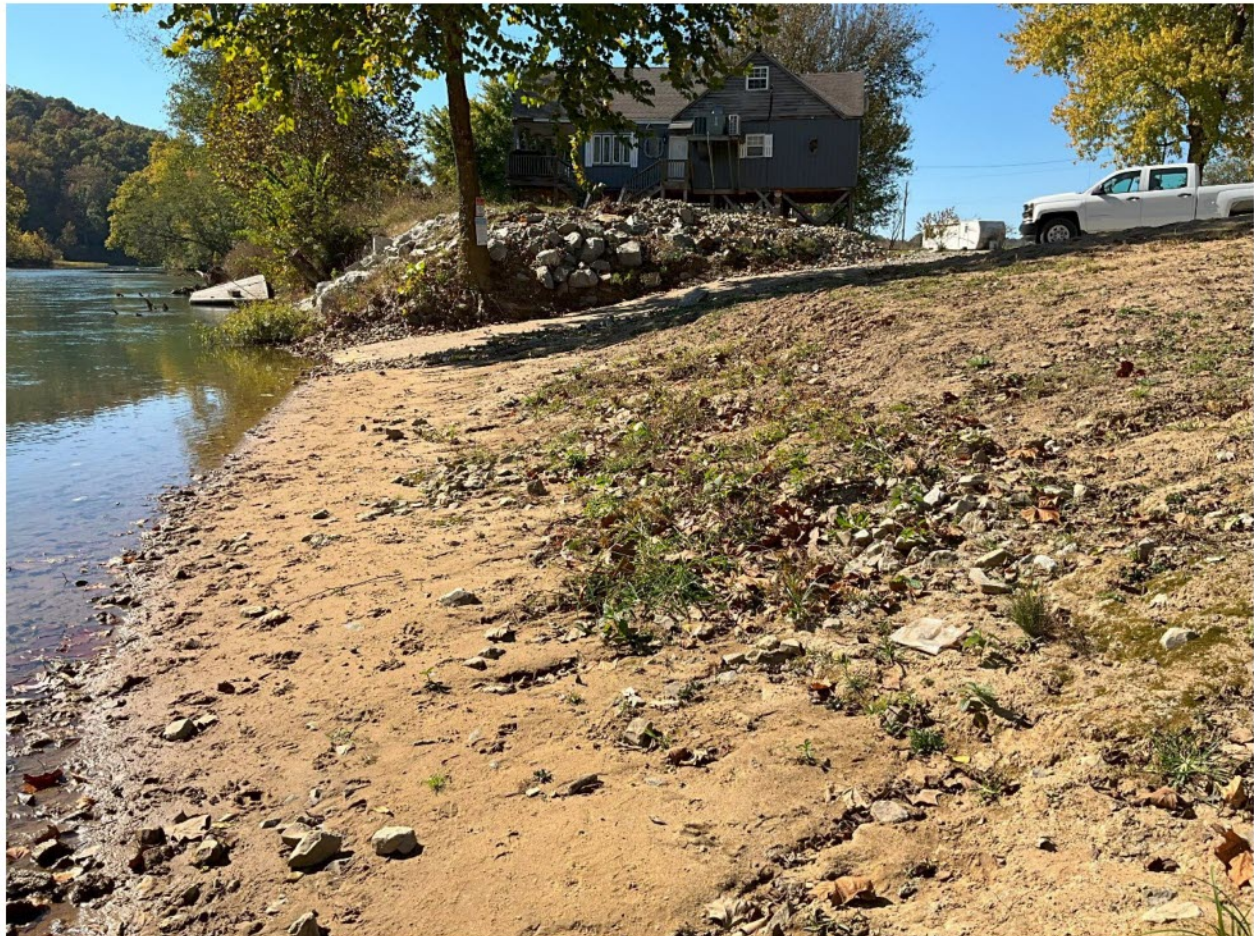
Photo No. 4

| Photo File Name | Date and Time of Photo | Photographer | Description |
|---|---|---|---|
| IMG_0114.HEIC | 10/23/2024, 2:14 PM | Chelsey Sherwood | Showing overall view of project area. Picture taken facing southwest. |

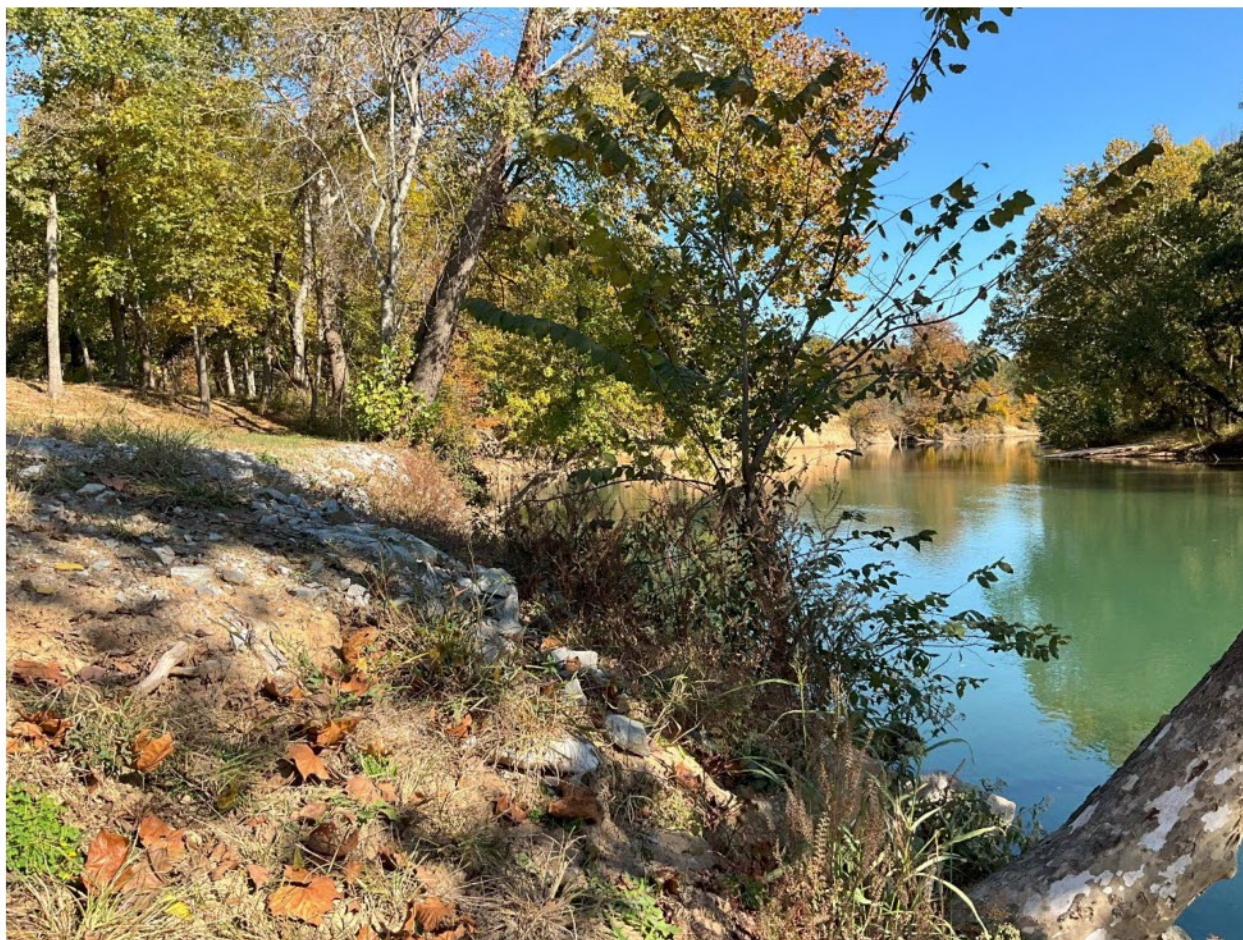
Photo No. 5

| Photo File Name | Date and Time of Photo | Photographer | Description |
|---|---|---|---|
| IMG_0115.HEIC | 10/23/2024, 2:15 PM | Chelsey Sherwood | Showing fill material along river left bank. Picture taken facing east. |
