**Region 6 - Enforcement & Compliance Assurance Division**  
**INSPECTION REPORT**

| Inspection Date(s): | 02/28/2023 | |
| Facility Name: | <b>Jacob A. Hands Wastewater Treatment Facility</b> | |
| Identification/Permit Number: | NM0023311 | |

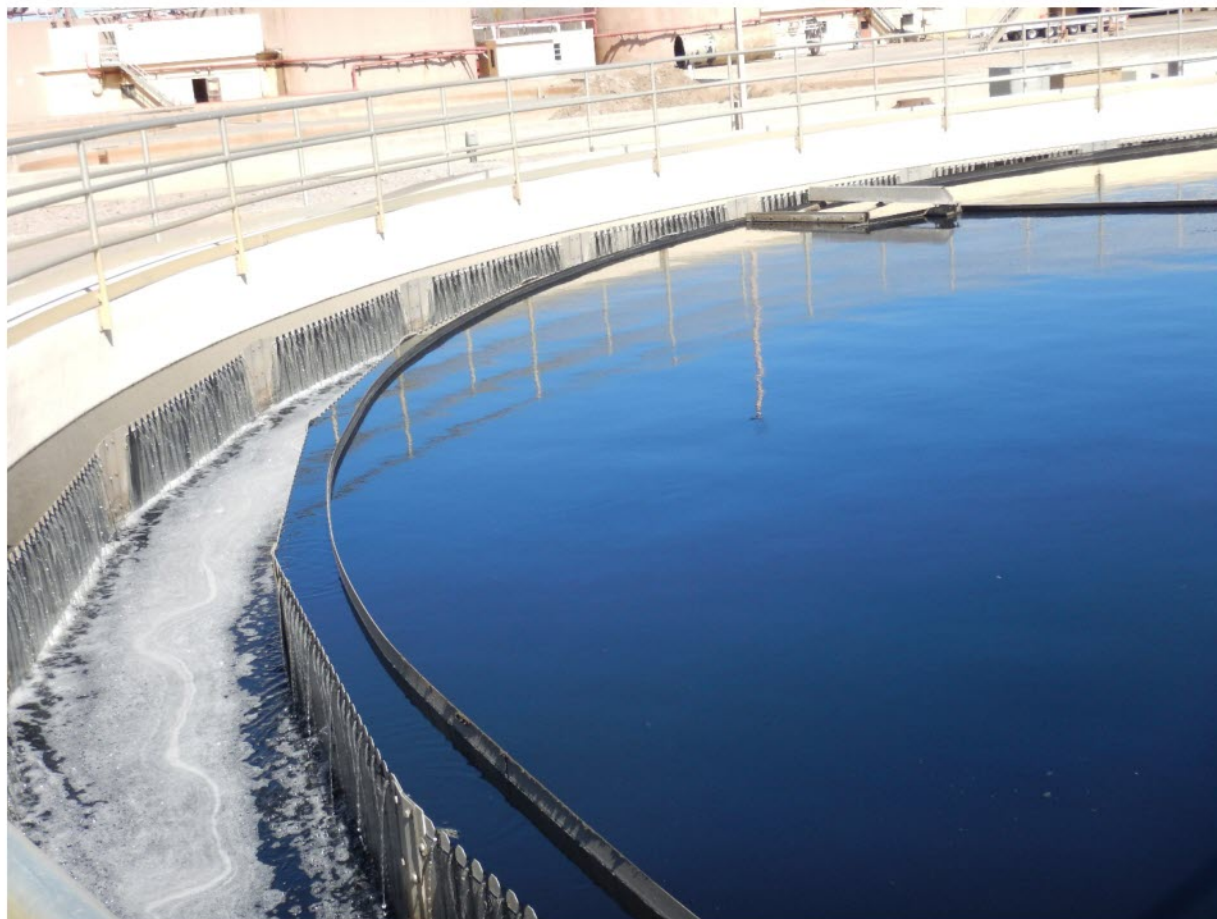
Photo No. 1

Description: View of primary clarifiers, showing newly leveled weirs, but some foaming issue is present after the weirs.

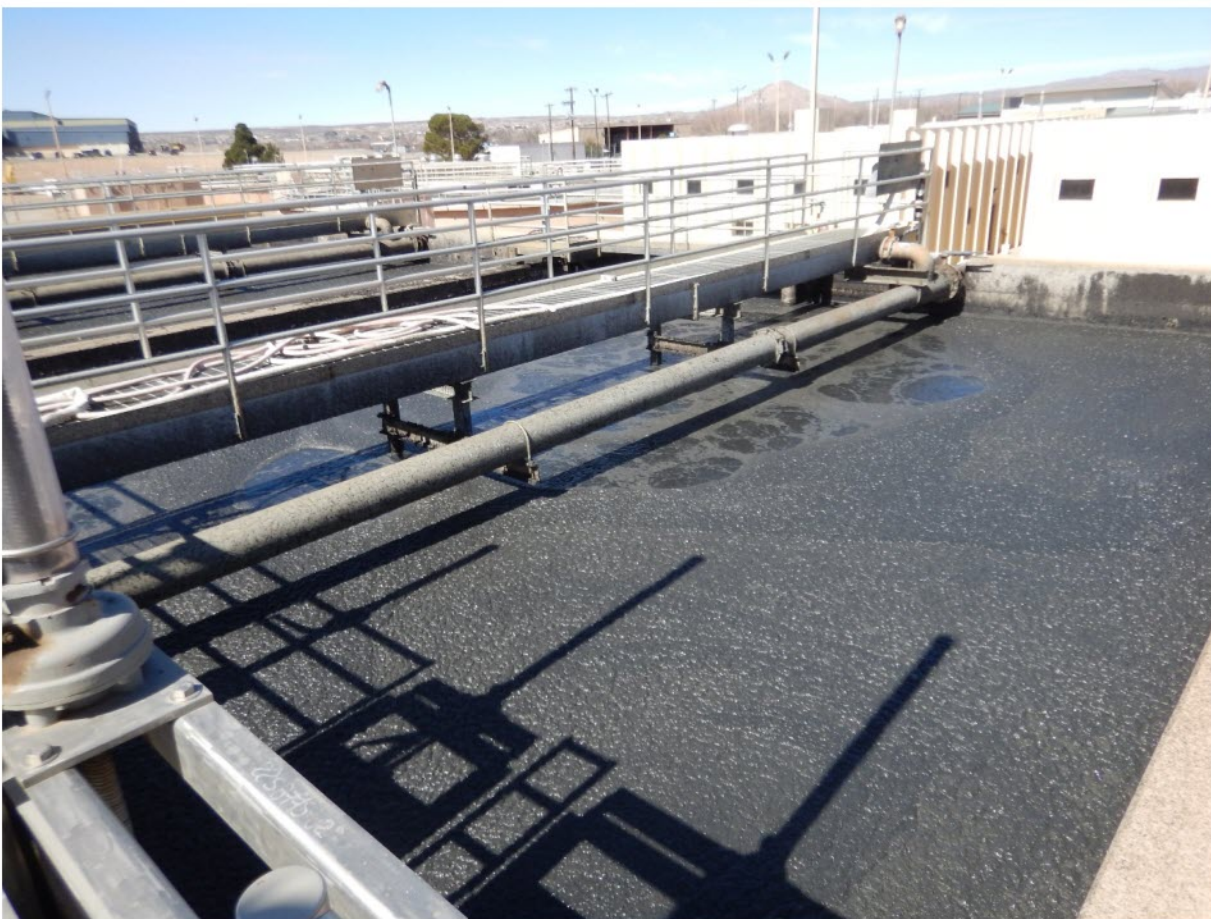
Photo No. 2

- There was an in-plant bypass at the roughing filters in December 2022.
- On the day of the inspection, the plant was having a filamentous issue and a foaming issue that started at the secondary clarifiers and peaked at the wet-well where the effluent auto-samplers were located, but dissipated prior to arrival at the outfall (see Photo Log. Facility personnel stated that they are trialing a SulFeLox addition at the primary clarifier that may have had some unintended consequences. SulFeLox turns the mixed liquor to a dark grey color.

Description: View of aeration basins showing the dark grey color of the mixed liquor caused by the SulFeLox.

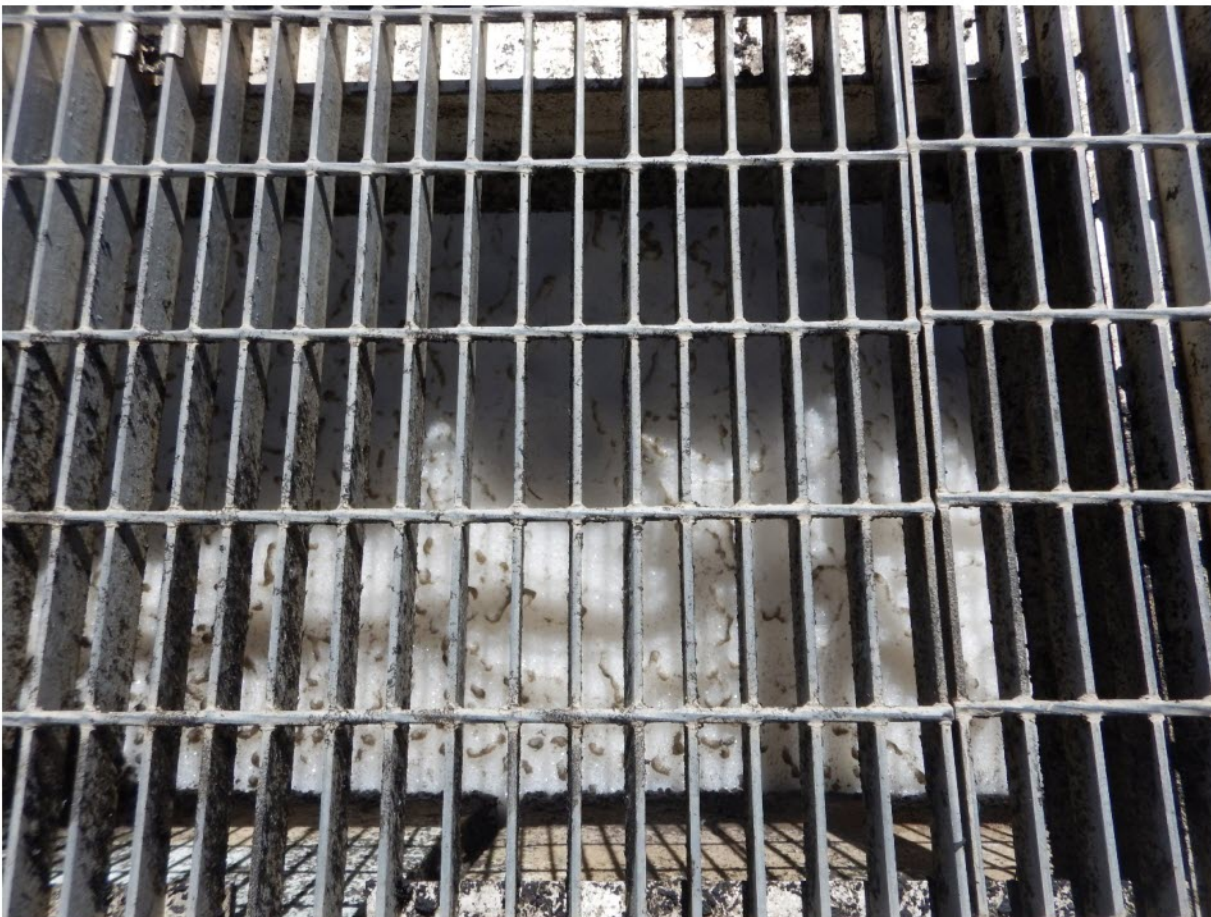
Photo No. 3

Description: View of foaming issue at the effluent sampling well.

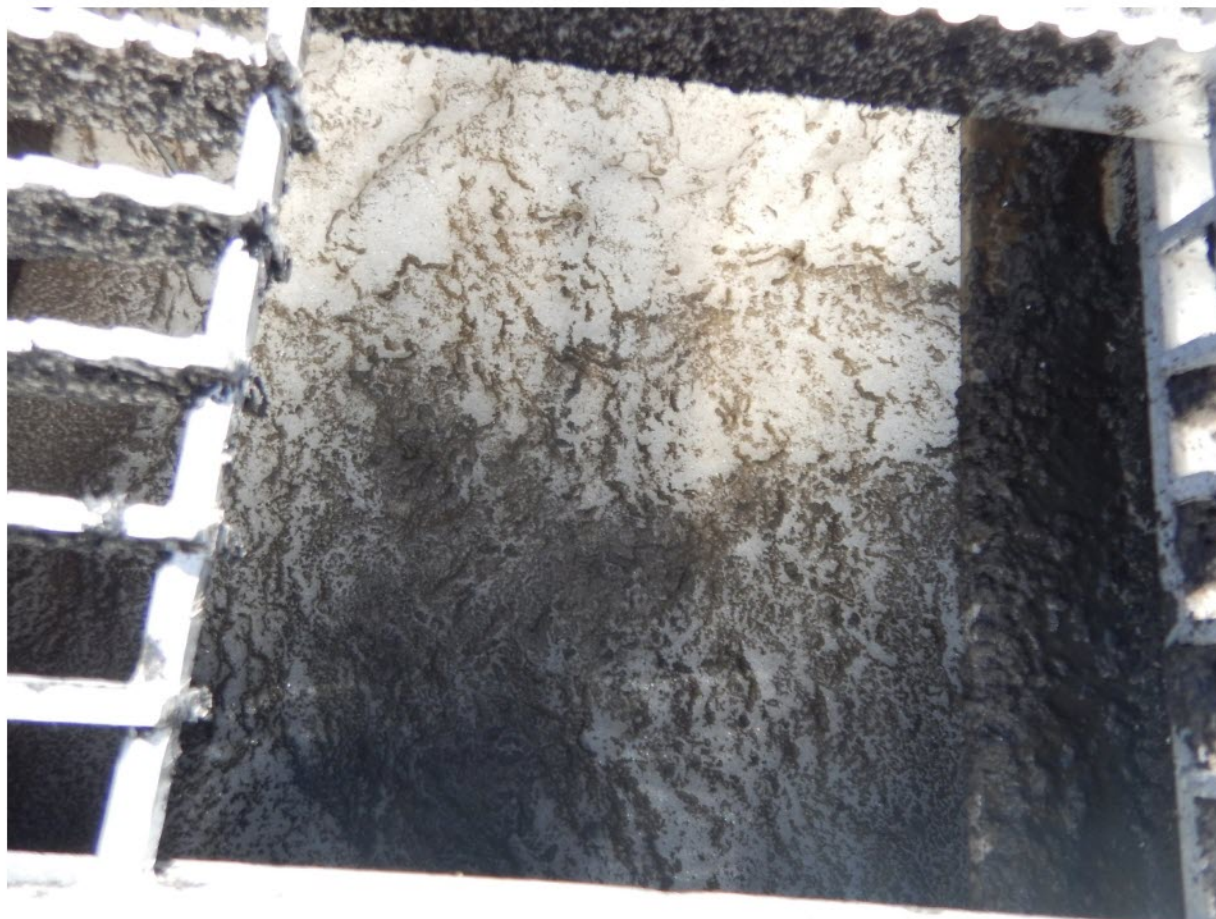
Photo No. 4

Description: View of foaming issue at the effluent sampling well.

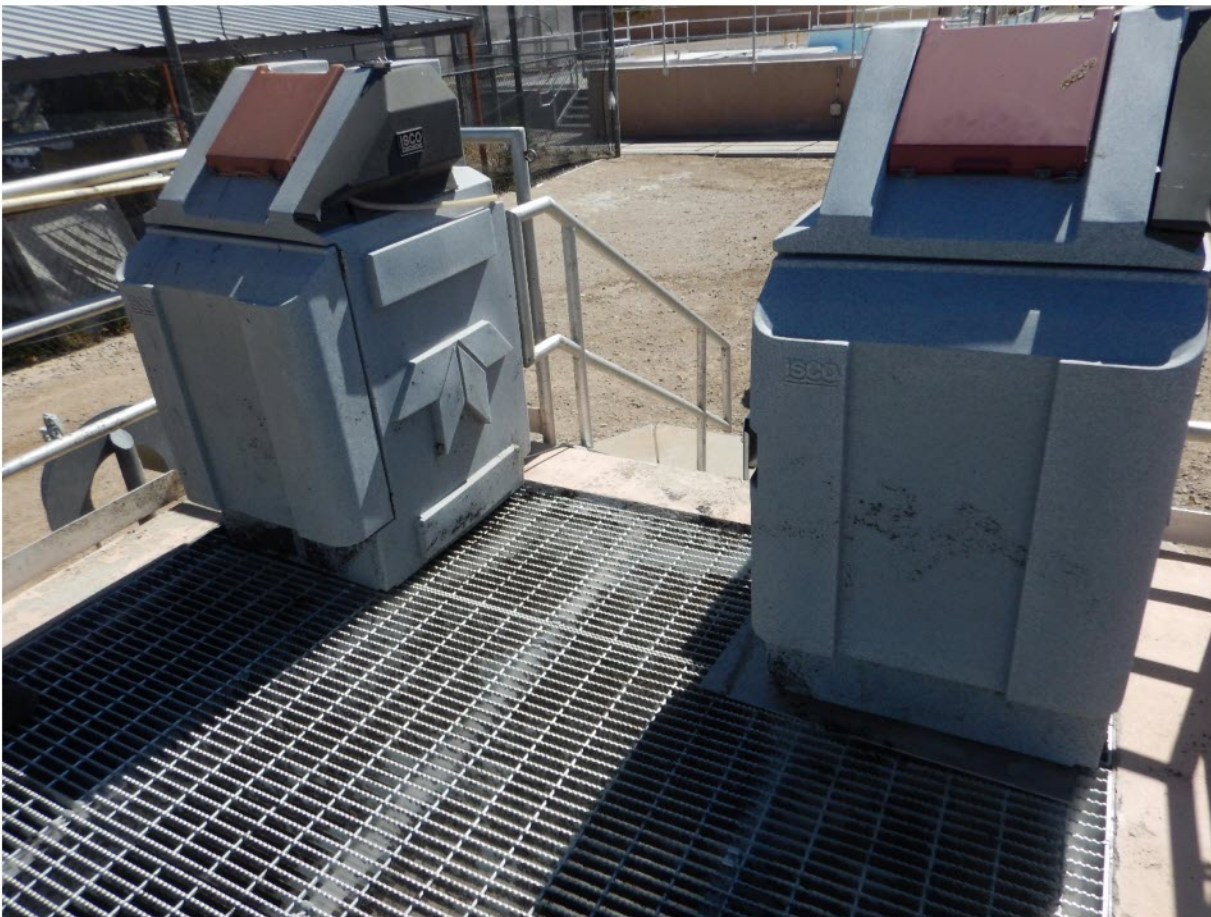
Photo No. 5

Description: View of foaming issue at the effluent sampling well. It is clear that the foam has been as high as half-way up the sides of the auto-samplers.
