## **RCRA Inspection Report**

U.S. Department of Veterans Affairs  
Atlanta VA Health Care System  
1670 Clairmont Road  
Decatur, Georgia 30033  
DeKalb County

EPA ID No.: GA7360015450

July 14, 2021, at 9:00 a.m.

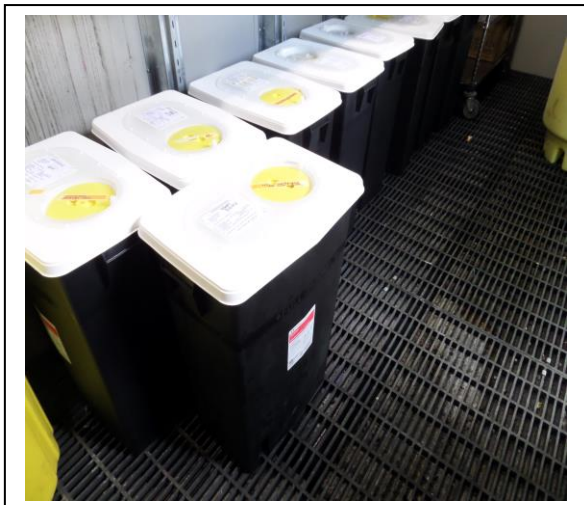
The inspectors observed nine 18-gallon containers accumulating hazardous waste solvents and corrosives. The containers were closed, in good condition with aisle space, labeled with the words hazardous waste and marked with dates in June or July 2021. The inspectors observed the containers were not labeled or marked indicating the hazards of the container contents (Photograph 1). At the time of the CEI, the facility placed new labels on each container and marked each label indicating the corrosive hazard of the container contents (Photographs 15 and 16).

Atlanta VA Health Care System (Atlanta VA). Central Accumulation Area (CAA 90-Day). The inspectors did not observe a hazard indicator on the containers. Photograph 1 taken at 10:19 a.m.

**Pursuant to Ga. Comp. R. and Regs. 391-3-11-.08(1) [40 C.F.R. § 262.17(a)(5)(i)(B)], which is a condition of the LQG Permit Exemption, a large quantity generator must mark or label its containers with the following: an indication of the hazards of the contents (examples include, but are not limited to, the applicable hazardous waste characteristic(s) (i.e., ignitable, corrosive, reactive, toxic); hazard communication consistent with the Department of Transportation requirements at 49 CFR part 172 subpart E (labeling) or subpart F (placarding); a hazard statement or pictogram consistent with the Occupational Safety and Health Administration Hazard Communication Standard at 29 CFR 1910.1200; or a chemical hazard label consistent with the National Fire Protection Association code 704).**

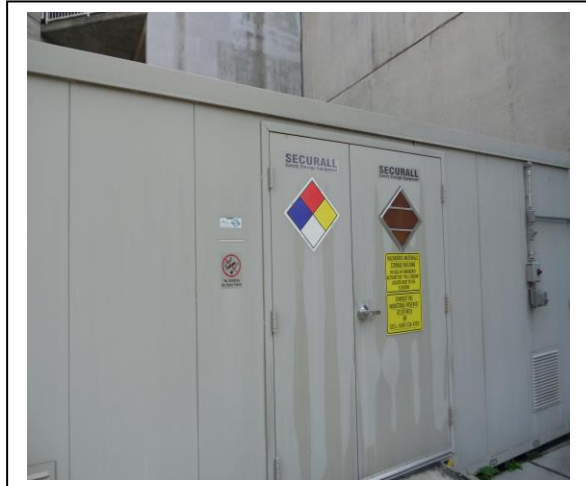
The CAA 90-Day is located outdoors between Parking Deck F and Parking Deck E. Hazardous waste is accumulated in containers for 90-days or less. The CAA is a 1,050 square foot portable steel shed constructed with double steel doors. The shed is constructed with a steel secondary containment system and covered with a grated steel floor. The inspectors observed an overhead wet chemical fire suppression system. The inspectors observed signs on the doors with the words, “No Smoking” and “Hazardous Materials Storage Building, contact the Industrial Hygienist at Ext 206115 or (404) 538-6703 (GEMS)” (Photograph 2).

Atlanta VA. 2 CAA 90-Day. The inspectors observed signs posted on CAA. Photograph 2 taken at 10:22 a.m.

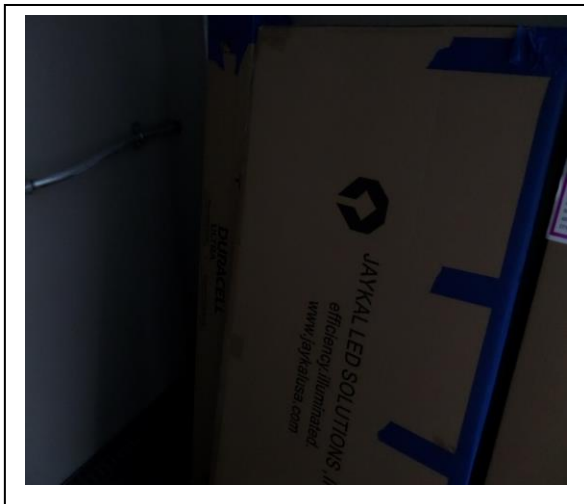
The inspectors observed 23 containers accumulating four-foot waste lamps and two containers accumulating U-shaped waste lamps that were closed and in good condition. Twenty-one containers were labeled with the words universal waste and marked with the dates October 2, 2020 or October 20, 2020. The inspectors observed two containers of waste lamps were not marked or labeled with the words universal waste and not marked with a date (Photograph 3). The inspectors observed three five-gallon containers accumulating waste batteries that were not marked or labeled with the words universal waste and not marked with a date (Photograph 5 and 6). At the time of the CEI, the facility labeled the two containers of waste lamps and the three containers of waste batteries with the words universal waste and marked the containers with the date October 2, 2020 (Photographs 4 and 7).

Atlanta VA. Universal Waste Shed. The inspectors did not observe the words universal waste and a date. Photograph 3 taken at 10:30 a.m.

**Pursuant to Ga. Comp. R. and Regs. 391-3-11-.18, [40 C.F.R. § 273.14(e)], a SQHUW must label or mark each lamp or container of lamps clearly with one of the following phrases: “Universal Waste-Lamp(s),” or “Waste Lamp(s),” or “Used Lamps.”**

**Pursuant to Ga. Comp. R. and Regs. 391-3-11-.18, [40 C.F.R. § 273.15(a) and (c)], a SQHUW may accumulate universal waste no longer than one year and must be able to demonstrate the length of time that the universal waste has accumulated from the date that it became a waste or was received.**

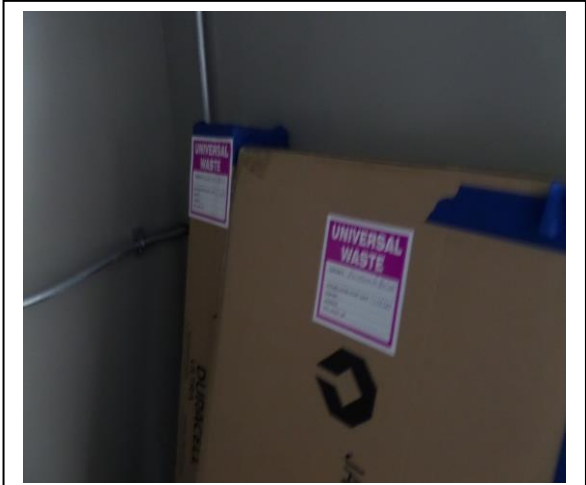
Atlanta VA. Universal Waste Shed. The facility labeled and dated the containers. Photograph 4 taken at 10:35 a.m.

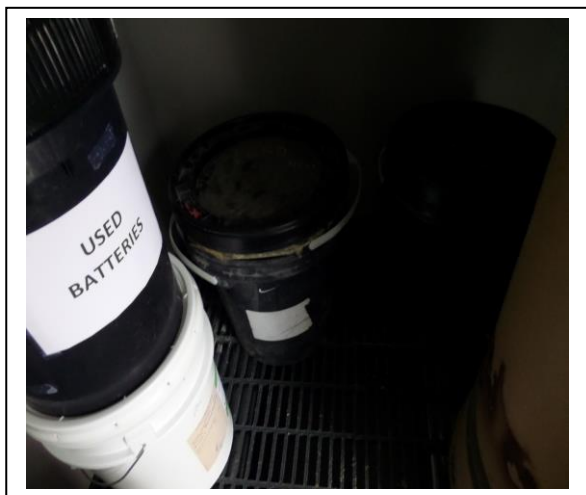
Atlanta VA. Universal Waste Shed. The inspectors did not observe the words universal waste and a date. Photograph 5 taken at 10:36 a.m.

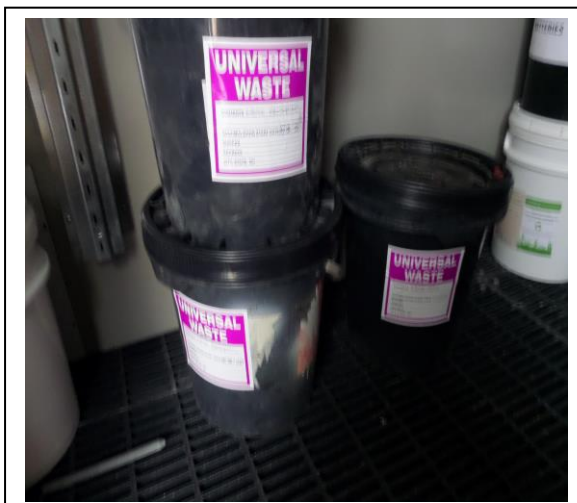
Atlanta VA. Universal Waste Shed. The facility labeled & dated the containers. Photograph 7 taken at 10:42 a.m.

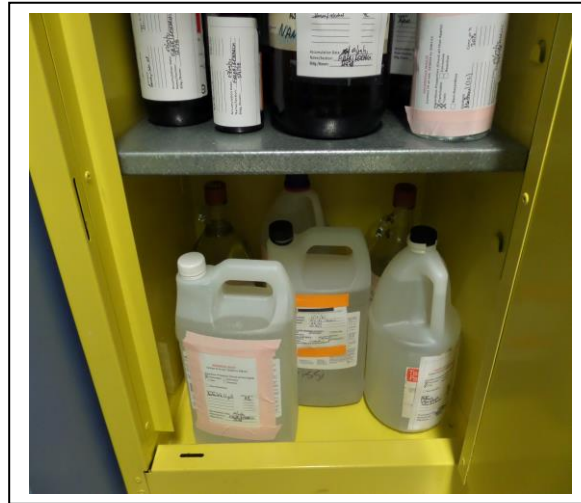
Located next to the metal shelf the inspectors observed a yellow fire cabinet accumulating four four-liter containers, two one-quart containers, three one-gallon containers, three small bottles and three two-liter containers of assorted waste solvents (methanol, xylene, isopropyl alcohol, acetonitrile). The containers were closed, in good condition with aisle space, labeled with the words hazardous waste, marked with dates in July 2021, and labeled with an indication of the hazards of the container contents (Photograph 8).

Atlanta VA. Research Laboratory Room 5A-178 90-Day Area. The inspectors observed labeled and dated containers accumulating waste solvent. Photograph 8 taken at 10:58 a.m.

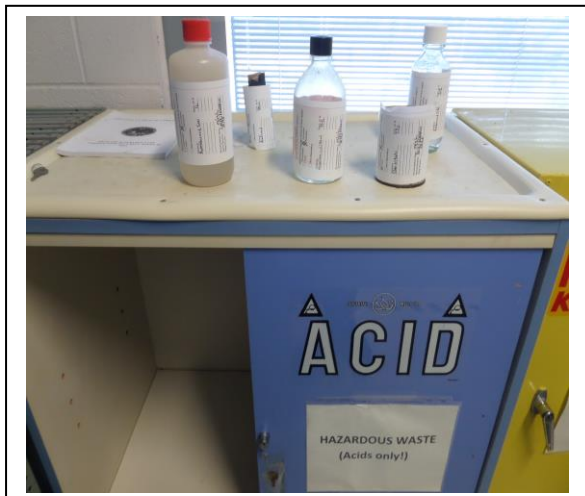
The inspectors observed a blue cabinet labeled with words “hazardous waste acids only”, accumulating five containers ranging from about 100-milliliters to 500-milliliters of corrosive, reactive and toxic waste (HCL, acetic acid, silver nitrate). The containers were closed, in good condition with aisle space, labeled with the words hazardous waste, marked with dates in July 2021, and labeled with an indication of the hazards of the container contents (Photograph 9).

Atlanta VA. Research Laboratory Room 5A-178 90-Day Area. The inspectors observed labeled and dated containers accumulating waste corrosives. Photograph 9 taken at 11:04 a.m.

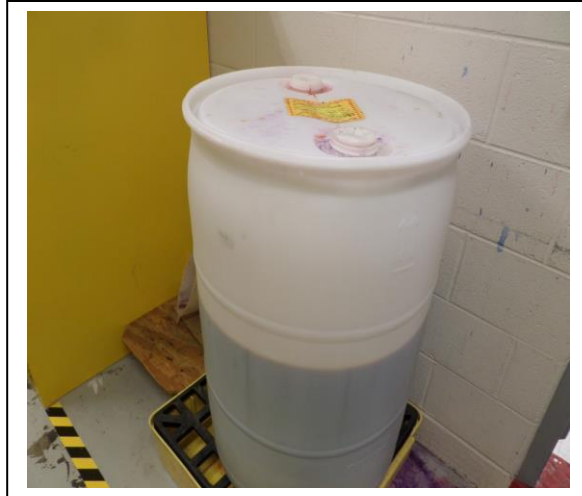
Hazardous waste generated in the histology, cytology, hematology, and microbiology laboratories is transferred from the SAA to a 90-Day or Less Accumulation Area located in Room 2B-176. Each laboratory has a supervisor. The inspectors observed a 55-gallon container accumulating spent solvents and water. The container was closed, in good condition with aisle space, labeled with the words hazardous waste, marked with date June 20, 2021, and labeled with an indication of the hazards of the container contents (Photograph 10 and 11). The hazardous waste label on the top of the container was beginning to deteriorate.

Atlanta VA. Clinical Laboratory Room 2B-176 90-Day Area. The inspectors observed the container accumulating waste solvents. Photograph 10 taken at 11:16 a.m.

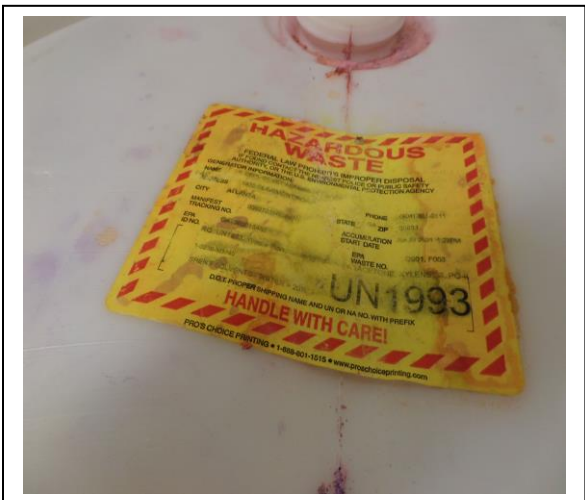
Atlanta VA. Clinical Laboratory Room 2B-176 90-Day Area. The inspectors observed the label on the container appeared to be deteriorating. Photograph 11 taken at 11:16 a.m.

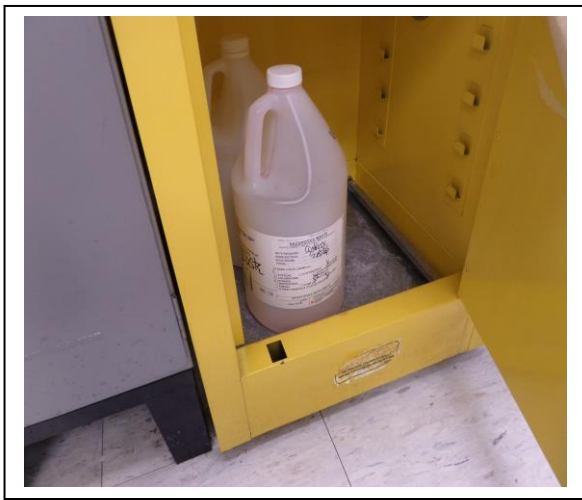
emptied from the instrument approximately once a week and accumulated in a container. The inspectors observed a SAA with a yellow fire cabinet accumulating an empty one-gallon container labeled with the words hazardous waste. The container was closed, in good condition with aisle space. The container was not labeled or marked with an indication of the hazards of the container contents (Photograph 12). A container accumulating hazardous must be labeled or marked with an indication of the hazards of the container contents.

Atlanta VA. Cytology Laboratory Room 2B-186. Satellite Accumulation Area. The inspectors observed the container is used to accumulate spent solvents. The container is empty. Photograph 12 taken at 11:35 a.m.

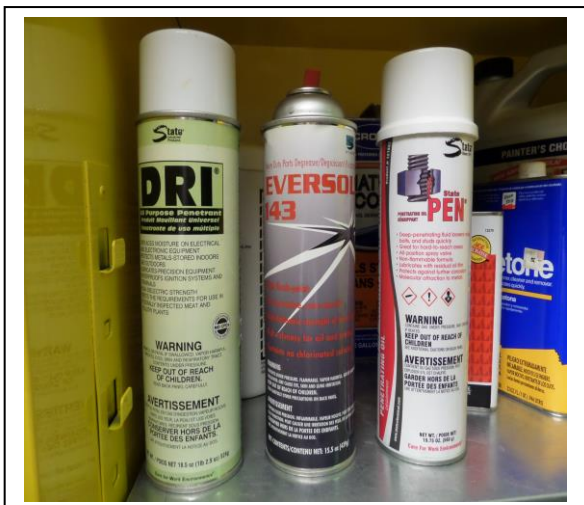
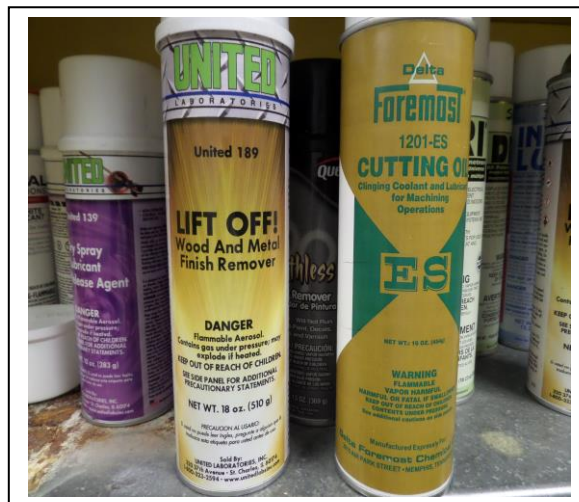
General facility repair and maintenance operations are conducted. Jack Tibadeau is the maintenance shop supervisor. The inspectors observed a storage cabinet containing aerosol products (Photographs 13 and 14). The aerosols are used at the locations where the repair and maintenance work are performed and returned to the maintenance shop cabinet. Spent aerosols are disposed as municipal solid waste (MSW). Mr. Tibadeau indicated the aerosol cans are empty when disposed. The inspectors reviewed the information on several aerosols and requested the safety data sheets (SDS) for review. Aerosol cans should be managed in accordance with the applicable regulations.

DRI penetrating compound contains perchloroethylene at 60 to 100 percent by weight, PEN penetrating oil contains perchloroethylene at less than 80 percent by weight and PGR paint remover contains methylene chloride at 40 to 70 percent by weight and methanol at 7 to 13 percent by weight. Perchloroethylene is RCRA regulated for the toxicity characteristic at the concentration equal to or greater than 0.7 milligrams/Liter. Perchloroethylene, methylene chloride and methanol may meet the listing from non-specific sources pursuant to 40 C.F.R. § 261.31.

Atlanta VA. Maintenance Shop. The inspectors observed aerosol products stored in the flammable cabinet. Photograph 13 taken at 11:59 a.m.

Atlanta VA. Maintenance Shop. The inspectors observed aerosol products stored in the flammable cabinet. Photograph 14 taken at 11:59 a.m.

The facility should conduct an audit of the aerosols and chemicals used in the maintenance shop to determine the potential waste streams, hazardous waste handling and management operations and comply with all requirements of the RCRA regulations.

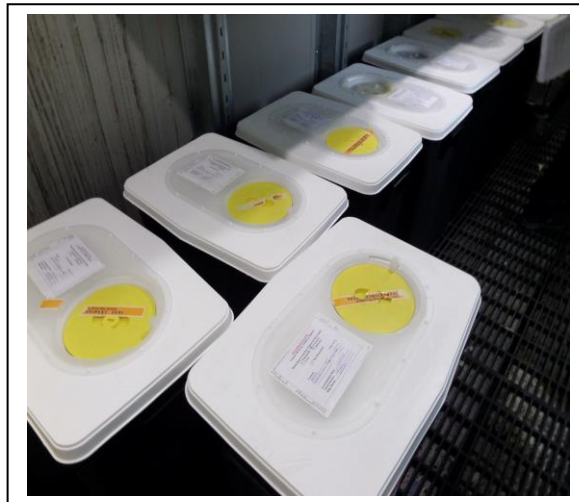
Atlanta VA. CAA 90-Day. The facility marked a hazard indicator on the containers. Photograph 15 taken at 2:55 p.m.

Atlanta VA. CAA 90-Day. The facility marked a hazard indicator on the containers. Photograph 16 taken at 2:56 p.m.
