## **RCRA Inspection Report**

Return Logistics International Corp.  
22 Artley Road  
Savannah, Georgia 31408  
EPA ID No: GAR000007997

April 06, 2022

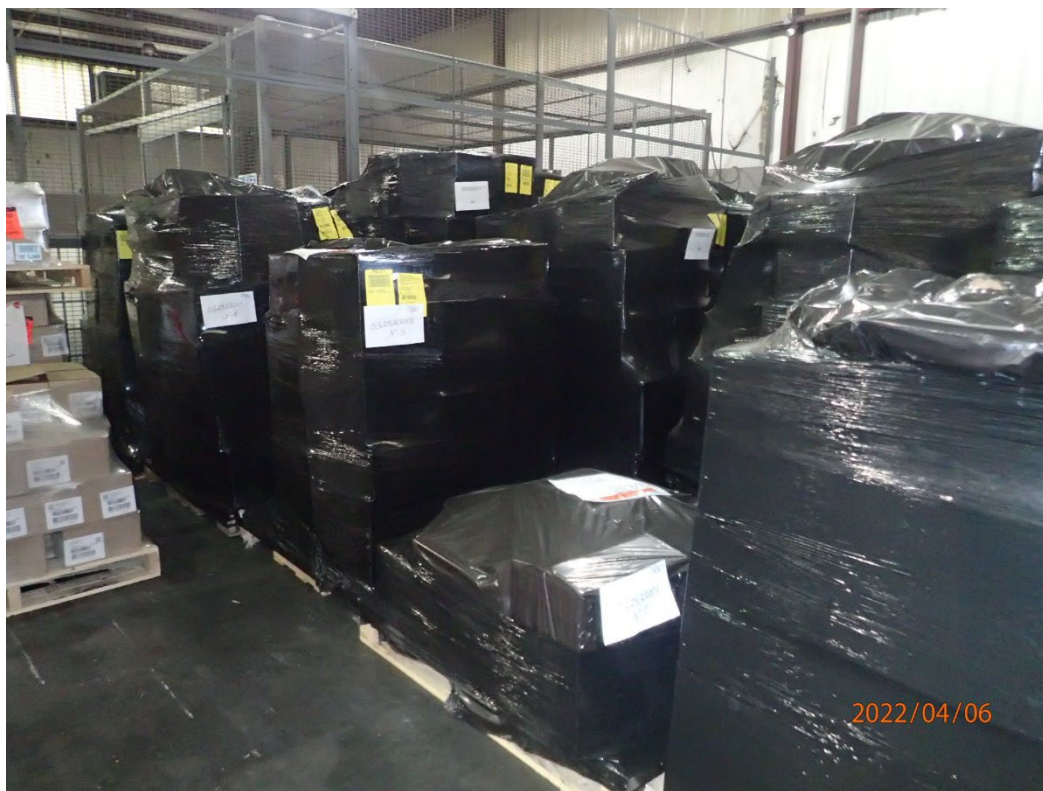
The receiving area is located on the east side of the facility north of the administrative offices. The receiving area is comprised of four (4) loading docks. The inspectors observed several rows of pallets of customer shipments that had been received and were awaiting inventory, processing, and sorting. Most of the incoming customer shipments were still shrink-wrapped and had an identification number and date received with additional labels on each order (Photo #1). It did not appear that any of the incoming shipments were staged here for longer than 30-days. DEA controlled substances are immediately placed in the Secured Area in the DEA Controlled Substances storage Area or DEA Controlled Substances Vault. No hazardous waste was observed in this area.

**Photo 1:** Several rows of pallets of customer shipments that had been received and were awaiting inventory, processing, and sorting. Most of the incoming customer shipments were still shrink-wrapped and had an identification number and date received with additional labels on each order.

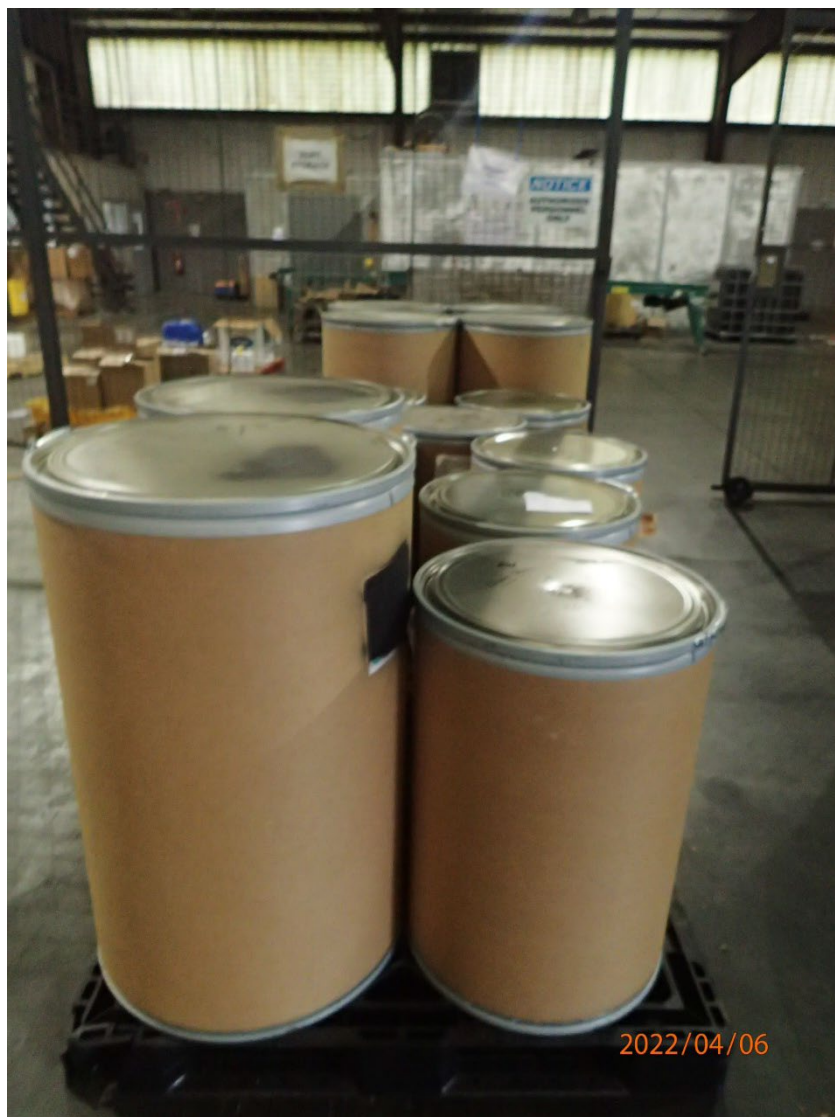
This area of the warehouse is secured by a fenced gate with secured access adjacent to the Receiving Area (Photo #2). The Secured Area is comprised of a DEA Controlled Substance storage Area, 90-Day CAA, SAA, and a DEA Controlled Substances Vault.

**Photo 2:** Photo of incoming shipment from customer (not pharmaceuticals or hazardous waste). Secured Area is behind this Receiving Area and has a gated entrance.

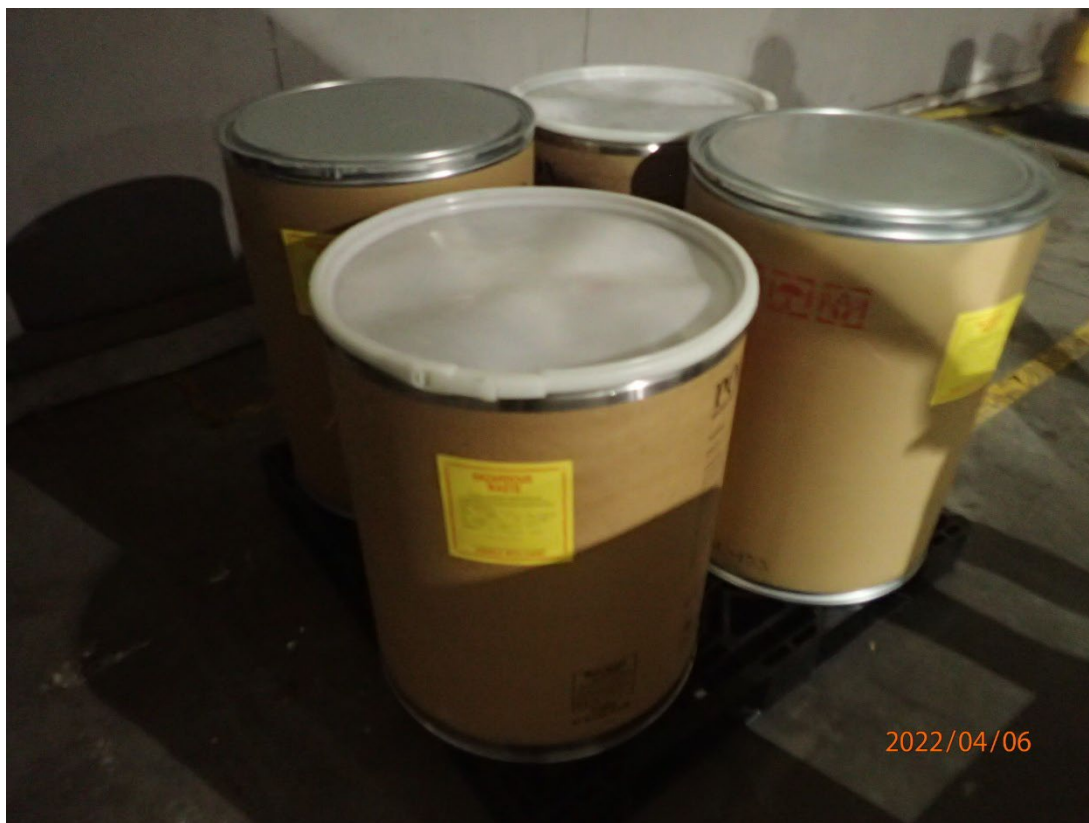
- Four (4) 35-gallon closed drums of flammable toxic waste. The drums were all labeled with the words “Hazardous Waste”, marked with an indication of hazard, and dated March 8, 2022.
- One (1) 35-gallon closed drum of flammable toxic waste. The drums were all labeled with the words “Hazardous Waste”, marked with an indication of hazard, and dated March 7, 2022.

**Photo 5:** Four (4) 35-gallon closed drums of flammable toxic waste. The drums were all labeled with the words "Hazardous Waste", marked with an indication of hazard, and dated 03/07/2022 and 03/08/2022

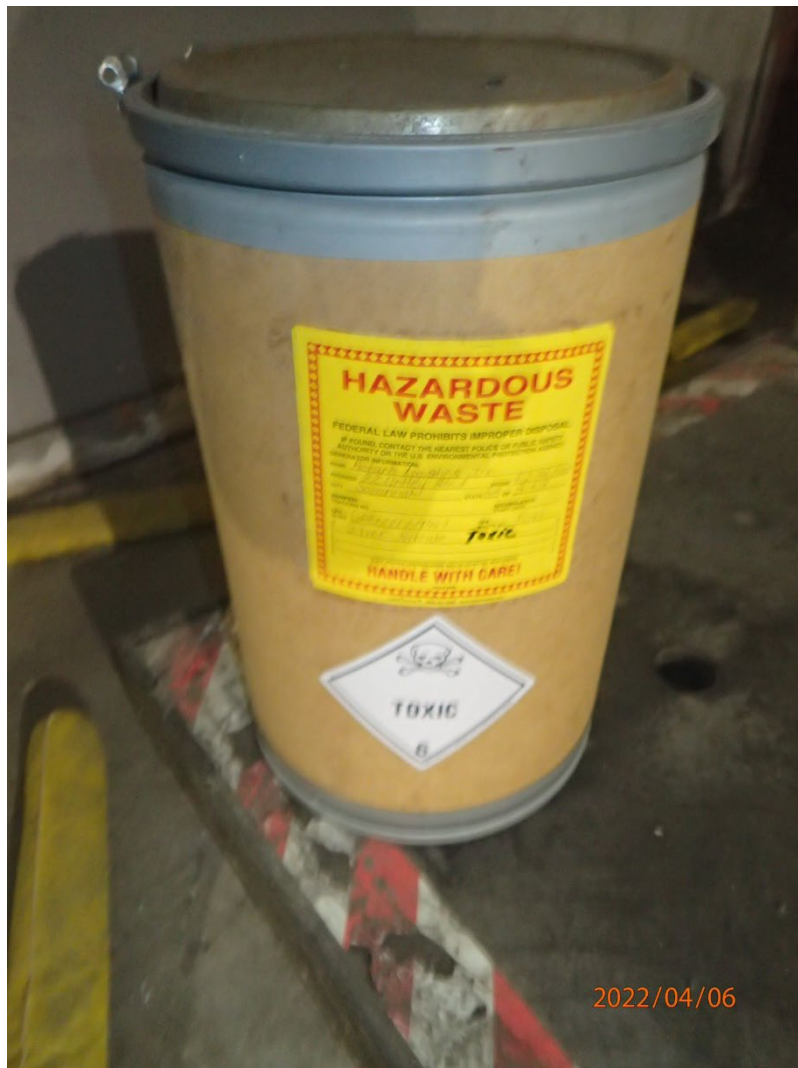
- One (1) 5-gallon closed container of silver nitrate. The container was labeled with the words “Hazardous Waste” but not marked with an indication of hazard.

**Pursuant to Ga. Comp. R. and Regs. 391-3-11-.08(1) [40 CFR 262.15(a)(5)(ii)], A generator must mark or label its container with the following: (ii) An indication of the hazards of the contents (examples include, but are not limited to, the applicable hazardous waste characteristic(s) (i.e., ignitable, corrosive, reactive, toxic); hazard communication consistent with the Department of Transportation requirements at 49 CFR part 172 subpart E (labeling) or subpart F (placarding); a hazard statement or pictogram consistent with the Occupational Safety and Health Administration Hazard Communication Standard at 29 CFR 1910.1200; or a chemical hazard label consistent with the National Fire Protection Association code 704).**

**Photo 6:** One (1) 5-gallon closed container of silver nitrate. Initially not marked with an indication of hazard. Corrected during the inspection.

CORRECTED ONSITE: Ms. Montgomery immediately marked all containers that were missing

an indication of hazard with the words for the corresponding hazard (flammable, toxic, or corrosive).

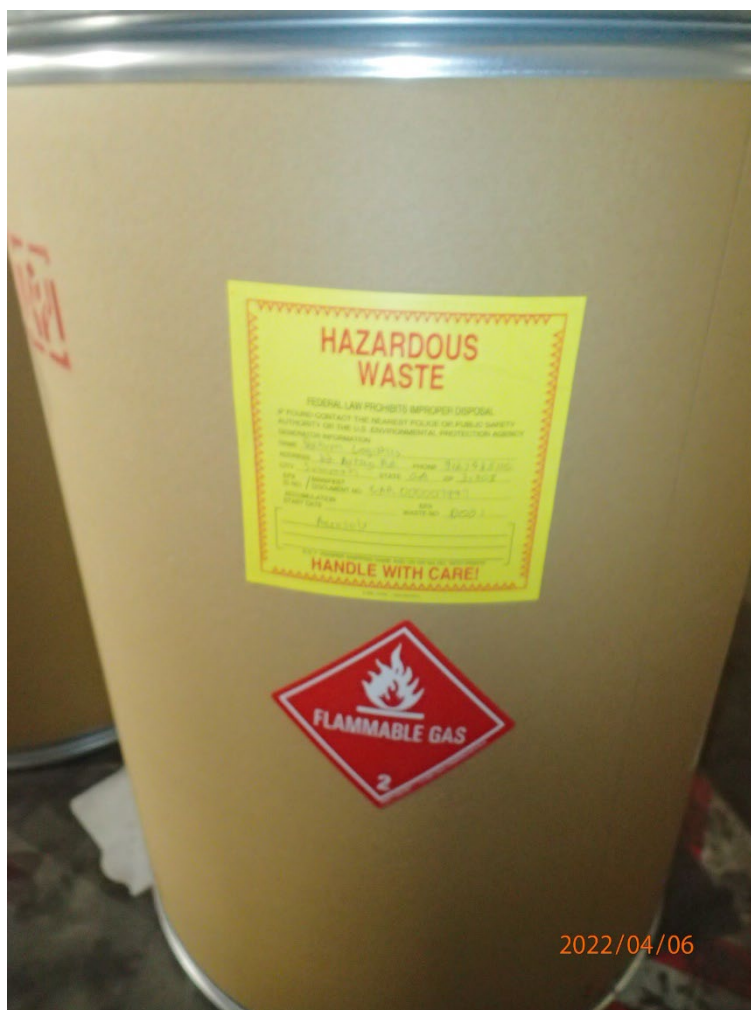
- One (1) 35-gallon closed drum of waste aerosol cans. The drum was labeled with the words “Hazardous Waste” but not marked with an indication of hazard.

**Photo 7:** One (1) 35-gallon closed drum of waste aerosol cans. The drum was labeled with the words "Hazardous Waste" but not marked with an indication of hazard.

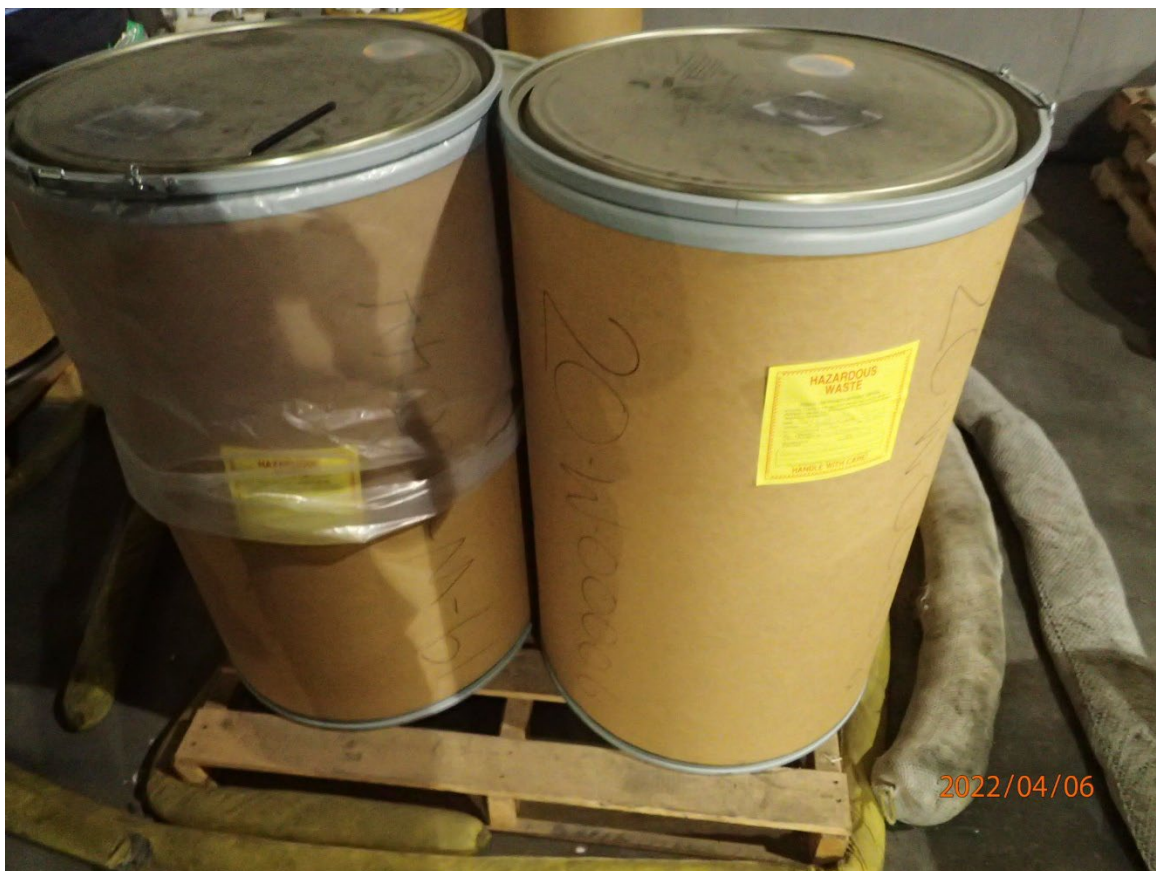
- One (1) 35-gallon closed drum of oxidizer waste. The drum was labeled with the words “Hazardous Waste” and marked with an indication of hazard.
- Two (2) 55-gallon closed drums of corrosive acid waste. The drums were labeled with the words “Hazardous Waste” and marked with an indication of hazard.

**Photo 8:** Two (2) 55-gallon closed drum of corrosive acid waste. The drums were labeled with the words "Hazardous Waste" and marked with an indication of hazard.

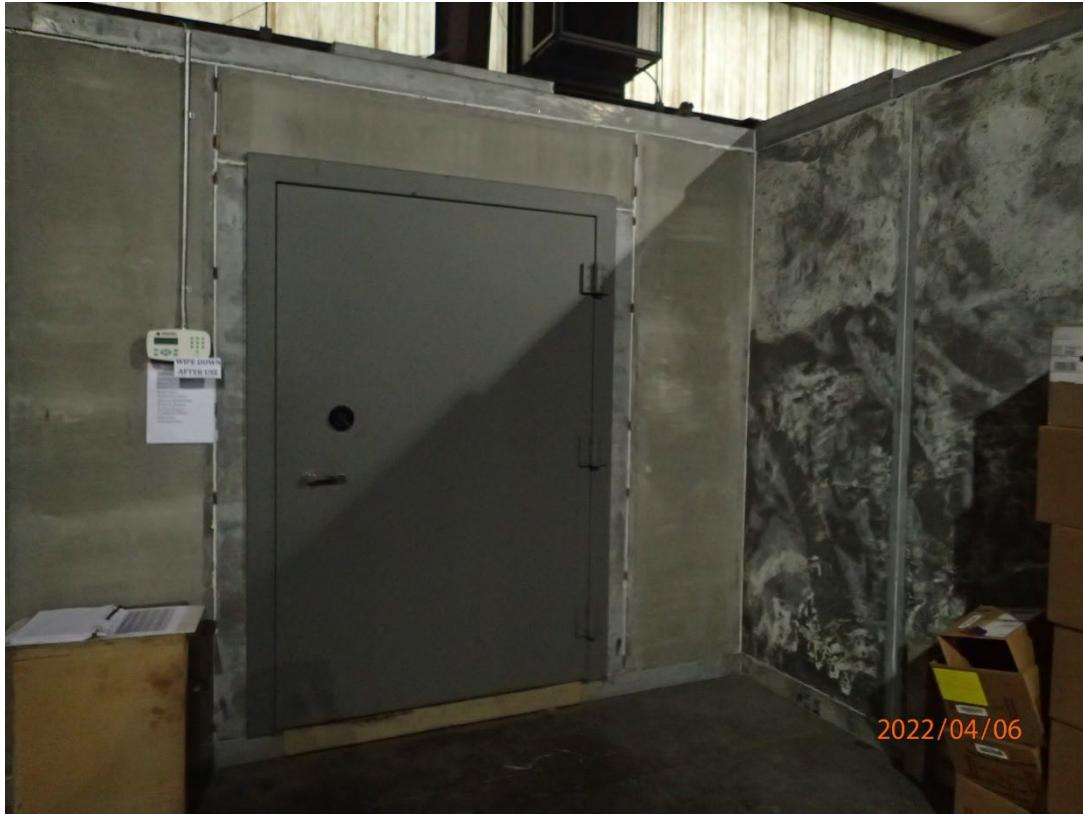
The DEA Controlled Substances Vault is a secured vault equipped with an alarm system (Photo #9). The secured vault is required to secure storage for schedule I & II controlled substances.

**Photo 9:** DEA Controlled Substances Vault.
