### INSPECTION REPORT

| <b>Facility or Site Name:</b> | HARVEST ALASKA - MIDSTREAM PIPELINE DIVISION - EAST FORELANDS | | |
| <b>Type of Operation:</b> | Natural gas pipeline junction facility | | |

Type of inspection: CEI - Compliance Evaluation Inspection

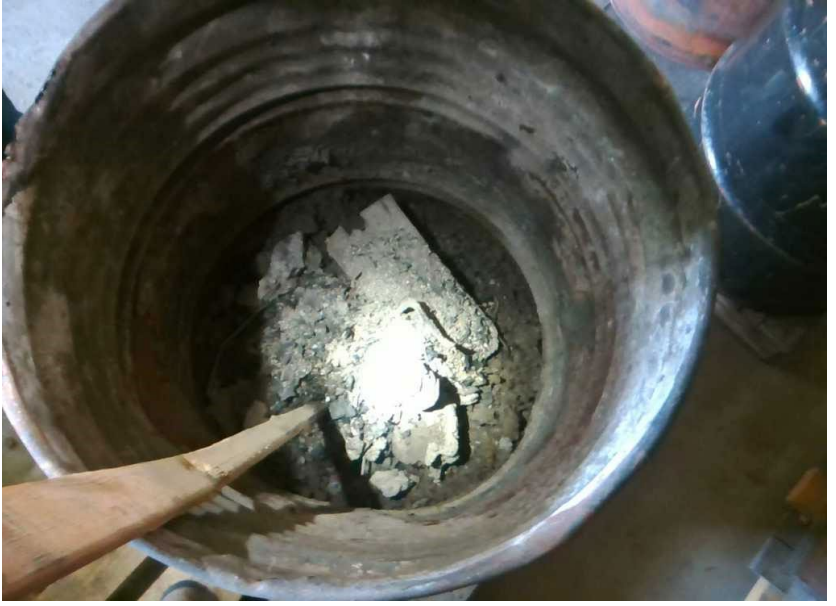
| <p>While I was inspecting the Filter room, I saw a smart ash burner. I also saw three 55-gallon containers that held ash from the burner as well as additional debris.</p> <p>According to Mr. Wilcox oil filters, rags, absorbent pads , and pig parts (Brushes) were burned using the smart ash burner. I asked about the burning of the pig brushes and Mr. Wilcox said the brushes were put in the smart ash burner to burn off the paraffin (Pig wax) from the pig brushes.</p> | |

| <div>[Title]</div> <div>Observation_Image-20210428152608268716803.jpg</div> <div>04/28/2021 03:26 PM (AKT)</div> <div>Jon Jones</div> <div>Filter room</div> <div>No CBI</div> <div>No PII</div> <div>View inside of a 55-gallon drum that contains ash residue from burning oil filters, rags, absorbent pads , and pig parts in a smart ash burner.</div> | |

Following the inspection, I sent an email, dated 5/6/2021, to Mr. Hong. In that email I asked, “While at the facility, there were three smart ash burn barrels located in the storage building. All of the barrels held ash and solids. One barrel contained brushes from a pig and the contents of the barrel had a very strong odor, similar to a solvent or maybe petroleum based. Can you tell me when the last time pig wax was generated at the facility and how that waste was managed? Please provide any applicable disposal paperwork you have too. There were remnants of filters in the other barrels too. Can you tell me what the filters would have been contaminated with? I am including the photos taken so you can see what I’m referring to. Let me know if you have any questions.”

- Can you tell me when the last time pig wax was generated at the facility and how that waste was managed?
  - **We have not received wax at this location for a long time (last 10 years).**
- Can you tell me what the filters would have been contaminated with?
  - **Motor Oil**
  - **Natural Gas Condensate**

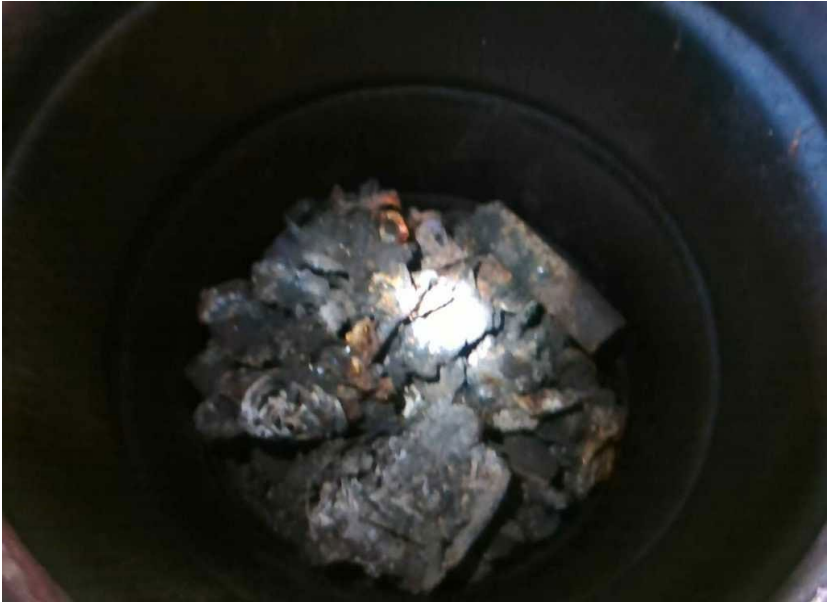
| <div>[Title]</div> <div>Observation_Image-202104281526192619386138.jpg</div> <div>04/28/2021 03:26 PM (AKT)</div> <div>Jon Jones</div> <div>Filter room</div> <div>No CBI</div> <div>No PII</div> <div>View inside of a second 55-gallon drum that contains ash residue from burning oil filters, rags, absorbent pads , and pig parts in a smart ash burner.</div> | |

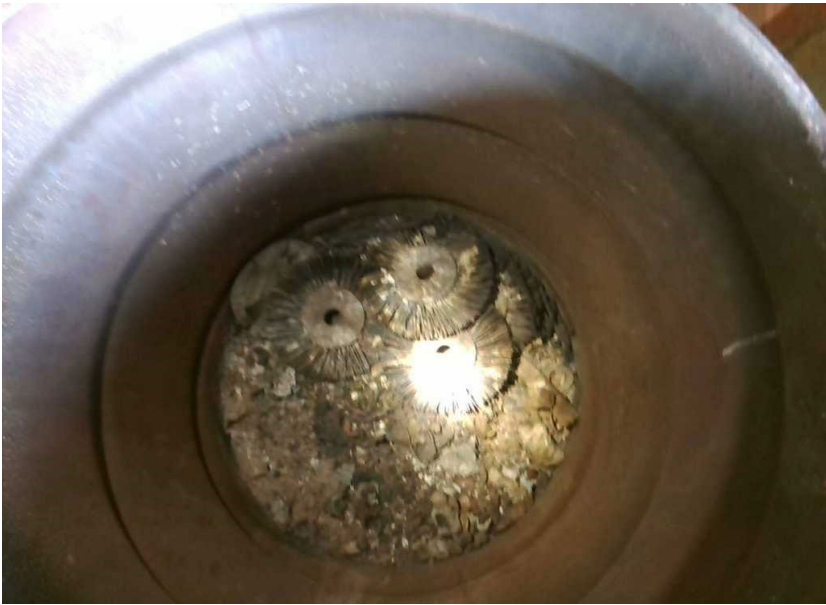
| Observation_Image-202104281526362636582430.jpg | |

| View inside of a third 55-gallon drum that contains ash residue from burning oil filters, rags, absorbent pads , and pig parts in a smart ash burner. Brushes from a pig can be seen here on top of the ash pile. | |
