## **RCRA Inspection Report**

Loveland Products  
917 Platte Road  
Clarksdale, Mississippi 38703

**COMPLIANCE EVALUATION Inspection**

**October 26, 2021**

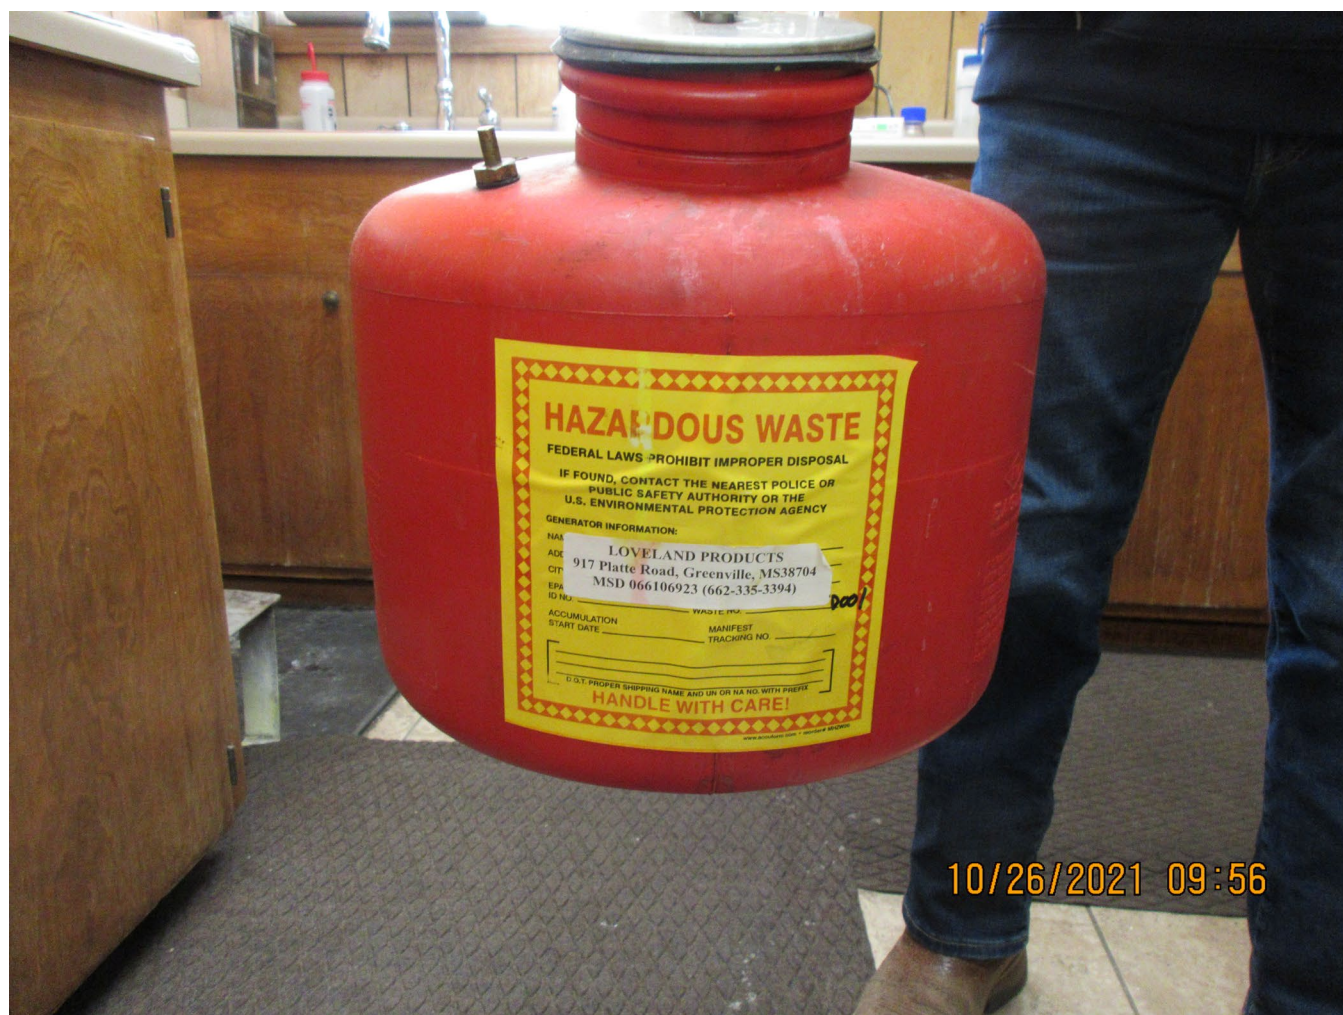
Within a "Wet Lab Area," ignitable hazardous wastes were generated in a three-gallon container (Photos 1 & 2) in a satellite accumulation area (SAA). At the time of the inspection, the container was closed and labeled with the words "Hazardous Waste." The container was not labeled with an indication of the hazard contents of the container.

Photo 1 – Label on 3-gallon container in Wet Lab Area

**Pursuant to 11 Miss. Admin. Code Pt. 3, R. 1.3 [40 C.F.R. § 262.15(a)(5)(ii)], which is a condition of the SAA Permit Exemption, a generator is required to mark or label its containers (ii) with an indication of the hazards of the contents.**

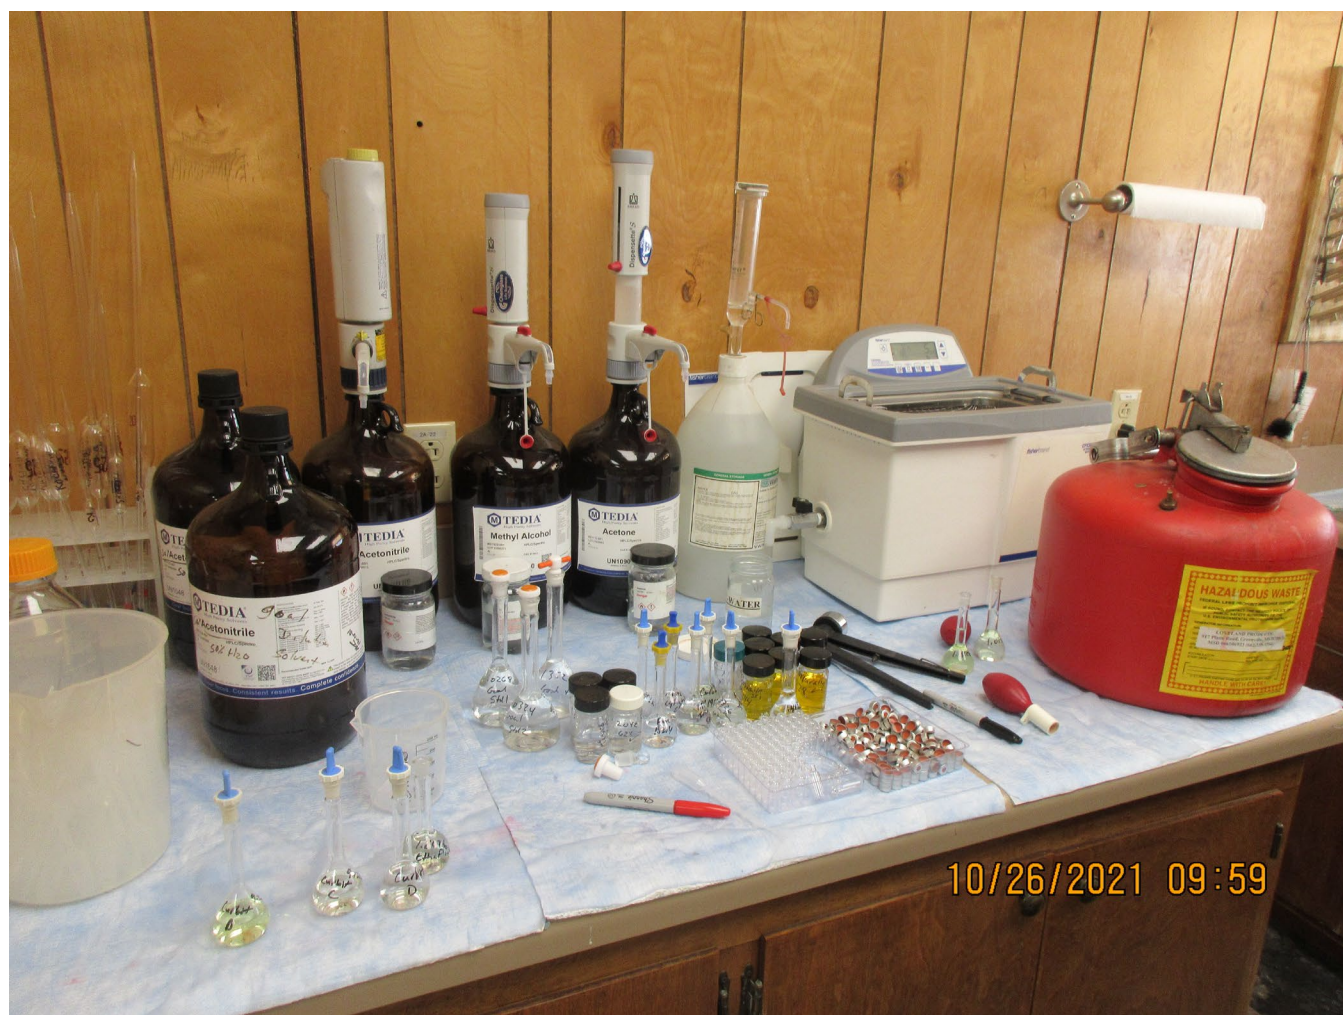
Photo 2 –Work table in Wet Lab Area where 3-gallon container was observed.

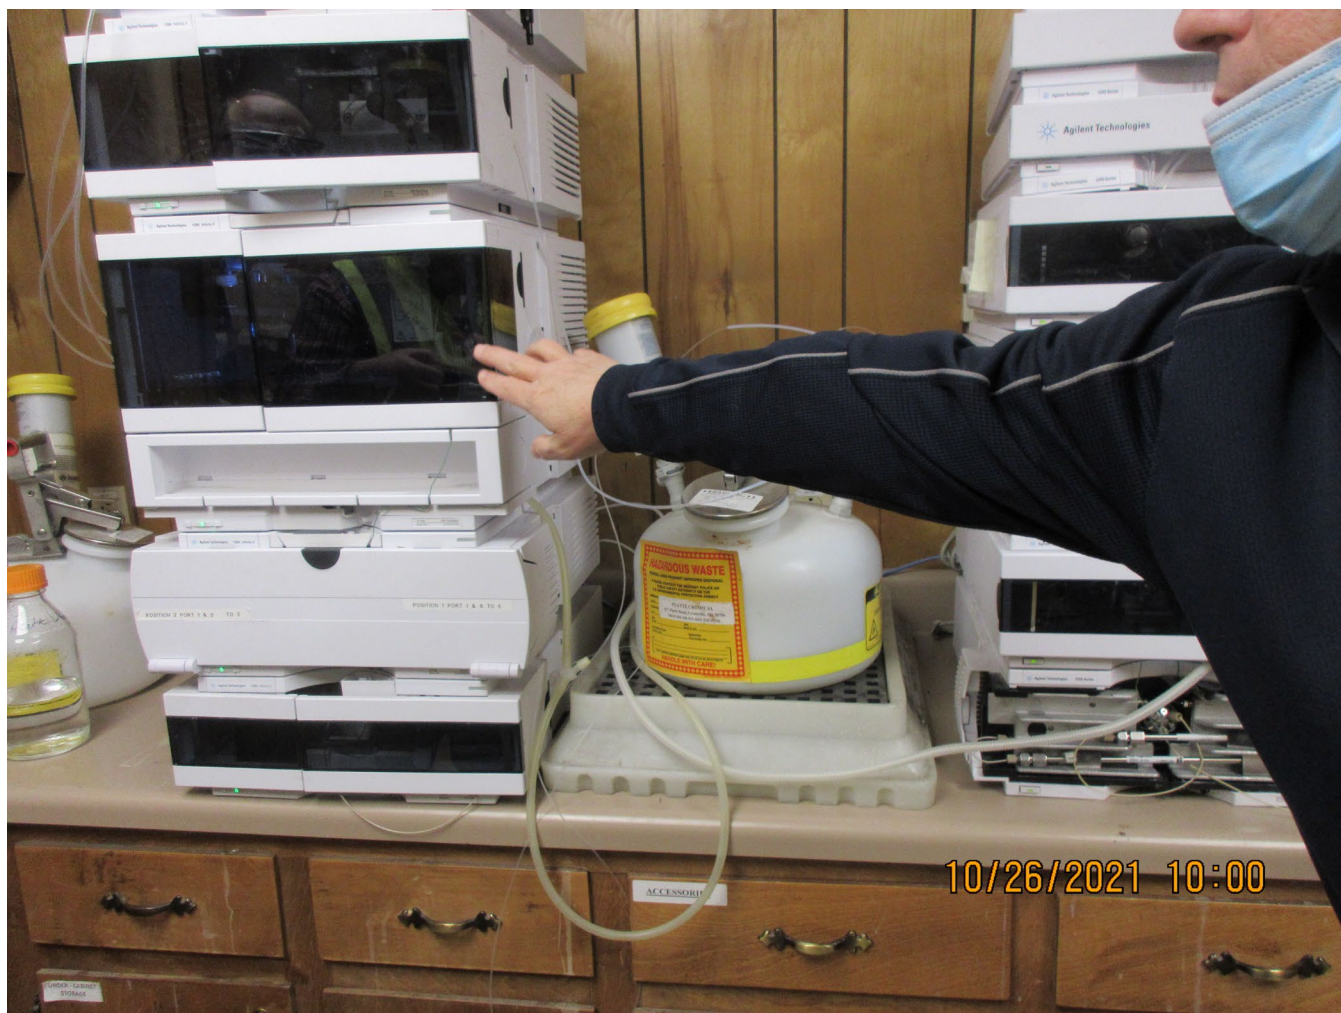
Within a LC Room in the Laboratory Building, hazardous waste was being generated in a two-gallon container within a SAA (Photo 3). At the time of the inspection, the container was closed and labeled with the words "Hazardous Waste." The container was not labeled with an indication of the hazard contents of the container.

Photo 3 –Work table in LC Area where 2-gallon container was observed.

**Pursuant to 11 Miss. Admin. Code Pt. 3, R. 1.3 [40 C.F.R. § 262.15(a)(5)(ii)], which is a condition of the SAA Permit Exemption, a generator is required to mark or label its containers (ii) with an indication of the hazards of the contents.**

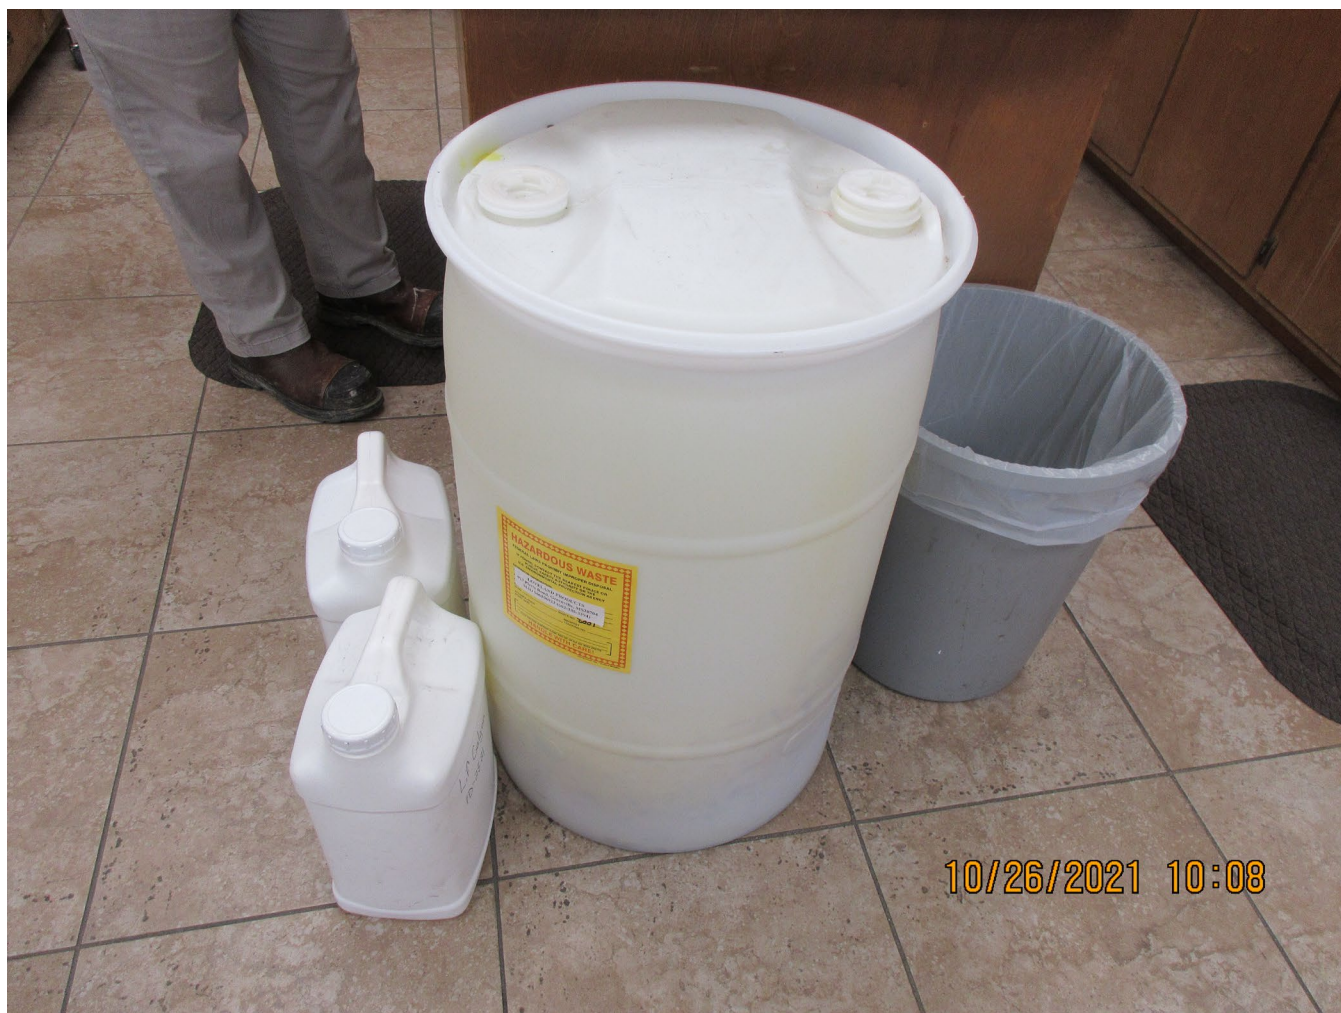
Within a near infrared light room in the Laboratory Building, hazardous waste vials containing isopropyl alcohol were being generated in a thirty-gallon plastic container within a SAA (Photo 4). At the time of the inspection, the container was closed and labeled with the words “Hazardous Waste.” The container was not labeled with an indication of the hazard contents of the container.

Photo 4 –30-gallon container in Infrared Light Room used to collect waste glass vials containing isopropyl alcohol.

**Pursuant to 11 Miss. Admin. Code Pt. 3, R. 1.3 [40 C.F.R. § 262.15(a)(5)(ii)], which is a condition of the SAA Permit Exemption, a generator is required to mark or label its containers (ii) with an indication of the hazards of the contents.**

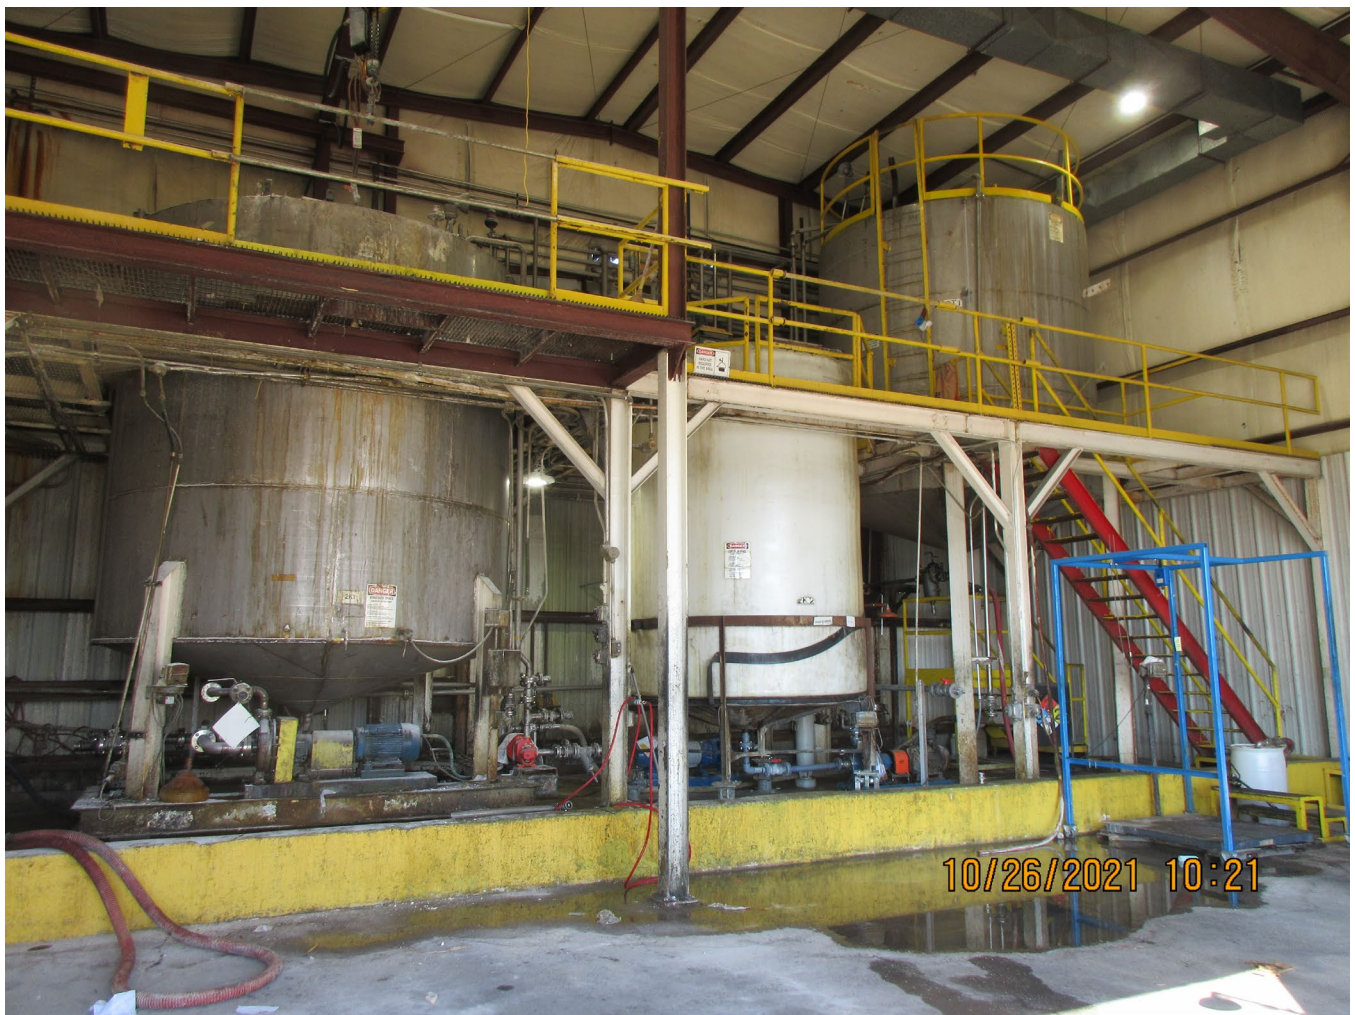
This area utilizes two 8,000-gallon tanks and one 4,000-gallon tank (Photo 5) for the formulation of various herbicides which include Ethephon. At the time of the inspection, Ethephon production had ceased since approximately mid-September. No hazardous waste was observed in this area at the time of the inspection. As discussed above, when Ethephon is being formulated in this area, corrosive characteristic hazardous waste (D002) may be generated when spills or mis-formulated batches of this herbicide are produced.

Photo 5 – Ethephon Production Unit Area

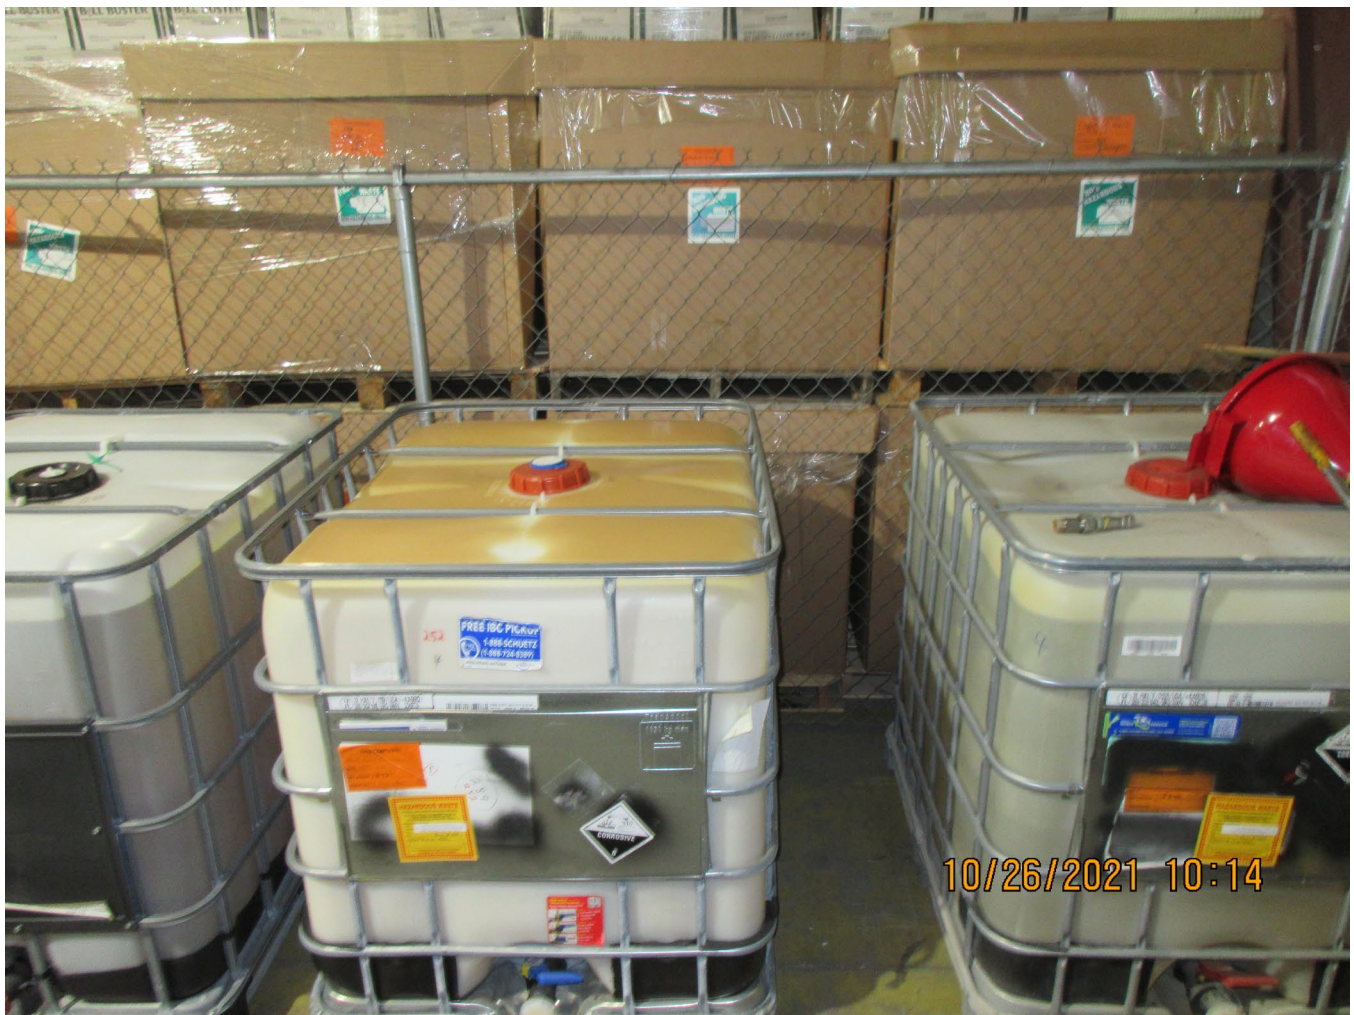
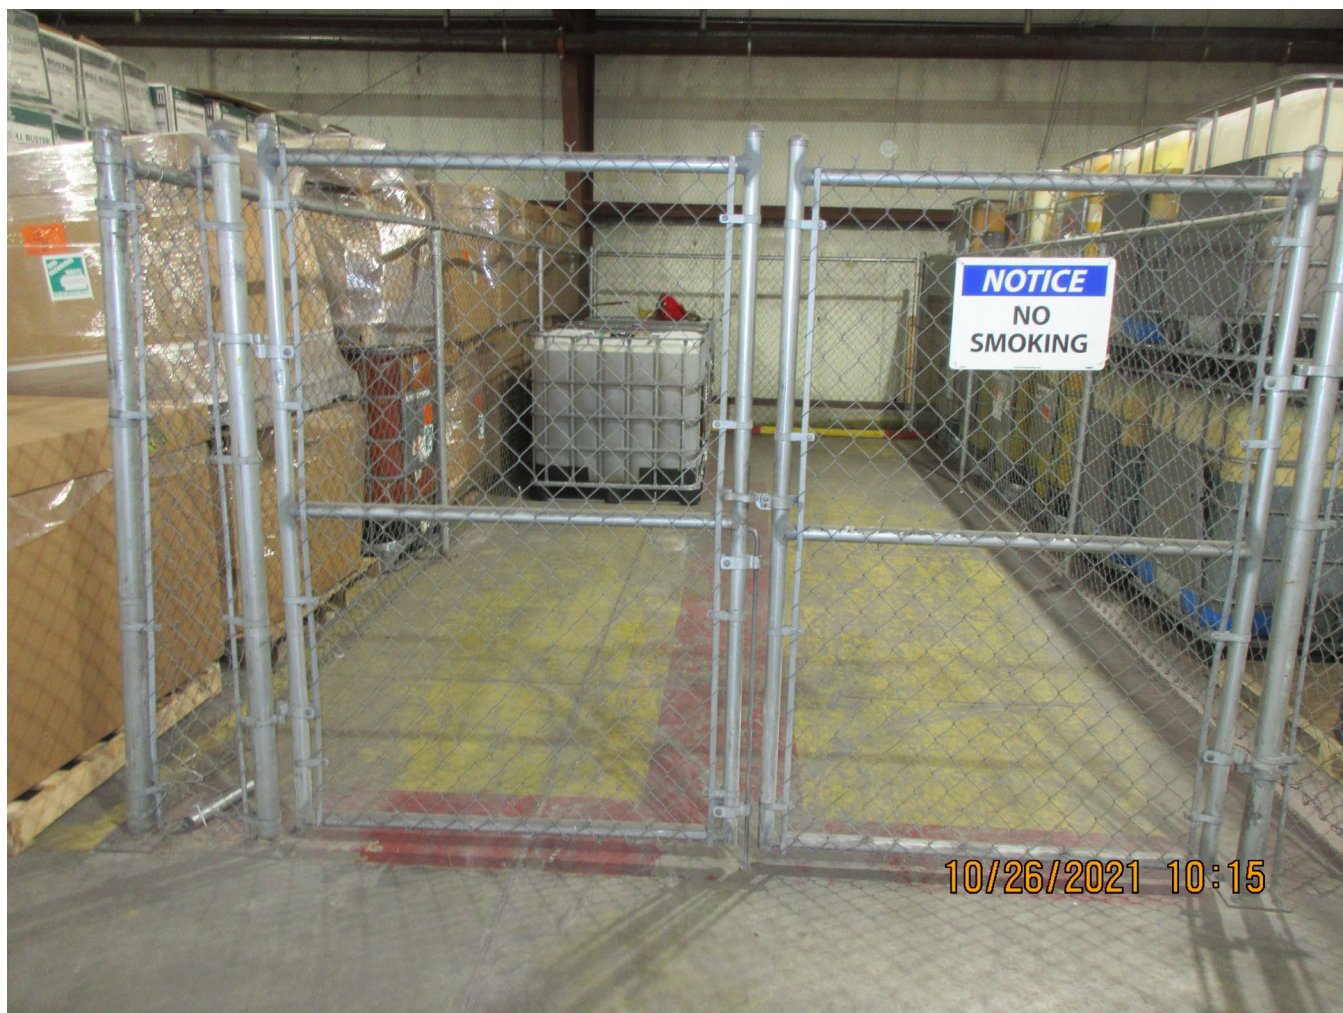
A caged area measuring approximately twelve feet by thirty feet within the Warehouse One building was used for the facility’s 90-day hazardous waste accumulation area (Photos 6 and 7). At the time of the inspection, three 250-gallon caged plastic totes of D002 hazardous waste from the Ethephon Production Unit were observed in this area. Each of the three containers were closed, labeled with the words “Hazardous Waste,” accumulation start dates within September of 2021 and corrosive placards.

Photo 6 – Totes of D002 corrosive hazardous waste from the Ethephon area located in the facility's 90-day accumulation area within Warehouse One.

Photo 7 – Totes of D002 corrosive hazardous waste from the Ethephon area located in the facility's 90-day accumulation area within Warehouse One.

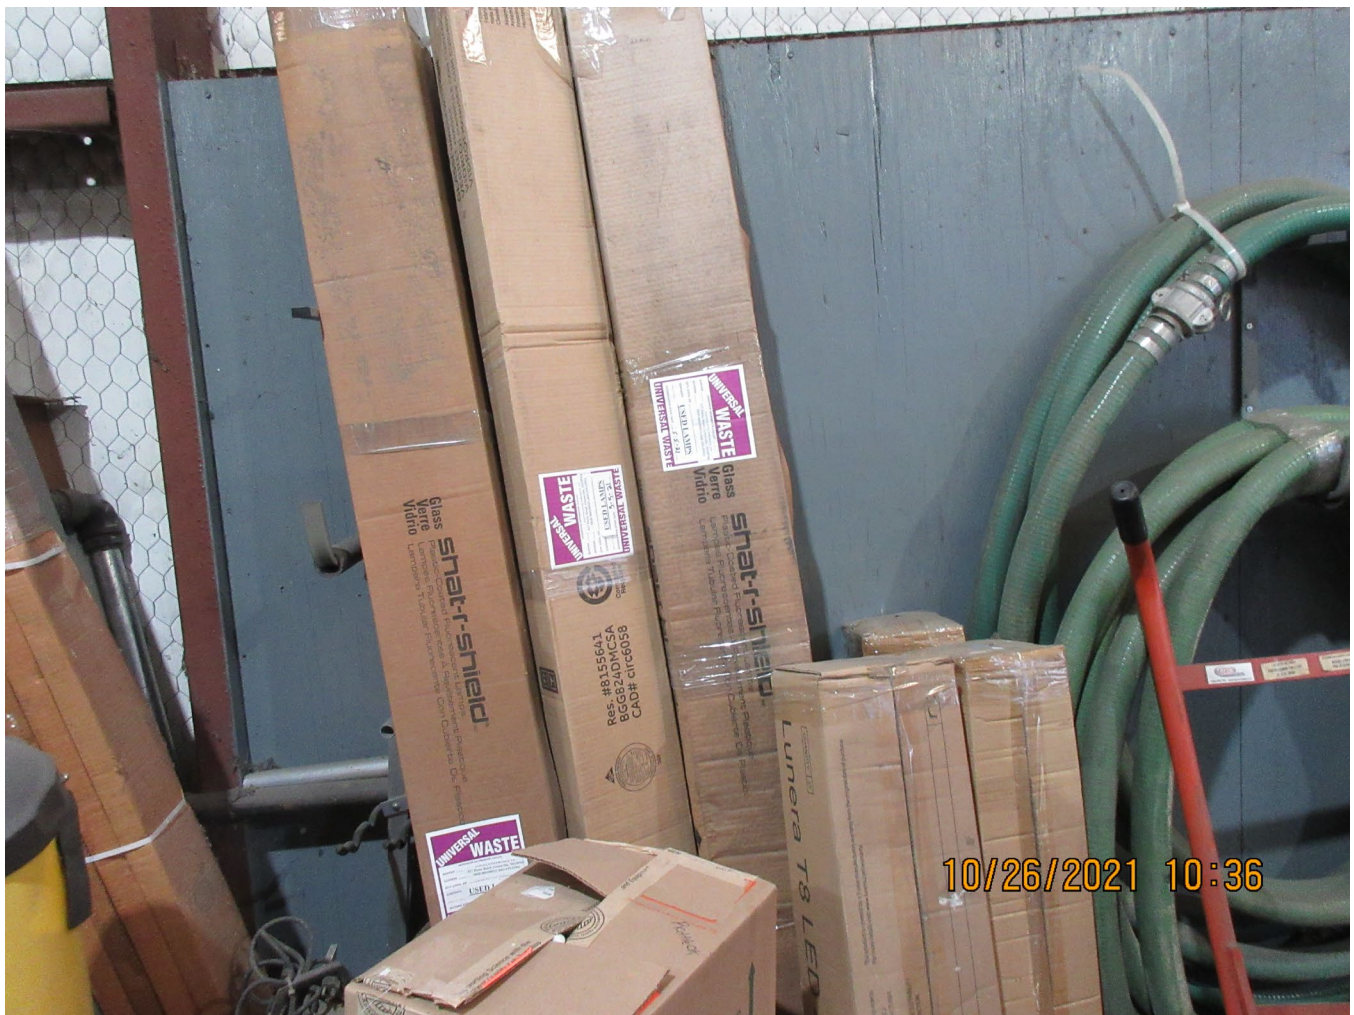
A separate caged area in this warehouse contained the facility’s universal wastes. Universal waste bulbs were observed in three 8-foot boxes, three 4-foot boxes and one 55-gallon container. Universal waste batteries were observed within one 25-gallon container and two 5-gallon containers. Universal waste ballasts were observed within on 55-gallon container. Each of the containers were closed, labeled with appropriate universal waste language and marked with accumulation start dates of less than one year (Photos 8 and 9).

Photo 8 – Universal Waste Bulbs in Warehouse One

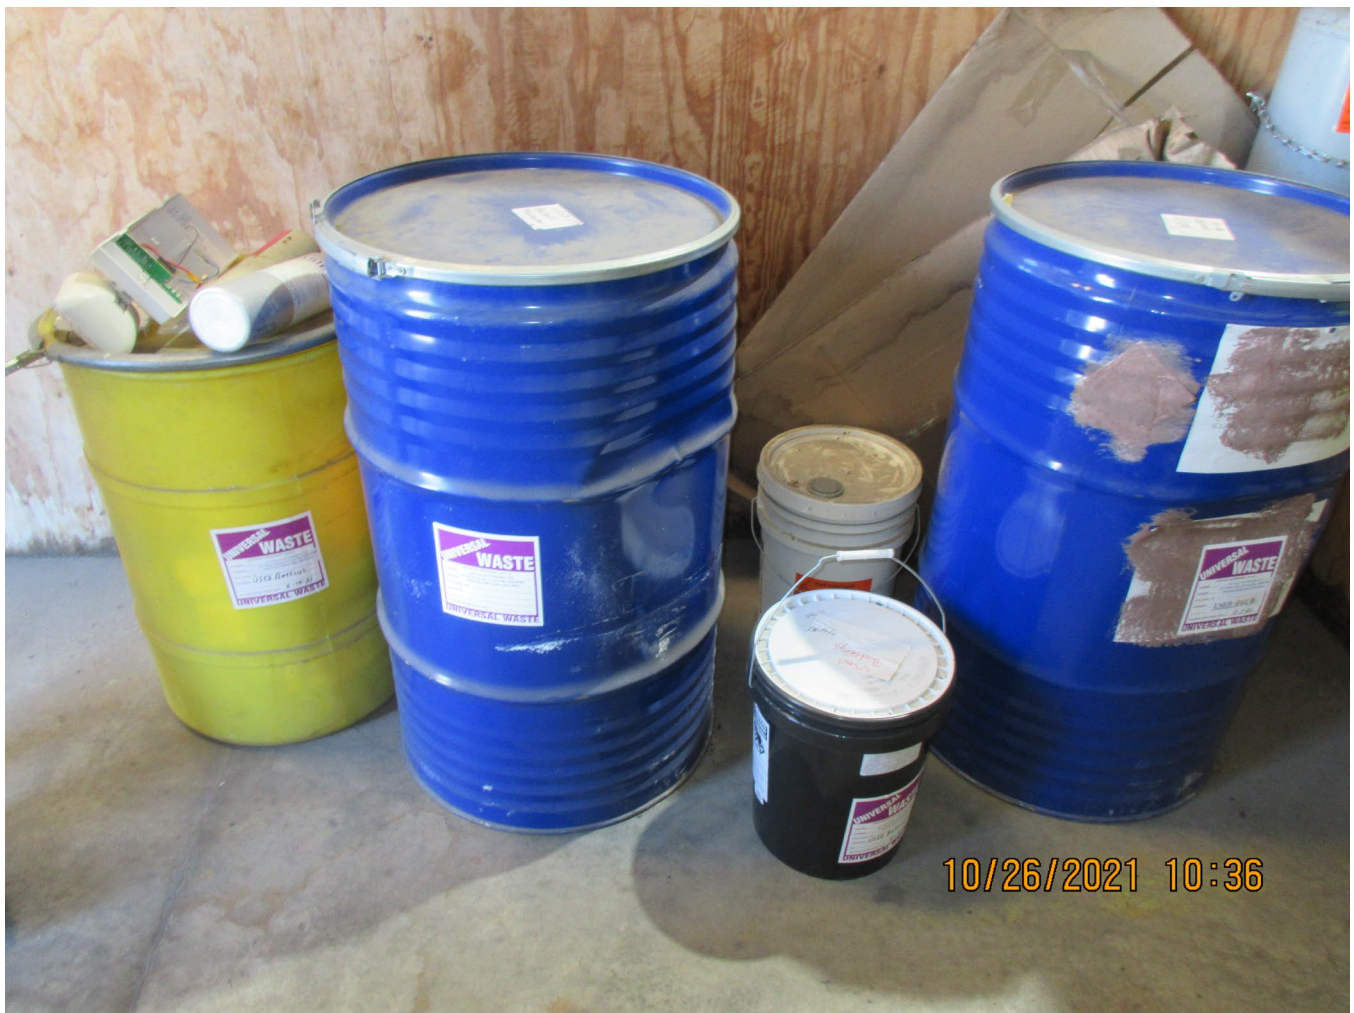
Photo 9 – Universal Waste Batteries in Warehouse One
