# Compliance Evaluation Inspection Report

## U.S. Postal Service – Yonkers Post Office

Yonkers, New York  
November 15, 2022

## COMPLIANCE EVALUATION INSPECTION REPORT

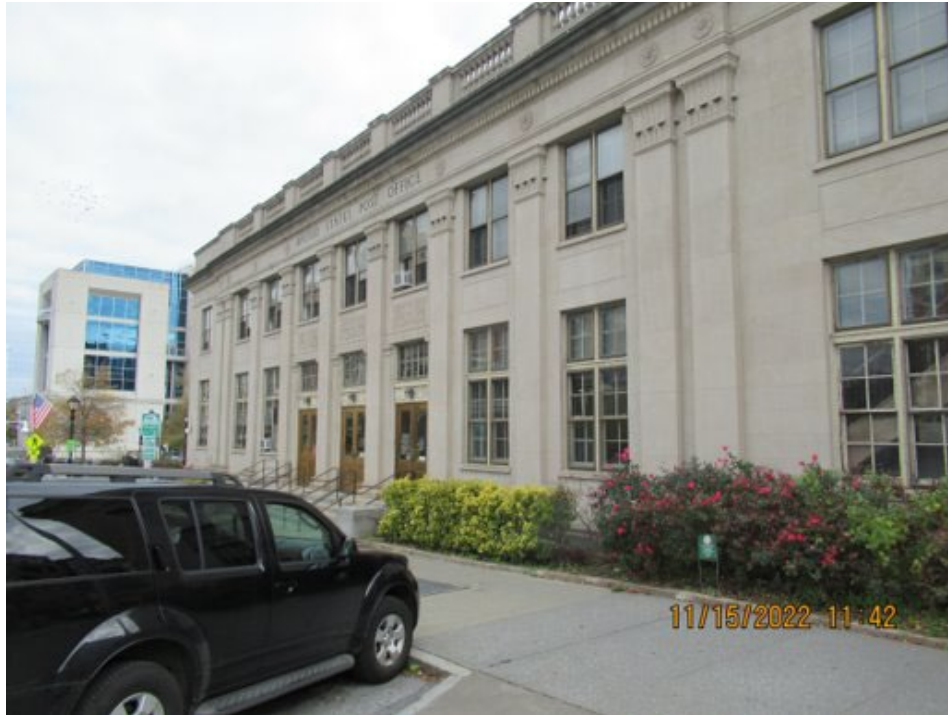
The YPO is a two-story stone building built in the late 1920s and is listed on the National Register of Historic Places (See, Photograph #1). The employees sort mail with zip codes between 10701 and 10710 for delivery, which include towns like Eastchester, Hastings-on-Hudson, Tuckahoe, Bronxville, as well as Yonkers.

Photograph #1 – U.S. Postal Service – Yonkers Post Office (Main Entrance)

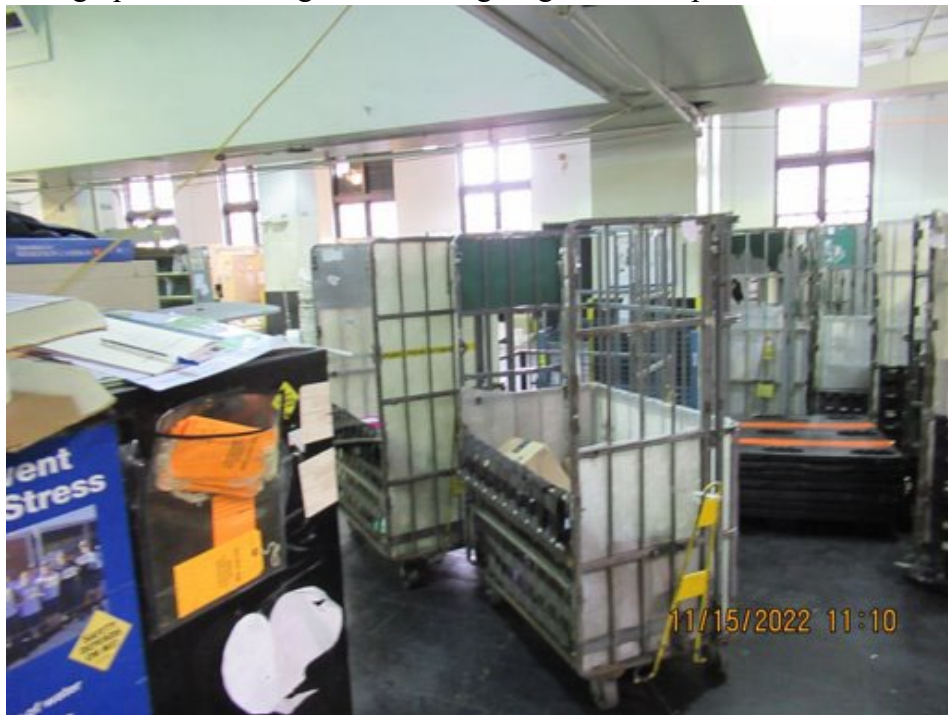
Mr. Wineski and I began the facility tour in the mail sorting area. There were numerous stations that were used for hand sorting of mail prior to the mail being placed on a reusable mail tray then transferred over to the loading dock for loading onto light transport mail trucks for residential delivery. There is rolling stock that is used to transport mail trays and packages to the loading dock. Mr Wineski indicated that when these carts are damaged, they are sent to the White Plains location for repair (See, Photograph #2).

Photograph #2 – Rolling stock. Orange tags are for repair orders.

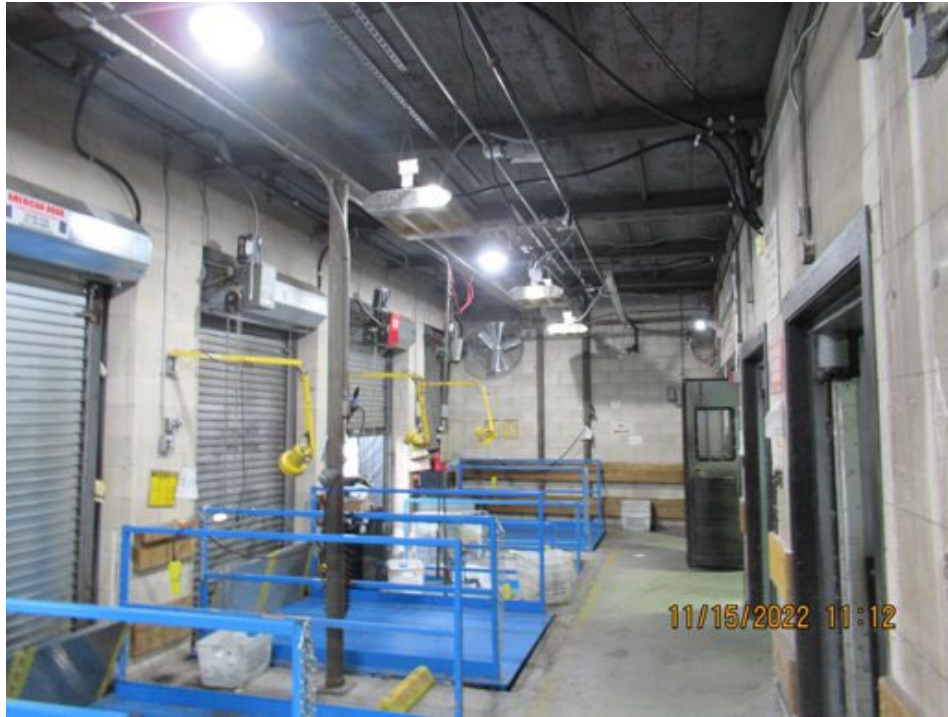
We then looked at the retail window and lobby of the YPO. From there we proceeded to the loading dock (See, Photograph #3). I asked Mr. Wineski whether there had been any leaks in the hydraulic systems of the docks and if so, how did they handle the spill. He indicated that there had not been any, but if there were, like almost every non-routine event at this site, it would be handled by the Postal Service's contractors.

Photograph #3 – Loading Dock

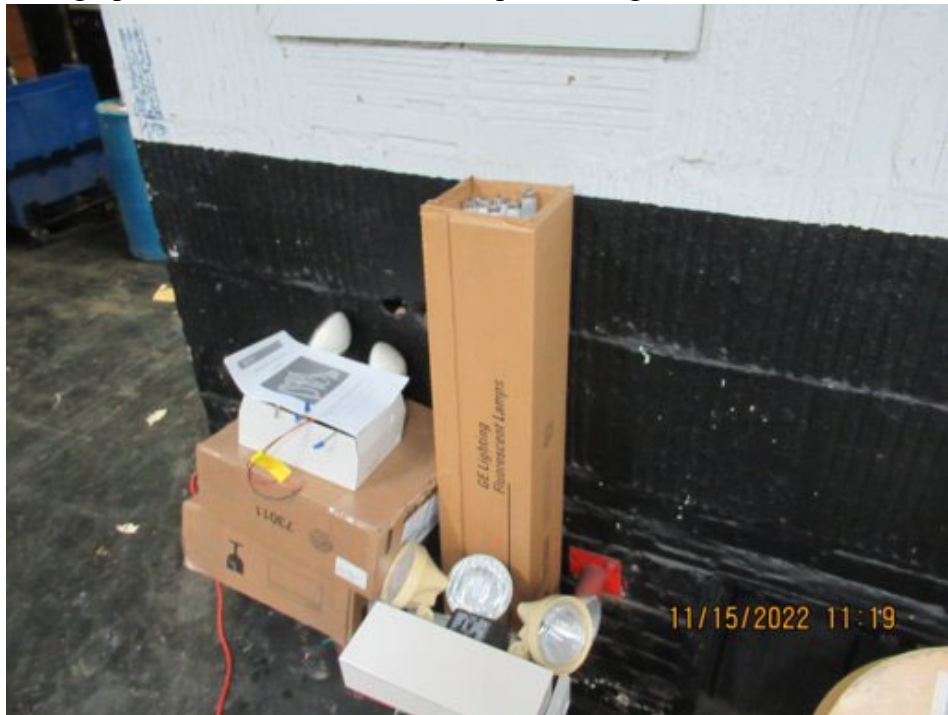
Next, we proceeded to the basement. Mr. Wineski indicated that no employees worked in the basement and aside from storage, the area was inactive. The basement had to be inspected because this was where the facilities universal waste bulbs were stored. We did find a container of universal waste bulbs that was not labeled as "Universal Waste" and was not kept closed (See, Photograph #4). Stored near this container were emergency lighting units that Mr. Wineski said were not part of the Postal Service's normal maintenance of the building, but waste likely generated by a contractor involved in upgrading the building's fire suppression system. Three of these emergency lighting units were not containerized.

| REGULATORY, STATUTORY OR PERMIT REFERENCE | FIELD OBSERVATION |
|---|---|
| In accordance with 6 NYCRR 374-3.2 (d)(4)(i), a small quantity handler of universal waste must contain any lamp in containers or packages that are structurally sound, adequate to prevent breakage, and compatible with the contents of the lamps. Such containers and packages must remain closed and must lack evidence of leakage, spillage or damage that could cause leakage under reasonably foreseeable conditions. | At the time of the inspection, at least one container of universal waste lamps was not closed ( <u>See</u> , Photograph #4). |

| REGULATORY, STATUTORY OR PERMIT REFERENCE | FIELD OBSERVATION |
|---|---|
| In accordance with 6 NYCRR 374-3.2 (e)(5), each [universal waste] lamp or a container or package in which such [universal waste] lamps are contained must be labeled or marked clearly with one of the following phrases: Universal Waste-Lamp(s), or Waste Lamp(s), or Used Lamp(s). | At the time of the inspection, at least one container of universal waste lamps was not labeled or marked clearly with one of the following phrases: Universal Waste-Lamp(s), or Waste Lamp(s), or Used Lamp(s) (See, Photograph #4). |

Photograph #4 – Universal Waste Lamps in storage

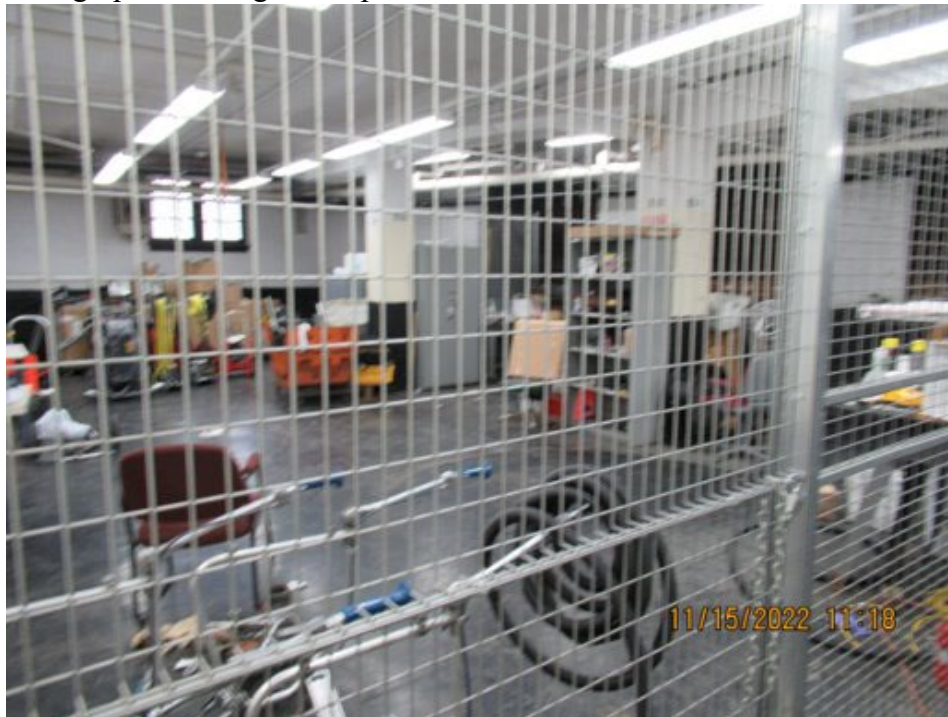
I also inspected a cage where the pushcarts that letter carriers use are repaired (See, Photograph #5); a meeting room that is available for training; the area where letter carriers were supposed to train on 9-unit mailboxes (the training project never launched) (See, Photograph #6); the area where the contractor upgrading the fire suppression system is keeping their supplies; another cage where painting supplies are stored (See, Photograph #7); the building's two gas-fired boilers (See, Photograph #8); and an auxiliary 1000-gallon vaulted tank of fuel oil that is drawn from if the gas supply is cut off (See, Photograph #9).

Photograph #5 – Cage for repair of satchel mail carts

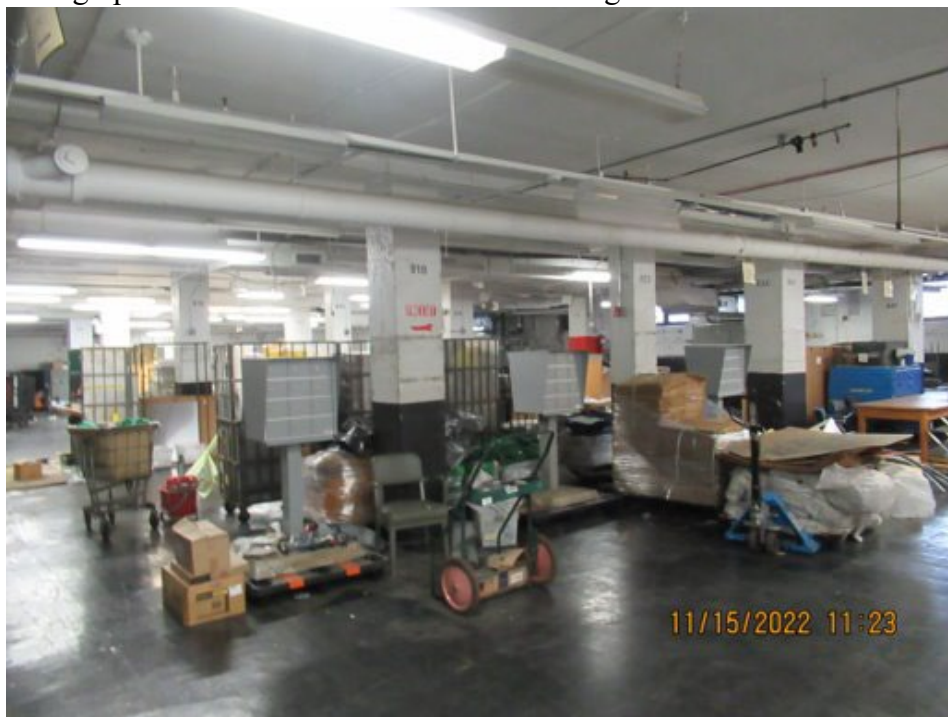
Photograph #6 – Unused 9-unit mailbox training area

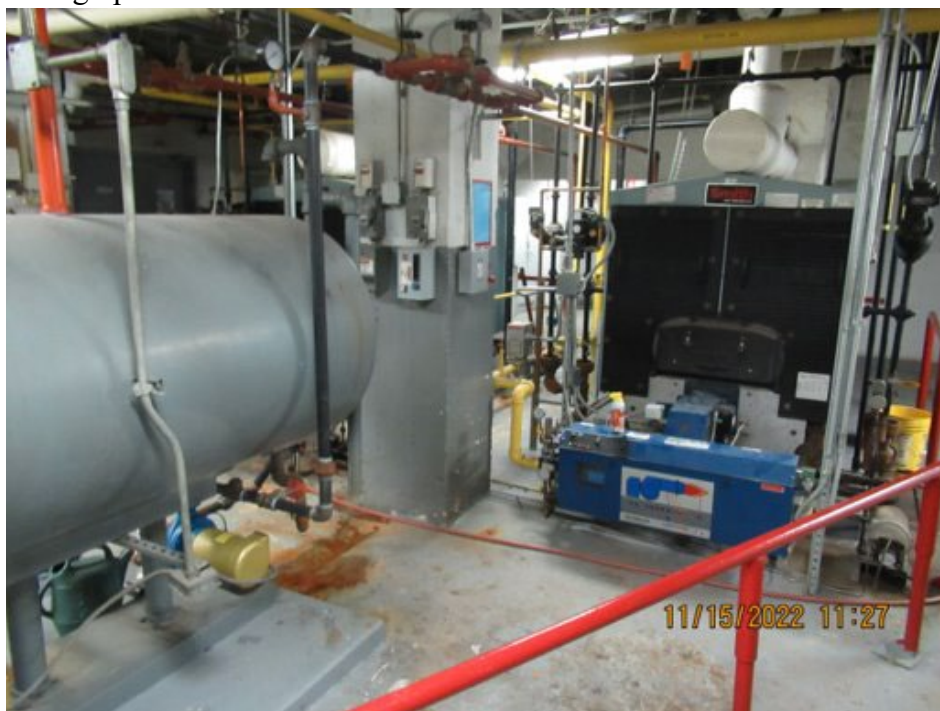
Photograph #8 – Boiler room

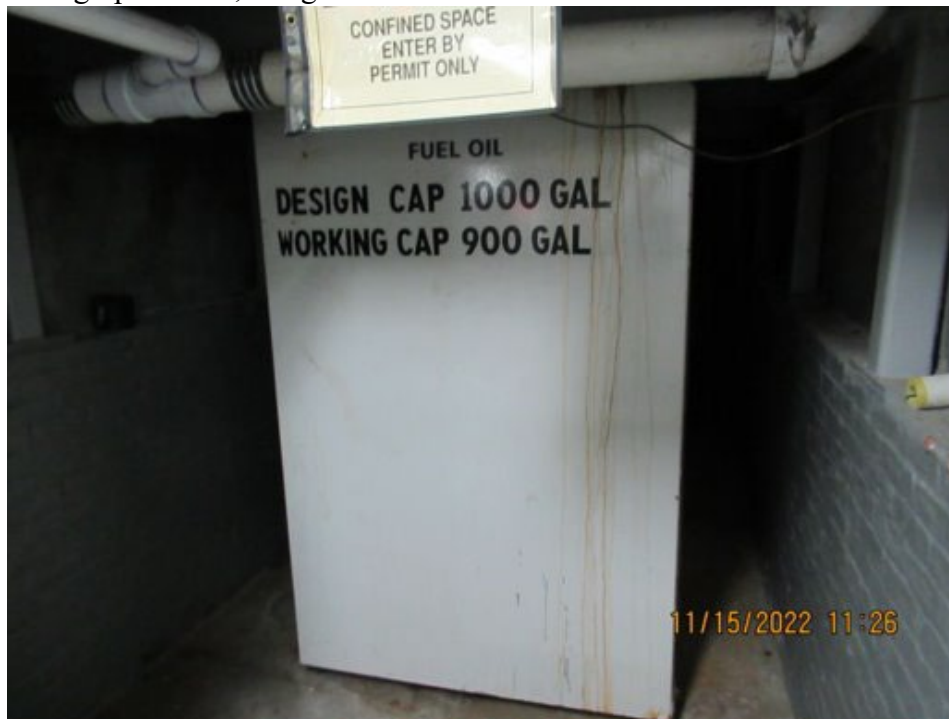
Photograph #9 – 1,000-gallon fuel oil tank located in basement
