# RCRA Compliance Evaluation Inspection Report

Reichhold LLC 2  
54 Wamsly Road  
Jacksonville, Florida 32254-2847  
County: Duval  
Latitude: 30.326730  
Longitude: -81.746970  
EPA ID Number: FLD004061529

## 5) **Dates of Inspection**

March 23, 2021, 9:00 a.m.

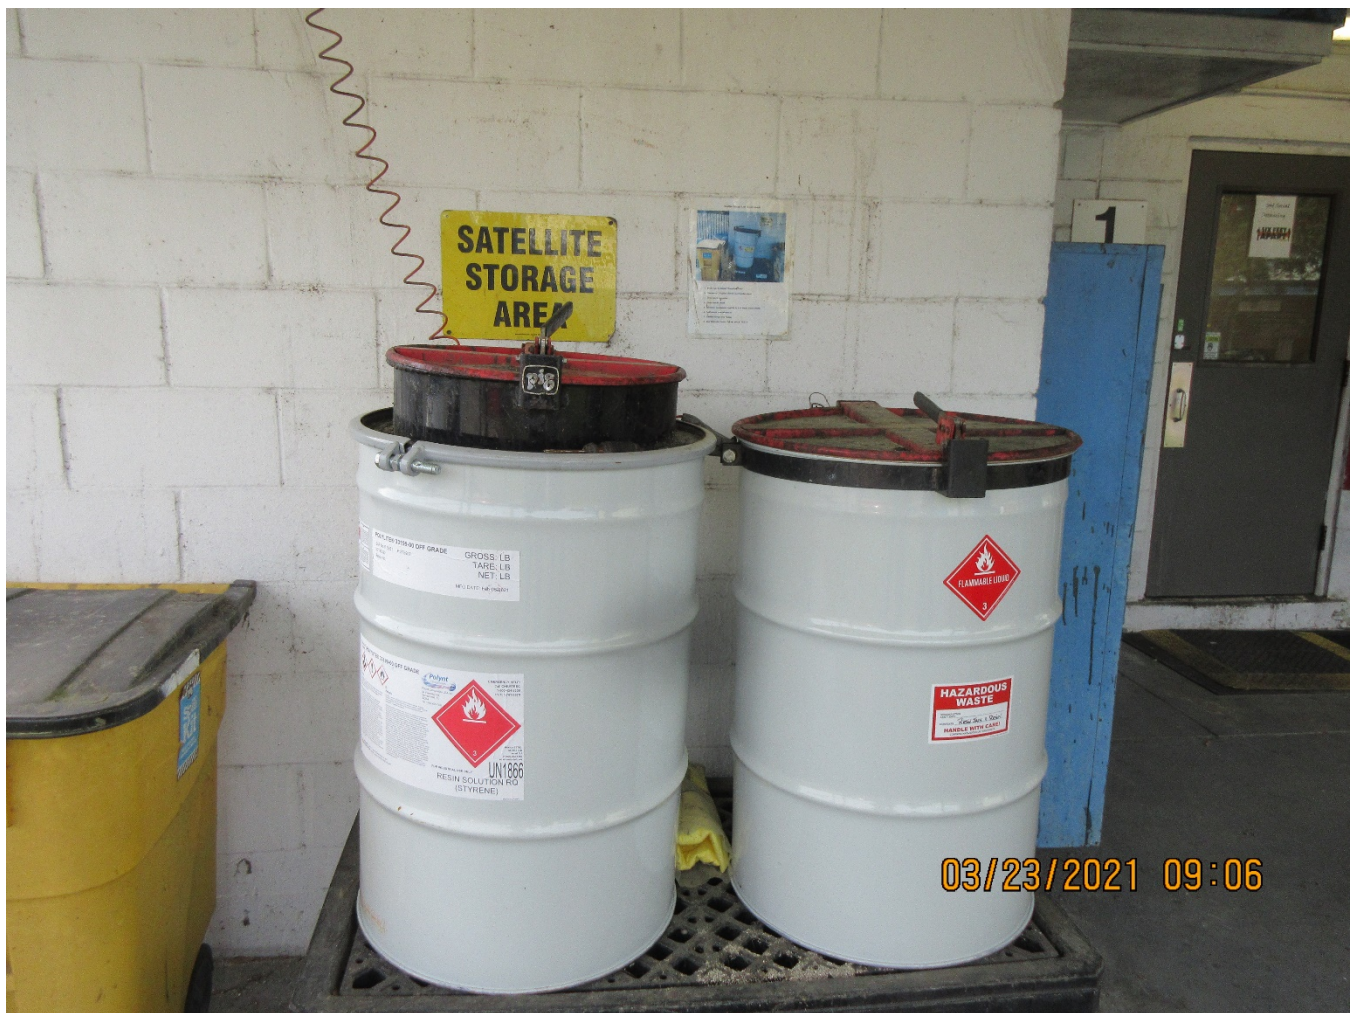
This lab is used for quality assurance testing at various stages of the resin manufacturing process. Small resin jars containing resins which have been tested are taken just outside of the lab and emptied into a 55-gallon drum. The resin in this container is returned to the process. The resin jars are then placed within a separate 55-gallon drum within a satellite accumulation area adjacent to the other drum. This drum was closed, labeled with a "Hazardous Waste" label and a label identifying the hazard contents of the container (Photo 1).

Photo 1 – Hazardous waste drum outside of the Quality Control Lab receiving resin jars used for holding samples

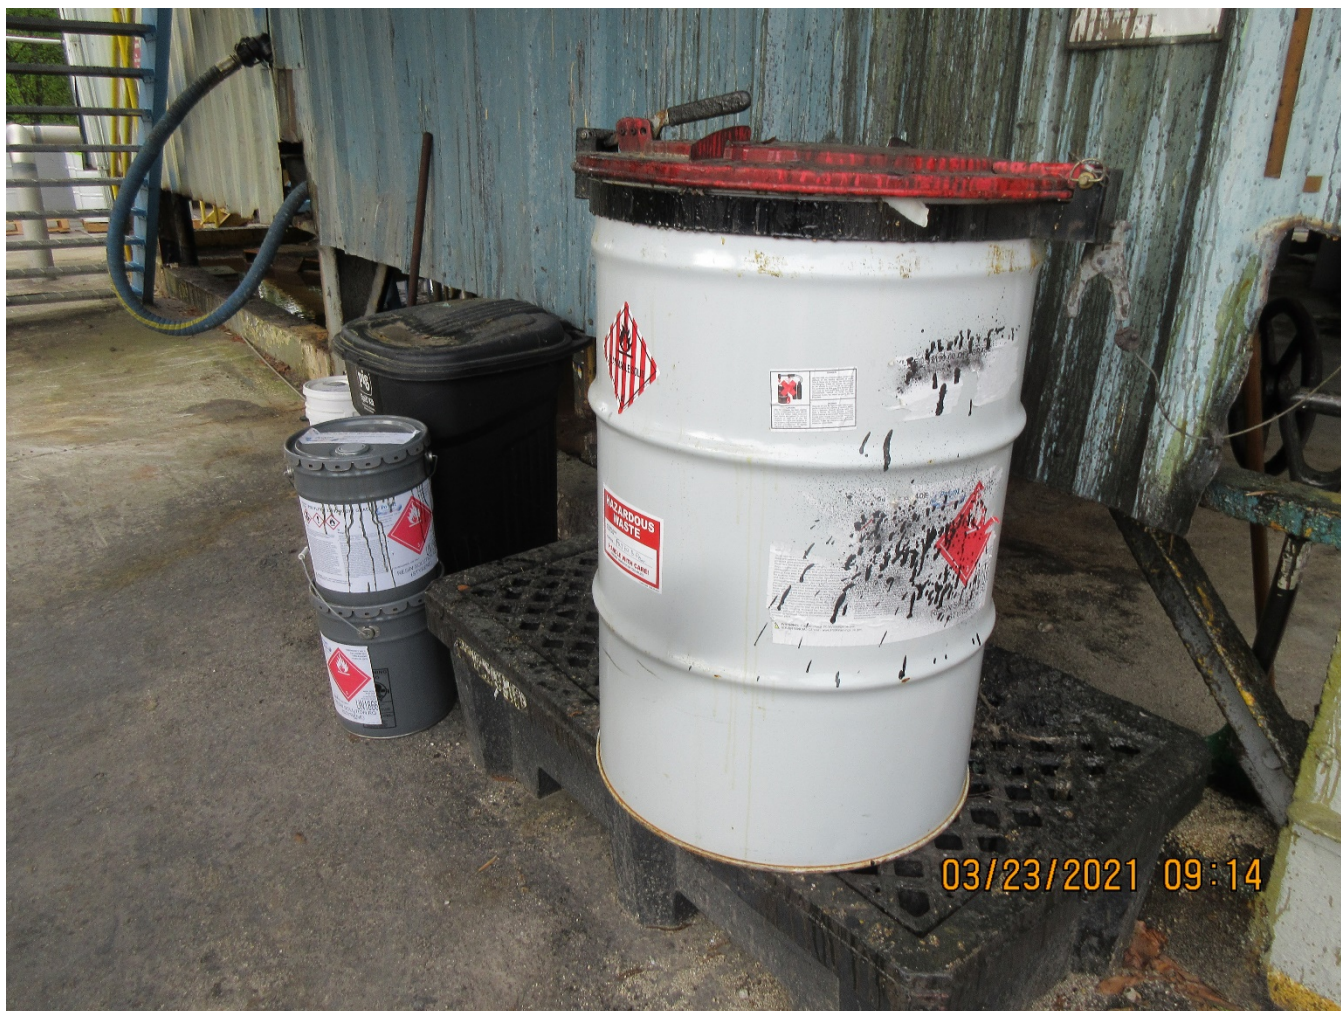
Filter socks used in the reactor building to remove unwanted solids are collected in a 55-gallon drum within a SAA outside of the Reactor Building (Photo 2). The drum was closed, labeled with the words "Hazardous Waste" and marked with a label indicating the hazard contents of the container. (Photo 2)

Photo 2 – 55-gallon drum receiving filter socks outside of the Reactor Building

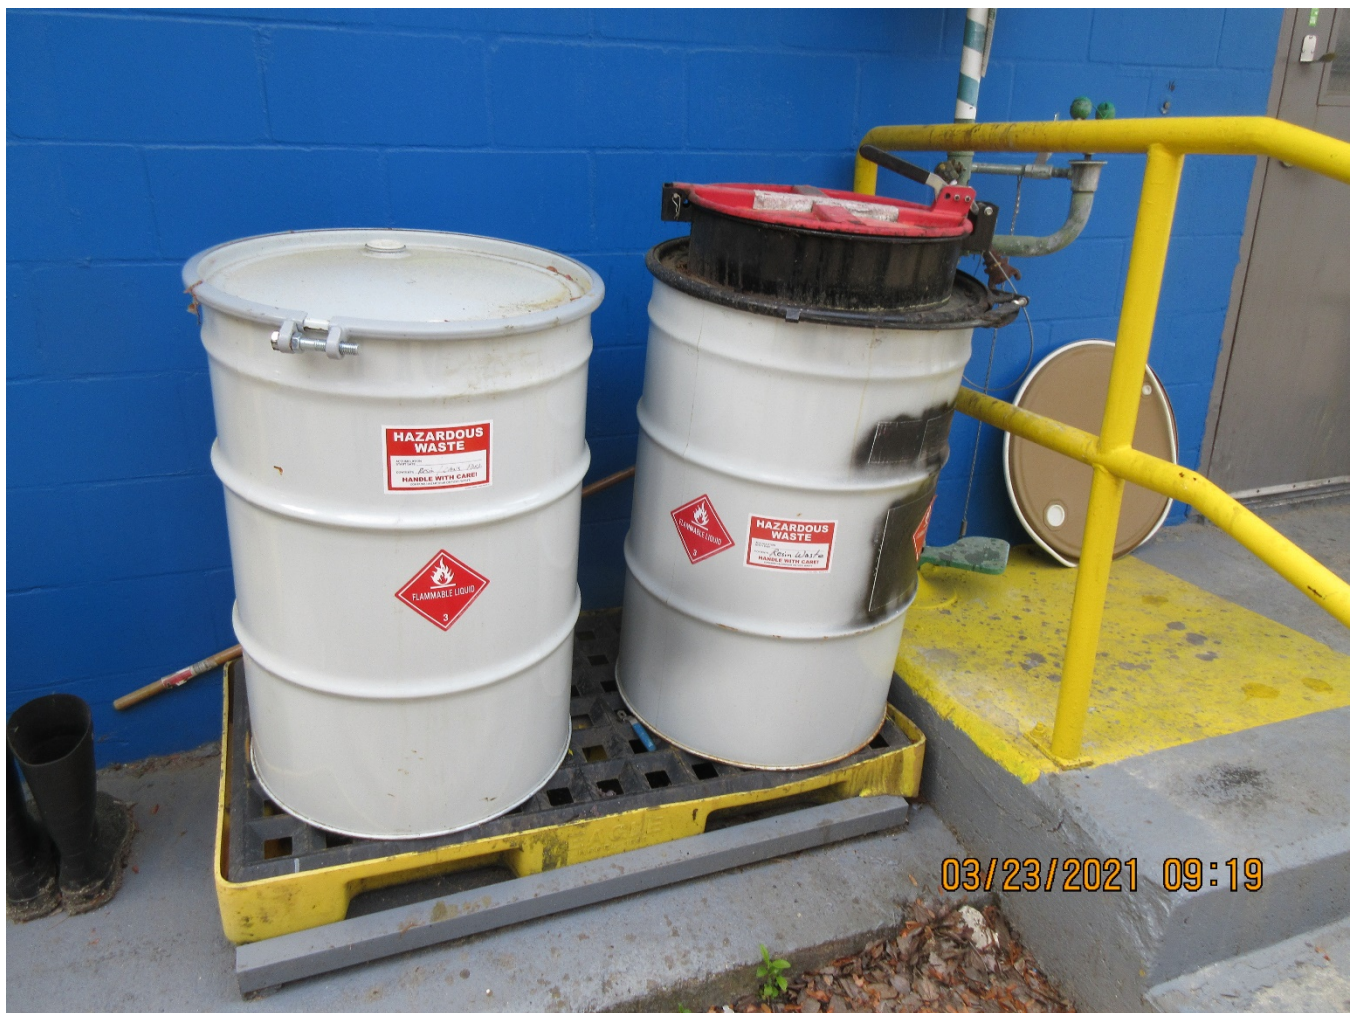
This lab is also used for quality assurance testing at various stages of the resin manufacturing process. Small resin cans containing resins which have been tested are taken just outside of the lab and emptied into a 55-gallon drum. The resin cans are then placed within a separate 55-gallon drum. Each of the drums are considered to be within separate satellite accumulation areas. These drums were closed, labeled with “Hazardous Waste” labels and a label identifying the hazard contents of the containers (Photo 3).

Photo 3 – Hazardous waste collection drums outside of the Production Lab receiving resin and resin cans used for holding samples.

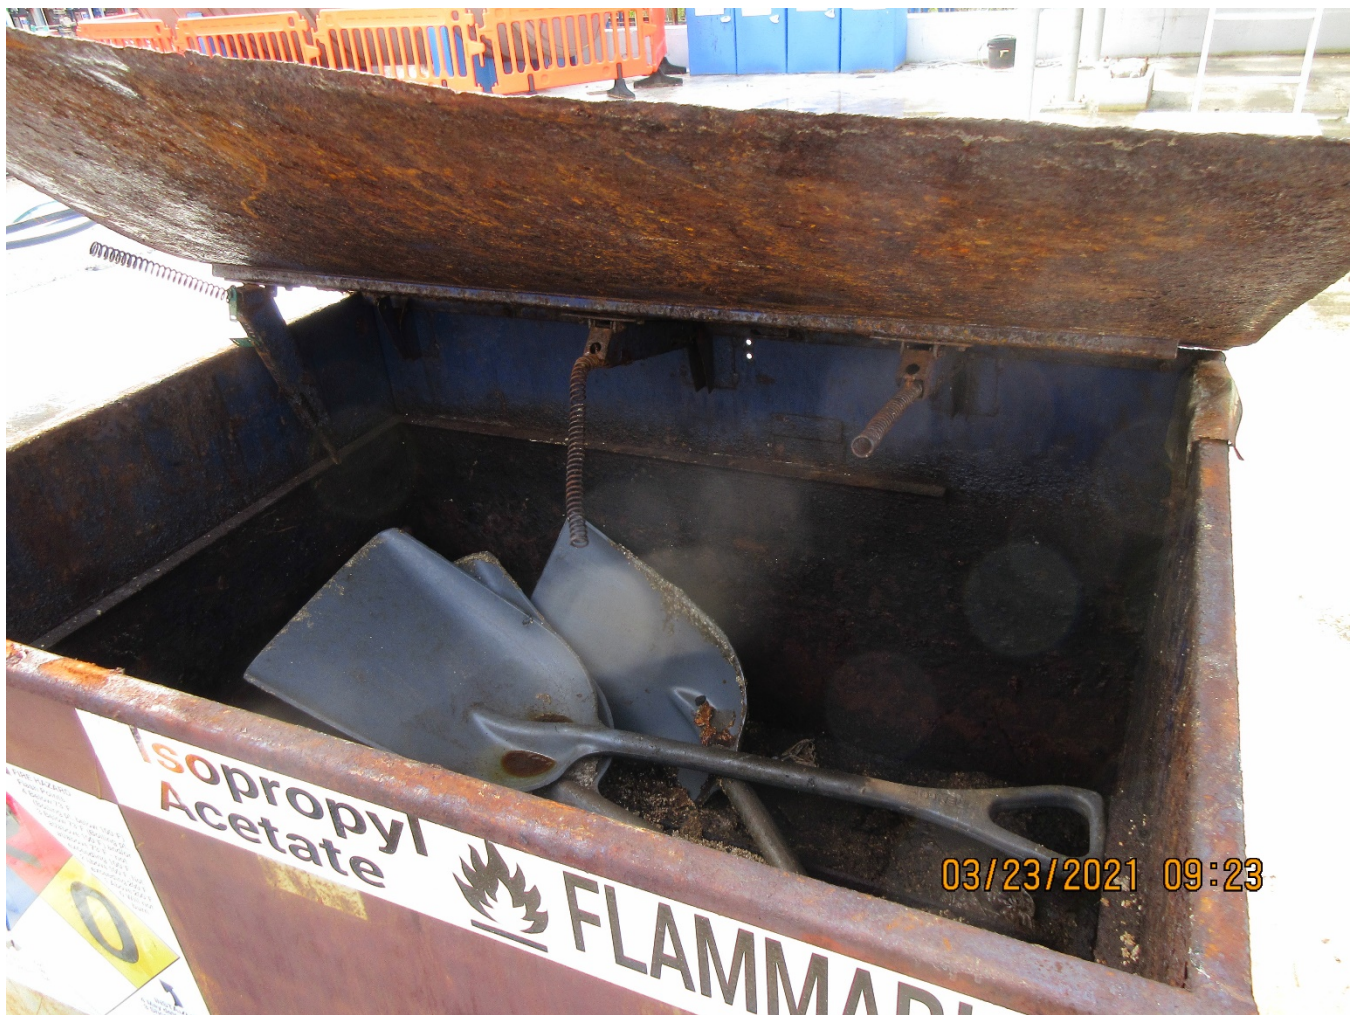
In an area between the Production Lab and the Tank Farm, a metal box measuring approximately 4’ by 3’ by 2’ was observed for the purpose of cleaning shovels used by the facility. Shovels are placed in the metal box and rinsed with isopropyl acetate. No liquid was observed within the metal box at the time of the inspection (Photo 4).

Photo 4 – Shovel Cleaning Box in area near the Production Lab

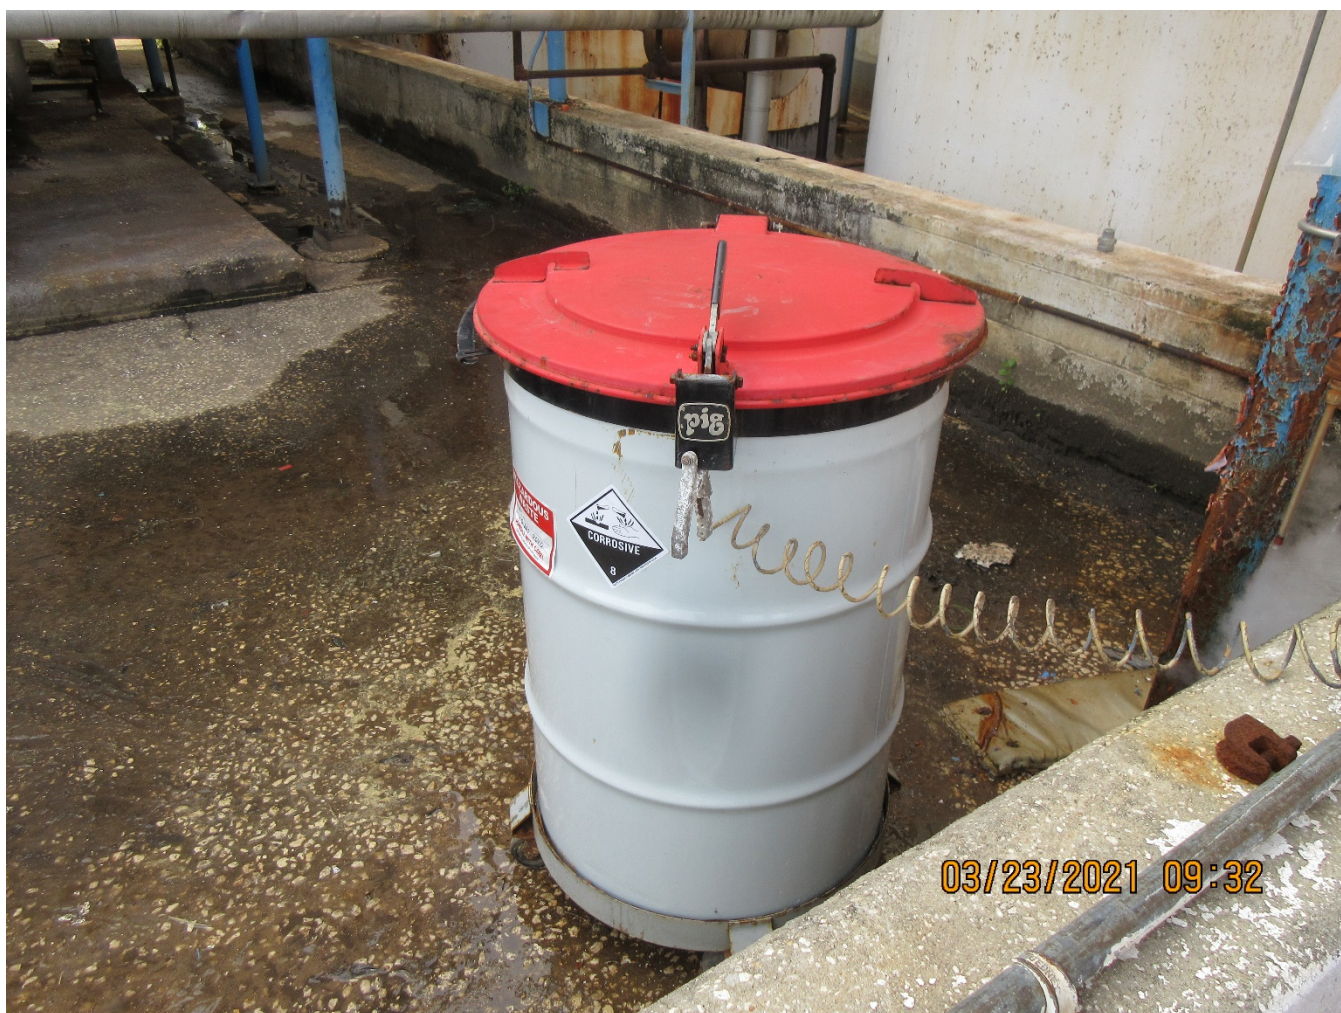
Filter socks used for the collection of solidified vapors from the off-loading of railcars are collected in a 55-gallon drum within a SAA in the area of two horizontal tanks in the Tank Farm (Photo 5). The drum was closed, labeled with the words “Hazardous Waste” and marked with a label indicating the hazard contents of the container. (Photo 5)

Photo 5 – Drum used to collect filter socks with solidified vapors from the off-loading of materials into tank within the tank farm.

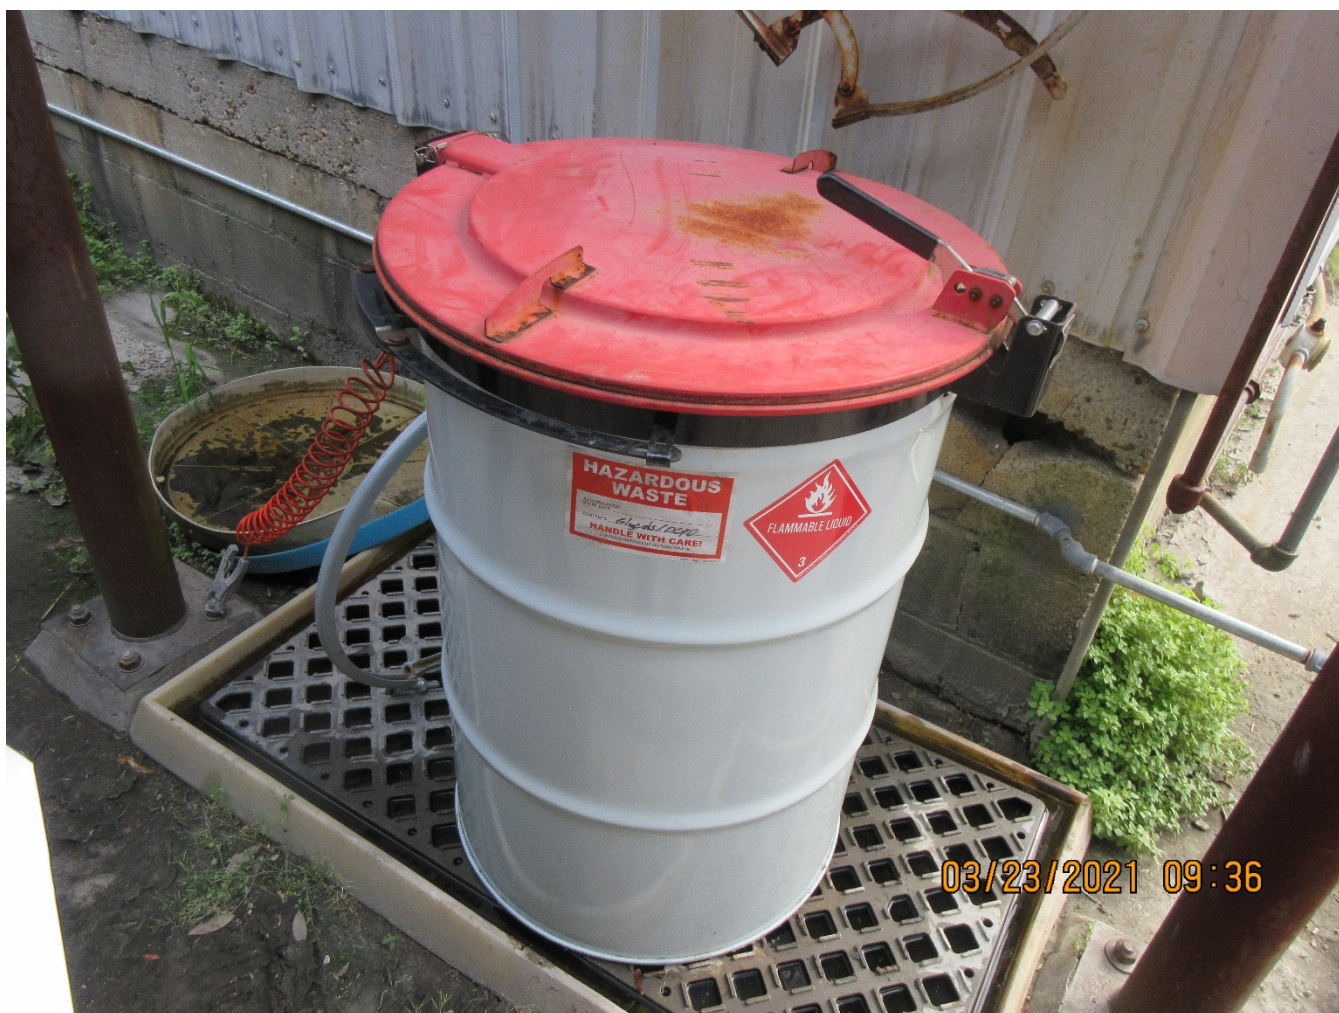
Hose cleanout material from the off-loading of DCPD from railcars is collected in a 55-gallon drum within a SAA in the area of the rail line (Photo 5). The drum was closed, labeled with the words “Hazardous Waste” and marked with a label indicating the hazard contents of the container. (Photo 6)

Photo 6 – Drum used to collect DCPD from hose cleanouts in the Rail Car off-loading area.

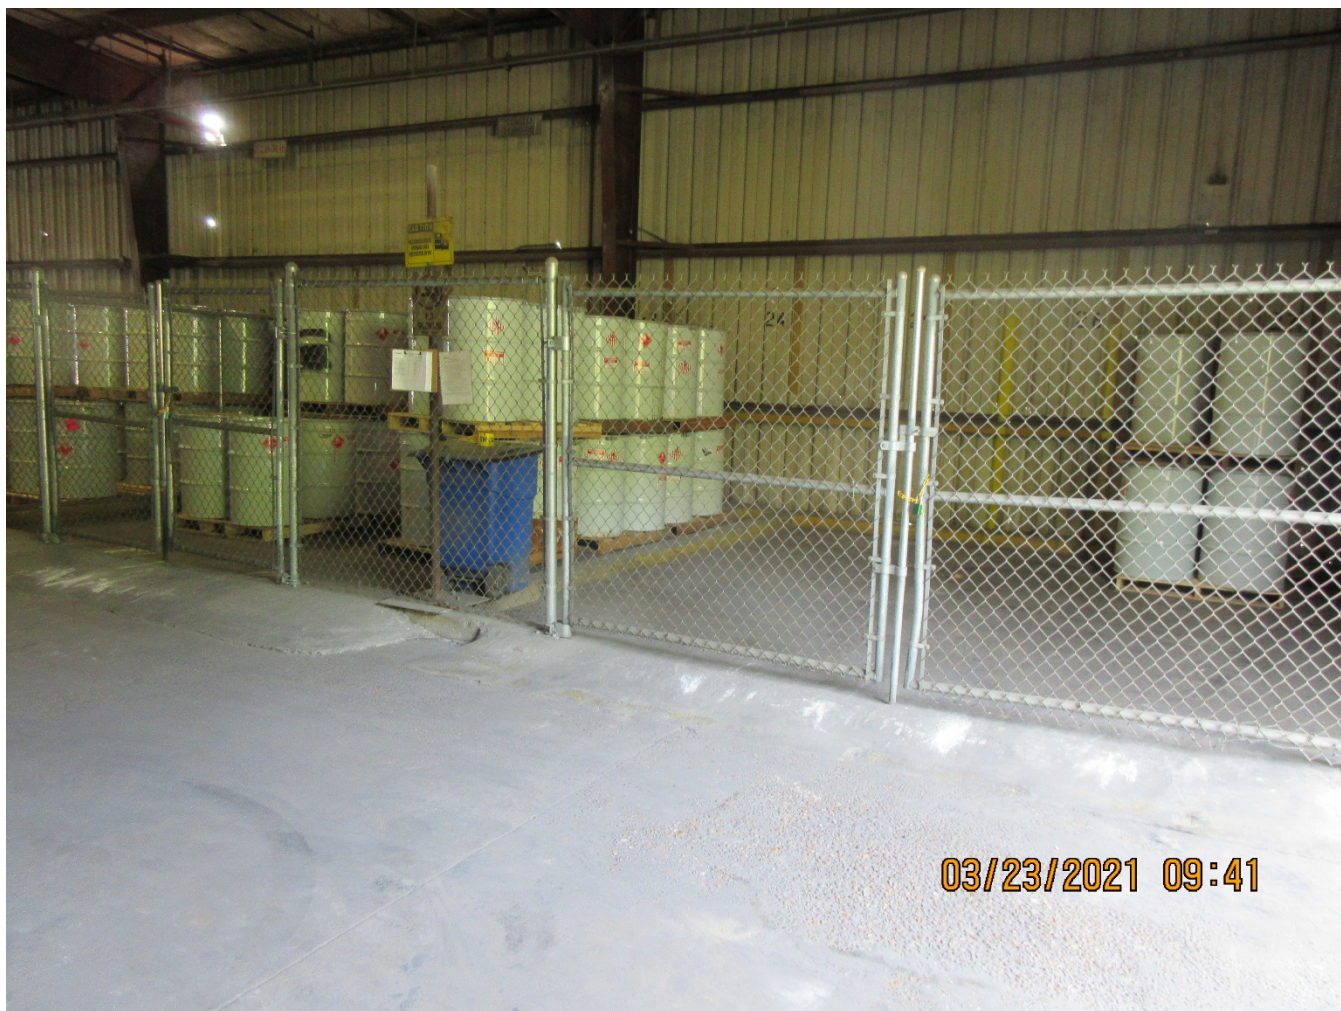
The smaller warehouse is divided into two sections. One section is used for the management of research and development materials, the other is set within a cage on top of a concrete pad with a concrete berm. At the time of the inspection, fifty 55-gallon drums of various hazardous wastes from the facility’s generation areas were observed in this area (Photo 7). Each of the containers were closed, labeled with the words “Hazardous Waste” and an indication of the hazard contents of the containers and marked with an accumulation start date of less than 90 days. This hazardous waste central accumulation area was equipped with a fire extinguisher, spill control, “No Smoking” signs and had service for emergency cell phone use.

A review of the facility's inspection logs for their hazardous waste container central accumulation area located within Warehouse 2 found missing records for numerous weeks. Below is a list of the days on which the facility performed an inspection of their hazardous waste accumulation area starting in March of 2018.

For the three-year time period from March 23, 2018 through March 22, 2021, a review of the weekly inspections performed find the facility to have conducted 53 weekly inspections. One hundred five weekly inspections were not performed.

Photo 7 –Hazardous Waste Container Central Accumulation Area

**Pursuant to Fla. Admin. Code Ann. r. 62-730.160(3) [40 C.F.R. § 262.17(a)(1)(v)], which is a condition of the LQG Permit Exemption, a generator is required to, at least weekly, inspect central accumulation areas looking for leaking containers and for deterioration of containers caused by corrosion or other factors. In addition, the generator shall keep written documentation of the inspections under this section for at least three years from the date of the inspection. At a minimum, this documentation shall include the date and time of the inspection, the legibly printed name of the inspector, the number of containers, the condition of the containers, a notation of the observations made, and the date and nature of any repairs or other remedial actions.**

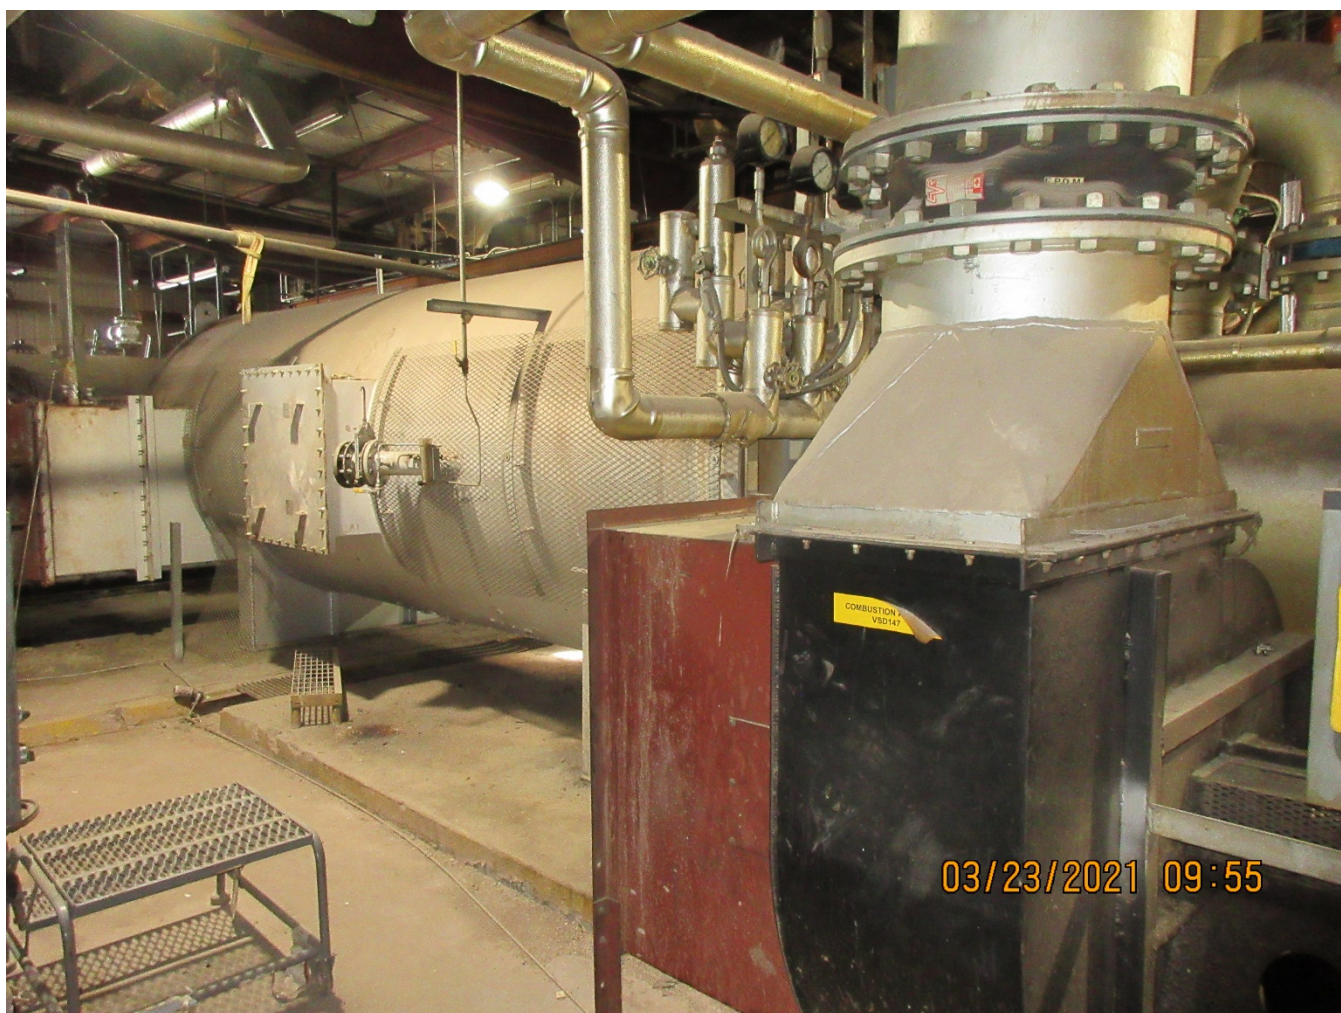
The facility was operating a thermal oxidizer within the Utilities Building. The device serves as an emission control device to burn fumes and condensed liquids generated during the production of resins in the Reactor Building. Two vapor lines and one liquid line feed the thermal oxidizer. The thermal oxidizer operates at a minimum temperature of 1400 degrees Fahrenheit. Exhaust from the thermal oxidizer passes through a waste heat boiler. The waste heat boiler captures heat from the exhaust to generate steam. The exhaust also passes through the tubes of a boiler in the utilities building and then is exhausted to the atmosphere. The facility has an Air Operating Permit for this unit with FDEP.

The facility personnel provided the EPA and FDEP inspection team with analysis of the liquid stream being fed to the thermal oxidizer on March 3, 2006. The waste stream was analyzed for pH and ignitability to determine if the waste stream would be characteristically hazardous for ignitability or corrosivity. The results of the analysis show the flashpoint of the sample to be greater than 142 degrees Fahrenheit and have a pH of 2.29. Duplicate samples taken at this time were stated to have given similar results. Upon going to the control room, a shut-off valve on the waste stream feed was said to be set for a pH of 2 at the low end and 13 at the high end. The pH of the feed stream at the time of the inspection was slightly greater than 8. Results for pH could only be saved for about 14 days so historic data for pH could not be obtained at the time of the inspection. The limits set for pH on the equipment would potentially allow for hazardous waste to be fed to the thermal oxidizer at the low and high end of the pH spectrum.

Photo 8 – Thermal Oxidation Unit

**Pursuant to [Fla. Admin. Code Ann. r. 62-730.160(1) [40 C.F.R. § 262.11], a person who generates a solid waste, as defined in Fla. Admin. Code Ann. r. 62-730.030(1), must make an accurate determination as to whether that waste is a hazardous waste in order to ensure wastes are properly managed according to applicable RCRA regulations articulated in Fla. Admin. Code Ann. r. 62-730.160(1) [40 C.F.R. § 262.11].**

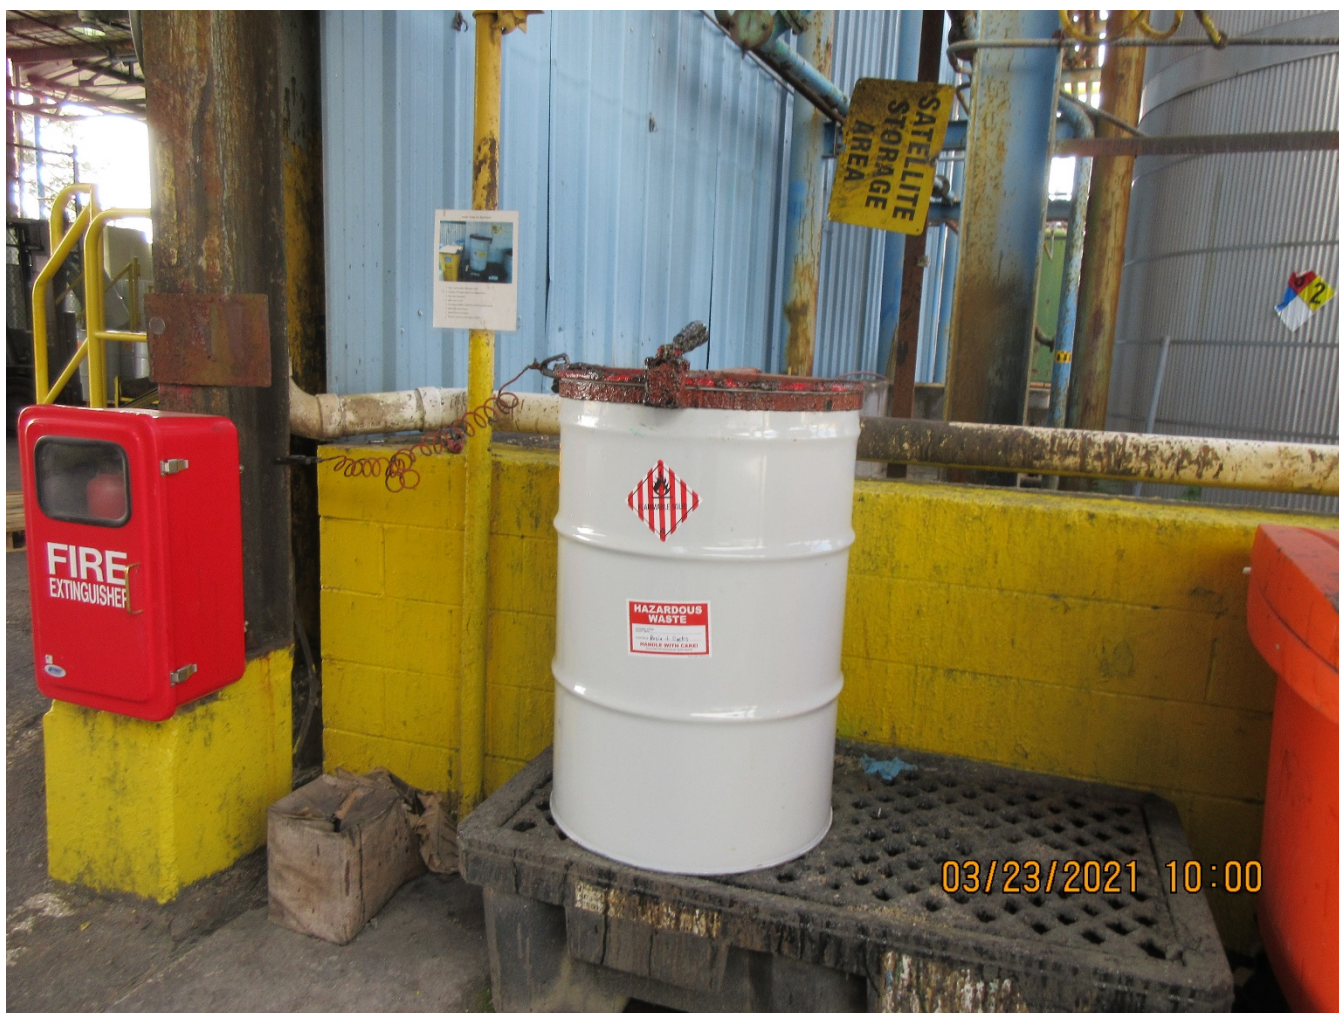
Socks used to filter the unloading of products coming into the facility to be used as ingredients are placed into a 55-gallon drum within a SAA. The drum was closed, labeled with the words “Hazardous Waste” and marked with a label indicating the hazard contents of the container.

Photo 9 – Hazardous waste accumulation container for socks in the truck offloading area.
