## NPDES Inspection Report - Stormwater Industrial

| Facility Location Information | |
|---|---|
| Site/Facility Name and Location:<br><br>Strata Construction – Devils Lake<br>2224 Hwy 19 West,<br>Devils Lake, North Dakota 58301 | Mail Report to:<br><br>Joshua Costello<br><a href="mailto:joshua.costello@stratacorporation.com">joshua.costello@stratacorporation.com</a> |

## Attachment 1 – Site Map

## Attachment 2 – Photograph Log

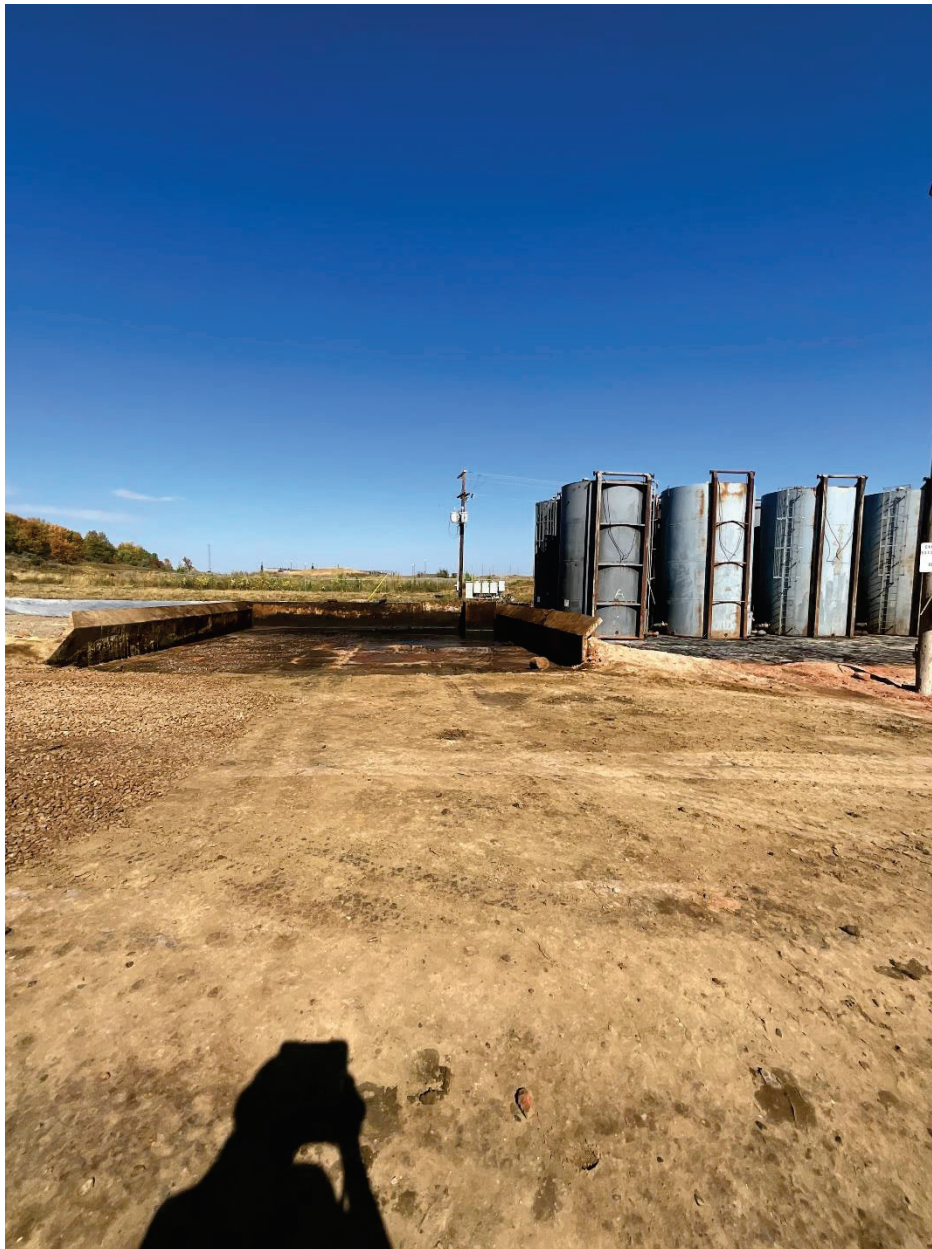
Photo 1: IMG\_0247.jpg, 9/17/2024, 1:26 p.m. – photo of an offload bay near the north side of the facility, taken facing north.

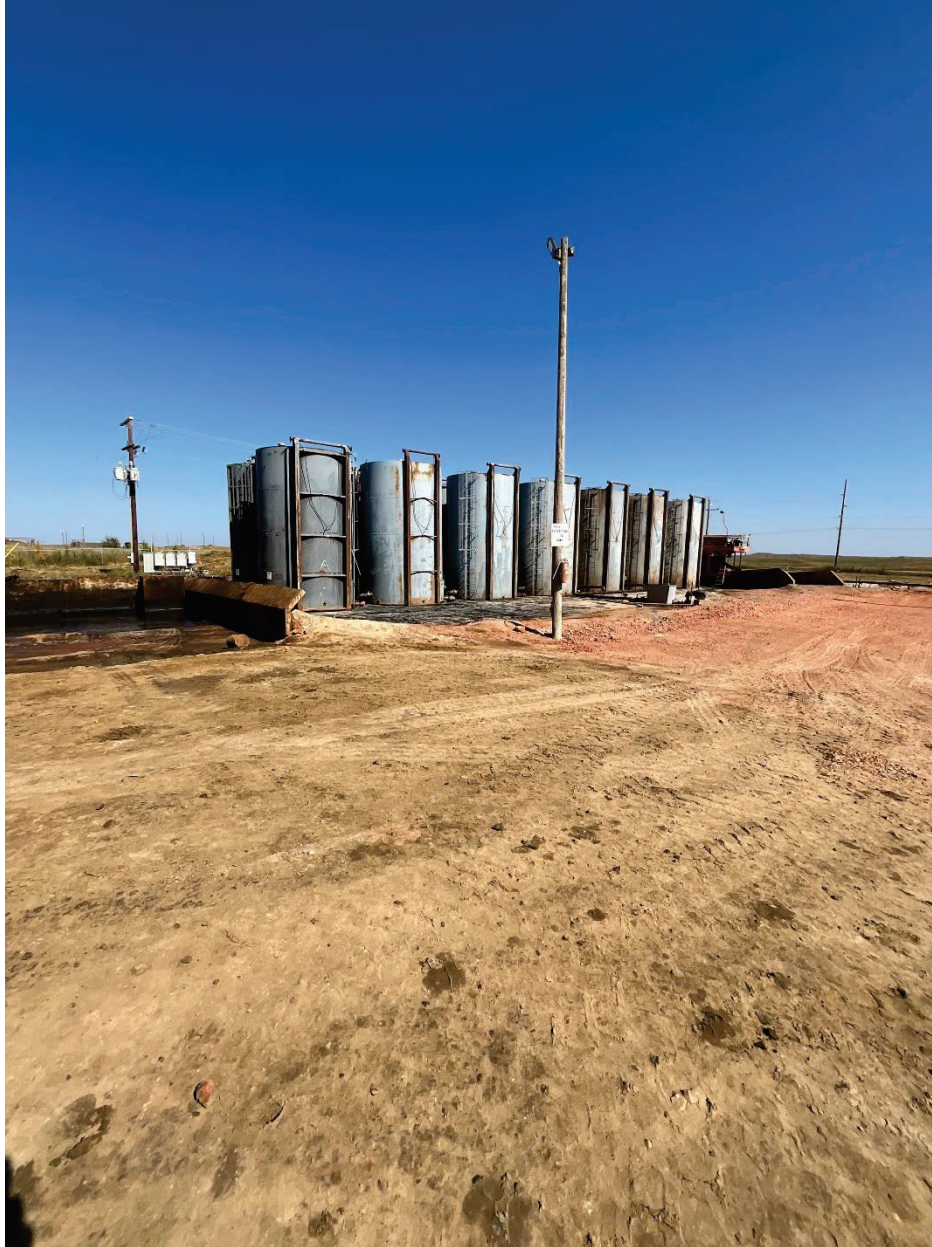
Photo 2: IMG\_0248.jpg, 9/17/2024, 1:26 p.m. – photo of tanks located near the northeast corner of the facility, panned right from photo 1.

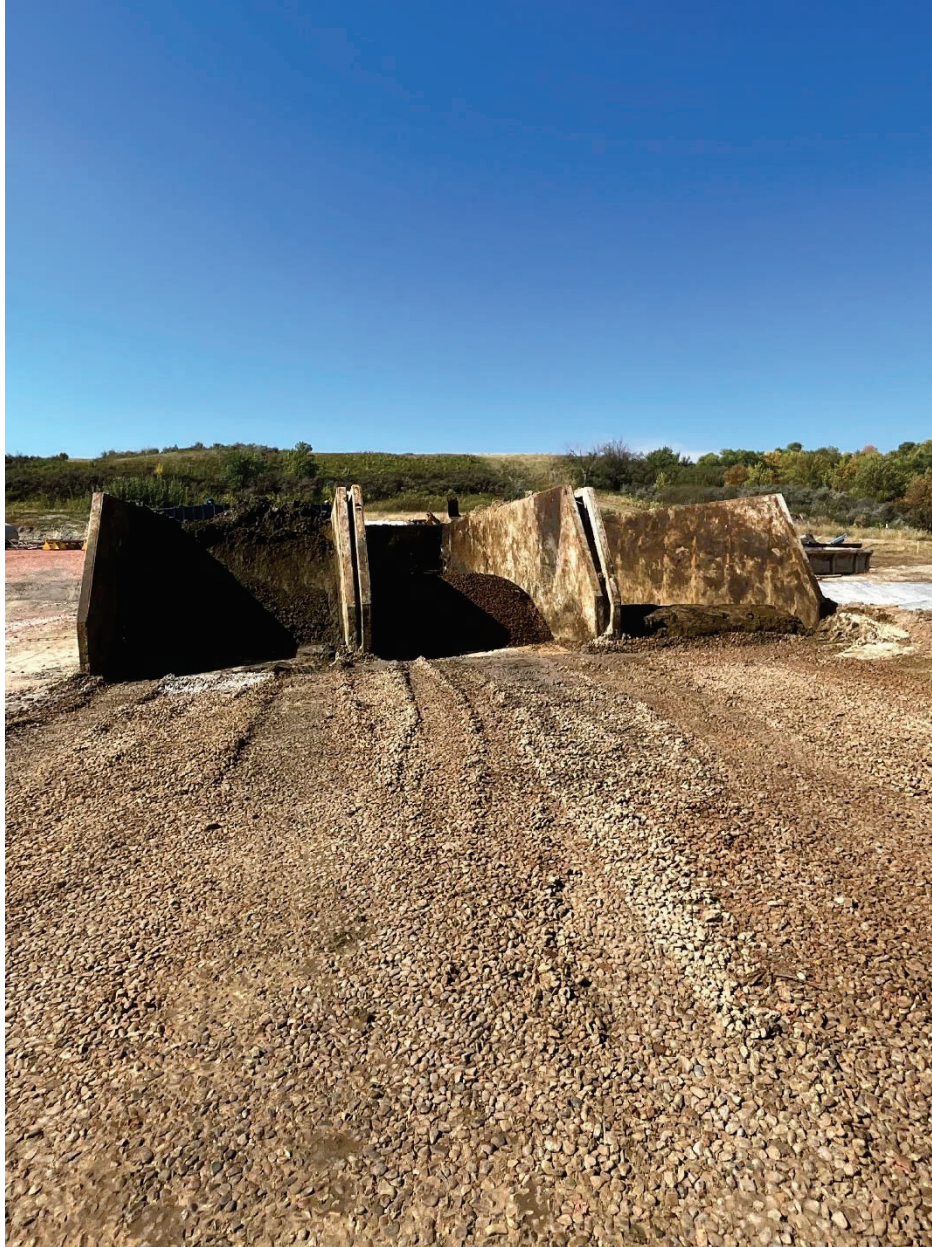
Photo 6: IMG\_0252.jpg, 9/17/2024, 1:30 p.m. – photo of bays storing solids located southwest of the bay shown in photo 1.

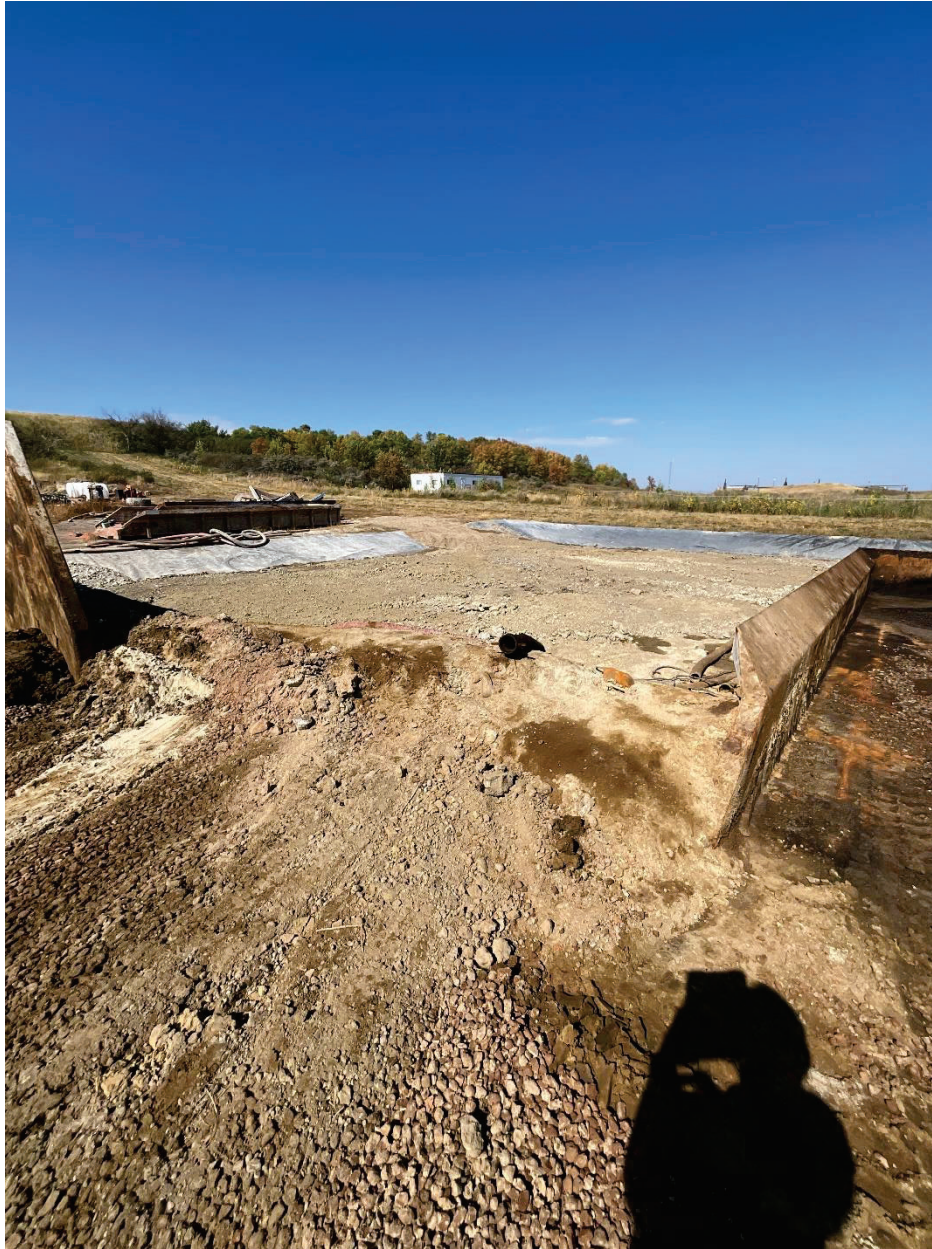
Photo 7: IMG\_0253.jpg, 9/17/2024, 1:30 p.m. – photo of a containment area located on the north side of the facility, west of the offload bay shown in photo 1 and north of the solids bays shown in photo 6.

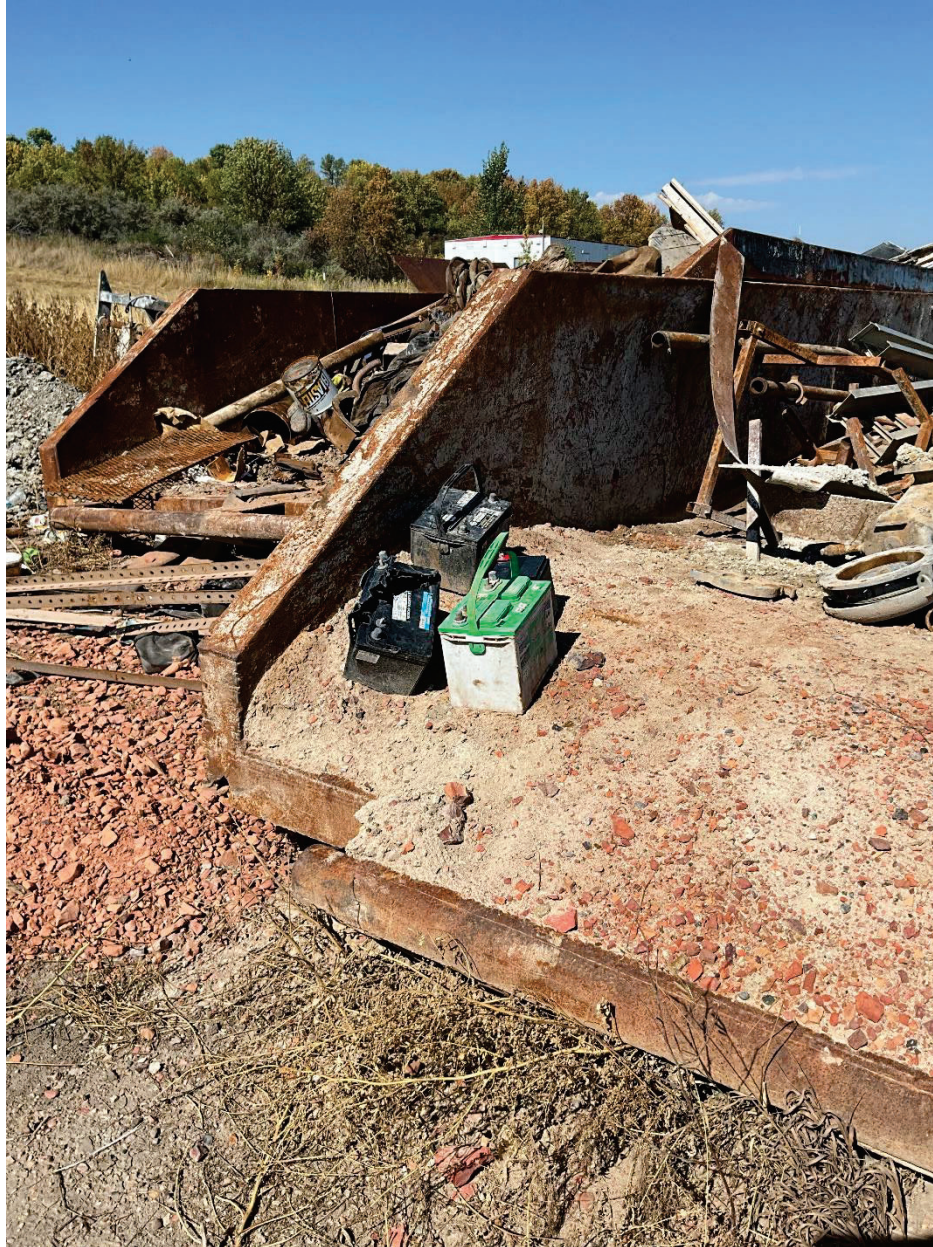
Near the solids bays, I observed three spent lead acid batteries (Attachment 2, photo 8) and supersacks of flyash (Attachment 2, photo 10).

Photo 8: IMG\_0254.jpg, 9/17/2024, 1:43 p.m. – photo of lead acid batteries stored on the north side of the facility in the western half of the site near the solids bays shown in photo 6.

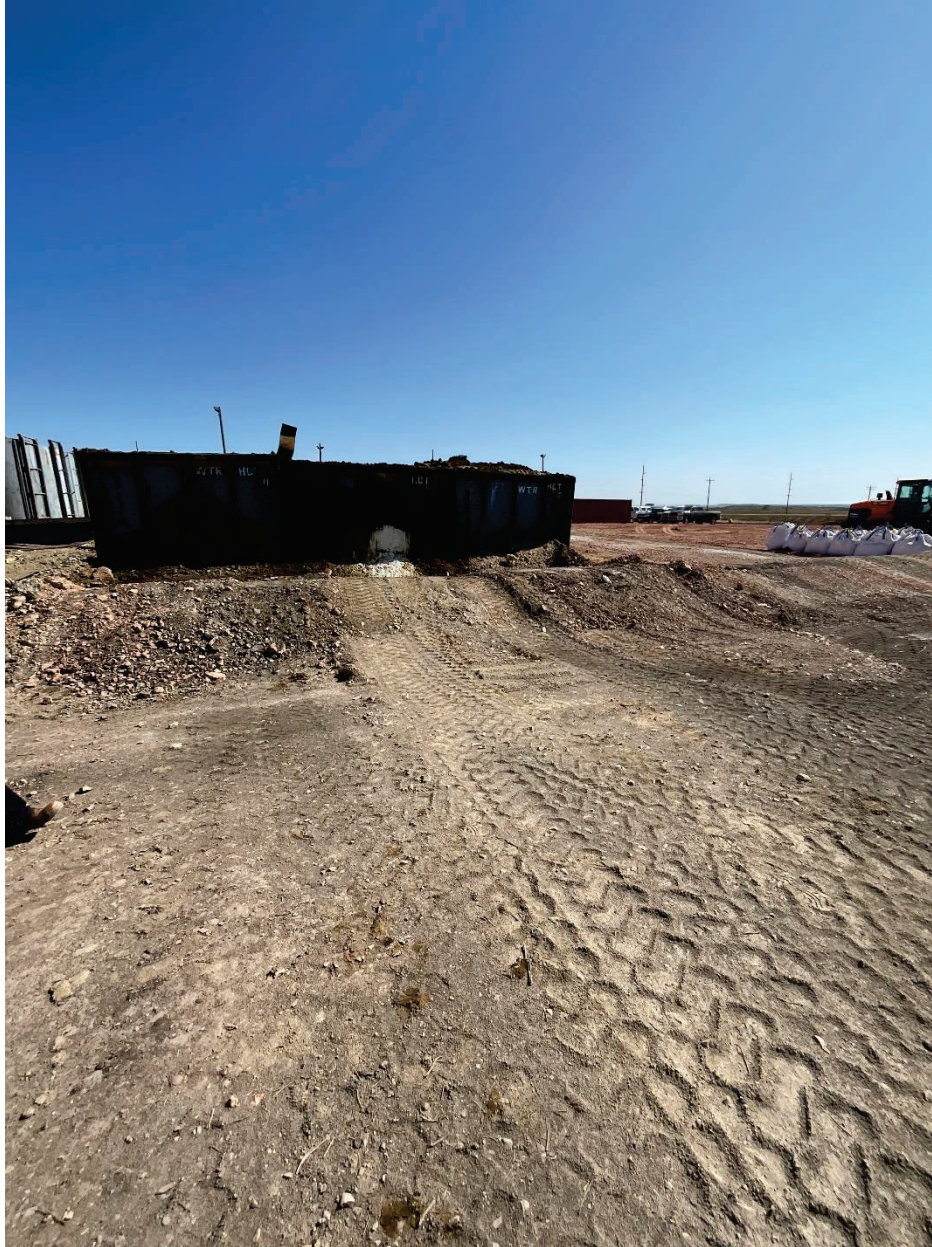
Photo 9: IMG\_0255.jpg, 9/17/2024, 1:45 p.m. – photo of the western side of the solids bays shown in photo 6, photo taken facing east.

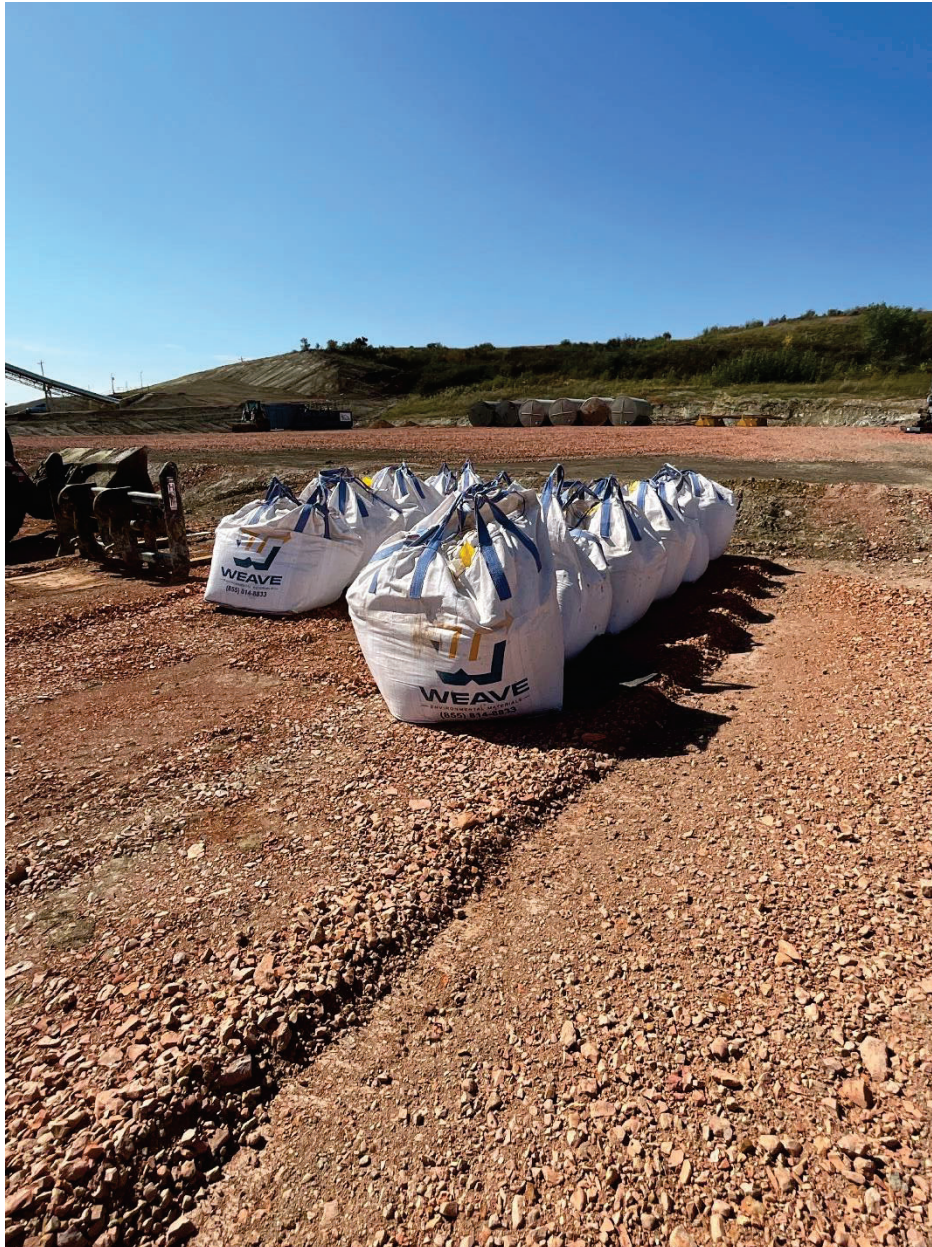
Photo 10: IMG\_0256.jpg, 9/17/2024, 1:46 p.m. – photo of bags of flyash.

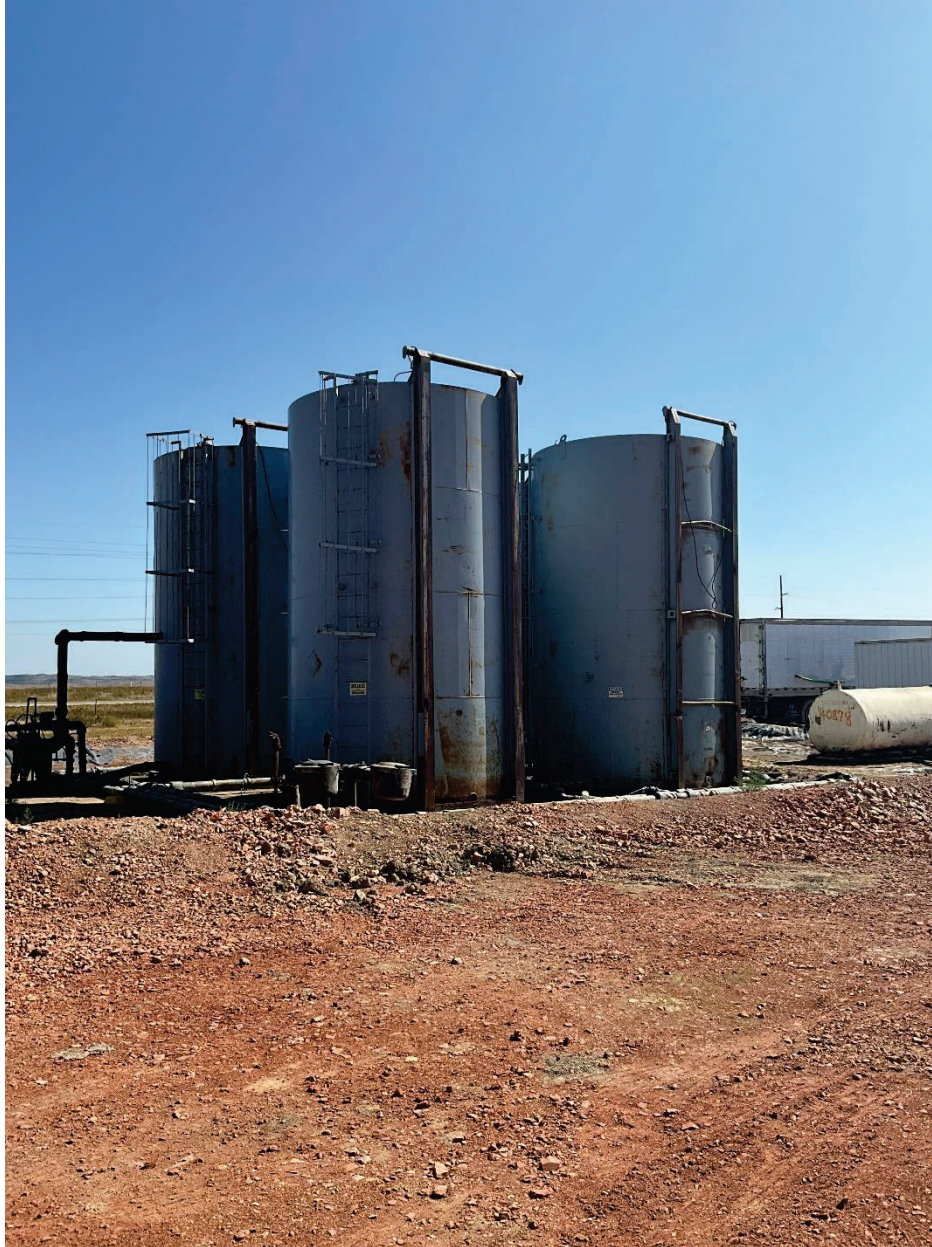
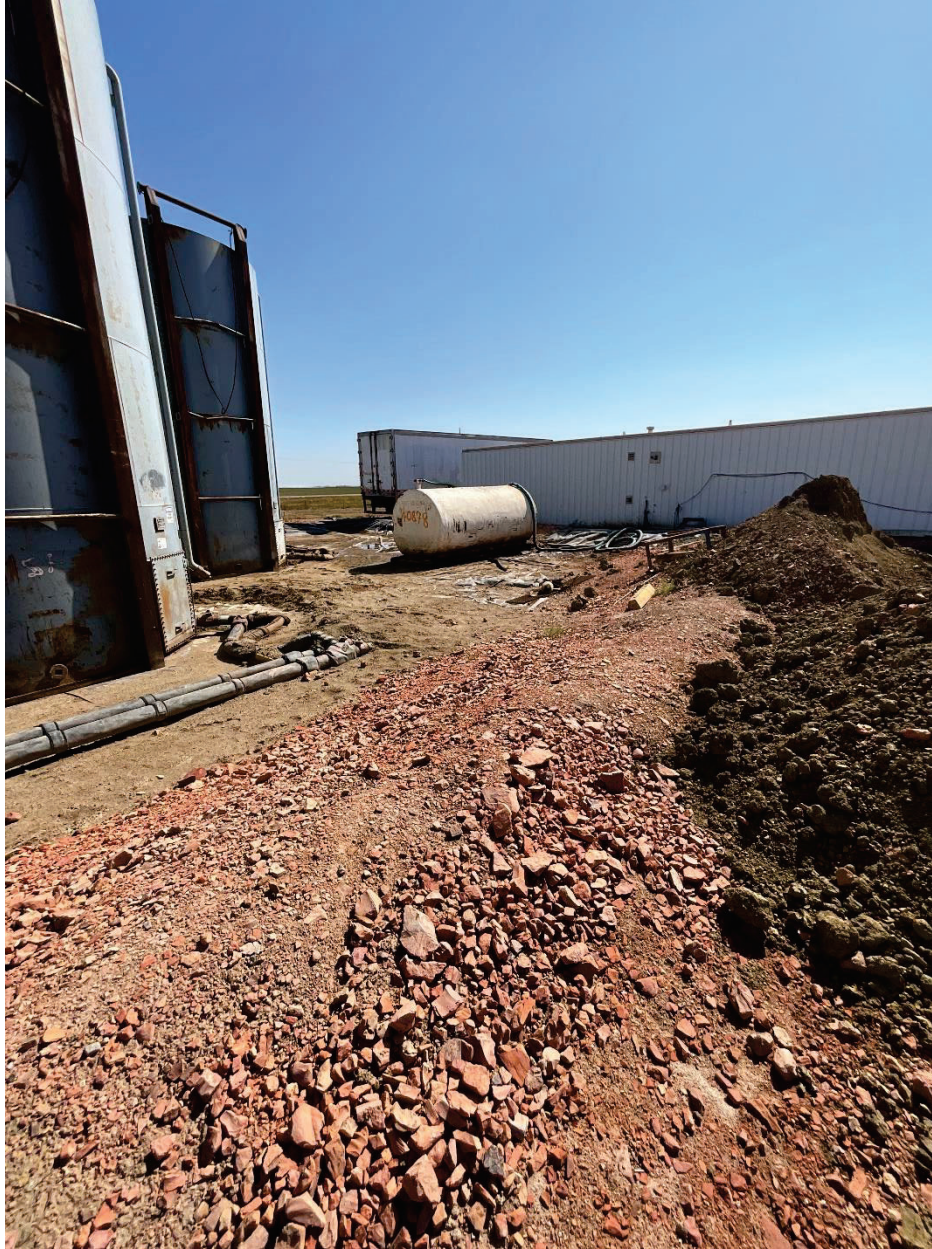
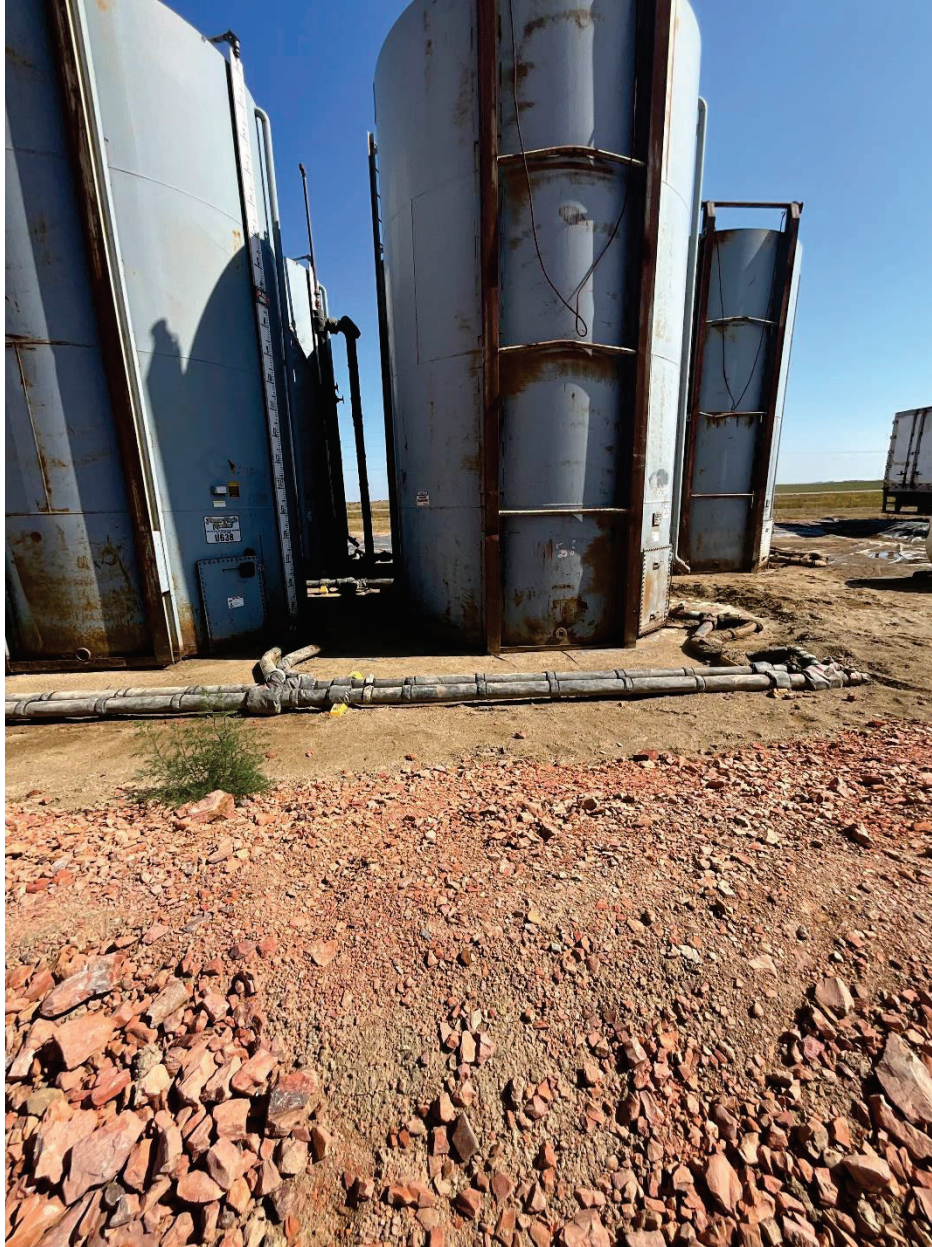
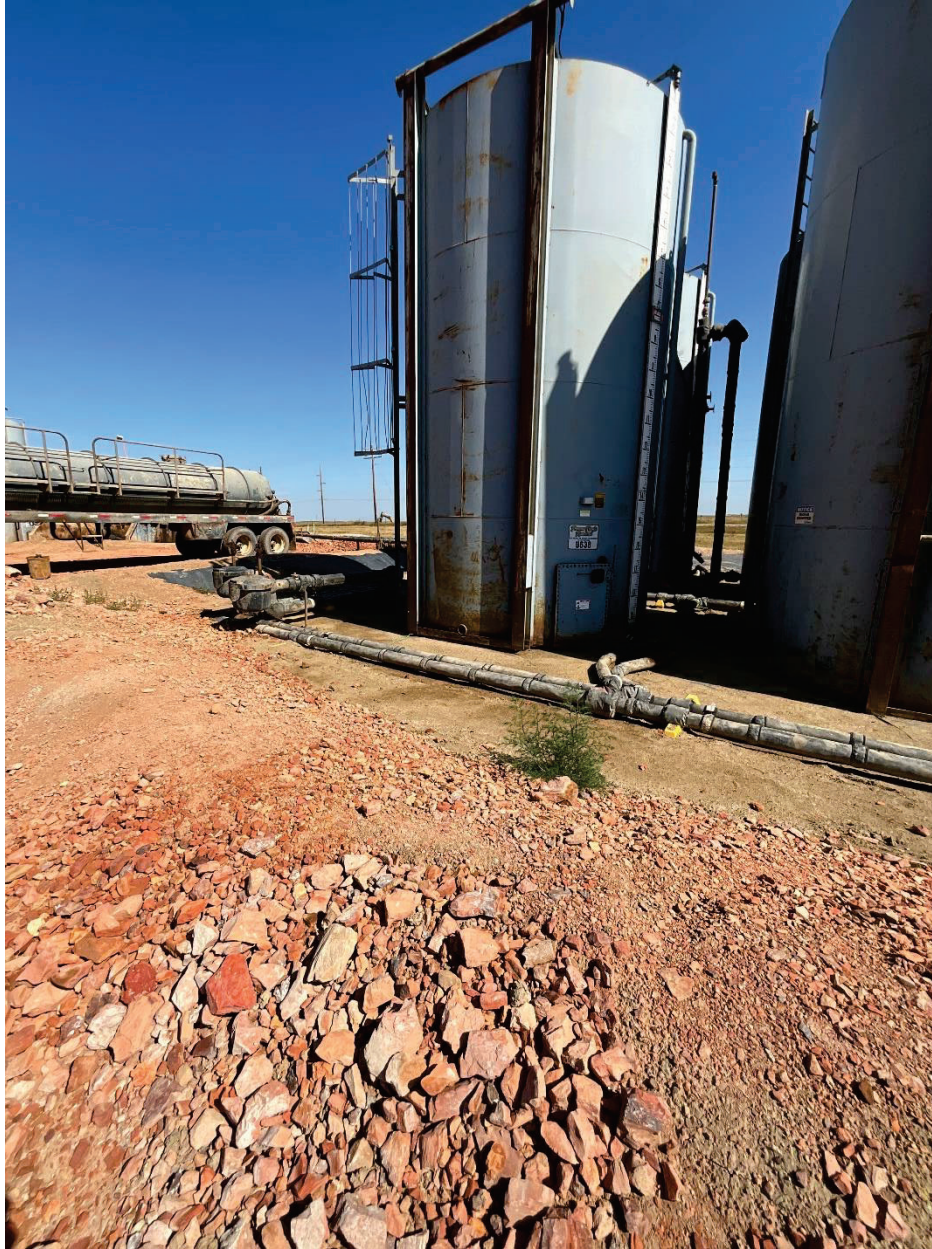
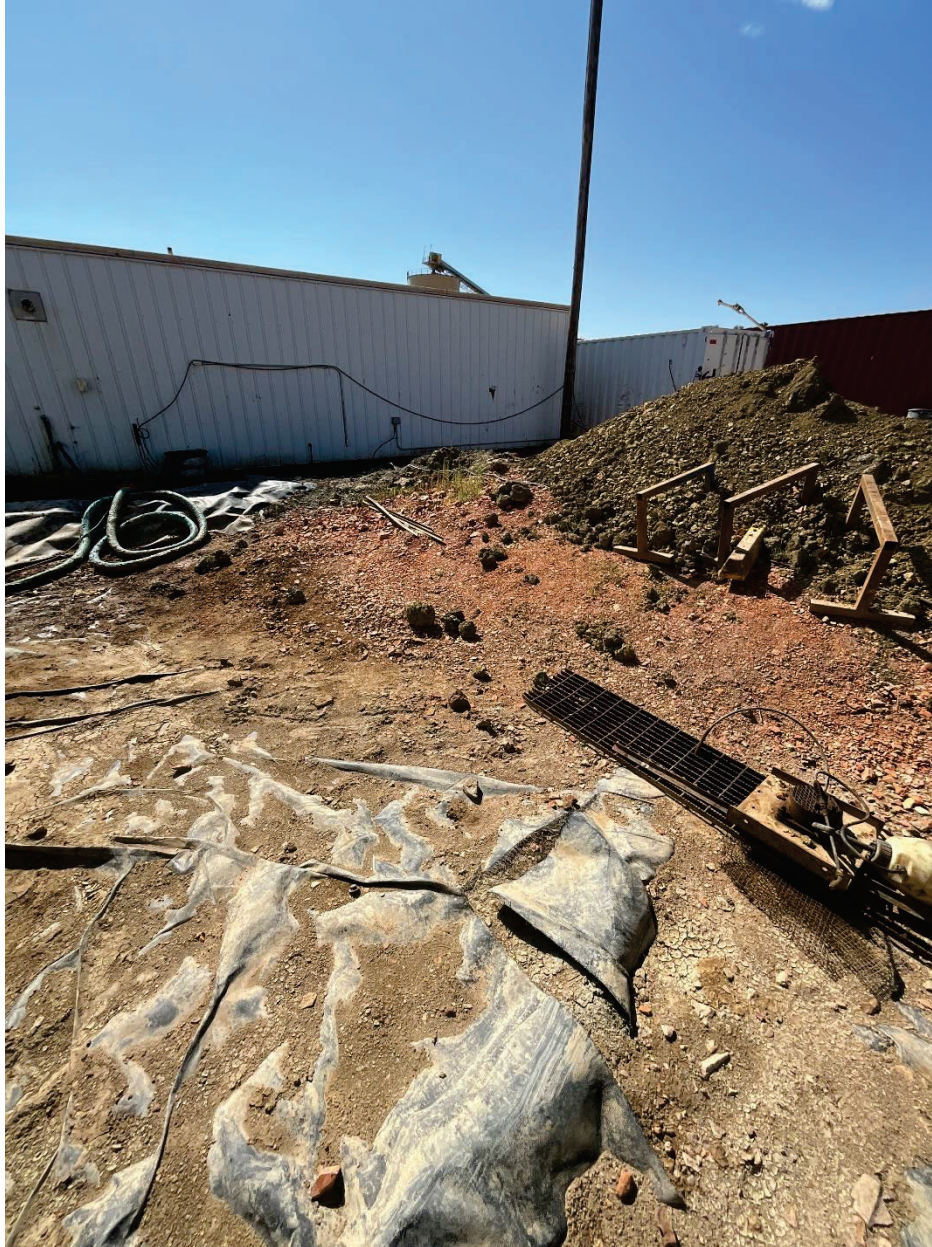
In both the north and south tank areas, I observed that liner materials were ripped and degraded. See Attachment 2, photos 11-19 and 26-28. Compliance with Spill Prevention, Control, and Countermeasure (SPCC) and other Oil Pollution Act requirements was beyond the scope of this inspection and was not evaluated.

Photo 11: IMG\_0257.jpg, 9/17/2024, 1:53 p.m. – photo of the south tank area, located on the east side of the facility approximately 120 feet south of the northwest corner.

Photo 12: IMG\_0258.jpg, 9/17/2024, 1:53 p.m. – photo of the same tank secondary containment shown in photo 11.

Photo 13: IMG\_0259.jpg, 9/17/2024, 1:53 p.m. – photo of the same secondary containment shown in photos 11 and 12.

Photo 14: IMG\_0260.jpg, 9/17/2024, 1:53 p.m. – photo of the same secondary containment shown in photos 11-13.

Photo 16: IMG\_0262.jpg, 9/17/2024, 1:54 p.m. – photo of the same secondary containment shown in photos 11-15.

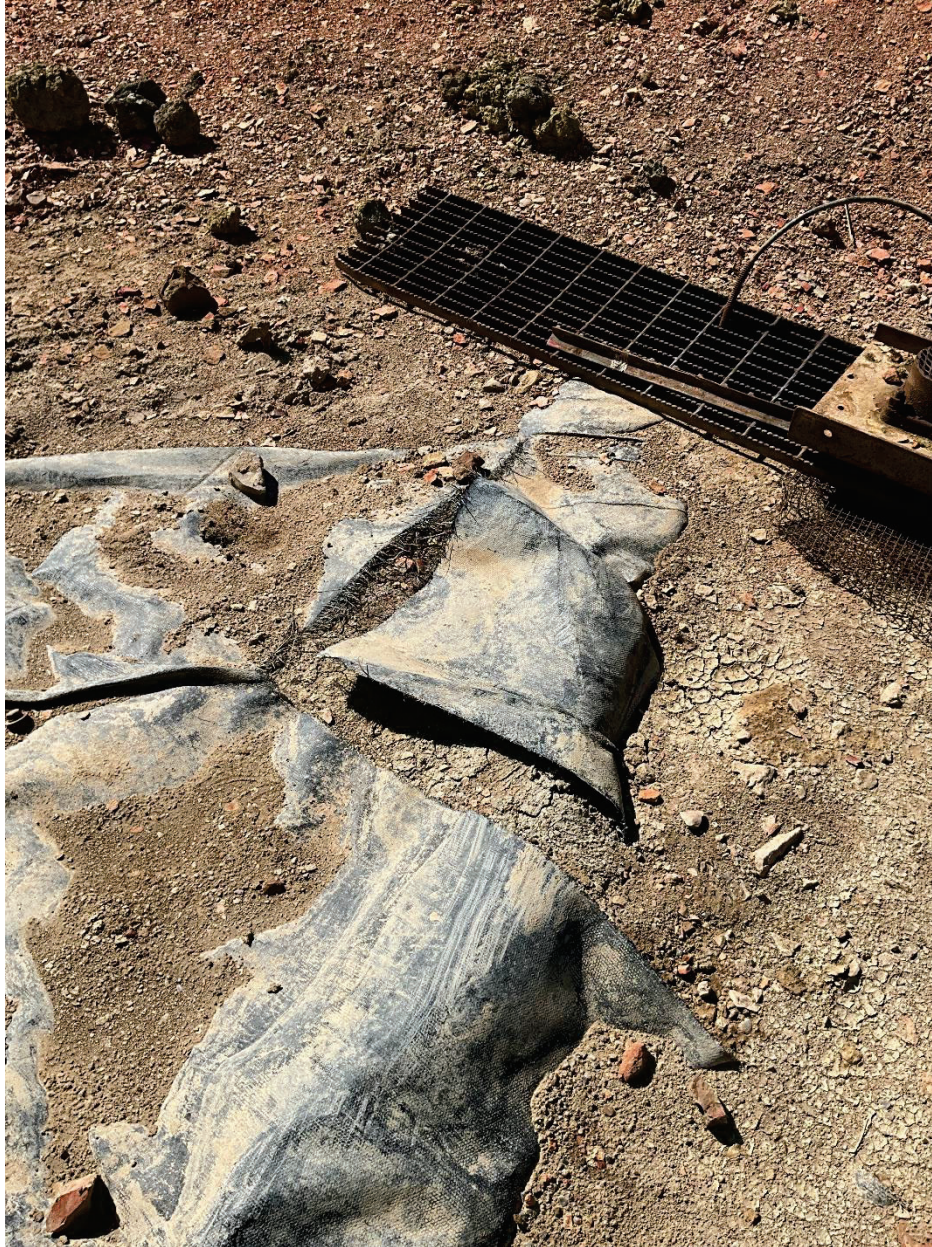
Photo 15: IMG\_0261.jpg, 9/17/2024, 1:54 p.m. – close-up of the secondary containment shown in photos 11-14, showing a rip in the liner material.

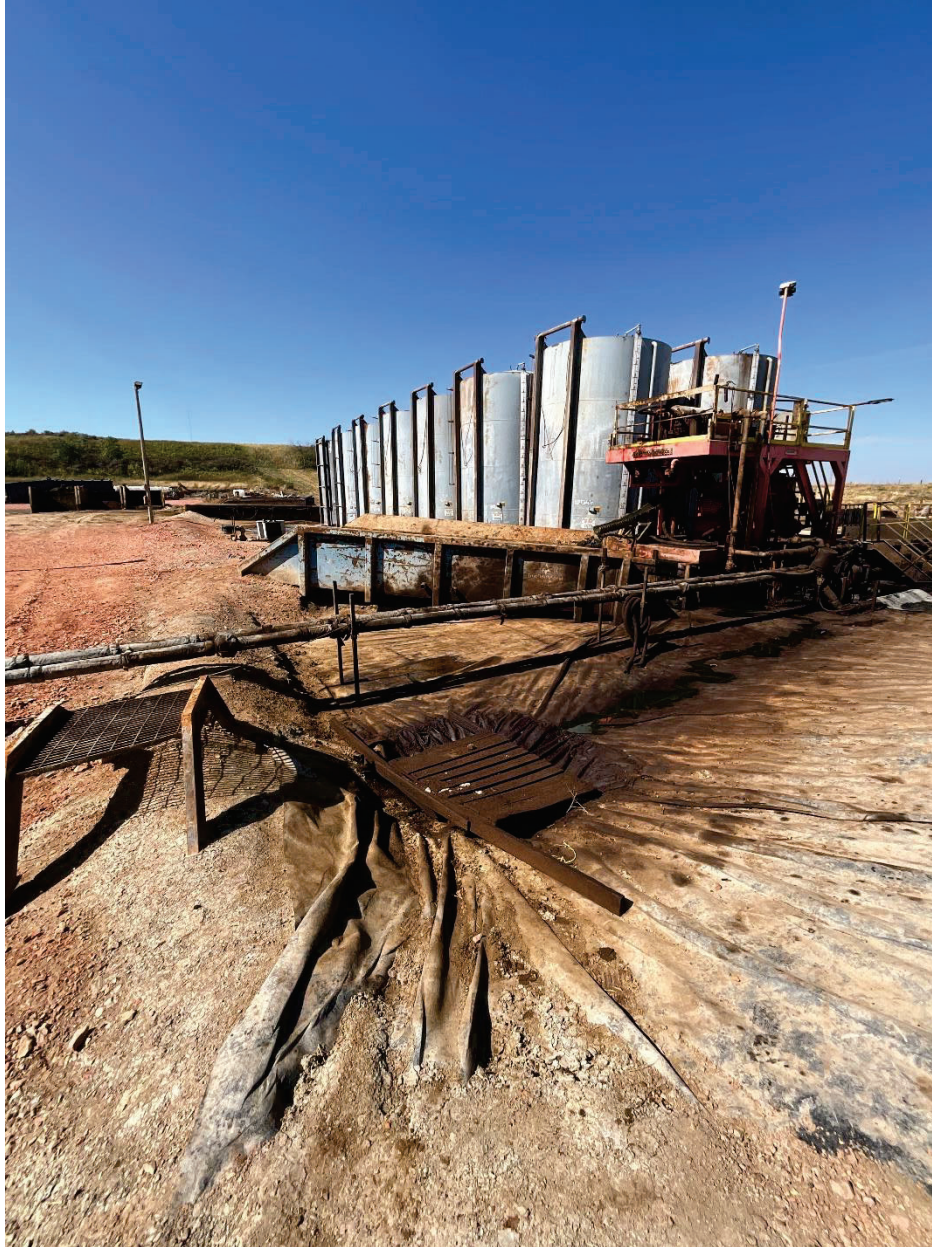
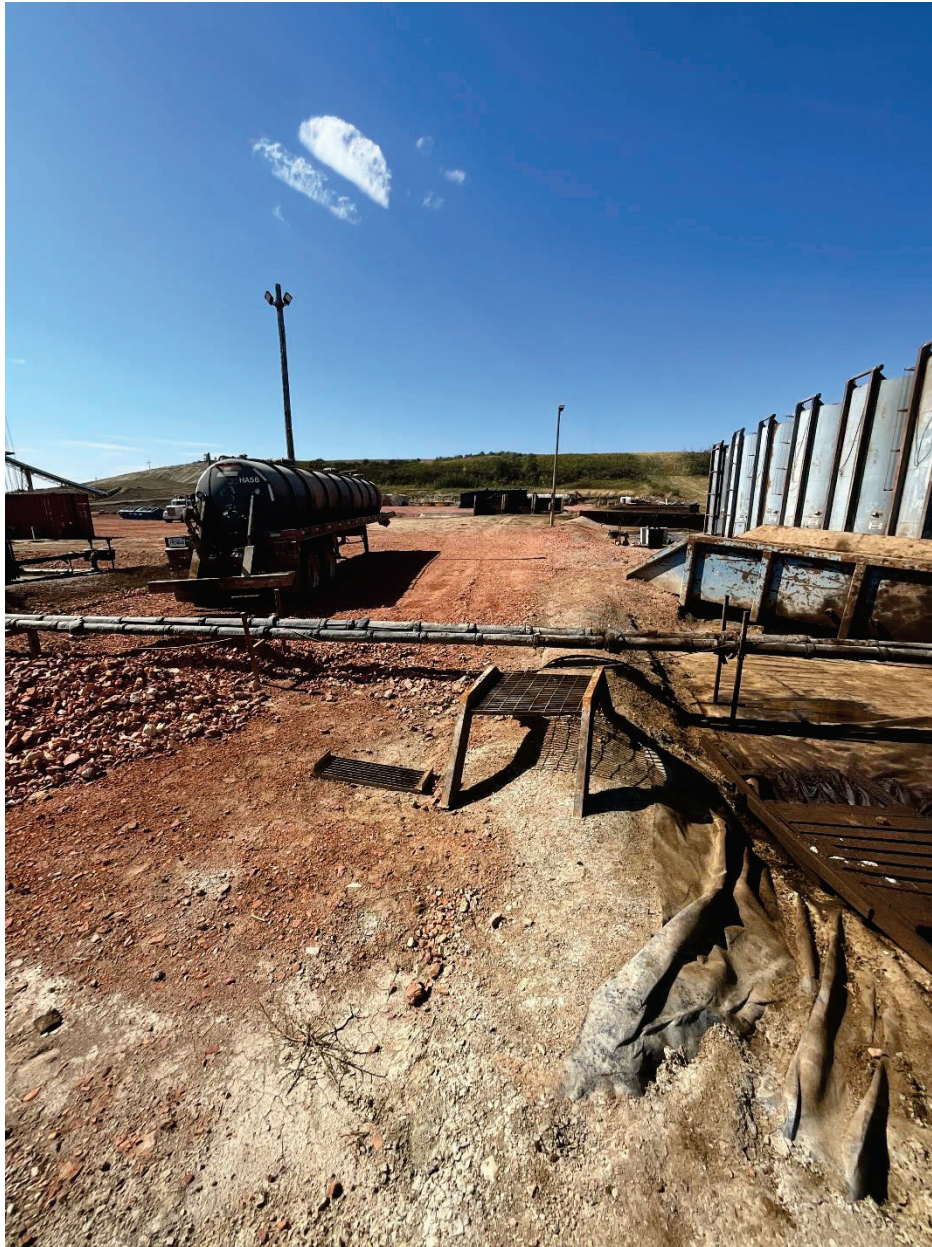
Photo 17: IMG\_0263.jpg, 9/17/2024, 1:58 p.m. – photo of a low point in the north tank area secondary containment that was covered by a grate.

Photo 18: IMG\_0264.jpg, 9/17/2024, 1:58 p.m. – photo panned left from photo 17.

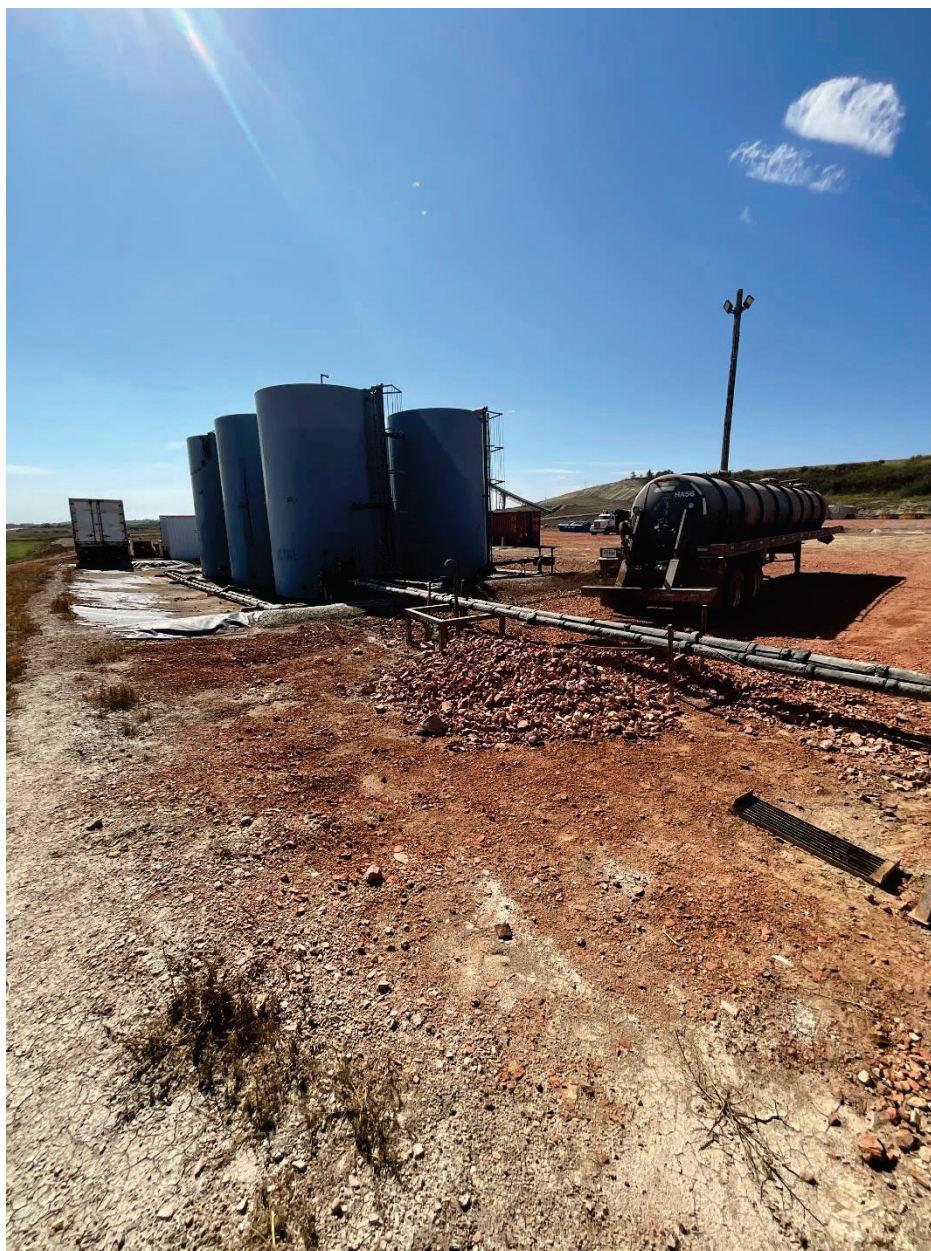
Photo 19: IMG\_0265.jpg, 9/17/2024, 1:58 p.m. – photo of the south tank area.

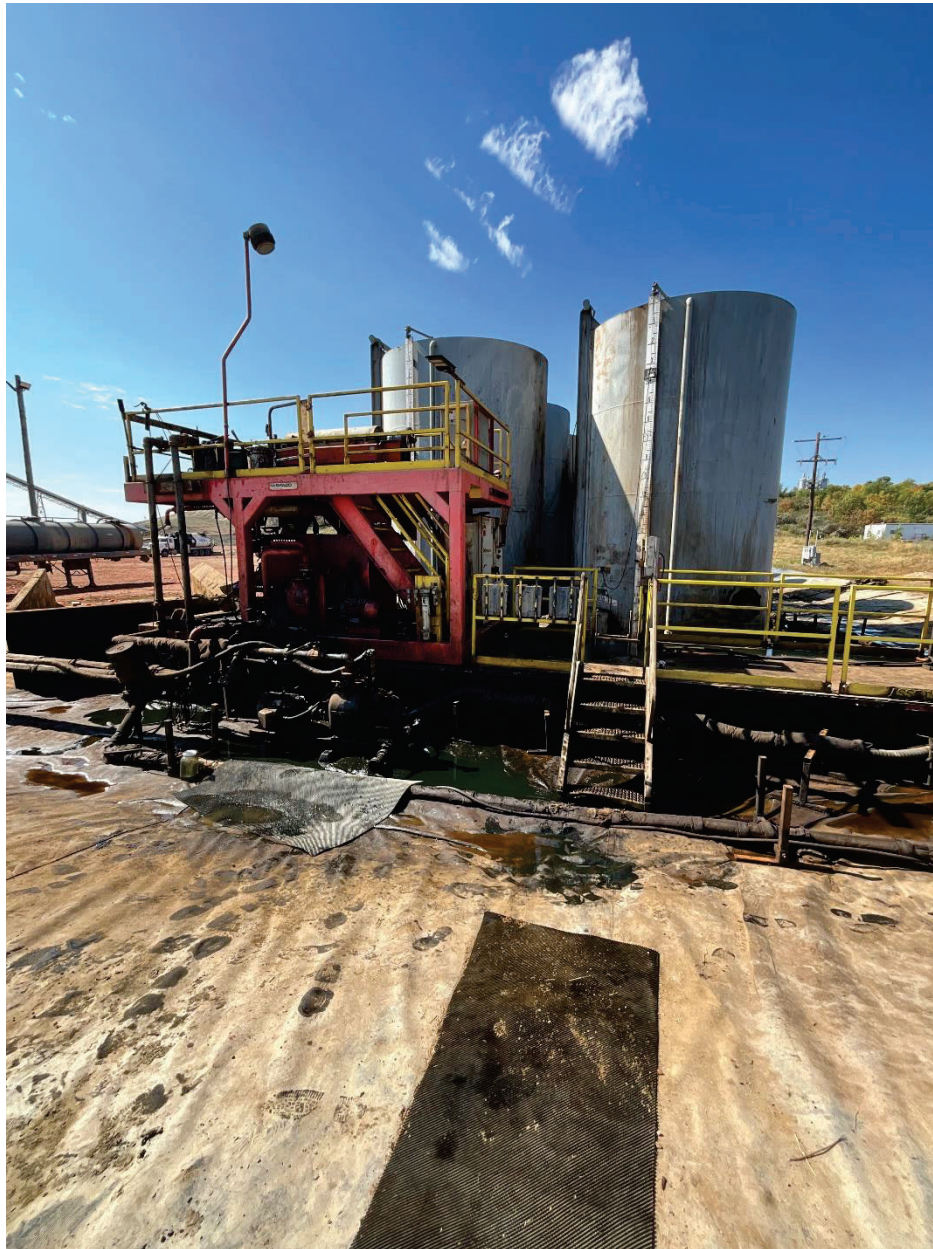
At the centrifuge area, I observed that oil was spilled on the ground, see Attachment 2, photo 20. Mr. Henry stated the oil was spilled earlier in the morning due to an issue with bearings, and that it would be cleaned up within about an hour. In regard to the centrifuge and other processes, he said that liquids are settled in tanks prior to running through the centrifuge, and that flyash is applied to solids before they are sent to a Republic landfill for disposal.

Photo 20: IMG\_0266.jpg, 9/17/2024, 2:03 p.m. – photo of the centrifuge located on the eastern edge of the north tank area and oil spilled onto the ground, located north of the grate shown in photo 17.

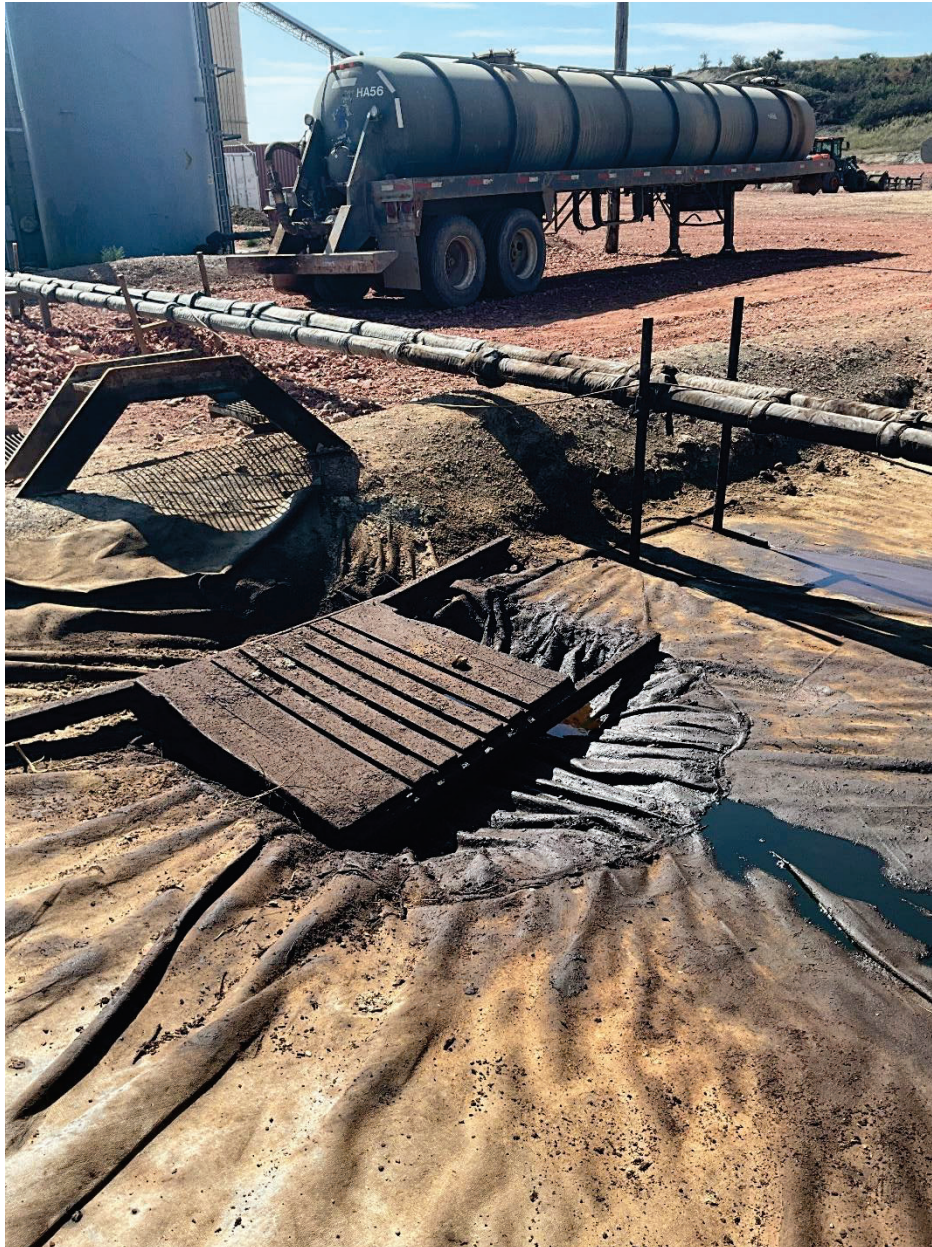
Photo 21: IMG\_0267.jpg, 9/17/2024, 2:07 p.m. – close-up of the grate shown in photo 17.
