## NPDES Inspection Report - Stormwater Industrial

| Facility Location Information | |
|---|---|
| Site/Facility Name and Location:<br><br>Strata Construction – Devils Lake<br>2224 Hwy 19 West,<br>Devils Lake, North Dakota 58301 | Mail Report to:<br><br>Joshua Costello<br><a href="mailto:joshua.costello@stratacorporation.com">joshua.costello@stratacorporation.com</a> |

## Attachment 1 – Site Map

## Attachment 2 – Photograph Log

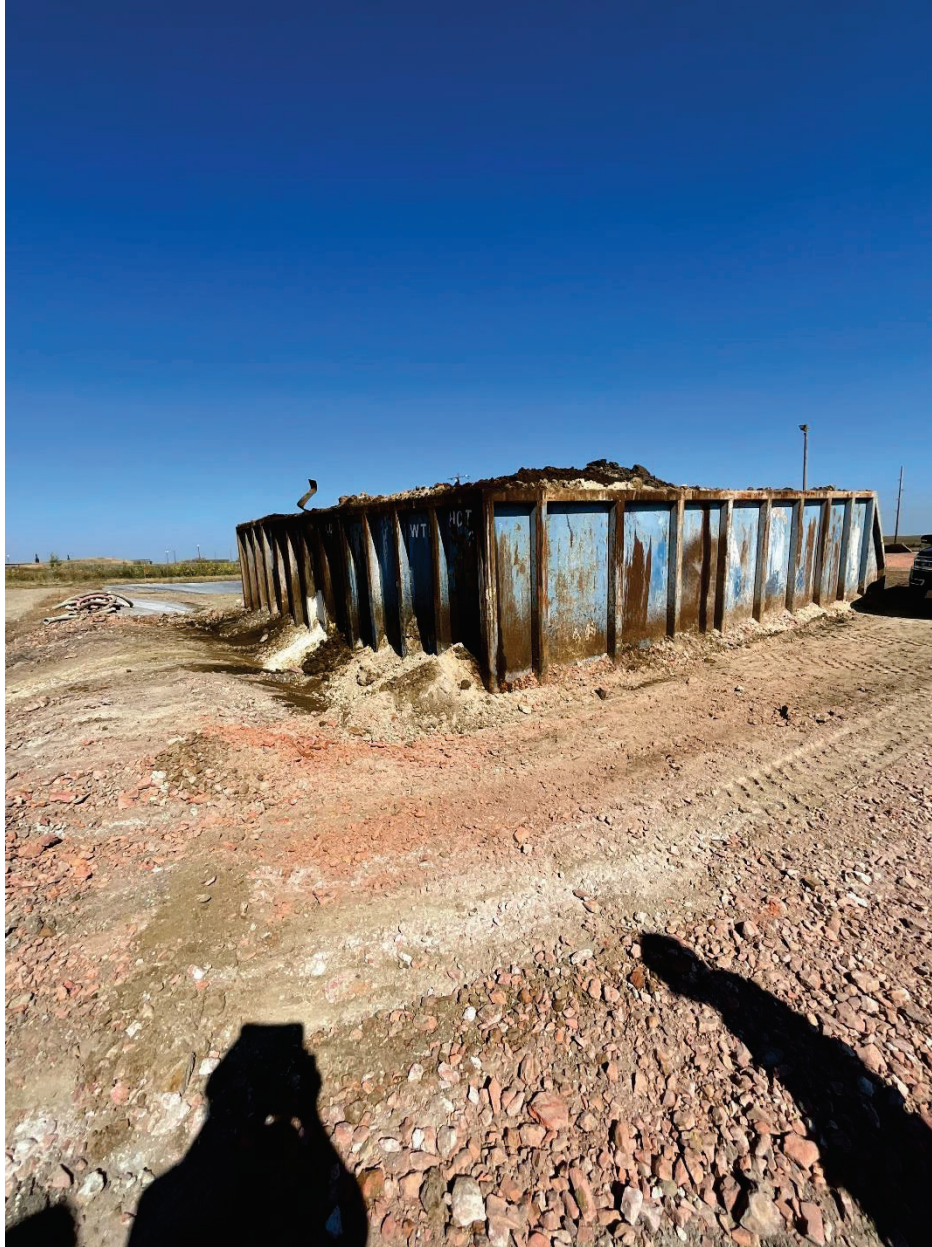
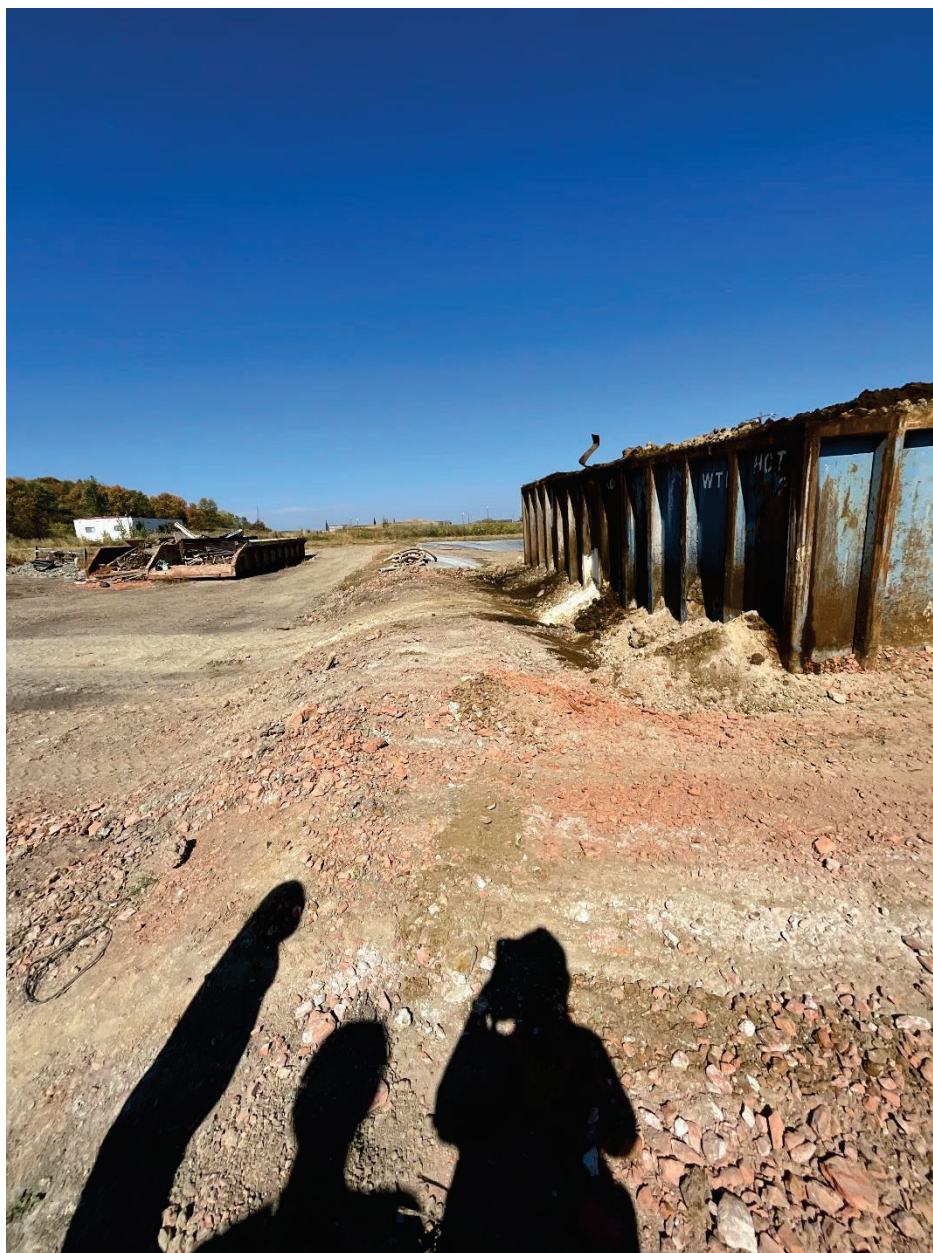
At the solids bay area, I observed that some oily solids had spilled out of the back to the west side. See Attachment 2, photo 22 and 23. Mr. Henry said the entire site was lined to contain spills.

Photo 22: IMG\_0268.jpg, 9/17/2024, 2:25 p.m. – photo of the back side of the solids bays shown in photo 6.

Photo 23: IMG\_0269.jpg, 9/17/2024, 2:25 p.m. – photo panned left from photo 22.

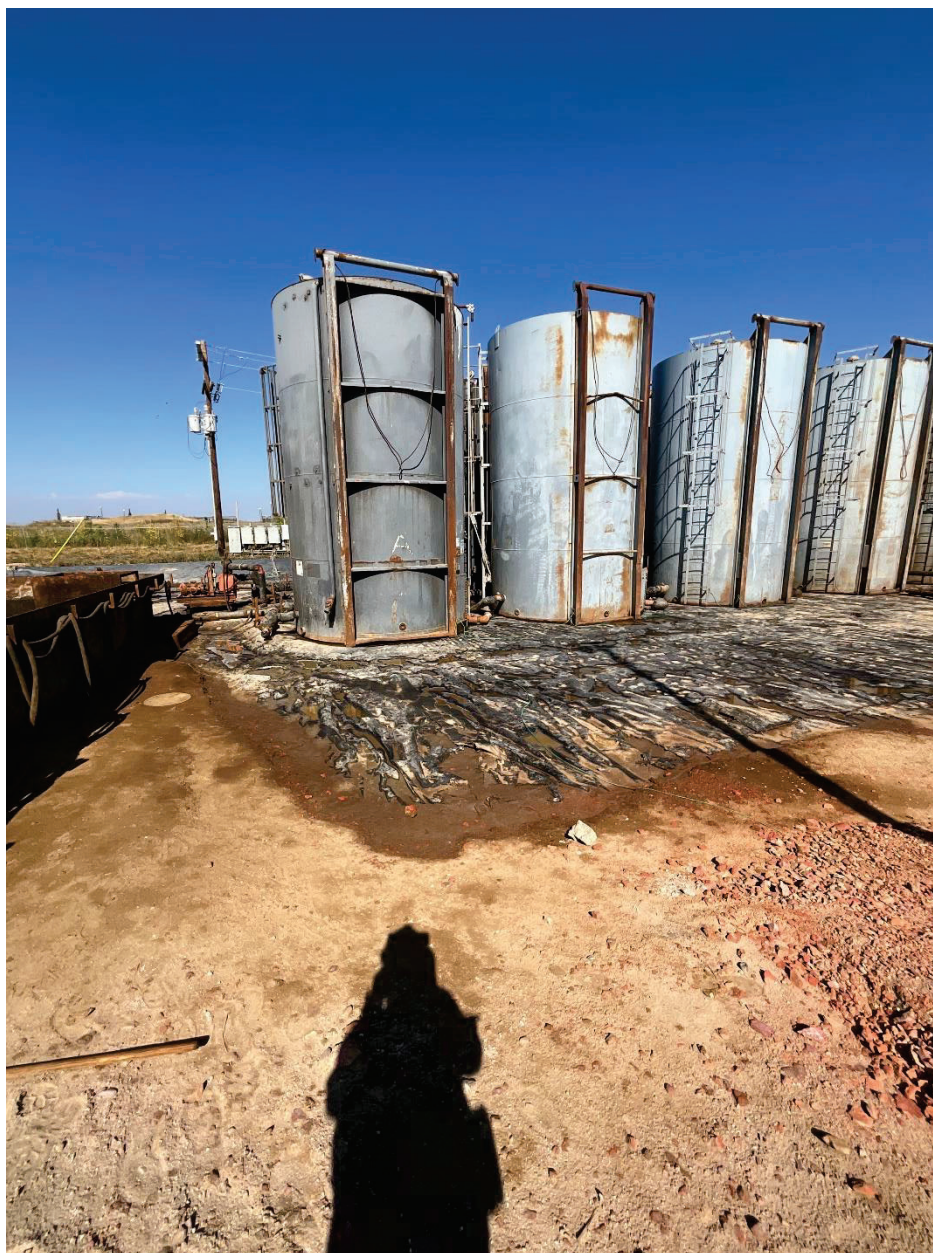
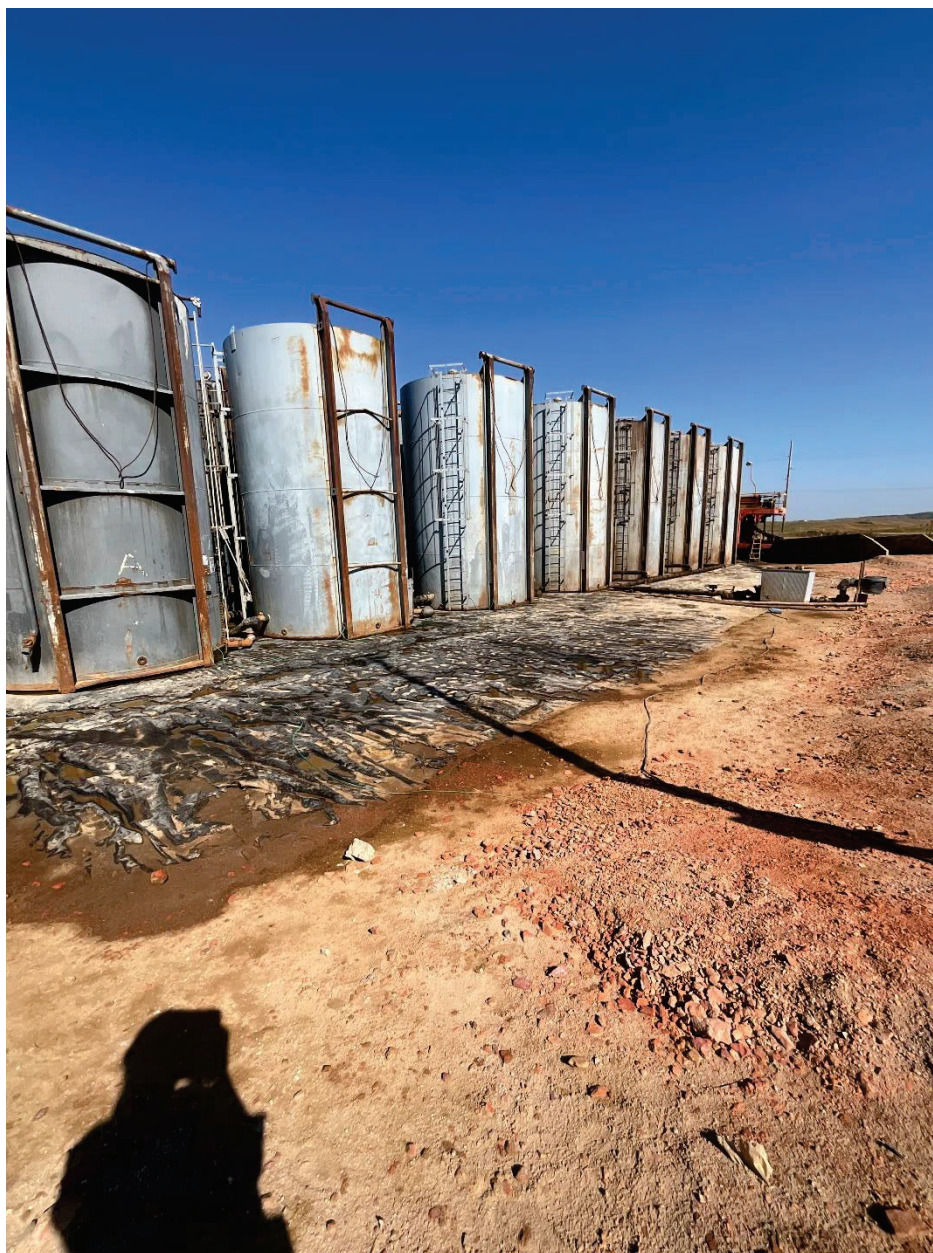
In both the north and south tank areas, I observed that liner materials were ripped and degraded. See Attachment 2, photos 11-19 and 26-28. Compliance with Spill Prevention, Control, and Countermeasure (SPCC) and other Oil Pollution Act requirements was beyond the scope of this inspection and was not evaluated.

Photo 26: IMG\_0272.jpg, 9/17/2024, 2:32 p.m. – photo of the north tank area, western end.

Photo 27: IMG\_0273.jpg, 9/17/2024, 2:33 p.m. – photo panned right from photo 26.

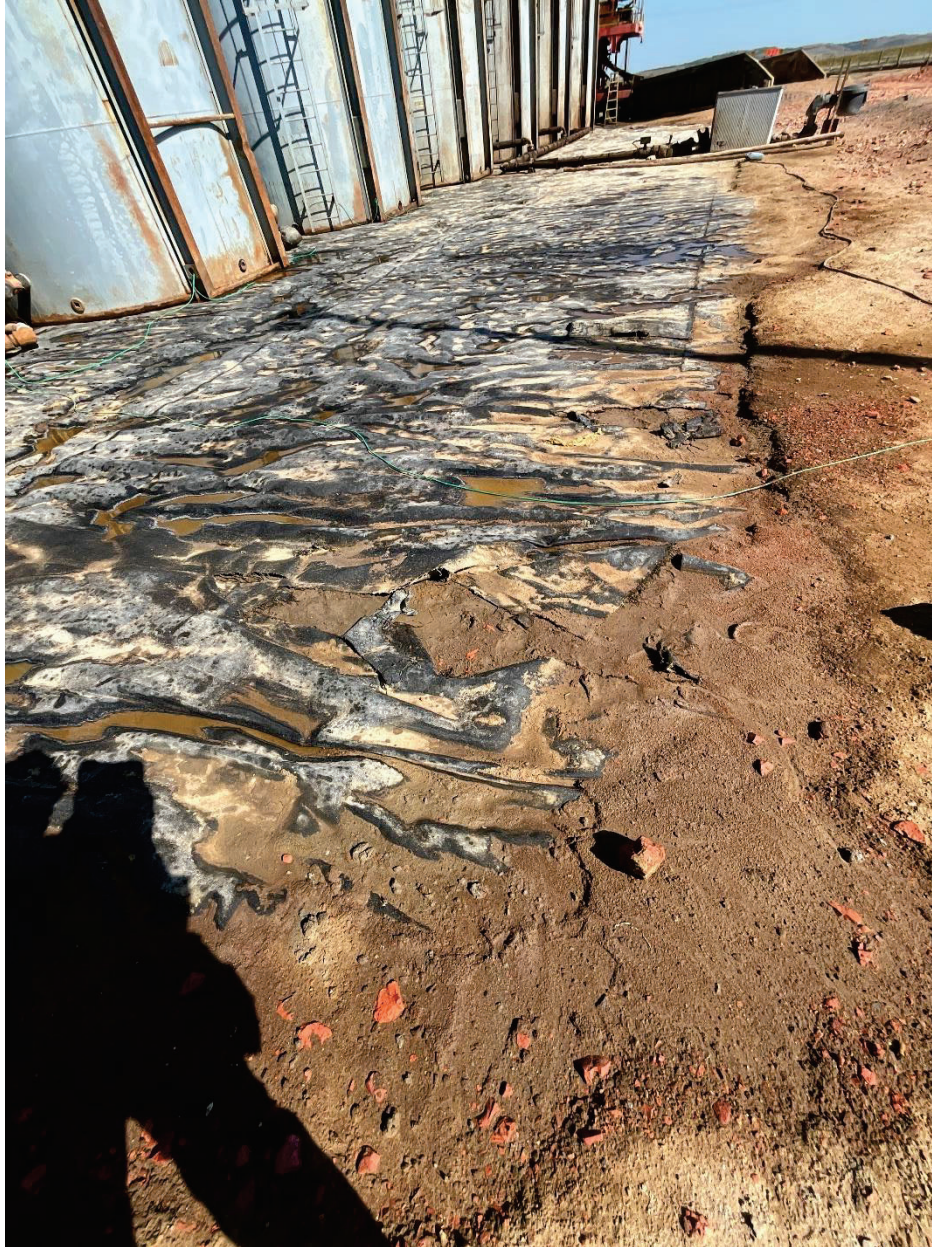
Photo 28: IMG\_0274.jpg, 9/17/2024, 2:33 p.m. – close-up of the liner shown in photos 26 and 27, with rips in the liner visible.
