INSPECTION REPORT

| <b>Type of Inspection</b> | Focused Compliance Inspection (FCI) | | | |
| <b>Facility or Site Name</b> | Clean Tank, LLC and Frac Tank, LLC (tenants of In Hot Water, LLC) | | | |

**SECTION II – OBSERVATIONS****Tenant:** Clean Tank, LLC**Section:** 2.1**Date:** 4/17/2024, 9:00 A.M.**Contains AOC:** Yes   **Contains CBI:** No**Lead Inspector:** Brook McKeown**Attendees:** Matt Labat (QHSE Manager), Darrell Lafont (Facility Foreman), Brennan Carriere (QHSE Coordinator), Keith Stacum (QHSE Coordinator), Adrian Rios (Manager)

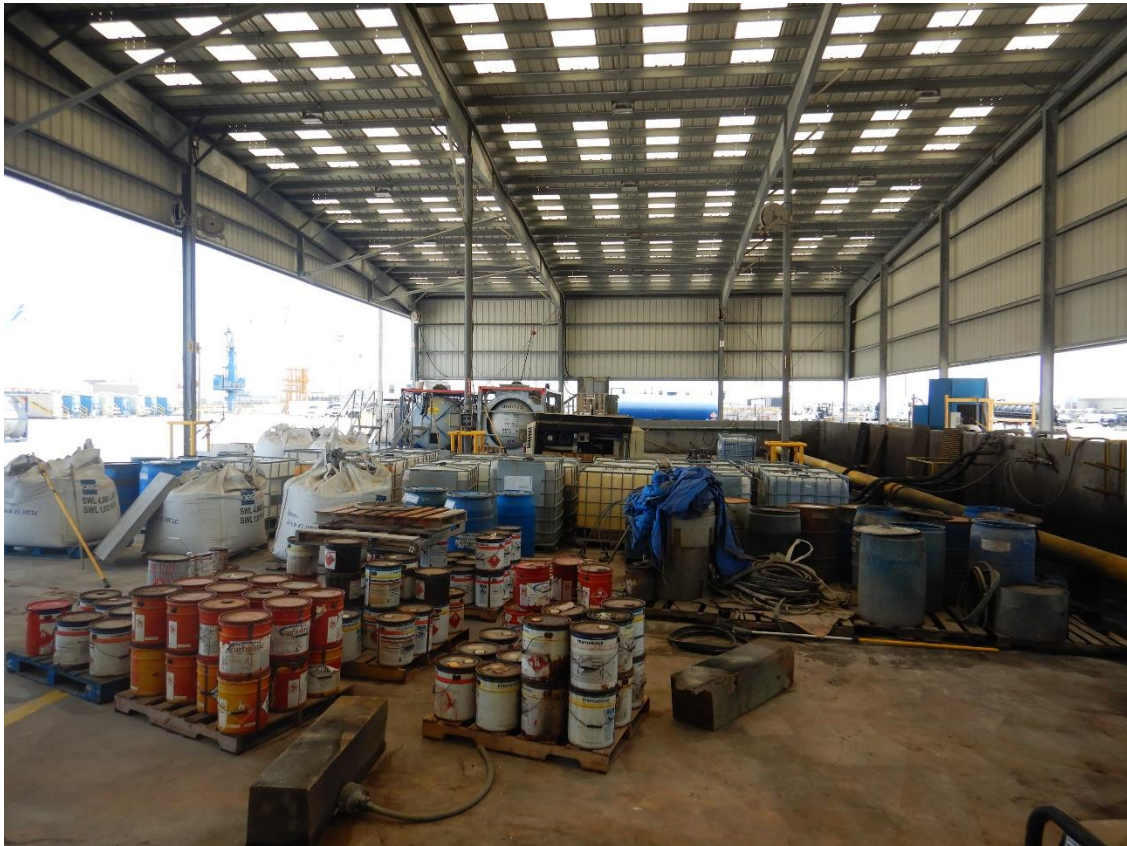
**Photo No. 1**

Description: View of the Slab with containers staged and container cleaning operations at the far end.

After the opening meeting, the inspection team conducted a visual walkthrough of the facility and dock areas starting at approximately 10:50 AM. The inspection team observed a cleaned container area, a scrapyards for out-of-service containers, several shipping crates used for supply storage, and a tightness testing area for frac tanks. The inspection team then observed a sheltered cleaning, staging, and maintenance area referred to as the “Slab” (see Appendix 1 – Photo 1). The inspection team observed the following at the Slab:

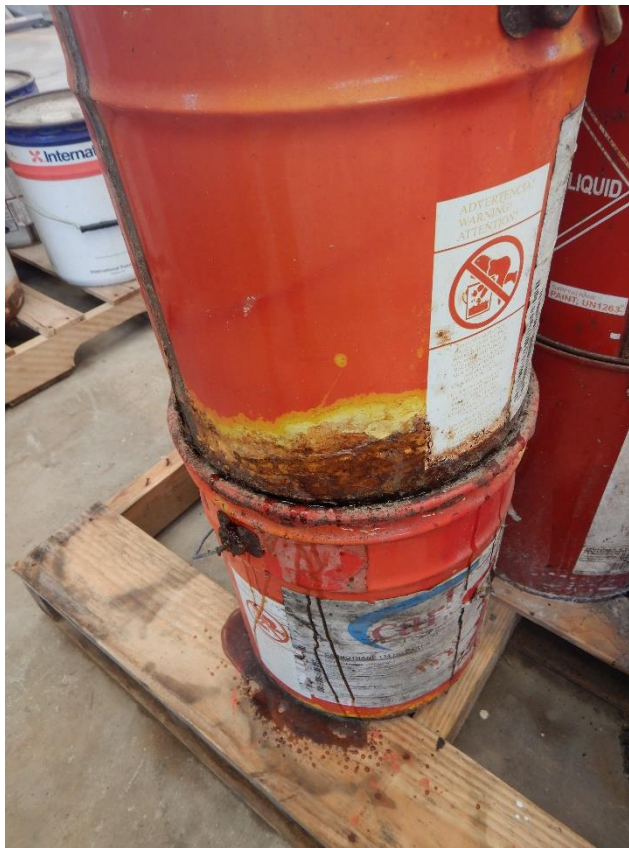
Description: Non-empty paint containers staged in the Slab that were received from a customer and had signs of corrosion and leaking.

- There were seven pallets of unused paint containers that Clean Tank had received from a customer (see Appendix 1 – Photos 4 through 6, and 12 through 14). Mr. Rios determined that most of the containers were only one part of two-part coating systems, and that Clean Tank will either dispose of the unused paint or purchase the other parts in order to use them. Mr. Rios stated that the containers had been on site at Clean Tank for a few weeks. **[AOC #5: Clean Tank may be storing paint cans before or in lieu of being abandoned, and therefore have not made a hazardous waste determination, as required. – 40 CFR 262.11.2(b)(3)].** Several of the containers were observed to be rusted and the contents were leaking.

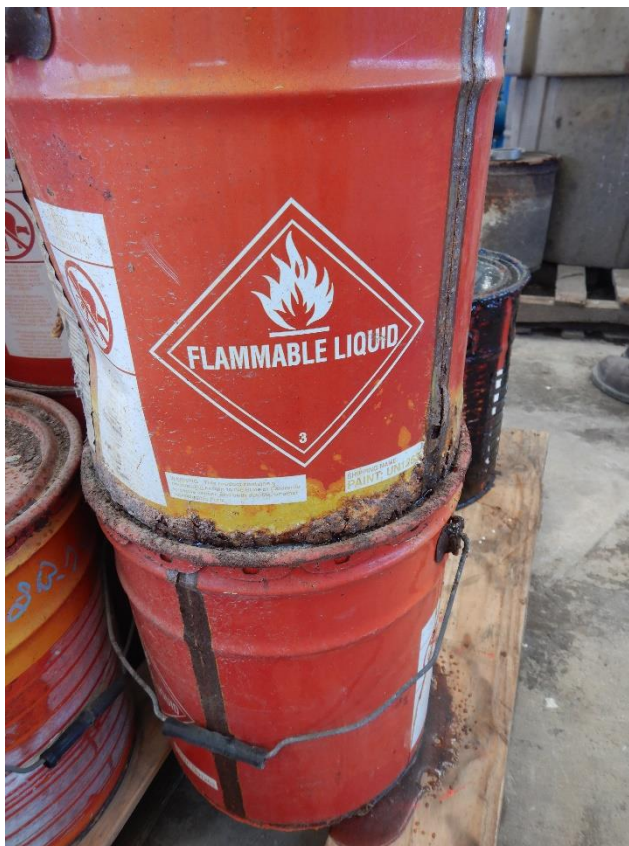
Description: Non-empty paint containers staged in the Slab that were received from a customer and had signs of corrosion and leaking.
