### INSPECTION REPORT

| <b>Statute (s)/Program(s):</b> | Clean Water Act, National Pollutant Discharge Elimination System (NPDES), Industrial | |
| <b>Type of inspection:</b> | Compliance Evaluation Inspection | |
| <b>Permittee Name:</b> | Plymouth Tube Co. | |

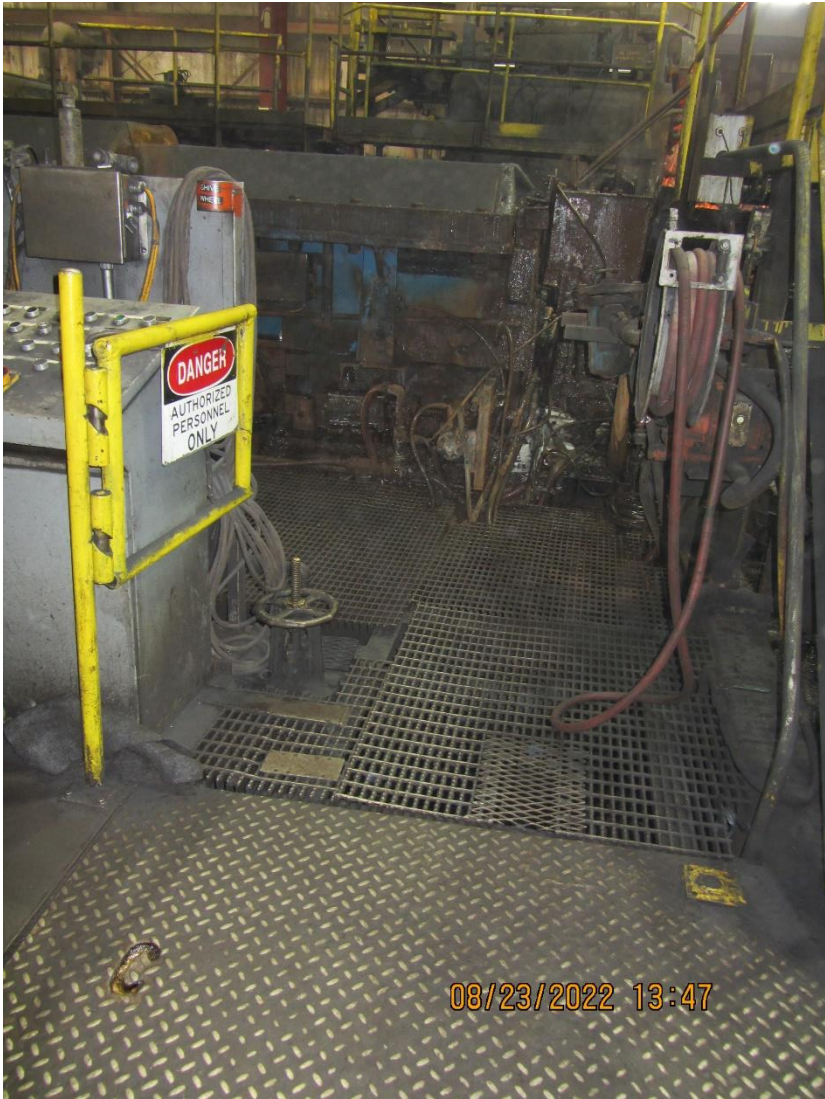
| <b>Photo No.:</b> 1 | <b>Time:</b><br>1: 47 PM | | |

| <b>Photo Description:</b><br>Open grating for any spills to contain water in closed loop system. | | | |

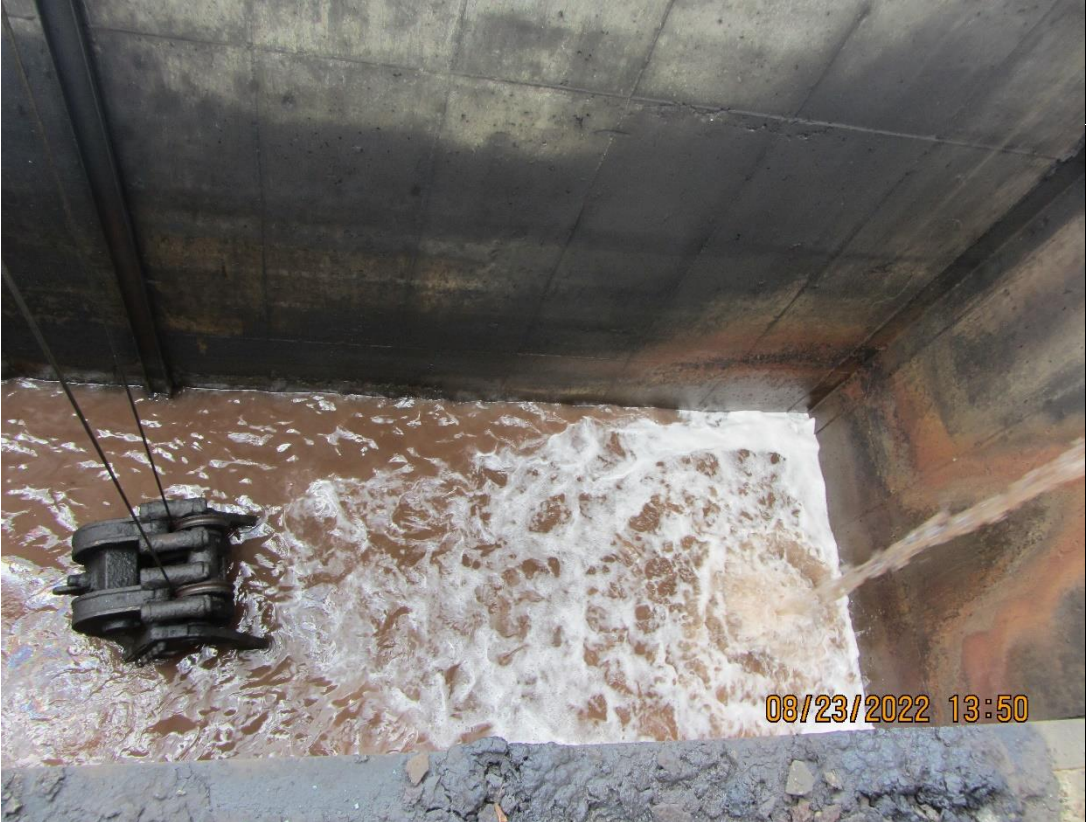
| <b>Photo No.:</b> 2 | <b>Time:</b><br>1:50 PM | | |

| <b>Unique Identifying No.</b> | <b>Observation</b> | <b>Area of Concern?</b> |
|---|---|---|
| <b>MS5-OB-007</b> | The scale pit and cooling tower are on closed loop system. Well water is used to replenish and water lost to evaporation on an as-needed basis. | No |

| <b>Photo Description:</b><br>Scale Pit. | | | |

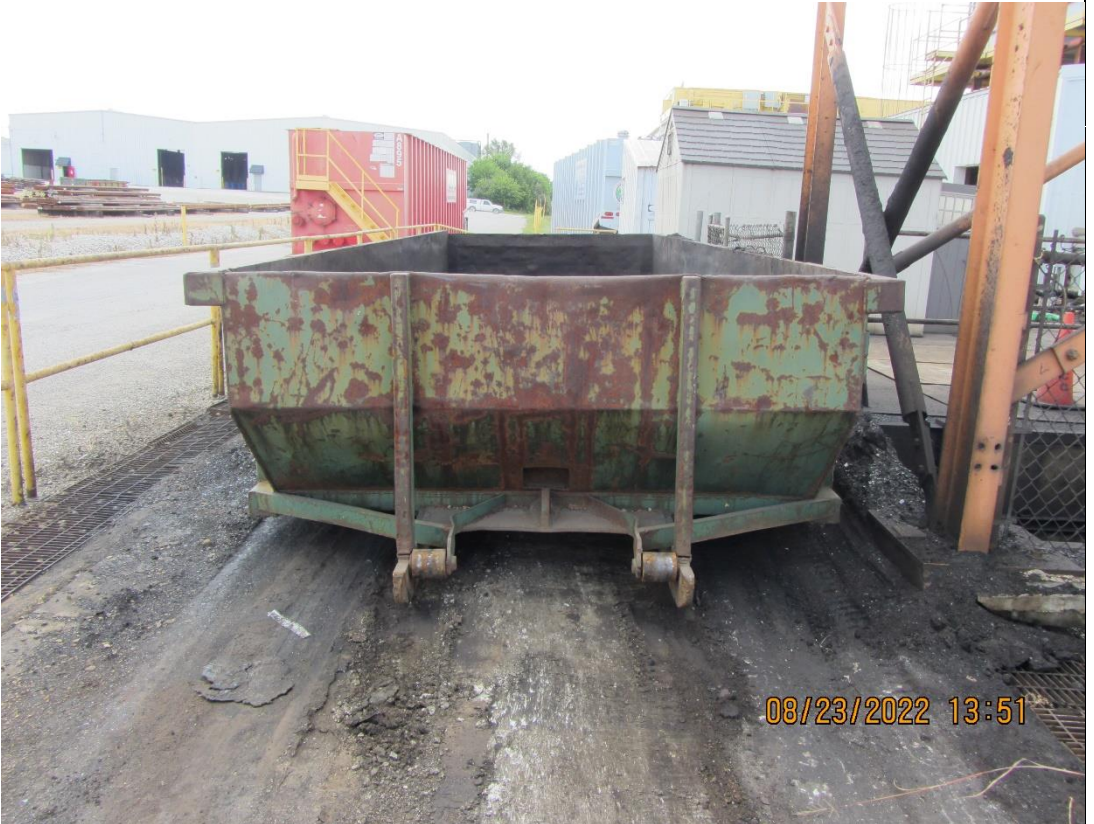
| <b>Photo No.:</b> 3 | <b>Time:</b><br>1:51 PM | | |

| <b>Photo Description:</b><br>Scale Hopper hauled every 6 weeks. | | | |

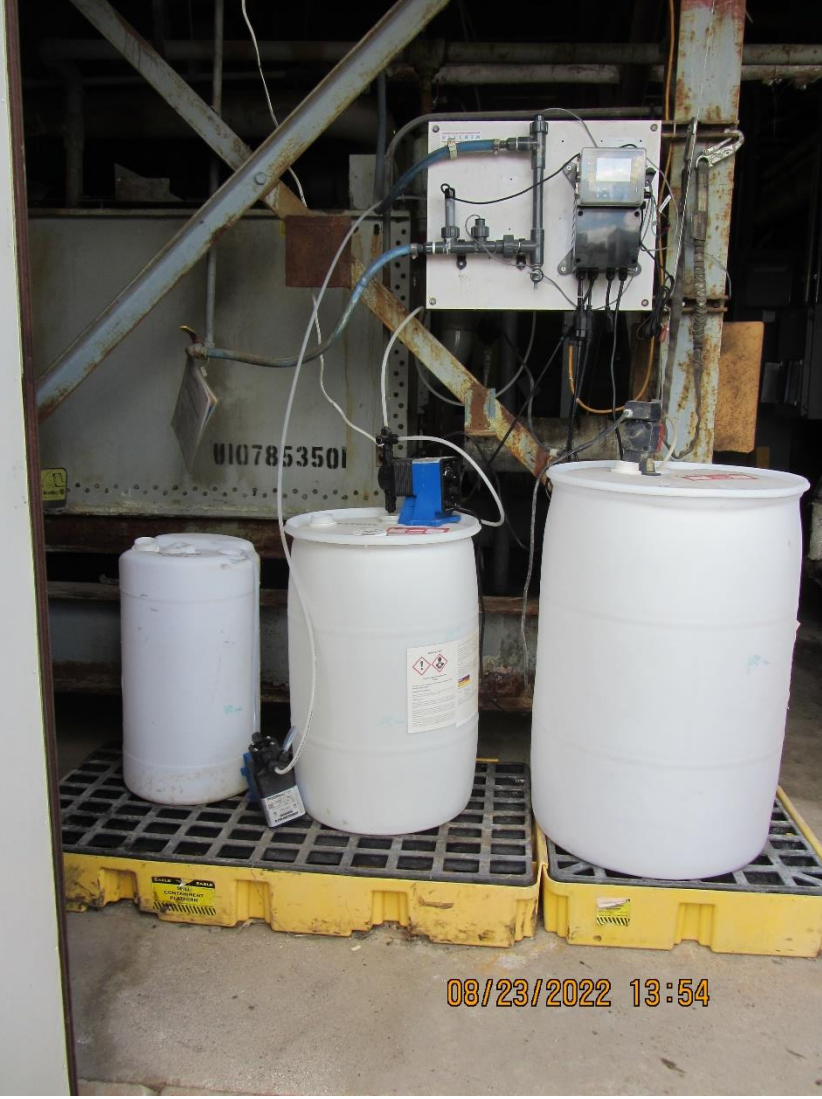
| <b>Photo No.:</b> 4 | <b>Time:</b> 1:54 PM | | |

| <b>Photo Description:</b><br>Cooling tower automatic refuel station. | | | |

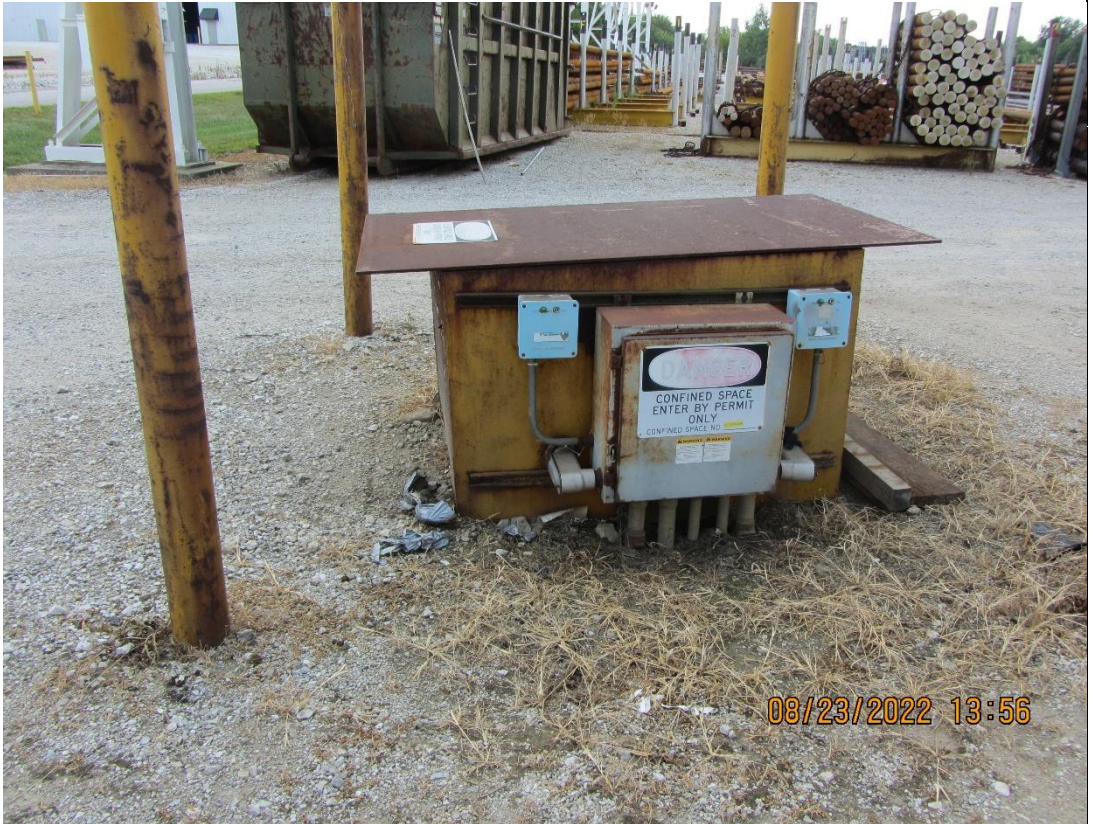
| <b>Photo No.:</b> 5 | <b>Time:</b> 1:56 PM | | |

| <b>Photo Description:</b><br>Lift station on the north side of Facility to sanitary. | | | |

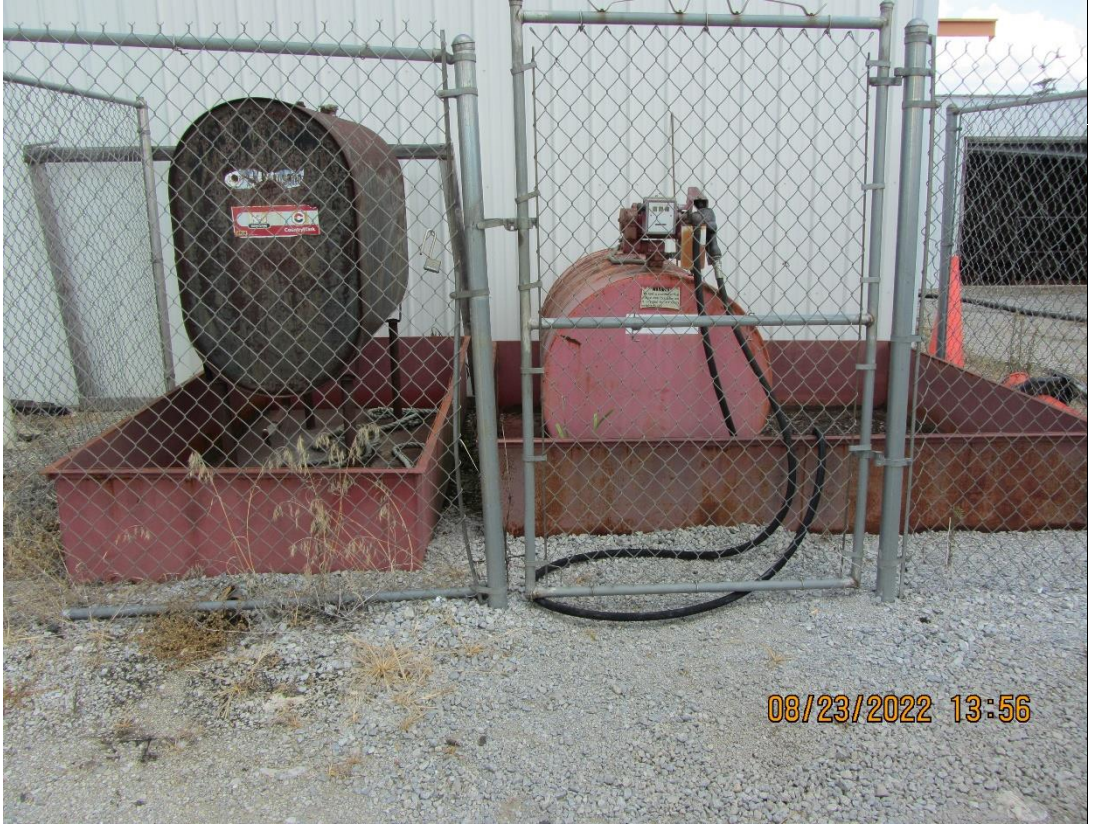
| <b>Photo No.:</b> 6 | <b>Time:</b> 1:56 PM | | |

| <b>Photo Description:</b><br>Diesel Station with secondary containment. | | | |

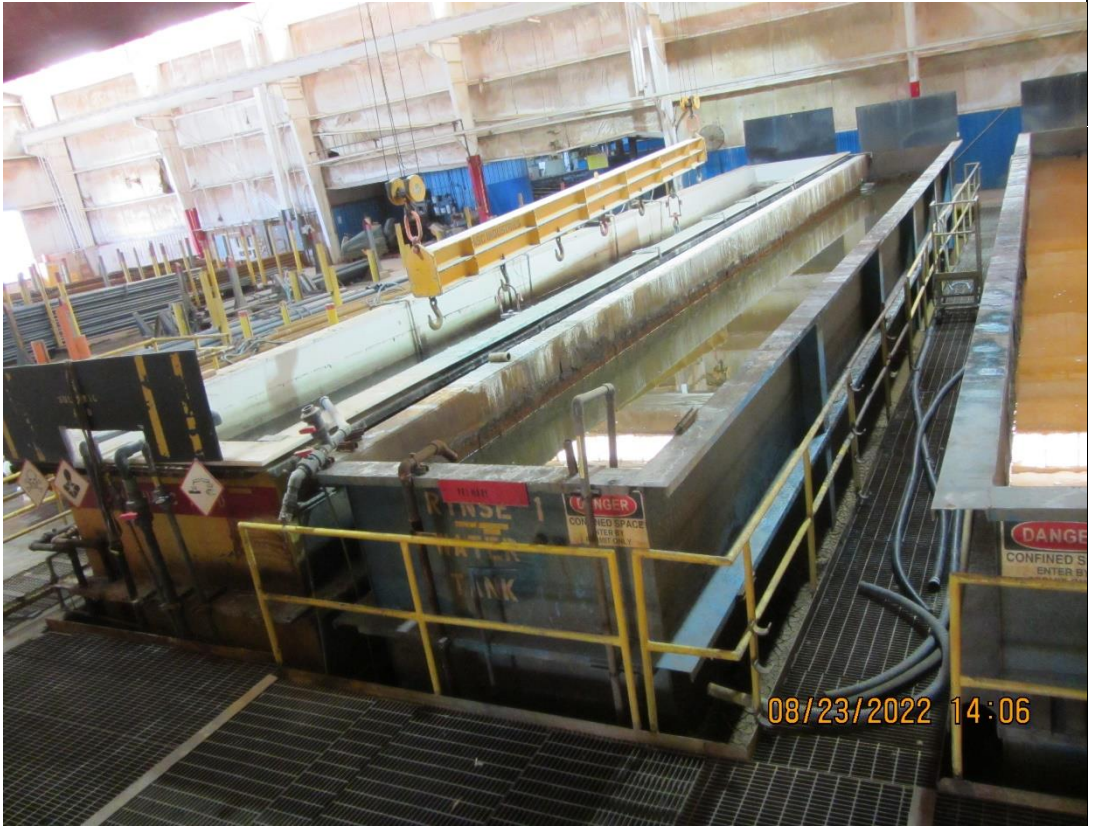
| <b>Photo No.:</b> 7 | <b>Time:</b><br>2:06 PM | | |

| <b>Unique Identifying No.</b> | <b>Observation</b> | <b>Area of Concern?</b> |
|---|---|---|
| <b>MS5-OB-003</b> | Secondary containment is present for all acid and rinse tanks on-site. | No |

| <b>Photo Description:</b><br>Acid and rinse tanks with open grating to capture and hold any spills. | | | |

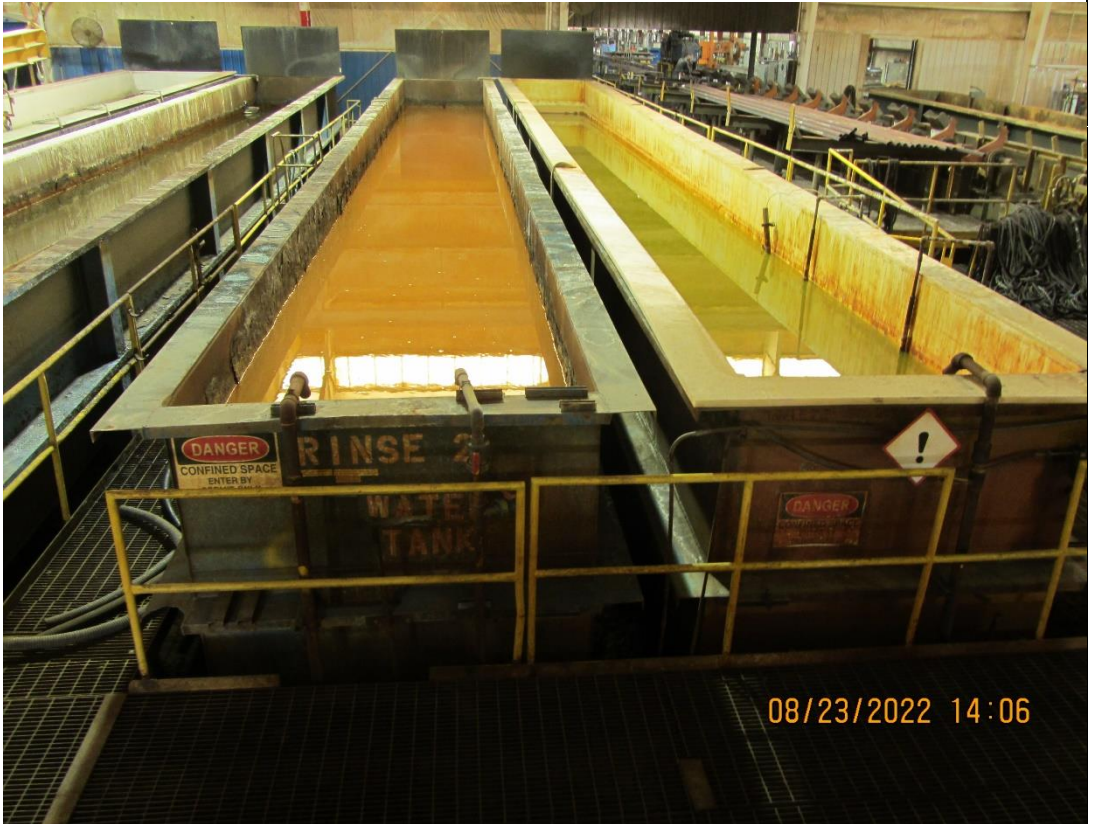
| <b>Photo No.:</b> 8 | <b>Time:</b><br>2:06 PM | | |

| <b>Photo Description:</b><br>Acid and Rinse tanks<br>Acid and rinse tanks with open grating to capture and hold any spills. | | | |

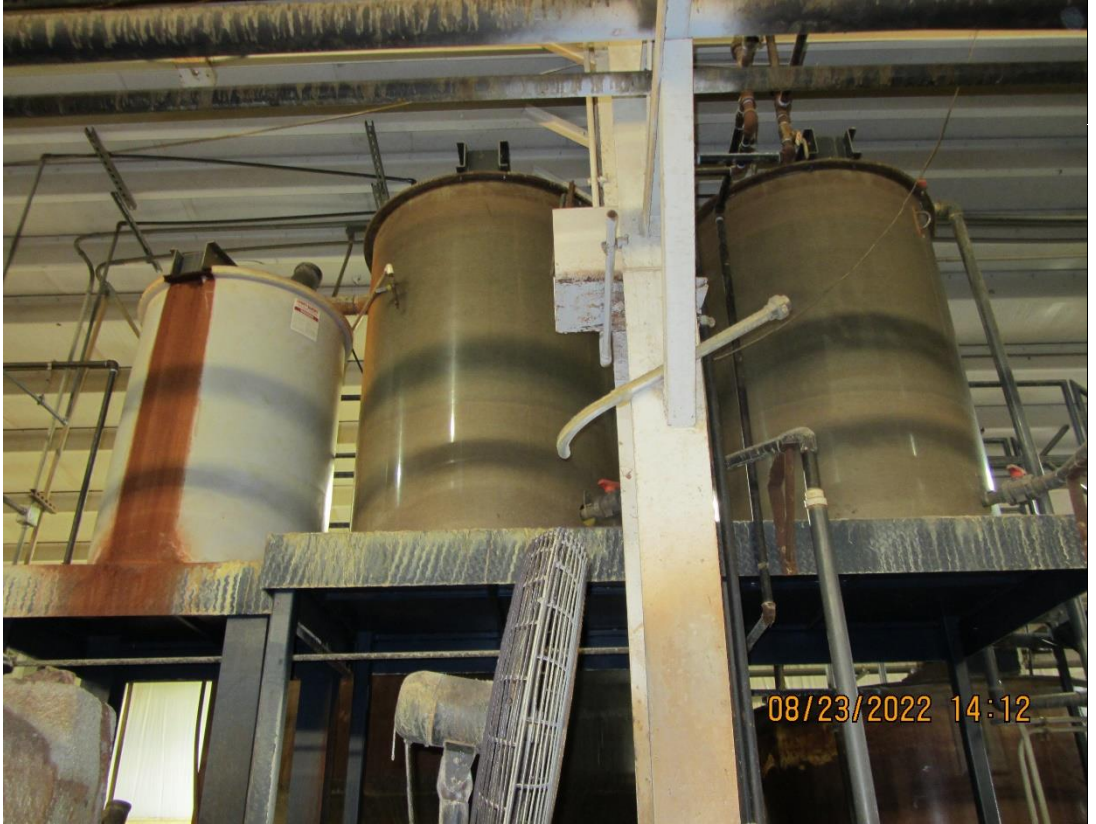
| <b>Photo No.:</b> 9 | <b>Time:</b><br>2:14 PM | | |

| <b>Photo Description:</b><br>Holding/floc/mix tanks for pH monitoring and adjustment. | | | |

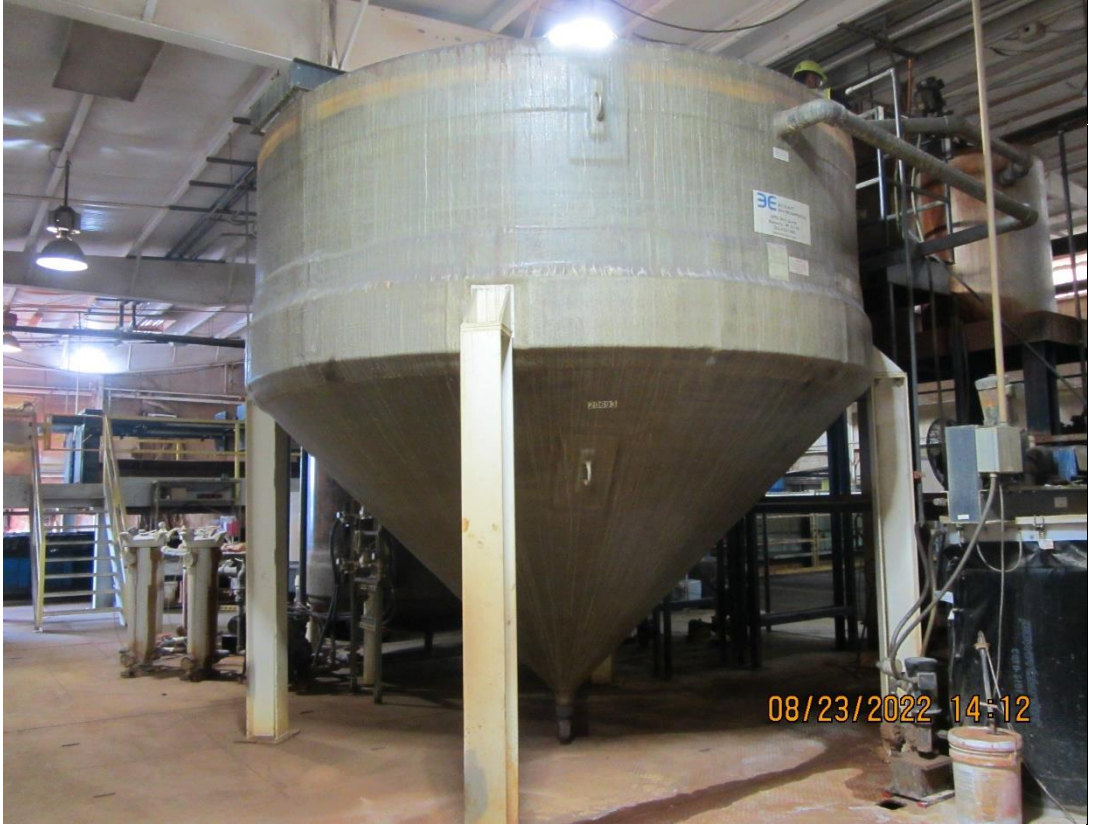
| <b>Photo No.: 10</b> | <b>Time:</b><br>2:12 PM | | |

| <b>Photo Description:</b><br>Holding/floc/mix tanks for pH monitoring and adjustment. | | | |

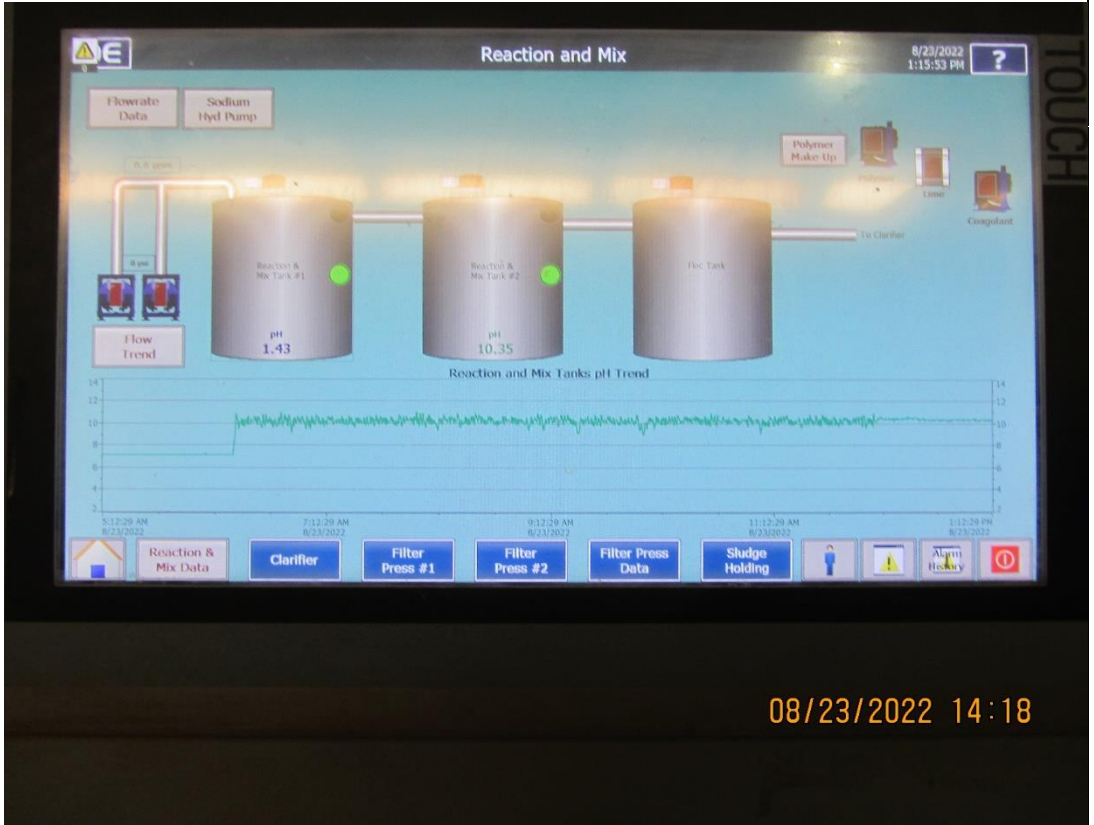
| <b>Photo No.:</b> 11 | <b>Time:</b><br>2:18 PM | | |

| <b>Photo Description:</b><br>Monitoring screen for reaction and mix tanks and pH monitoring. | | | |

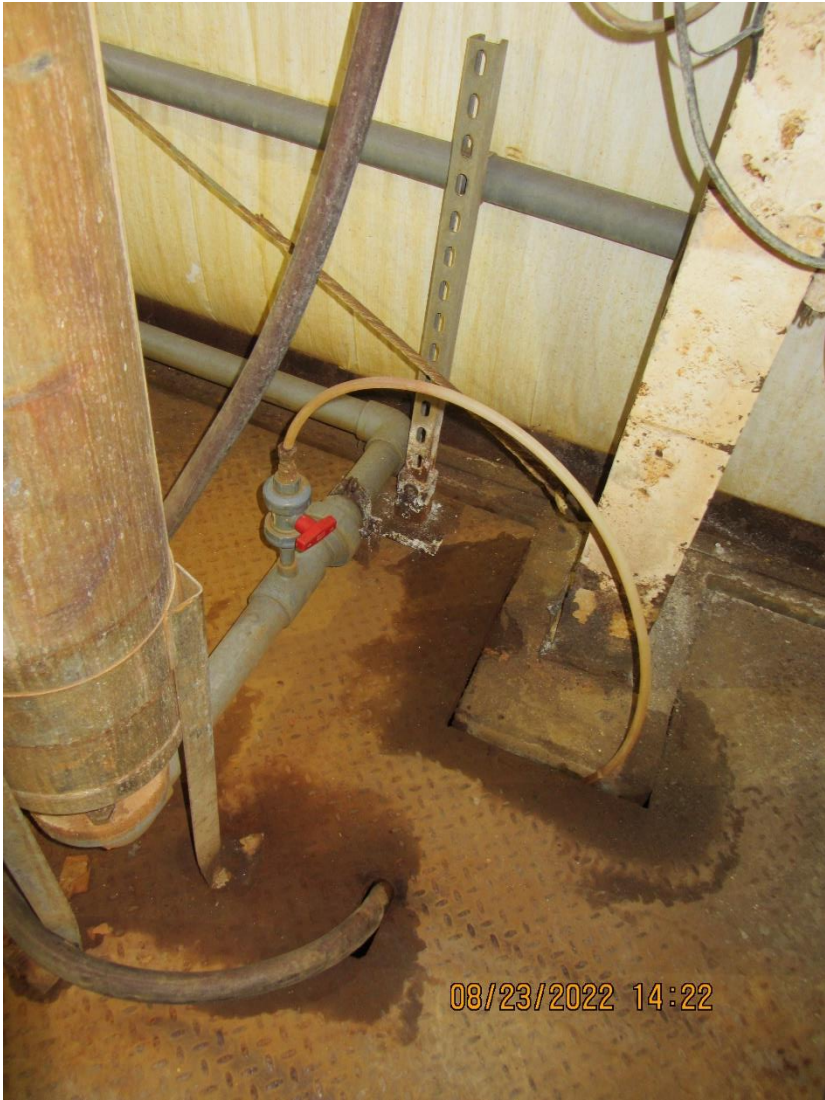
| <b>Photo No.: 12</b> | <b>Time:</b><br>2:22 PM | | |

| <b>Photo Description:</b><br>Connection to monitoring equipment. | | | |

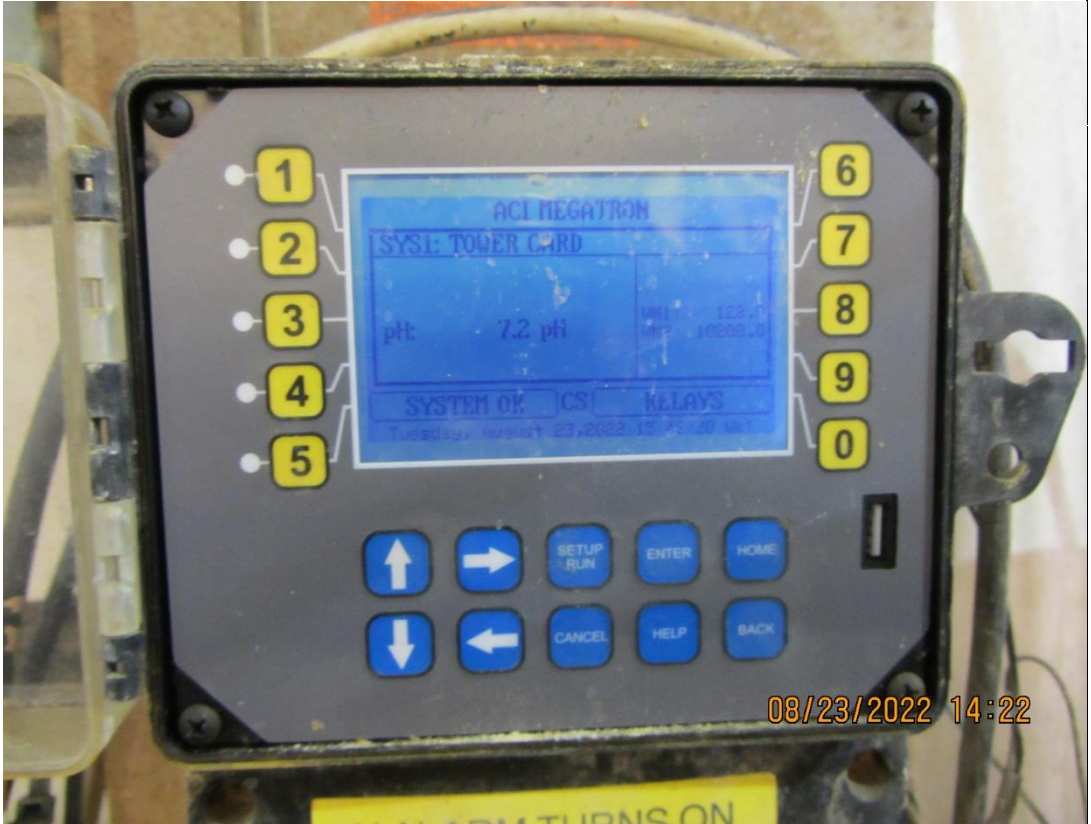
| <b>Photo No.:</b> 13 | <b>Time:</b><br>2:22 PM | | |

| <b>Unique Identifying No.</b> | <b>Observation</b> | <b>Area of Concern?</b> |
|---|---|---|
| <b>MS5-OB-001</b> | Calibrations for daily pH readings are not recorded. | Yes |

| <b>Photo Description:</b><br>pH monitoring screen. | | | |

| No. | |
|---|---|
| MS5-OB-001 | Calibrations for daily pH readings are performed daily, but are not recorded.<br><br>All calibrations should be recorded and include the date and time for when they are performed. |

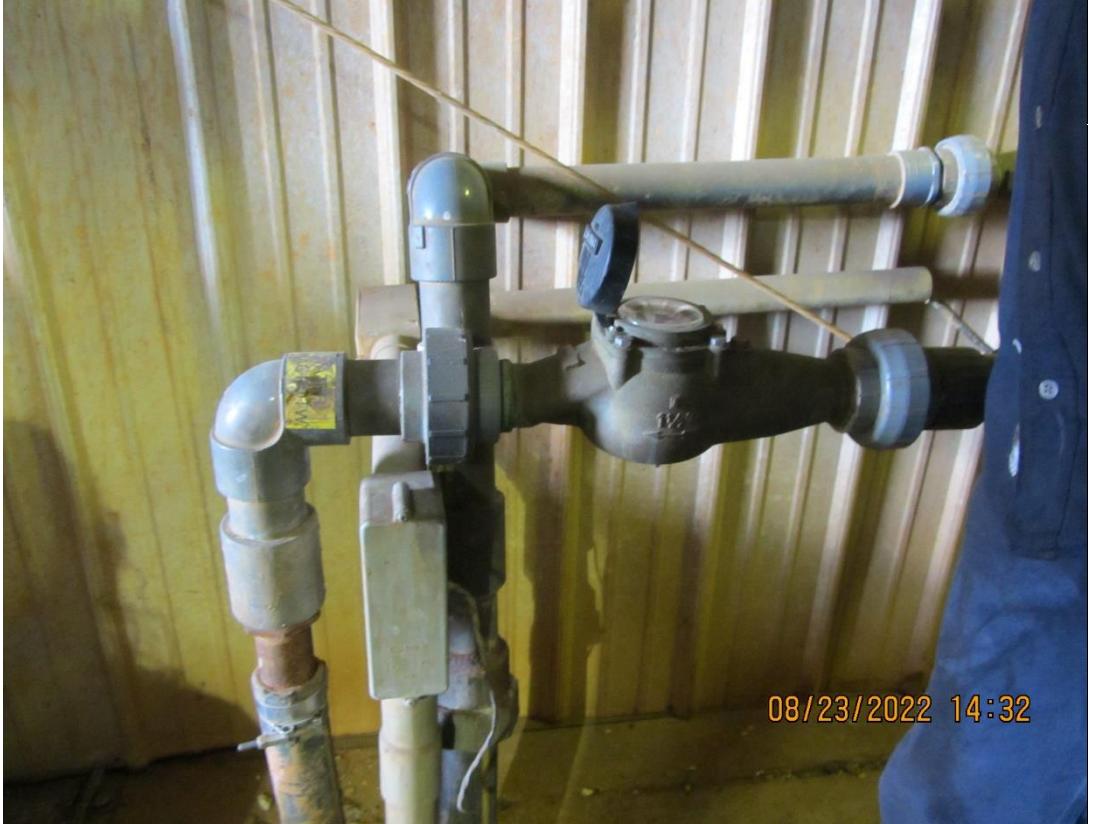
| <b>Photo No.:</b> 16 | <b>Time:</b> 2:32 PM | | |

| <b>Photo Description:</b><br>Flow meter for water connection to City | | | |

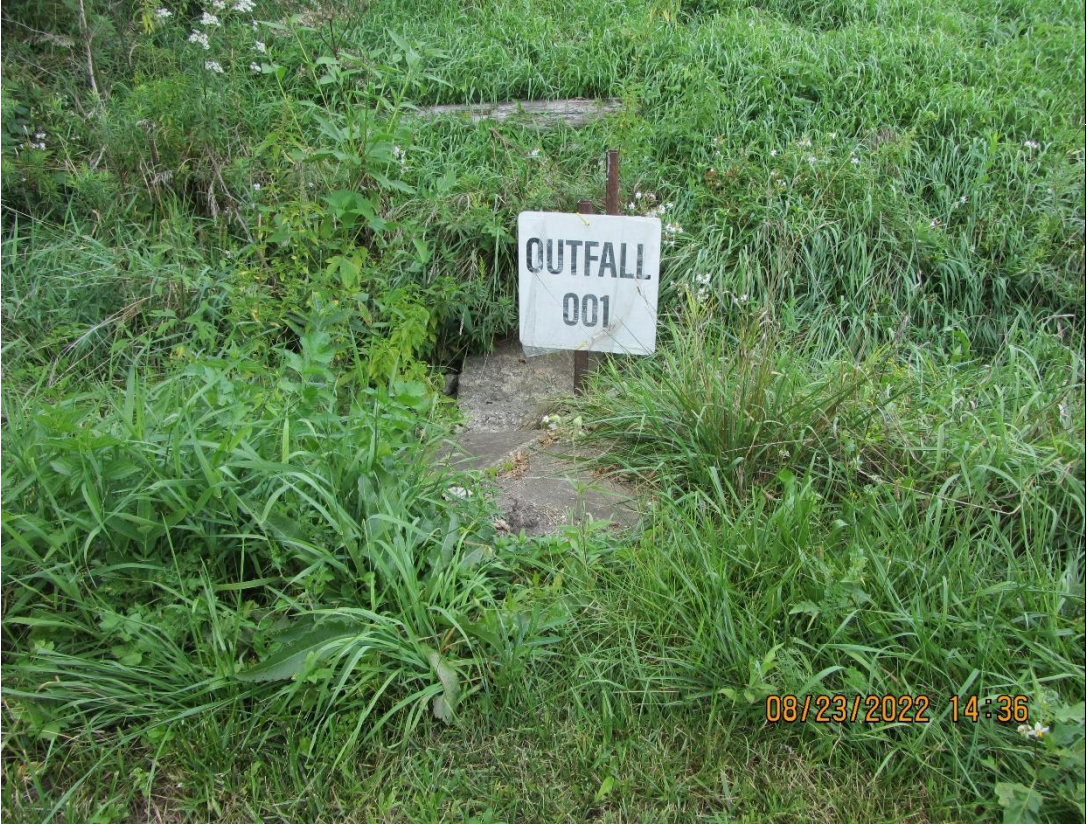
| <b>Photo No.:</b> 17 | <b>Time:</b> 2:36 PM | | |

| <b>Photo Description:</b><br>Stormwater outfall 001 located on the North end of Facility. | | | |

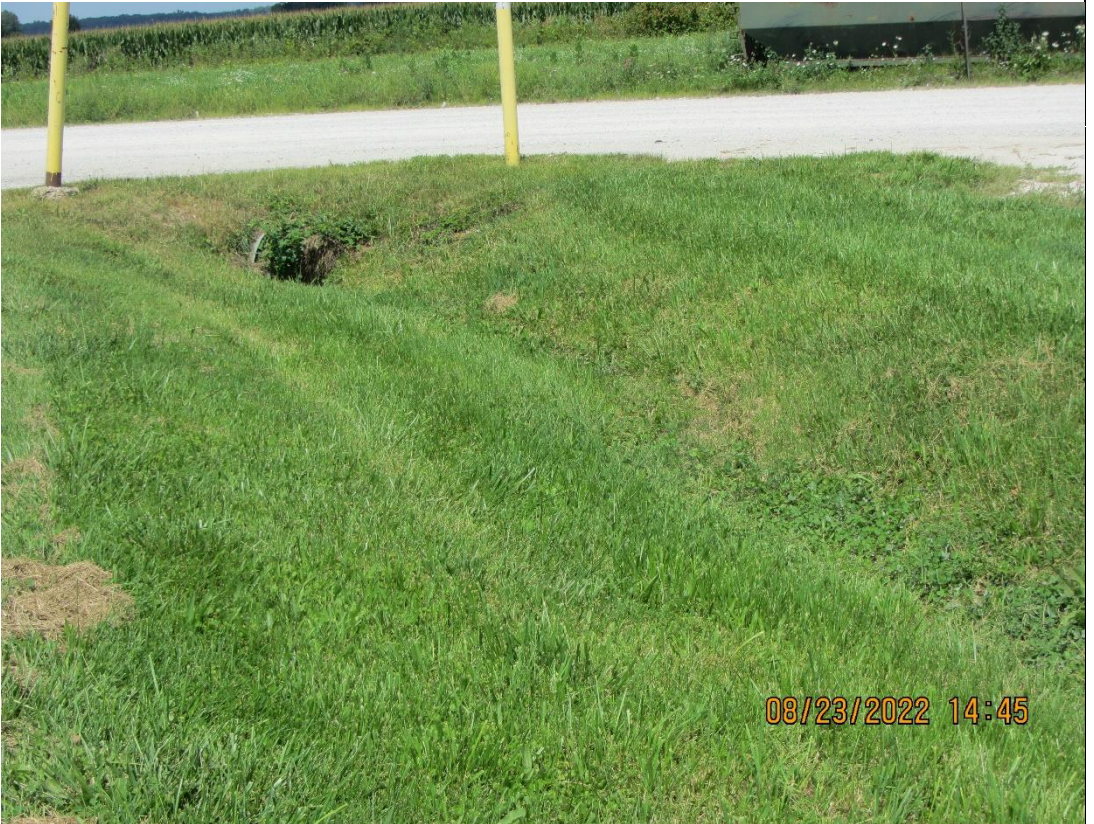
| <b>Photo No.: 18</b> | <b>Time:</b><br>2:45 PM | | |

| <b>Unique Identifying No.</b> | <b>Observation</b> | <b>Area of Concern?</b> |
|---|---|---|
| <b>MS5-OB-004</b> | Stormwater samples are taken at a culvert located within the plant upstream from Outfall 001. | Yes |

| <b>Photo Description:</b><br>Culvert/sampling location for Outfall 001. | | | |

| No. | |
|---|---|
| MS5-OB-004 | Stormwater samples are taken at a culvert located within the plant upstream from Outfall 001.<br><br>Samples taken should be taken at the specified outfall location and be representative of the Facility's discharge. |

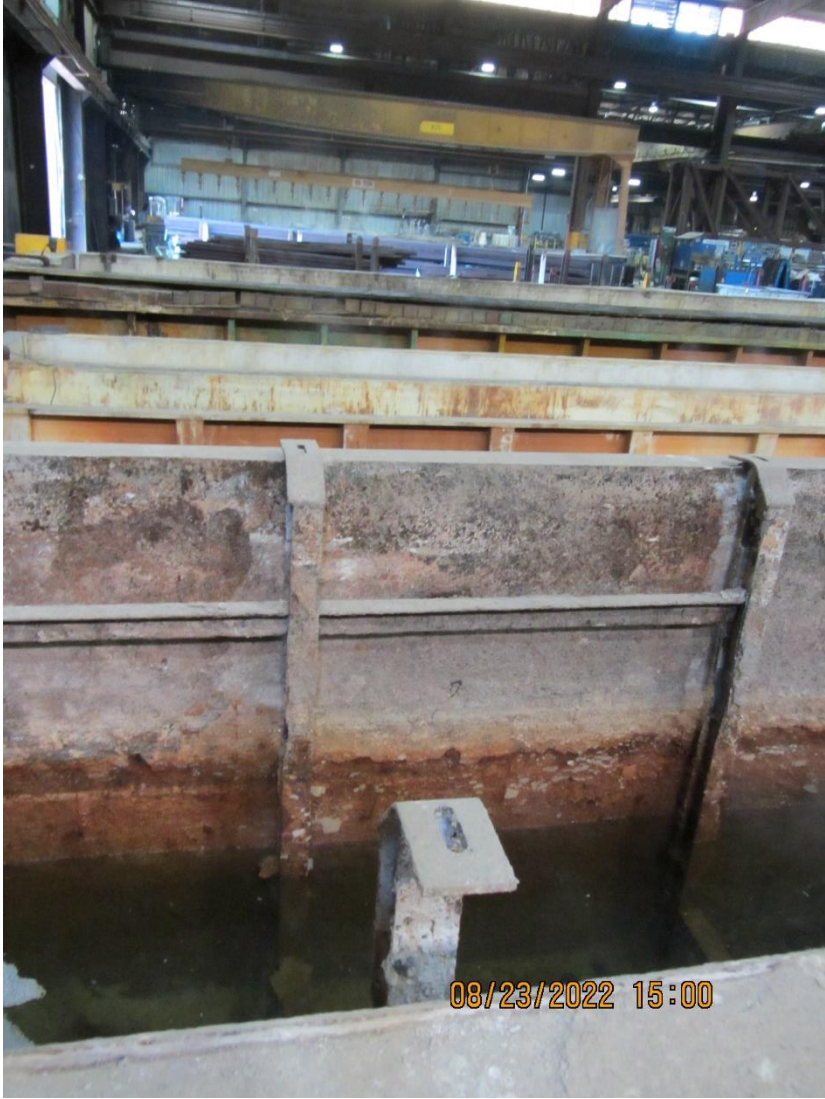
| <b>Photo No.:</b> 19 | <b>Time:</b><br>3:00 PM | | |

| <b>Photo Description:</b><br>Rinse tanks with secondary containment underneath. | | | |

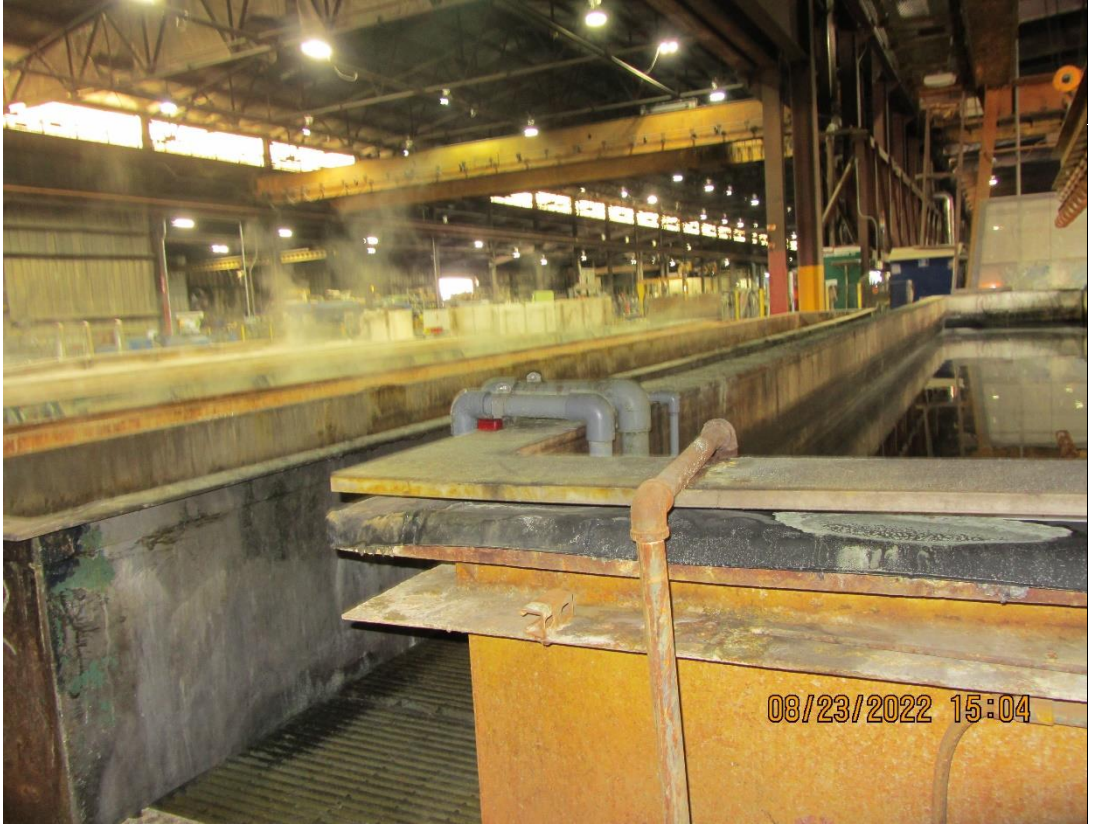
| <b>Photo No.: 20</b> | <b>Time:</b><br>3:04 PM | | |

| <b>Photo Description:</b><br>Rinse and acid tanks with secondary containment underneath. | | | |

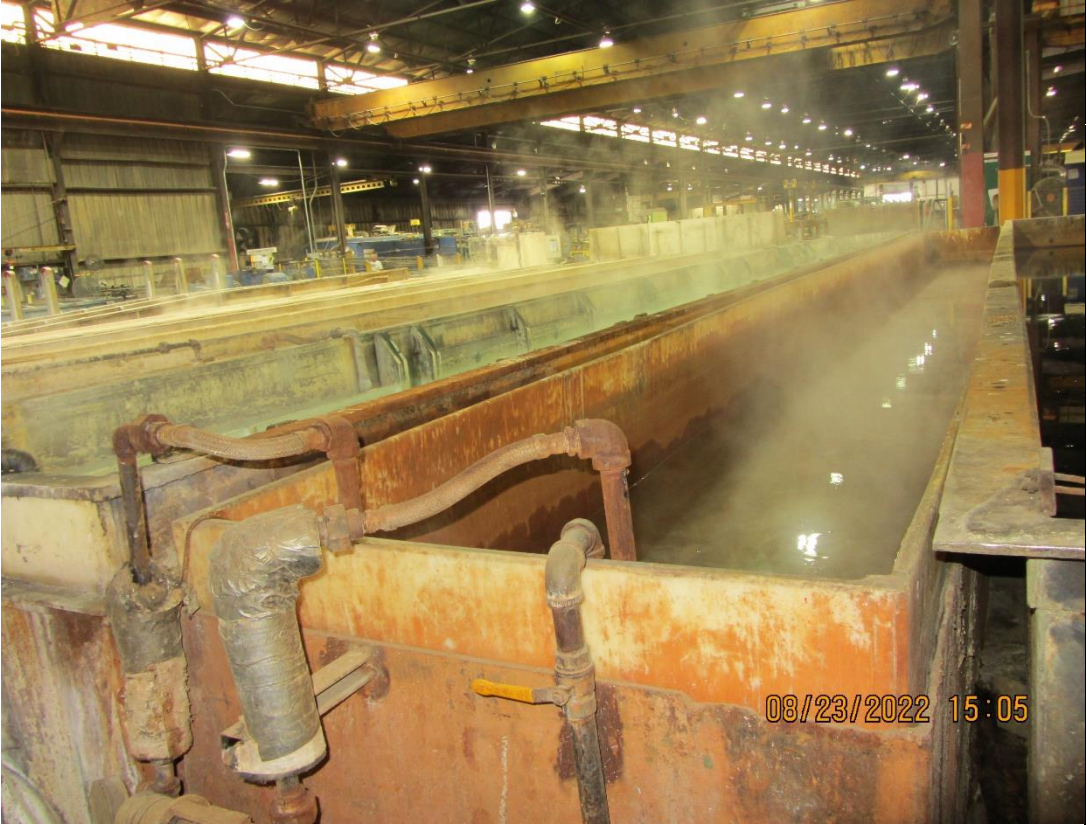
| <b>Photo No.:</b> 21 | <b>Time:</b><br>3:05 PM | | |

| <b>Photo Description:</b><br>Rinse and acid tanks with secondary containment underneath. | | | |

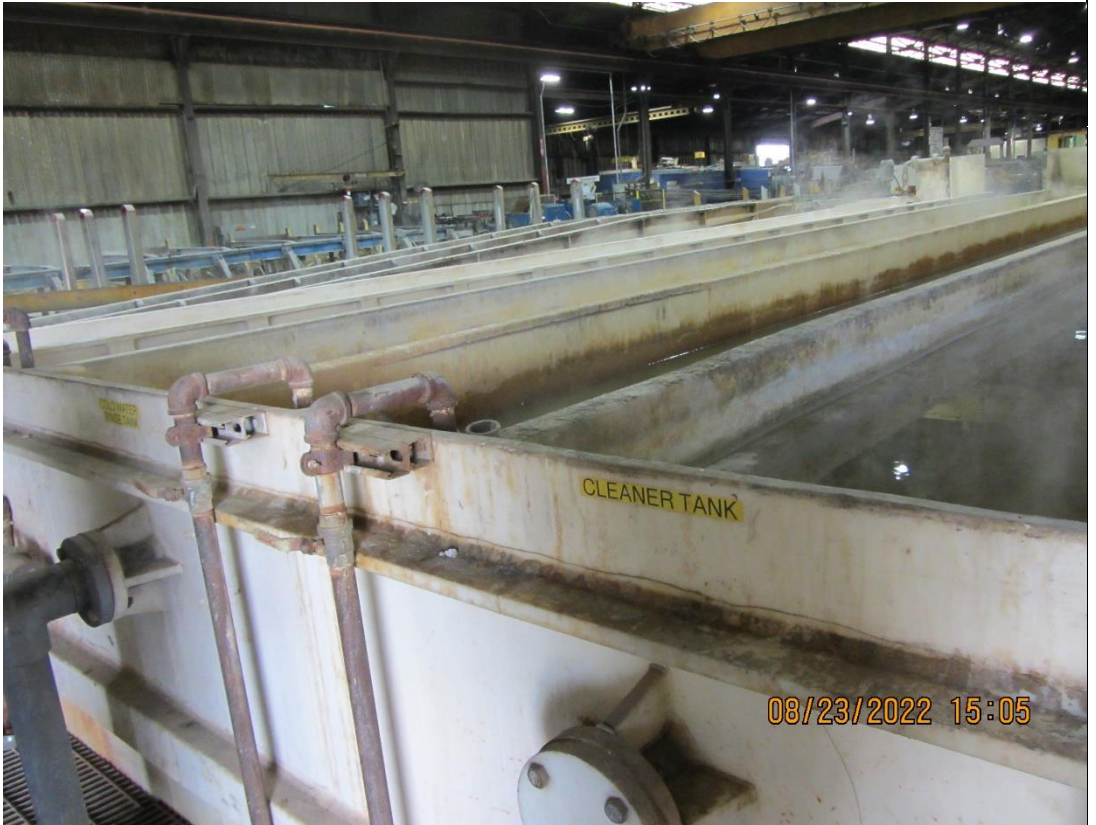
| <b>Photo No.:</b> 22 | <b>Time:</b><br>3:05 PM | | |

| <b>Photo Description:</b><br>Cold water rinse tank and cleaner tank with secondary containment underneath. | | | |

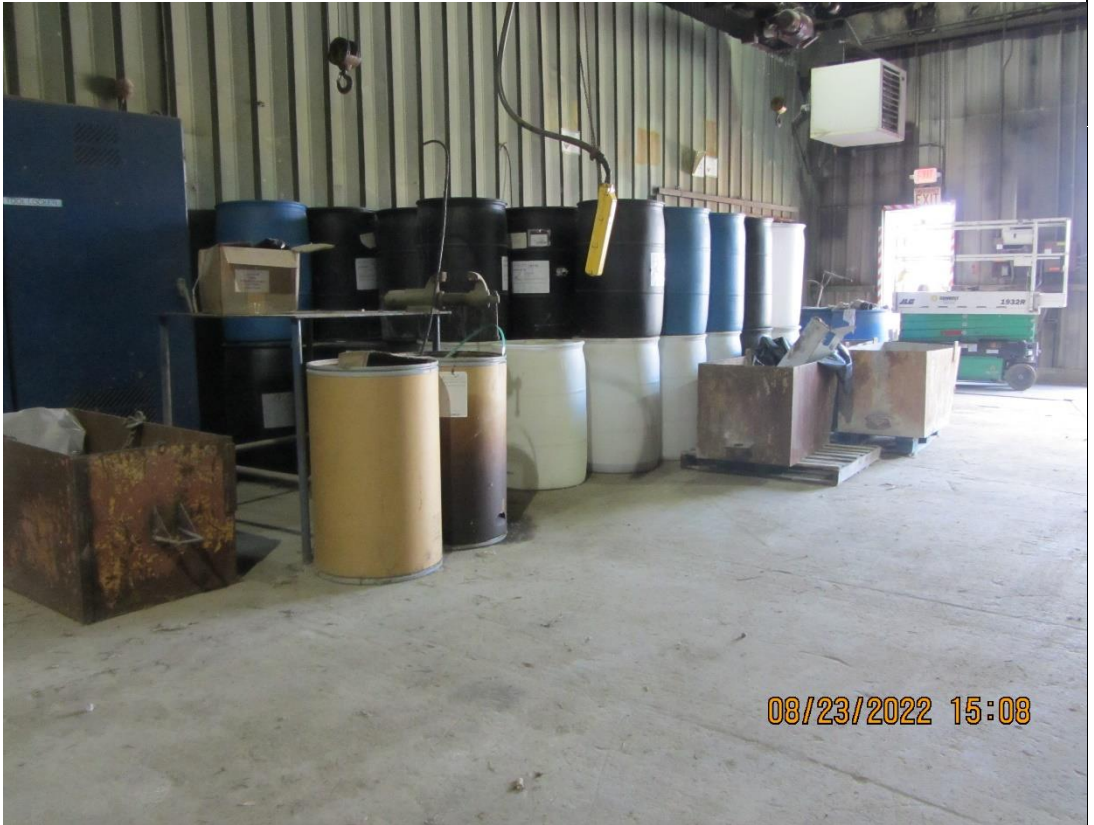
| <b>Photo No.:</b> 23 | <b>Time:</b><br>3:08 PM | | |

| <b>Photo Description:</b><br>Empty container and waste storage area. | | | |
