## REGION 10 Enforcement Division

### INSPECTION REPORT

| <b>Company Name:</b> | OBI Seafoods, LLC | | |
| <b>Facility or Site Name:</b> | OCEAN BEAUTY SEAFOODS INC KODIAK FACILITY | | |

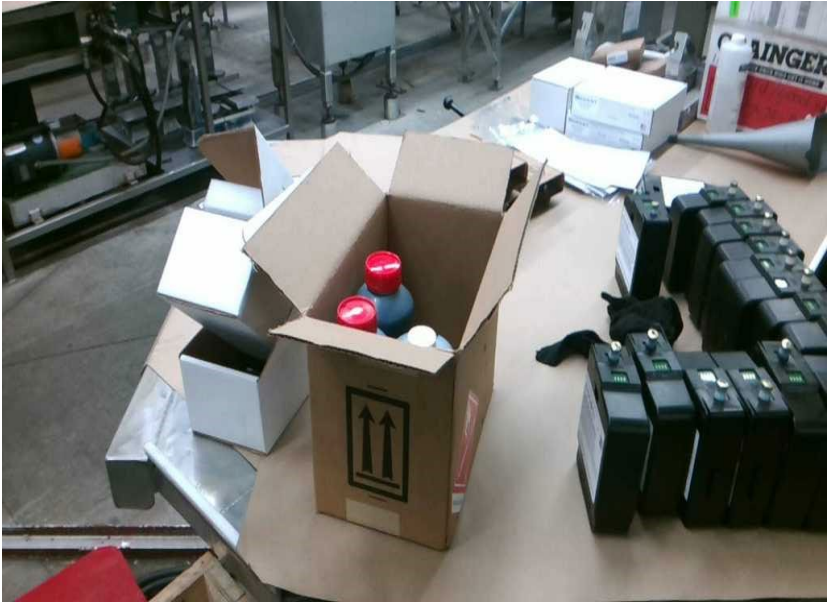
| Observation_Image-202105271019511951421272.jpg | |

| While in the Cannery I saw three additional quart size containers of waste ink on a table. | |

| View of three, quart size containers of waste ink seen here on a table in the cannery. | |

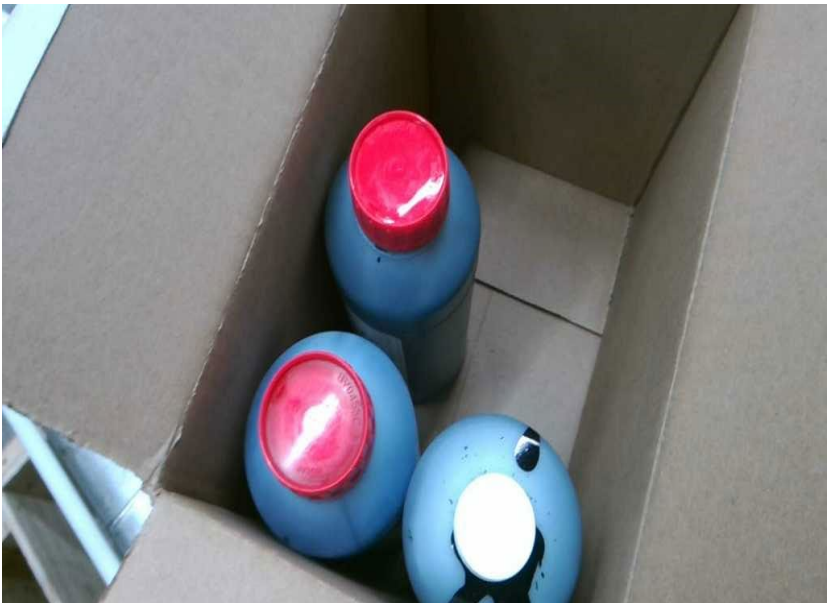
| Observation_Image-202105271019581958331812.jpg | |

| Close-up view of the three, quart size containers of waste ink on a table in the cannery. | |

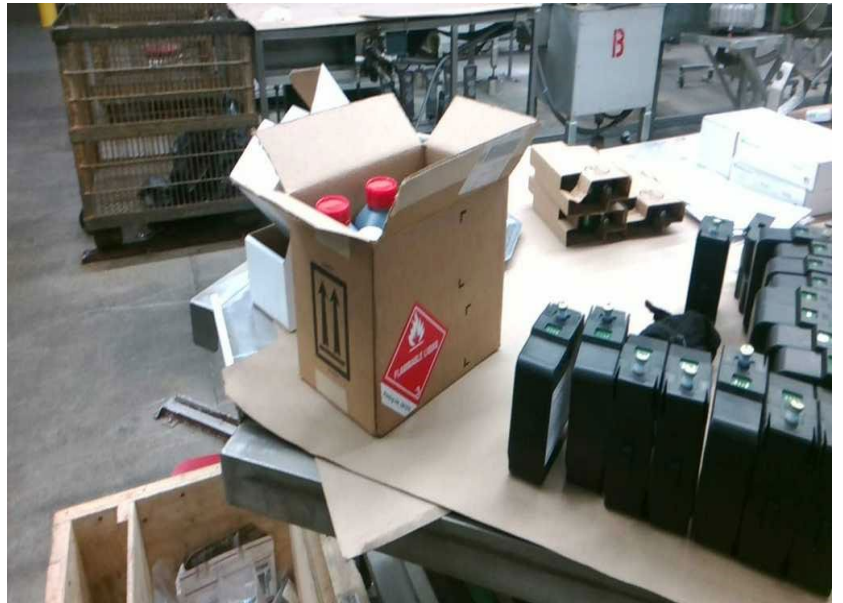
Observation\_Image-  
20210527102007207439341.jpg

Another view of the same three, quart size containers of waste ink seen here on a table in the cannery.

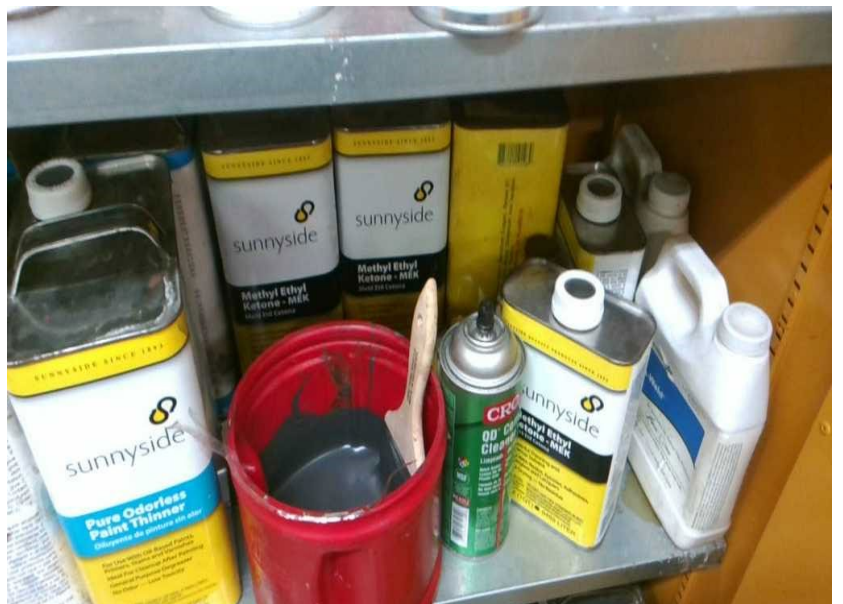
Observation\_Image-  
202105270857185718495419.jpg

| While inspecting the contents of some flammable storage cabinets, I saw some containers of Methyl Ethyl Ketone (MEK). I asked what the MEK was used for and Mr. Dillon said it was used for thinning paint and clean up. I asked if rags/wipes were used with the MEK. Mr. Dillon told me that rags/wipes were used for clean-up. I then asked how the rags/wipes were being managed and he told me they were disposed of into the trash as solid waste. | |

While inspecting the contents of flammable storage cabinets, I saw some containers of MEK. I asked what the MEK was used for and Mr. Dillon said it was used for thinning paint and clean up. I asked if rags/wipes were used with the MEK and he told me they were, and the rags/wipes were disposed of as solid waste.

View of the MEK containers inside the flammable storage locker.

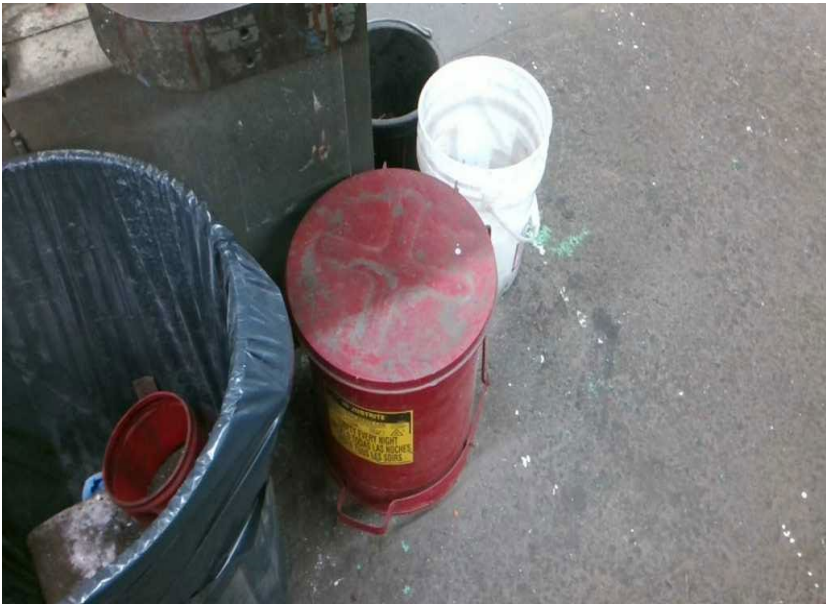
| Observation_Image-202105270858105810433334.jpg | |

| View of the red step can, where the waste rags/wipes, contaminated with MEK, are disposed as solid waste. | |

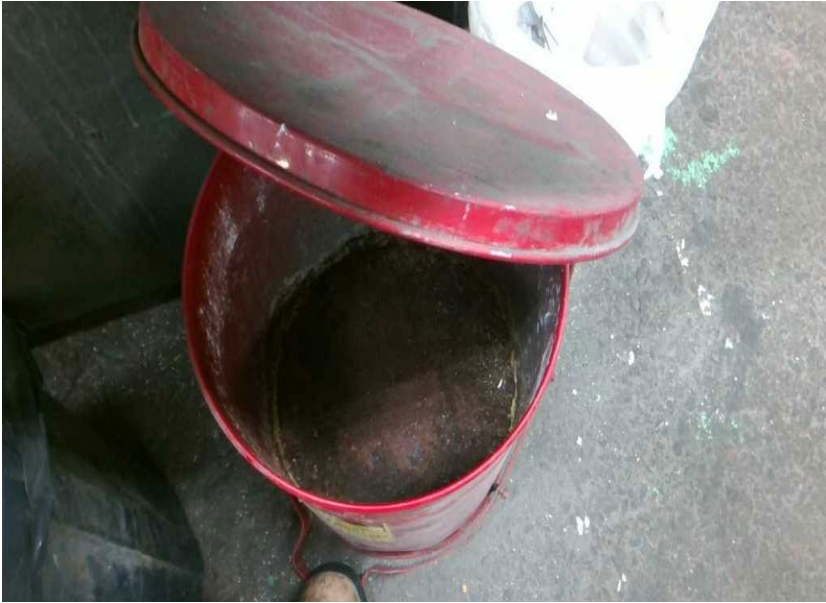
| Observation_Image-202105270858165816434646.jpg | |

| View inside the red step can, showing that there were no rags/wipes in the step can at the time of the inspection. | |

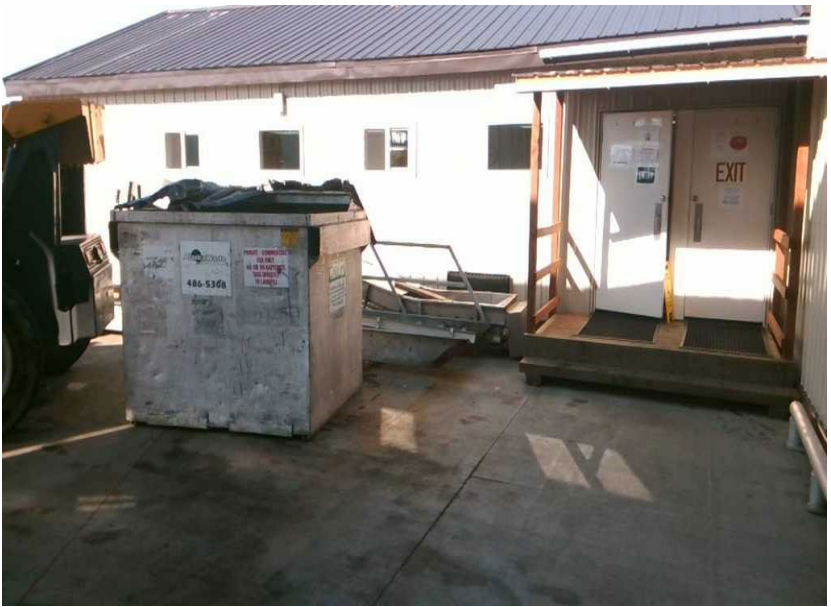
| Observation_Image-202105270927352735413791.jpg | |

| During the inspection, Mr. Dillon told me that the rags/wipes, contaminated with MEK, were disposed of into the trash dumpster just outside the galley. The trash is picked up by Alaska Waste and disposed of at the Kodiak Borough Landfill. The rags/wipes contaminated with MEK are an F-listed waste. | |

During the inspection, Mr. Dillon told me that the rags/wipes contaminated with MEK were disposed of into the trash. The trash is picked up by Alaska Waste and disposed of at the Kodiak Borough Landfill. The rags/wipes contaminated with MEK are an F-listed waste.

| View of the trash dumpster, just outside of the galley, where the rags/wipes, contaminated with MEK, have been disposed. | |

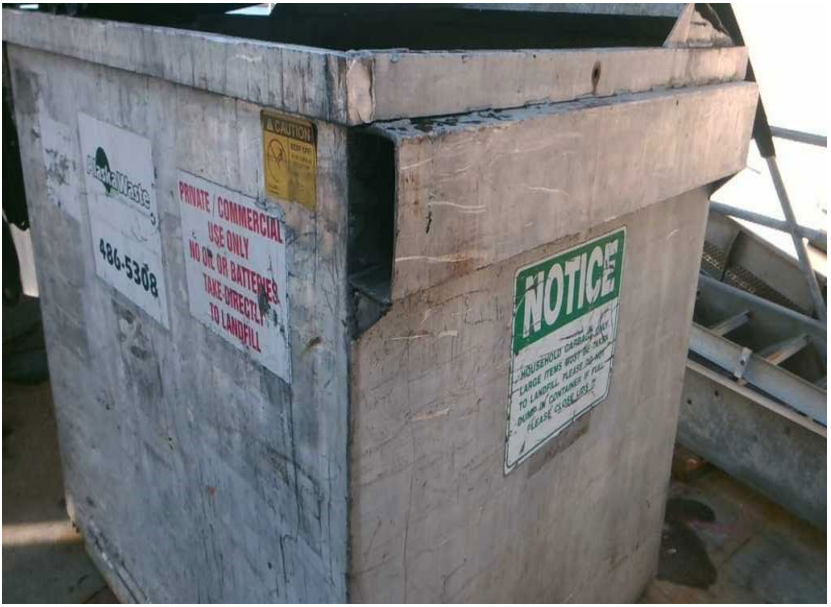
| Observation_Image-202105270928102810448006.jpg | |

| View of the labeling on the outside of the trash dumpster, indicating the only household garbage is acceptable. | |

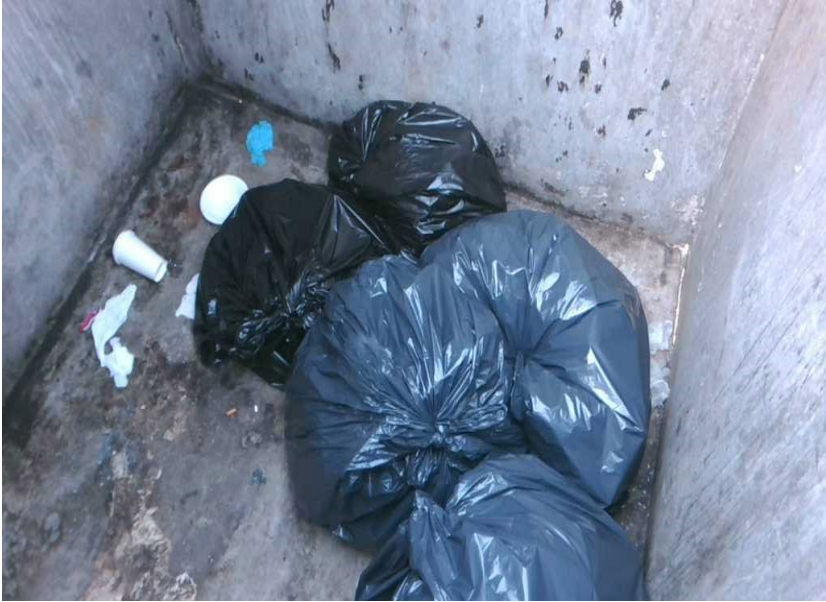
| Observation_Image-202105270928192819518973.jpg | |

| View inside the trash dumpster. | |

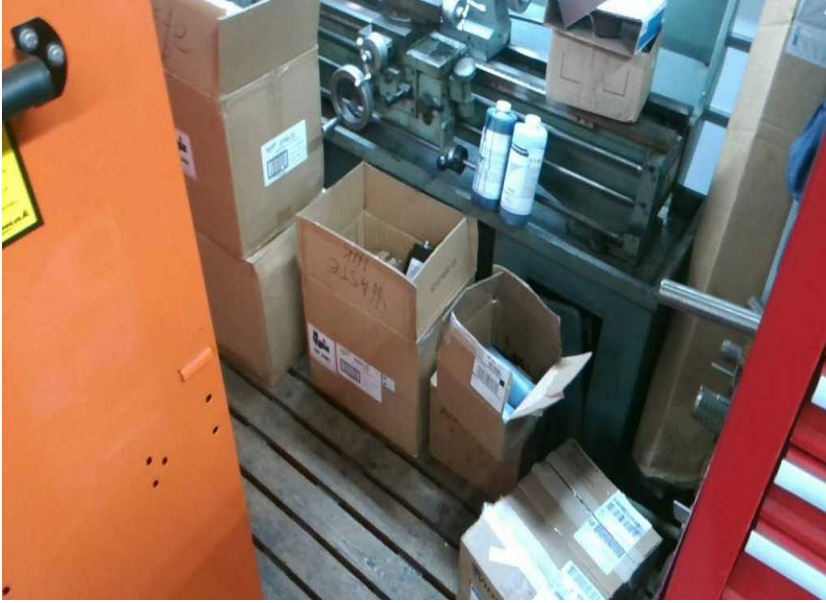
| Observation_Image-20210527095505555441011.jpg | |

| <p>During my inspection of the maintenance shop, I saw four, quart size, containers of what Mr. Dillon said was waste ink, along with nine boxes, each containing six waste ink cartridges. The ink and ink cartridges are used in product labeling. At the time of the inspection, the boxes of ink were labeled as waste and three of the quart size containers were leaking.</p> <p>Mr. Dillon said the ink would be shipped down to their Arlington, WA facility for final disposal. Mr. Thatcher told me that the Arlington facility was a WA state SQG (federal VSQG). However, information contained in the facility's RCRA site detail report indicates the facility is not a generator. Information for the receiving facility is as follows:</p> <p>Arlington, WA EPA I.D.# WAH 00005 7800<br/> OBI Seafoods Arlington<br/> 19405 68th Drive NE (Bldg B)<br/> Arlington, WA 98223</p> <p>During the inspection, I requested a copy of the Safety Data Sheet (SDS) for Videojet makeup fluid and cartridges, and one was provided.</p> | |

During my inspection of the maintenance shop, I saw four, quart size containers of what Mr. Dillon said was waste ink, along with nine boxes, each containing six waste ink cartridges. The ink and ink cartridges are used in product labeling. At the time of the inspection, three of the quart size containers were leaking.

| View of the containers and boxes of containers of waste ink. | |

| shipped down to their Arlington, WA facility for final disposal. Mr. Thatcher told me that the Arlington facility was a WA state SQG (federal VSQG). | | |

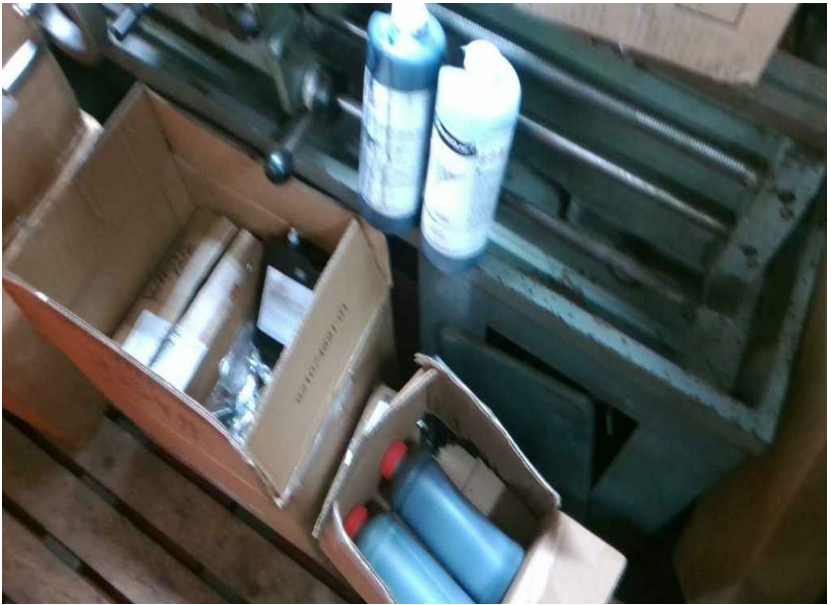
| <div data-bbox="65 129 687 174">[Title]</div> <div data-bbox="65 174 687 271">Observation_Image-202105270955175517448929.jpg</div> <div data-bbox="65 271 687 322">05/27/2021 09:55 AM (AKT)</div> <div data-bbox="65 322 687 374">Jon Jones</div> <div data-bbox="65 374 687 425">Maintenance Shop</div> <div data-bbox="65 425 687 477">No CBI</div> <div data-bbox="65 477 687 528">No PII</div> <div data-bbox="65 528 687 846">View of the leaking waste ink containers.</div> | |

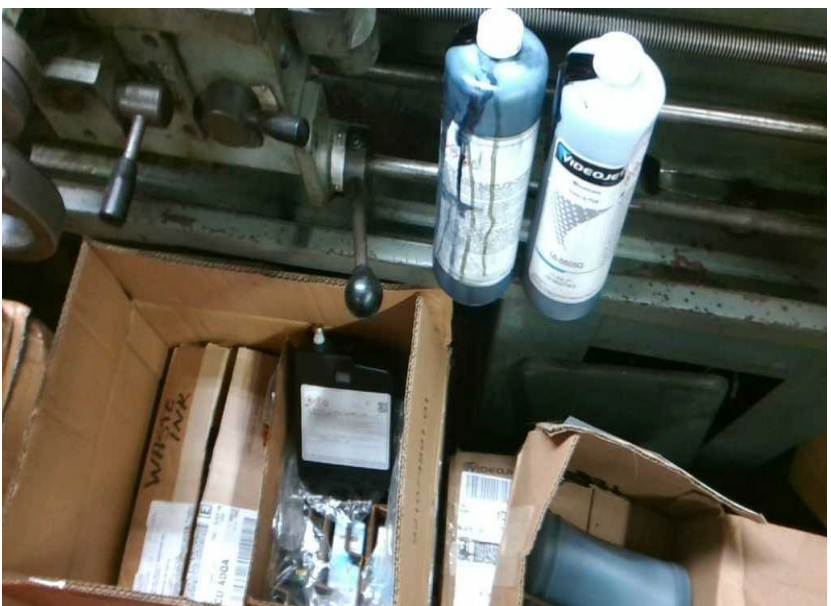
| <div data-bbox="65 846 687 891">[Title]</div> <div data-bbox="65 891 687 987">Observation_Image-202105270955315531450960.jpg</div> <div data-bbox="65 987 687 1039">05/27/2021 09:55 AM (AKT)</div> <div data-bbox="65 1039 687 1090">Jon Jones</div> <div data-bbox="65 1090 687 1142">Maintenance Shop</div> <div data-bbox="65 1142 687 1193">No CBI</div> <div data-bbox="65 1193 687 1245">No PII</div> <div data-bbox="65 1245 687 1559">Close-up view of the waste ink containers and cartridges.</div> | |

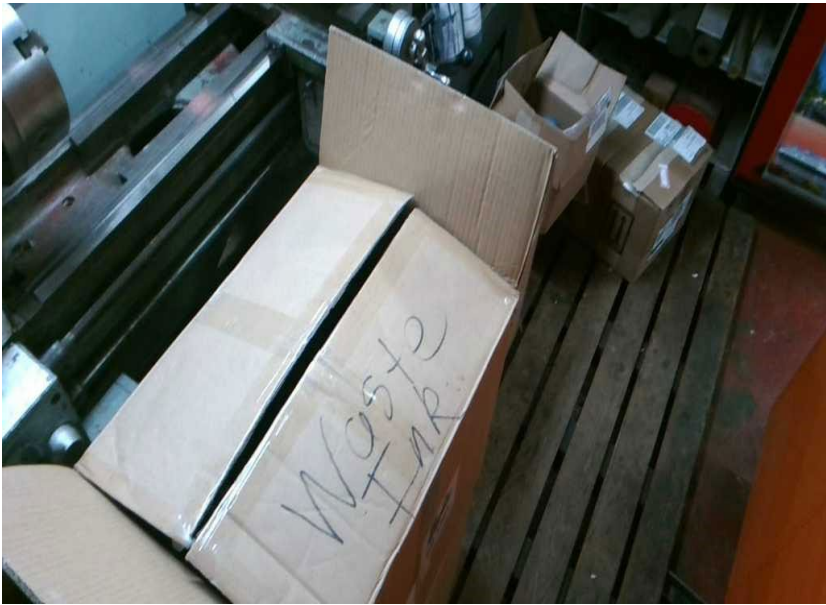
| <p>[Title]</p> <p>Observation_Image-202105270958545854429364.jpg</p> <p>05/27/2021 09:58 AM (AKT)</p> <p>Jon Jones</p> <p>Maintenance Shop</p> <p>No CBI</p> <p>No PII</p> <p>View of the boxes that were labeled with the words, "Waste Ink."</p> | |

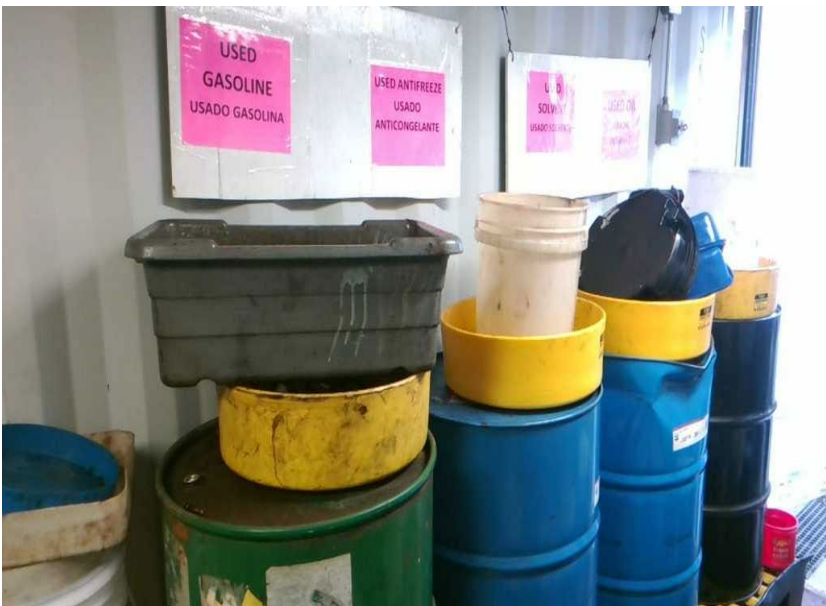
| <p>While inspecting the Oil Storage Van, I saw four 55-gallon containers being used to accumulate the following four wastes:</p> <ul style="list-style-type: none"> <li>used gasoline</li> <li>used antifreeze</li> <li>used solvent</li> <li>used oil</li> </ul> <p>There was labeling on the wall behind and just above each container which indicated what each container held. However, at the time of the inspection, none of the 55-gal accumulation containers were labeled.</p> <p>Specifically, the 55-gal container being used to accumulate used oil was not labeled with the words, "Used Oil."</p> | |

| <p>[Title]</p> <p>Observation_Image-20210527090930930407376.jpg</p> <p>05/27/2021 09:09 AM (AKT)</p> <p>Jon Jones</p> <p>Oil Storage Van</p> <p>No CBI</p> <p>No PII</p> <p>View of the unlabeled containers inside the Oil Storage Van.</p> | |

| Following the inspection, Mr. Thatcher sent me an email, dated 6/8/21, in which he provided photo documentation of containers that were labeled after the inspection. He also elaborated on the generation of off-spec gasoline and solvent at the facility. |

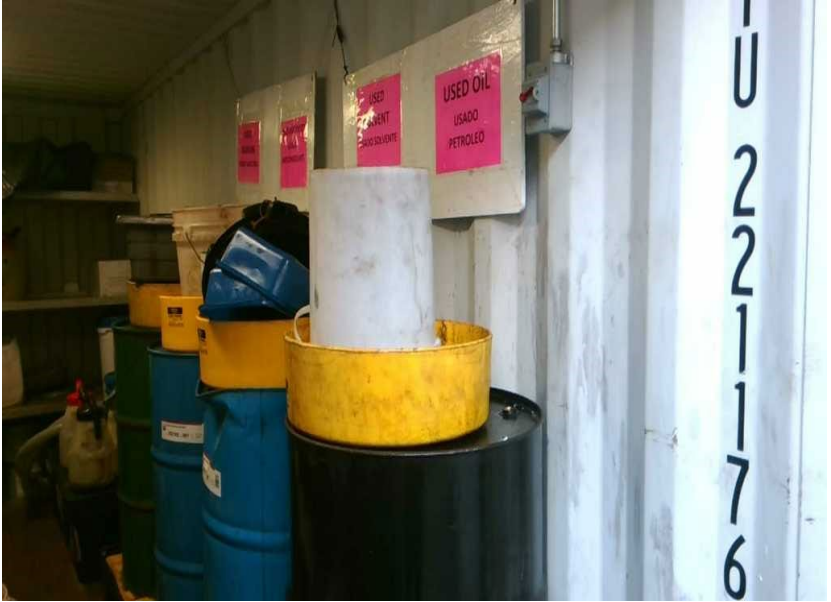
| Observation_Image-20210527090959959356168.jpg | |

| At the time of the inspection, the 55-gal container being used to accumulate used oil was not labeled with the words, "Used Oil." | <b>Citation:</b> | <b>Section:</b> |

| View of the black, 55-gallon unlabeled used oil storage container. | |

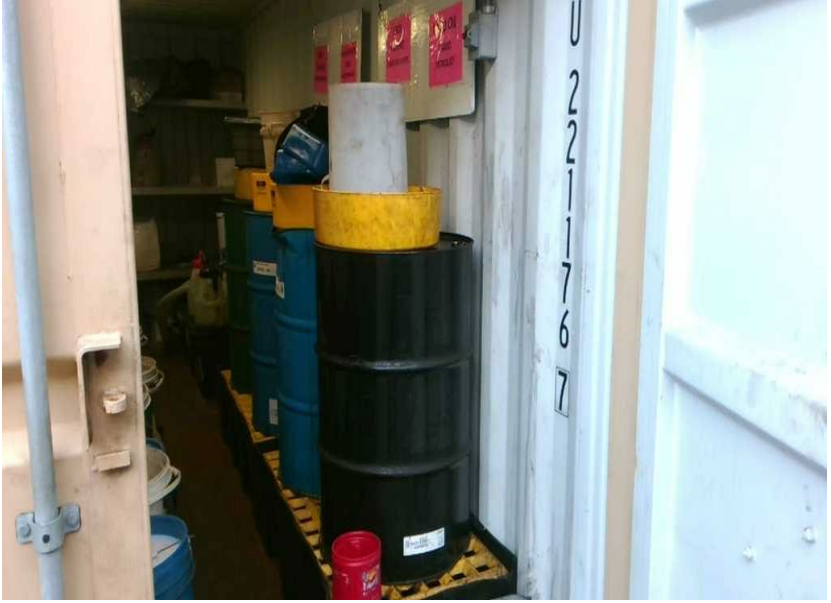
| Observation_Image-202105270912141214337223.jpg | |

| Another view of the 55-gal container being used to accumulate used oil, showing that it was not labeled with the words, "Used Oil." | |

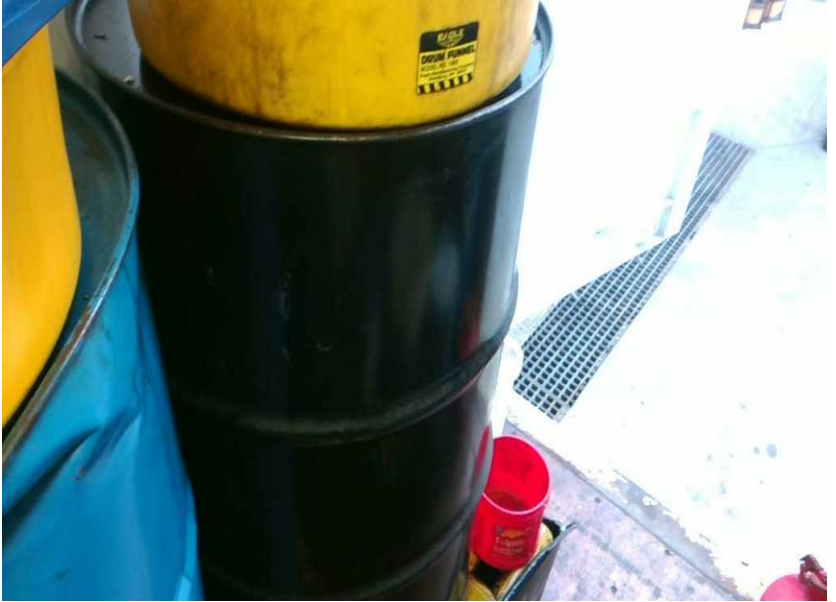
| Observation_Image-202105270912261226338214.jpg | |

| Another view of the 55-gal container being used to accumulate used oil, showing that it was not labeled with the words, "Used Oil." | |

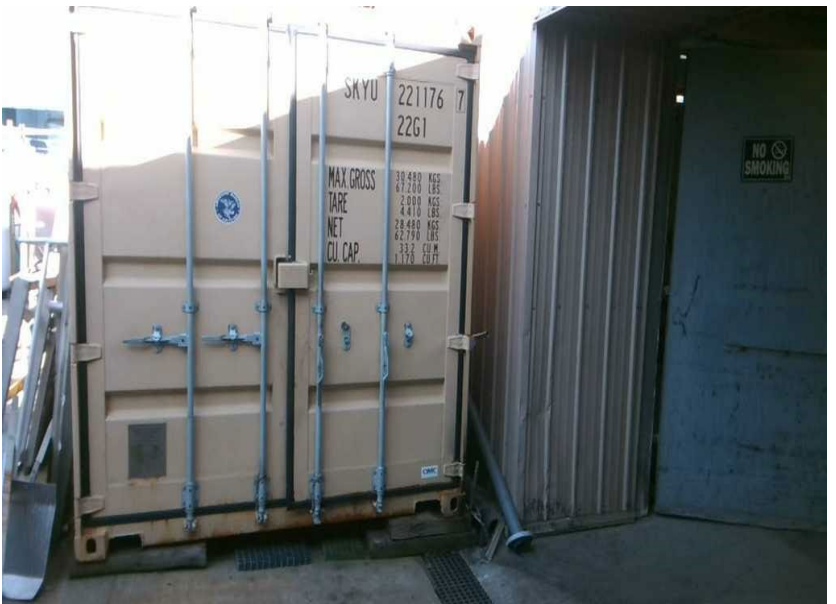
| Observation_Image-202105270932323232357384.jpg | |

| View of the Oil Storage Van. | |

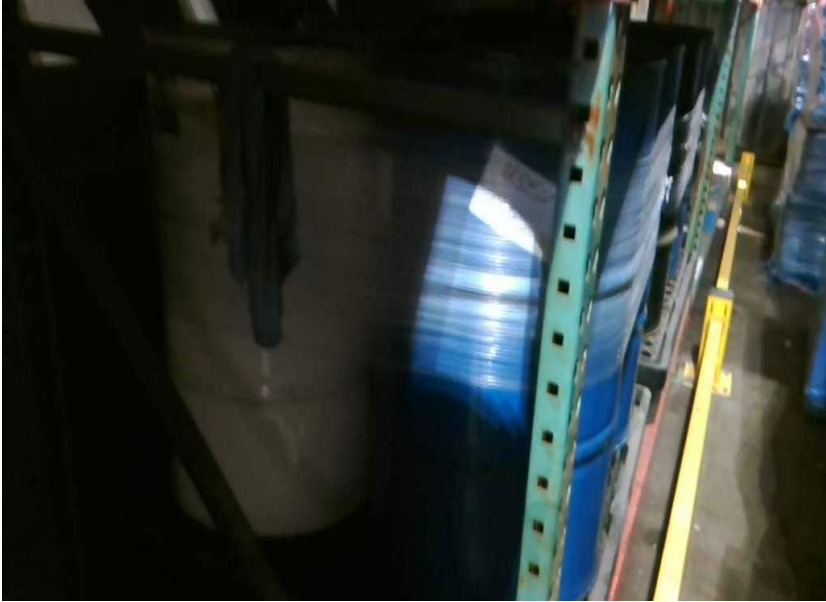
| Observation_Image-202105270846464646289742.jpg | | |

| <p>I saw four, 55-gallon containers on a pallet that were wrapped with a band of cellophane that was labeled with the words, "Galley Dirty Oil." According to Mr. Dillon they held used cooking oil.</p> | |

| View of containers holding used cooking oil. | | |

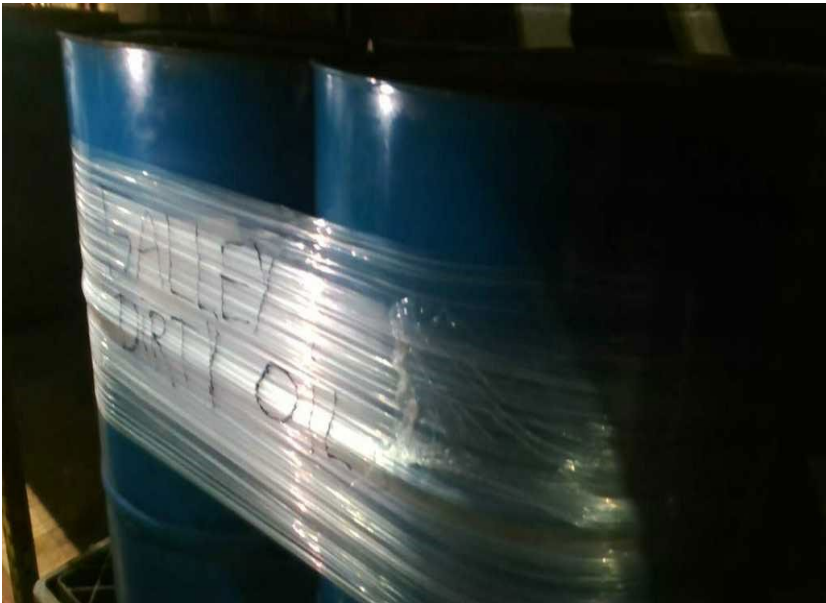
| Observation_Image-202105270847294729253245.jpg | | |

| Another view of the used cooking oil. | | |

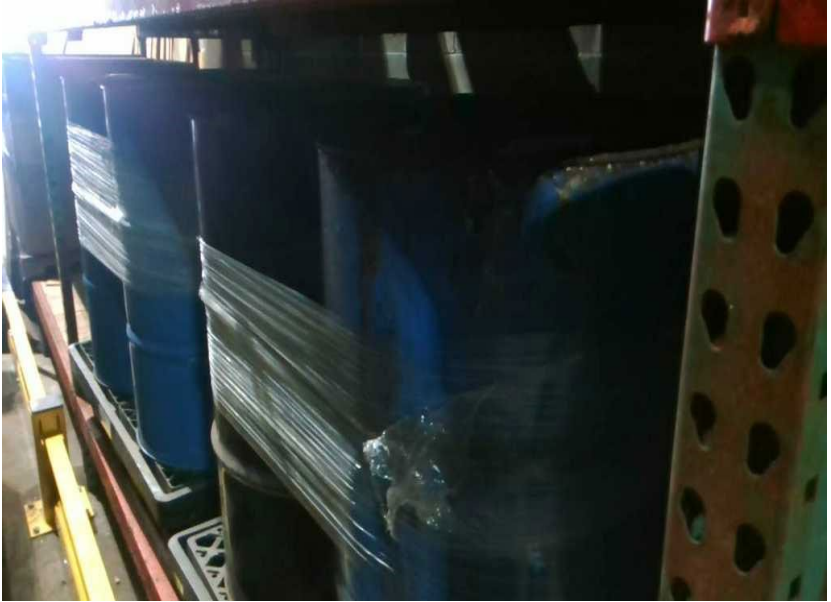
| Observation_Image-202105270847584758309983.jpg | |

| Another view of the used cooking oil. | |
