**Region 6 - Enforcement & Compliance Assurance Division**  
**INSPECTION REPORT**

| Media Program: | RCRA Compliance Evaluation Inspection | |
| Facility Name: | Choctaw Manufacturing and Defense Contractors Hugo | |

During the week of August 10, 2022, I, Angela Hays, conducted an unannounced inspection of the Choctaw Manufacturing and Defense Contractors facility (Choctaw) located at 203 Choctaw Industrial Drive, Oklahoma for compliance with the Resource Conservation and Recovery Act (RCRA). I was assisted on this inspection by Environmental Protection Agency (EPA) inspectors John Penland, Sandesh Thapa and Elizabeth Pham. The inspection included a walkthrough of the facility's production, waste generation, and management units and a review of the facility records related to hazardous waste management.

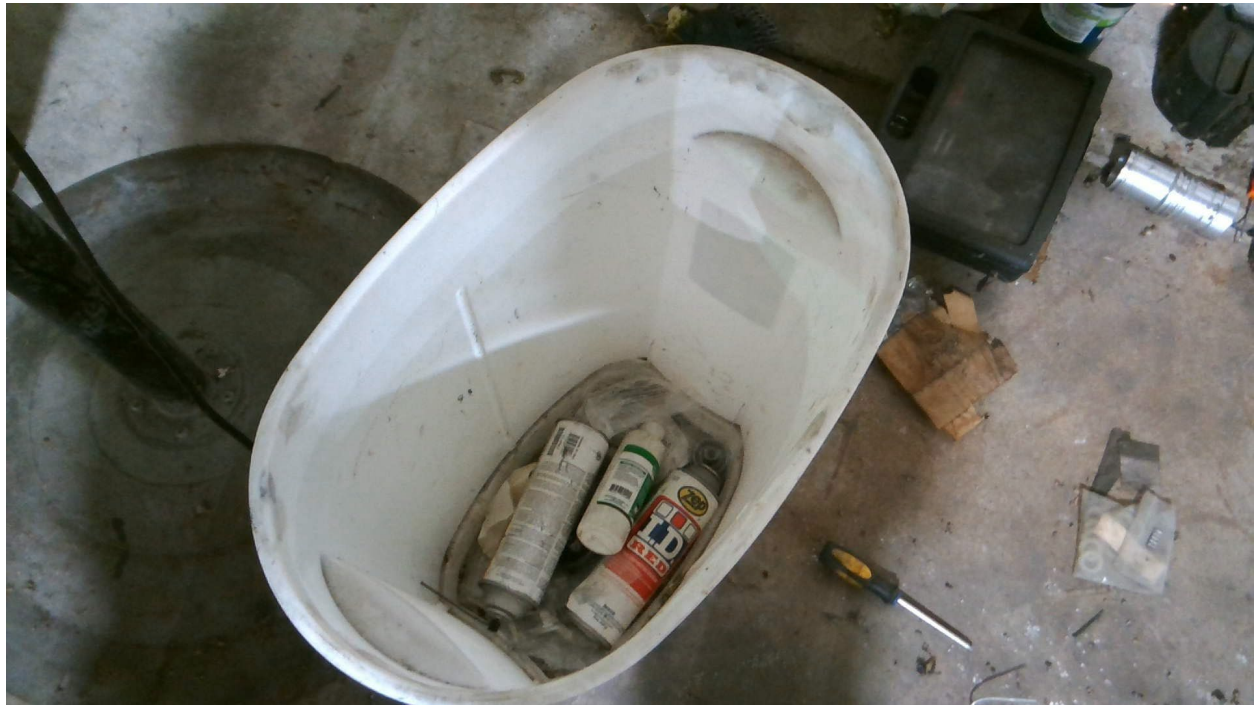
Photo No. 2

We noticed aerosol cans being disposed in a container without a label. The facility labeled the container during the walkthrough.

| Description: | Aerosol cans disposed in trash bin without label. Inside Building 105 |

- Aerosol can container with label
      - Adequate aisle space in 90 day storage area
      - Bulbs contained in box with proper universal waste label Cleaned corrosion from antifreeze drum

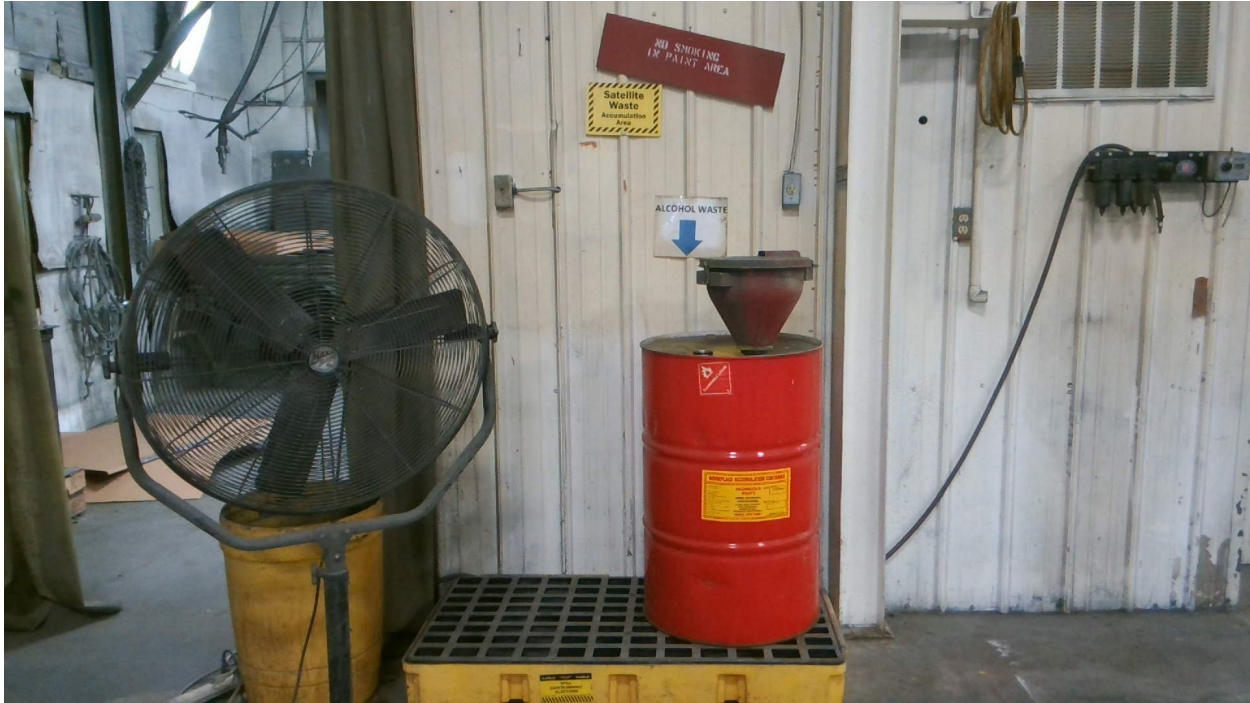
Photo No. 3

| Description: | SAA with open drum dated 9/2/2020 inside Building 203 |

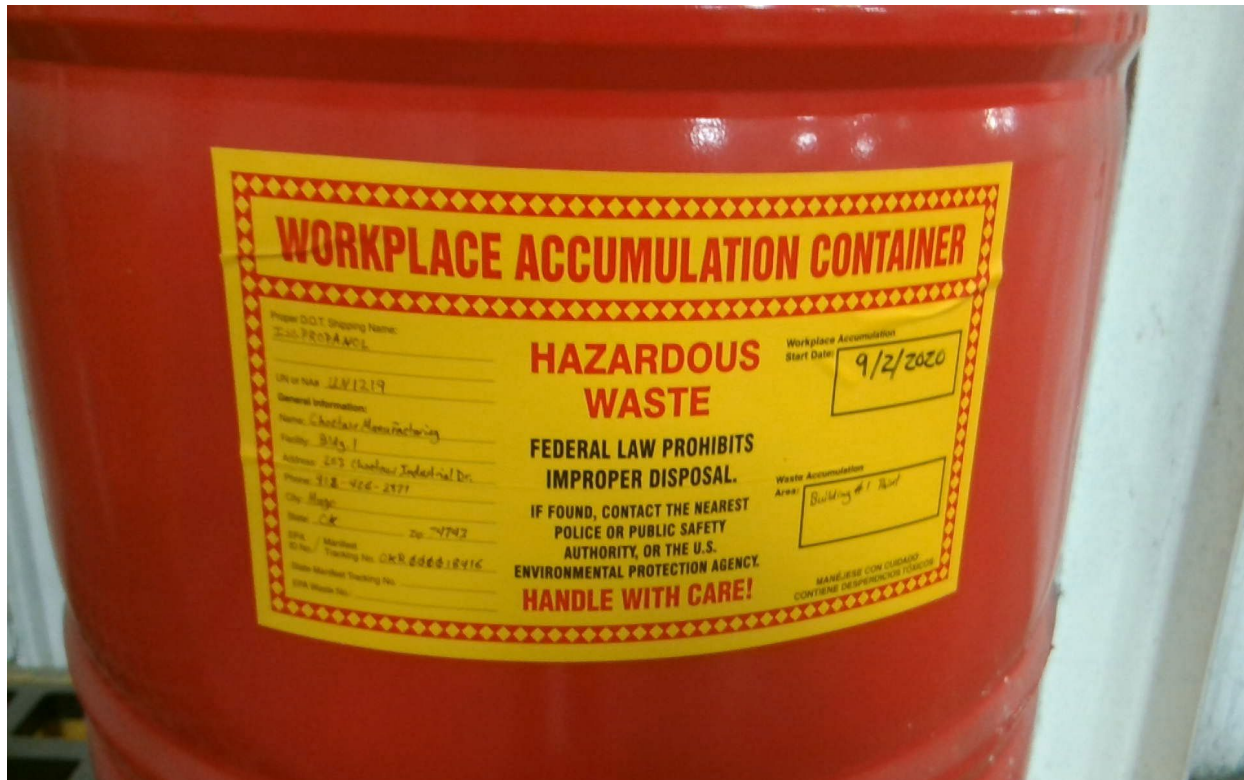
Photo No. 4

| Description: SAA with open drum dated 9/2/2020 inside Building 203 | |

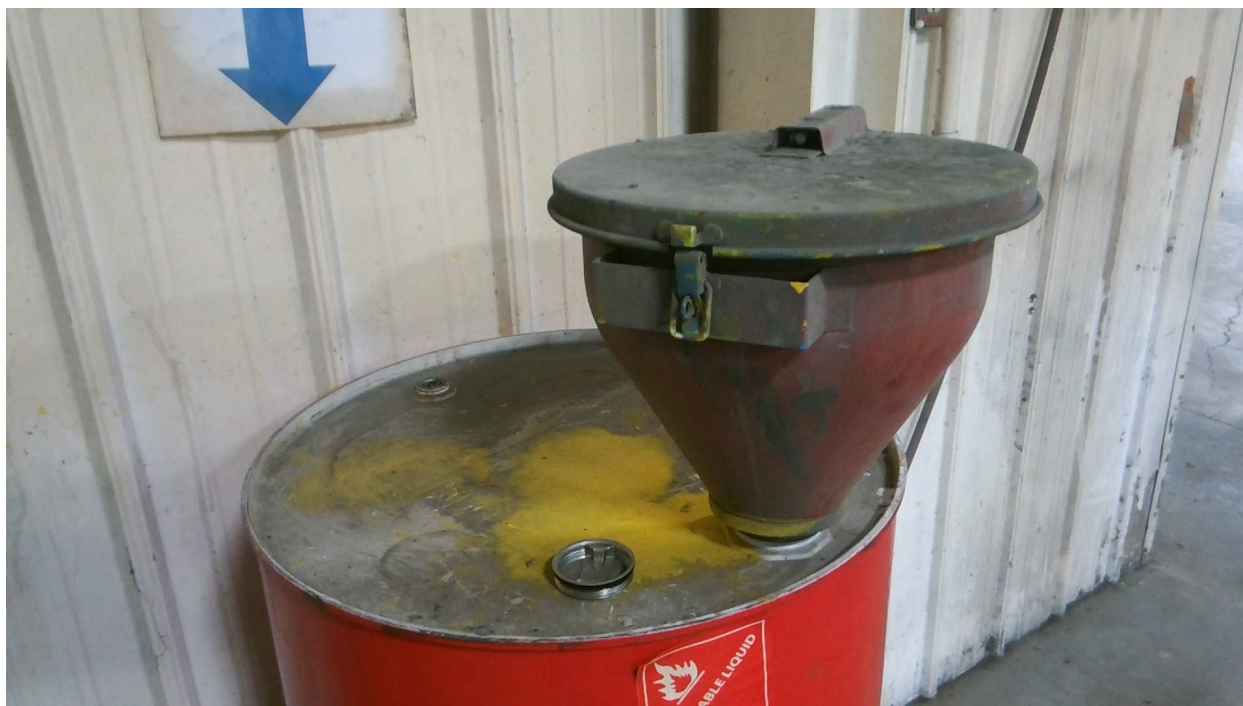
Photo No. 5

| Description: Close view of open latch on funnel in SAA area inside Building 203 | |

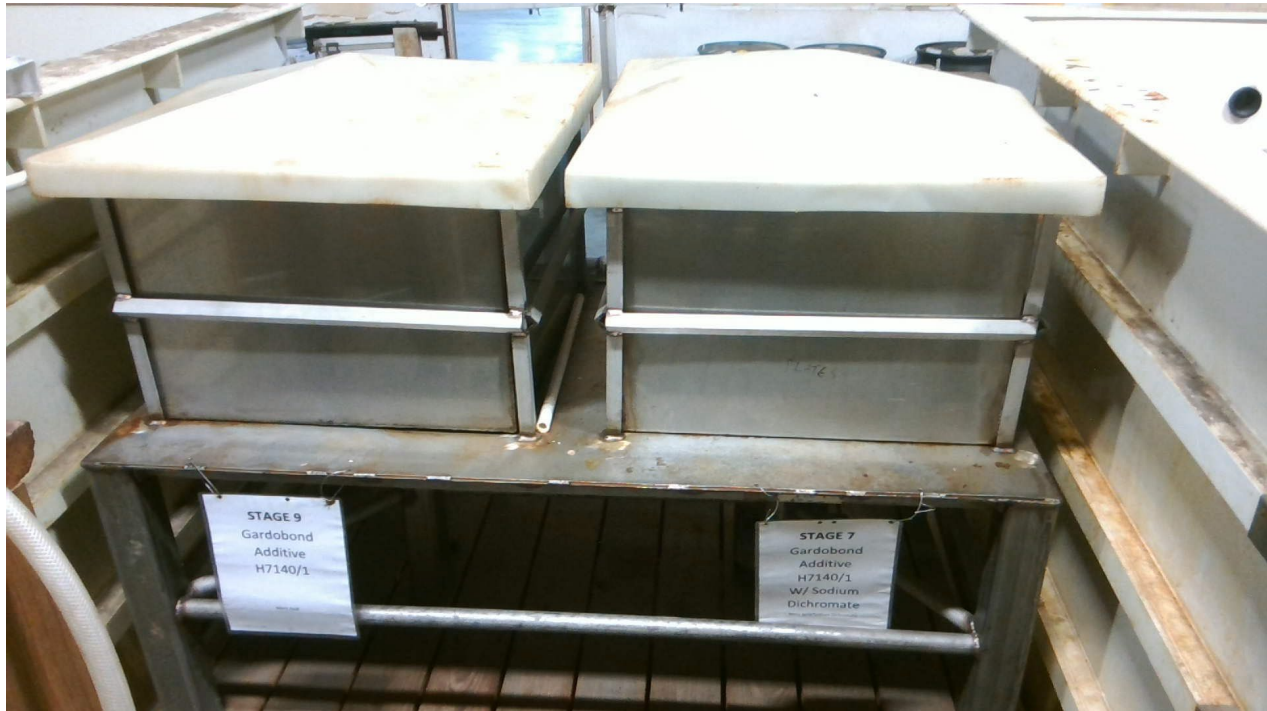
Photo No. 6

The facility conducts stainless steel passivation. We saw three tanks being used for the process- Nitric Sodium Dichromate, Nitric and Rinse tanks. Every few months, the facility runs this process based on received orders. The most recent waste generated from this process was in July 2022. See Appendix 1.

| Description: | Nitric passivation with Na dichromate inside Building 203 last used on Nov 2022. |

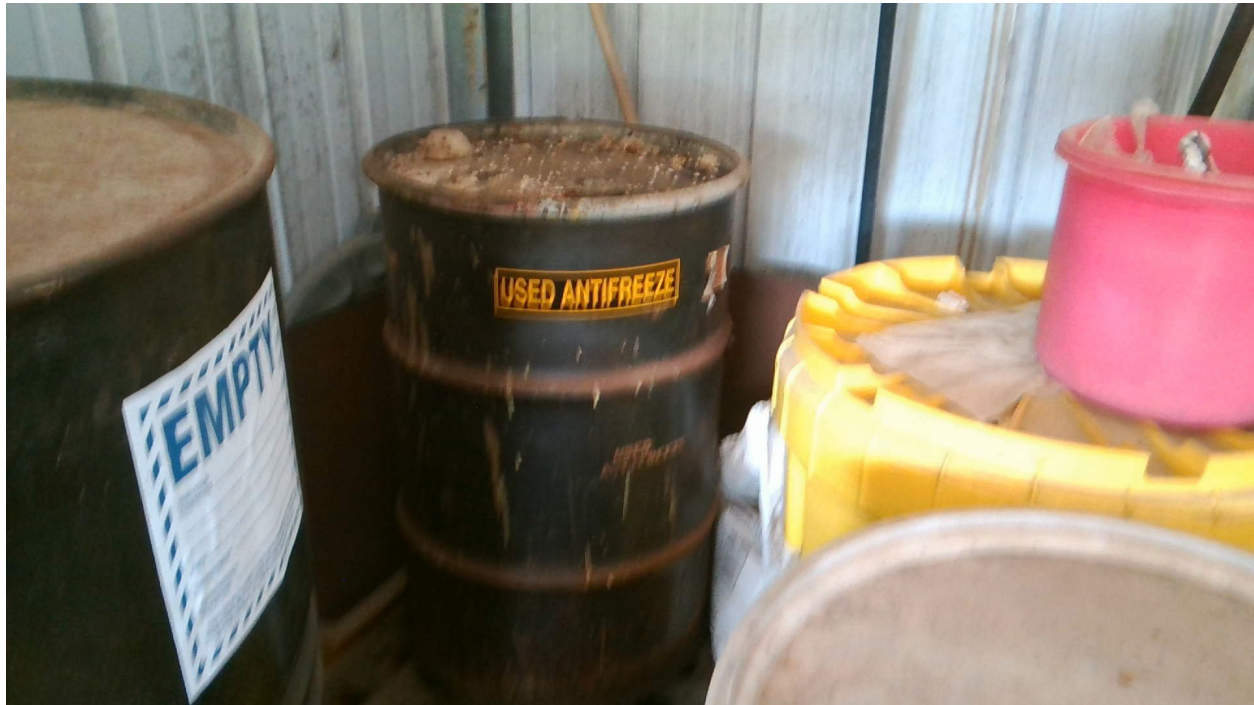
Photo No. 7

The CAA is located outside Building 203 and it contained 22 drums. There were 19 empty drums, 1 used oil drum, 1 hazardous waste drum and 1 drum of antifreeze staged at CAA. The drums were tightly stacked next to each other. We noticed a corrosion on top of the antifreeze drum. See Appendix 1. Facility representatives cleaned the corrosion on top of the antifreeze drum and corrected the aisle spacing inside the CAA.

| Description: | Used antifreeze drum with rust on top inside CAA located outside Building 203. |

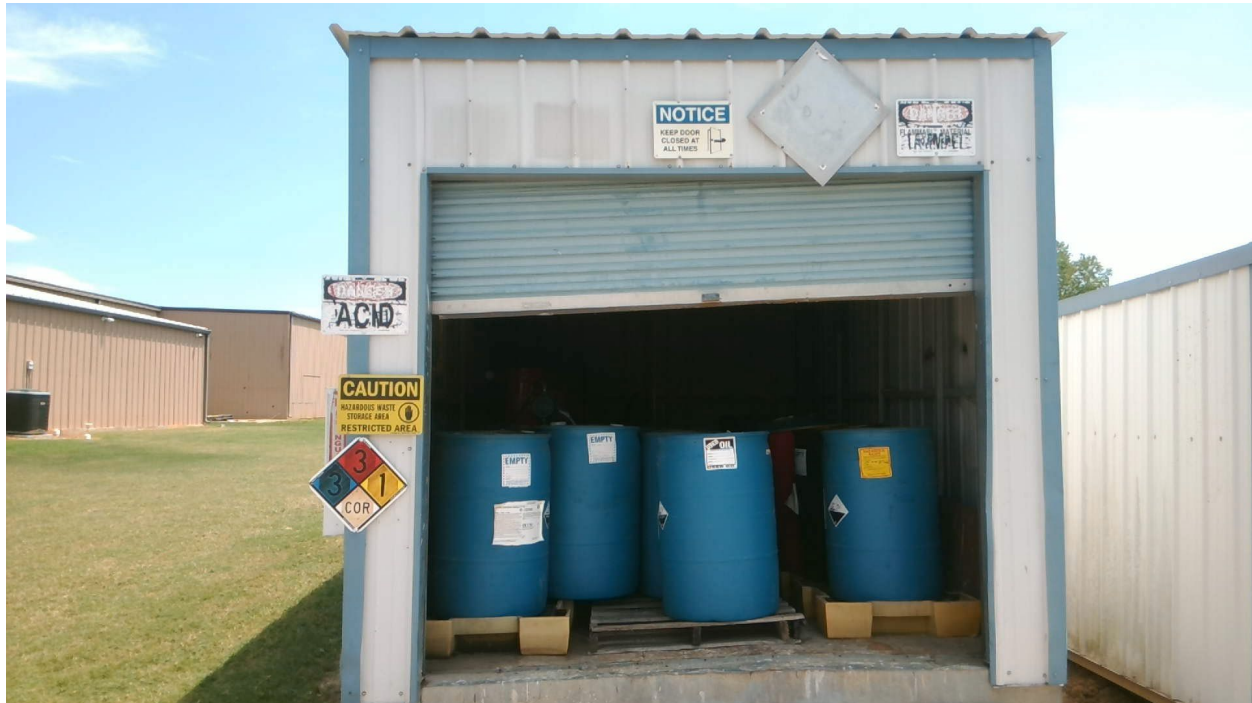
Photo No. 8

| Description: View of CAA containing 22 drums. CAA is located outside Building 203. Note lack of aisle spacing. | |

- 90 day storage area
    - Consisted of 19 empty drums, 1 used oil drum, 1 hazardous waste drum, and 1 drum of antifreeze.
      - AOC isle space in between drum rows.
