INSPECTION REPORT

| Type of Inspection | Compliance Evaluation Inspection (CEI) | |
| Permittee Name | City of Gonzales Water System | |
| Permit Number(s) (If Applicable) | LA0109576 | |

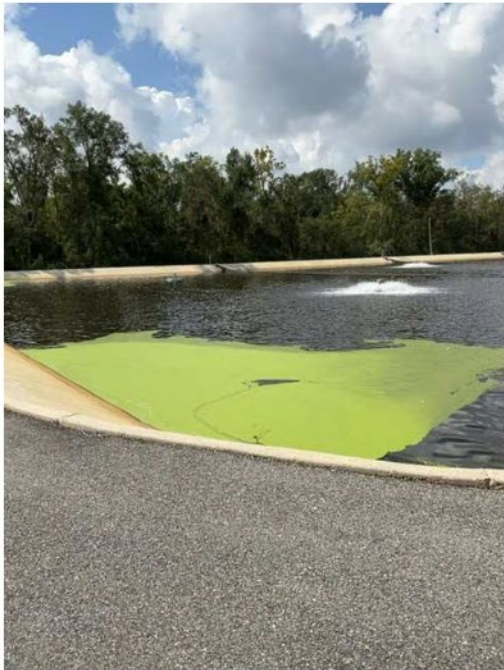
| Treatment System | | | IMG-202409171047424742112459.jpg |

| Aeration lagoon | | | |

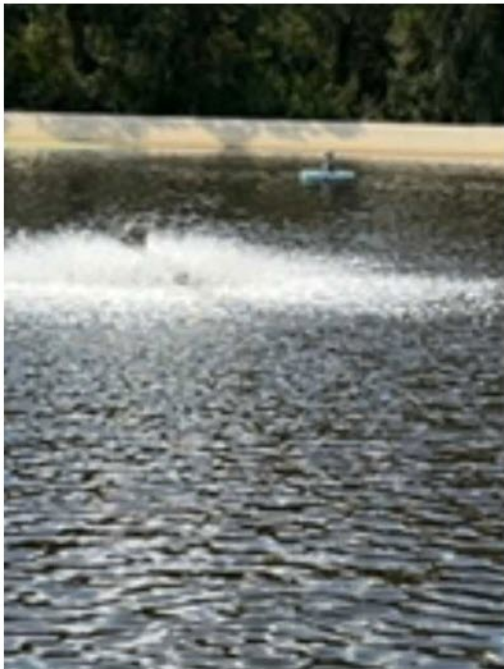
| Aerators and duckweed in aeration lagoon 1. | | | IMG-202409171047454745125168.jpg |

| Aerators and duckweed in aeration lagoon 1. | | | |

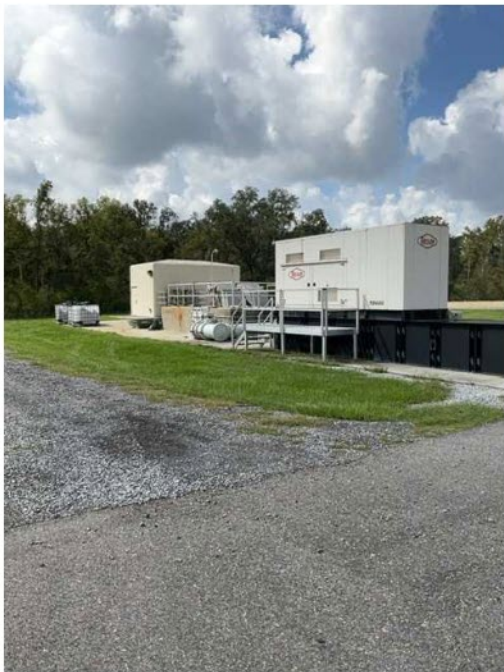
| Aerator in aeration lagoon 1 | | | IMG-20240917104837483768758.jpg |

| Aerator in aeration lagoon 1 | | | |

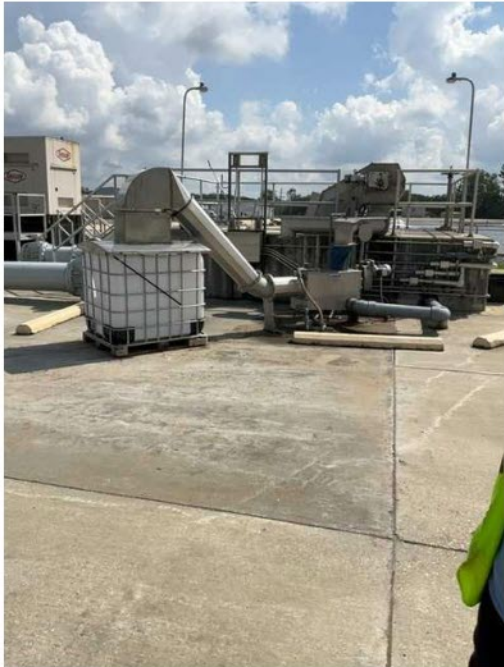
| New Headworks | | | IMG-20240917105714571466637.jpg |

The area around the head works is a source for stormwater contamination. BMPs are needed to reduce contact with stormwater and/or capture contaminated stormwater in the area. This area was not included in the site's SWPPP as required.

| New screen that is a potential stormwater pollution source. | | | |
