## **RCRA Inspection Report**

Mississippi Air National Guard (MS ANG) Combat Readiness Training Center (CRTC)  
4715 Hewes Avenue  
Gulfport, Mississippi 39501  
EPA ID No.: MS6570090013

**COMPLIANCE EVALUATION Inspection**

**November 17, 2021**

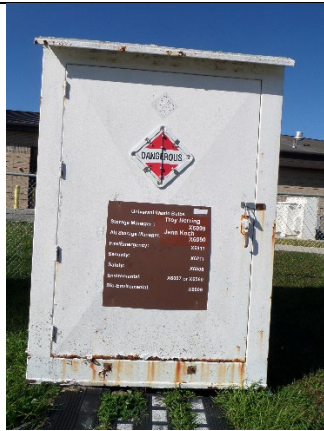
The inspectors observed a white color metal fabricated shed with rust on the bottom part of the door locked at the time of inspection. The door had a hazard placard as "Dangerous" and a sign indicating "Universal Waste Bulbs" and emergency contact information on the door (Photo-1). The inspectors observed three 4-foot boxes and one 8-foot box containing spent fluorescent lamps. One 4-foot box and one 8-foot box containing spent fluorescent lamps were observed to be open and two 4-foot boxes and one 8-foot box were observed to be undated at the time of inspection (Photo-2 and 3).

Photo-1 Universal Waste Shed

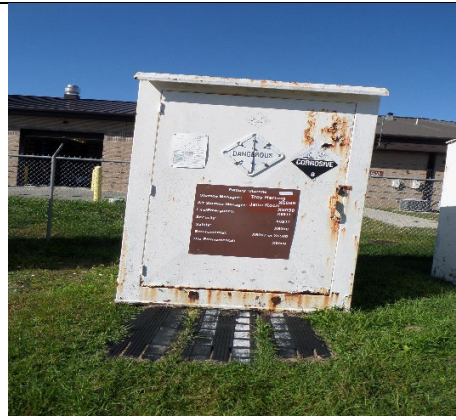
The inspectors observed SAA comprising of a white color metal fabricated shed with rust on the top and bottom part of the door locked at the time of inspection. The door had a hazard placard as "Dangerous" and "Corrosive". The inspectors observed a sign indicating that the shed was used for storing spent batteries and hazardous waste (Photo-5). The inspectors observed two unlabeled wooden boxes stored on pallets containing non-hazardous alkaline batteries (Photo-6). The inspectors also observed three 1-gallon containers with hazard indication as "Corrosive". The trade name on the container was marked as "CHEMPRIME", rust inhibitor (Photo-7). The containers were observed to be closed and unlabeled as "Hazardous Waste". There were no leaks and spills observed near the containers.

Photo-5 Spent Batteries and Corrosive Waste Shed

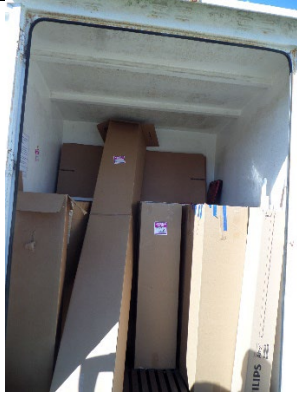
**Pursuant to 11 Miss. Admin. Code Pt. 3, R. 1.21 [40 C.F.R. § 273.15(a) and (c)], a SQHUW may accumulate universal waste no longer than one year and must be able to demonstrate the length of time that the universal waste has accumulated from the date that it became a waste or was received.**

Photo-2 Open and Undated Universal Waste Lamps

An email with photos was sent on November 18, 2021, documenting the corrective action taken for closure and dating the boxes containing the spent fluorescent lamps at the storage shed (Photo-4).

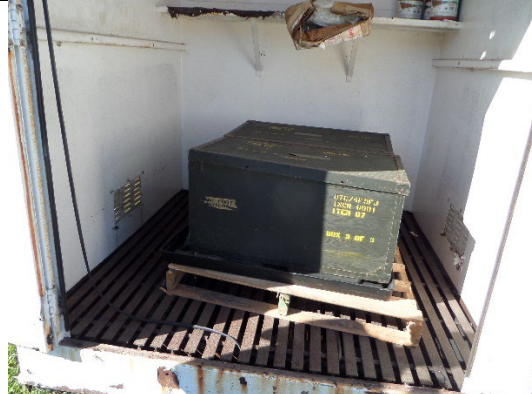
Photo-6 Nonhazardous Spent Batteries Boxes

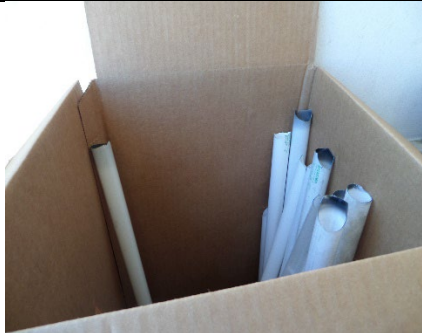
**Pursuant 11 Miss. Admin. Code Pt. 3, R. 1.21 [40 C.F.R. § 273.13(d)], a SQHUW must manage universal waste lamps in a way that prevents releases of any universal waste or component of a universal waste to the environment**

Photo-3 Open Universal Waste Lamps

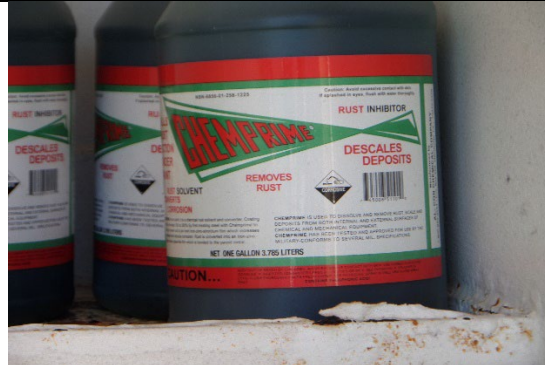
**Pursuant to 11 Miss. Admin. Code Pt. 3, R. 1.3 [40 C.F.R. § 262.15(a)(5)], which is a condition of the SAA Permit Exemption, a generator is required to mark or label its containers (i) with the words “Hazardous Waste” and (ii) with an indication of the hazards of the contents.**

Photo-7 Unlabeled Corrosive (D002) Waste

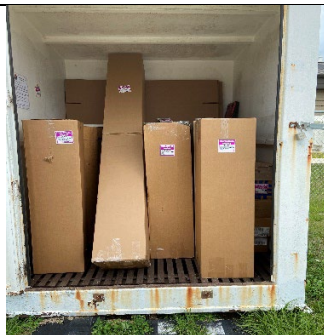
Photo-4 Closed, labelled and Dated Universal Waste Lamps

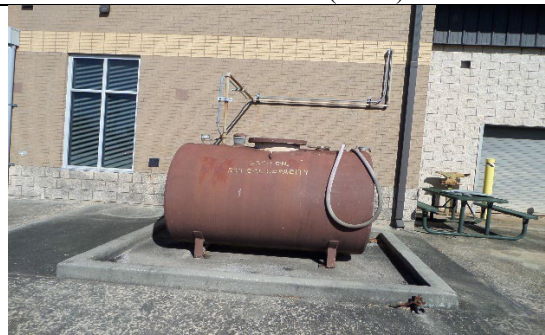
The inspectors observed a 500-gallon double walled tank inside a secondary containment located outside the maintenance shop. The closed tank had a faded “Used Oil” label on it (Photo-8). The inspectors recommended a clear and visible label on the tank. An email with a photo of the used oil storage tank marked with a visible label was sent on November 18, 2021, (Photo-9). There were no leaks and spills observed in the secondary containment.

Photo-8 Used Oil Tank (Faded Label)

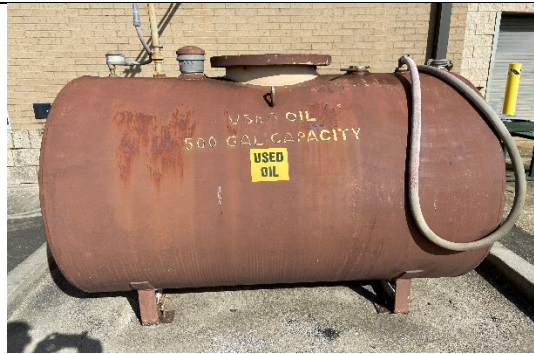
Photo-9 Used Oil Tank with a visible label

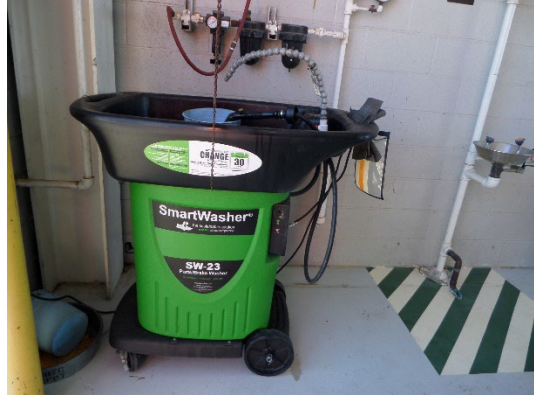
The Aerospace Ground Shop provides maintenance and servicing support for various aircraft equipment. There is no painting activity conducted on site. The inspectors observed a Smart Washer, SW-23 Model, Parts/Brake equipment (Photo-10). The equipment was not in service at the time of inspection. The equipment used a biodegradable solution for parts washing. The cleaning fluid was determined to be nonhazardous. In the same area, the inspectors observed an unlabeled parts washer in the service area (Photo-11). The equipment was not in use at the time of inspection. The maintenance personnel stated that the facility had a contract with Safety-Kleen Systems Inc. for servicing the parts washer equipment. The equipment was later labeled before the end of the inspection.

Photo-10 Nonhazardous Parts Washer Unit

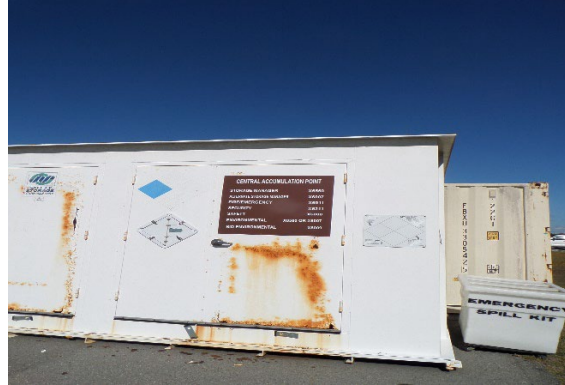
The Central Accumulation Point storage is a separate building with a sign at the entrance indicating the building use and emergency contact information (Picture-13). The storage area was equipped with fire protection equipment. The waste streams stored in the storage included corrosives, universal waste, and nonregulated waste. The inspectors observed one 55-gallon drum labeled as “Nonhazardous Waste” and one empty 30-gallon container. In addition, the inspectors observed three unlabeled and undated 5-gallon buckets containing spent batteries. One of the 5-gallon bucket containing spent batteries had a corrosive label on it (Picture-14).

Photo-13 Central Accumulation Point Storage Unit

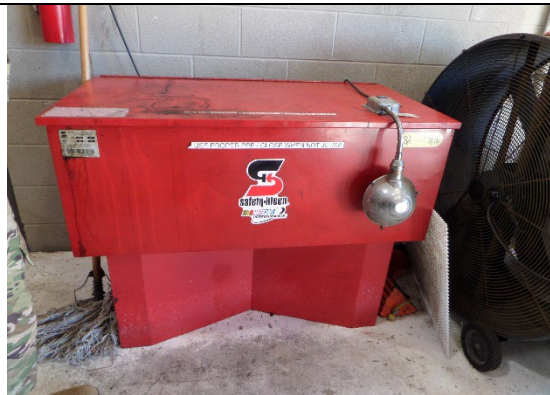
**Pursuant to 11 Miss. Admin. Code Pt. 3, R. 1.3 [40 C.F.R. § 262.15(a)(5)], which is a condition of the SAA Permit Exemption, a generator is required to mark or label its containers (i) with the words “Hazardous Waste” and (ii) with an indication of the hazards of the contents.**

Photo-11 Unlabeled Safety-Kleen Parts Washer Unit

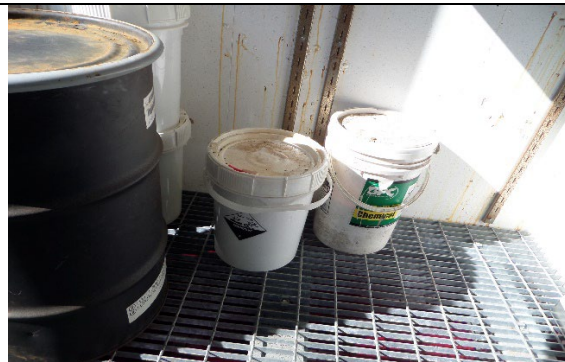
**Pursuant to 11 Miss. Admin. Code Pt. 3, R. 1.3 [40 C.F.R. § 273.14(a)], a SQHUW must label or mark each Universal Waste battery or container or tank in which the batteries are contained clearly with one of the following phrases: “Universal Waste - Battery(ies),” or “Waste Battery(ies),” or “Used Battery(ies).”**

**Pursuant to 11 Miss. Admin. Code Pt. 3, R. 1.3 [40 C.F.R. § 273.15(a) and (c)], a SQHUW may accumulate universal waste no longer than one year and must be able to demonstrate the length of time that the universal waste has accumulated from the date that it became a waste or was received.**

Photo-14 Spent Batteries with hazard indication

An email was later sent indicating that all the buckets containing spent batteries were labeled, dated, and moved to the universal waste storage shed. The inspectors observed bright reddish colored fluid on the grated floor of the storage building. Mr. Akozbek suspected the liquid to be antifreeze fluid. He said that he was in the process of making a waste determination prior to disposing of the unknown liquid (Photo-15). The inspectors requested Mr. Akozbek to provide a copy of the manifest and/or a bill of lading for the unknown liquid for disposal.

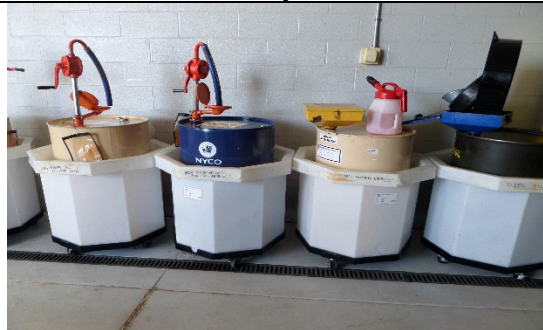
The inspectors also observed five 5-gallon containers in secondary containment in corner of the maintenance shop (Photo-12). The containers were observed to be closed and labeled as “New Engine Oil”; “New Turbine Oil”; “Used Antifreeze”; and “Used Oil”. The containers containing “New Engine Oil” and the “New Turbine Oil” were connected to a hand operated pumps connected to separate hoses.

Photo-12 Used Oil and Product Containers

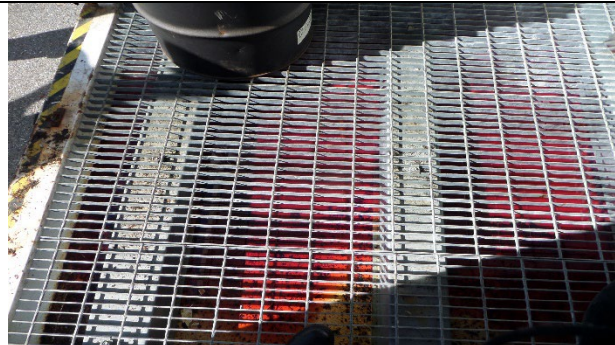
**Pursuant to 11 Miss. Admin. Code Pt. 3, R. 1.3 [40 C.F.R. § 262.11], a person who generates a solid waste, as defined in 11 Miss. Admin. Code Pt. 3, R. 1.3 [40 C.F.R. § 261.2], must make an accurate determination as to whether that waste is a hazardous waste in order to ensure wastes are properly managed according to applicable RCRA regulations articulated in 11 Miss. Admin. Code Pt. 3, R. 1.3 [40 C.F.R. § 262.11].**

**Pursuant to 11 Miss. Admin. Code Pt. 3, R. 1.3 [40 C.F.R. § 262.16(b)(8)(i)], which is a condition of the SQG Permit Exemption, a generator is required to maintain and operate its facility to minimize the possibility of a fire, explosion, or any unplanned sudden or non-sudden release of hazardous waste or hazardous waste constituents to air, soil, or surface water which could threaten human health or the environment.**

Photo-15 Unknown liquid spill in the secondary containment of Central Accumulation Point Storage Unit
