## **RCRA Inspection Report**

Arnold Engineering Development  
Complex  
100 Kindel Drive, Suite B-322  
Arnold AFB, Tennessee 37389-2322

May 7 - 8, 2024 at 8:42 AM

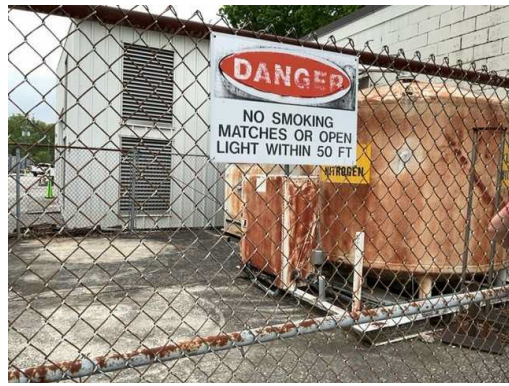
Outside of the chemistry lab, inspectors observed two IAP cabinets surrounded by a locked chain link fence (Photo 1). The fence was equipped with a “Danger: No Smoking” sign. One cabinet held a 55-gallon container of ignitable waste marked with the words “hazardous waste, ignitable, Oil, Solvents, Mixed Chemicals.” The second cabinet held one 5-gallon container labeled “Hazardous waste, corrosive, acid samples.” Waste is brought to the IAP cabinets from the individual laboratory rooms at the end of each shift. The IAP containers are managed as satellite accumulation area containers. Facility representatives informed inspectors that the 55-gallon container is emptied approximately twice a year.

Photo 1 – IAP outside if chemistry laboratory

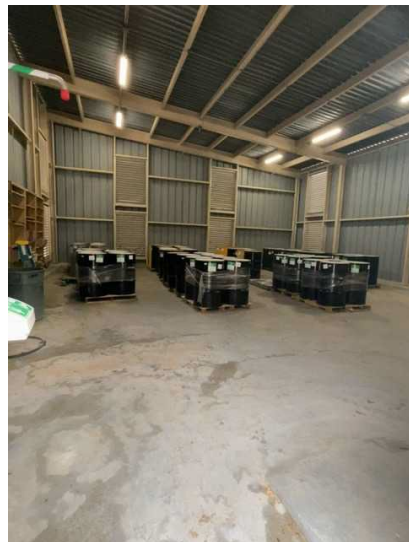
The chemistry laboratory 90-day central accumulation area is in a small concrete storage room outside of the chemistry lab (Photo 3). Facility representatives informed inspectors that this area was established to store hazardous waste generated in the chemistry lab, however this and the other CAAs across the facility are now primarily used for used oil storage due to the high volume of used oil waste generated on site. Facility representatives informed inspectors

Photo 3 – Chem Lab CAA.

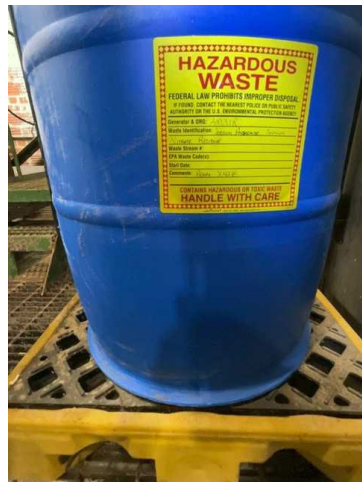
The AEDC Model Shop conducts the planning and building of model subjects used for testing tunnels across the facility. The model shop staffs 200 employees. Inspectors were greeted in this area by John Grisham, Outside Lead Machinist, and Ronald Silver, Safety Professional of NAS. Waste generated at the model shop includes nickel penetrate black oxide and sodium hydroxide waste which is managed in the Model Shop IAP. Product black oxide is managed in a tank at the model shop and is used as an anti-rusting agent that treats metals of oils and makes the metal porous. At the time of the CEI, the Model Shop IAP consisted of a 55-gallon container on a secondary containment pallet segregated by a chain around the area. Inspectors observed one 55-gallon container in this area labeled with the words “Contains hazardous waste or Toxic Waste, Sodium Hydroxide, Sodium Nitrate Residue” (Photo 4). Inspectors requested that facility personnel label this container with a corrosive indication of hazards. This was corrected on site.

Photo 4 – Model Shop IAP container.

**Pursuant to Tenn. Comp. R. & Regs. 0400-12-01-.03(1)(f)1.(v) [40 C.F.R. § 262.15(a)(5)], which is a condition of the SAA Permit Exemption, a generator is required to mark or label its containers (ii) with an indication of the hazards of the contents.**

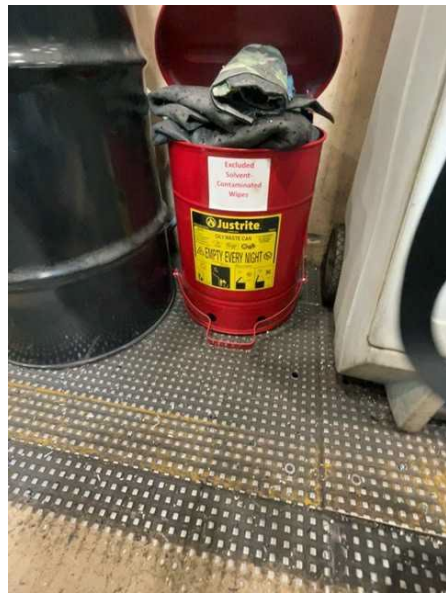
Inspectors observed one 15-gallon and one 5-gallon container labeled “Excluded Solvent Contaminated Wipes” in the model shop. Both appeared to be clear of free liquids, however the 5-gallon container was overfilled with rags and could not be closed (Photo 5).

Photo 5 – Excluded Solvent Contaminated Rags container overfilled and unable to close.

**Pursuant to Tenn. Comp. R. & Regs. 0400-12-01-.02(1)(d)2. [40 C.F.R. § 261.4(a)(26)(i)], which is an exclusion for materials which are not solid wastes, the solvent-contaminated wipes, when accumulated, stored, and transported, are contained in non-leaking, closed containers.**

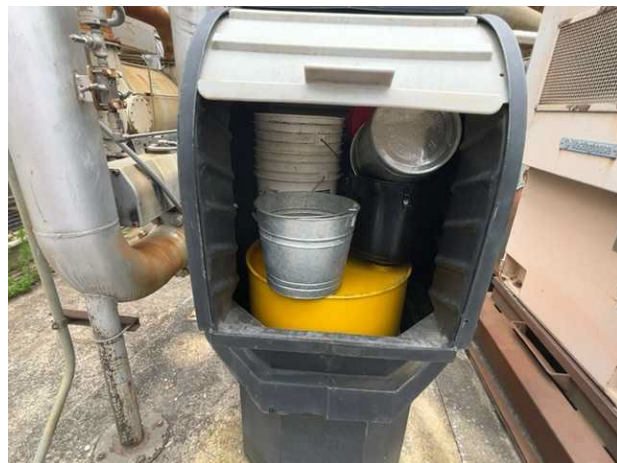
At the time of the inspection, inspectors observed a water pump pouring water into a drain under the PWT. Facility representatives said that this was a leak to be repaired, and the drain collected water to be recirculated throughout the system. Inspectors observed a 55-gallon container labeled "PPE PCB Contaminated" and four 55-gallons containers labeled "Used oil and water" in the PWT. Two of the oily water containers were located under the wind tunnel and two were inside of a clamshell container that was also labeled as oil and water (Photo 6).

Photo 6 – PWT IAP container.

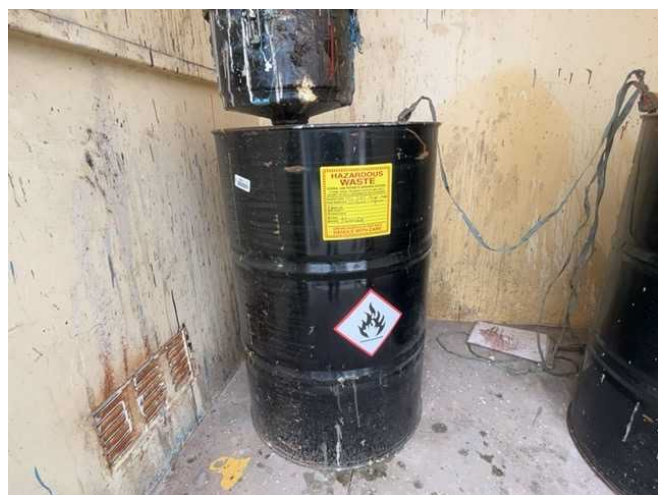
Outside paint shop: One 55-gallon container labeled “nonhazardous latex paint” and one 55-gallon container labeled “Hazardous Waste, Oil paint thinner epoxy, Flammable” (Photo 9). Both containers in the outside IAP were closed with funnels attached. The outside IAPs were stored in a closed and locked trailer.

Photo 9 – Paint Shop IAP container

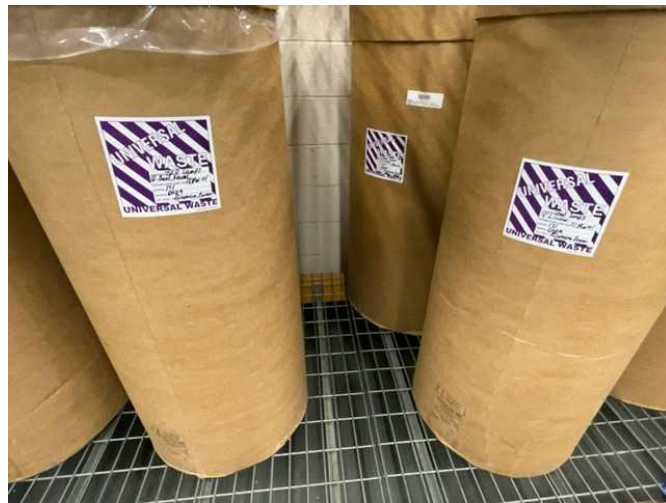
Photo 11 – Universal Waste lamps stored in the permitted hazardous waste storage unit.
