## **RCRA Inspection Report**

TE Connectivity  
719 Pegg Road  
Greensboro, North Carolina 27409

EPA ID#: NC0000202523  
NAICS #: 336320 – Motor Vehicle Electrical  
and Electronic Equipment Manufacturing

March 4, 2025, 9:20 AM

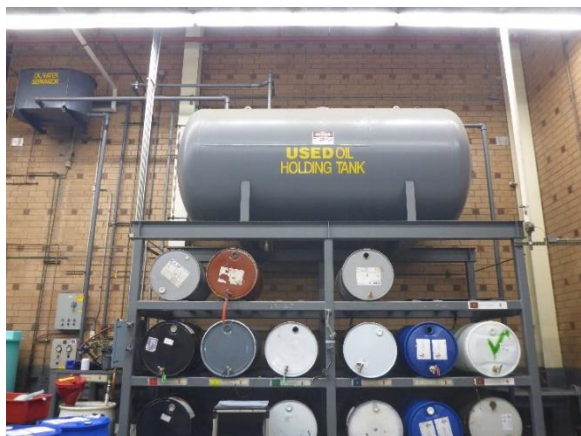
TE stores containers of lubrication oil products and accumulates used oil in the area referred to as the Scrap Room. The inspectors observed containers of new and used oil, a used oil storage tank (Photo 1), an emergency eyewash and shower station, and a fire extinguisher in this area. Michelle Kareis explained that used oil is accumulated in a small container at each stamping press. According to Michelle Kareis, TE personnel bring those small containers to this area and pour their contents into a funnel that drains into a 55-gallon used oil accumulation container (Photo 2) next to the shelving unit that holds the used oil tank. Used oil is then pumped from the 55-gallon used oil accumulation container into the used oil storage tank. The inspectors observed that the 55-gallon accumulation container and the storage tank were each labeled with the words "used oil."

**Photo 1:** Used oil storage tank stored at the top of a shelving unit holding oil products in the Scrap Room.

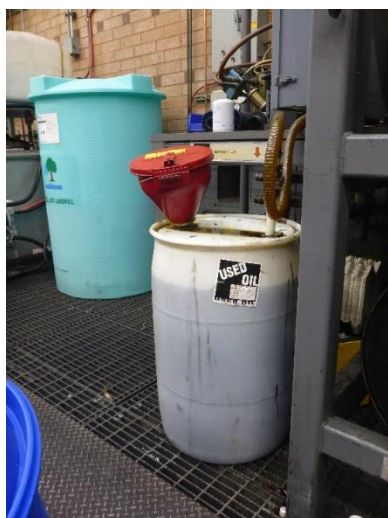
The inspectors noted an oily film on the floor in the Scrap Room, which made the surface very slick to walk upon, and observed used oil on the lid of the 55-gallon used oil accumulation container. The inspectors also observed oily liquid in the room's secondary containment sump, and in the secondary containment pallet beneath the oil product containers (Photo 5). Michelle Kareis stated that the liquid in the secondary containment pallet will be pumped into the used oil tank.

**Photo 2:** 55-gallon container accumulating used oil in the Scrap Room. Personnel bring containers of used oil to this area and pour their contents through the funnel into the 55-gallon container. The contents of the container are pumped to the used oil storage tank.

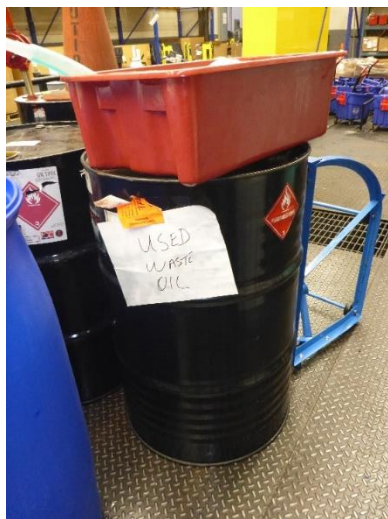
The inspectors observed two additional 55-gallon containers, which also appeared to be storing used oil, in this area. One of the containers was labeled with the words "used waste oil" and identified with a DOT flammable liquid hazard sticker (Photo 3). This container was approximately  $\frac{3}{4}$  full and the bung was completely open. The second container was brought to this area by TE personnel during the inspection. The container was also identified with a DOT flammable liquid hazard sticker, and the employee used a universal waste label to identify the contents of the container as "waste oil DTE 24" (Photo 4).

**Photo 3:** 55-gallon container labeled "used waste oil" observed in the Scrap Room.

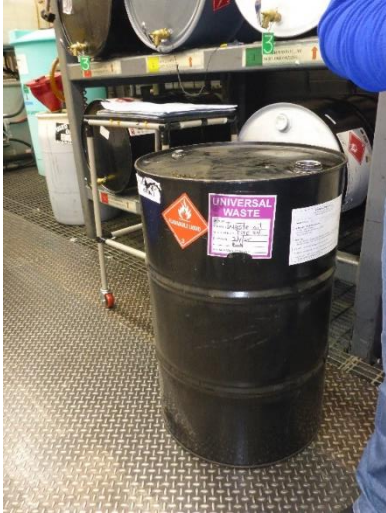
**Photo 4:** Container of used oil that was brought to the Scrap Room by TE personnel during the inspection. The container was identified with a DOT flammable liquid hazard sticker, and the employee used a universal waste label to identify the contents of the container as “waste oil DTE 24.”

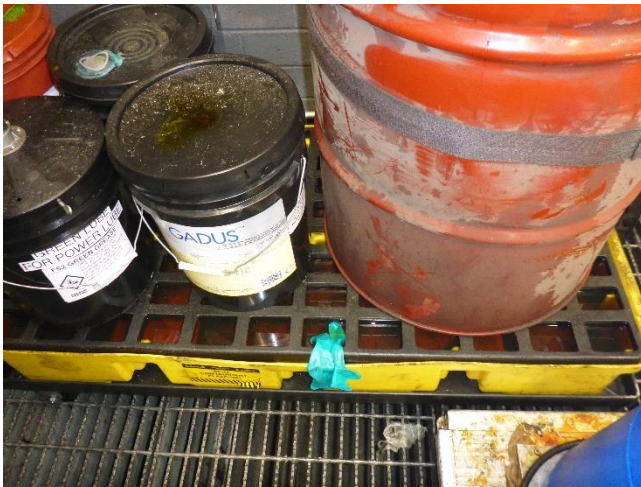
Containers of lubrication oil products were observed on a metal shelf beneath the used oil tank and on a secondary containment pallet near the door into the Scrap Room. The room is equipped with a secondary containment sump that was visible beneath the portion of the floor constructed of a metal grate and that appears to fill the entire length of the room beneath the oil containers and storage tank. Michelle Kareis explained that the secondary containment sumps are washed out and pumped to the nonhazardous waste storage tanks located outside of the building. She also explained that TE is able to pump liquid from the secondary containment sump to the oil/water separator so that the oil can be accumulated in the used oil

**Photo 5:** Secondary containment pallet beneath oil product containers near the door of the Scrap Room. The pallet was nearly full of liquid.

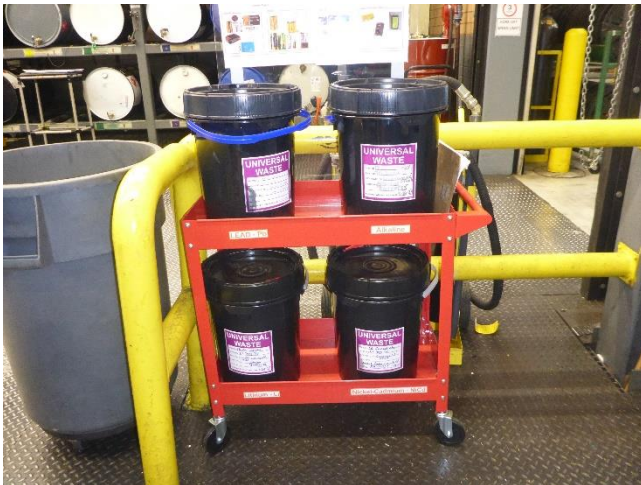
In addition to lubrication oil products and used oil, TE also manages containers of universal waste in the Scrap Room. The inspectors observed a red mobile cart holding containers of universal waste that was staged near the entrance into the room (Photo 6). The cart held one 5-gallon container labeled "universal waste lead acid batteries" and dated August 6, 2024; one 5-gallon container labeled "universal waste alkaline batteries" and dated May 16, 2024; one 5-gallon container labeled "universal waste lithium batteries" and dated January 24, 2025; and one 5-gallon container labeled "universal waste nickel-cadmium batteries" and dated January 24, 2025.

**Photo 6:** A red mobile cart holding containers of universal waste that was staged near the entrance into the Scrap Room. The cart held one 5-gallon container labeled “universal waste lead acid batteries” and dated August 6, 2024; one 5-gallon container labeled “universal waste alkaline batteries” and dated May 16, 2024; one 5-gallon container labeled “universal waste lithium batteries” and dated January 24, 2025; and one 5-gallon container labeled “universal waste nickel-cadmium batteries” and dated January 24, 2025.

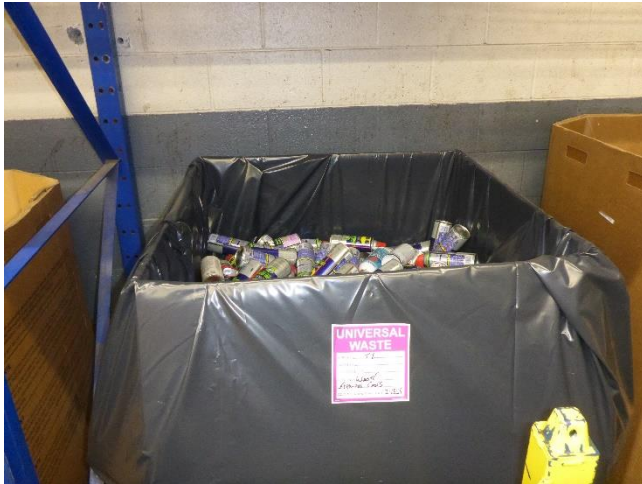
Two cubic yard cardboard boxes were also observed behind a pallet of material from the Quality Department in the far corner of the room. One box was labeled "universal waste aerosol cans" and dated February 18, 2025; the other box was labeled "alum cans." It appears that TE intended to use one box for accumulating used aerosol spray cans, and the other for accumulating empty aluminum cans (such as beverage cans). However, the inspectors observed used aerosol cans of WD-40 in both the universal waste container (Photo 7) and in the aluminum can container (Photo 8), and four used aerosol cans of WD-40 on the floor near the boxes (Photo 9).

**Photo 7:** One of two cubic yard cardboard boxes observed behind a pallet of material from the Quality Department in the far corner of the Scrap Room. The box was labeled "universal waste aerosol cans" and dated February 18, 2025.

**Pursuant to 15A NCAC 13A .0119(b) [40 C.F.R. § 273.13(e)(1)], a SQHUW must accumulate universal waste aerosol cans in a container that is structurally sound, compatible with the contents of the aerosol cans, lacks evidence of leakage, spillage, or damage that could cause leakage under reasonably foreseeable conditions, and is protected from sources of heat.**

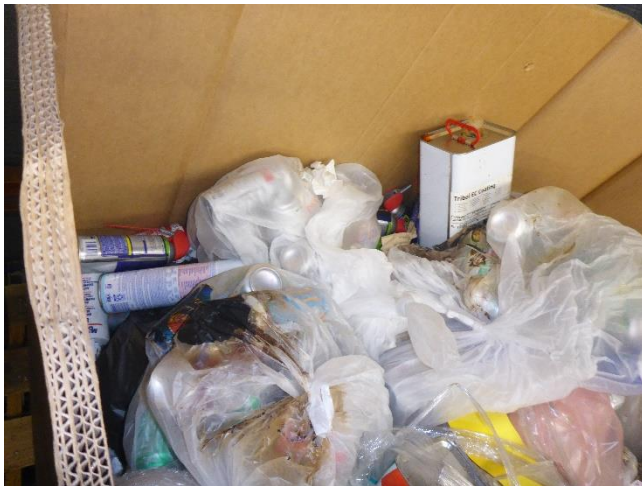
**Photo 8:** One of two cubic yard cardboard boxes observed behind a pallet of material from the Quality Department in the far corner of the Scrap Room. The box was labeled "alum cans," but contained used aerosol cans of WD-40 as well as aluminum cans.

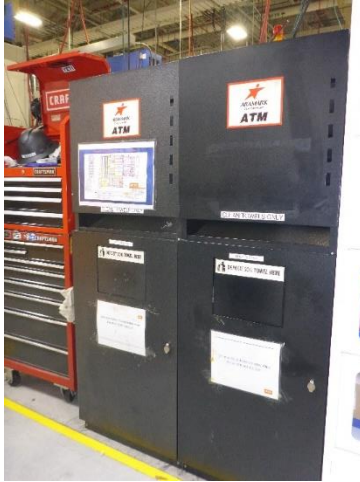
Although most solvent contaminated wipes are generated when cleaning molds in the Mold Shop, TE's Aramark Towel Manager (ATM) is located in the Stamping Area. The ATM stores clean towels that are used on-site and soiled towels that are shipped to Vestis Uniforms, 200 E. J.J. Drive, Greensboro, NC, to be laundered and re-used. The inspectors observed the ATM, which was closed and labeled "excluded solvent contaminated wipes, 40 C.F.R. § 261.4(a)(26)" (Photo 10).

**Photo 10:** Aramark Towel Manager (ATM) in the Stamping Area. Unit was closed and labeled "excluded solvent contaminated wipes, 40 C.F.R. § 261.4(a)(26)."

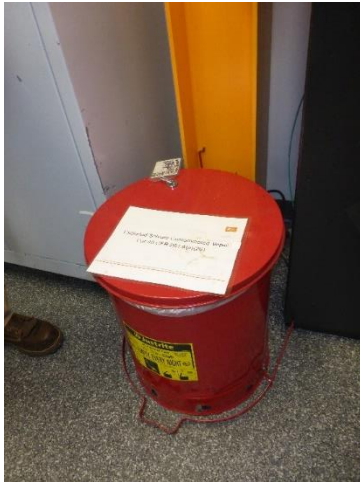
Contaminated cloth towels are accumulated in the ATM, which was observed in the Stamping Area, and contaminated paper towels are accumulated in 20-gallon flammable cans, which were observed in the Molding Tool Room. The inspectors observed two 20-gallon flammable cans in the Molding Tool Room (Photo 11). Each can was labeled with the words "excluded solvent contaminated wipes, 40 C.F.R. § 261.4(a)(26)."

Note that, while the container labeling requirements found in the Solvent-Contaminated Disposable Wipe Exclusion are identical to those found in the Solvent-Contaminated Reusable Wipe Exclusion (i.e. each require containers to be labeled "excluded solvent-contaminated wipes"), the conditions of the Solvent-Contaminated Disposable Wipe Exclusion are found in 15A NCAC 13A .0106(a) [40 C.F.R. § 261.4(b)(18)], not in 15A NCAC 13A .0106(a) [40 C.F.R. § 261.4(a)(26)], as indicated on the labels on the containers of disposable excluded solvent-contaminated wipes observed in the Molding Tool Room.

**Photo 11:** One of two 20-gallon flammable cans observed in the Molding Tool Room. Each can was labeled with the words "excluded solvent contaminated wipes, 40 C.F.R. § 261.4(a)(26)."

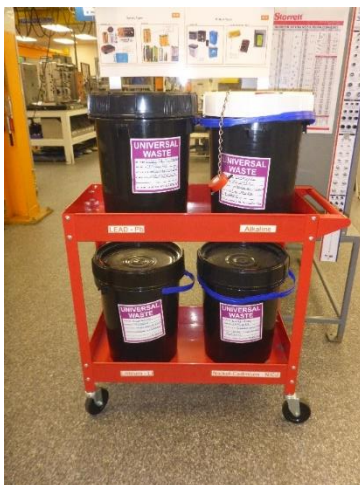
The inspectors also observed a red mobile cart holding containers of universal waste in the Molding Tool Room (Photo 12). The cart held one 5-gallon container labeled "universal waste lead acid batteries" and dated April 8, 2024; one 5-gallon container labeled "universal waste alkaline batteries" and dated December 3, 2024; one 5-gallon container labeled "universal waste lithium batteries" and dated April 8, 2024; and one 5-gallon container labeled "universal waste nickel-cadmium batteries" and dated April 8, 2024.

**Photo 12:** A red mobile cart holding containers of universal waste observed in the Molding Tool Room. The cart held one 5-gallon container labeled "universal waste lead acid batteries" and dated April 8, 2024; one 5-gallon container labeled "universal waste alkaline batteries" and dated December 3, 2024; one 5-gallon container labeled "universal waste lithium batteries" and dated April 8, 2024; and one 5-gallon container labeled "universal waste nickel-cadmium batteries" and dated April 8, 2024.

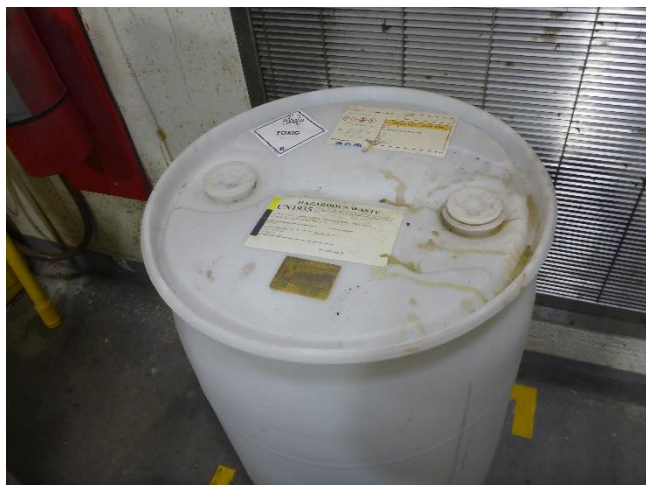
Small drips, spills and releases of potassium gold cyanide plating bath liquids are accumulated in the first SAA. The inspectors observed approximately 5-10 gallons of hazardous waste in one 55-gallon container in this SAA (Photo 13). The container was labeled as UN1935 hazardous waste cyanide solutions (potassium gold cyanide); it was marked with EPA hazardous waste numbers D003 and F007; and it was identified with a DOT hazard sticker indicating that the contents are toxic.

**Photo 13:** One 55-gallon container observed in the first SAA in the Plating Area. The container was labeled as UN1935 hazardous waste cyanide solutions (potassium gold cyanide); it was marked with EPA hazardous waste numbers D003 and F007; and it was identified with a DOT hazard sticker indicating that the contents are toxic.

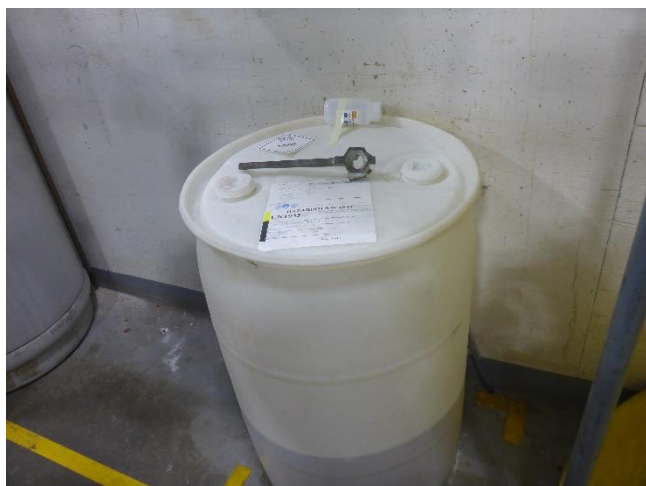
Small drips, spills and releases of potassium silver cyanide plating bath liquids are accumulated in the second SAA. The inspectors observed one 55-gallon container in this SAA (Photo 14). The container was labeled as UN1935 hazardous waste cyanide solutions (potassium silver cyanide); it was marked with EPA hazardous waste numbers D003 and F007; and it was identified with a DOT hazard sticker indicating that the contents are toxic.

**Photo 14:** One 55-gallon container in the second SAA in the Plating Area. The container was labeled as UN1935 hazardous waste cyanide solutions (potassium silver cyanide); it was marked with EPA hazardous waste numbers D003 and F007; and it was identified with a DOT hazard sticker indicating that the contents are toxic.

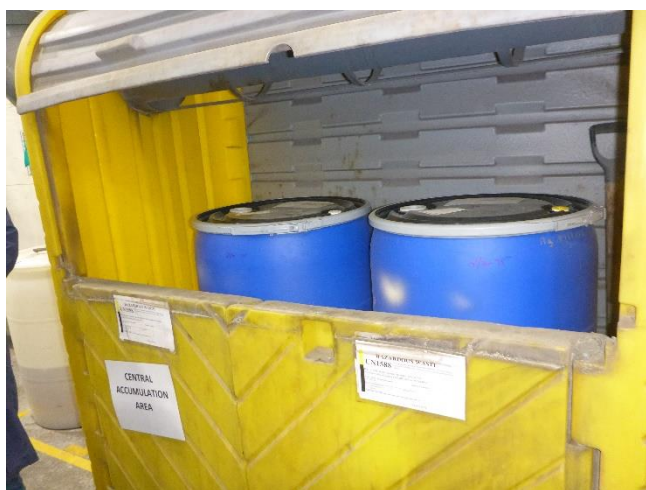
February 20, 2024. Neither container was labeled with the words “hazardous waste,” but the clam shell was labeled as “UN 1588 hazardous waste cyanides (potassium gold cyanide) D003, F007” and “UN 1588 hazardous waste cyanides (potassium gold cyanide) D003, F007.”

**Photo 15:** CAA for accumulating and storing used wipes, filters, PPE and other solids contaminated with plating bath solutions. The clam shell held two 55-gallon containers: one labeled as Ag filters, identified as toxic, and dated February 20, 2024, and one labeled as gold filters, identified as toxic, and dated February 20, 2024. Neither container was labeled with the words “hazardous waste,” but the clam shell was labeled as “UN 1588 hazardous waste cyanides (potassium gold cyanide) D003, F007” and “UN 1588 hazardous waste cyanides (potassium gold cyanide) D003, F007.”

**Pursuant to 15A NCAC 13A .0107(a) [40 C.F.R. § 262.17(a)(5)(i)(A)], which is a condition of the LQG Permit Exemption, a LQG accumulating hazardous waste in containers must mark or label its containers with the words “Hazardous Waste.”**

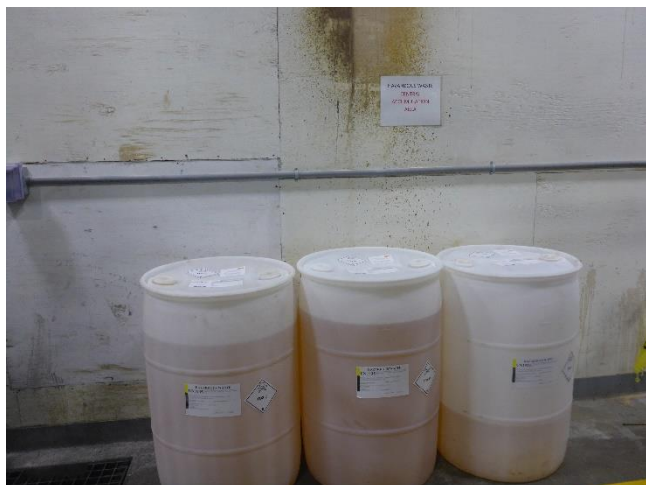
TE manages a second CAA in the Plating Area for accumulating and storing old process material that will be sent off-site to Sipi Metals Corporation (ILD005121439) or to Abington Reldan Metals, LLC (PAR000521294) for precious metals reclamation. The inspectors observed three 55-gallon containers in this CAA (Photo 16):

- One 55-gallon container of AgS-341, which was labeled as UN1935 hazardous waste potassium silver cyanide, identified as DOT toxic, marked with EPA hazardous waste numbers D003, D011, and F007, and dated February 28, 2025;
- One 55-gallon container of AgS-342, which was labeled as UN1935 hazardous waste potassium silver cyanide, identified as DOT toxic, marked with EPA hazardous waste numbers D003, D011, and F007, and dated February 28, 2025; and
- One 55-gallon container of AgS-340, which was labeled as UN1935 hazardous waste potassium silver cyanide, identified as DOT toxic, marked with EPA hazardous waste numbers D003, D011, and F007, and dated February 28, 2025.

**Photo 16:** CAA in the Plating Area for accumulating and storing old process material that will be sent off-site for reclamation.
