**Region 6 - Enforcement & Compliance Assurance Division**  
**INSPECTION REPORT**

| Company Name: | <b>KNOC Eagle Ford Corporation</b> | |
| Facility Name: | <b>B / Simba Facility (Permitted Feature 0002)</b> | |
| Facility Description: | A tension leg platform | |

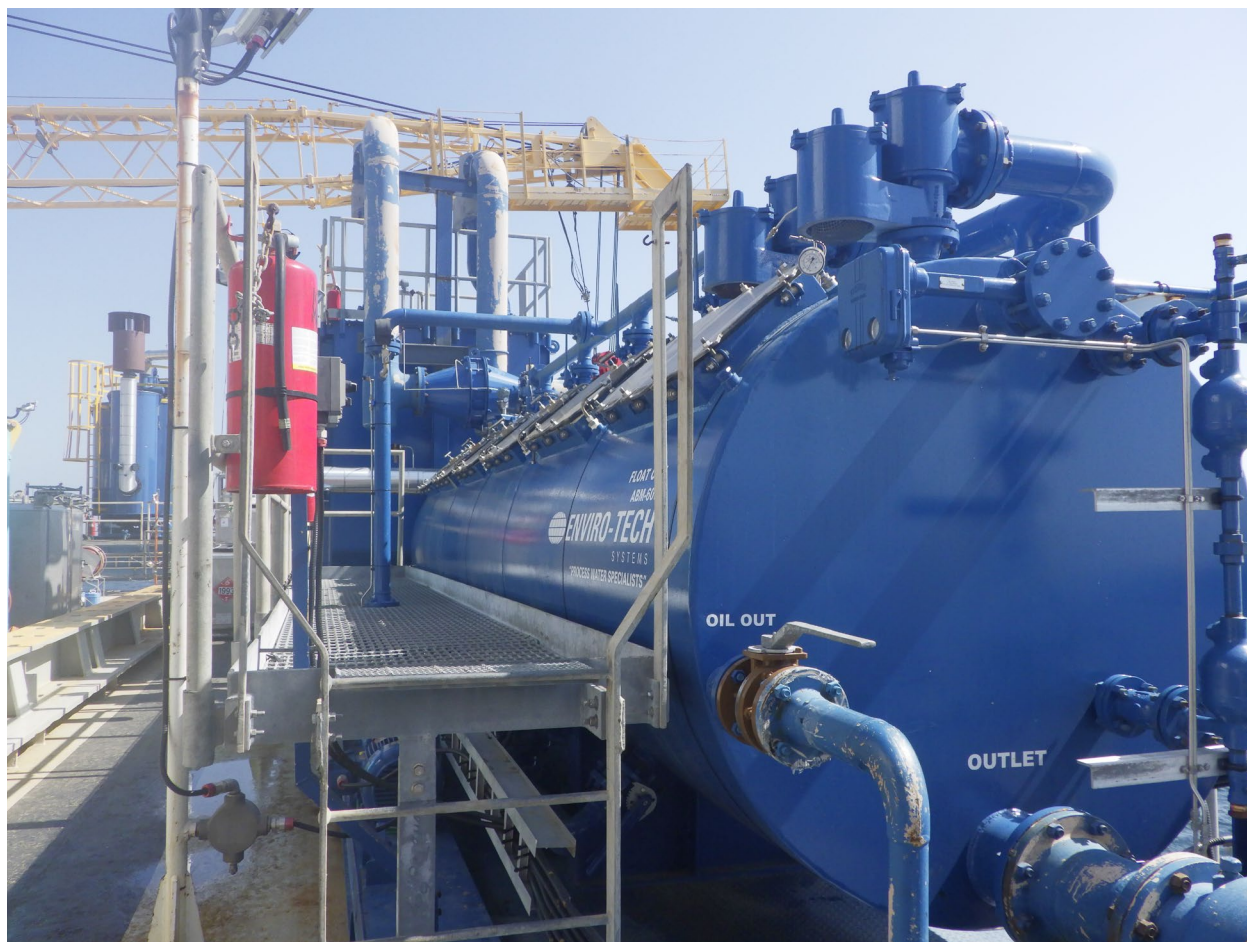
Photo No. 1

**Description:** Looking N, this photo shows an overview of the flotation cell for the facility used to treat produced water. Note: metadata did not transfer from satellite system.

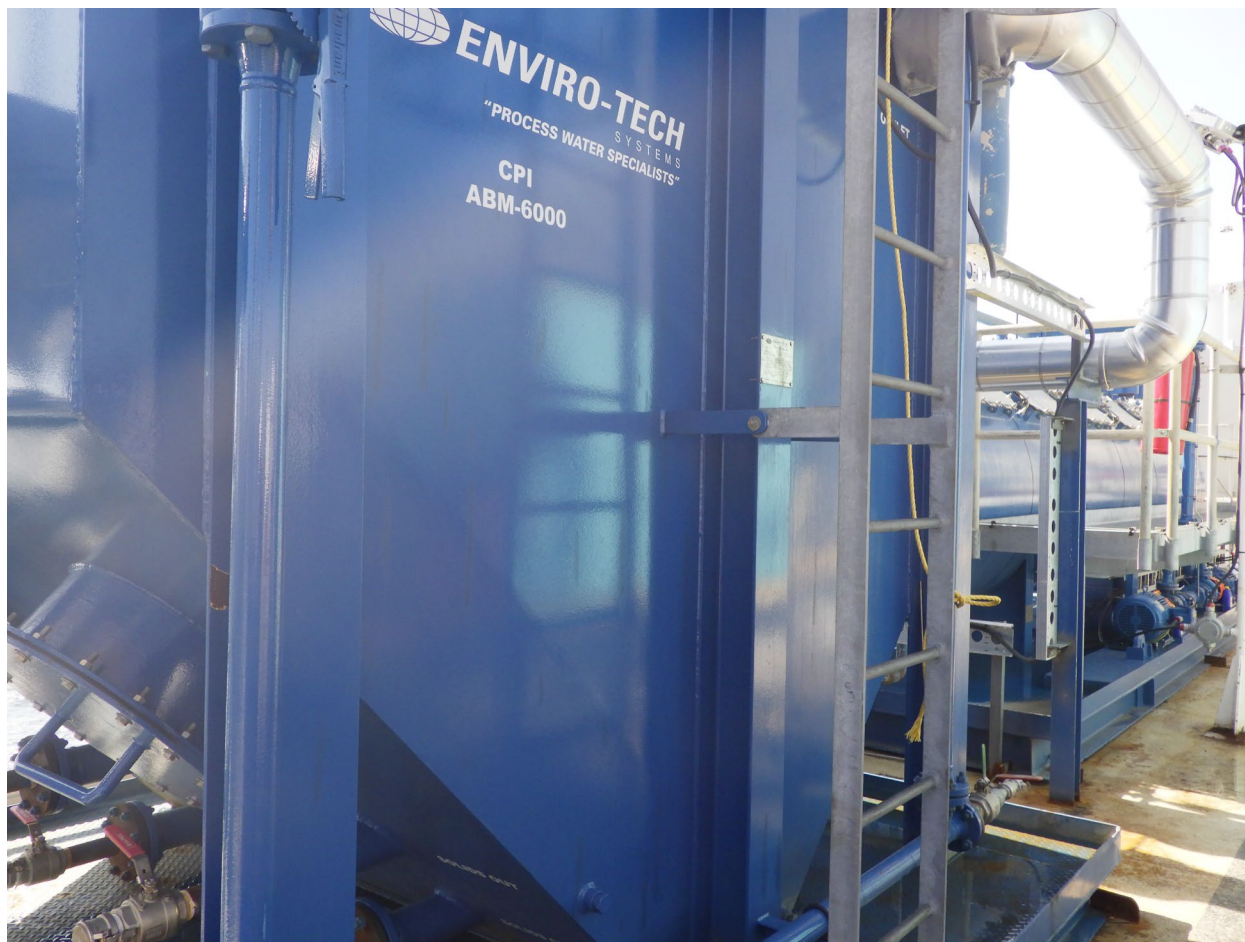
Photo No. 3

**Description:** Looking SW, this photo shows an additional view of the flotation cell used to treat produced water at the facility.

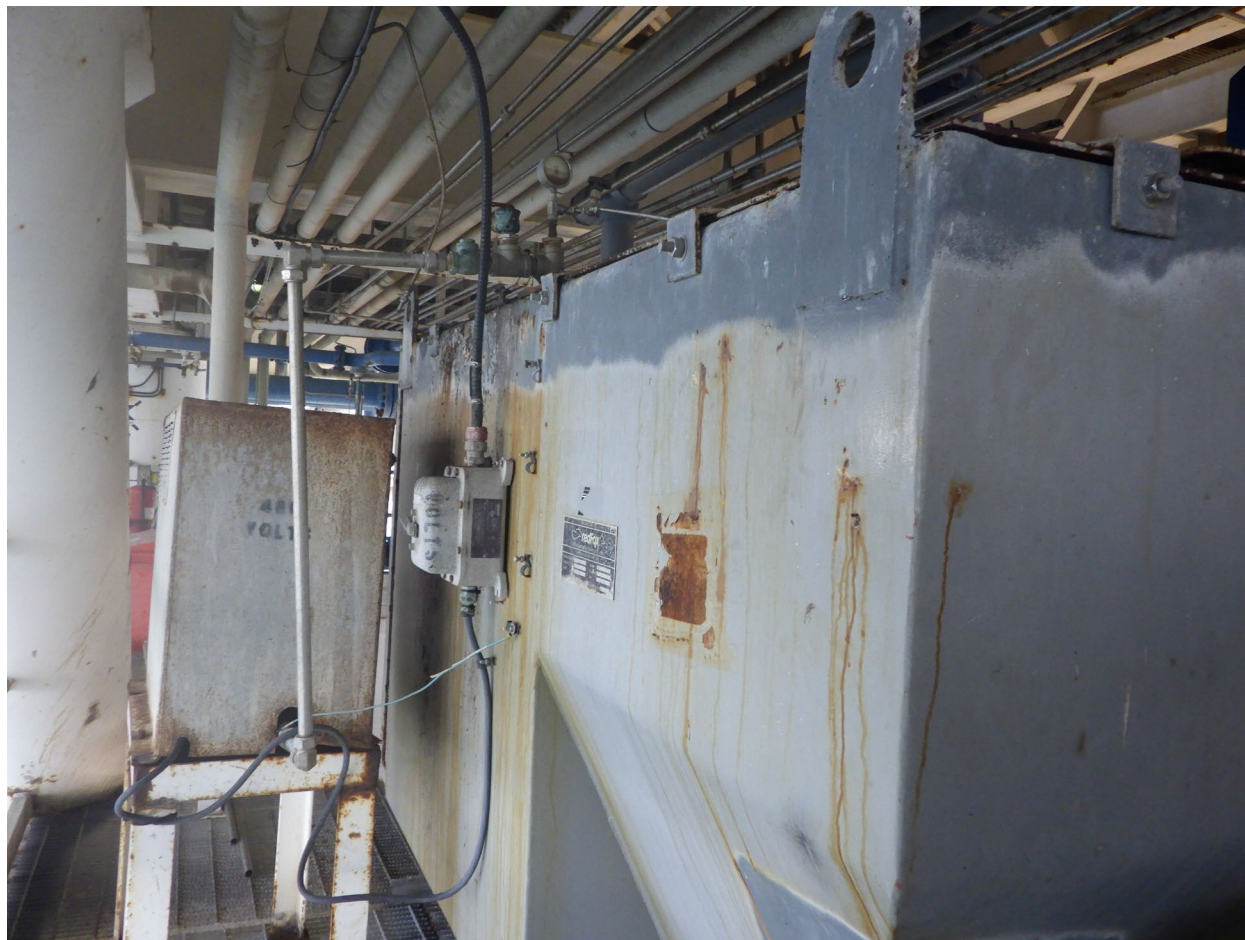
Photo No. 4

**Description:** Looking NW, this photo shows the marine sanitation device (MSD) utilized at the facility.

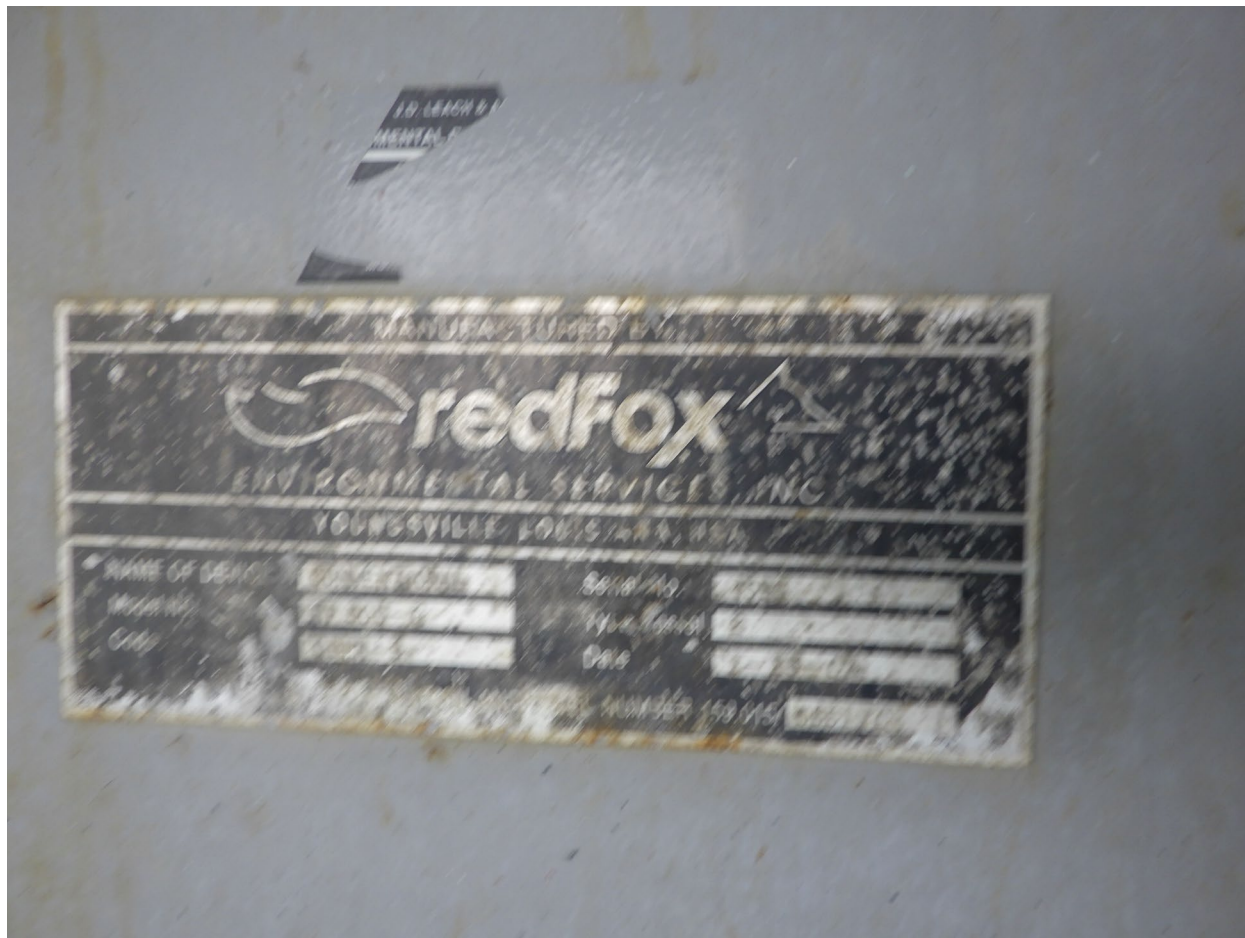
Photo No. 5

- The MSD did not have a legible USCG certification plate (Part I, Sec. B, 7, Exception),
- Deck drainage sheens were observed on 9/11/2023, 9/13/2023, and 2/21/2025 (Part I, Sec. B, 3, a Free Oil)\*, and
- Facility had an uncontrolled bypass line for produced water treatment (Part II, Sec. B, 3, a)\*.

**Description:** Looking N, this photo shows the manufacture's plate for the MSD used at the facility.

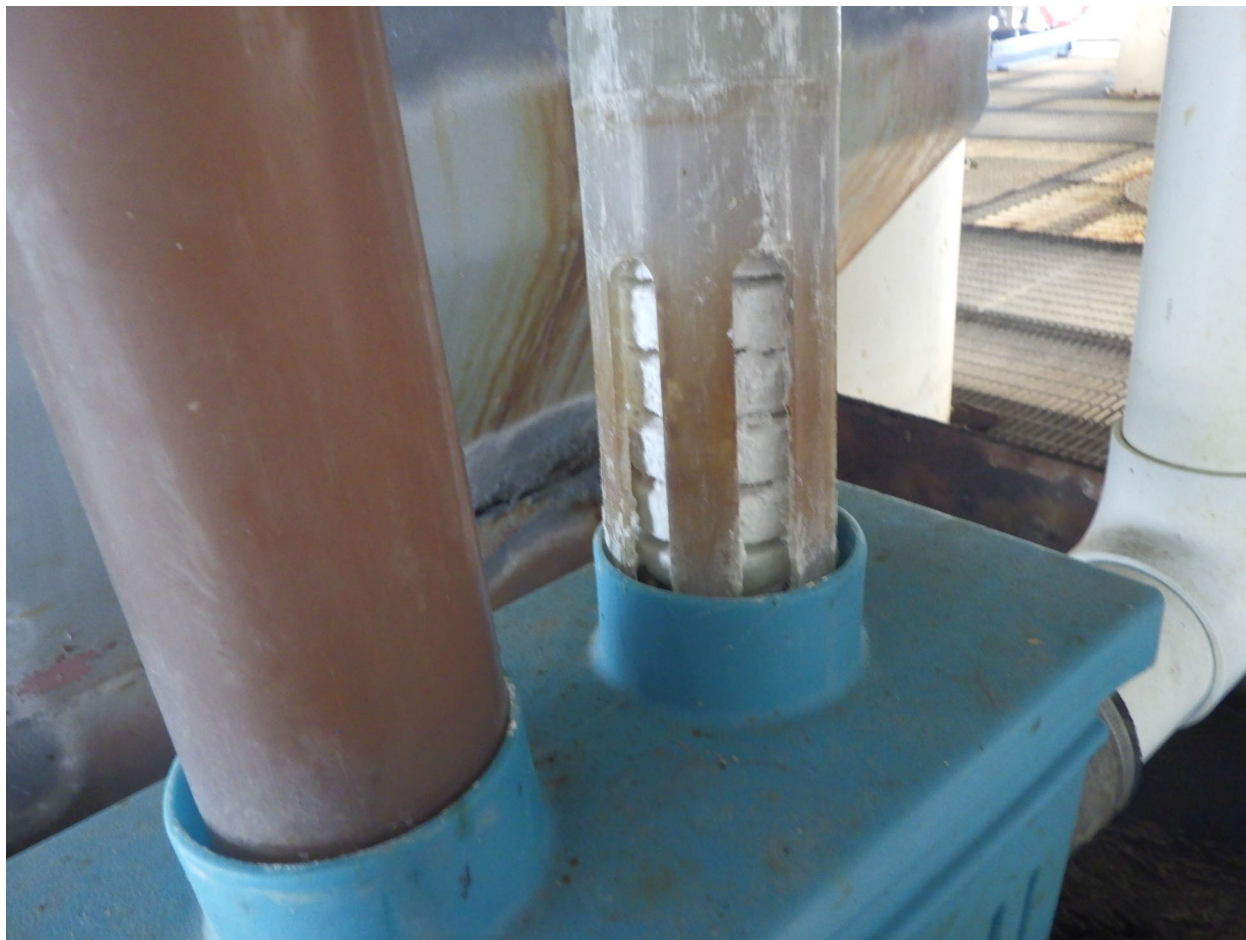
Photo No. 6

**Description:** Looking NNW, this photo shows chlorine tablets inside the chlorinator for the MSD for the facility.

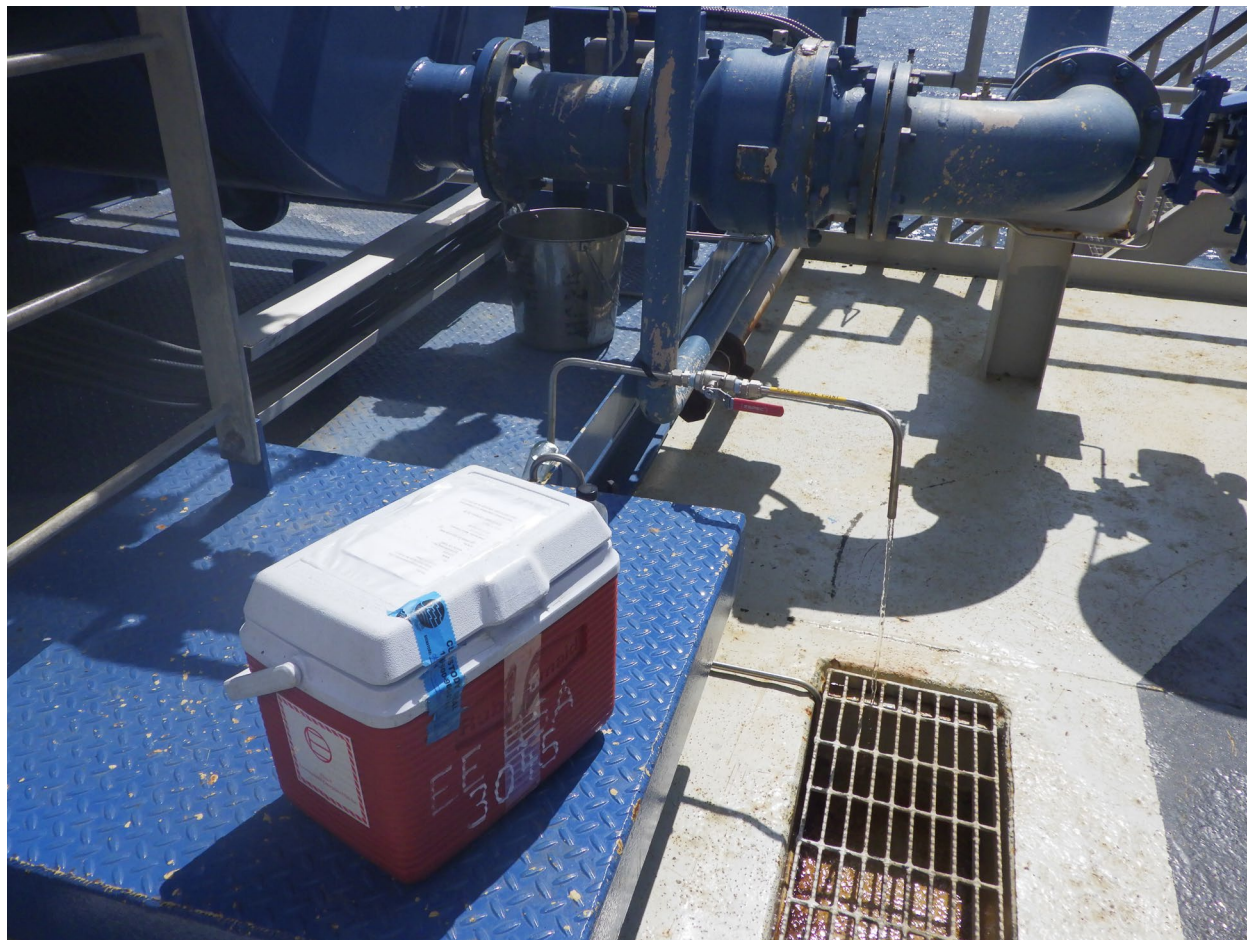
Photo No. 7

- A review of the facility spill and release history from NRC reports,
- A review of BSEE environmental enforcement actions,
- A facility tour and review of general housekeeping practices, with an emphasis on viewing containment and treatment systems utilized, including the facility’s Marine Sanitation Device (MSD; see Photos No. 4 through No. 6) and floatation cell (see Photos No. 1 through No. 3). EPA and BSEE also discussed and observed KNOC personnel collect produced water oil and grease sample (see Photos No. 7 through No. 9).

**Description:** Looking NE, this photo shows the produced water sample kit supplied by the contract lab and the port used to collect the produced water sample from the flotation cell. Note: metadata did not transfer from satellite system.

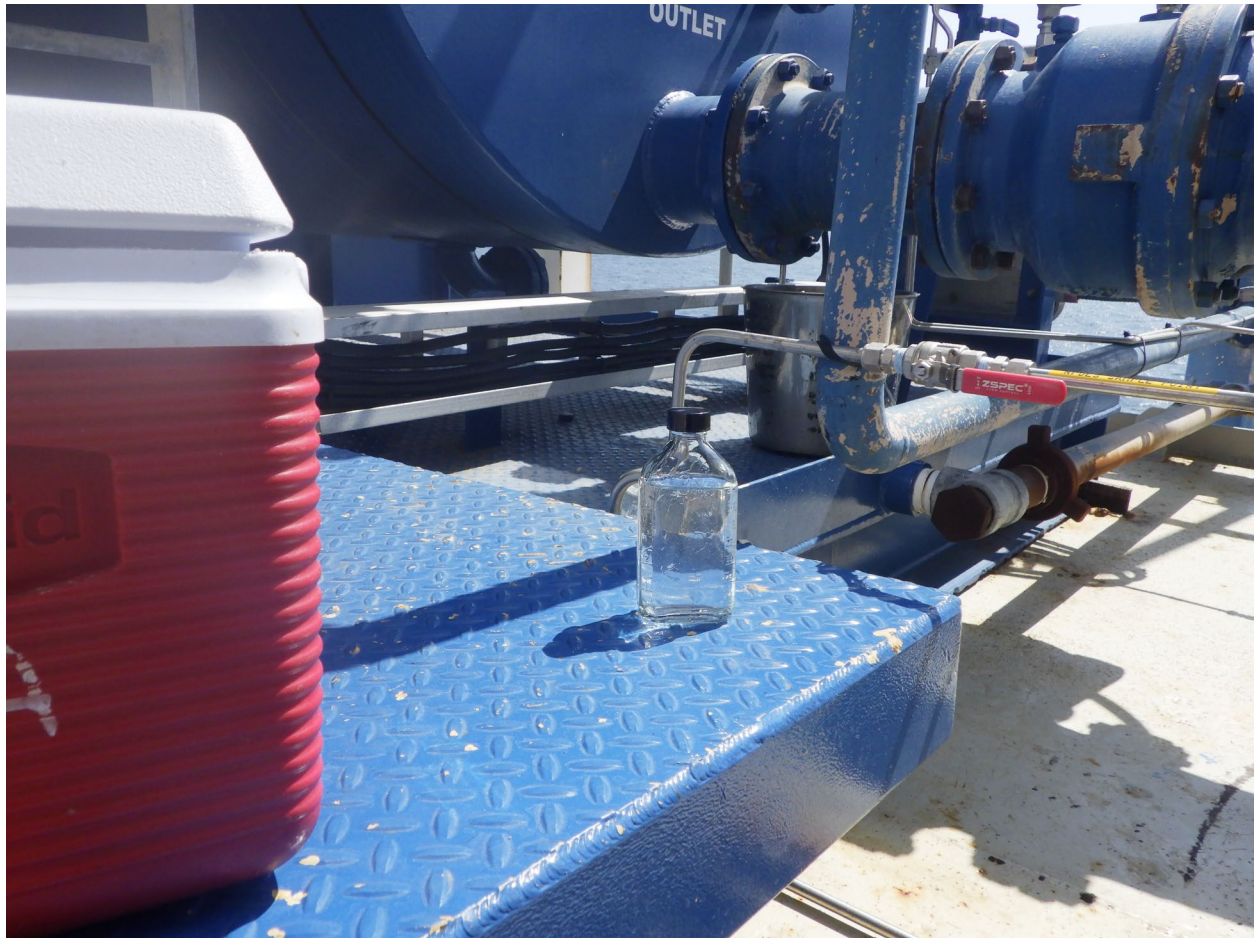
Photo No. 8

**Description:** Looking NE, this photo shows a produced water sample collected by the operator from the flotation cell that is used as monitoring (Oil & Grease Method 5520 C; not approved for reporting purposes).

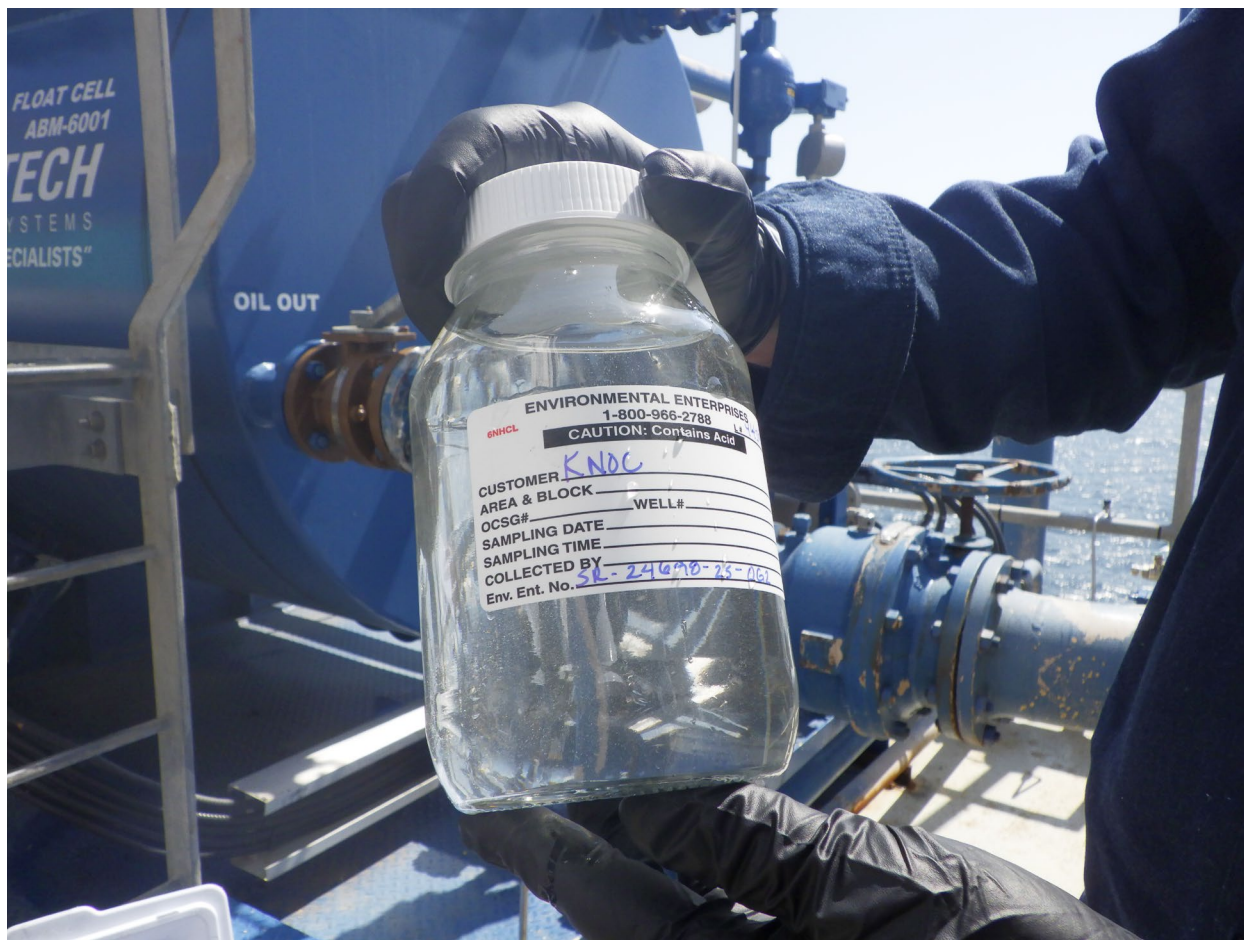
Photo No. 9

- The operator did not describe or demonstrate the correct procedures used for sheen sample protocol (Part II, Sec. B, 3, b),
- The operator did not use proper custody seals for samples (Part I, Sec. B, Note 1-2; 40 CFR 136), and
- Incomplete chains of custody (COC; Part I, Sec. B, Note 1-2, 40 CFR 136).

**Description:** Looking ENE, this photo shows the produced water sample with custody label that was collected from the flotation cell for the facility; sample to be analyzed by approved method (Oil & Grease Method(s) 5520 B or 5520 G-2021; 5520 B or 5520 G-2021 and 5520 F-2021).
