**UNITED STATES ENVIRONMENTAL PROTECTION AGENCY  
REGION 5  
77 WEST JACKSON BOULEVARD  
CHICAGO, ILLINOIS 60604**

**SUBJECT:** CLEAN AIR ACT INSPECTION REPORT  
Waste Connections Winnebago Landfill, Rockford, IL

**Facility Name:** Waste Connections Winnebago Landfill

**Purpose of Inspection:** To determine Clean Air Act (CAA) compliance and perform a comparative Surface Emissions Monitoring (SEM) survey

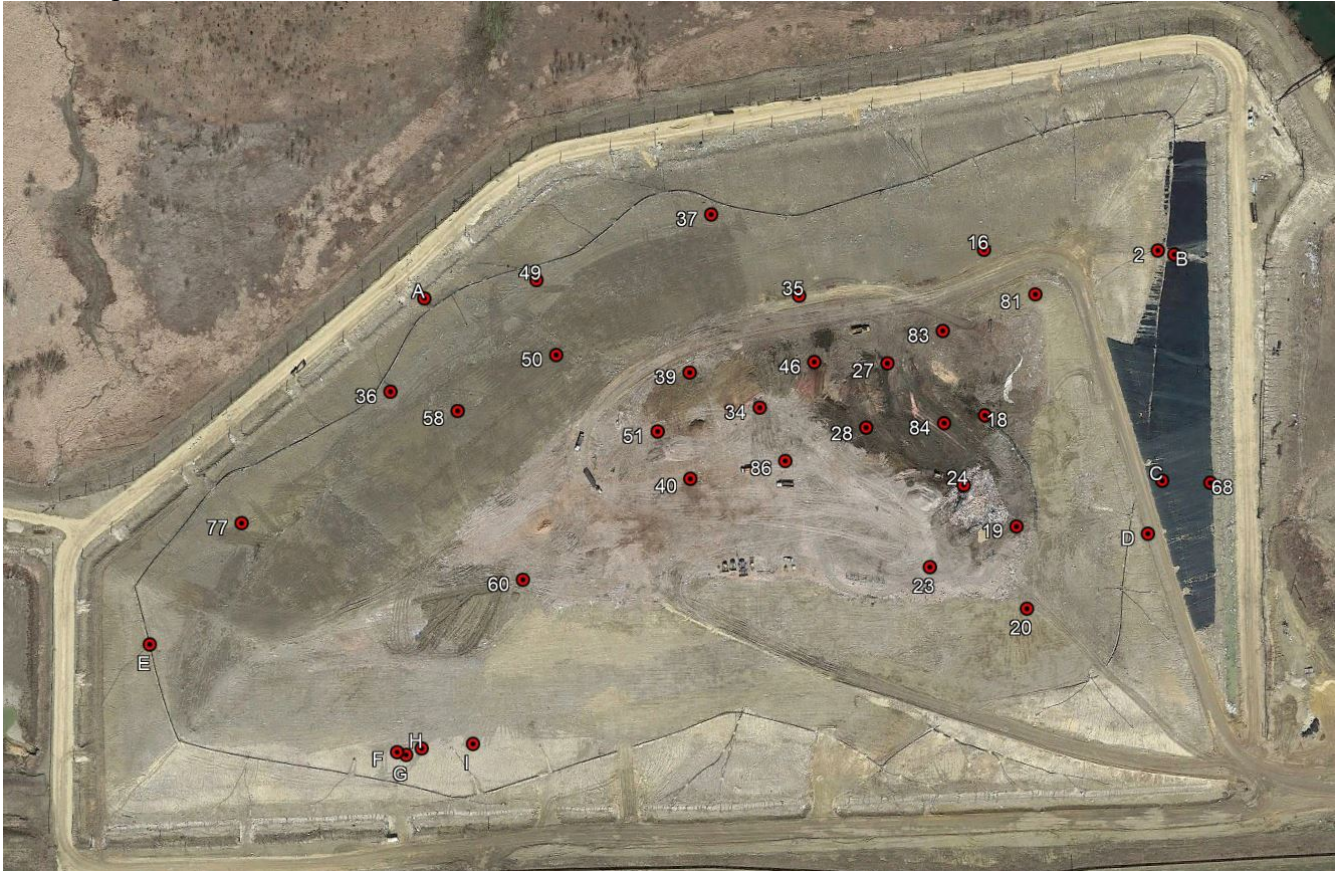
West Expansion Unit

WEU well #8 had a hole in the PVC header. Large portions of both the WEU and NEU were bare soil. EPA observed erosional features and leachate breakouts. Some areas of the landfill appeared to have persistently elevated methane concentrations above 100 ppm, though EPA did not evaluate if these areas were above the 50 ppm grid-average threshold from the consent order.

**West Expansion Unit Hits**

SEM hit locations plotted over satellite imagery from April 7, 2019 as depicted on Google Earth.

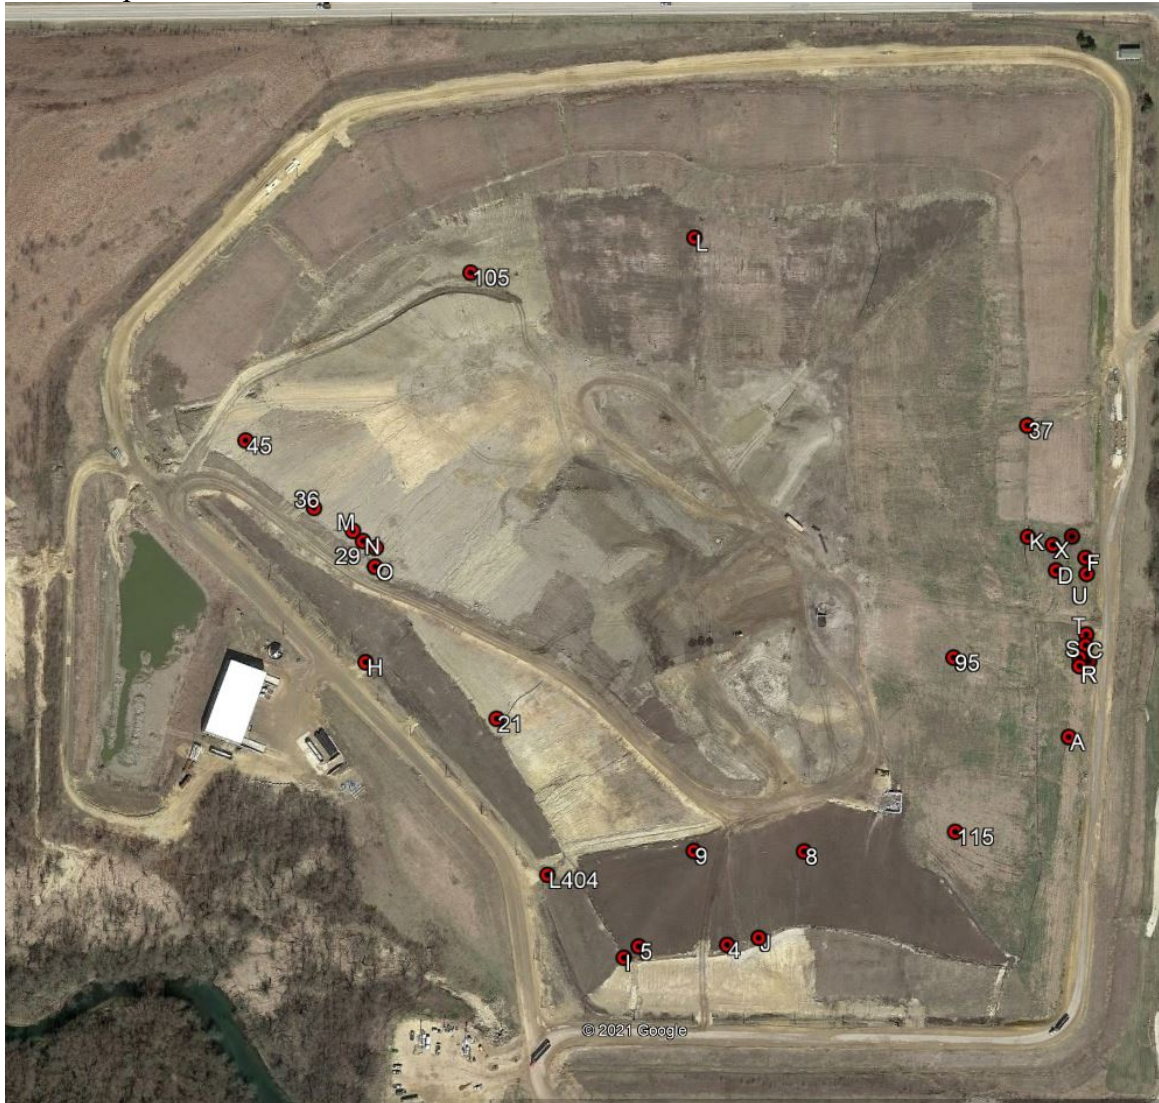
North Expansion Unit

### **North Expansion Unit Hits**
